December 2003
03/12/WQPC-WWF
EPA/600/R-04/035

Environmental Technology Verification Report

ADS Environmental Model 3600 Open Channel Flow Monitor

Part II – Field Test Results

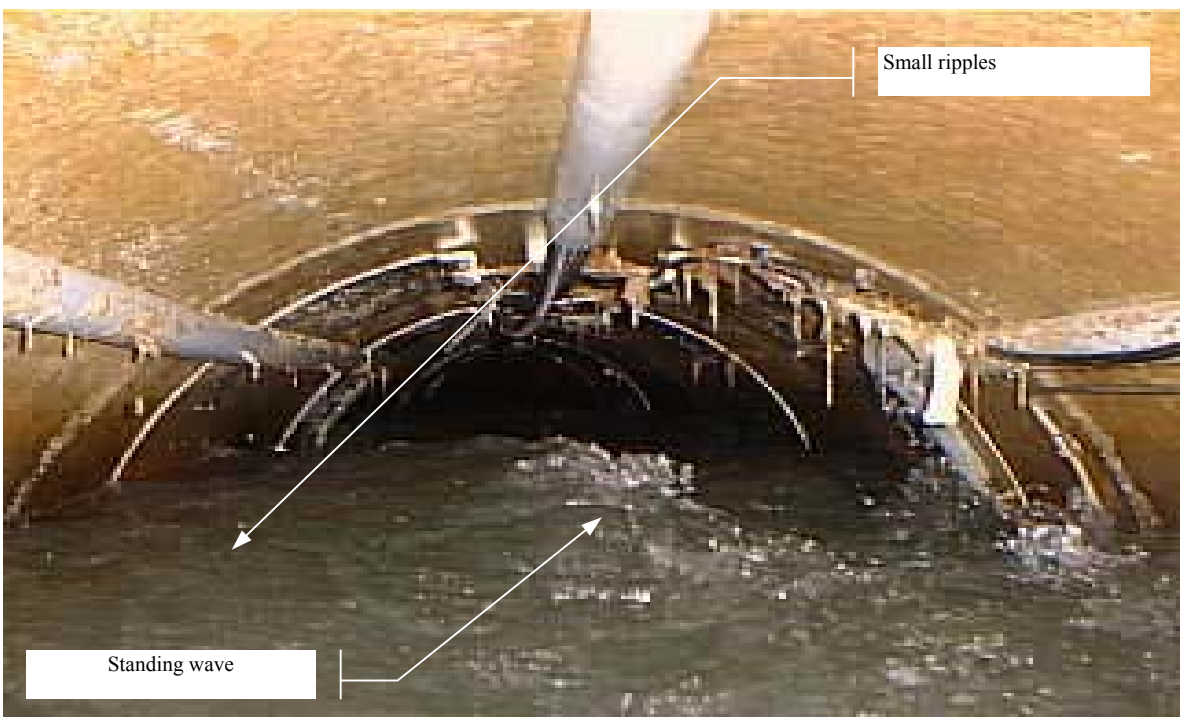
Figure 4-5. Waves in test pipe.

2. Short, local standing waves: Small waves with lengths 3 to 6 in. (75 to 150 mm) that stood at a specific location on the water surface, without moving forward or upward. Their amplitude, approximately 1 to 3 in. (25 to 75 mm), was also a function of the flow rate and water level. These waves were rare (two or less per pipe section) and were mostly asymmetric in the pipe (Figure 4-5). They were visual signs of surge. At the test site, the negative slope, the downstream manhole, or the reference flow meter probes could have caused short local standing waves.

3. Long, standing waves: Long waves with lengths of several feet. Their number and amplitude (>2 in. [>50 mm]) were a function of the flow rate, water level and wave length. Most of these waves were symmetric in the pipe.
