DOCUMENTATION OF ENVIRONMENTAL INDICATOR DETERMINATION

RCRA Corrective Action
Environmental Indicator (EI) RCRIS code (CA725)
Current Human Exposures Under Control

Facility Name: **Solvents and Petroleum Service, Inc.**
Facility Address: **SYRACUSE, NEW YORK**
Facility EPA ID #: **EPA ID # NYD013277-454**

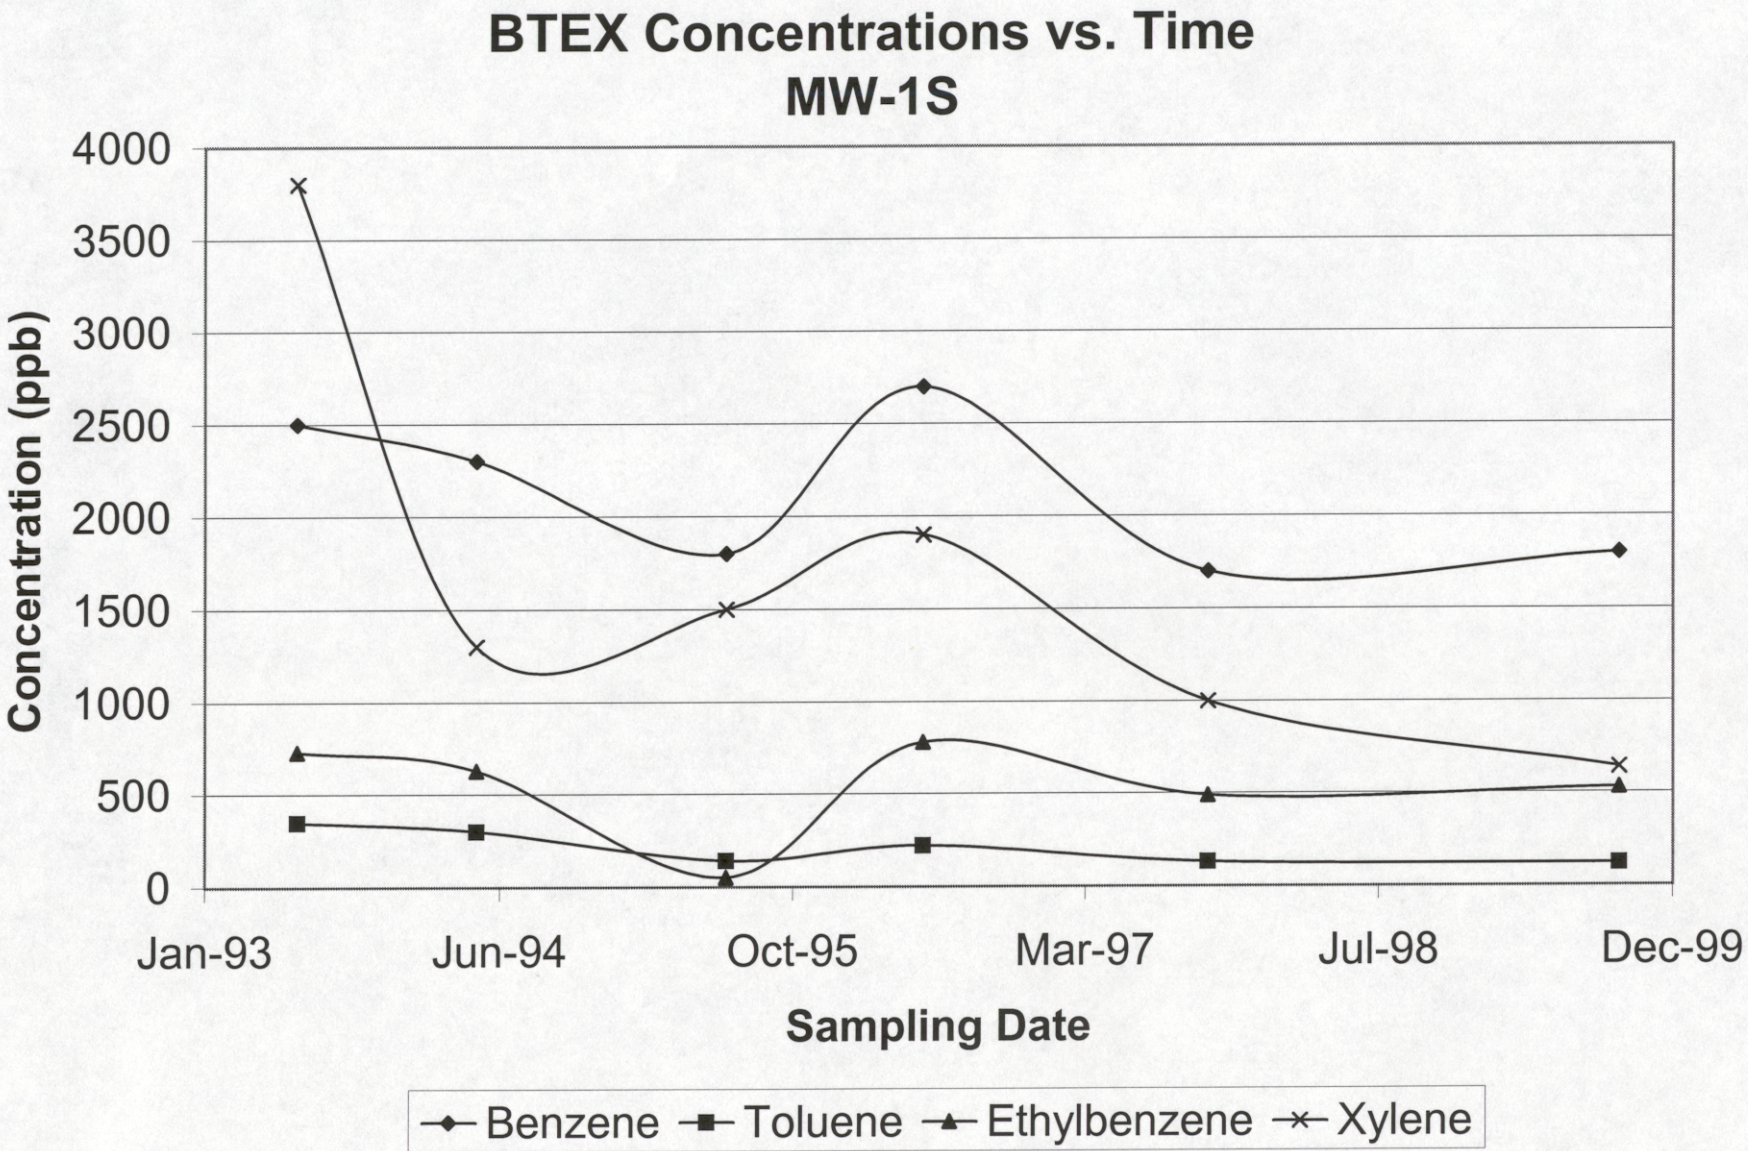
FIGURE 7
BTEX CONCENTRATIONS IN MW-1S
SOLVENTS AND PETROLEUM SERVICES, INC.

The highest levels of aromatic hydrocarbons are present at background monitoring well MW-IS. MW-IS is located in the vicinity of the former gasoline station USTs. Benzene has been reported at concentrations ranging from 1,800 micrograms per liter (ppb) to 2,700 /ppb. Toluene has been reported at concentrations ranging from 140 ppb to 350 ppb. Ethylbenzene has been reported at concentrations ranging from < *100* ppb to 780 ppb. Xylenes have been reported at concentrations ranging from 1,300 ppb to 3,800 ppb. The NY State groundwater standards for each of these parameters are 5 /ppb or less. It should be noted that chlorinated volatile organic compounds (vinyl chloride, 1,2-DCE, 1,1-DCA, and TCE) were not detected at this monitoring well from 1993 through 1999.

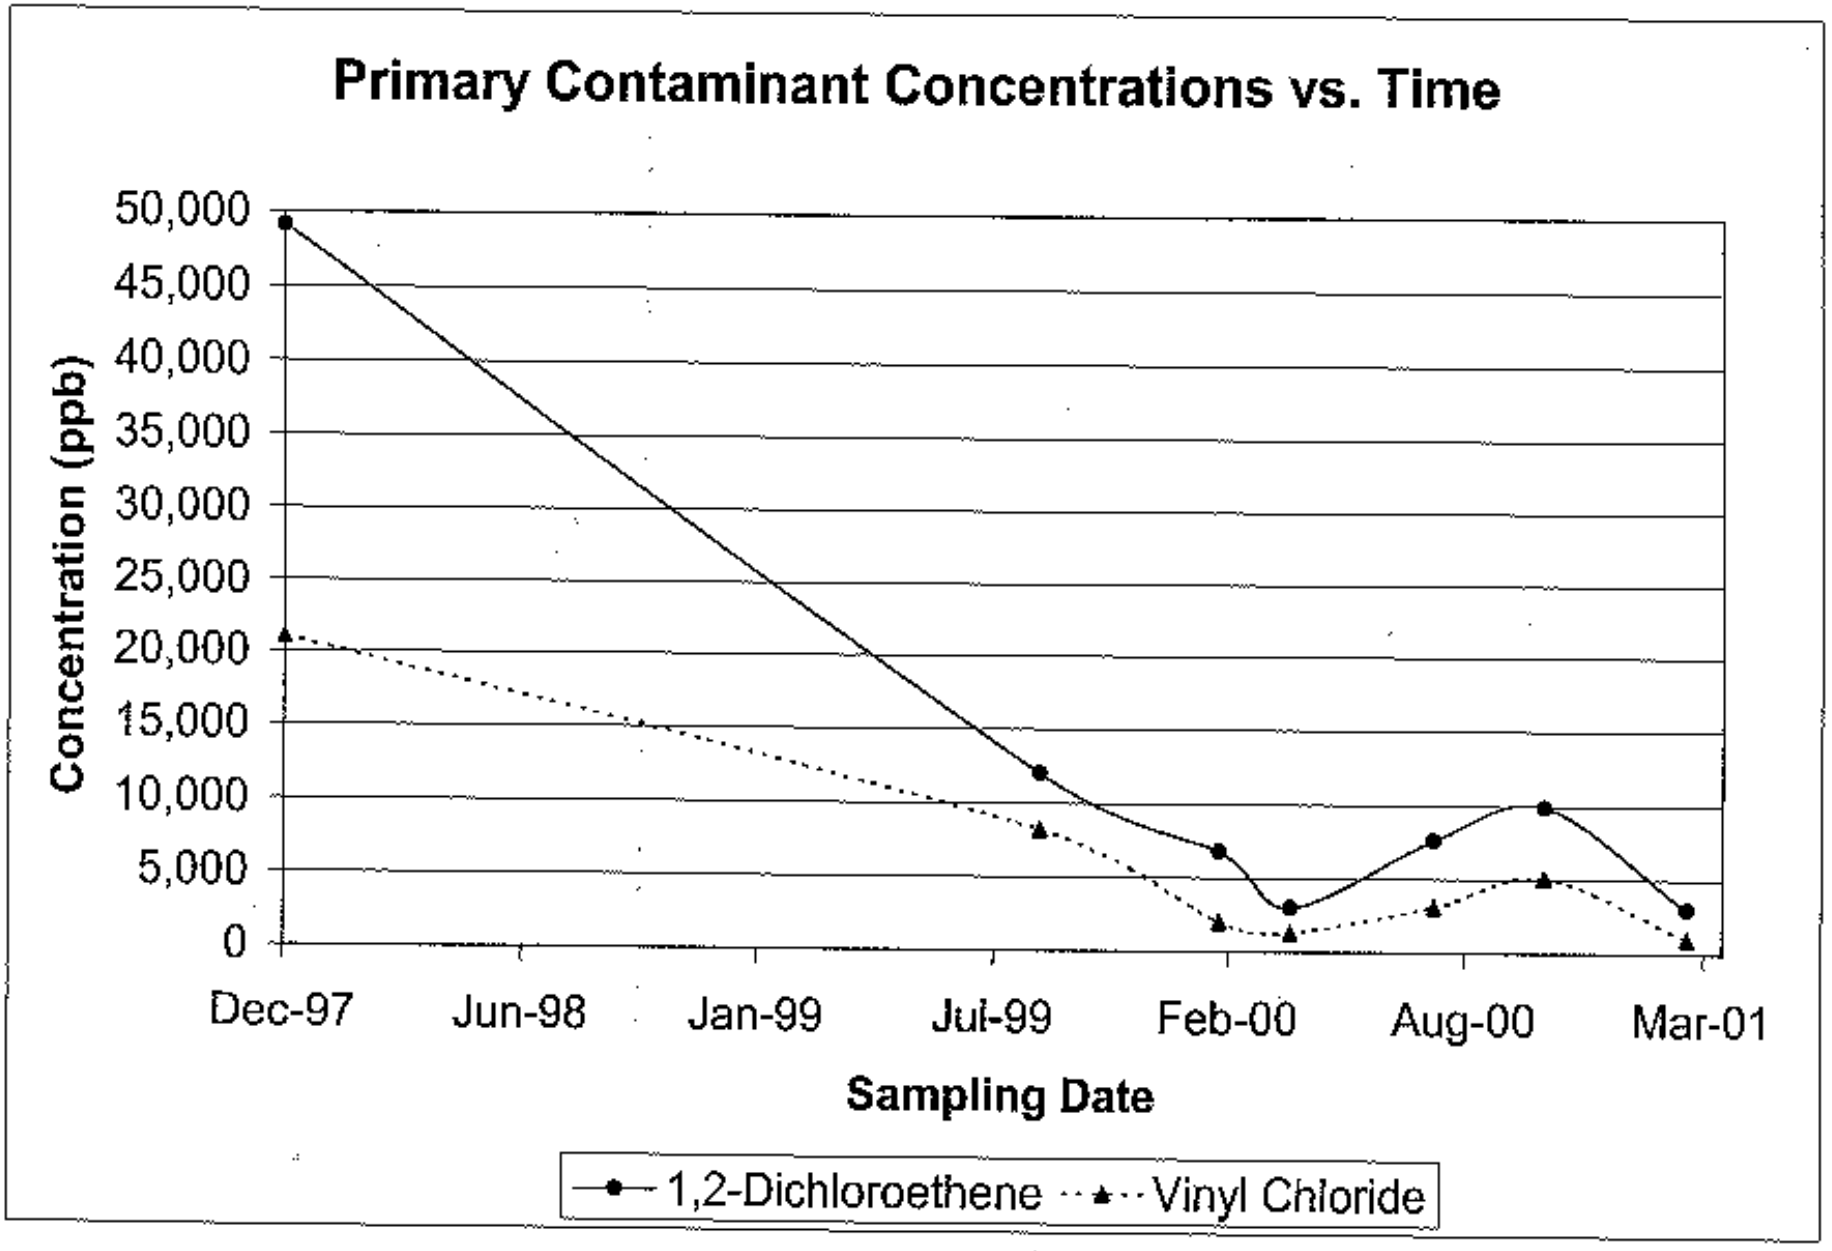
FIGURE 8
CAH CONCENTRATIONS IN MW-4R
SOLVENTS AND PETROLEUM SERVICE, INC.

chloroethane and trichloroethene. When MW-4S was deepened and renamed MW-4R in 1997, the concentrations of vinyl chloride and 1,2-DCE increased by over 100 times. Since that time the measured concentrations of VOC have decreased considerably (Figure 8).
