Navajo Abandoned Uranium Mine

Site Screen Report

Montezuma Creek AUM Site

August 2010

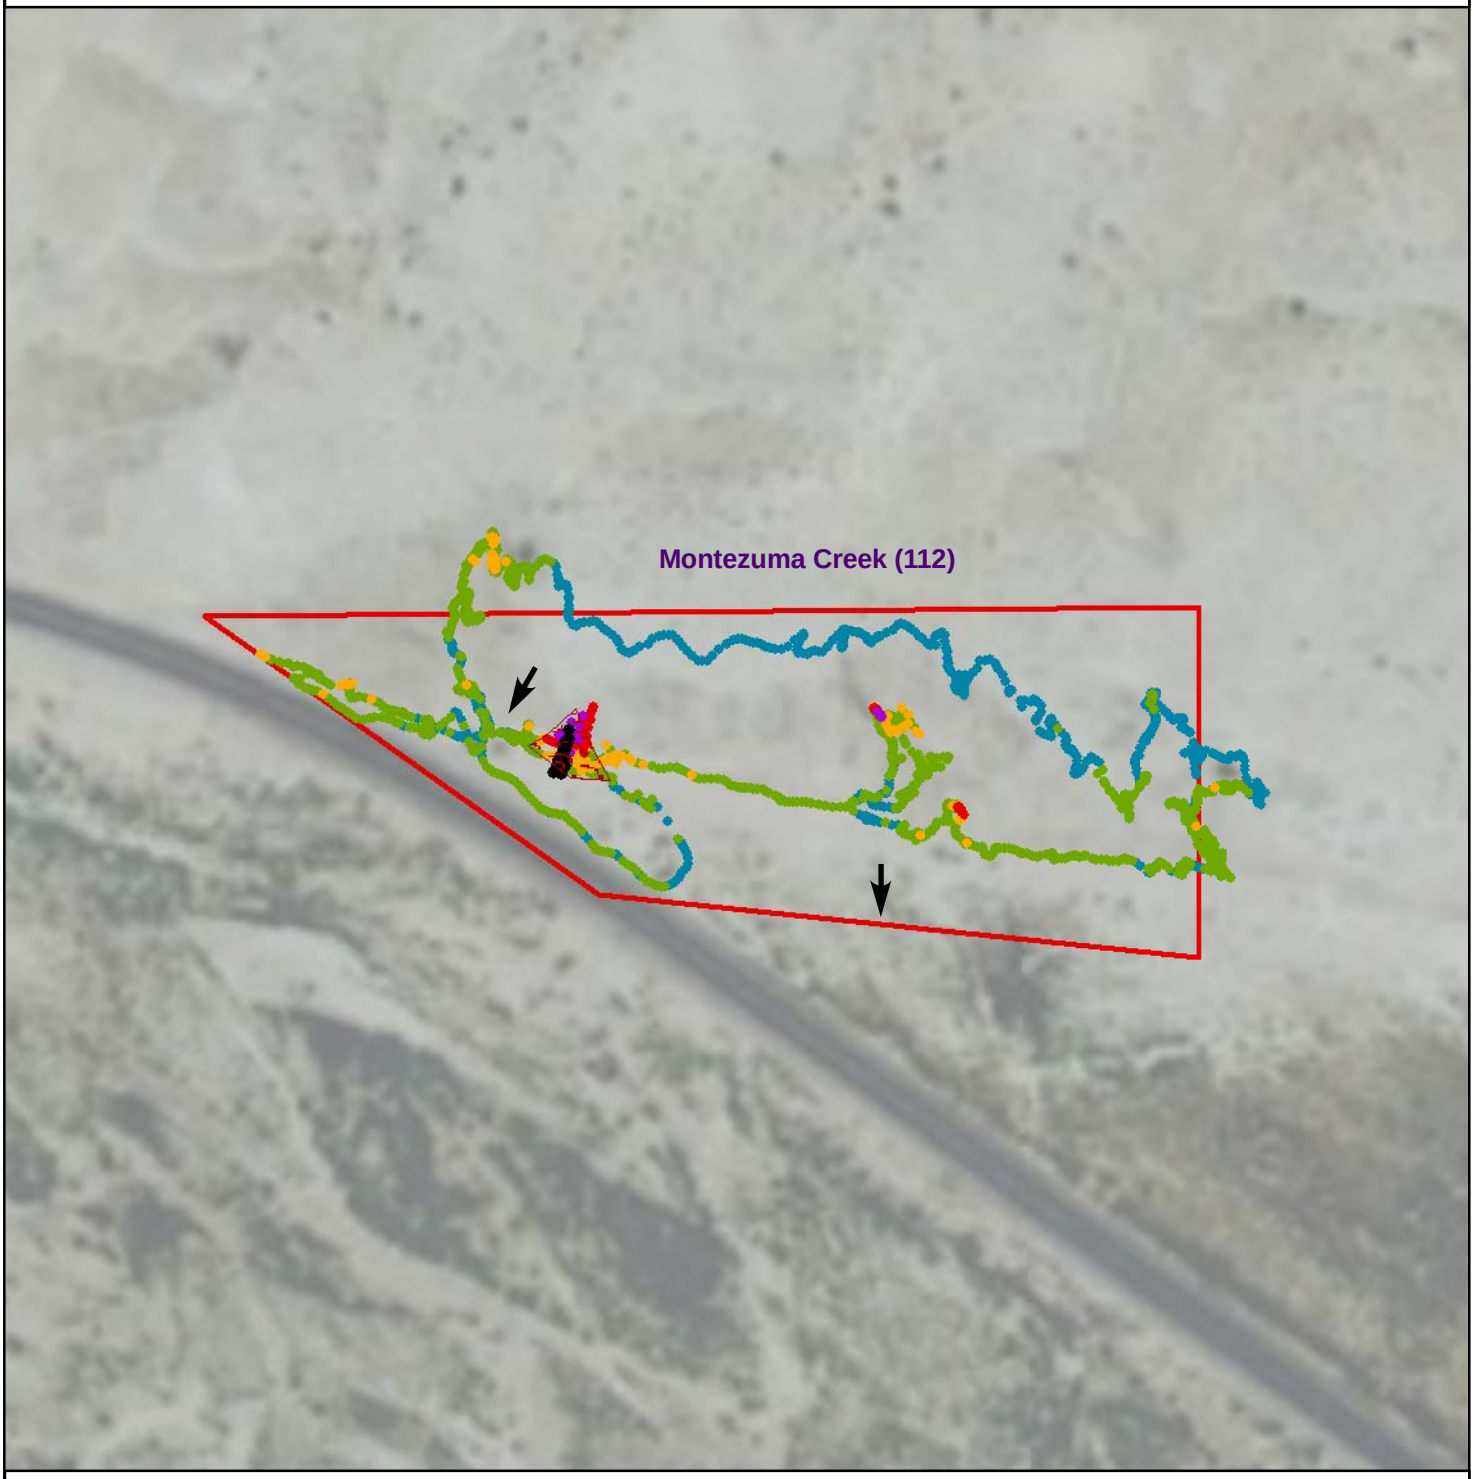
Figure 2 - Gamma Radiation Measurements
Montezuma Creek (112)
Aneth Chapter, Navajo Nation

A total of 2,164 gamma radiation measurements were collected from the mine site, ranging from 5,444 cpm to 999,960 cpm. Measurements collected in the vicinity of the waste debris were found at levels up to approximately 1,000,000 cpm (the maximum gamma radiation level the equipment can detect). The measurements are represented in Figures 1 and 2.
