Navajo Abandoned Uranium Mine

Site Screen Report

Jackpot No. 40 AUM Site

January 2011

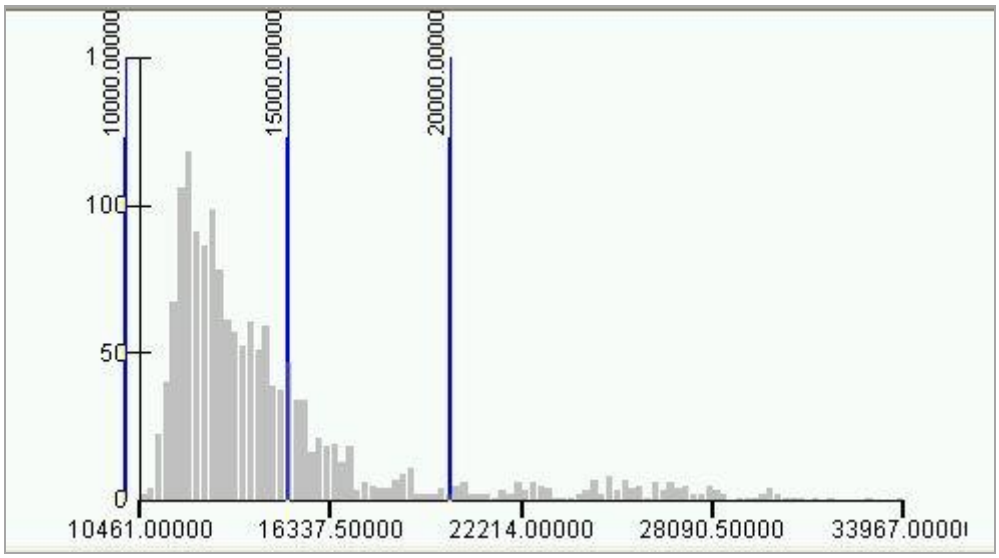
Count:	1557
Minimum:	10461.00000
Maximum:	33967.00000
Sum:	22737264.00000
Mean:	14603.25241
Median:	13319.00000
Standard Deviation:	3931.04300

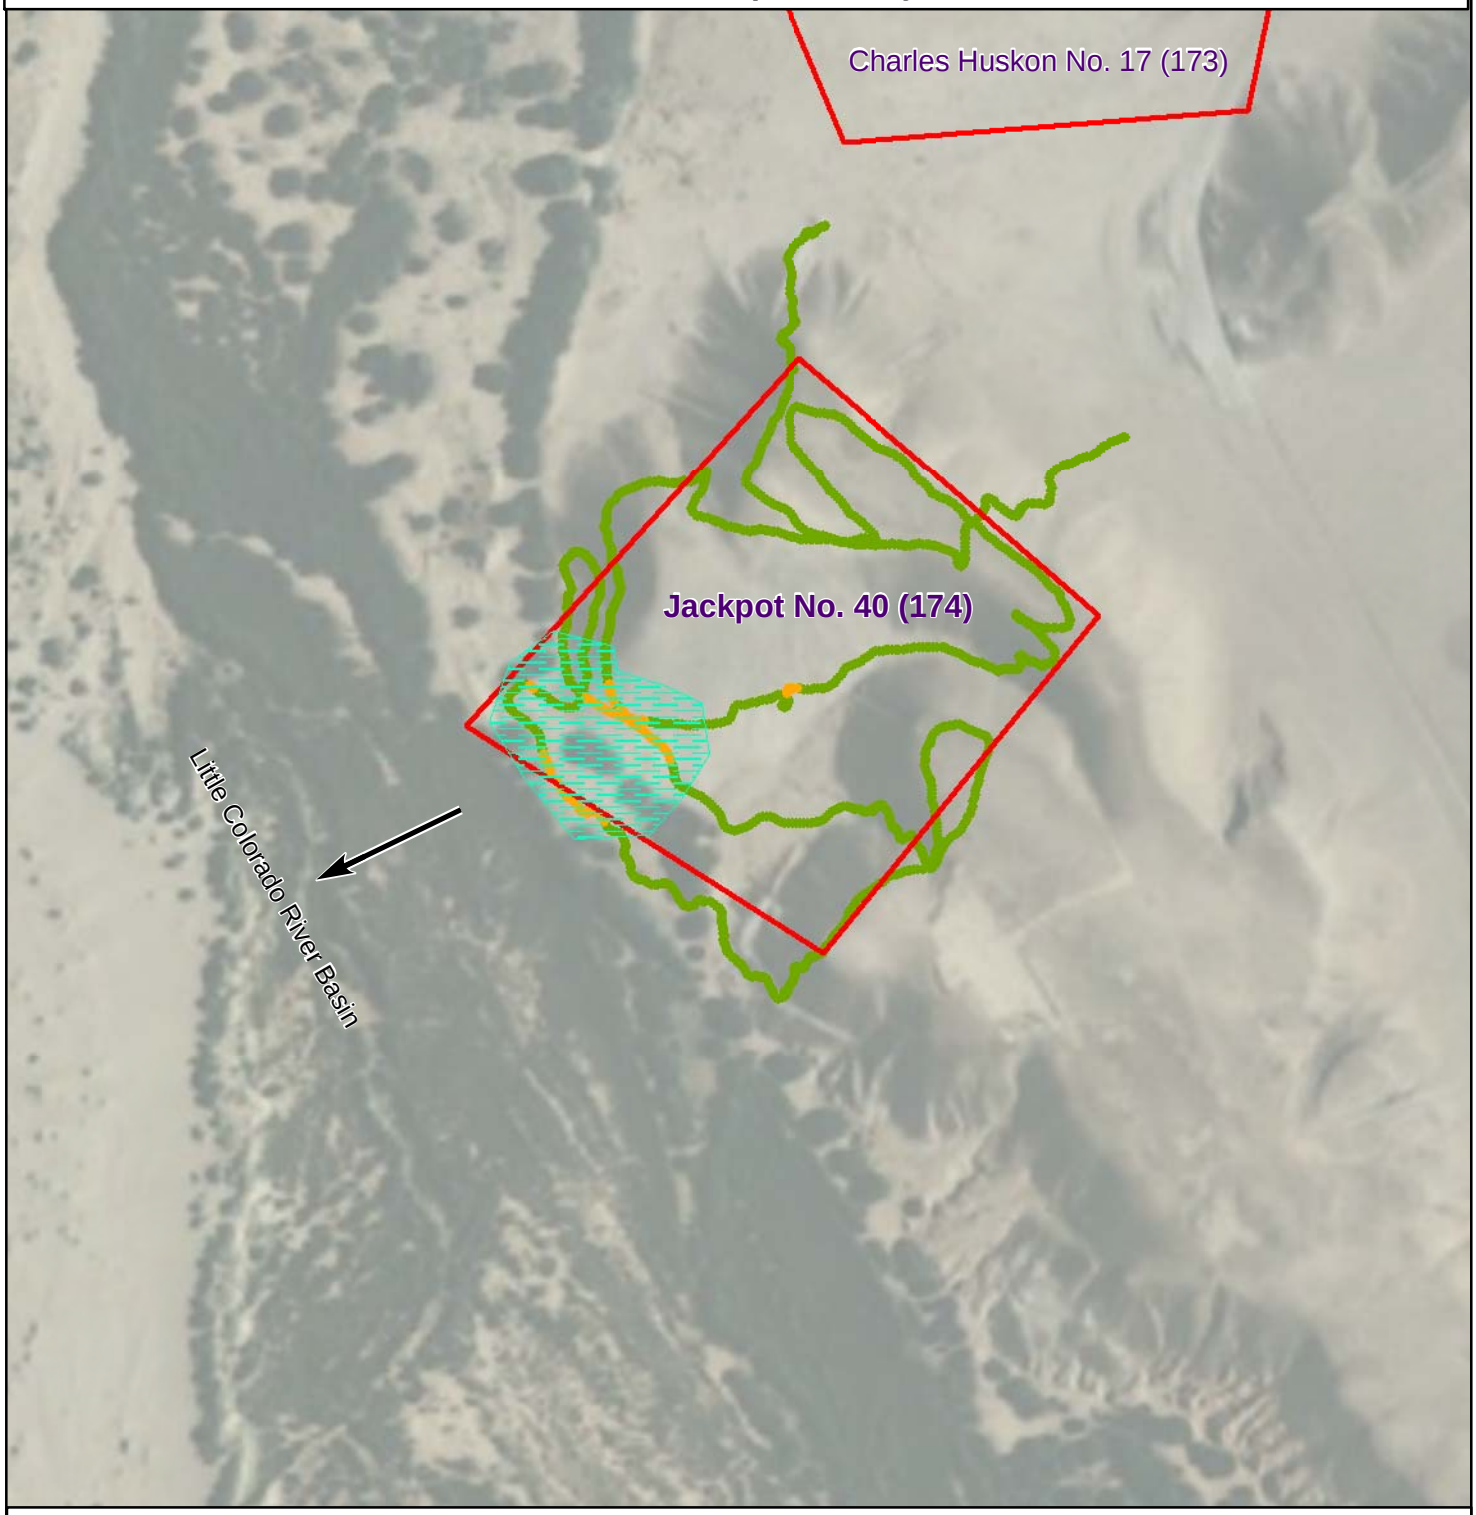
Figure 1 - Gamma Radiation Measurements, Above Two Times Background
Jackpot No. 40 (174)
Coalmine Mesa Chapter, Navajo Nation

A total of 1,557 gamma radiation measurements were collected from the mine site, ranging from 10,461 cpm to 33,967 cpm. The measurements collected at the reclamation area were found at a maximum level of approximately 25,000 cpm. The measurements are represented in Figures 1 and 2.
