Remedial Investigation Report

Libby, Montana

Operable Unit 5
Libby Asbestos National Priorities List Site

September 2010

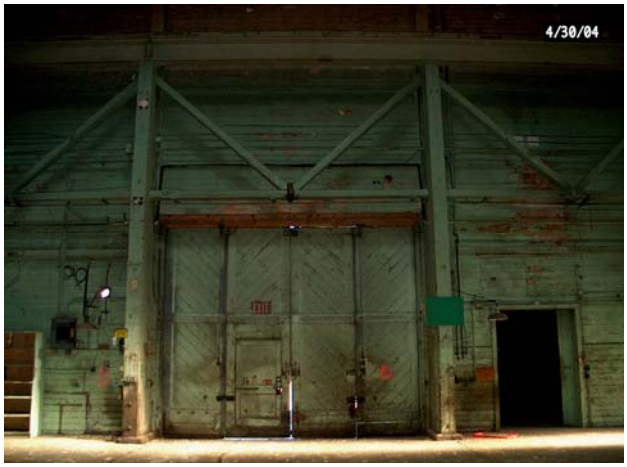
North side bay 13, note obstacles to work area. The stairway accesses the catwalk on the west side of the Former Mobile Shop.	North side bays 11, 10, 9 from left to right. A door and solid wall are at lower section of bay 10, Wall cavities with VCI are in all of bays 9 and 11. Trusses for crane track in front of all wall bays.

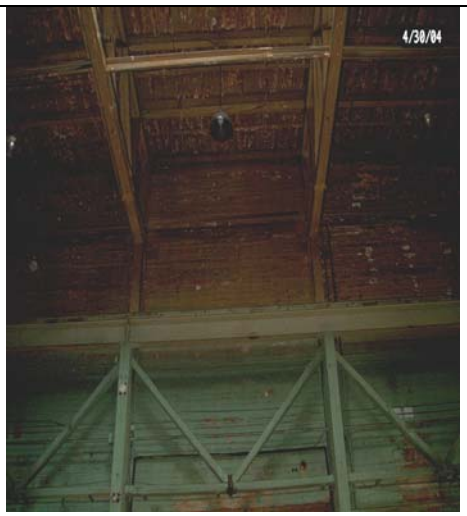
Typical upper section of bays. Note steel beam and trusses along north and south side, this feature is for the 35 ton crane stationed on the east side of shop. VCI has settled onto many of the horizontal surfaces.	West wall of the Former Mobile Shop. The catwalk is located where the color changes from green to brown. Steel bracing is at the ceiling in northeast and southeast corners, but is not visible in this photo.
Typical south bays, photo shows bays 8 and 9. The lower 19 ft. wall sections are solid in all south bays.	South side bay 12, showing some of the typical obstacles, penetrations, and utilities in the work areas.

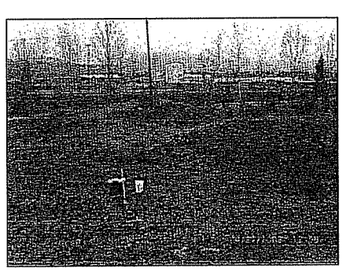
1 SITE ACCESS AND EXCAVATION AREA C

2 SOUTHERN EXTENT OF RIPRAP LOOKING DOWNSTREAM

3 CENTER OF RIPRAP AREA LOOKING DOWNSTREAM

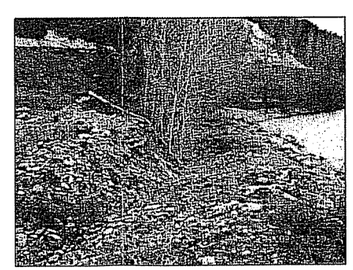
4 SOUTHERN PORTION OF RIPRAP LOOKING UPSTREAM

5 NORTHERN PORTION OF RIPRAP LOOKING UPSTREAM
