**APPENDIX A**

**TERRATHERM, INC. VENDOR REPORT: IN-SITU THERMAL DESTRUCTION (ISTD)  
AT ROCKY MOUNTAIN ARSENAL HEX PIT**

Ralph S. Baker, James P. Galligan, and John M. Bierschenk  
(TerraTherm, Inc., Fitchburg, Massachusetts 01450, USA)

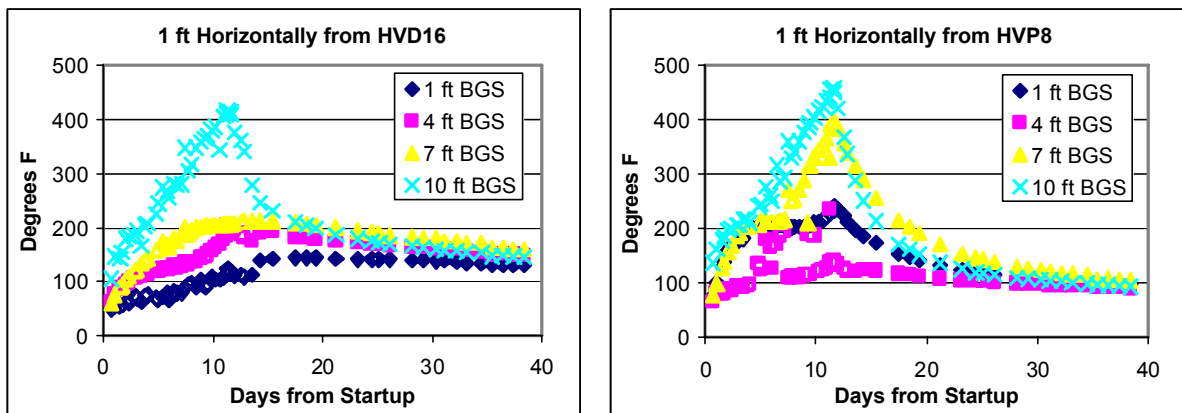
150°F, while the shallower (1 to 4' deep) thermocouples were approximately 100-120°F. At this time, soil temperatures approximately 3 feet from the wells were 75-100°F. By heating Day 10, temperatures measured in thermocouples located 2 feet from south-end wells were at or above the boiling point of water at the 5280-ft elevation of RMA (200°F), and temperatures 3 feet from the wells were very nearly 200°F, again with the exception of the 1'-deep zone which was lagging 20 to 30 degrees behind.

In the northern two-thirds of the pit (Heater Rows 1-16) where only heater-vacuum wells were operating, the temperature distributions were somewhat more irregular, as this area did not have the benefit of superposition of heating, as did the fully operational southern end. By Heating Day 5, thermocouples located at the southern edge of that portion of the pit, approximately 1 foot from heater vacuum well HVD16 (Figure 8a) were approximately 250°F at 10' depth, and ranged from 120 to 170°F at the 4 to 7 foot depth ranges, while the near-surface temperature was approximately 70°F. By the end of the 12-day heating period, the 10'-deep thermocouple at this location had reached a temperature of 416°F, and the mid-depth thermocouples were just over 200°F, while the shallow thermocouple was lagging behind at approximately 120°F. Further north in the field, temperatures within 1 foot of an energized heater-vacuum well in Row 8 (HVP8) on Heating Day 5 were at or above 200°F (Figure 8b), with the exception of the mid-depth 4' deep thermocouple reading, which was approximately 125°F. This may be indicative of locally saturated conditions in the mid-depth region. In contrast, soil temperatures measured by thermocouples installed in the far northern end of the pit had typically increased only 20 to 30°F and were still below 100°F after 12 days of heating. Those locations that increased by 30°F were nearer to the operating heater vacuum wells. This rate of heating was normal and as expected.

**Figure 8a,b – Representative temperature data from thermocouple arrays located 1.0 ft horizontally from each of two heater-vacuum wells. Maximum temperatures were achieved on day 12, at which time heaters were turned off. Deeper locations were generally hotter, attributable to the boosted wattage in the lower two feet of the heaters. After shutdown, temperatures equilibrated and gradually declined.**
