Coal Combustion Residue Impoundment

Round 9 - Dam Assessment Report

Oklahoma Power Station

Wastewater Evaporation Pond 6 – WMU 001

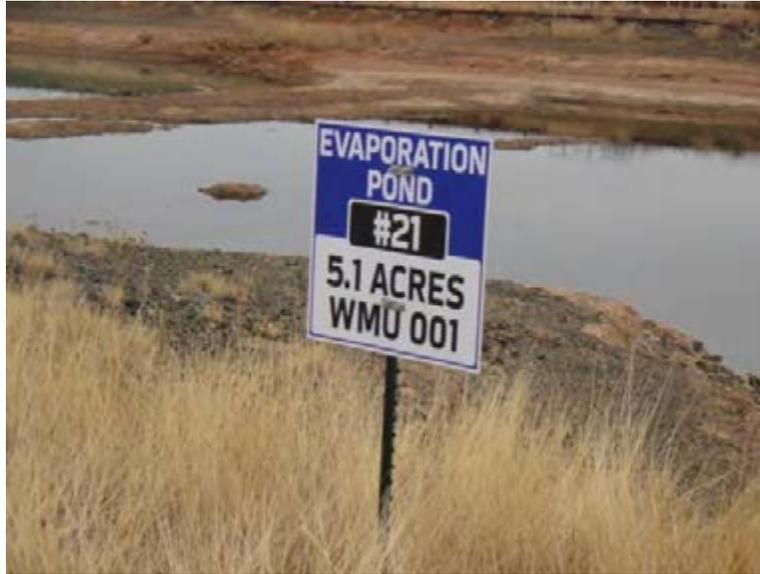
Figure C-1. Additional incised CCR pond #21

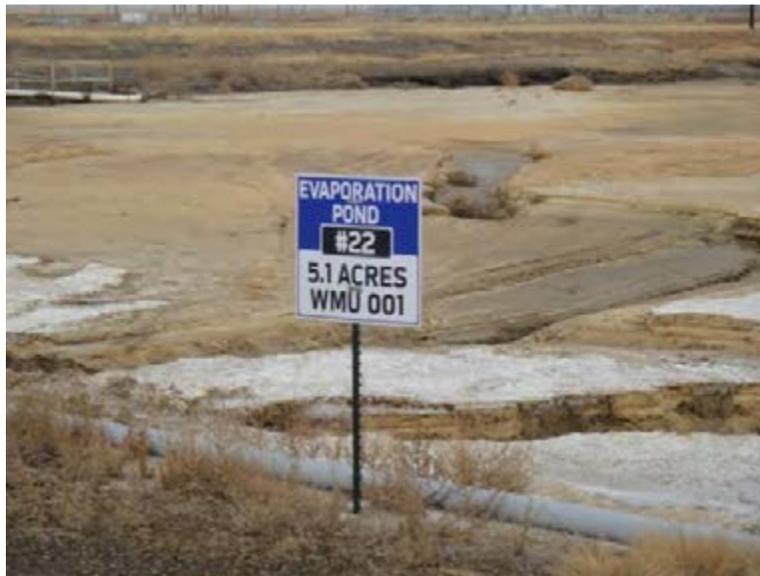
Figure C-2. Additional incised CCR pond #22

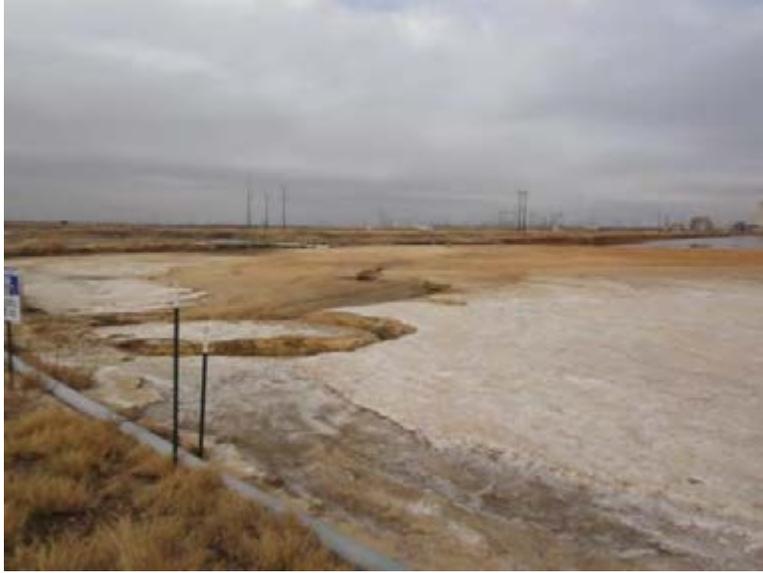
Figure C-3. Additional incised CCR pond #23

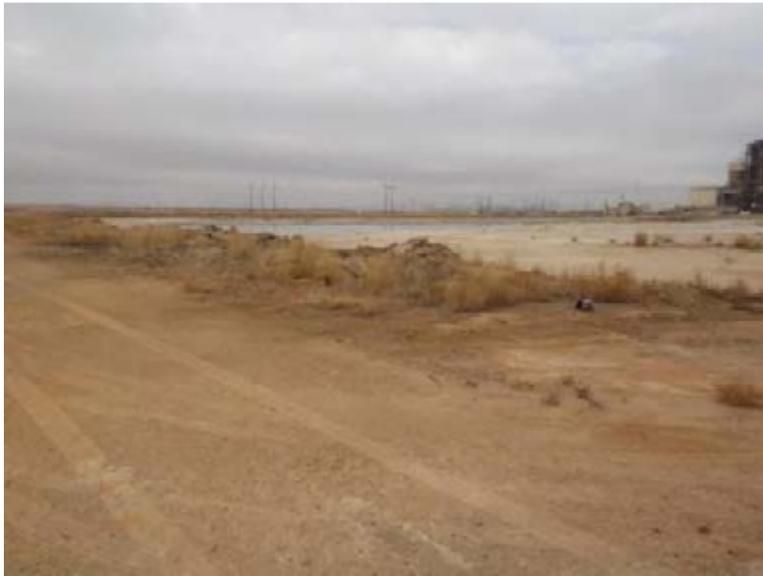
Figure C-4. Additional incised CCR pond #7
