**DRAFT REPORT
ROUND 7 DAM ASSESSMENT
CONSUMERS ENERGY COMPANY - D.E. KARN PLANT
1 & 2 SOLID WASTE DISPOSAL AREA
ESSEXVILLE, MICHIGAN**

January 12, 2011

**GZA GeoEnvironmental, Inc.
19500 Victor Parkway, Suite 300
Livonia, MI 48152
GZA File No. 01.0170142.20**

Re: Round 7 Dam Assessment - Draft Report
EPA Contract No. EP10W001313
Consumers Energy Company D.E. Karn Plant
DE Karn 1 & 2 Solid Waste Disposal Area
Essexville, Michigan

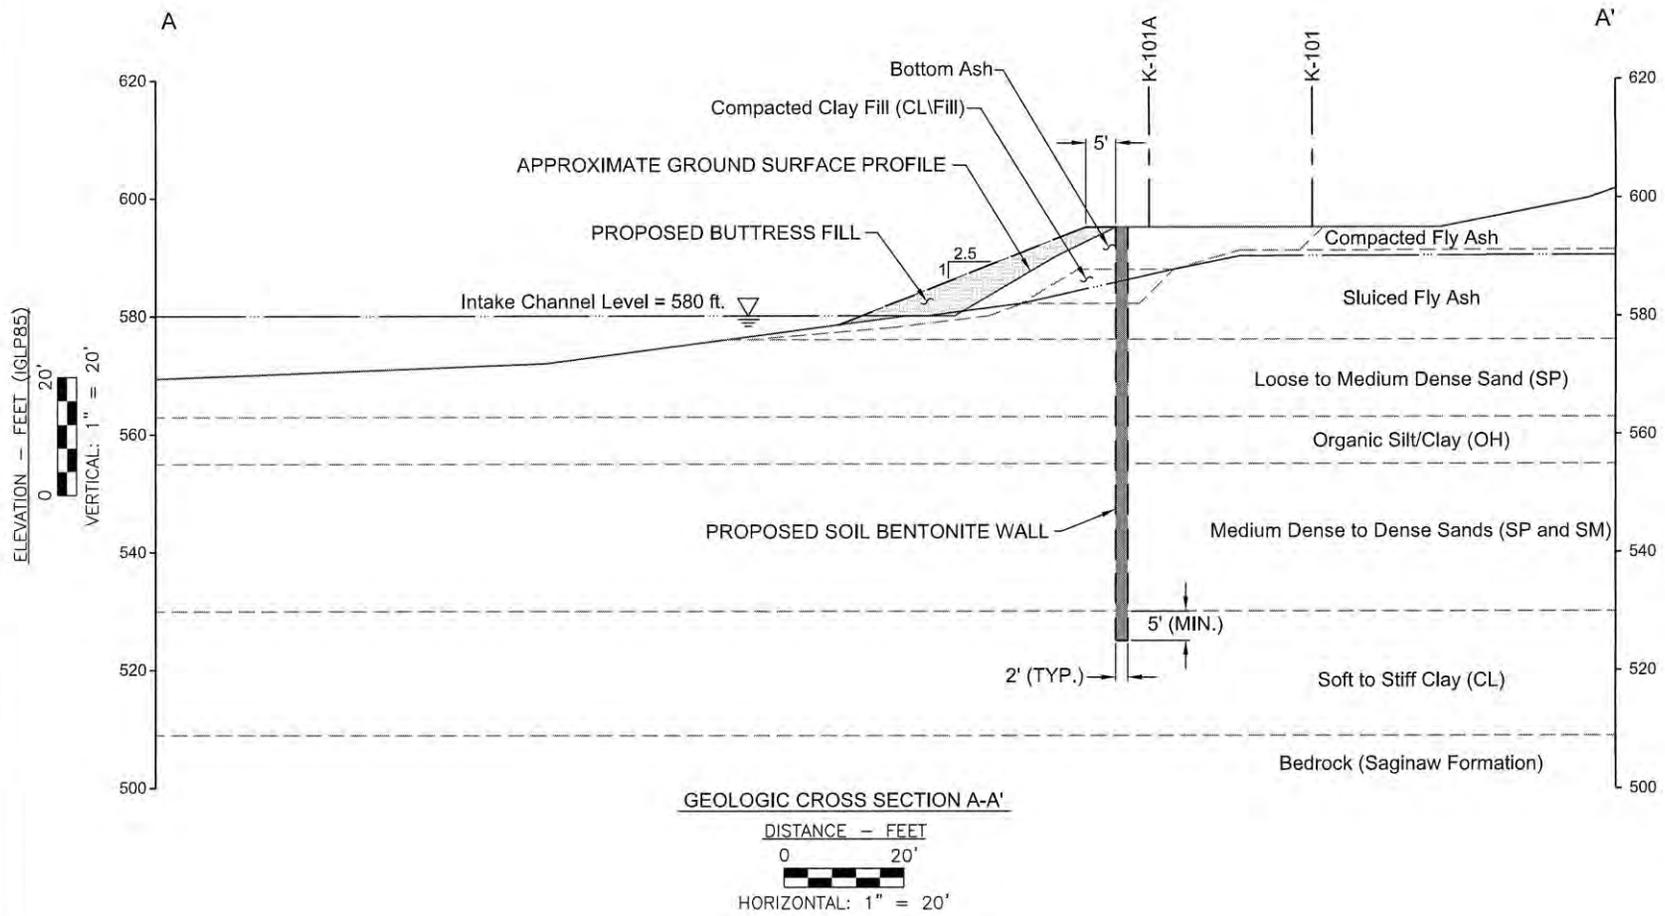
Cross Section A-A'

The reported subsurface profile of the dike area near the Intake Channel north of the Chemical Treatment Ponds is presented on **Figure 5**. The dike in this area was reportedly initially constructed with a mechanically-placed clay compacted over sluiced fly ash that was placed on the natural ground surface. A later expansion raised the dike elevation with compacted fly ash. The dike material is underlain by natural sands with interbedded native organic clay and silt strata. The natural sands are underlain by native medium silty clays.

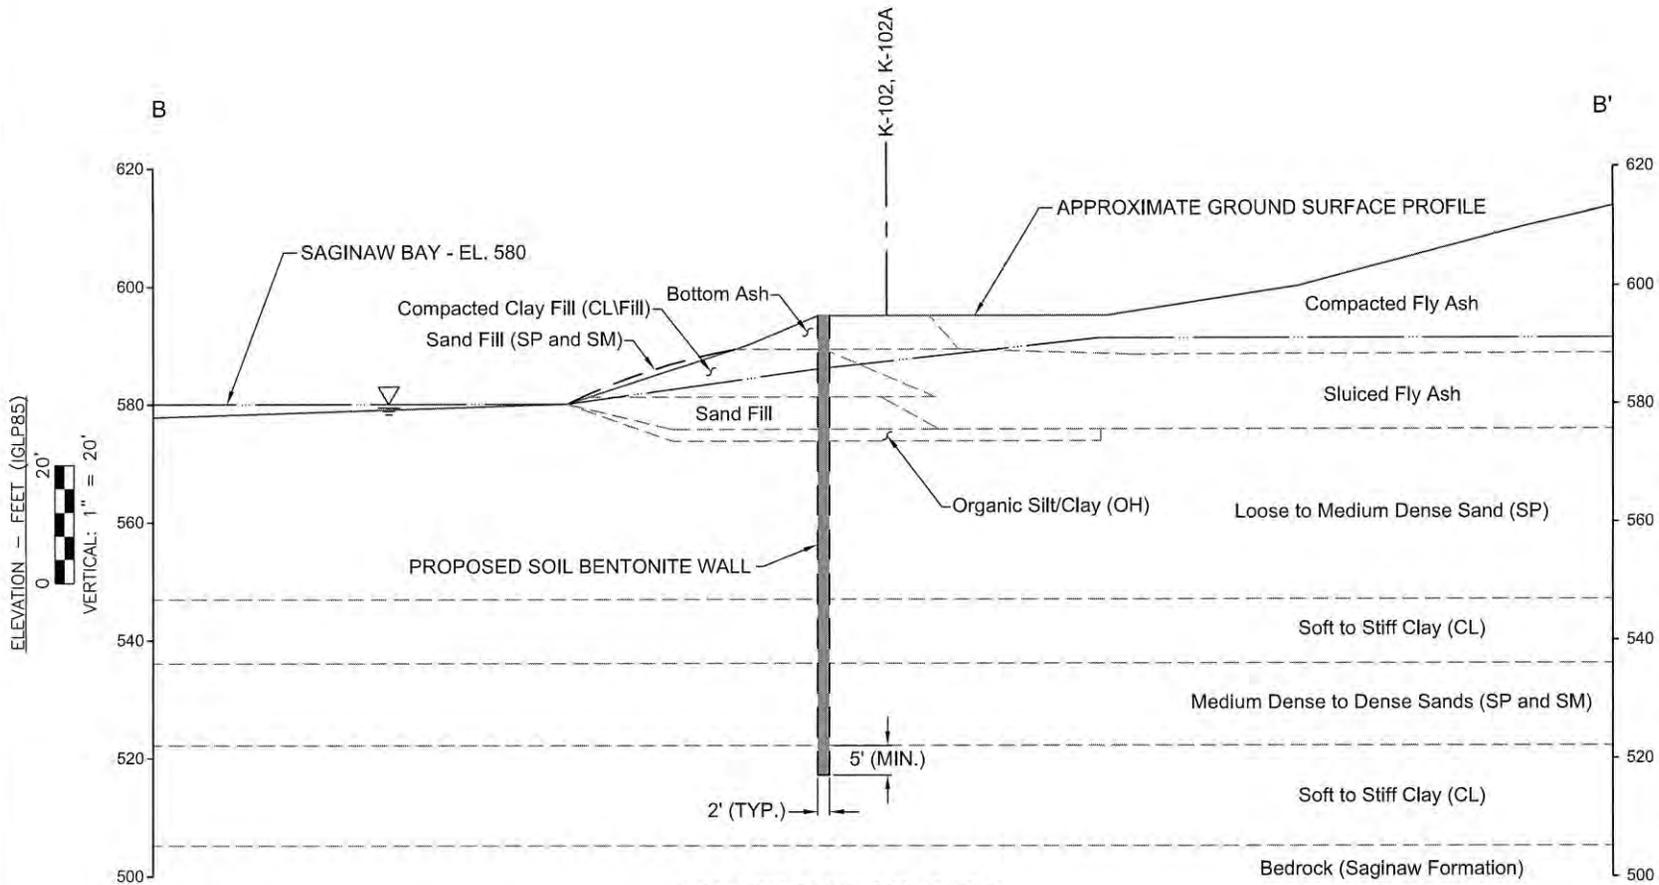
Cross Section B-B'

The reported subsurface profile of the northern and western perimeter dikes is presented on **Figure 6**. The dike in this area reportedly consists of a mechanically-placed clay dike constructed over sand fill. Fly ash is present along the upstream side of the dike but did not appear to extend below the original dike material. The dike fill materials are underlain by natural sands with interbedded clay layers. The natural sands are underlain by native stiff clays. A relatively thin strata of natural organic clay and/or organic silt is present at the interface between the dike material and natural foundation soils.

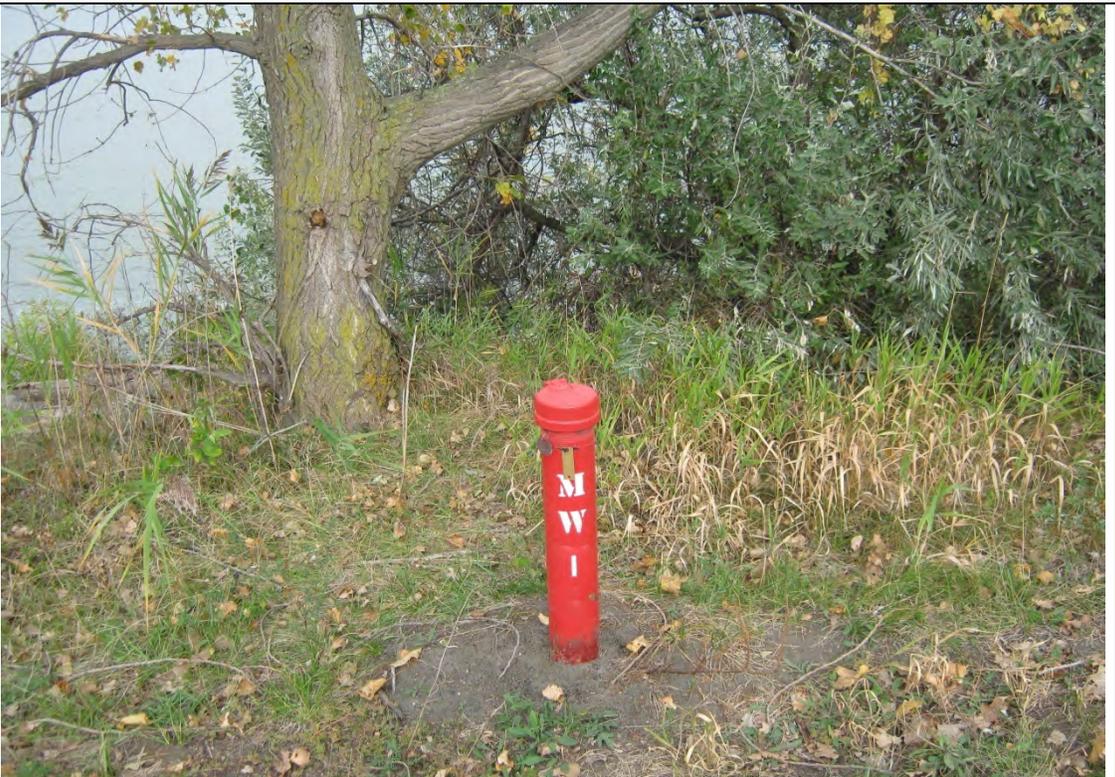
Photo No. 6	Date: 9/27/2010
Direction Photo Taken: Northwest

Description:
One of the monitoring wells at the Karn Disposal Area.

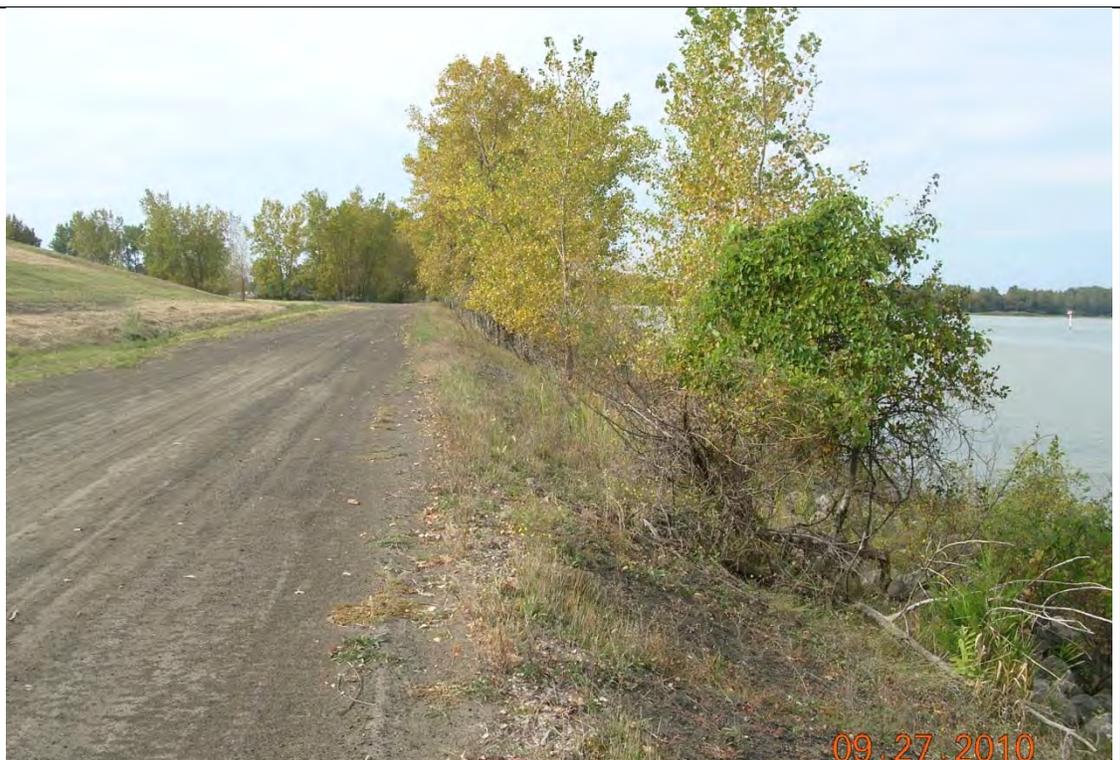
Photo No. 8	Date: 9/27/2010
Direction Photo Taken: Southwest

Description:
 Crest and outer dike slope near the northwestern corner of the Karn Disposal Area.

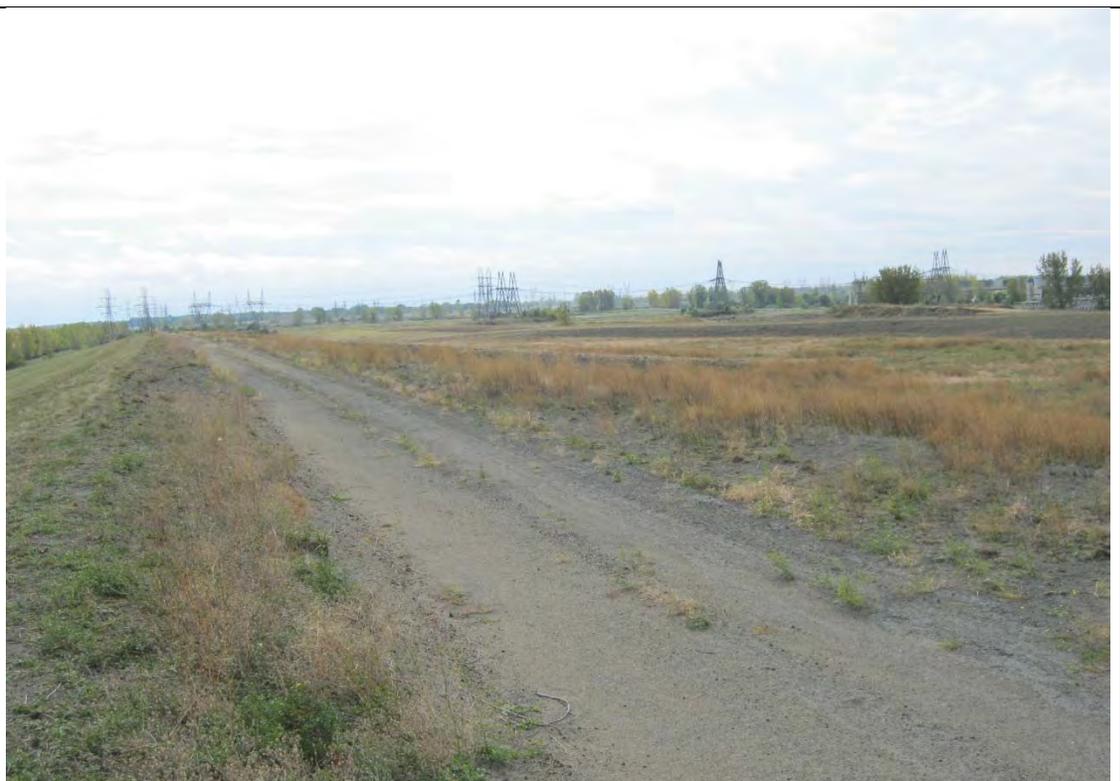
Photo No. 12	Date: 9/27/2010
Direction Photo Taken: Southeast

Description:
Top of the compacted fly ash disposal area.

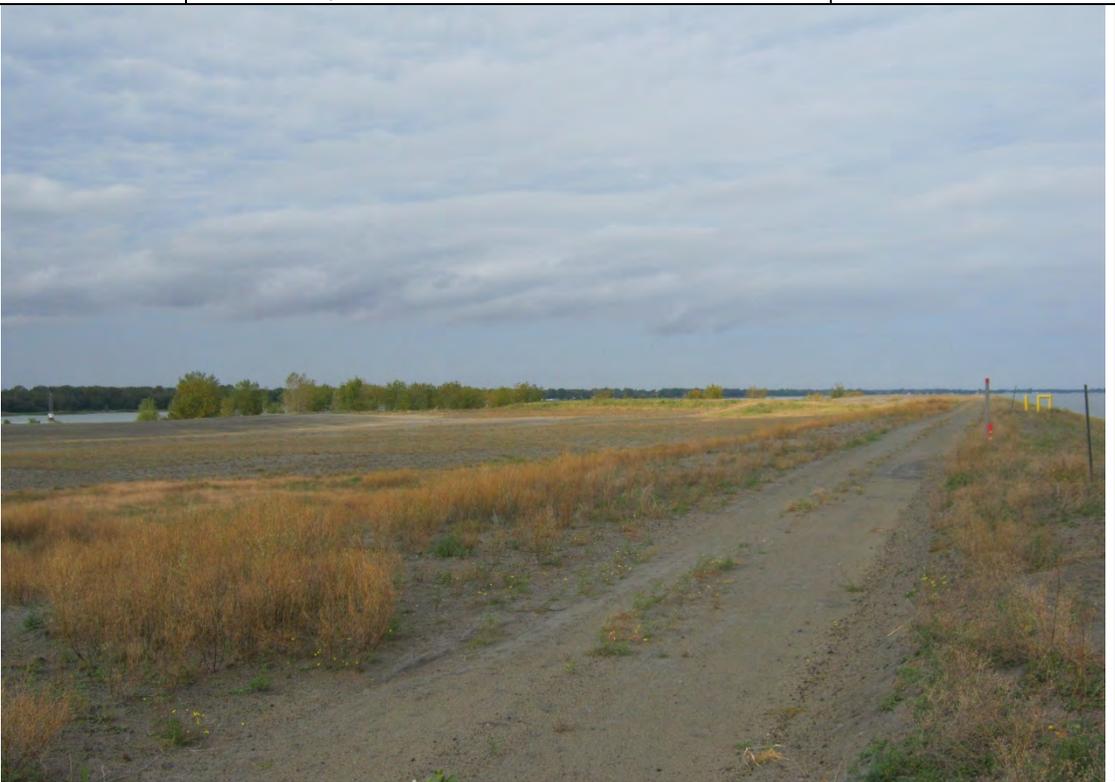
Photo No. 13	Date: 9/27/2010
Direction Photo Taken: Northwest

Description:
Top of the compacted fly ash disposal area.

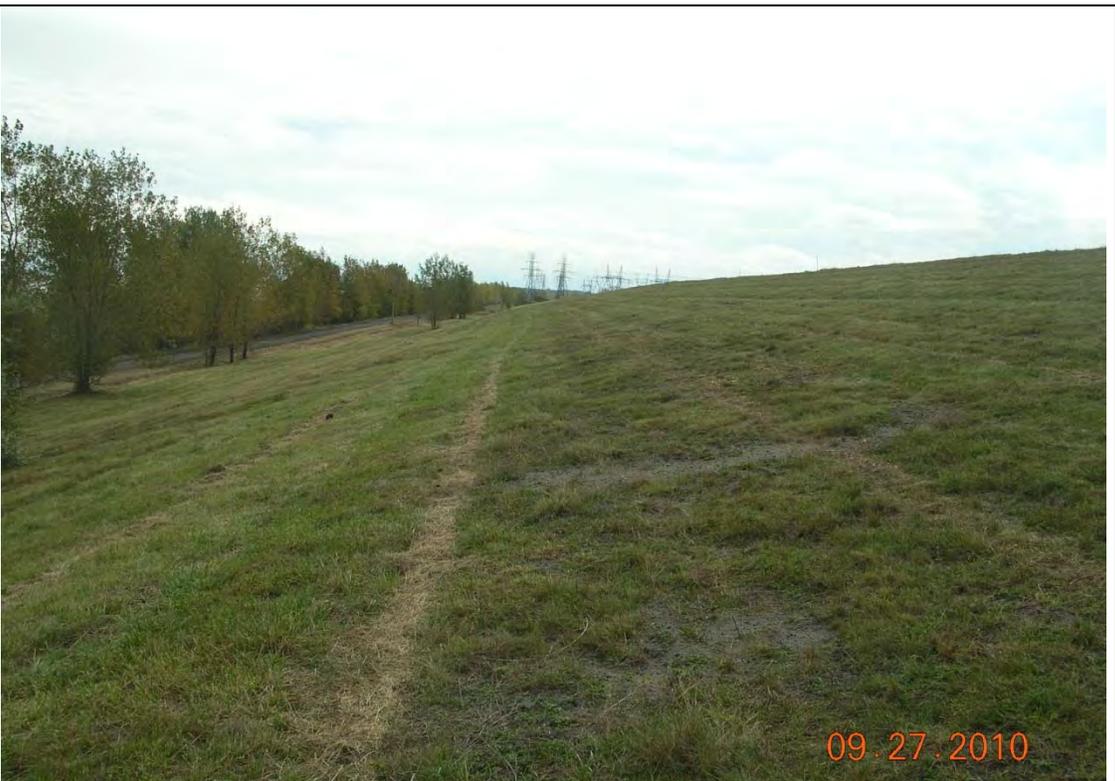
Photo No. 14	Date: 9/27/2010
Direction Photo Taken: Southeast

Description:
View from approximately the mid point between the toe of the inner dike slope and the top of the fly ash disposal area.

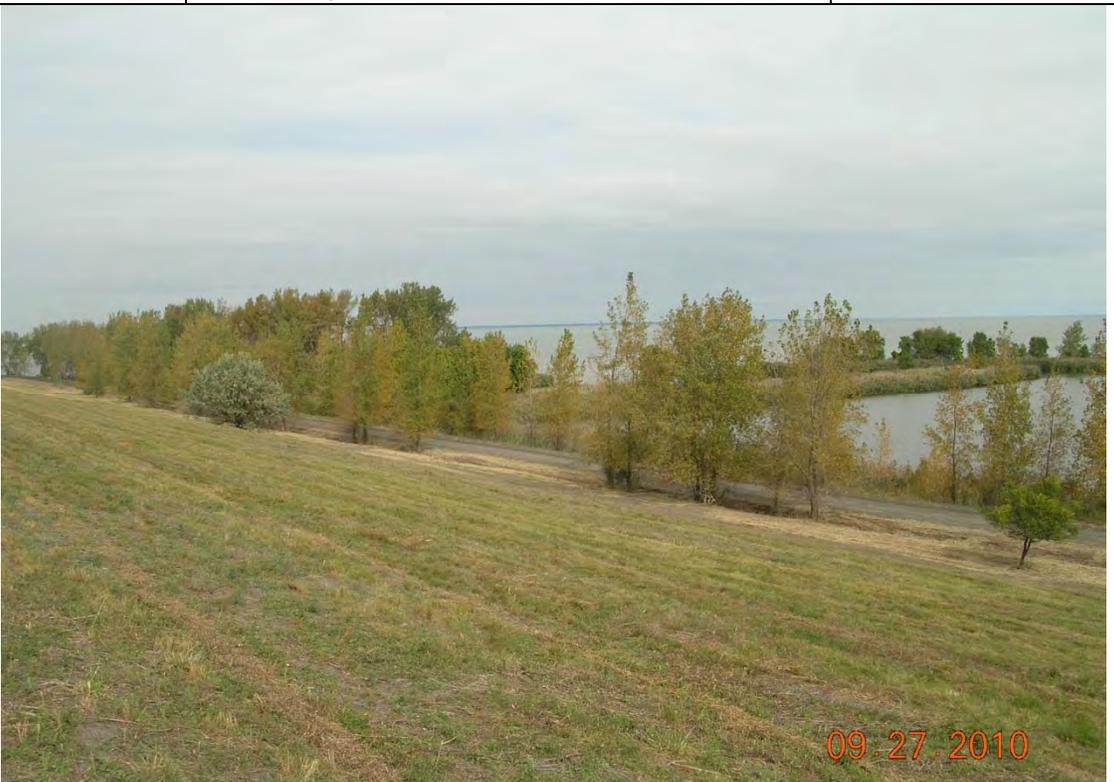
Photo No. 15	Date: 9/27/2010
Direction Photo Taken: Northwest

Description:
Overview of the fly ash disposal area slope, dike slope, and Lake Huron in the background.

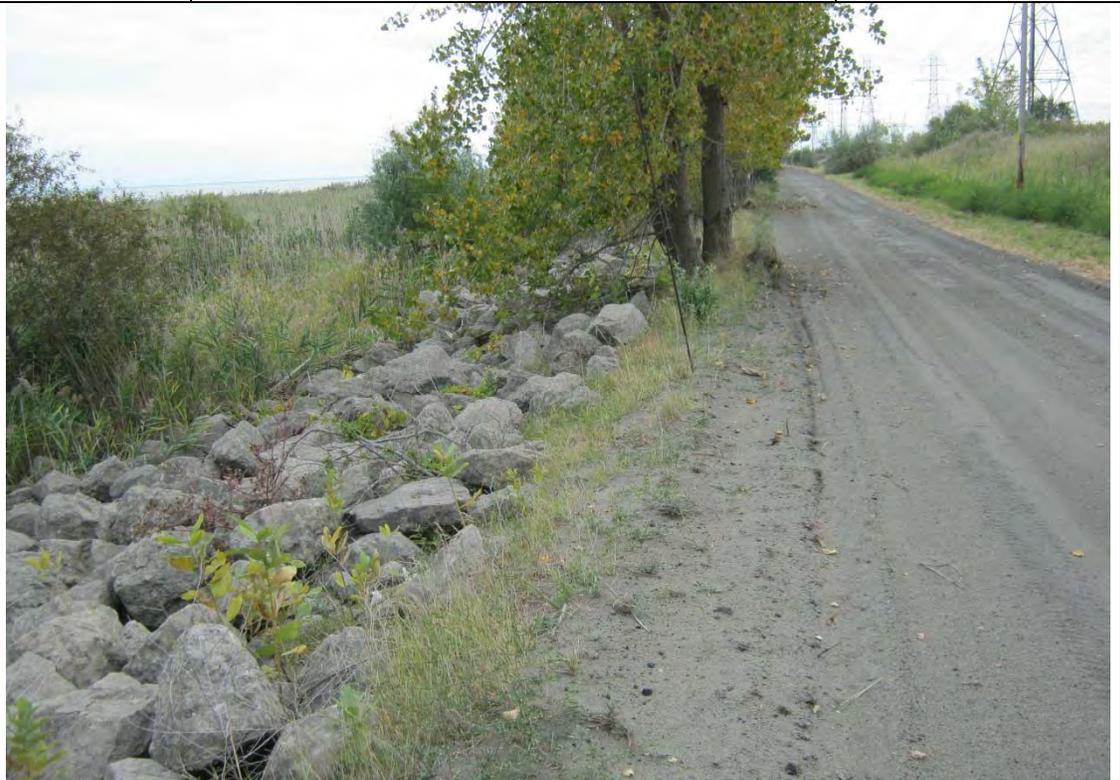
Photo No. 16	Date: 9/27/2010
Direction Photo Taken: Southeast

Description:
Vegetation and rip rap on the outer slope of the dike. Note the bottom ash that was used to build up the crest.

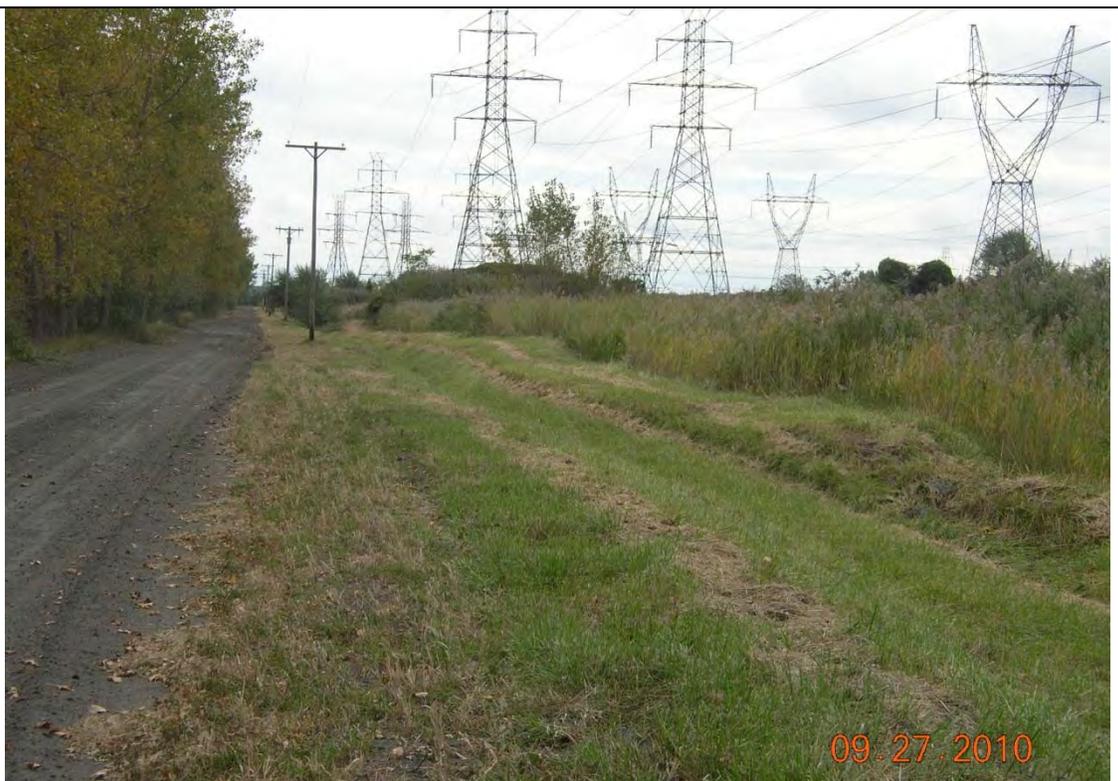
Photo No. 20	Date: 9/27/10
Direction Photo Taken: Southwest

Description:
The inner dike slope and stormwater ditch was recently mowed in this area.

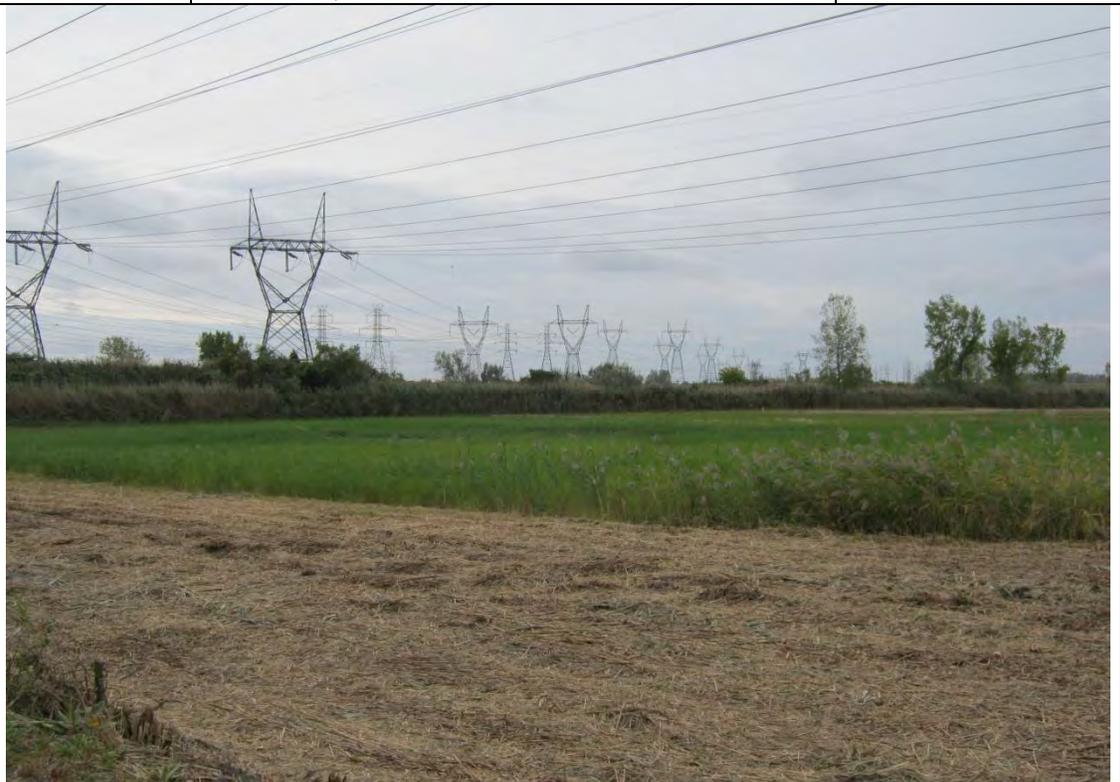
Photo No. 21	Date: 9/27/2010
Direction Photo Taken: South

Description:
High voltage utility lines cross the Karn Disposal Area.

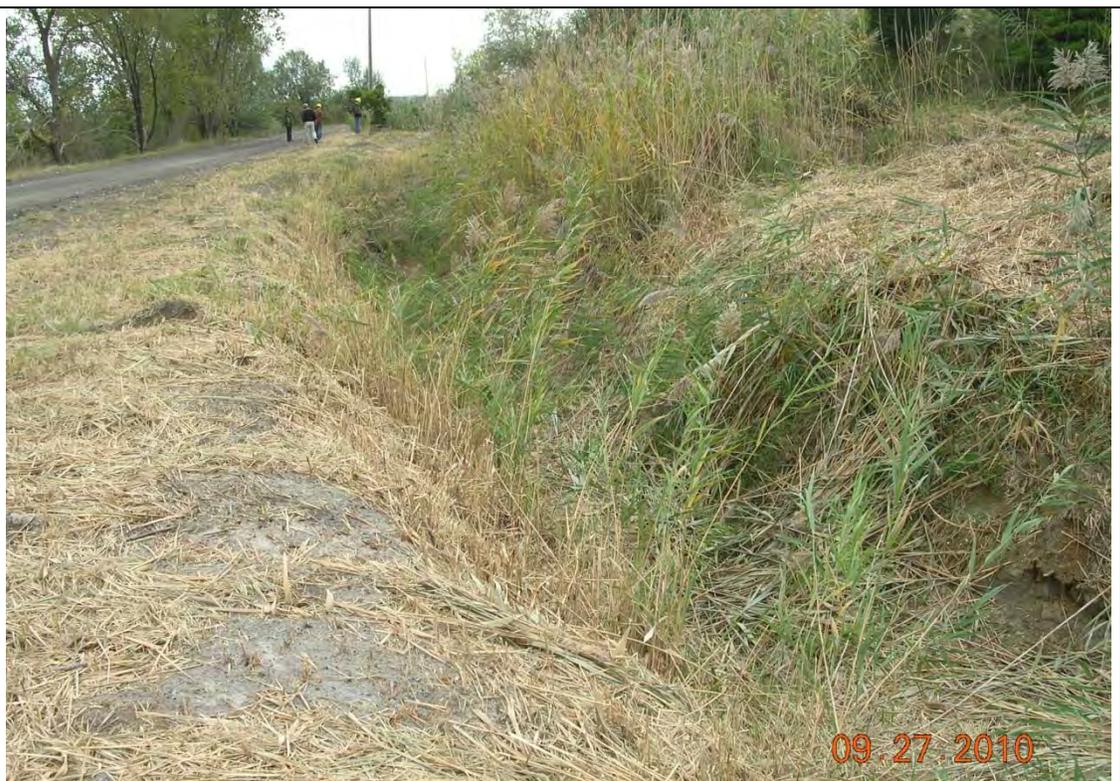
Photo No. 22	Date: 9/27/10
Direction Photo Taken: Southeast

Description:
The inner dike slope and stormwater drainage ditch.

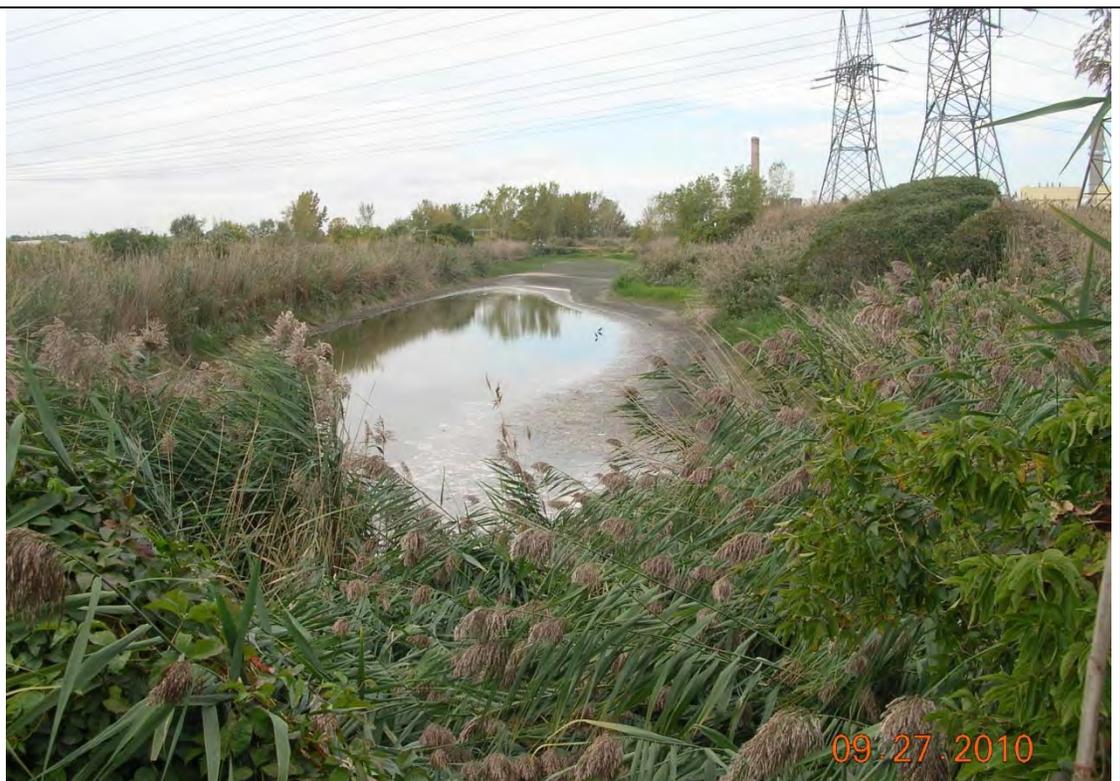
Photo No. 24	Date: 9/27/10
Direction Photo Taken: Southwest

Description:
Pond E.

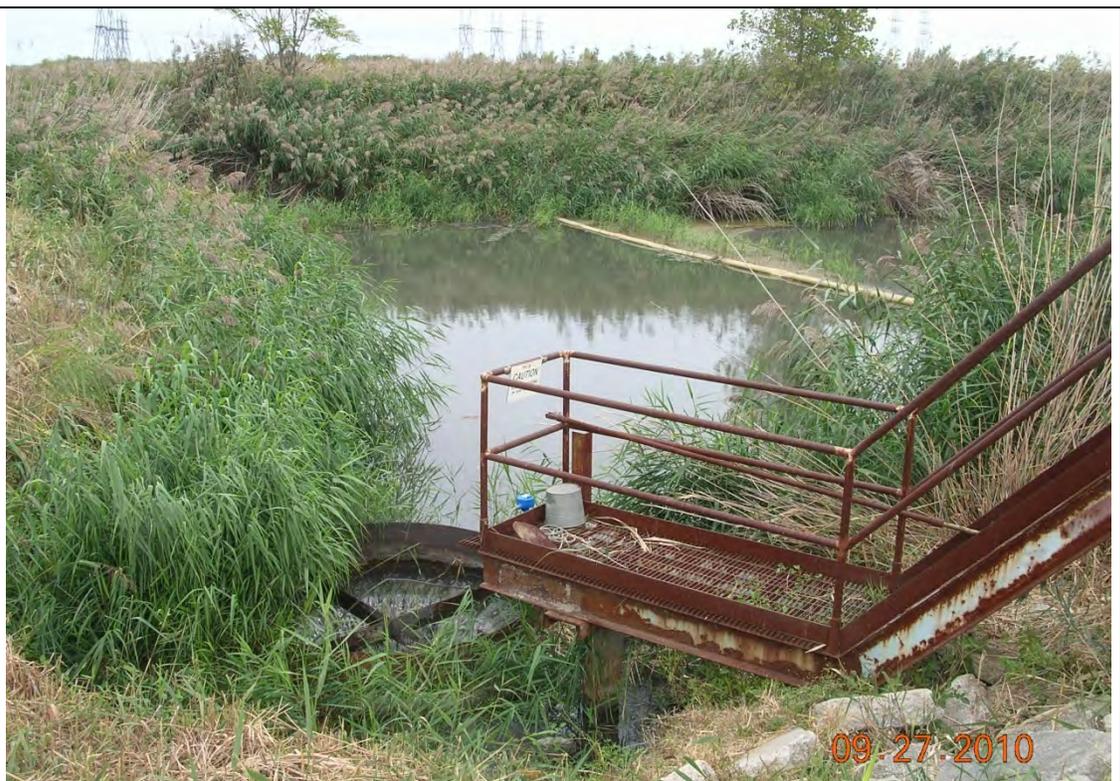
Photo No. 30	Date: 9/27/10
Direction Photo Taken: North

Description:
The NPDES outlet structure in Pond F.

1. Remove the former NPDES discharge structure, including excavating and removing the former pipes, and replace with compacted fill.

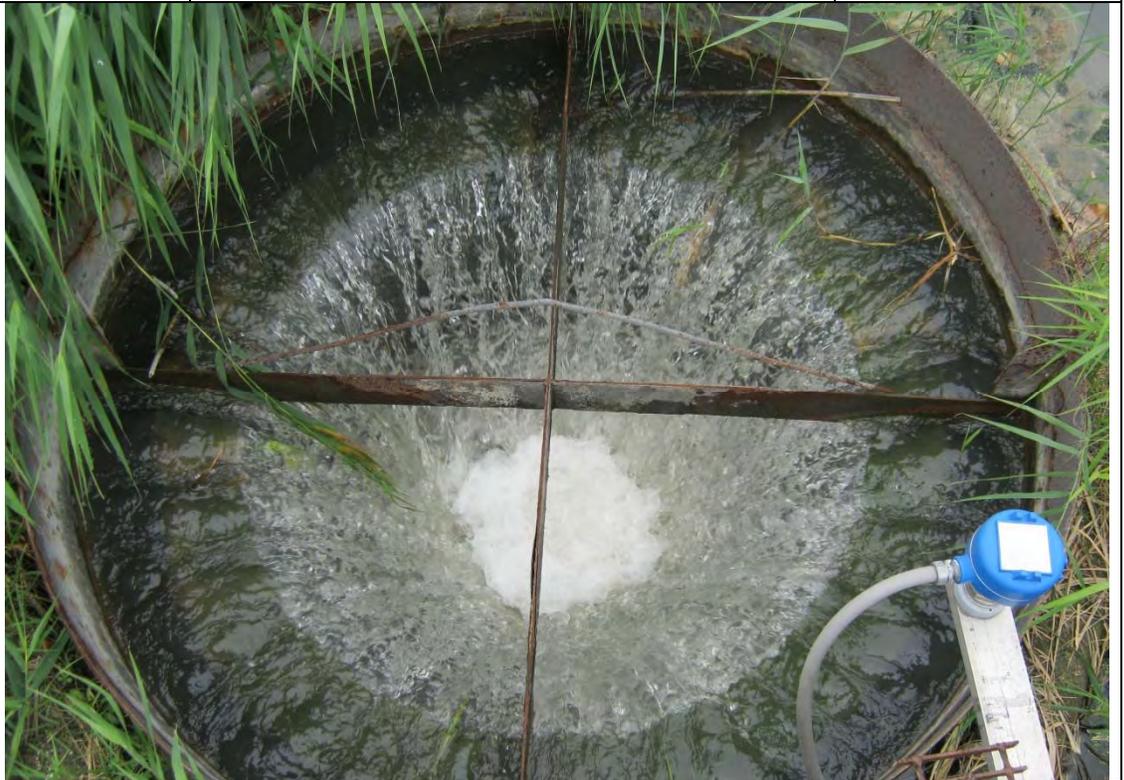
The metal ring and concrete pipe at the NPDES discharge structure. The electronic water level meter is in the lower right hand corner of the picture.

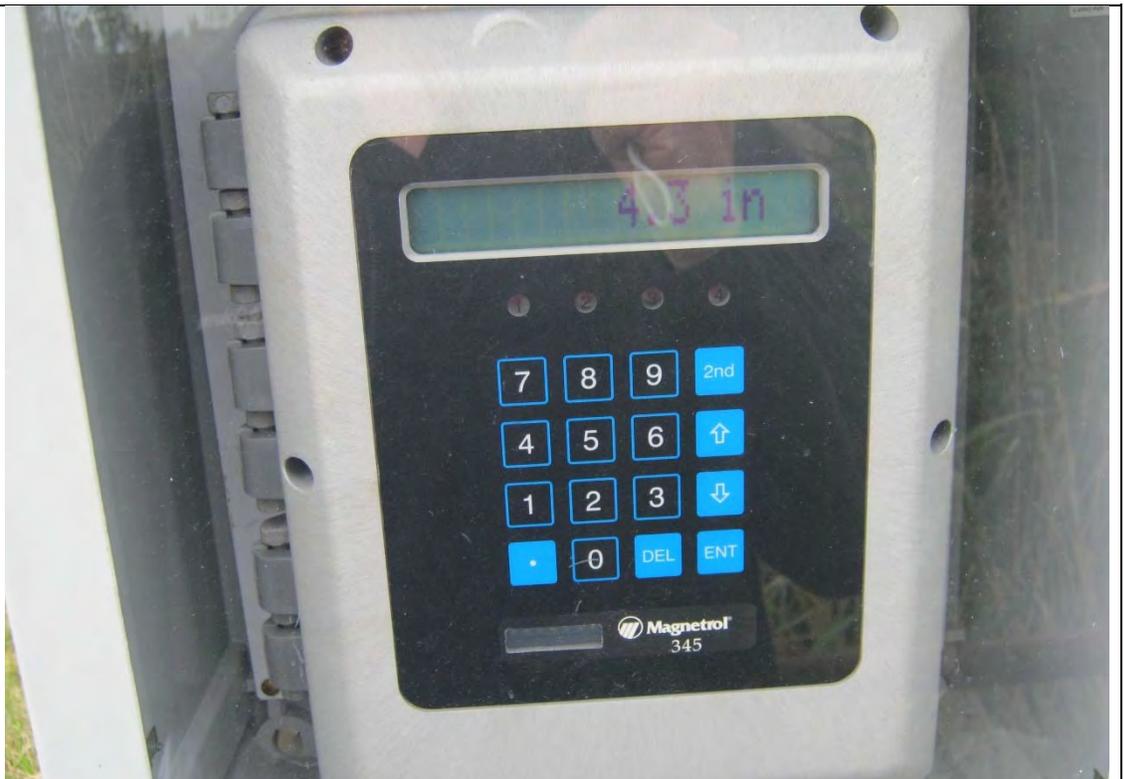
Photo No. 32

The readout for the electronic water level meter.

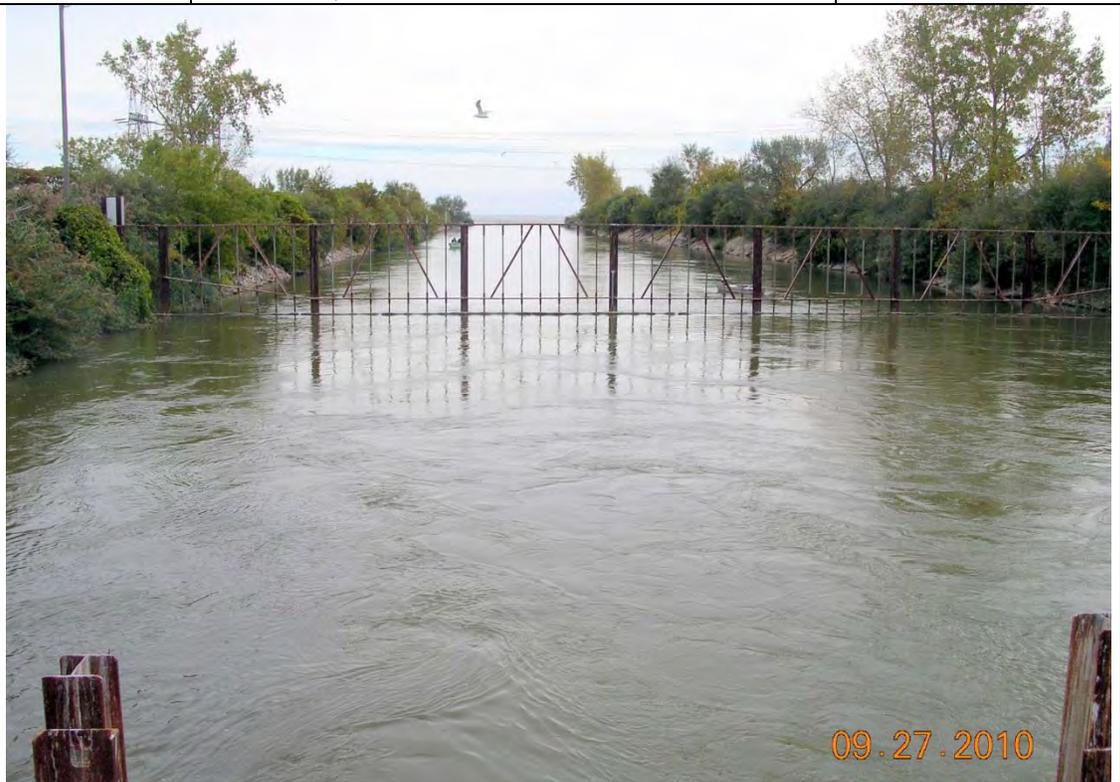
Photo No. 35	Date: 9/27/2010
Direction Photo Taken: Northeast

Description:
The Discharge Canal flows into Lake Huron. The gate shown prevents fishermen from driving up the Discharge Canal.

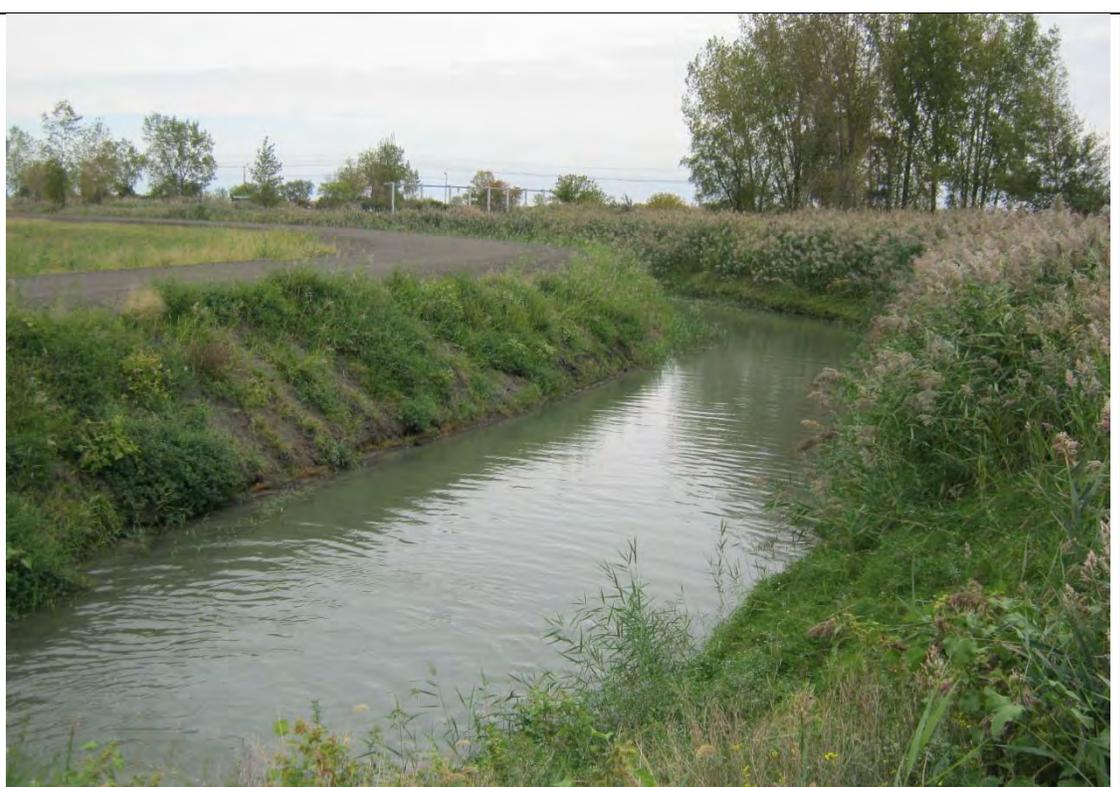
Photo No. 36	Date: 9/27/10
Direction Photo Taken: East

Description:
One of the drainage ditches that conveys Bottom Ash wastewater to Pond F.

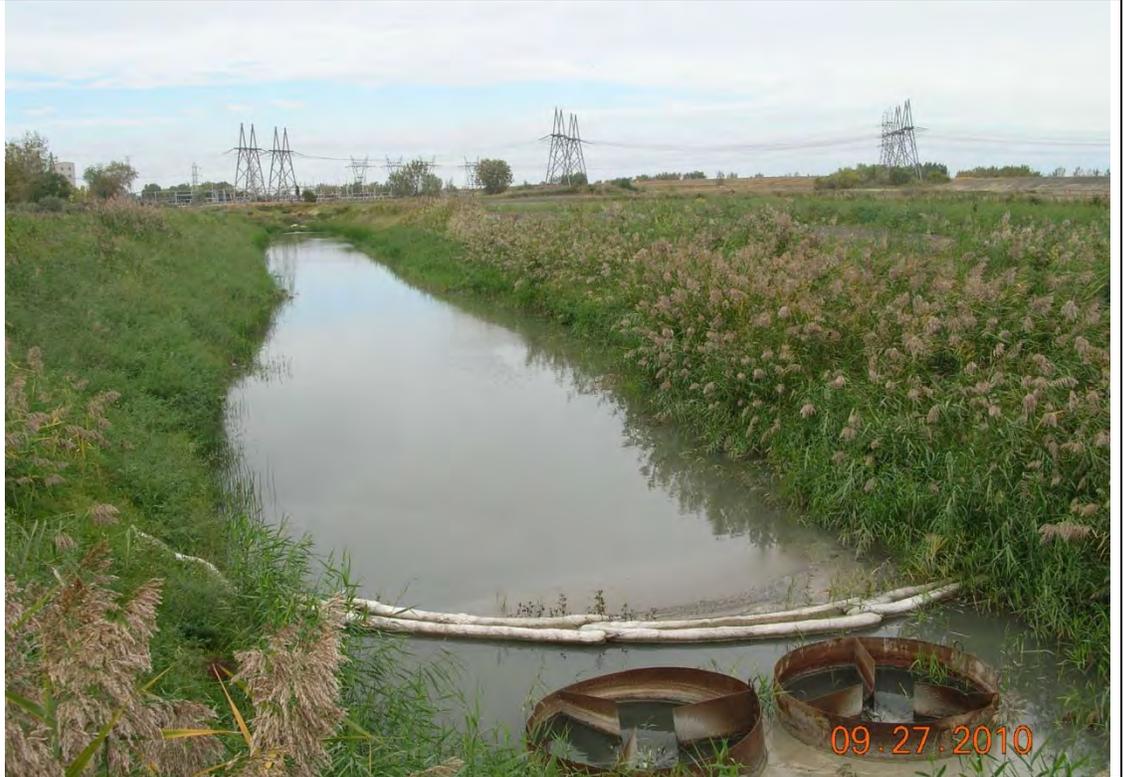
One of the drainage ditches that conveys Bottom Ash wastewater to Pond F. The drop structures shown in the bottom of the photo are typical of the transfer structures in the drainage ditches.

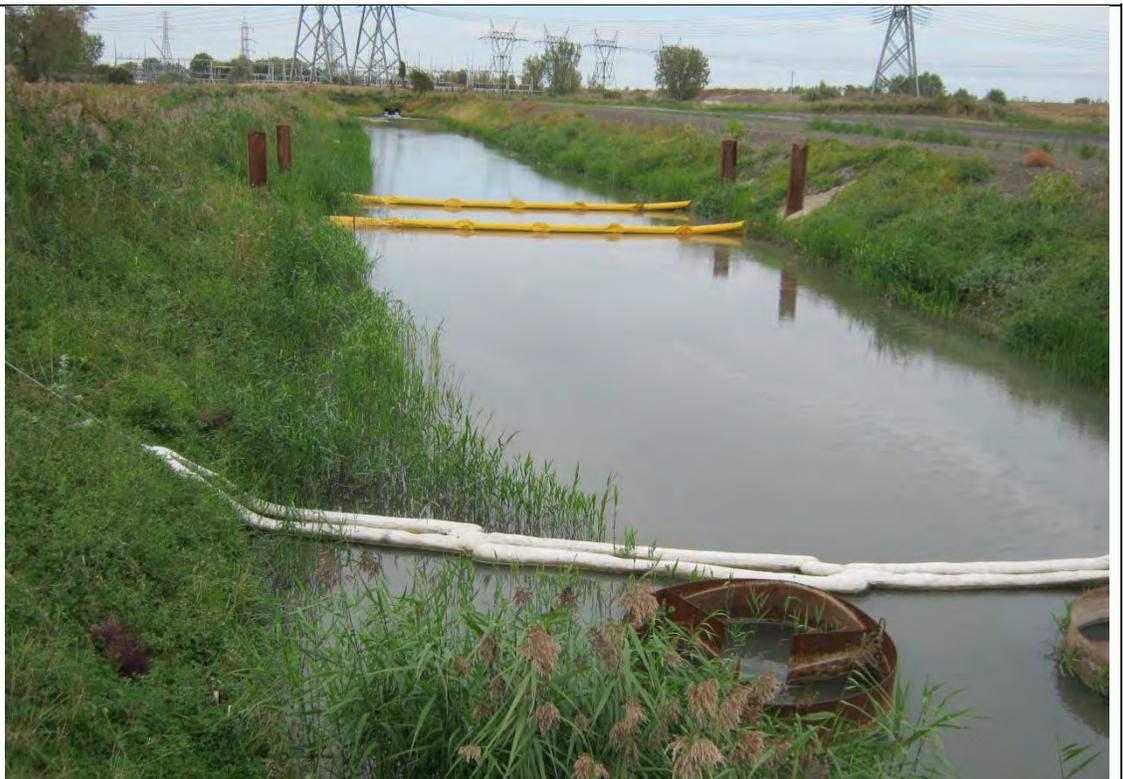
Photo No.
38

One of the drainage ditches that conveys Bottom Ash wastewater to Pond F. Yellow turbidity curtains reduce particulate in the wastewater.

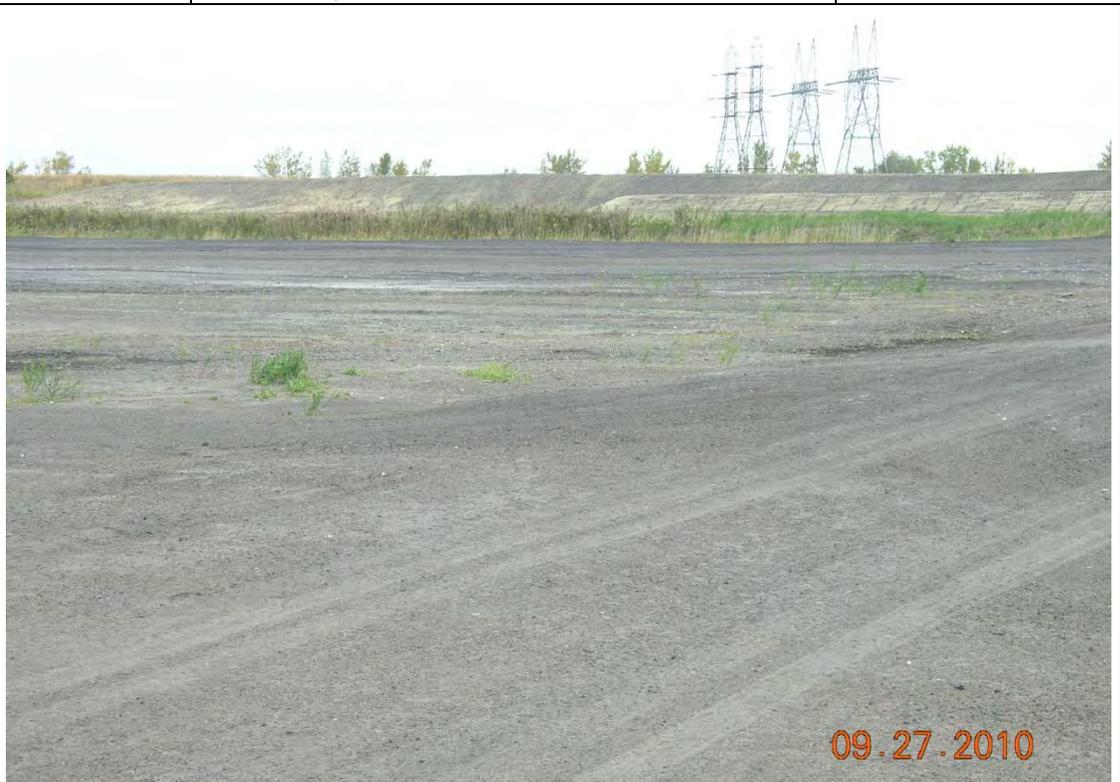
Photo No. 39	Date: 9/27/2010
Direction Photo Taken: North

Description:
The interior of the Karn Disposal Area.

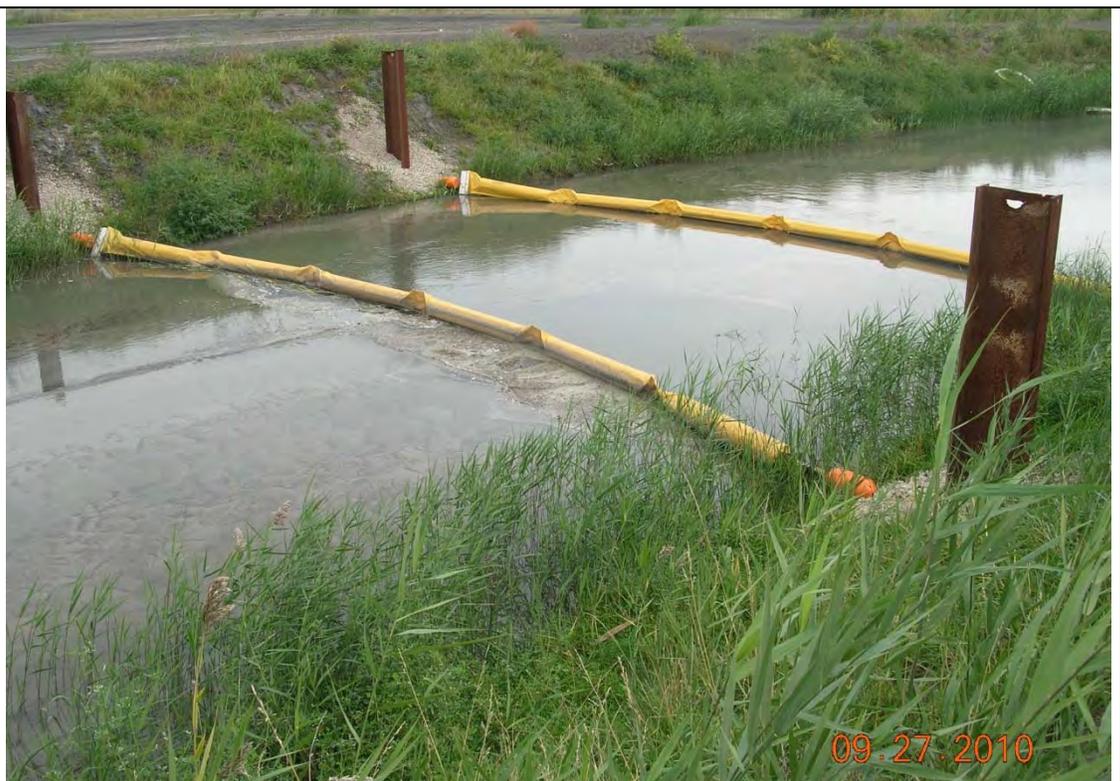
Photo No. 40	Date: 9/27/10
Direction Photo Taken: Northeast

Description:
Turbidity curtains in the bottom ash drainage ditches.

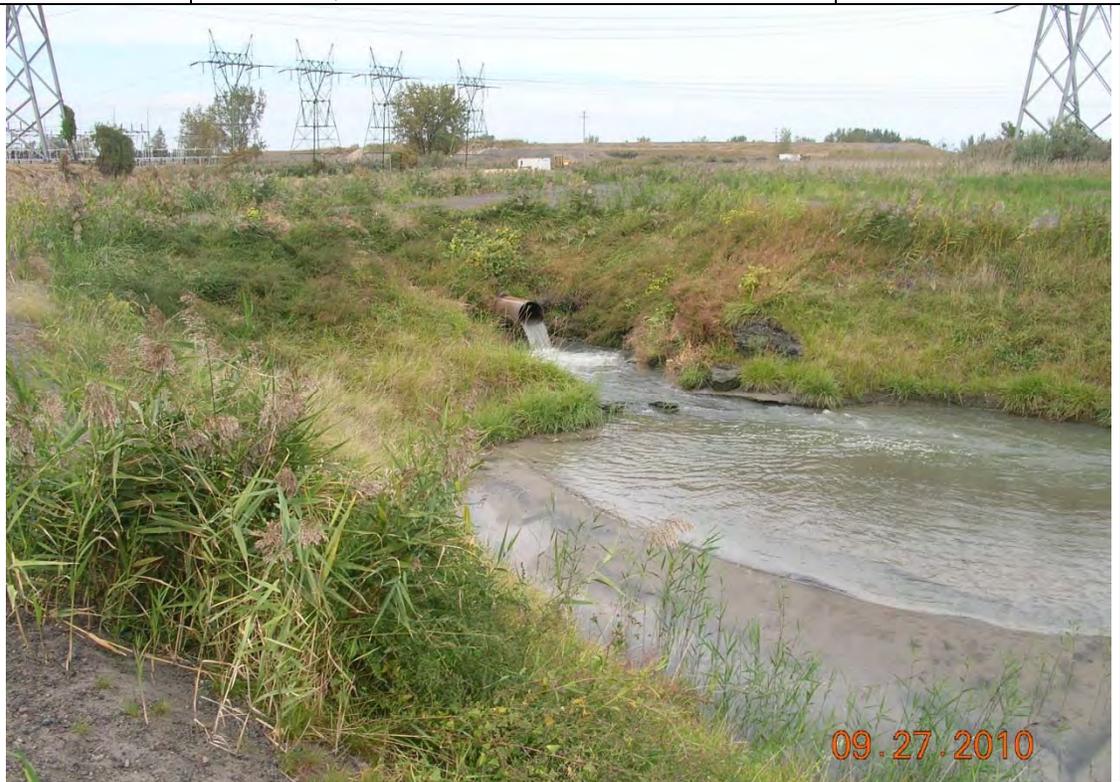
Photo No. 41	Date: 9/27/2010
Direction Photo Taken: Northwest

Description:
Outlet for transfer of bottom ash wastewater between the drainage ditches.
