**DRAFT REPORT
ROUND 7 DAM ASSESSMENT
CONSUMERS ENERGY COMPANY - D.E. KARN PLANT
1 & 2 SOLID WASTE DISPOSAL AREA
ESSEXVILLE, MICHIGAN**

January 12, 2011

**GZA GeoEnvironmental, Inc.
19500 Victor Parkway, Suite 300
Livonia, MI 48152
GZA File No. 01.0170142.20**

Re: Round 7 Dam Assessment - Draft Report
EPA Contract No. EP10W001313
Consumers Energy Company D.E. Karn Plant
DE Karn 1 & 2 Solid Waste Disposal Area
Essexville, Michigan

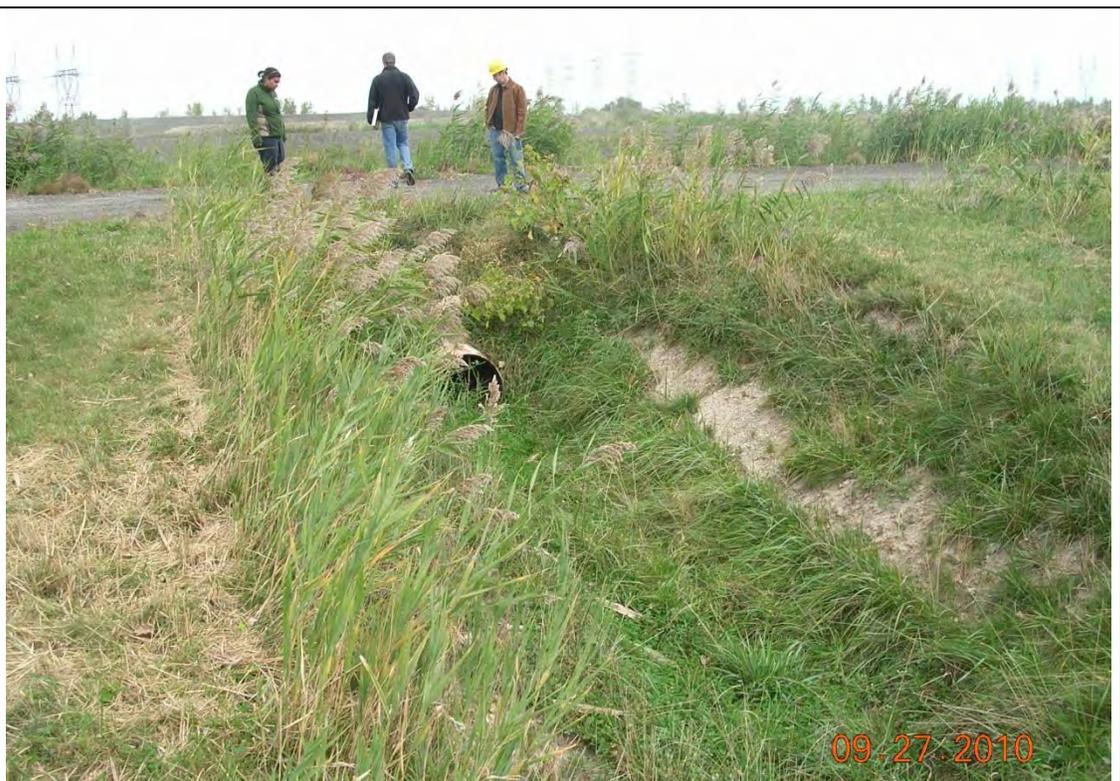
Photo No. 42	Date: 9/27/10
Direction Photo Taken: North

Description:
Stormwater overflow outlet that empties the drainage ditches into the Discharge Canal.

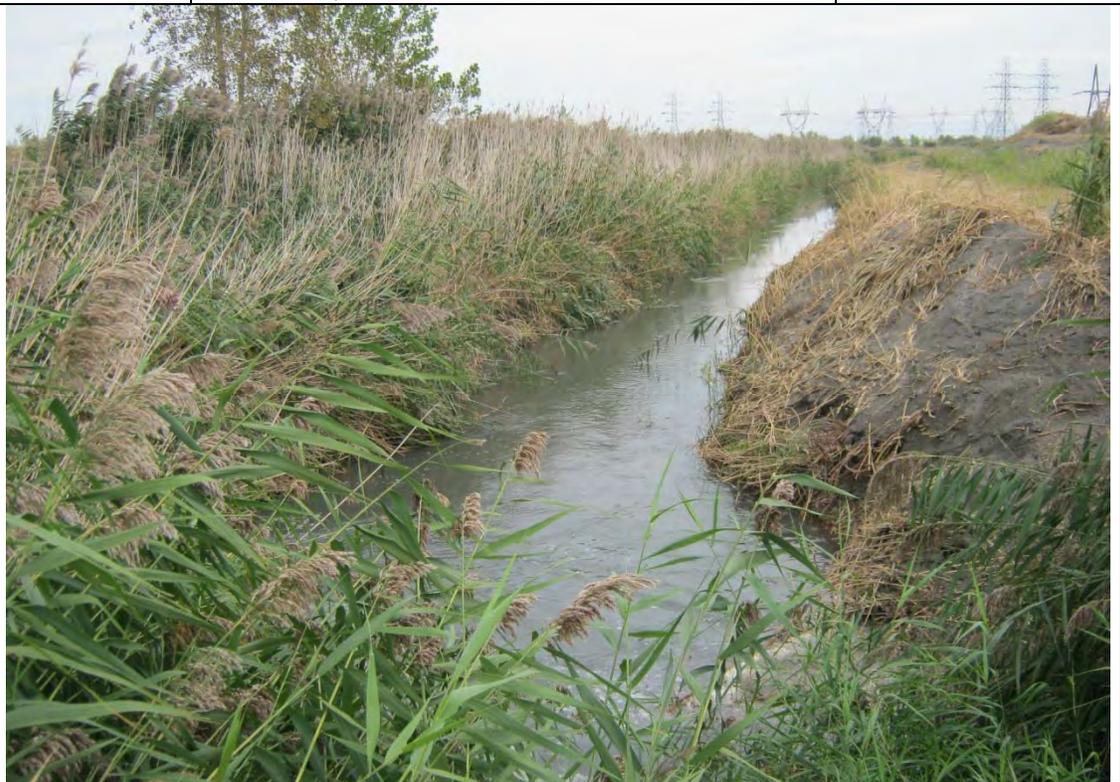
Photo No. 43	Date: 9/27/2010
Direction Photo Taken: Southeast

Description:
One of the drainage ditches that conveys Bottom Ash wastewater to Pond F.

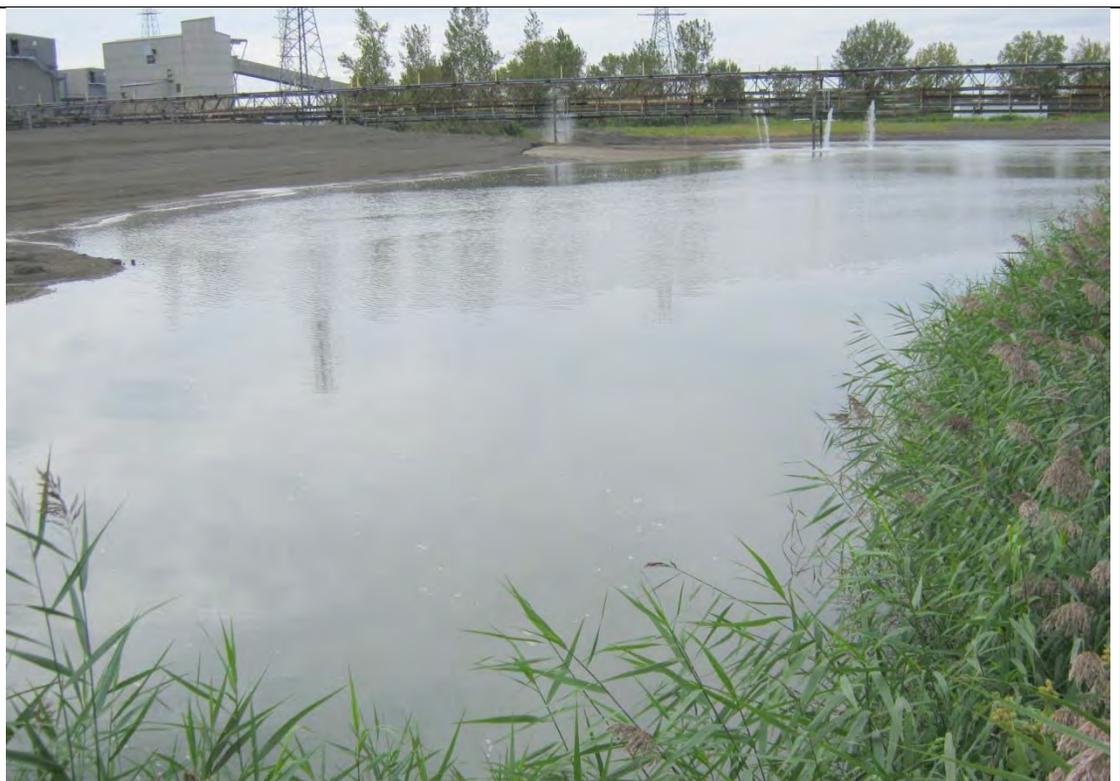
Photo No. 44	Date: 9/27/10
Direction Photo Taken: West

Description:
Bottom Ash wastewater discharge pond.

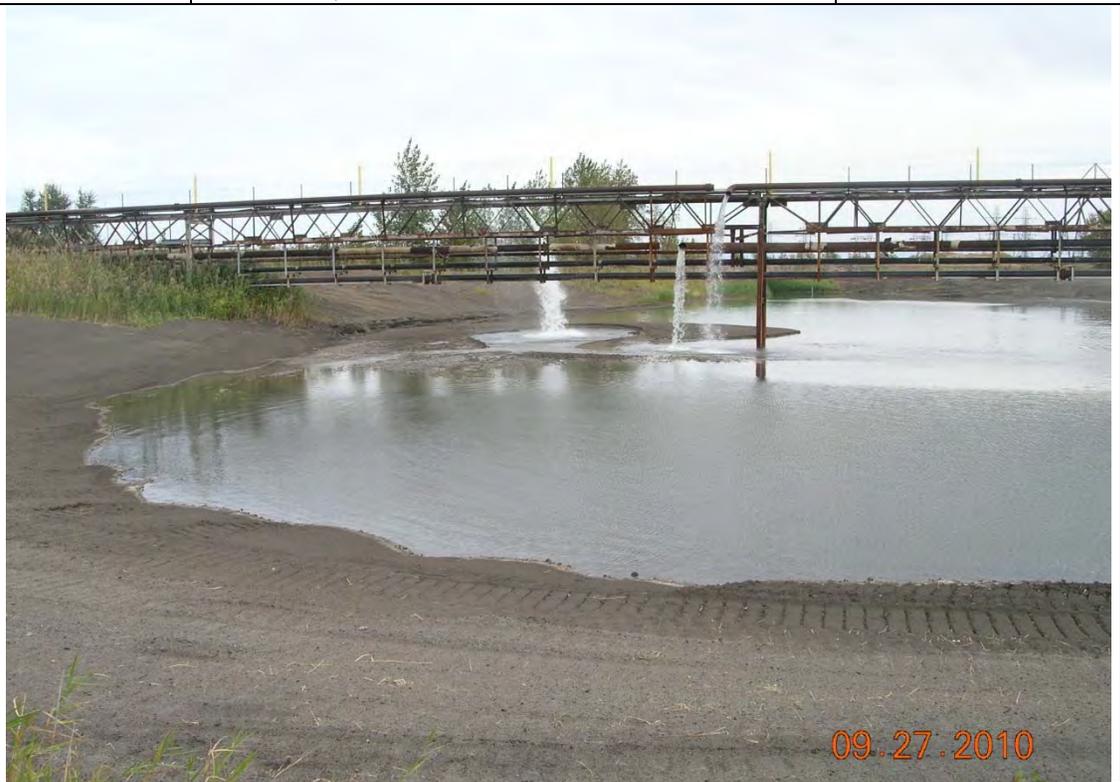
Photo No. 45	Date: 9/27/2010
Direction Photo Taken: East

Description:
Bottom Ash wastewater discharge pond and pipe trestle.

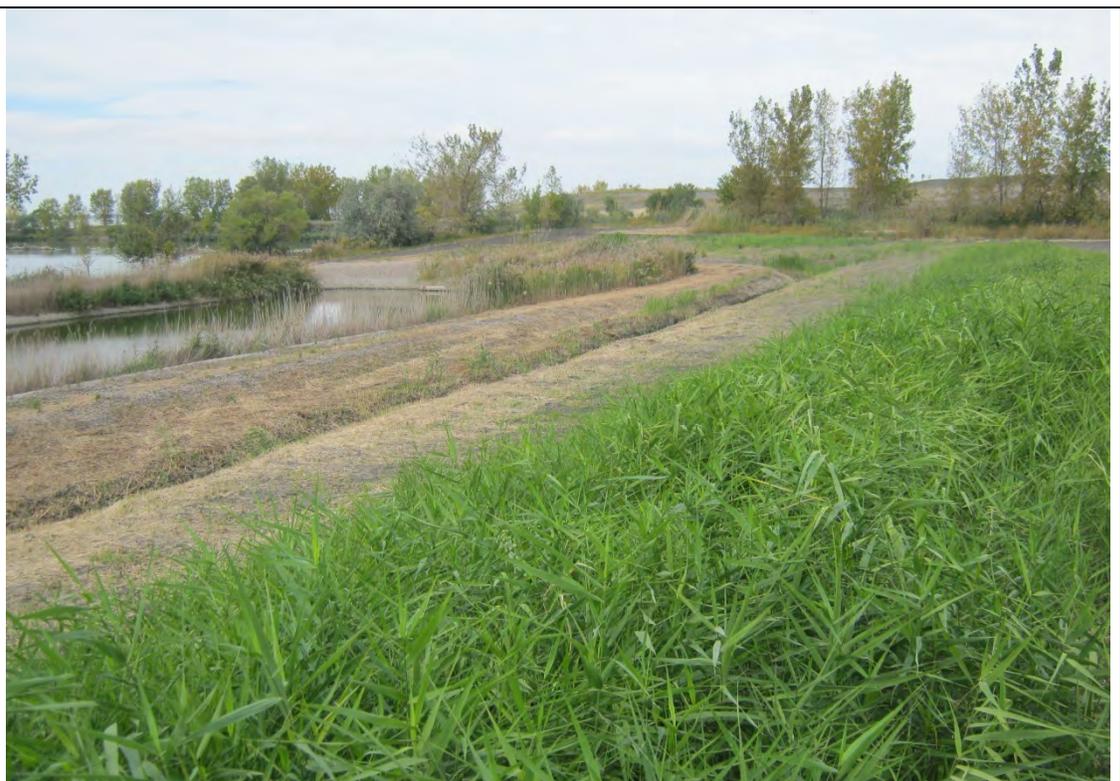
Photo No. 46	Date: 9/27/10
Direction Photo Taken: Northwest

Description:
Chemical treatment ponds are located within the Karn Disposal Area.
