**Coal Combustion Residue Impoundment**

**Round 9 - Dam Assessment Report**

*H. B. Robinson Steam Electric Plant*

*Progress Energy Carolinas, Inc.*

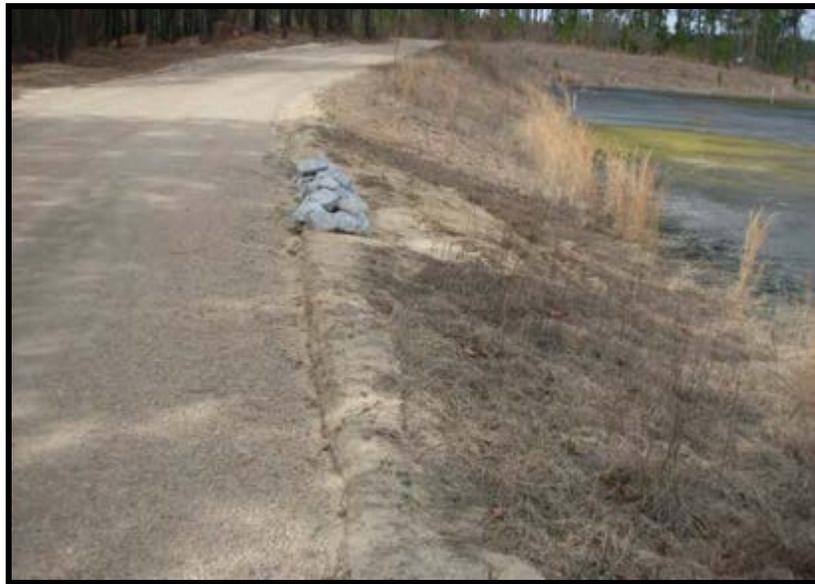
**Photograph 5.2. Minor erosion at the upstream edge of crest at south side of embankment, looking west.**

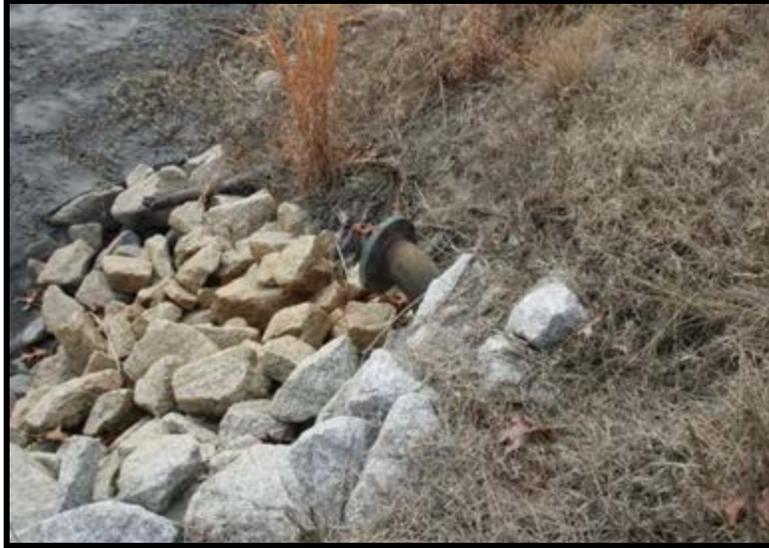
**Photograph 5.3b. Discharge pipe from oil-water separator through north end of Ash Pond embankment.**

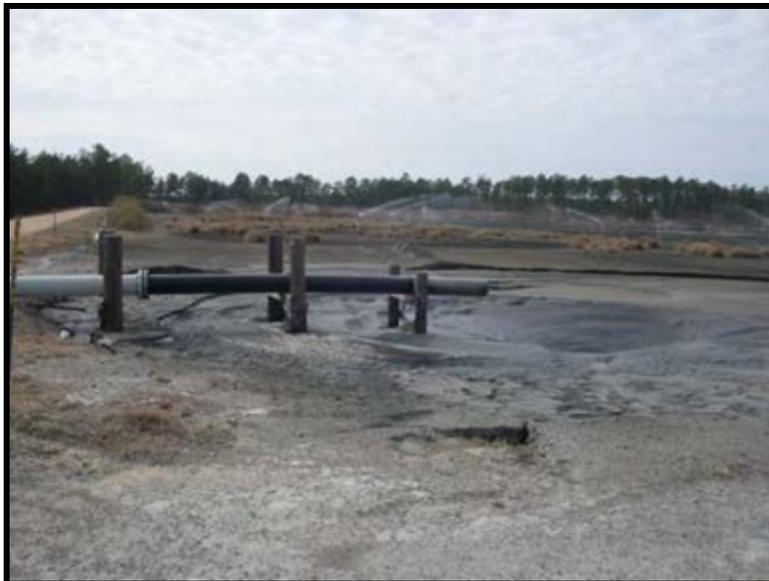
**Photograph 5.3c. View of ash-sludge discharge line and ash-filled south portion of pond, looking south. (Note operation of sprinklers for dust control in south portion of pond).**

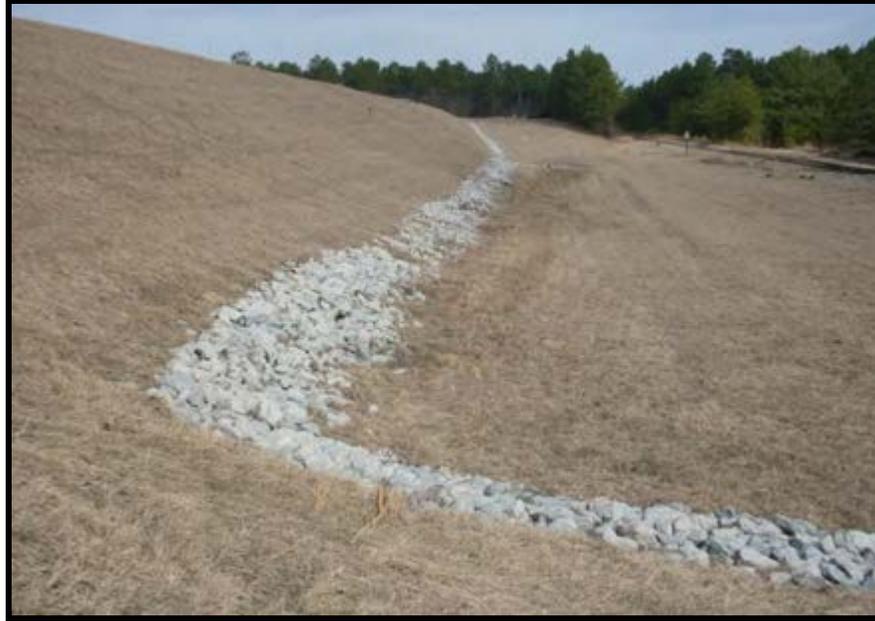
**Photograph 5.4b. Downstream slope and toe of north portion of dike, looking north.**

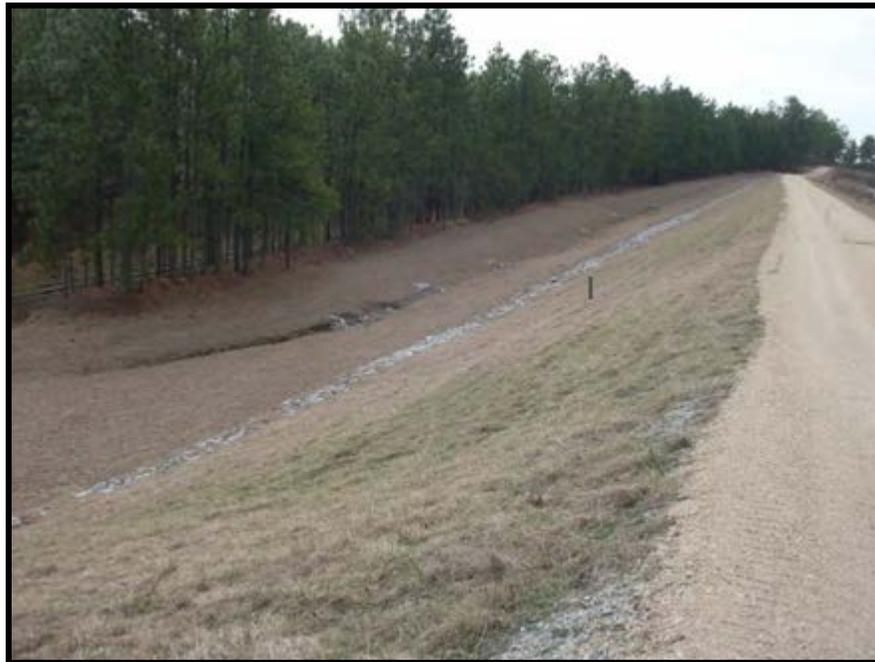
**Photograph 5.4c. Downstream slope and toe of south portion of dike, and south abutment, looking south.**

No erosion or displacements were observed where the finger dike intersects the embankment. No erosion, displacements, or noticeable seepage was observed where the embankment ties into high ground at the north and south ends. Previous erosion of the lower part of the right (south) abutment ditch located beyond the outside toe of the dike was observed. However, it was noted that rock check dams had been placed at intervals across the ditch to control the erosion. The abutment ditch with check dams is visible in Photograph 5.4c.

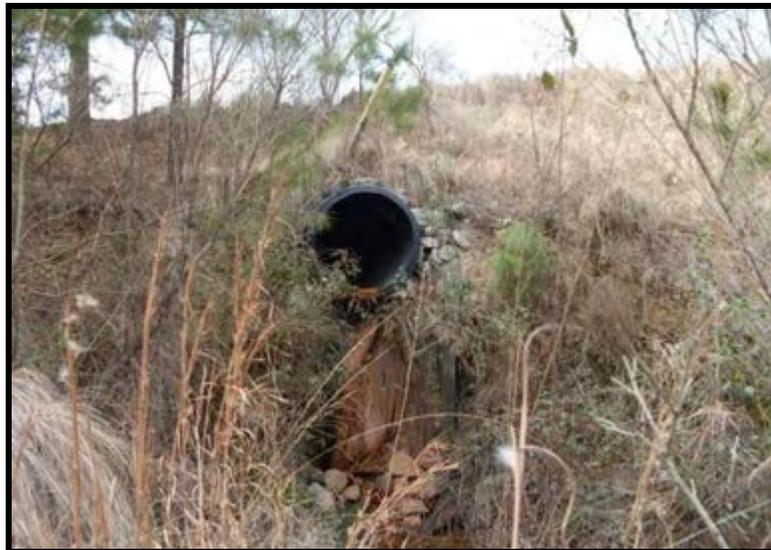
**Photograph 5.9. HDPE outlet into outfall channel downstream of junction box, looking west. (Note steep bank and eroded small riprap around end of pipe,)**

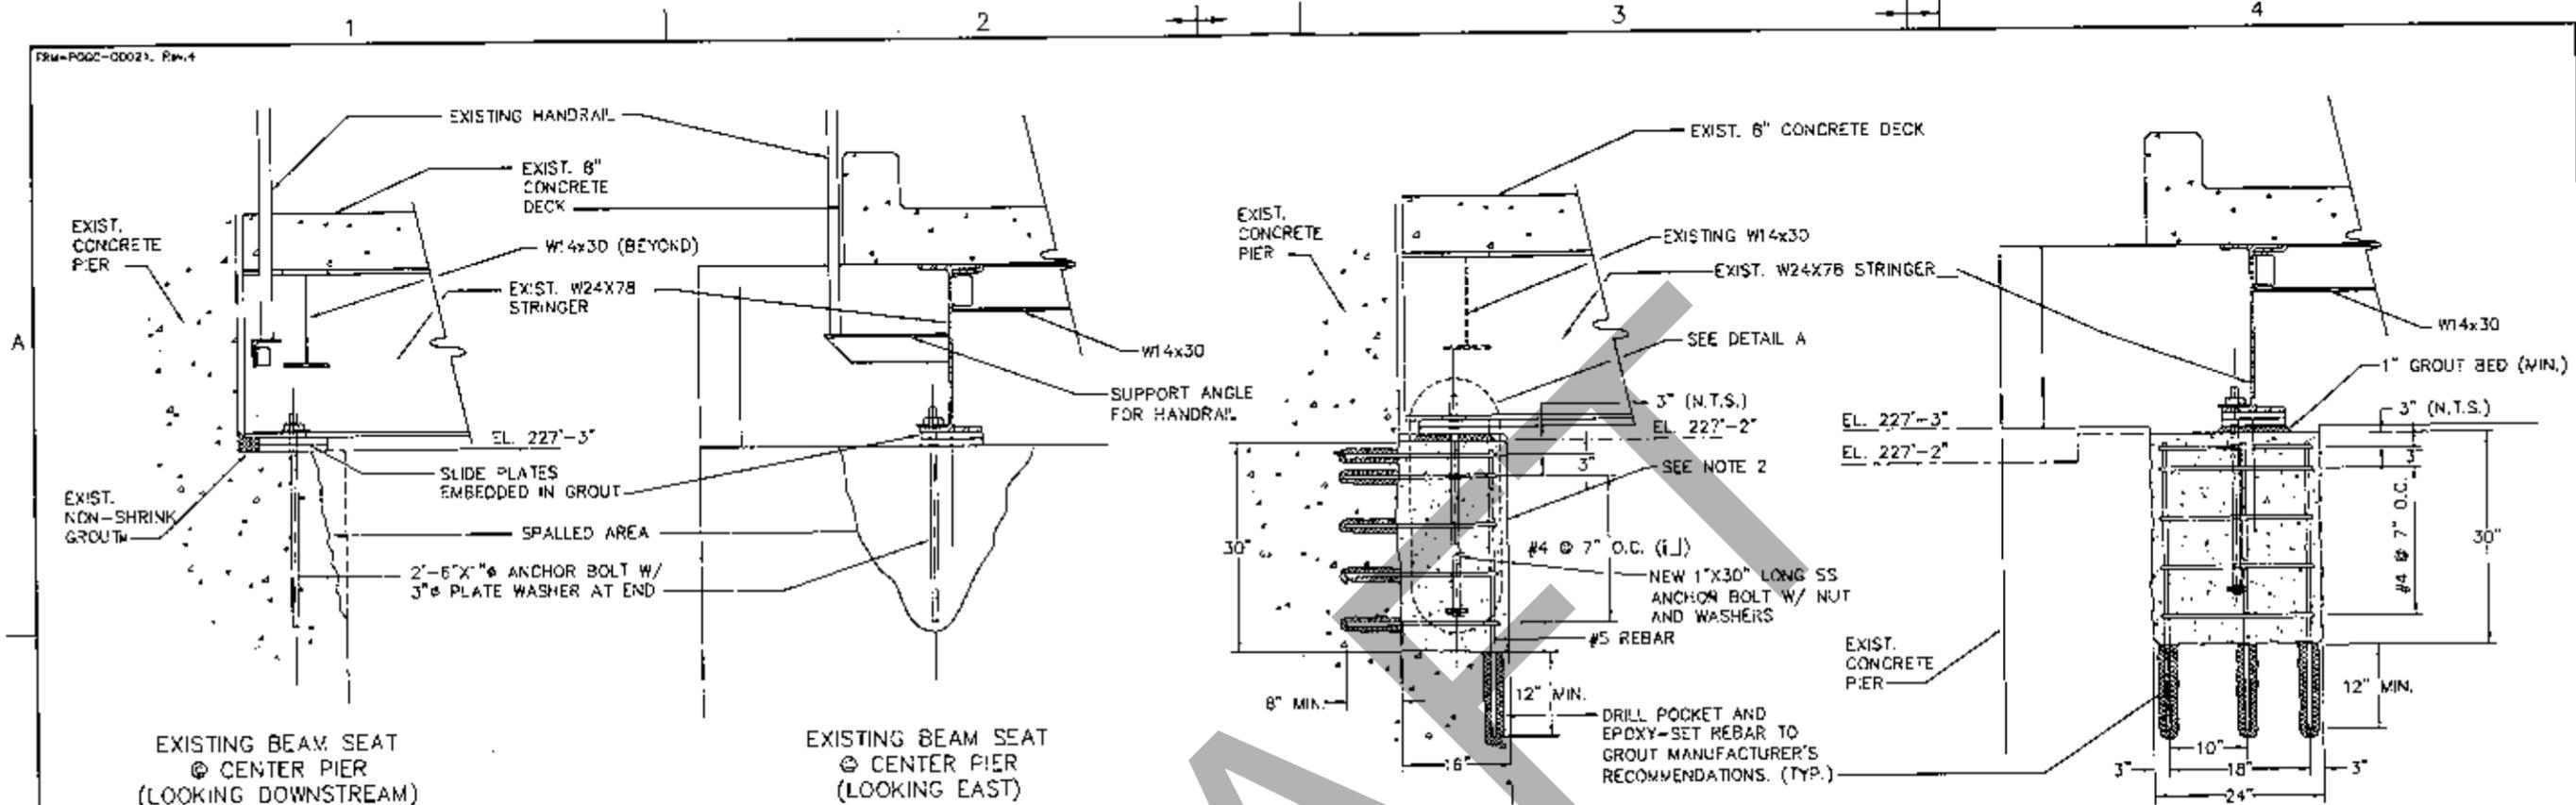
**BEAM SEAT - EXISTING CONDITIONS**

The spillway structure for the dam is in good condition (Photograph 10). The concrete entry walls do not show cracking (Photographs 11 and 12). Two areas of concrete scaling first noted in 1990 on the eastern bridge beam seats of the west spillway bridge were repaired in 2003 in general accordance with plans prepared by Progress Energy and shown in Exhibit 12. Photograph 13

**BEAM SEAT - BEAR PLATE MODIFICATIONS**

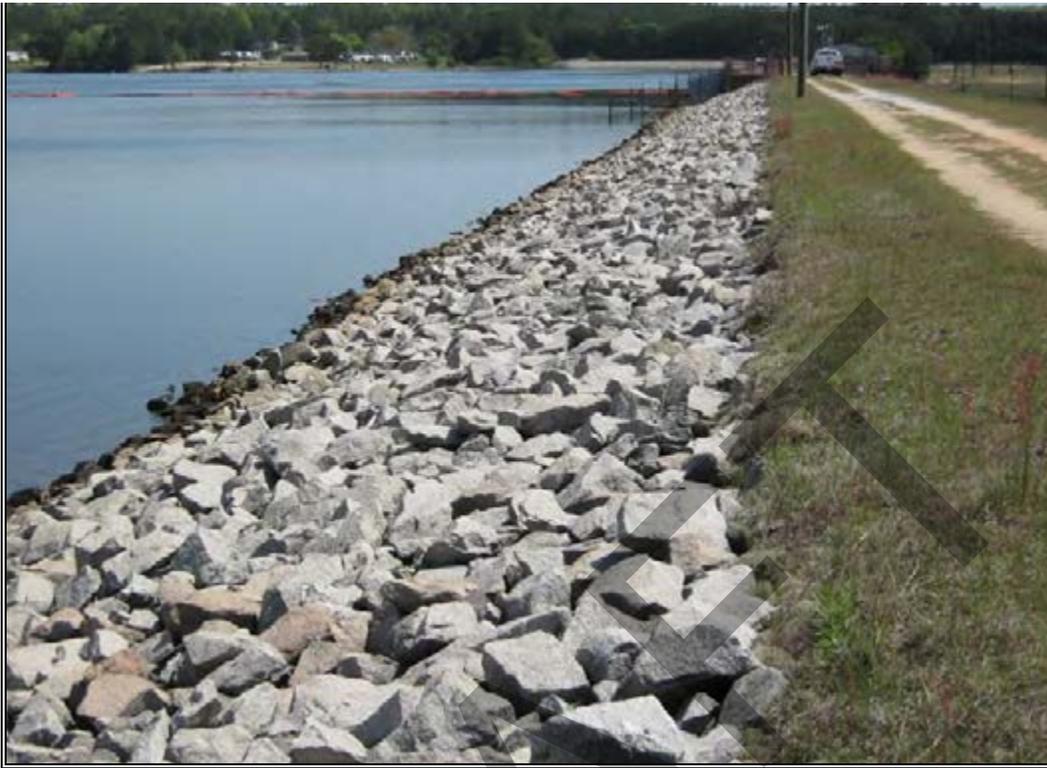
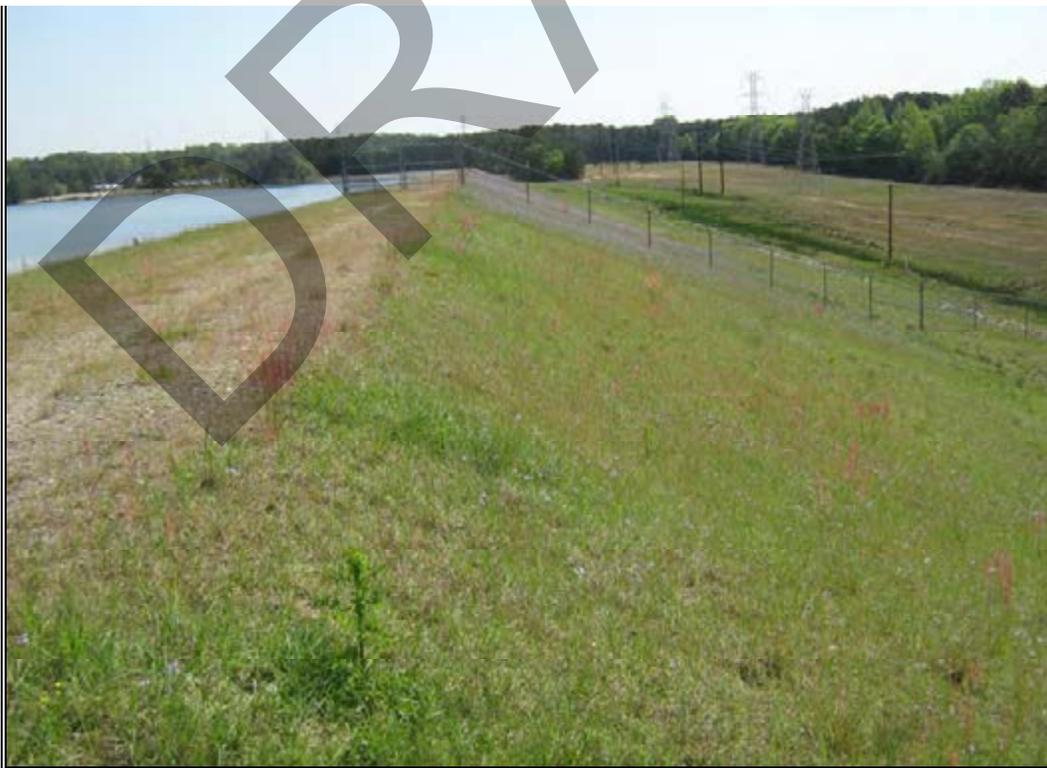
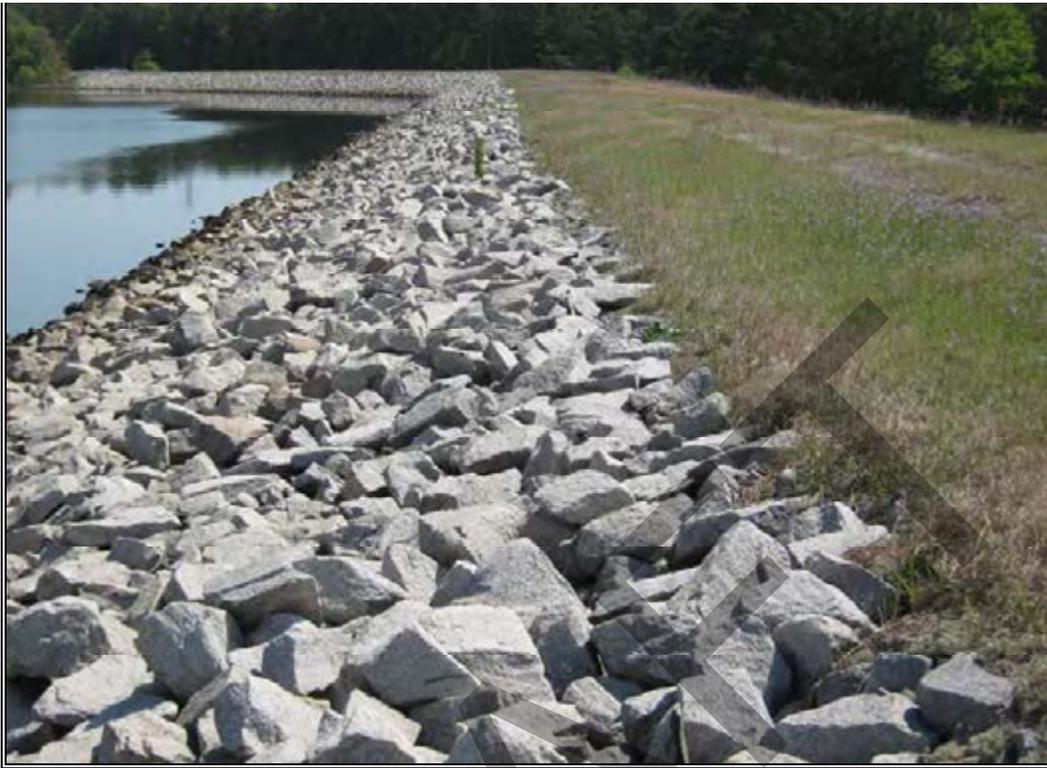
**Photograph 1:**

The cooling lake dam crest, upstream slope and downstream slope are in good condition with no visible dips, sags, slumps, sinks or other evidence of distress (Photographs 1 through 5). The upstream slope above water level is covered with rip rap to within about 3 feet of the crest, The soil portion of the upstream slope and the downstream slope have a well established grass cover. A crushed stone gravel surface covers the crest and provides the erosion protection for the crest. Previous inspections have seen a few instances where it appeared the riprap on the upstream crest had subsided slightly near the crest or crept down slope. The current inspection did not see crest edge depressions, indicating the previous depressions were routinely filled by the maintenance personnel. Any marked increase in the occurrence or the size of the depressions should be brought to the attention of Progress Energy engineers.

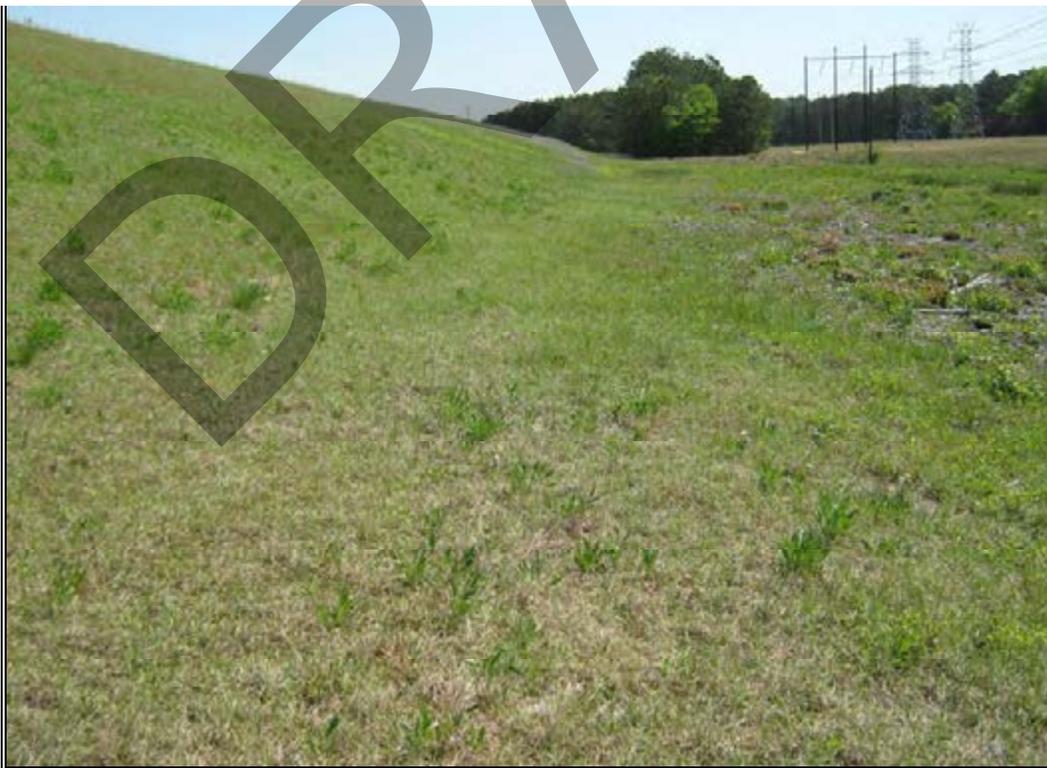
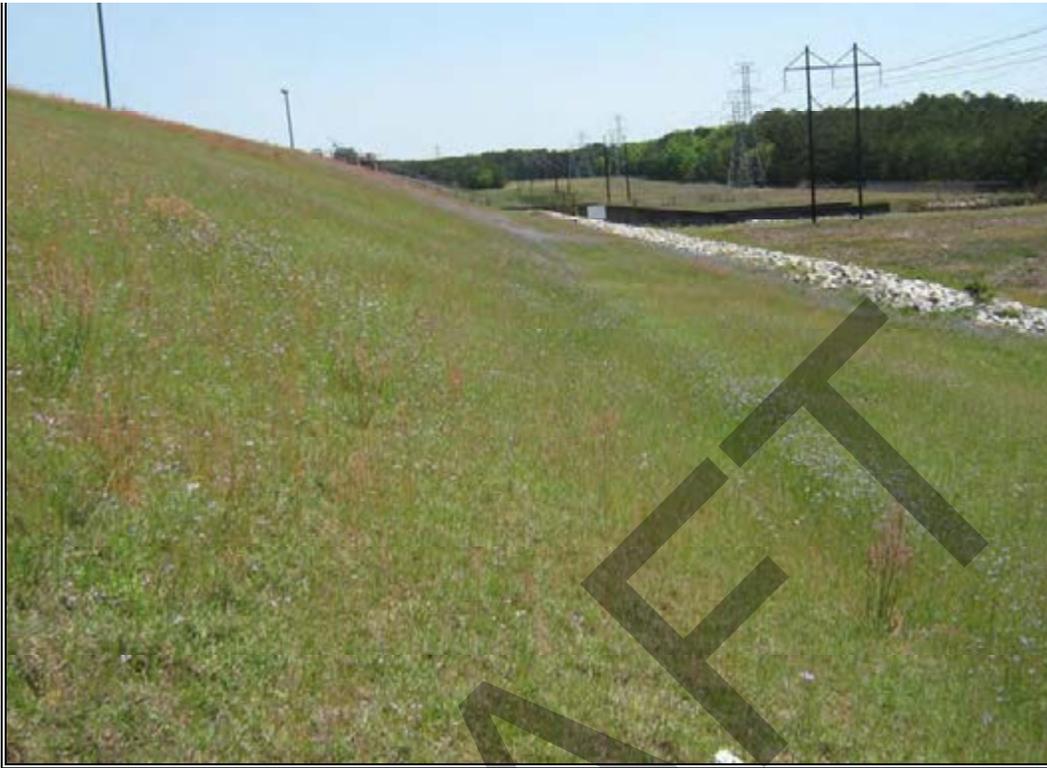
**Photograph 4:**

downstream slope is well vegetated on both east and west sides of the spillway (Photographs 4 and 5).

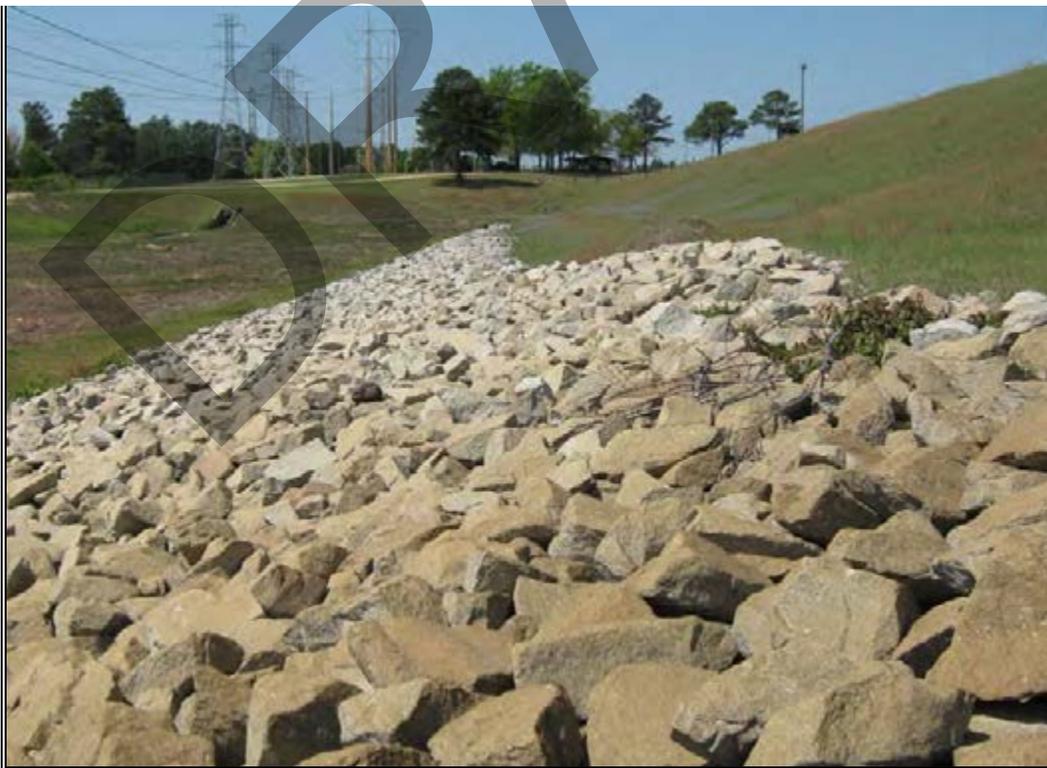
**Photograph 6:**

The lower portion of the downstream slope, on which the rip rap flood protection layer is present, is in good condition. The rip rap west of the spillway has negligible vegetation growth (Photograph 6). The area below the dam has been cleared of trees for security purposes. From near the spillway west for about 300 feet, the natural ground is slightly depressed relative to the adjacent natural ground. Wet conditions due to the poor surface drainage have been observed during some inspection visits. The area was generally dry at the time of the present inspection. The sporadic wet conditions are not interpreted as seepage and appear to present no dam safety concerns.

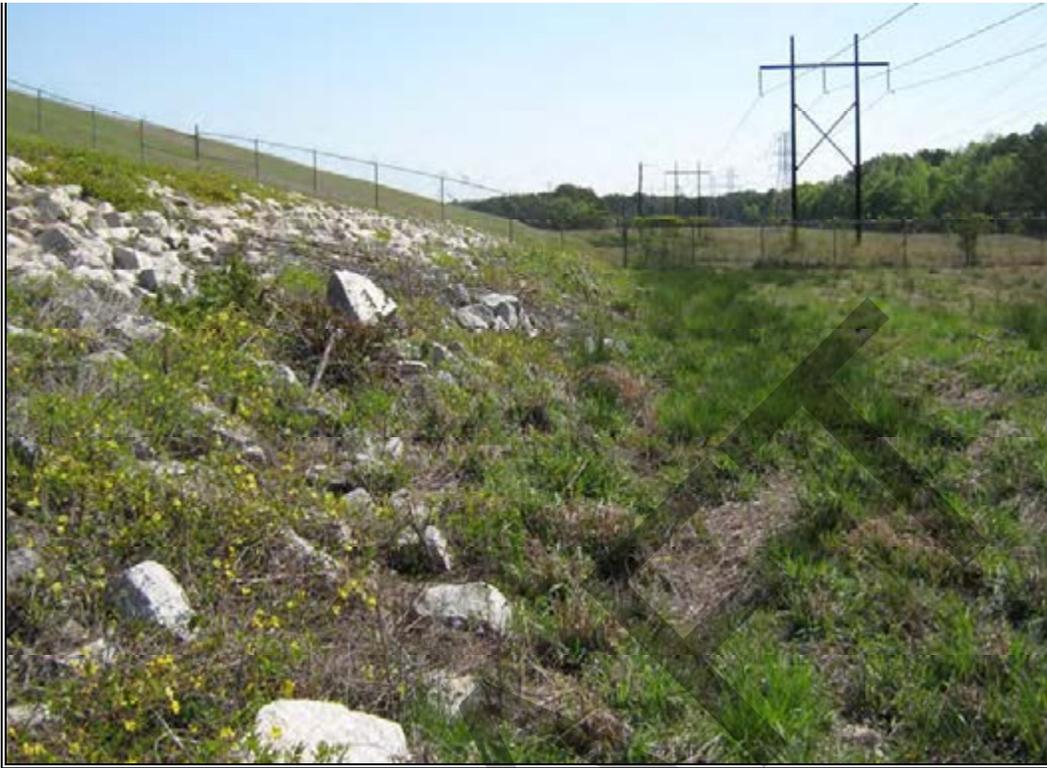
**Photograph 7:**

East of the spillway, the rip rap on the lower part of the dam is in good condition with some minor vegetation (Photograph 7). Progress Energy continues to cut and spray the vegetation in the rip rap to control growth. Some standing water was noted in the natural ground just beyond the toe of the dam in an area of low topography and ruts from mowing equipment (Photograph 8). The area is evident by color change in vegetation (Photograph 9). A walk along the toe of the dam did not find water emerging from the riprap. These areas have been observed during past inspections.

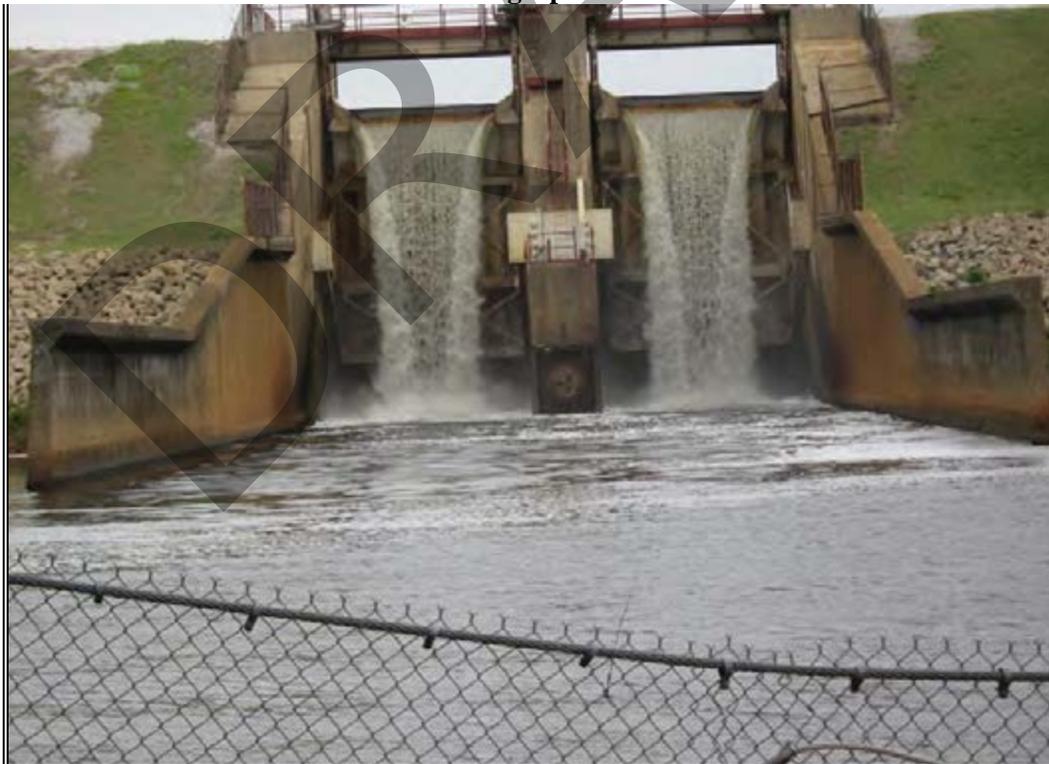
**Photograph 14:**

The spillway training/retaining walls are in good visual condition (Photographs 14, 15 and 16). The offsets in the spillway side retaining walls noted in previous inspections appeared to show no change. A crack movement gauge (now broken) was placed on the west wall offset in 1996 (Photograph 17). A similar monitor was placed on the east wall at the request of the State of South Carolina Department of Health and Environmental Control after their routine inspection conducted in 1999. Movements monitored since 1996 (west wall) and since 2000 (east wall) were erratic, but less than 1 millimeter in any direction. There are no signs of wall distress and the movements seen are not unusual for walls of their design and height. After review of the monitoring records in 2004 by MACTEC, a recommendation was made to discontinue monitoring based on the lack of change. The South Carolina Department of Health and Environmental Control agreed with the recommendation.

Water discharged from the spillway flows into a downstream channel lined with rip rap (Photograph 14). The banks of the channel appear stable and adequately maintained. The artesian water flow encountered during construction in 1961 was piped through the 6-inch diameter drain line at the spillway channel (Photograph 29). The drain line is flowing at a rate approximately the same as observed in previous inspections. Iron sediment deposits accumulate inside the pipe (Photograph 30). It appeared these deposits had been partly cleared since the last site visit in 2009. We recommend the pipe be cleaned of accumulated deposits when they block approximately 50% of the pipe opening.

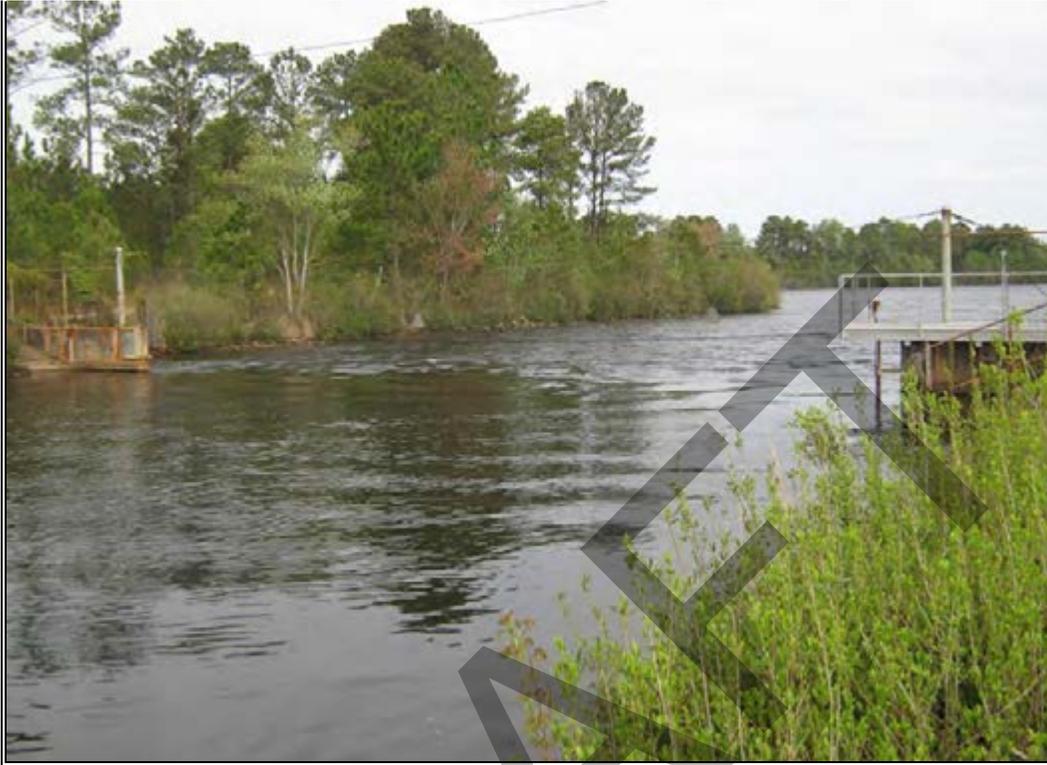
**Photograph 40:**

The discharge canal has a strip of natural ground between the lake and the canal. The lake side slope has riprap and natural vegetation (Photograph 40) that is in satisfactory condition.

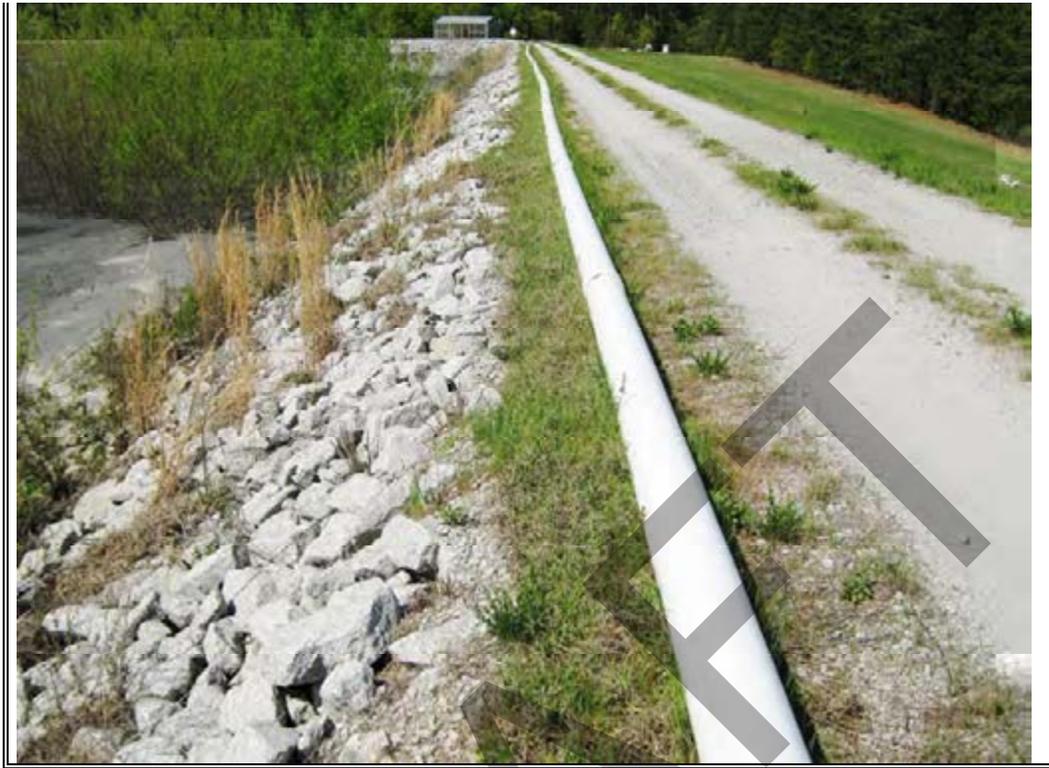
**Photograph 41:**

of distress were seen, and the weir end structures were in apparently good condition (Photograph 41).

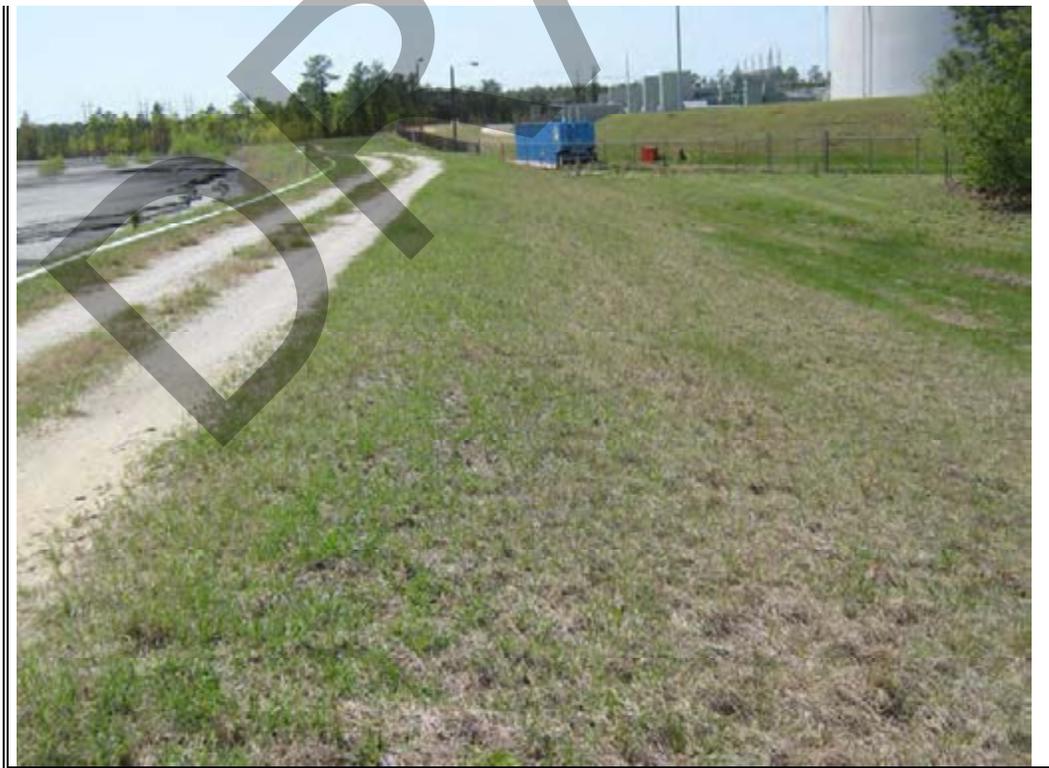
The crests of the northern and southern ash pond dike sections and the separator dike are in good visual condition with no significant visible dips or other evidence of distress (Photographs 42 through 45). A gravel road is present in the center of the dikes with sparse grass growth in the gravel and moderate grass growth where there is no gravel.

**Photograph 42:** Crest and upstream slope of North Pond dike.

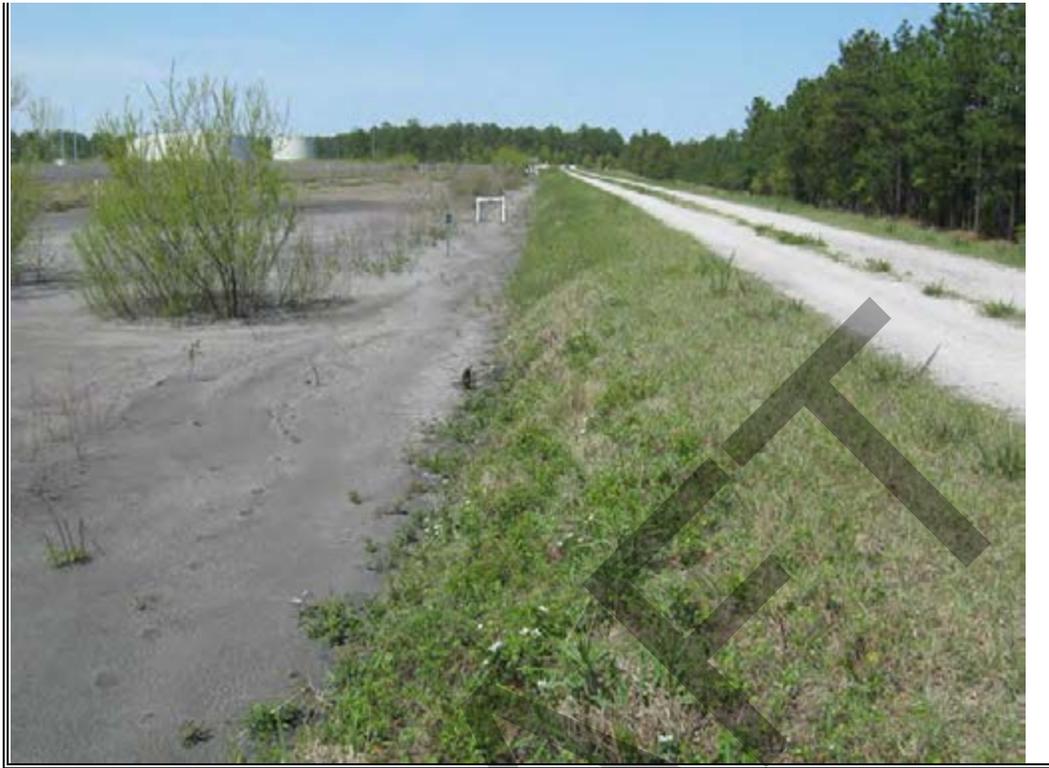
**Photograph 43:** Crest and exterior of northern extension dike at North Pond.

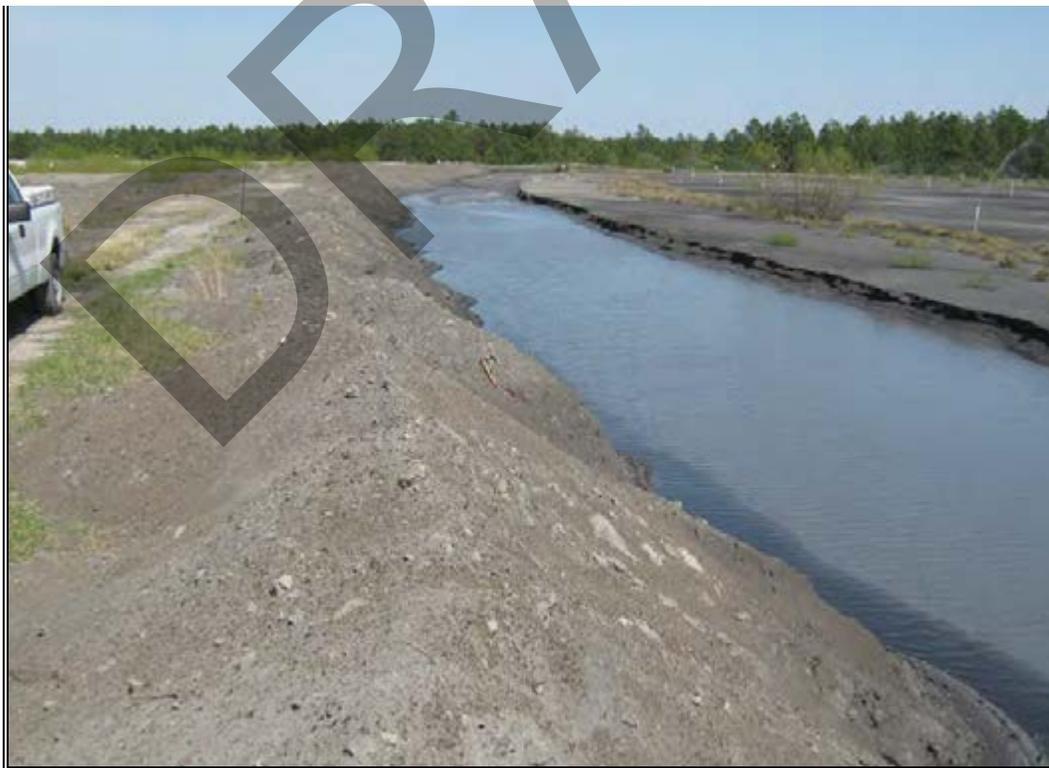
Because of the sedimented ash, the interior slope of the south section has no impounded water against it. The slope is has been cleared of small trees and briars; a grass cover remains and is in good condition (Photograph 44). The vegetation is effective for controlling erosion from surface runoff. Progress Energy cuts small trees if they begin to appear. Evidence of active animal burrows has been reported on the interior slope of the south dike in some previous inspection reports. No burrows were seen during the present inspection. Progress Energy fills in animal burrows when they are observed.

**Photograph 44:** Crest and interior slope of South Pond dike.

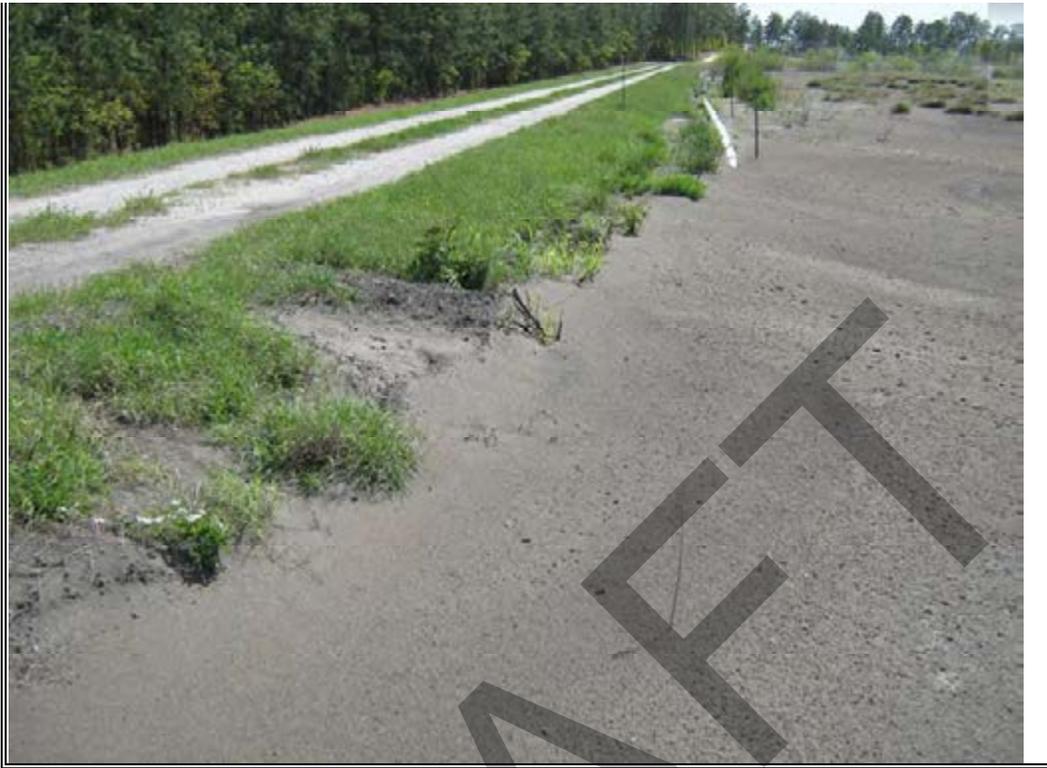
**Photograph 45:** Crest and south side of separating dike between North and South Ponds.

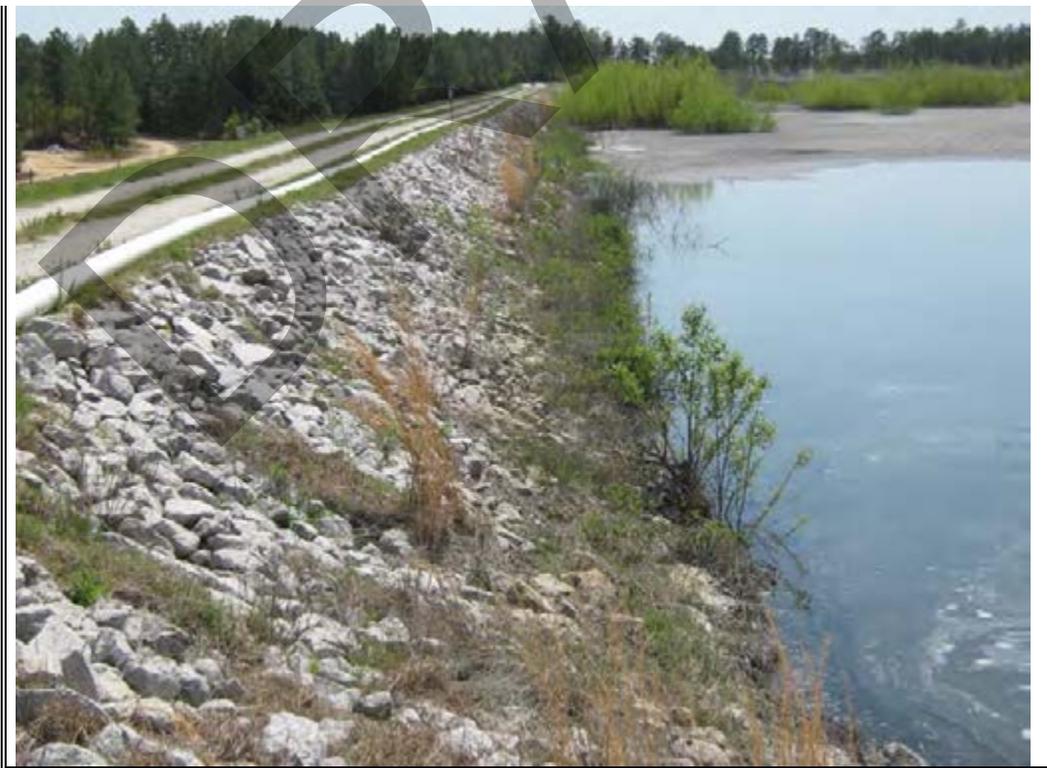
The sedimented ash has reduced the available freeboard for the south dike in an area near the ash discharge line (Photograph 46). In this area, the freeboard appears to be as little as 12 inches below the top of the dike. From the hydrologic studies made during the design of the dike raise in 2002, this is the minimum freeboard needed under the design storm (50-year, 24-hour). Further

**Photograph 46:** Limited freeboard of South Pond dike near ash line discharge.

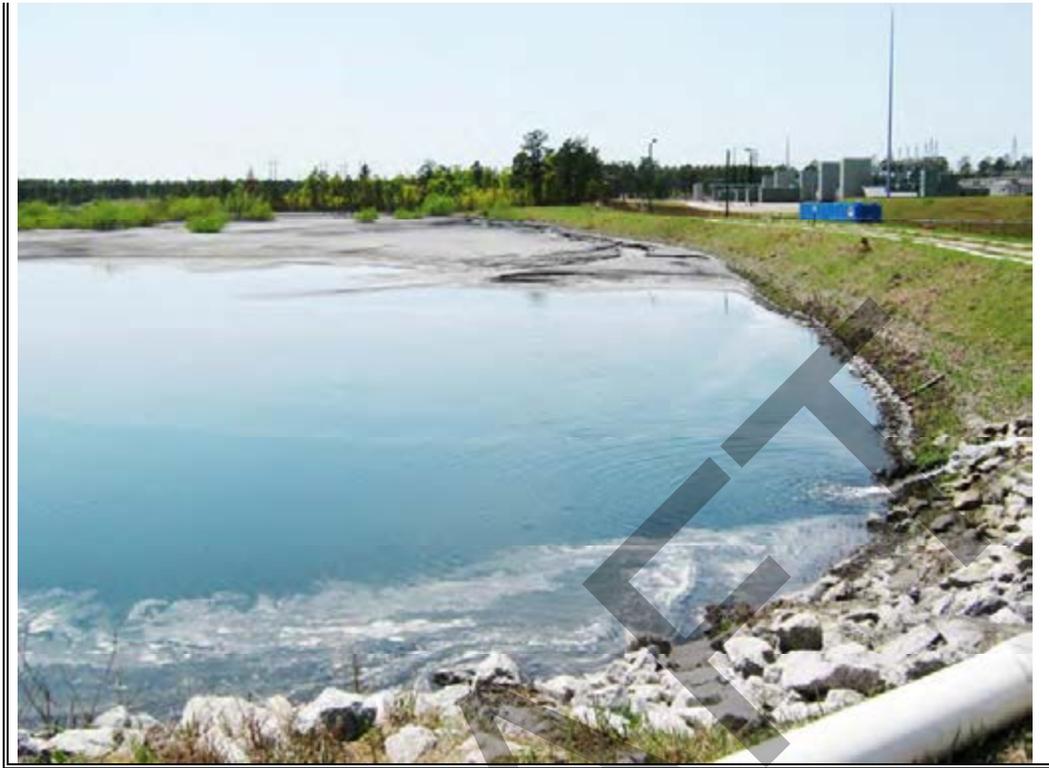
The interior slope of the north section is in good condition (Photographs 42 and 47). There is minor vegetative growth in the slope rip rap. Spraying is recommended to keep the vegetation under control. Sedimented ash has accumulated in the pond; the ash level is approximately 38 inches below the top of the riser pipe, or approximately elevation 266.3 feet. Some water is ponded in the north end of the pond and is against the dike. Progress Energy reported that the water level in the pond had risen to within about six to eight inches of the top of the riser during some extended rain events, but had not overtopped the riser.

**Photograph 47:** Interior slope of North Pond dike. Note minor vegetation.

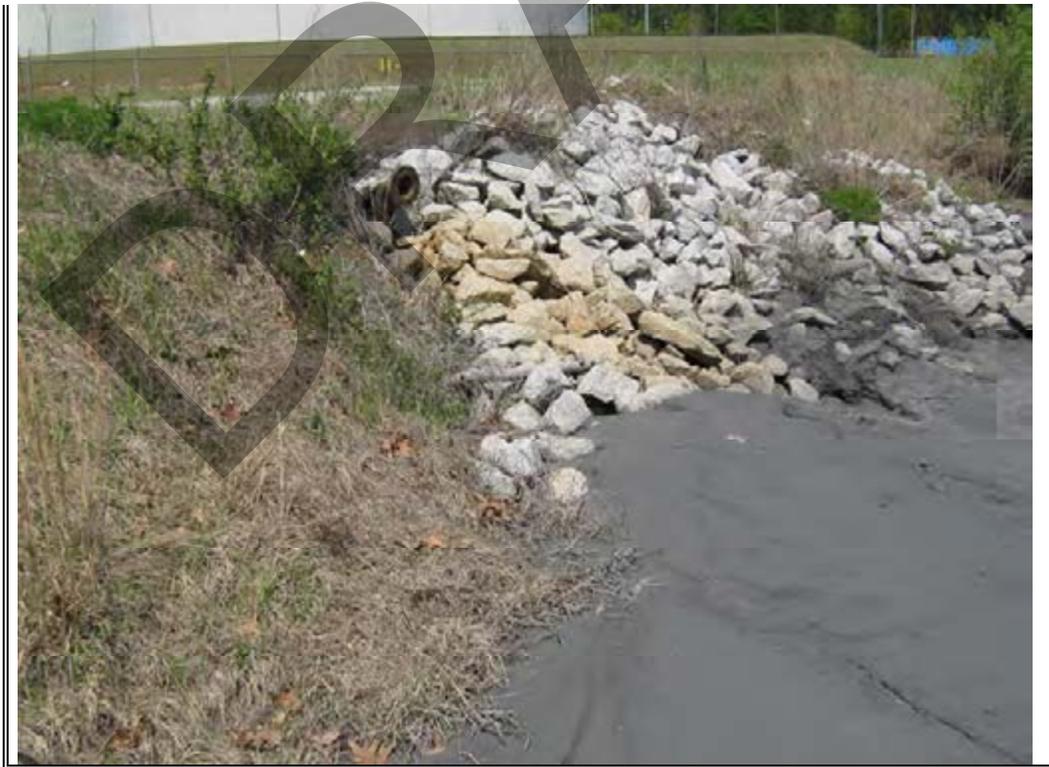
The dike raise in 2002 created a low height dike on the north end of the pond that continues west from the main dike. The crest, interior and exterior slopes of this dike are in good condition (Photograph 48). There has been a continuing minor erosion condition where a drain pipe from the Darlington oil-water separator penetrates the dike to discharge into the ash pond. The erosion has been stabilized reasonably well with rip rap (Photograph 49). The outflow from the Darlington pipe discharge has created an erosion channel in the ash adjacent to the dike that can be seen in photograph 48, but it does not pose a safety risk for the dike. At the intersection of the west extension with the north dike, the riprap placed in 2005 is in reasonably good condition (Photograph 50). Similar erosion at the intersection of the north dike and the separator dike that was also repaired with rip rap is in good condition.

**Photograph 48:** Interior slope of northern extension dike at North Pond.

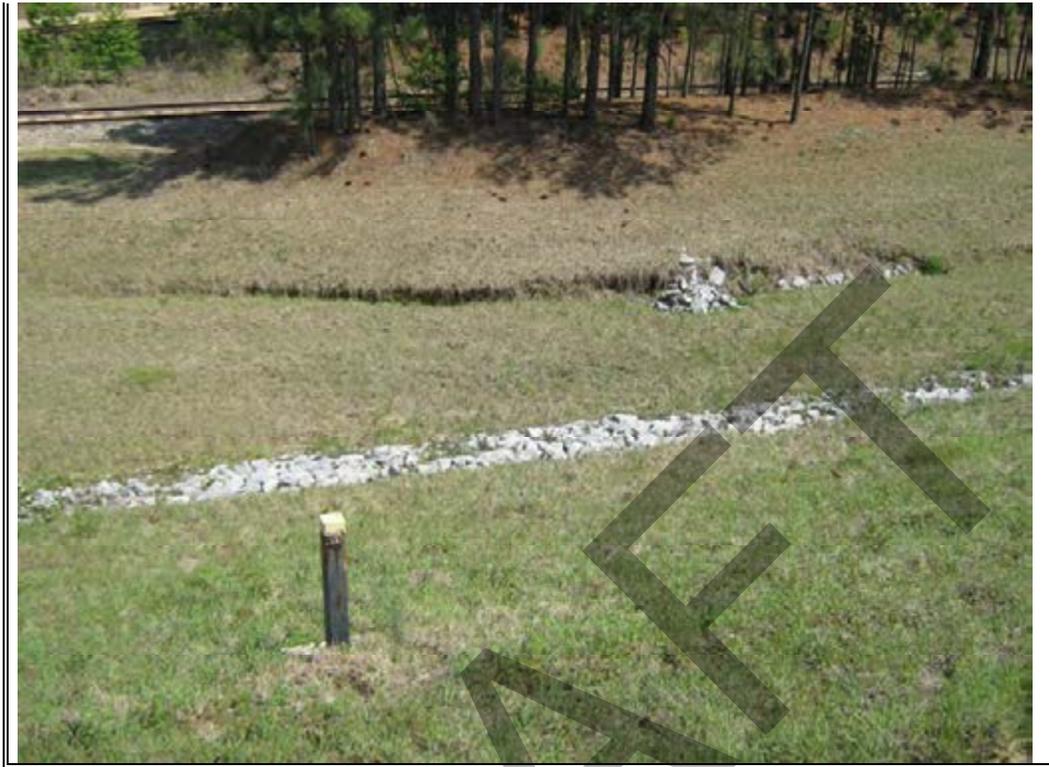
The exterior slope of the south dike is in good visual condition with a good grass cover (Photograph 51). No trees were noted. No indications of seepage, slumps or significant surface erosion were seen. A surface drainage ditch was constructed roughly parallel to the toe of the south dike and about 25 to 50 feet away. There has been erosion in the ditch resulting in deepening. Rock check dams were constructed in 2003. These are generally retarding the erosion and grass has taken root in the ditch and adjacent areas (Photograph 51). Some erosion is still present near the lower end of the ditch (Photograph 52). The ditch erosion is not impacting dam safety. If further erosion deepening or bypassing of rock check dams occurs, additional rock placement may be necessary.

**Photograph 51:** Exterior of South Pond dike. Note good vegetative cover of slope and drainage ditch adjacent to dike toe.
