**Coal Combustion Residue Impoundment**

**Round 9 - Dam Assessment Report**

*H. B. Robinson Steam Electric Plant*

*Progress Energy Carolinas, Inc.*

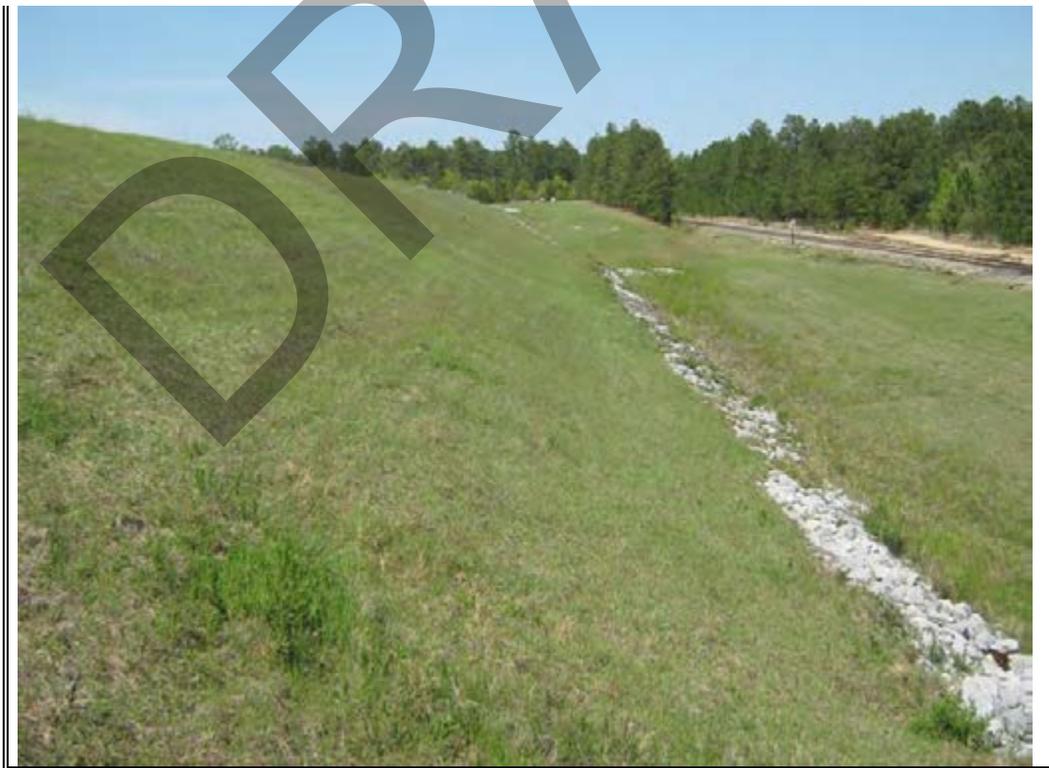
**Photograph 52:** Old erosion in drainage ditch area adjacent to South Pond dike toe.

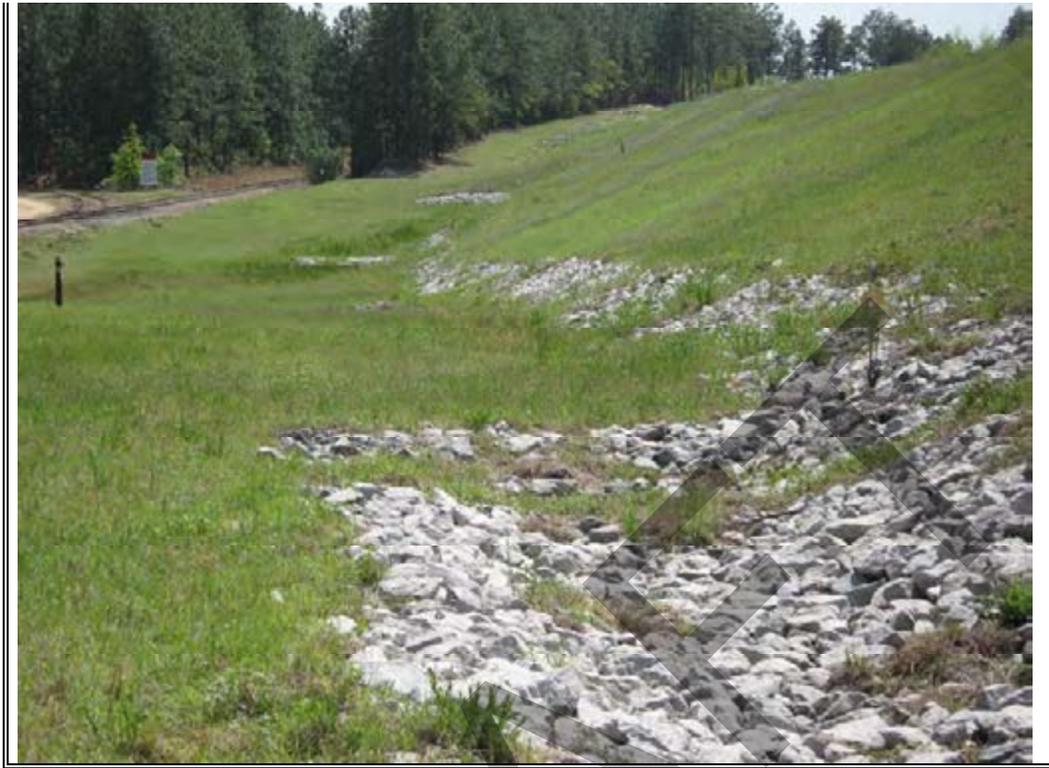
The exterior slope of the north dike is in good visual condition with a good grass cover (Photographs 53 and 54). Small spots where soil above the toe rip rap had eroded into the rip rap have been noted during some past site visits. These are routinely filled with gravel by Progress Energy. A few similar spots were noted in the area north of the catch basin (Photograph 55) and will be filled. A storm drain culvert passes under the north end of the north dike and outlets onto a rip rap apron. The apron was in good condition; grass has grown up in the rip rap, but the grass does not affect its function (Photograph 54). There was some ditching erosion adjacent to the downstream toe prior to a good vegetative cover being established. This ditching now has vegetation, and some rock check dams have been constructed (Photograph 56). The erosion appears inactive.

**Photograph 53:** Exterior slope and rock toe of North Pond dike.

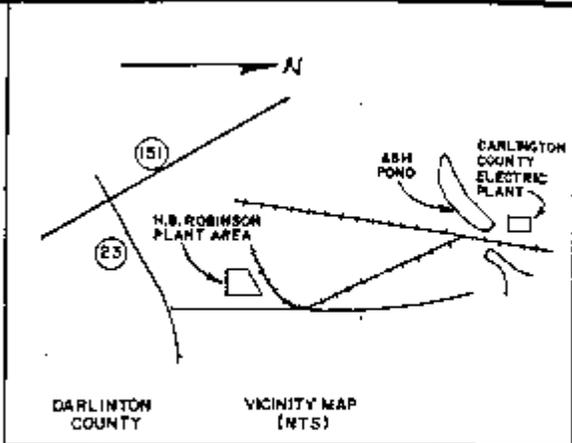
PIEZOMETRIC SURFACE OF THE  
UPPER AQUIFER AT THE PLANT SITE,  
MARCH 24, 1983  
FIGURE 2.4.7-7

With the assumption that the permeability value of 194 gpd/ft<sup>2</sup> is representative for the upper aquifers at the site, the velocity of ground water movement can be computed. In Figure 2.4.7-7, a map of the piezometric surface of ground water is shown. The direction of ground water flow is normal to the piezometric contours, and its velocity is a function of gradient and permeability. The general flow lines on the map indicate that ground water moves toward the ash pond from its north side and ultimately toward Lake Robinson.

The shortest route of travel from the ash pond to the lake is from the dam to the lagoon, a distance of 400 feet. From the mid-point of the west bank of the ash pond, the route of flow is rather circuitous, as shown on the map (Figure 2.4.7-7), and is approximately 3550 feet in length, ending at the discharge canal.

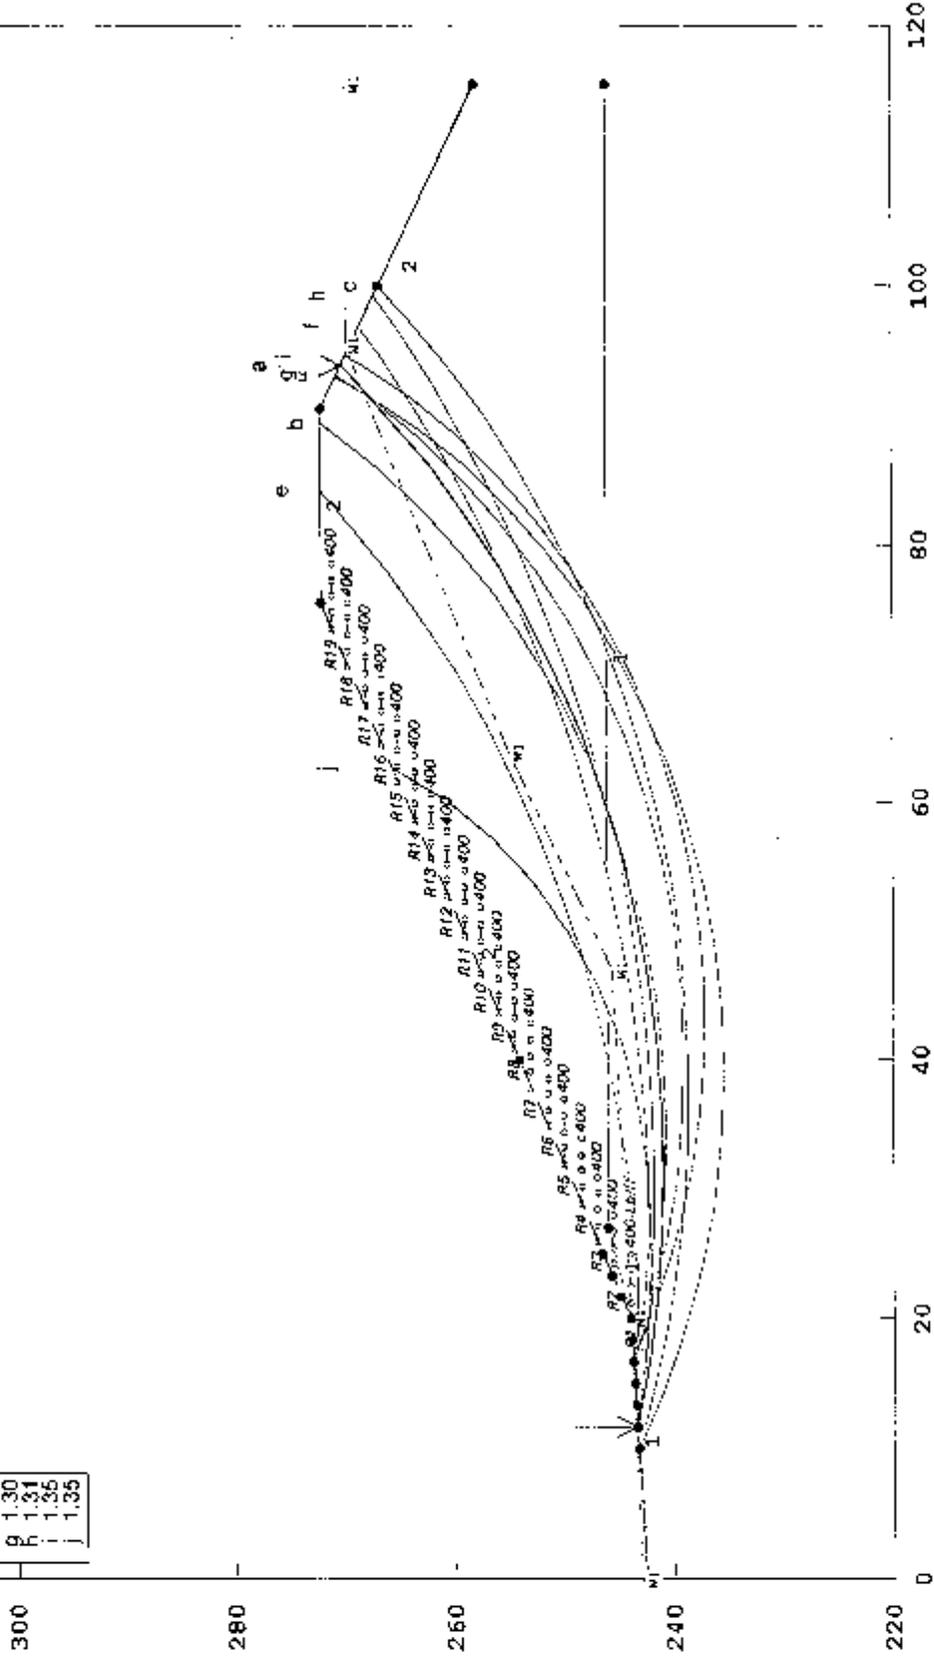
STABL6H FSmin=1.26  
Safety Factors Are Calculated By The Modified Bishop Method

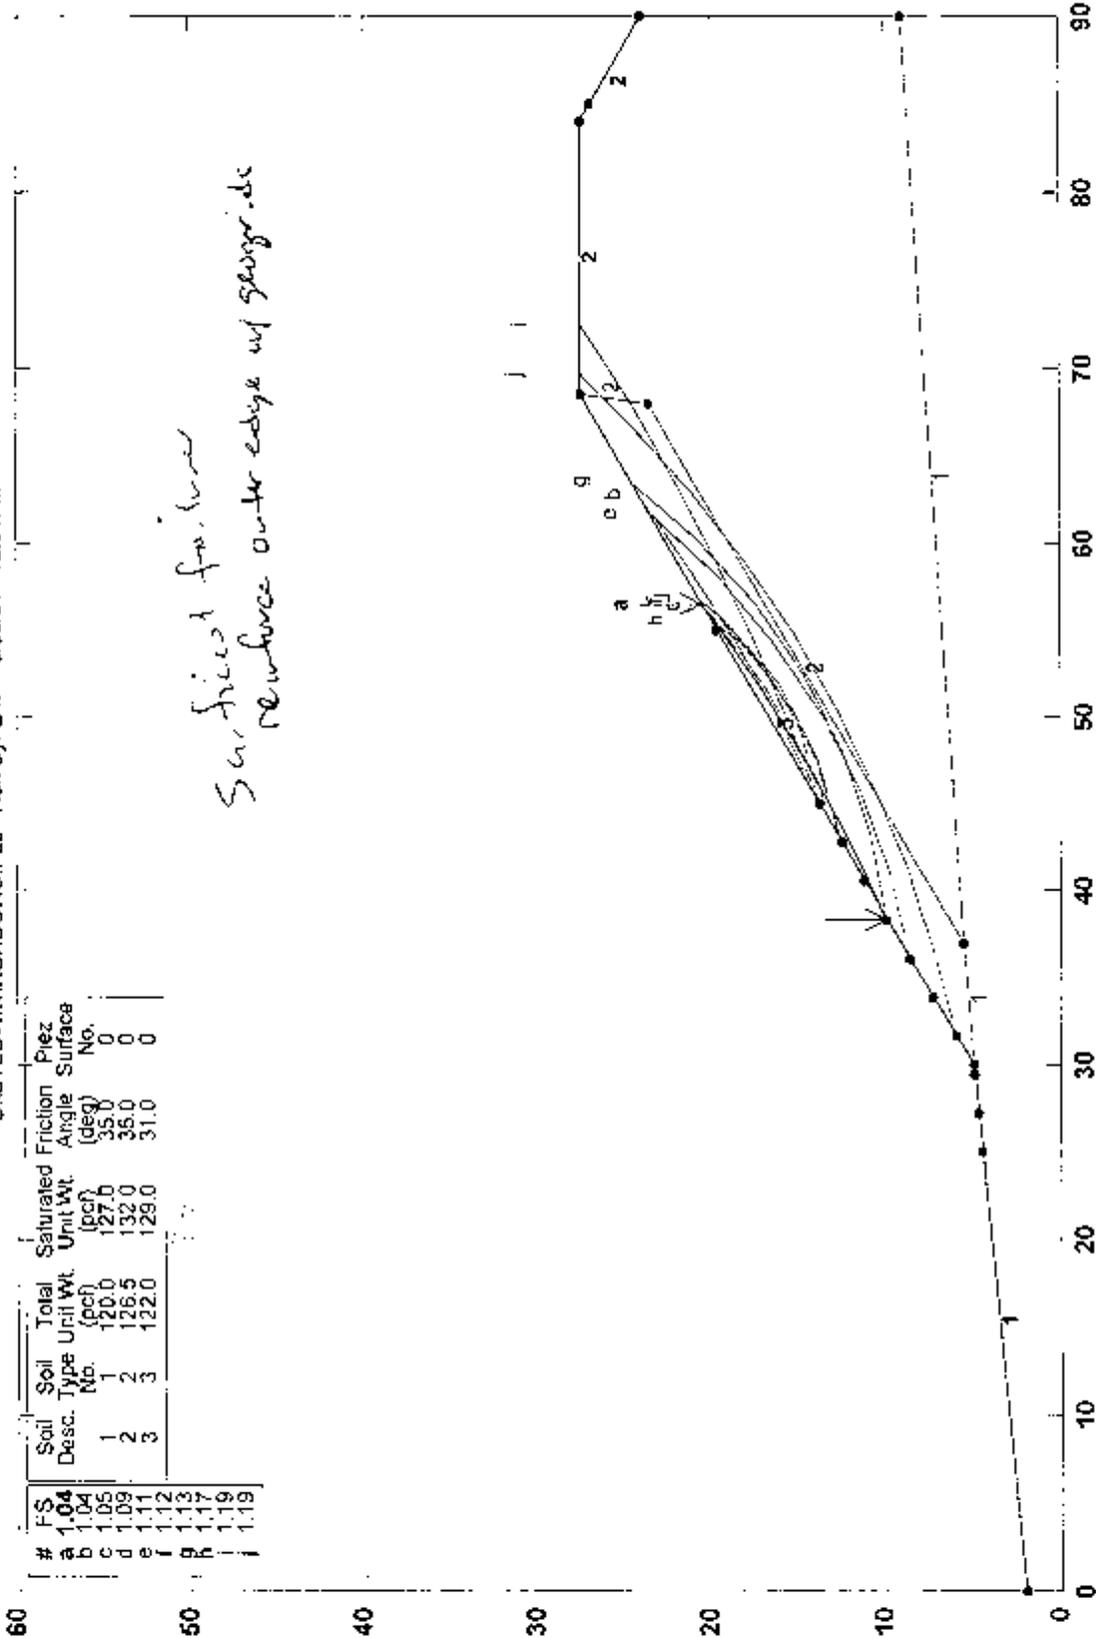
*Surficial failure  
Reinforce outer edge of geogrids*

PCSTABL5M/si FSmin=1.04  
Safety Factors Are Calculated By The Modified Bishop Method

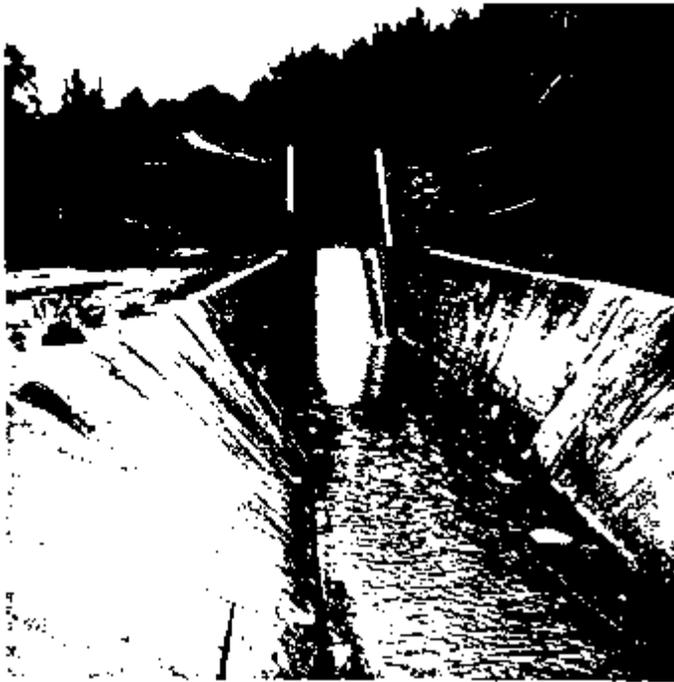
Photo No. 5

Station Drainage Outfall Structure,  
Note weep holes in Invert.

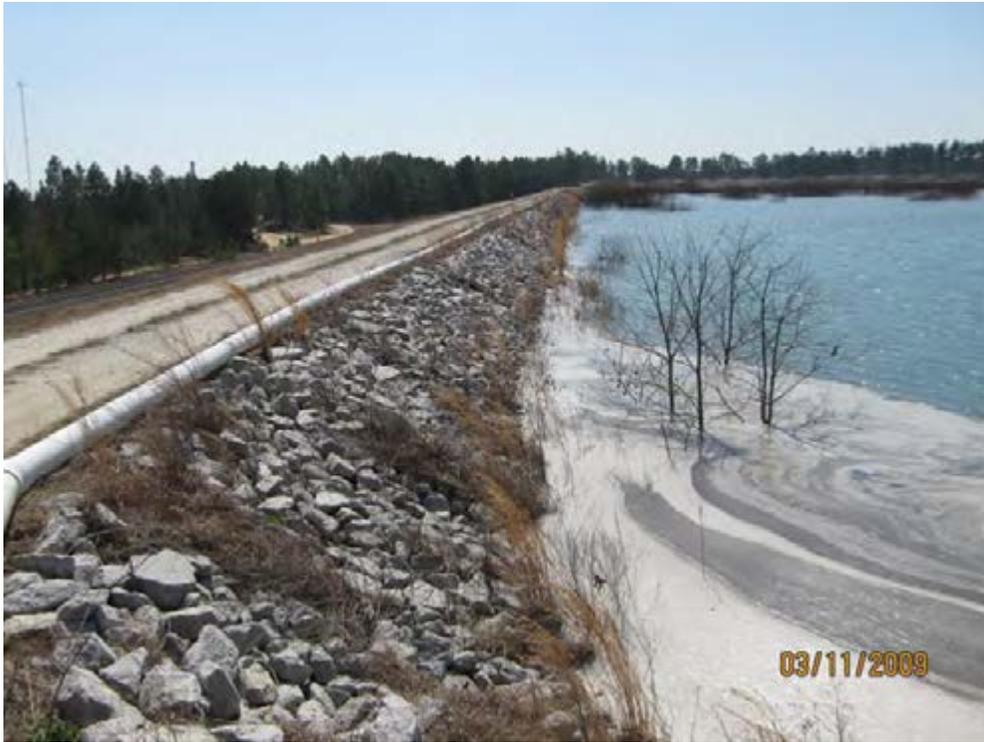
1. ASH POND - Crest and interior slope of north pond area looking south.

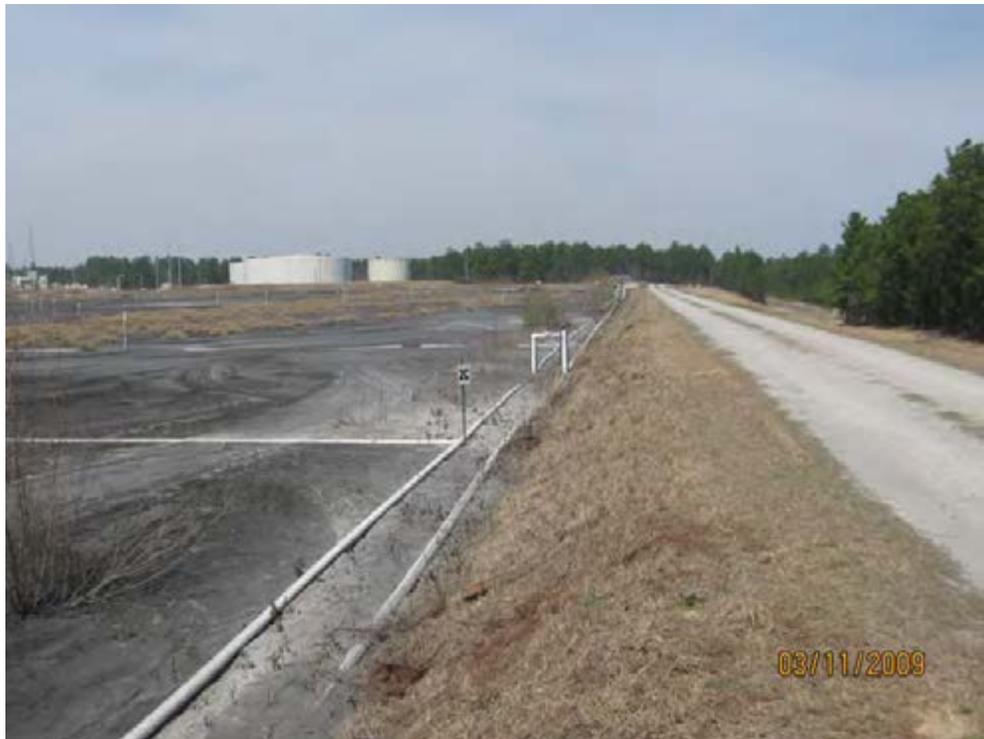
2. ASH POND – Crest and interior slope of south pond area looking north.

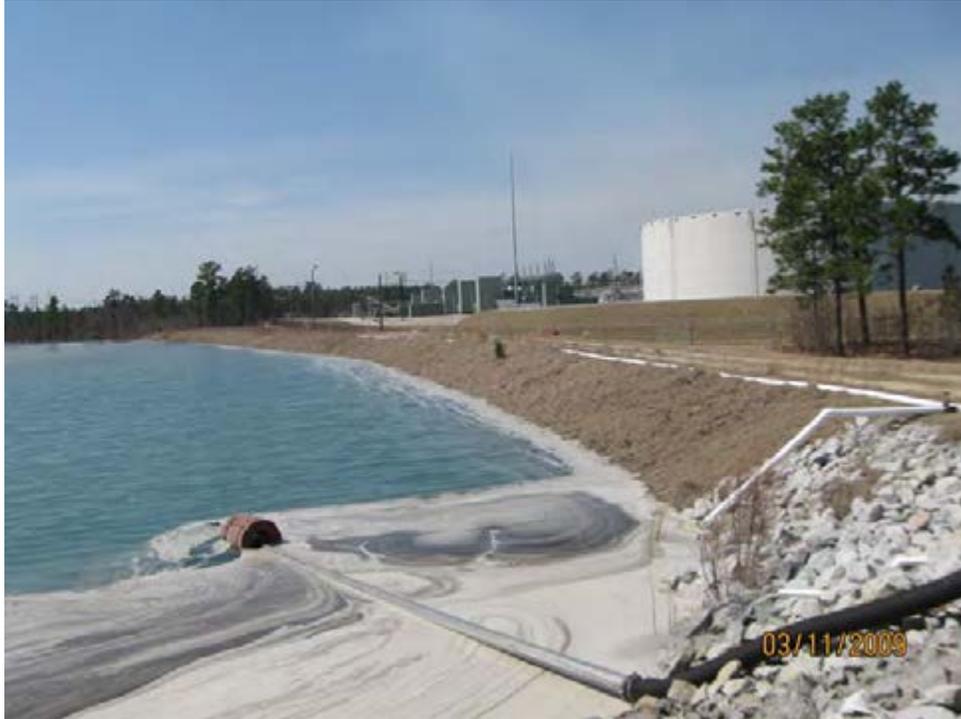
3. ASH POND – Crest and interior slope of north dike of north pond looking west.

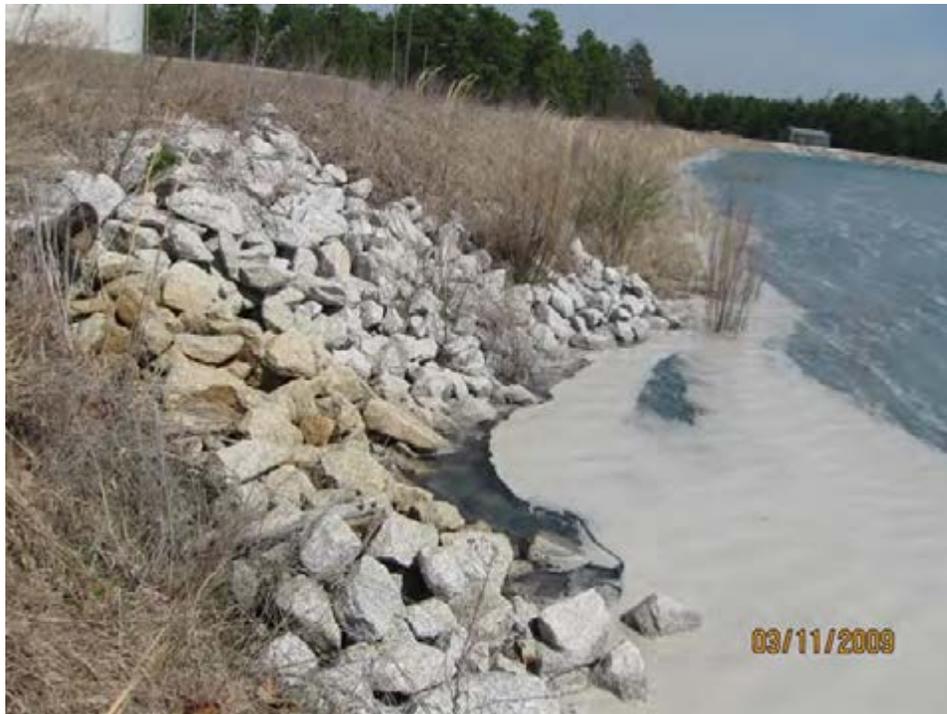
4. ASH POND – View of oil-water separator drain along the interior slope of north pond adjacent to Darlington County Plant.

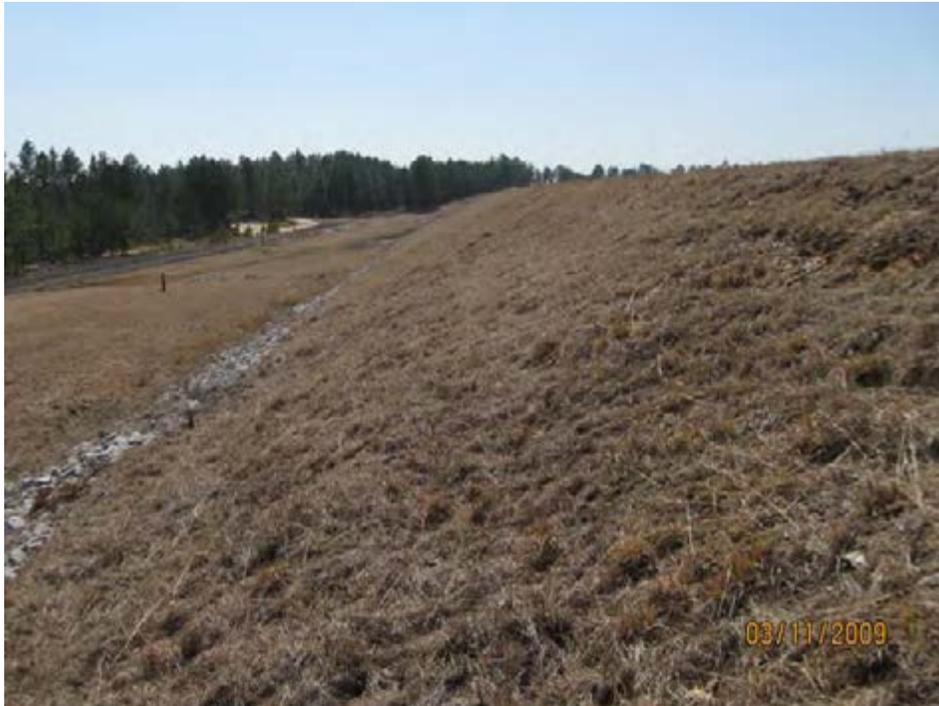
5. ASH POND – Toe of north pond area exterior slope looking south.

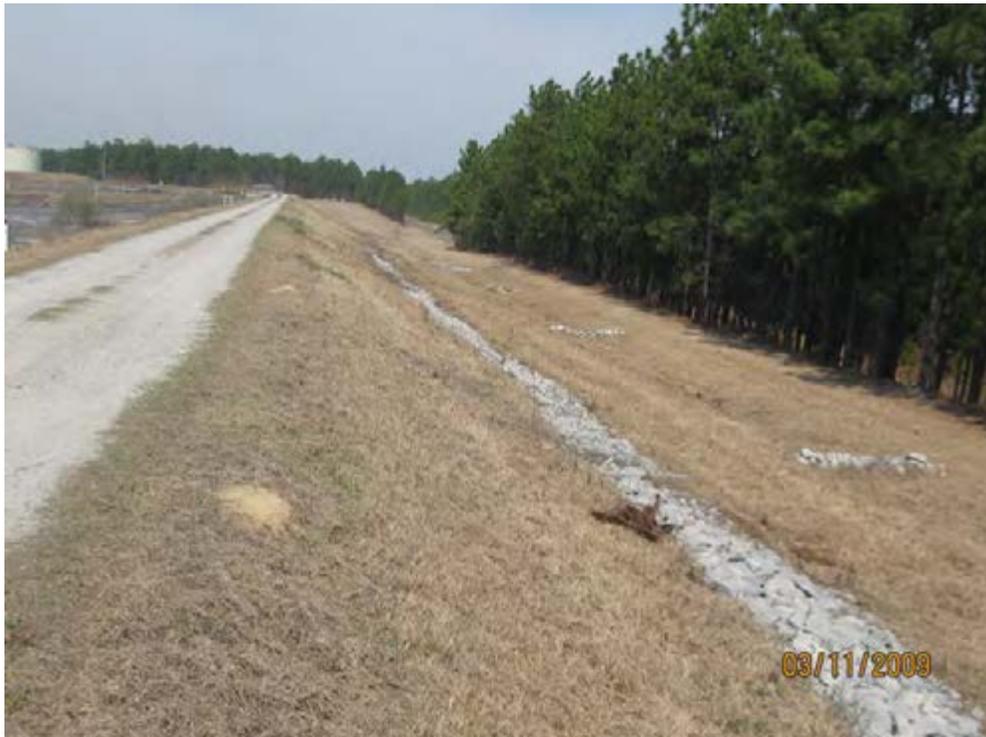
6. ASH POND – Exterior slope of South Pond looking north from southern end.

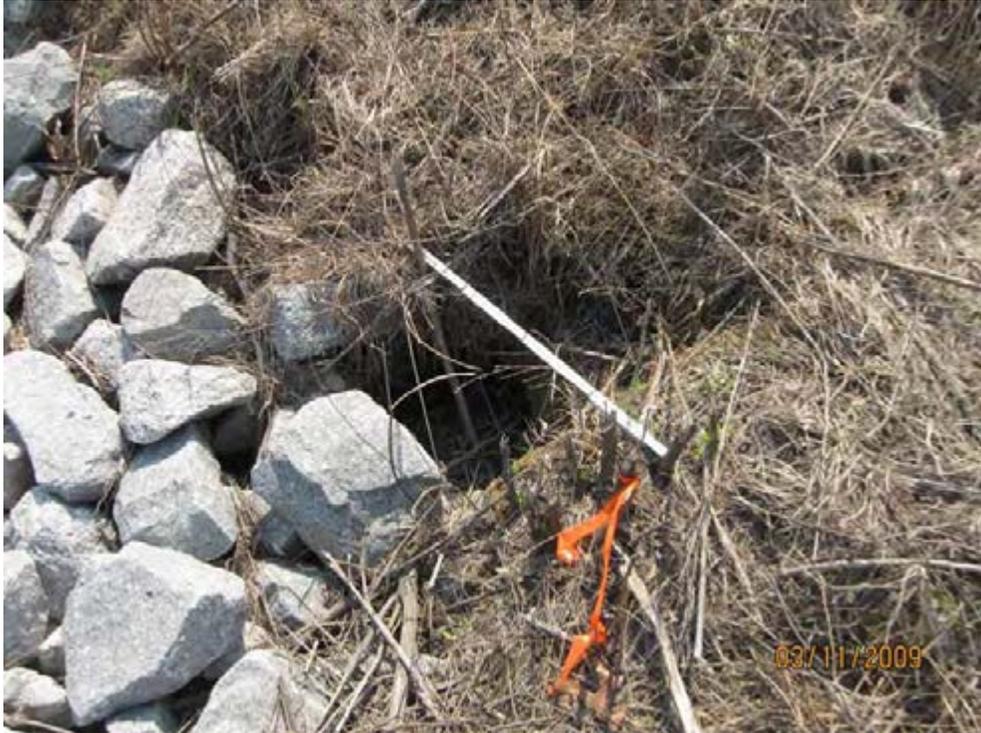
7. ASH POND – Typical local erosion hole at top of North Pond rock toe. Fill with gravel as a routine maintenance activity.

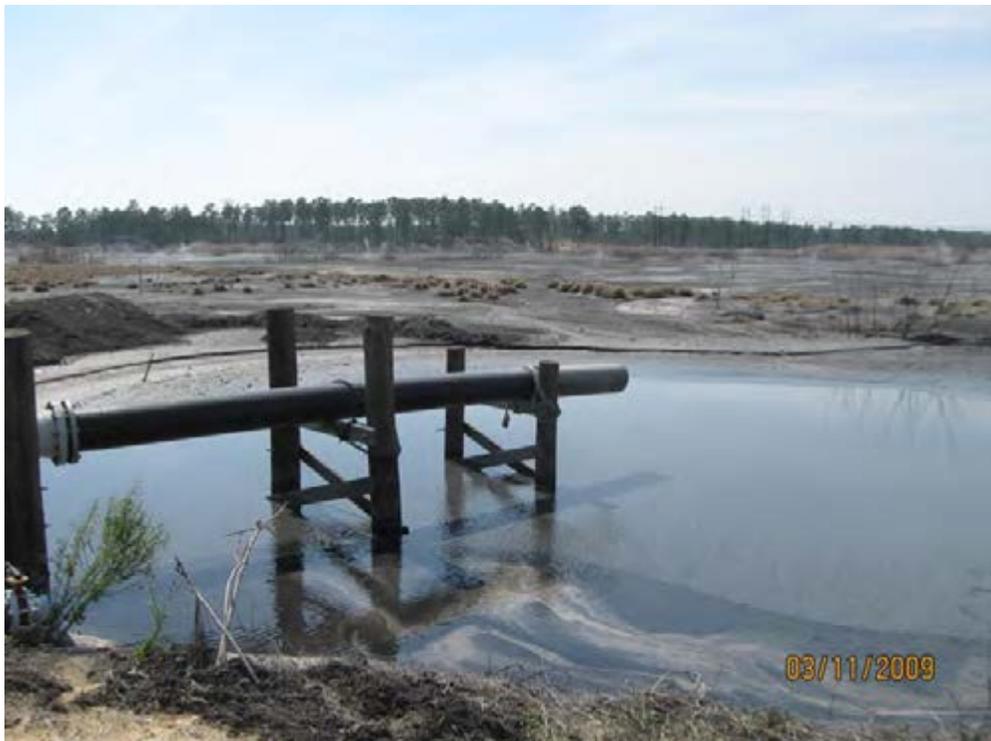
8. ASH POND – Ash discharge location in South Pond.

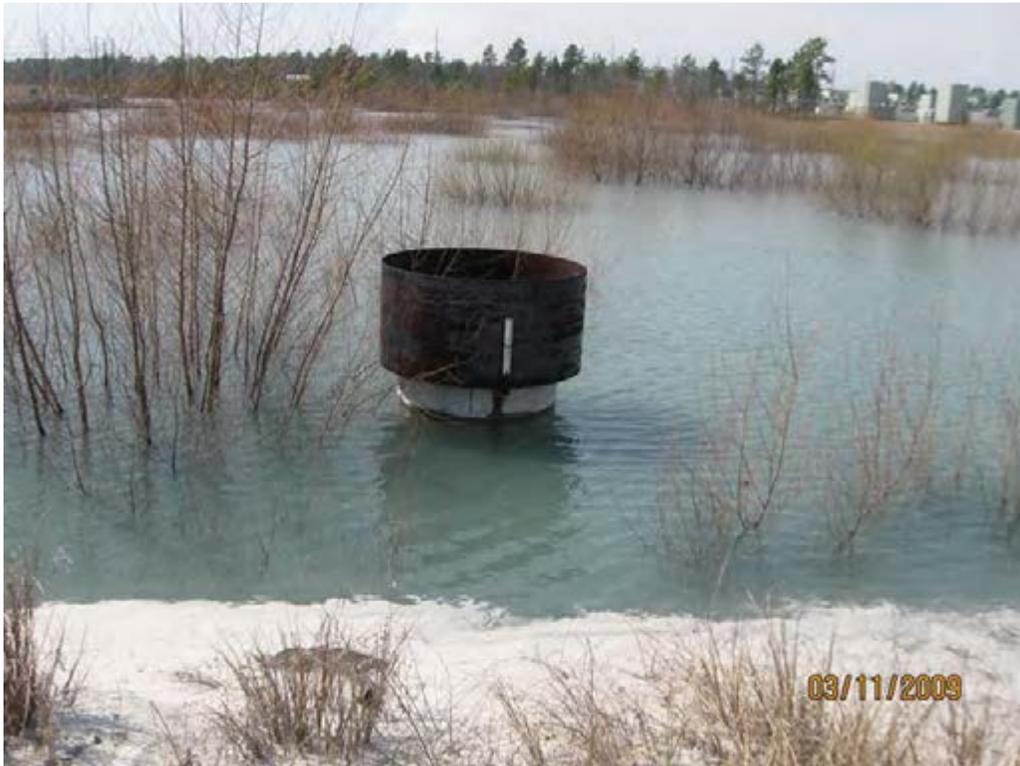
9. ASH POND – Vertical riser and trash guard at inlet point.

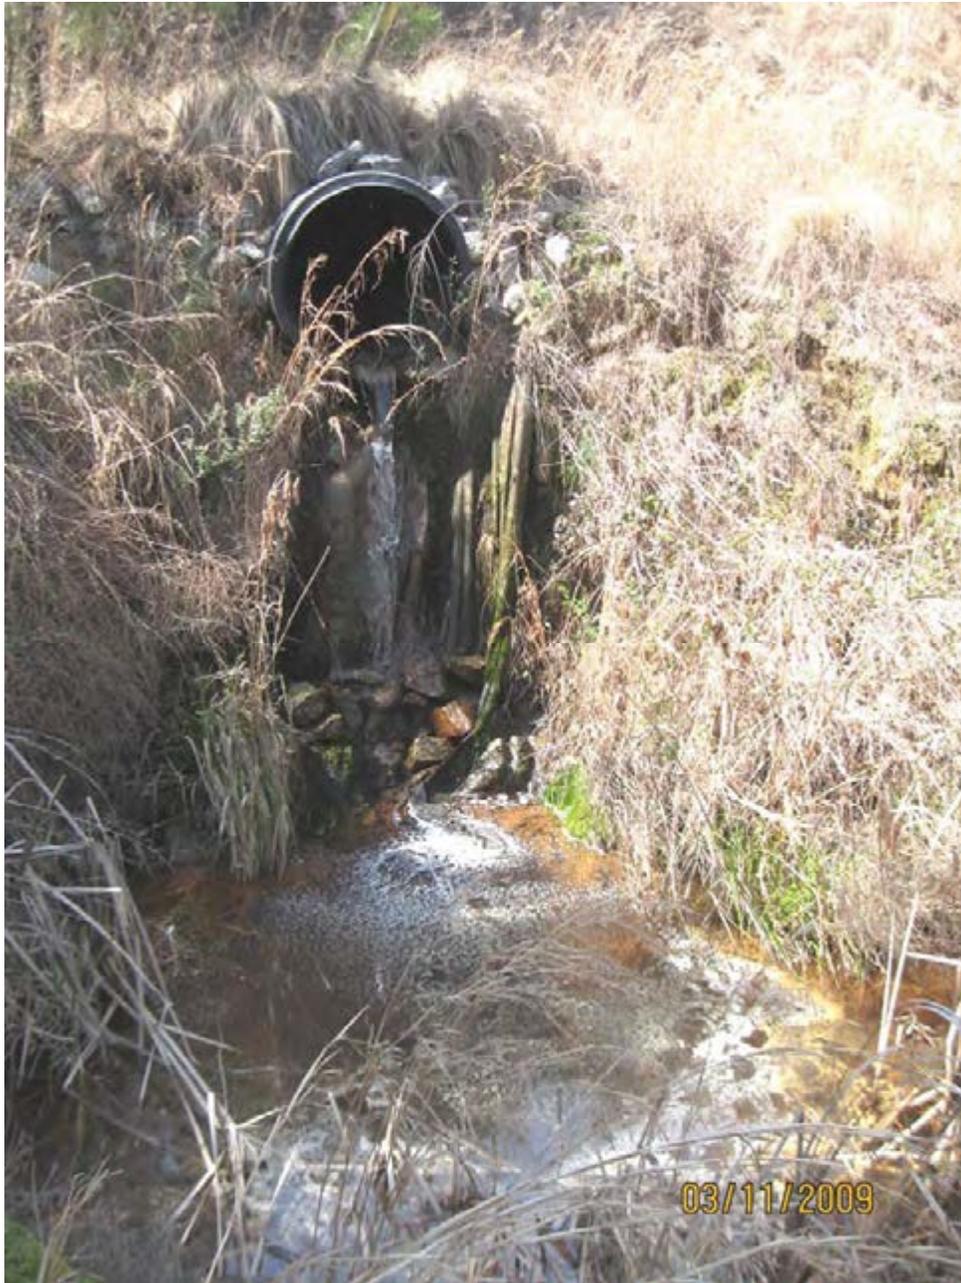
10. ASH POND – Outlet end of ash pond discharge pipe.
