**COLORADO DEPARTMENT OF PUBLIC HEALTH
AND ENVIRONMENT
HAZARDOUS MATERIALS AND WASTE MANAGEMENT DIVISION**

FIVE-YEAR REVIEW

DENVER RADIUM SITE

DENVER, COLORADO

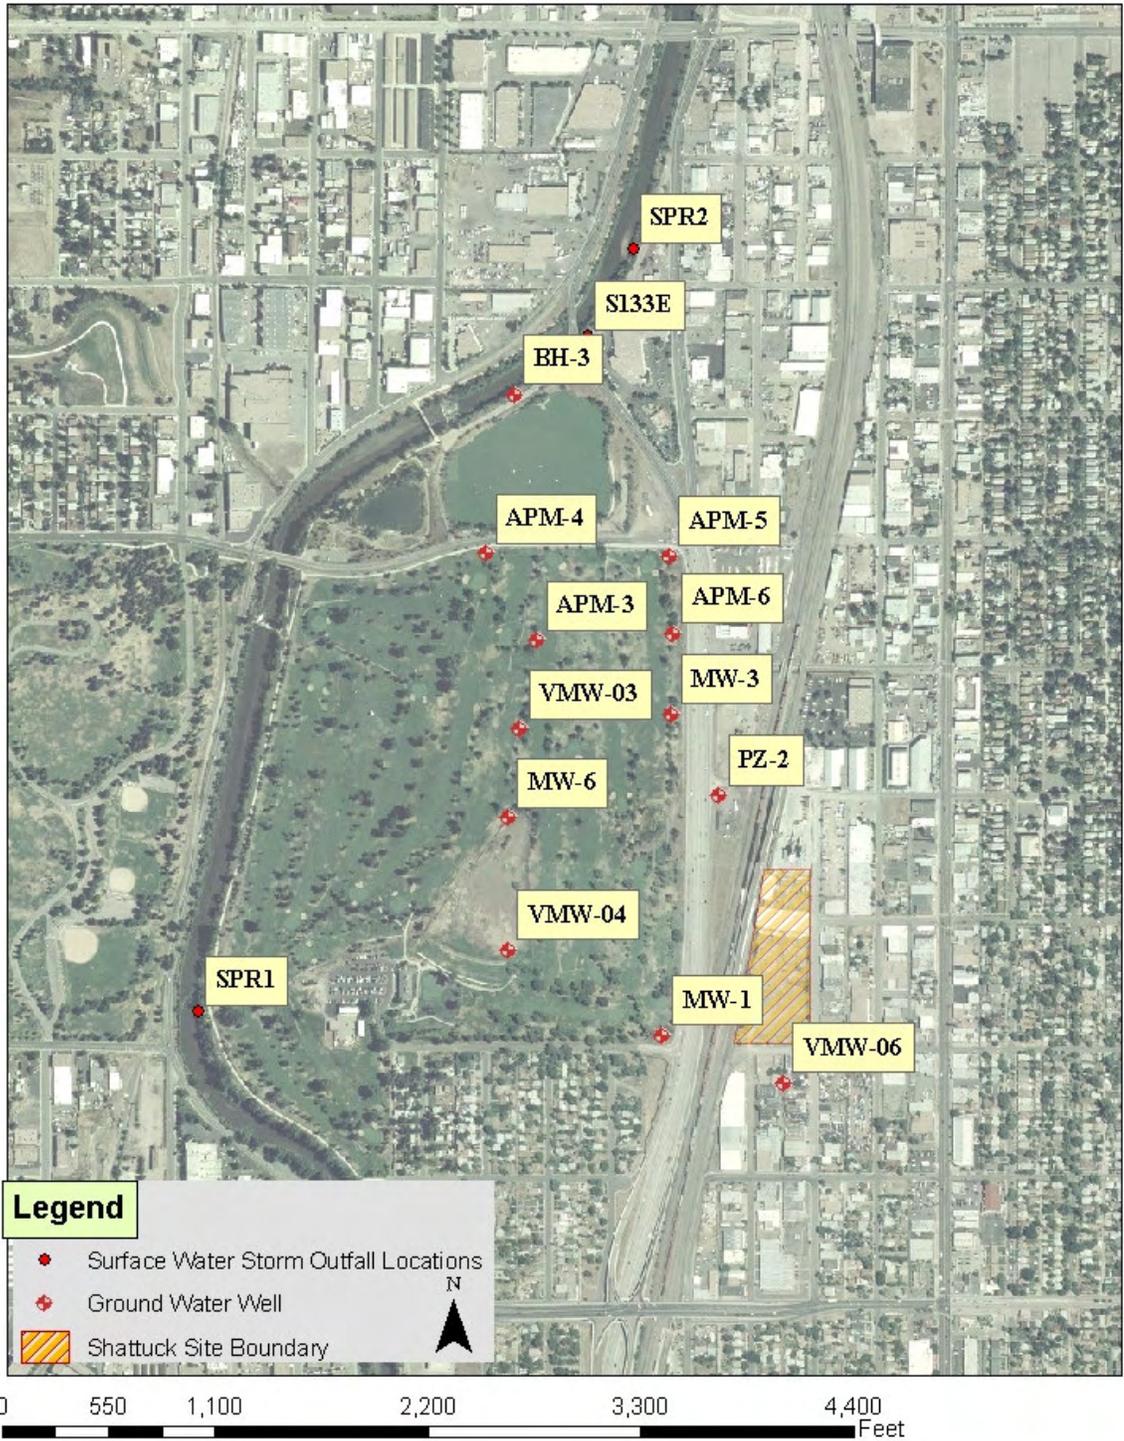
Figure 1
Ground Water, Surface Water and Storm Sewer Outfall
Sample Locations
Shattuck Denver Radium OU8

Groundwater in the area of the Site generally flows west across the Site and then northwest toward the South Platte River. Figure 1 shows the Site vicinity and the groundwater monitoring network. Four of the monitor wells (MW-1, MW-3, PZ-2 and VMW-06) are located on the terrace, while the remaining wells are in the floodplain. VMW-06 is located upgradient from the Site. The floodplain wells are located on or adjacent to the Overland Park Golf Course. High concentrations of Site-related contaminants occur in the terrace wells, with floodplain wells exhibiting better water quality. Previous investigations identified groundwater infiltrating a subsurface storm sewer line located along South Santa Fe Drive, west and downgradient of the Site. A portion of the sewer was lined with an epoxy-based liner in 1997. Infiltration of contaminated groundwater into the storm sewer resulted in elevated concentrations of Site related contaminants in the storm sewer discharge.

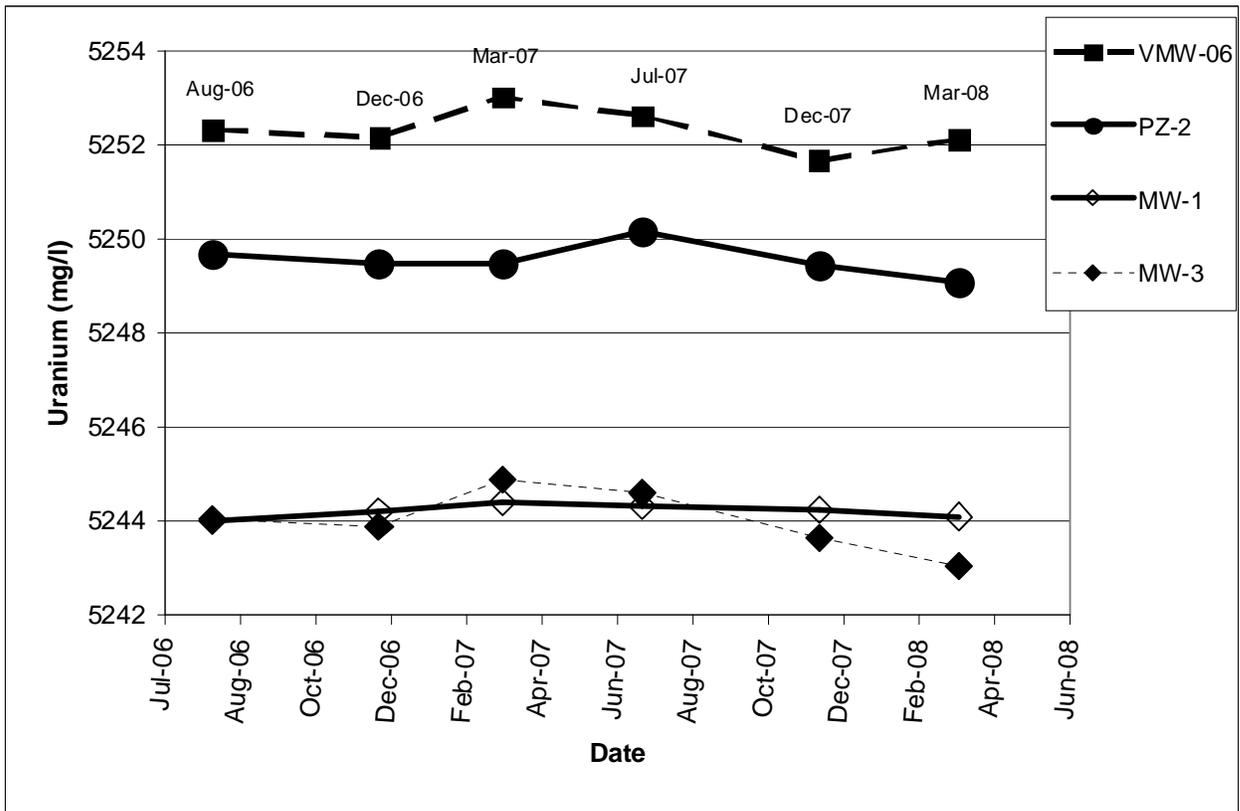
Figure 2 – Water Levels in Terrace Wells

Wells closest to the Site, VMW-06, PZ-2 and MW-1, show very little variation in water level throughout the year. Floodplain wells show more variation, with wells APM-5 and BH-3 showing the highest degree of variation in water level. BH-3 is located adjacent to both the Aqua Golf pond and the South Platte River, therefore, this well is more affected by changes in the surface water regime. Water levels in the terrace wells during the recent quarterly sampling are shown below in Figure 2. Water levels in the floodplain wells are shown in Figure 3.

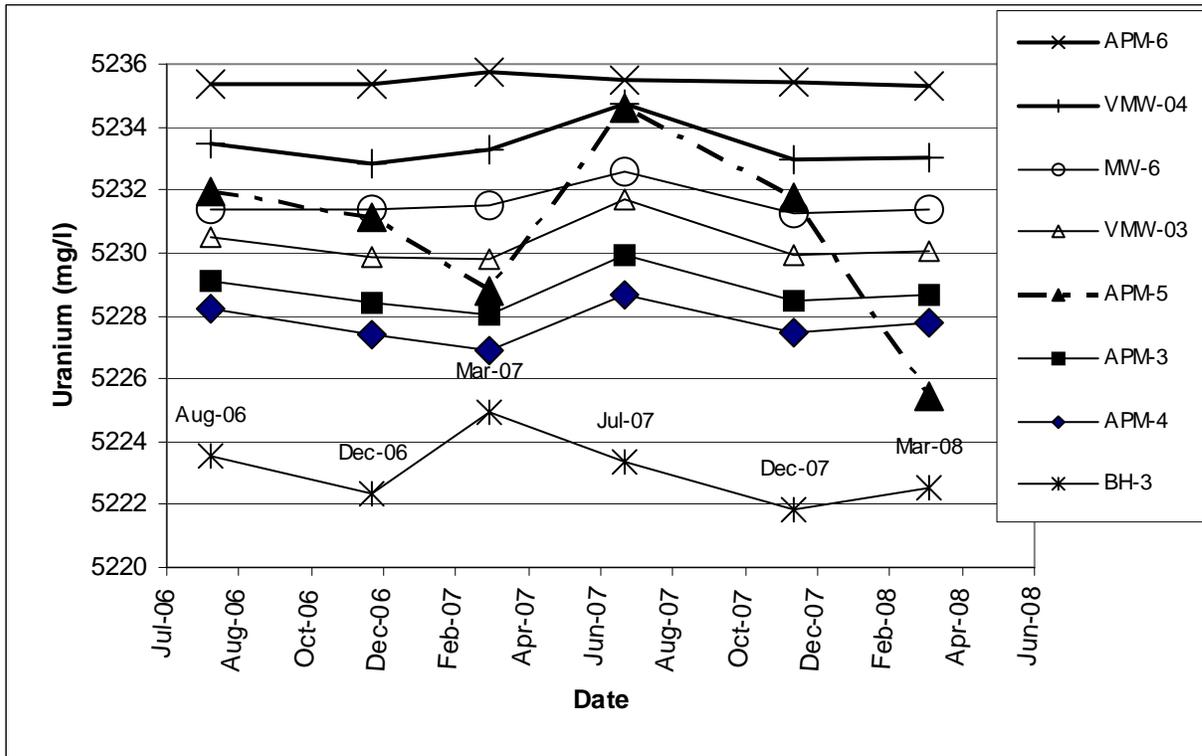
Figure 3 – Water Levels in Floodplain Wells

Well APM-5 (see Figure 3) fluctuates up to 9 feet and is bailed dry during each sampling round. In addition, this well also contains much lower concentrations of uranium and, molybdenum than the remainder of the floodplain wells. It appears that some clean water source may be affecting this well. This well is most likely screened at too shallow of depth, and is not intersecting the alluvial aquifer. Instead, it is being recharged by surface water inflows after being bailed dry. Due to the fact that it provides anomalous results, sampling of this well should be discontinued. At a future date, it should be plugged and abandoned.

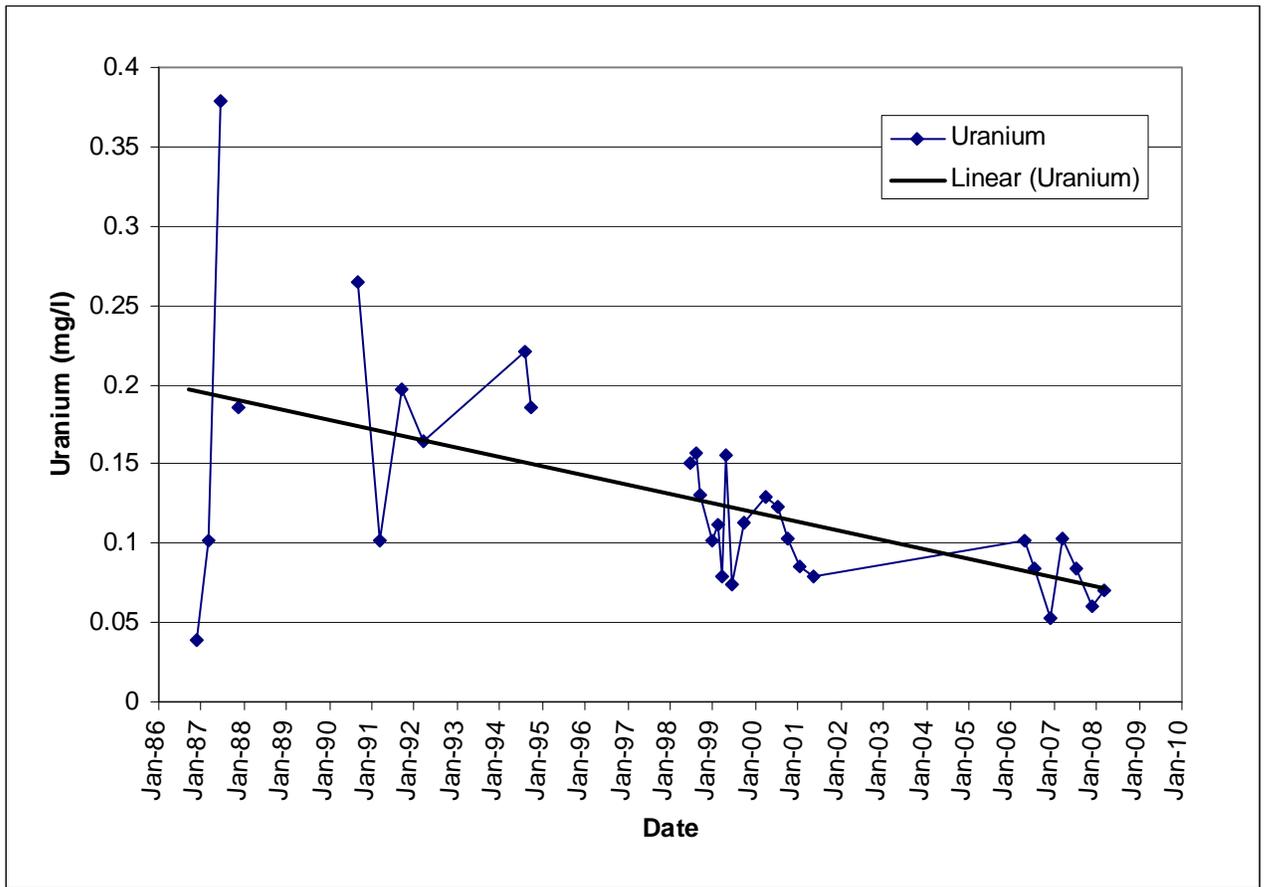
Figure 8 – Uranium in Well MW-3

With regard to molybdenum, several wells exhibit statistically significant declining trends, including VMW-06, MW-3, PZ-2, APM-3, APM-6 and MW-6. Examples of the declining molybdenum trends are shown in Figures 8 and 9 below. Technically, because wells MW-3 (uranium), APM-4 (uranium) and APM-3 (molybdenum) indicated both seasonal trends and concentration trends, a different configuration of the Mann-Kendall test, called a Seasonal Kendall should be used. However, use of the Seasonal Kendall test requires 10 or more years of data. Because the sampling program has had two significant periods of hiatus, 10 years of data are not available to run this test. The upward trend in Well VMW-06, which is located upgradient of the Site, is unexplained.

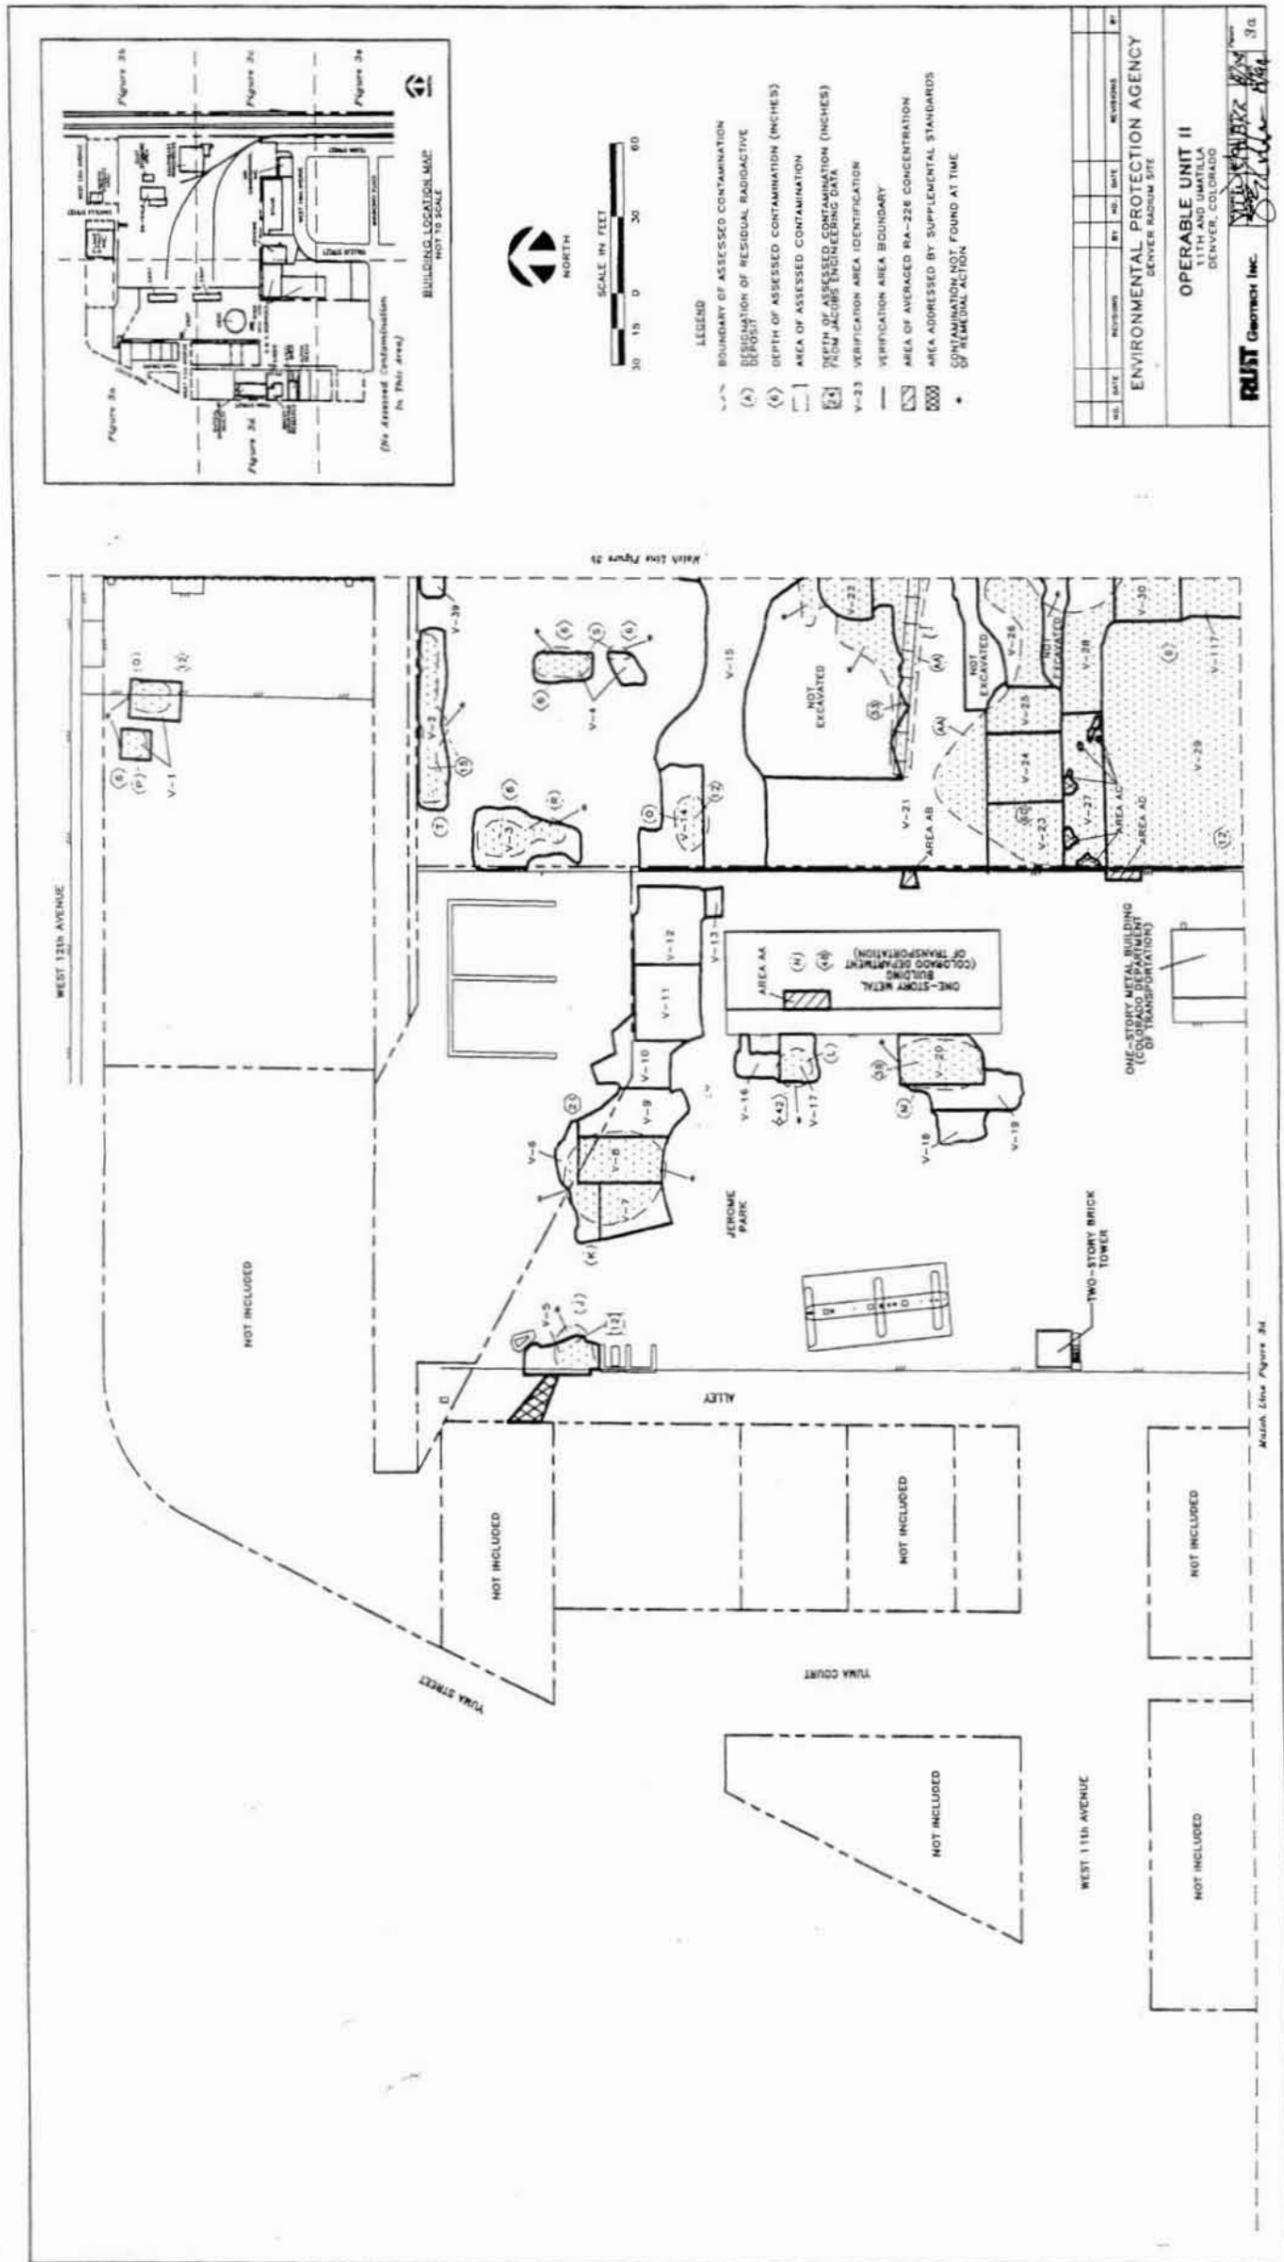
Figure 3
Denver Radium Site - OU2

Waste left in place under
Area Averaging

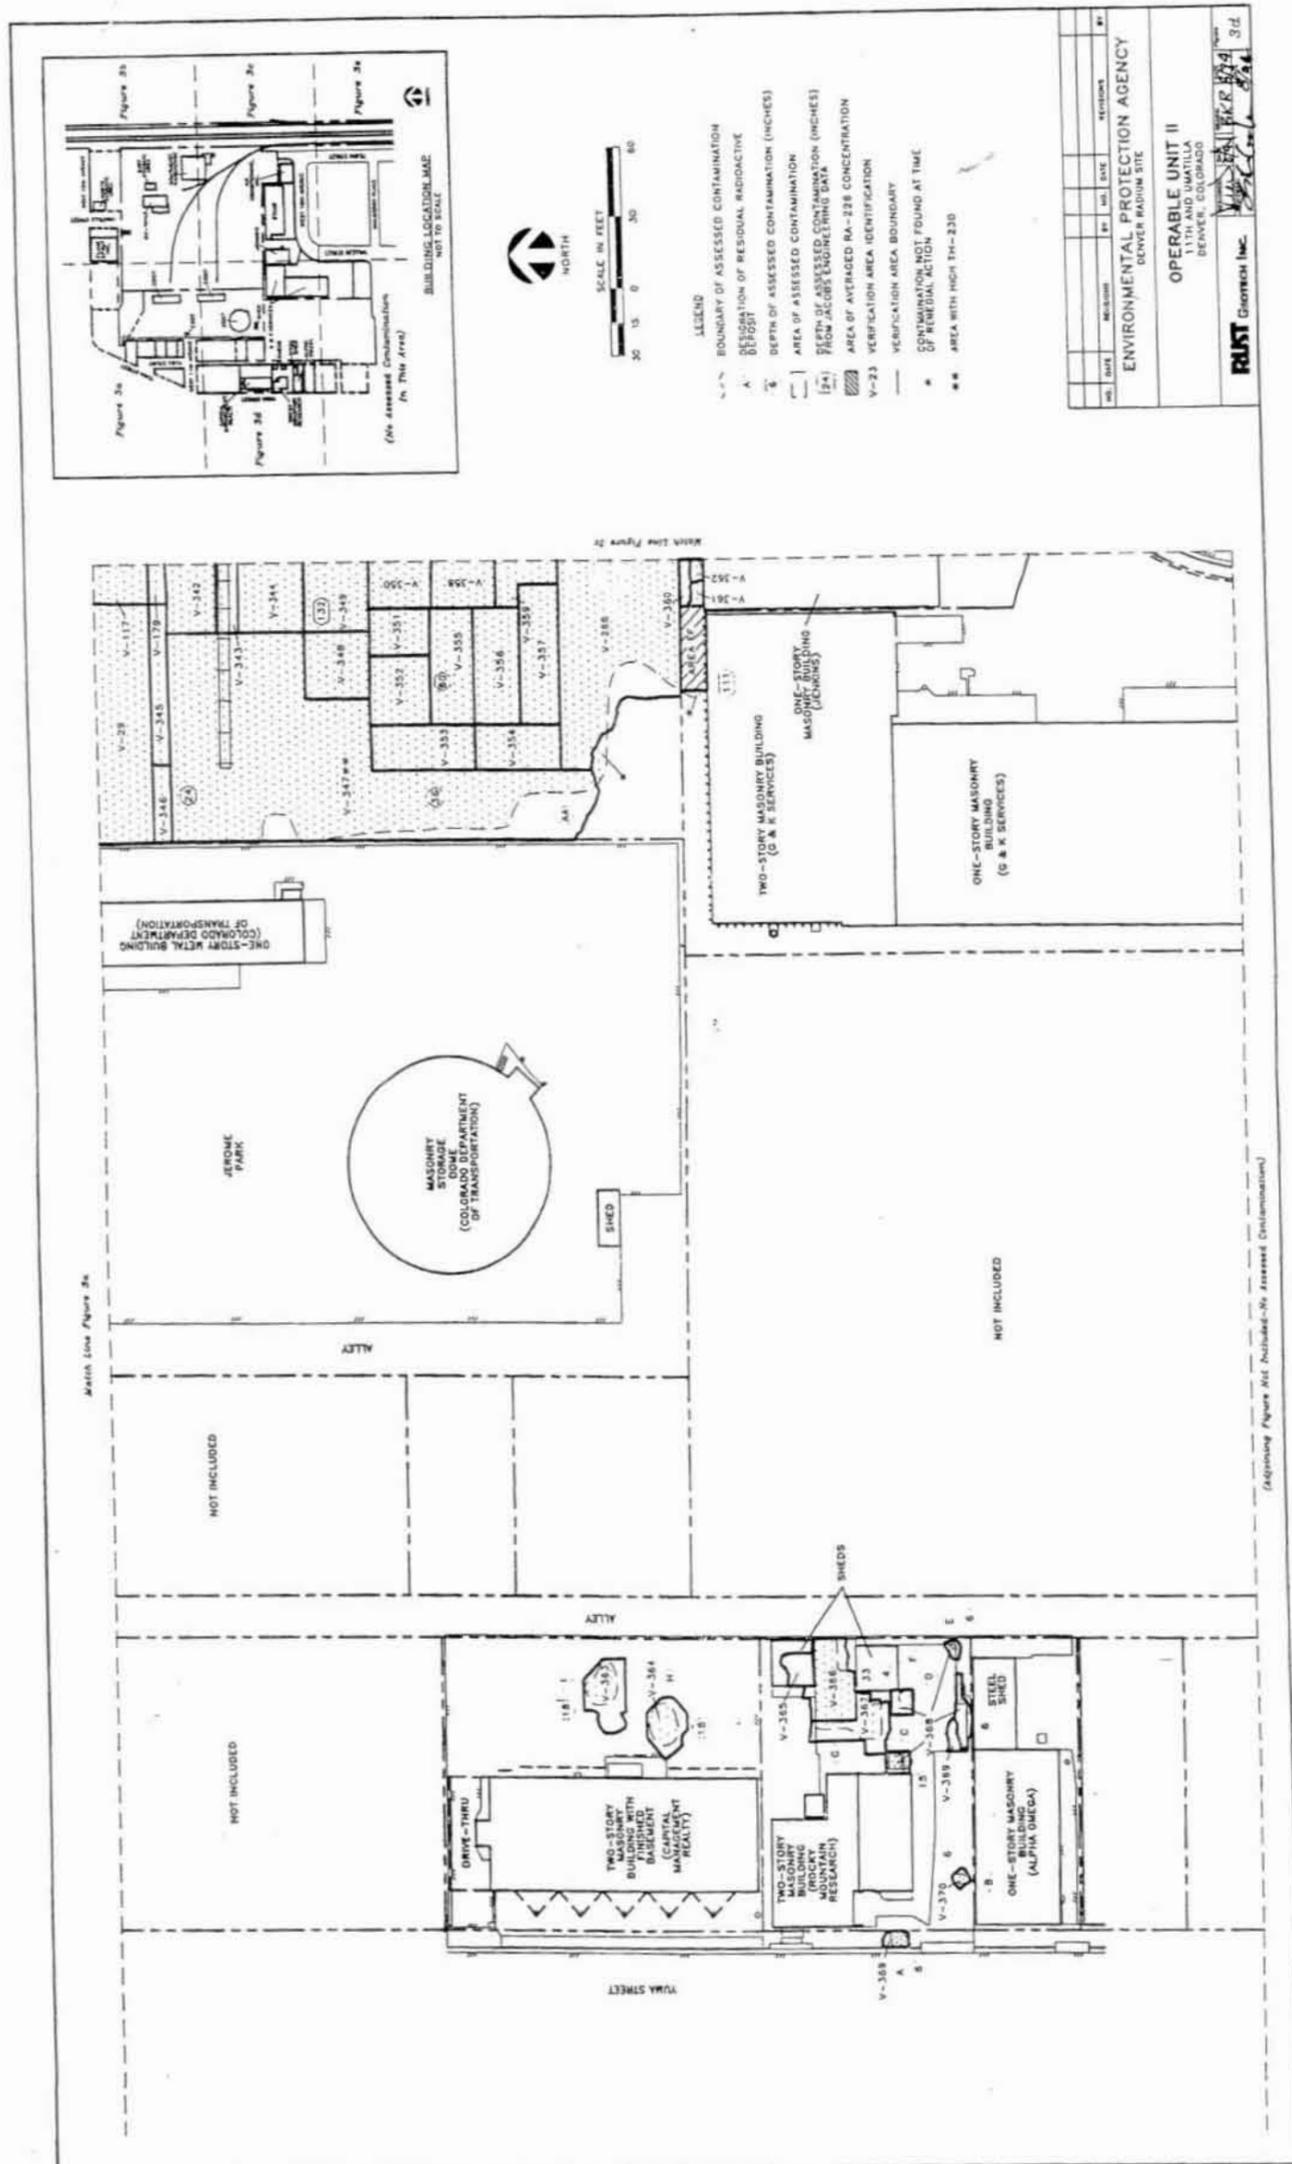
Figure 6
Denver Radium Site - OU2

Waste left in place under Area Averaging

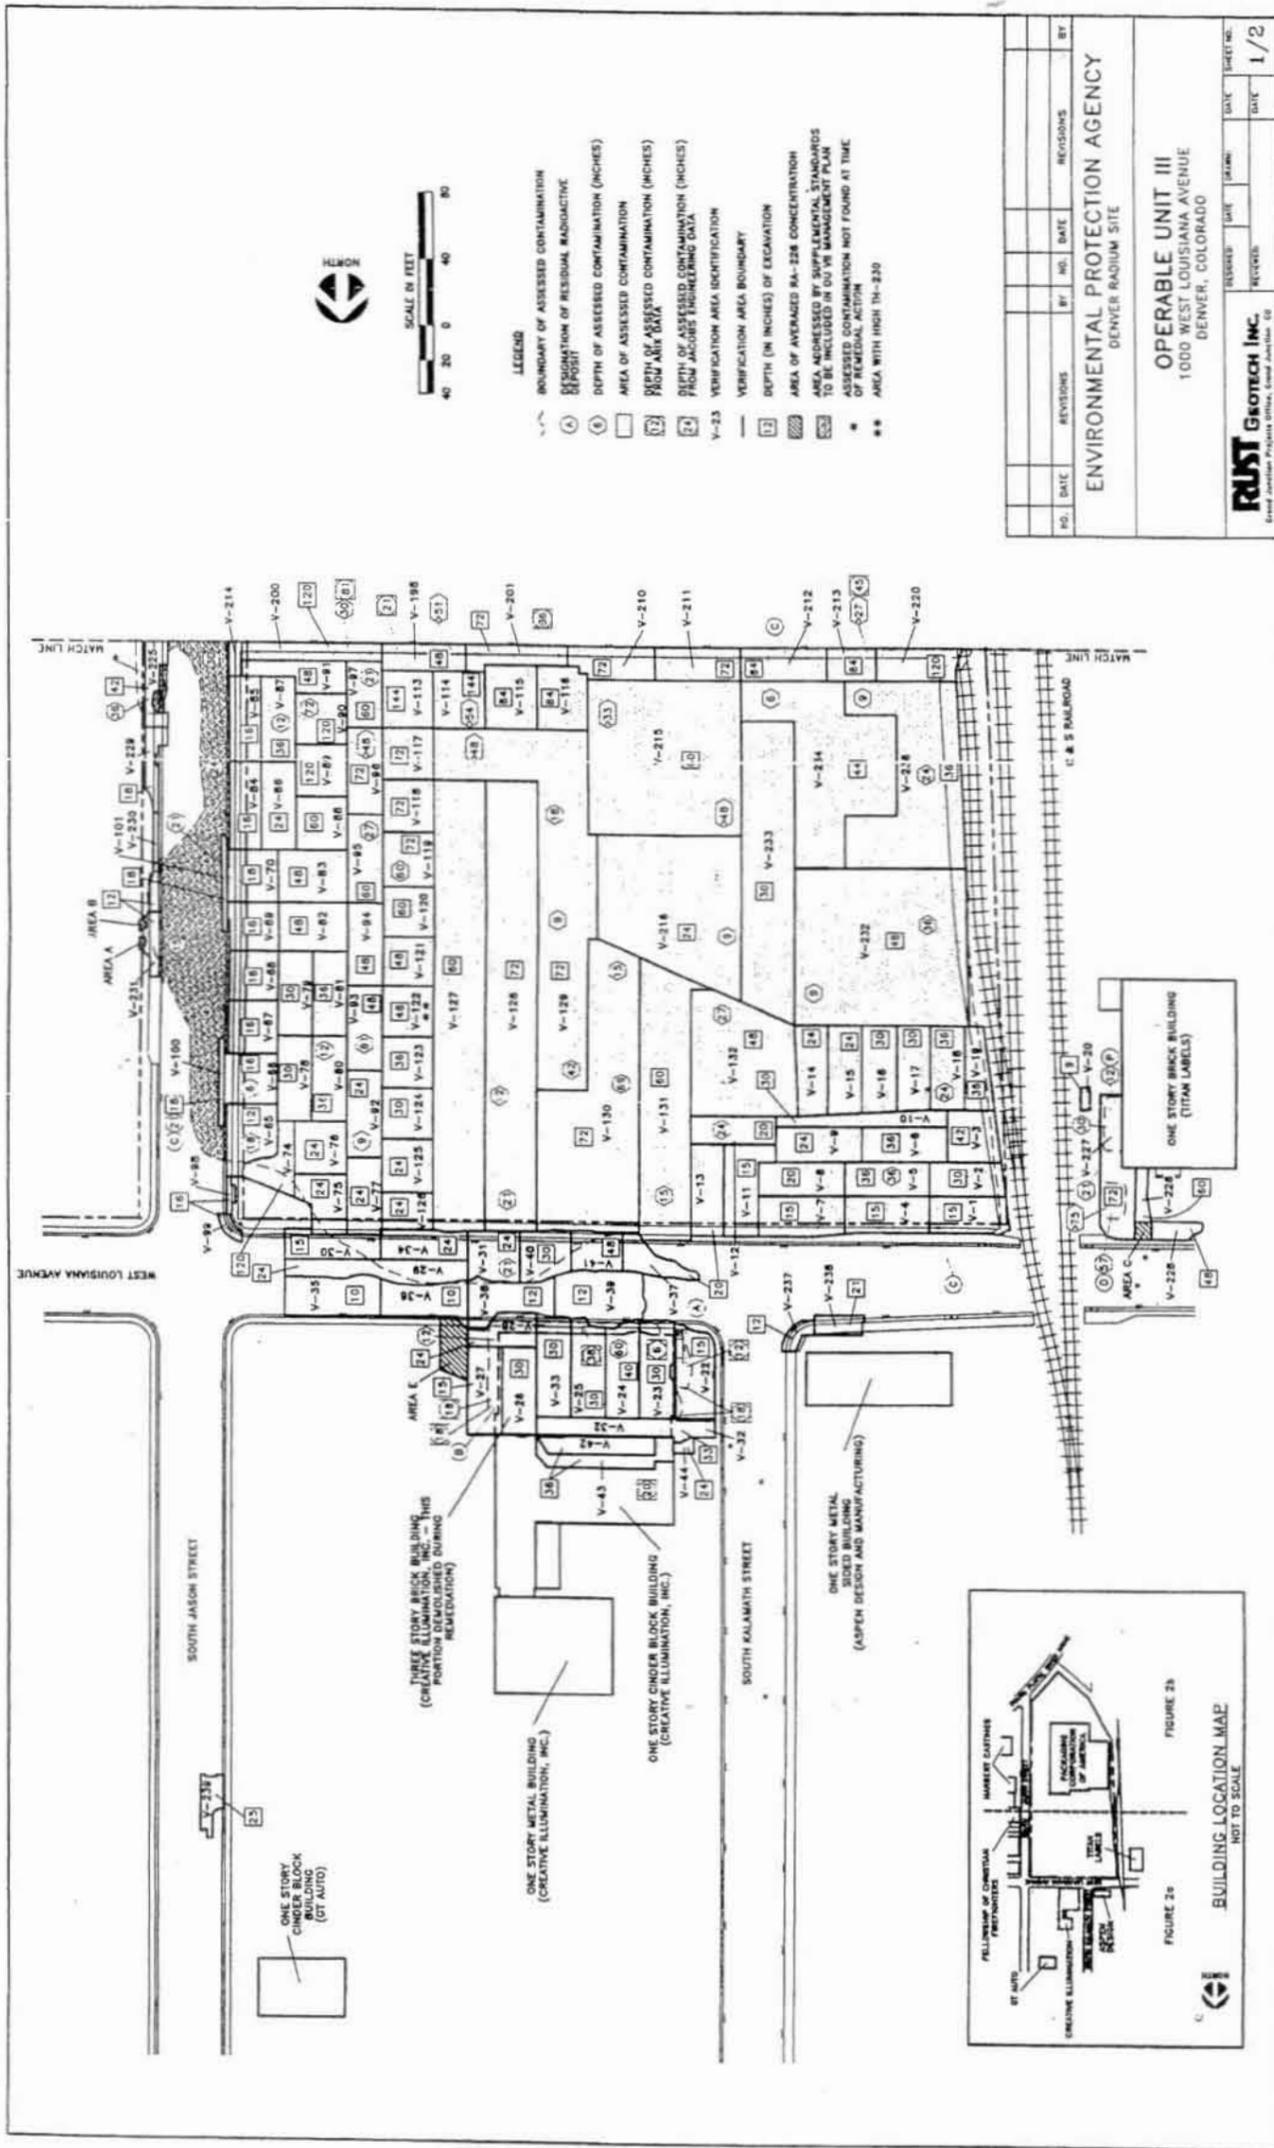
Figure 8
Denver Radium Site - OUI3

A Supplemental Standards Report was prepared in June 1995 to document the 5,868 cubic yards of radiological contaminated soil that remain onsite under South Jason Street, around the Packaging Corporation of America building, and along South Platte River Drive at OU3. The location of this contamination is shown on Figures 8 and 9.

Waste left in place under Area Averaging

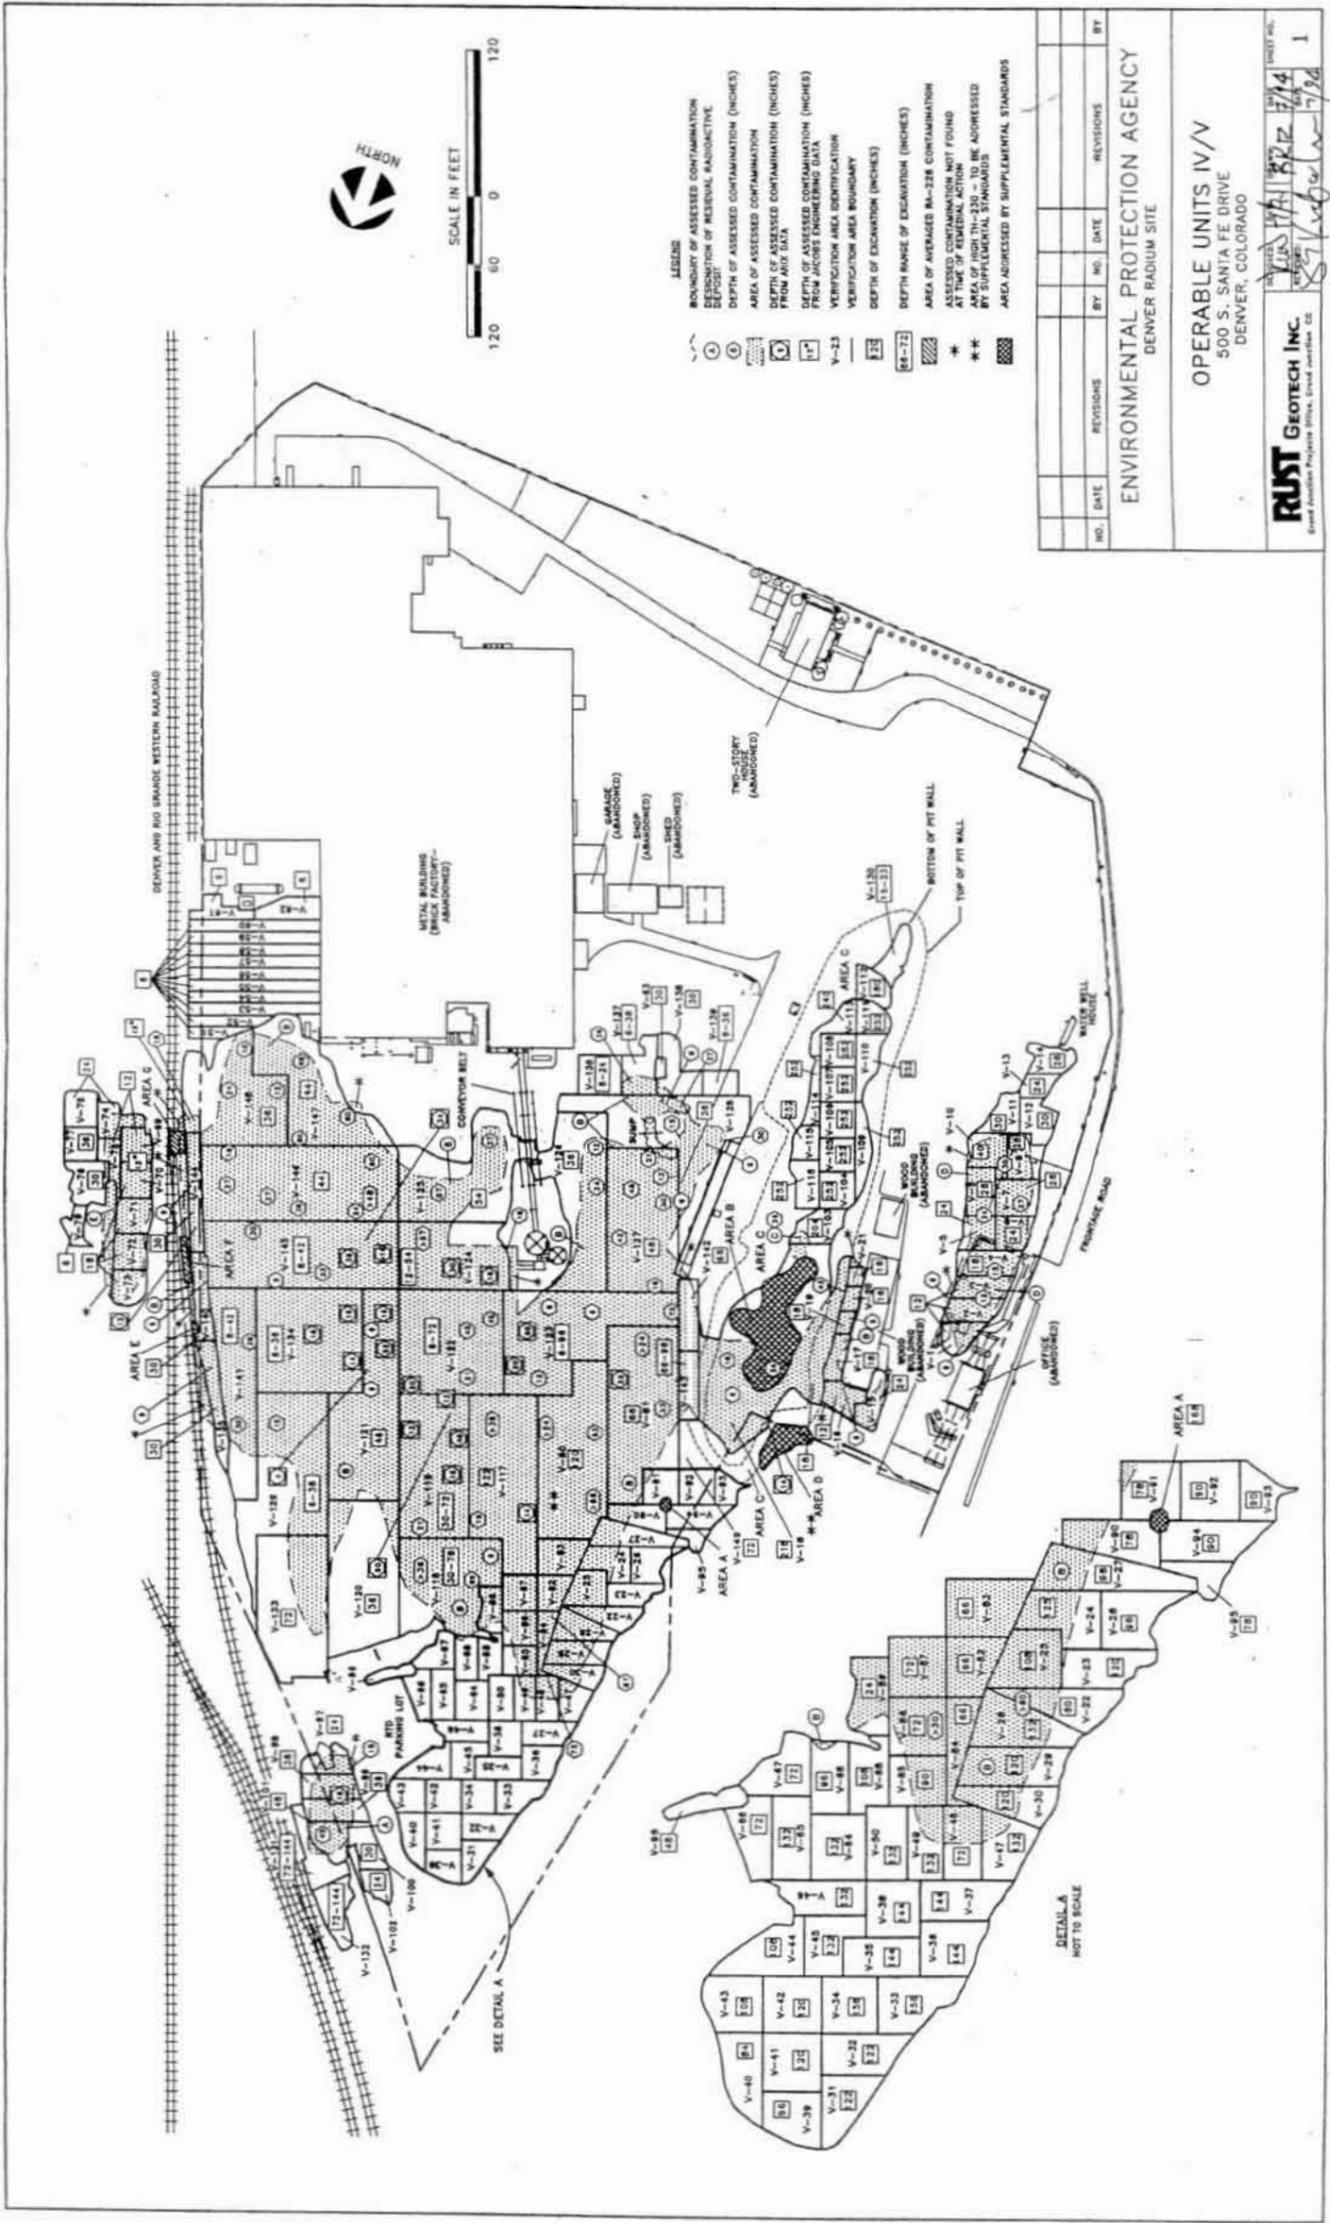
Figure 10
Denver Radium Site – OU4 and OU5

A Supplemental Standards Report, prepared in March 1994, documented radiological contamination that remains onsite at OU4. The location of this contamination is shown in Figure 10.

Waste left in place under Area Averaging

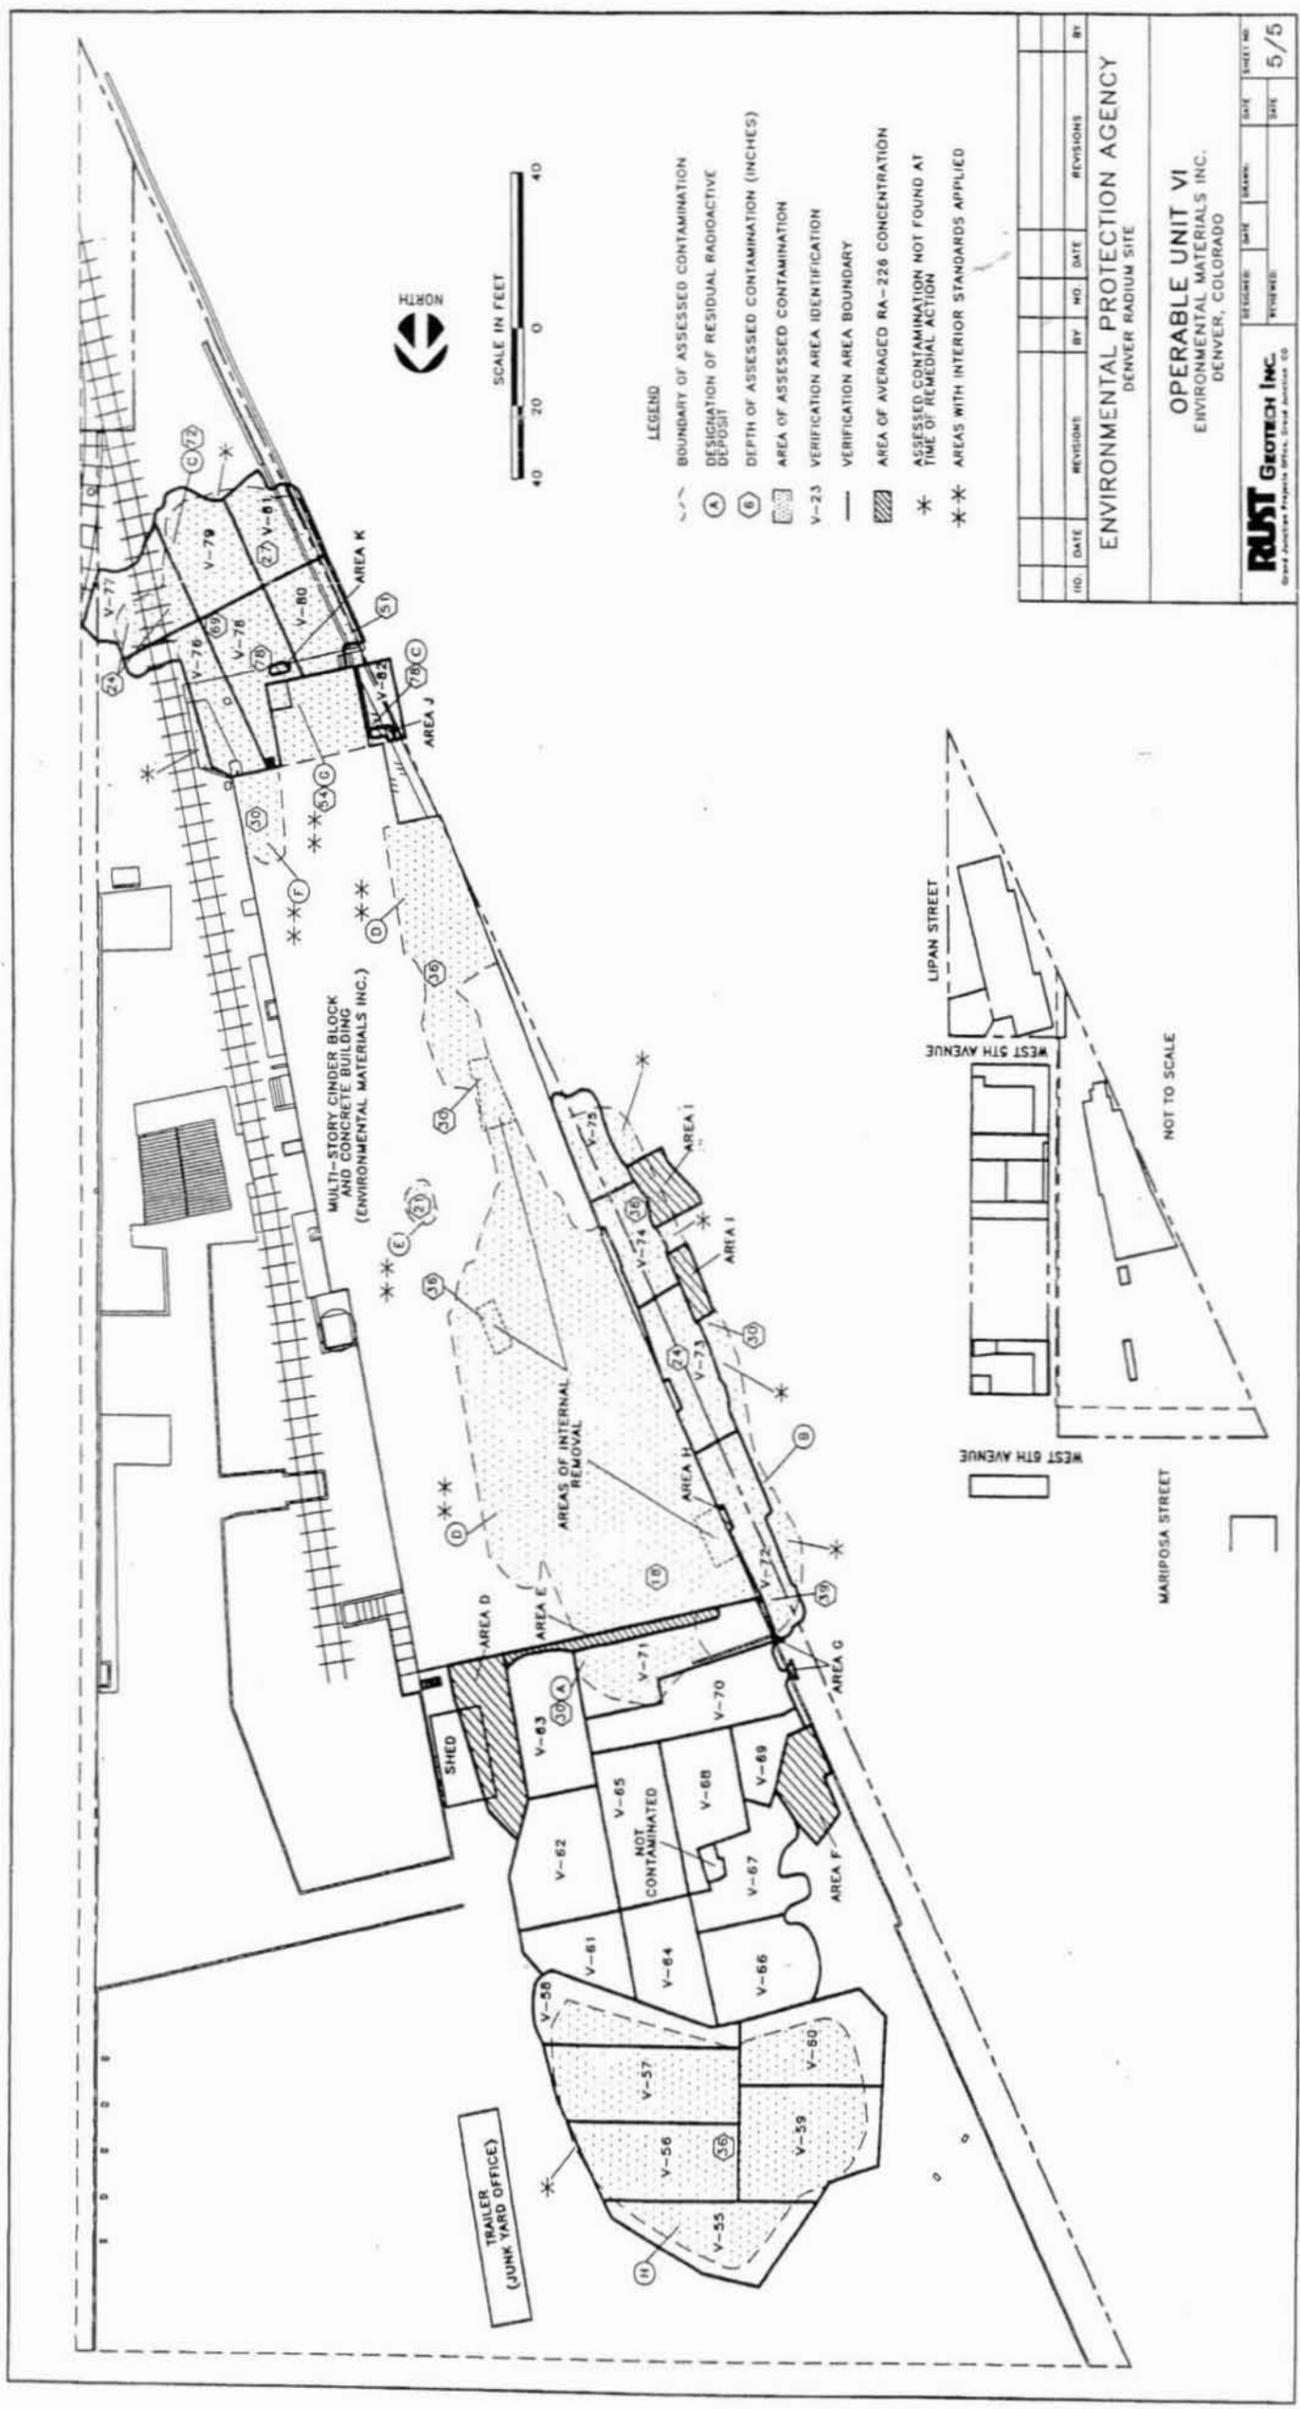
Figure 11
Denver Radium Site - OU6

Waste left in place under Area Averaging
