**COLORADO DEPARTMENT OF PUBLIC HEALTH
AND ENVIRONMENT
HAZARDOUS MATERIALS AND WASTE MANAGEMENT DIVISION**

FIVE-YEAR REVIEW

DENVER RADIUM SITE

DENVER, COLORADO

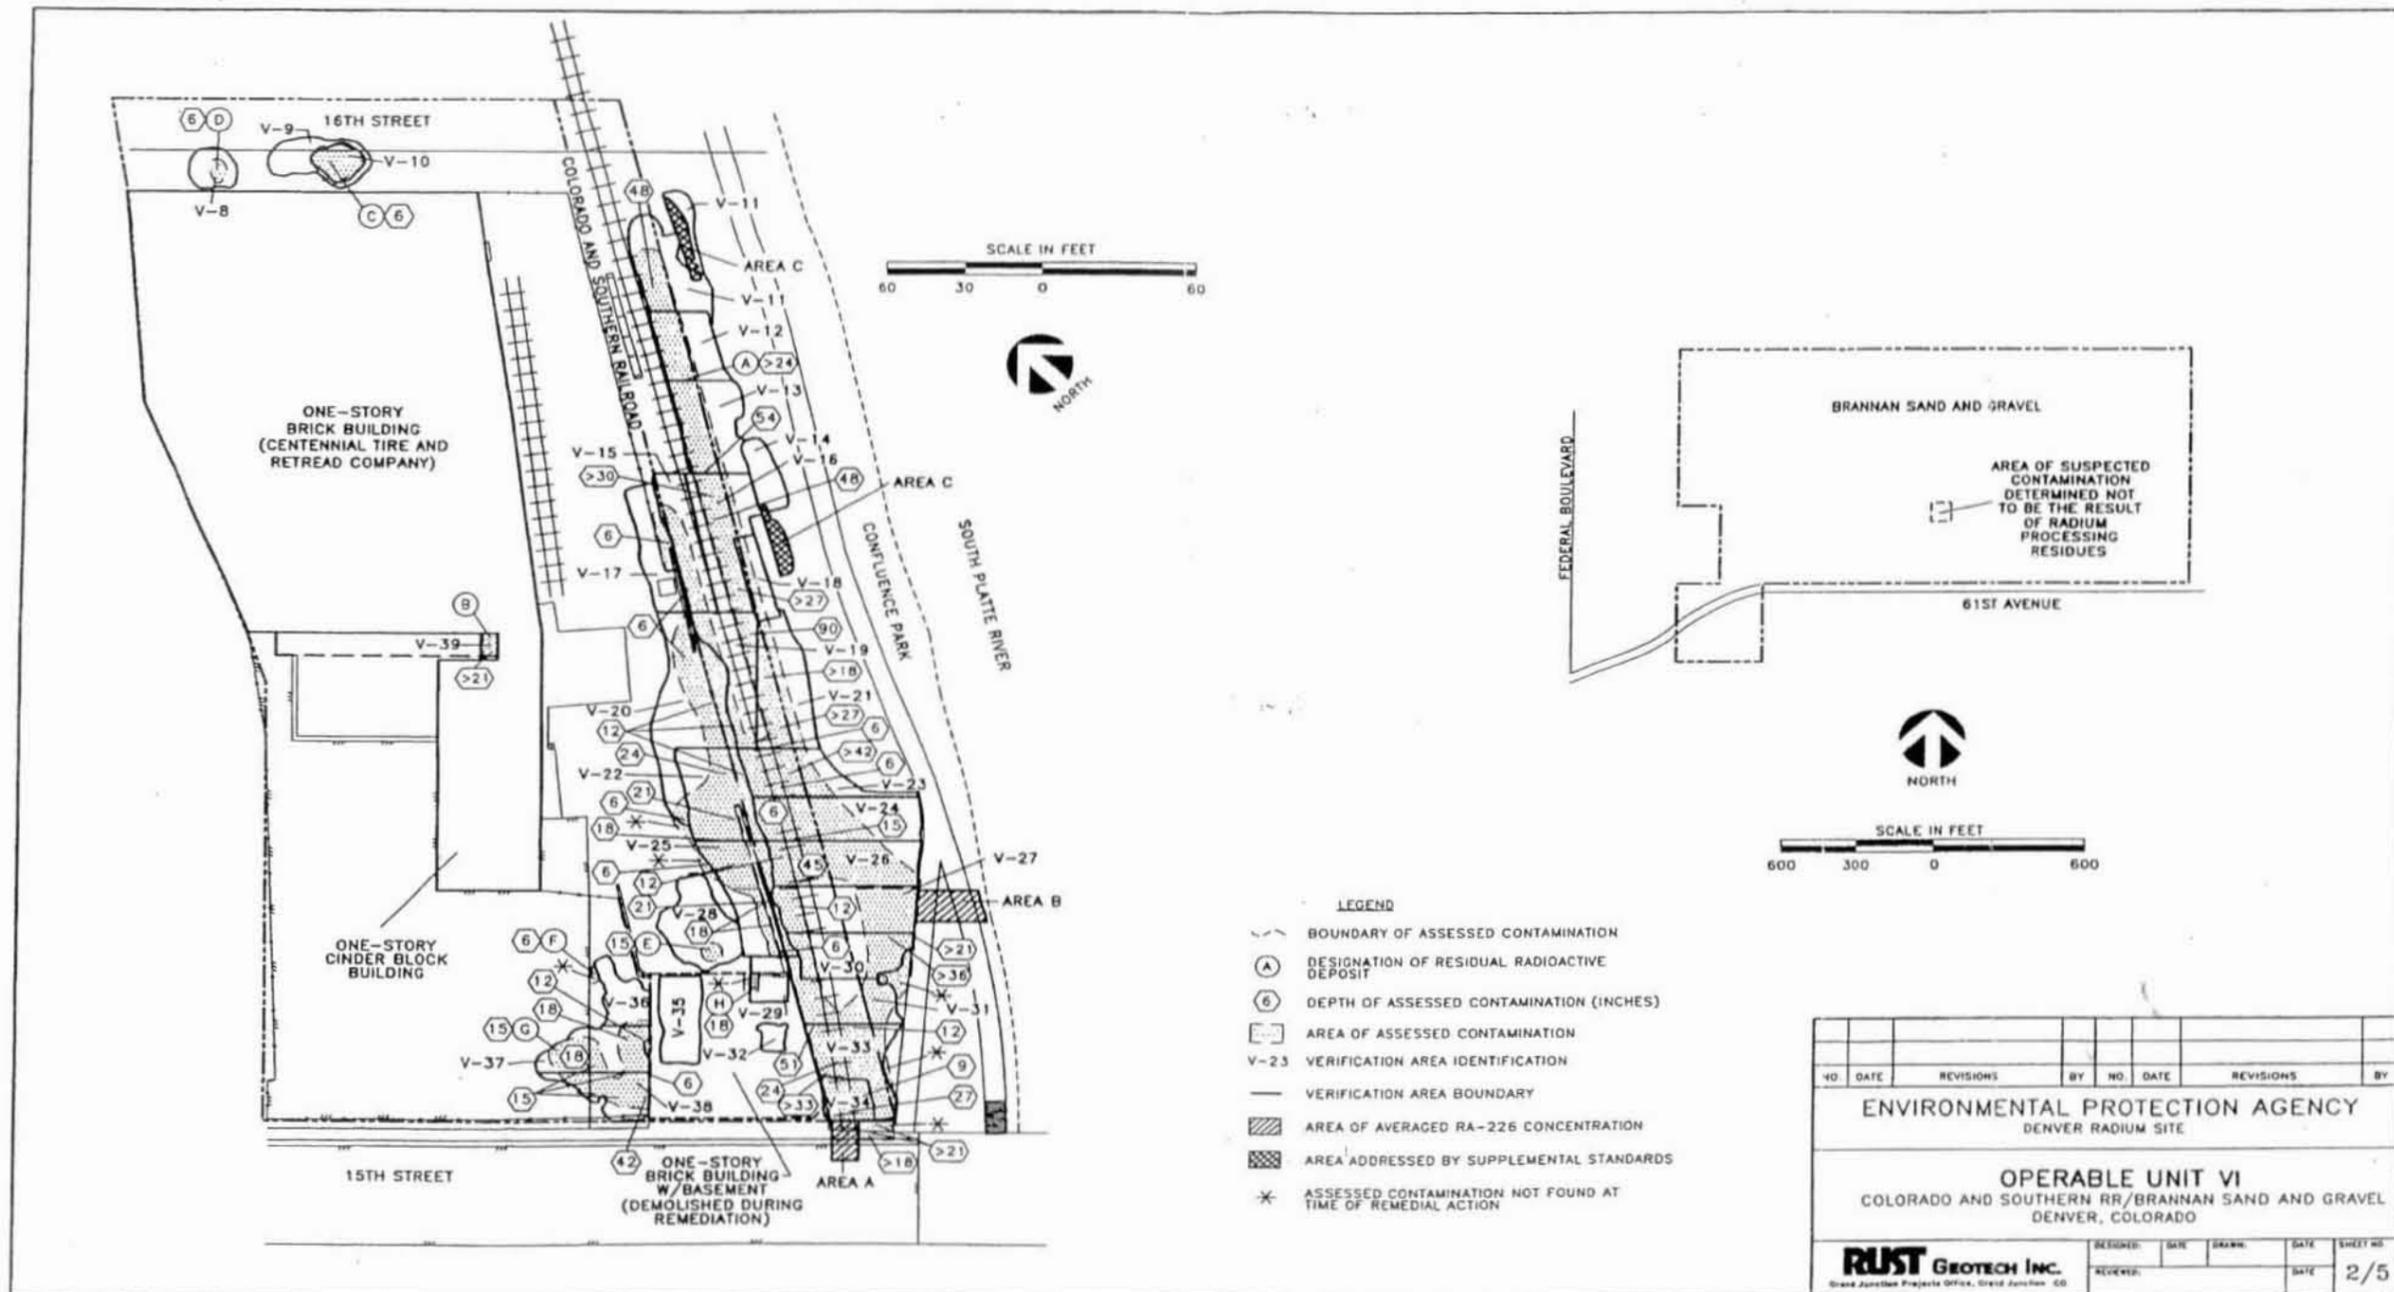
Figure 13
Denver Radium Site - OU6

- Waste left in place under Supplemental Standards
- Waste left in place under Area Averaging
