Navajo Abandoned Uranium Mine Site Screen Report

Section 5 AUM Site

Navajo AUM Eastern Region

May 2009

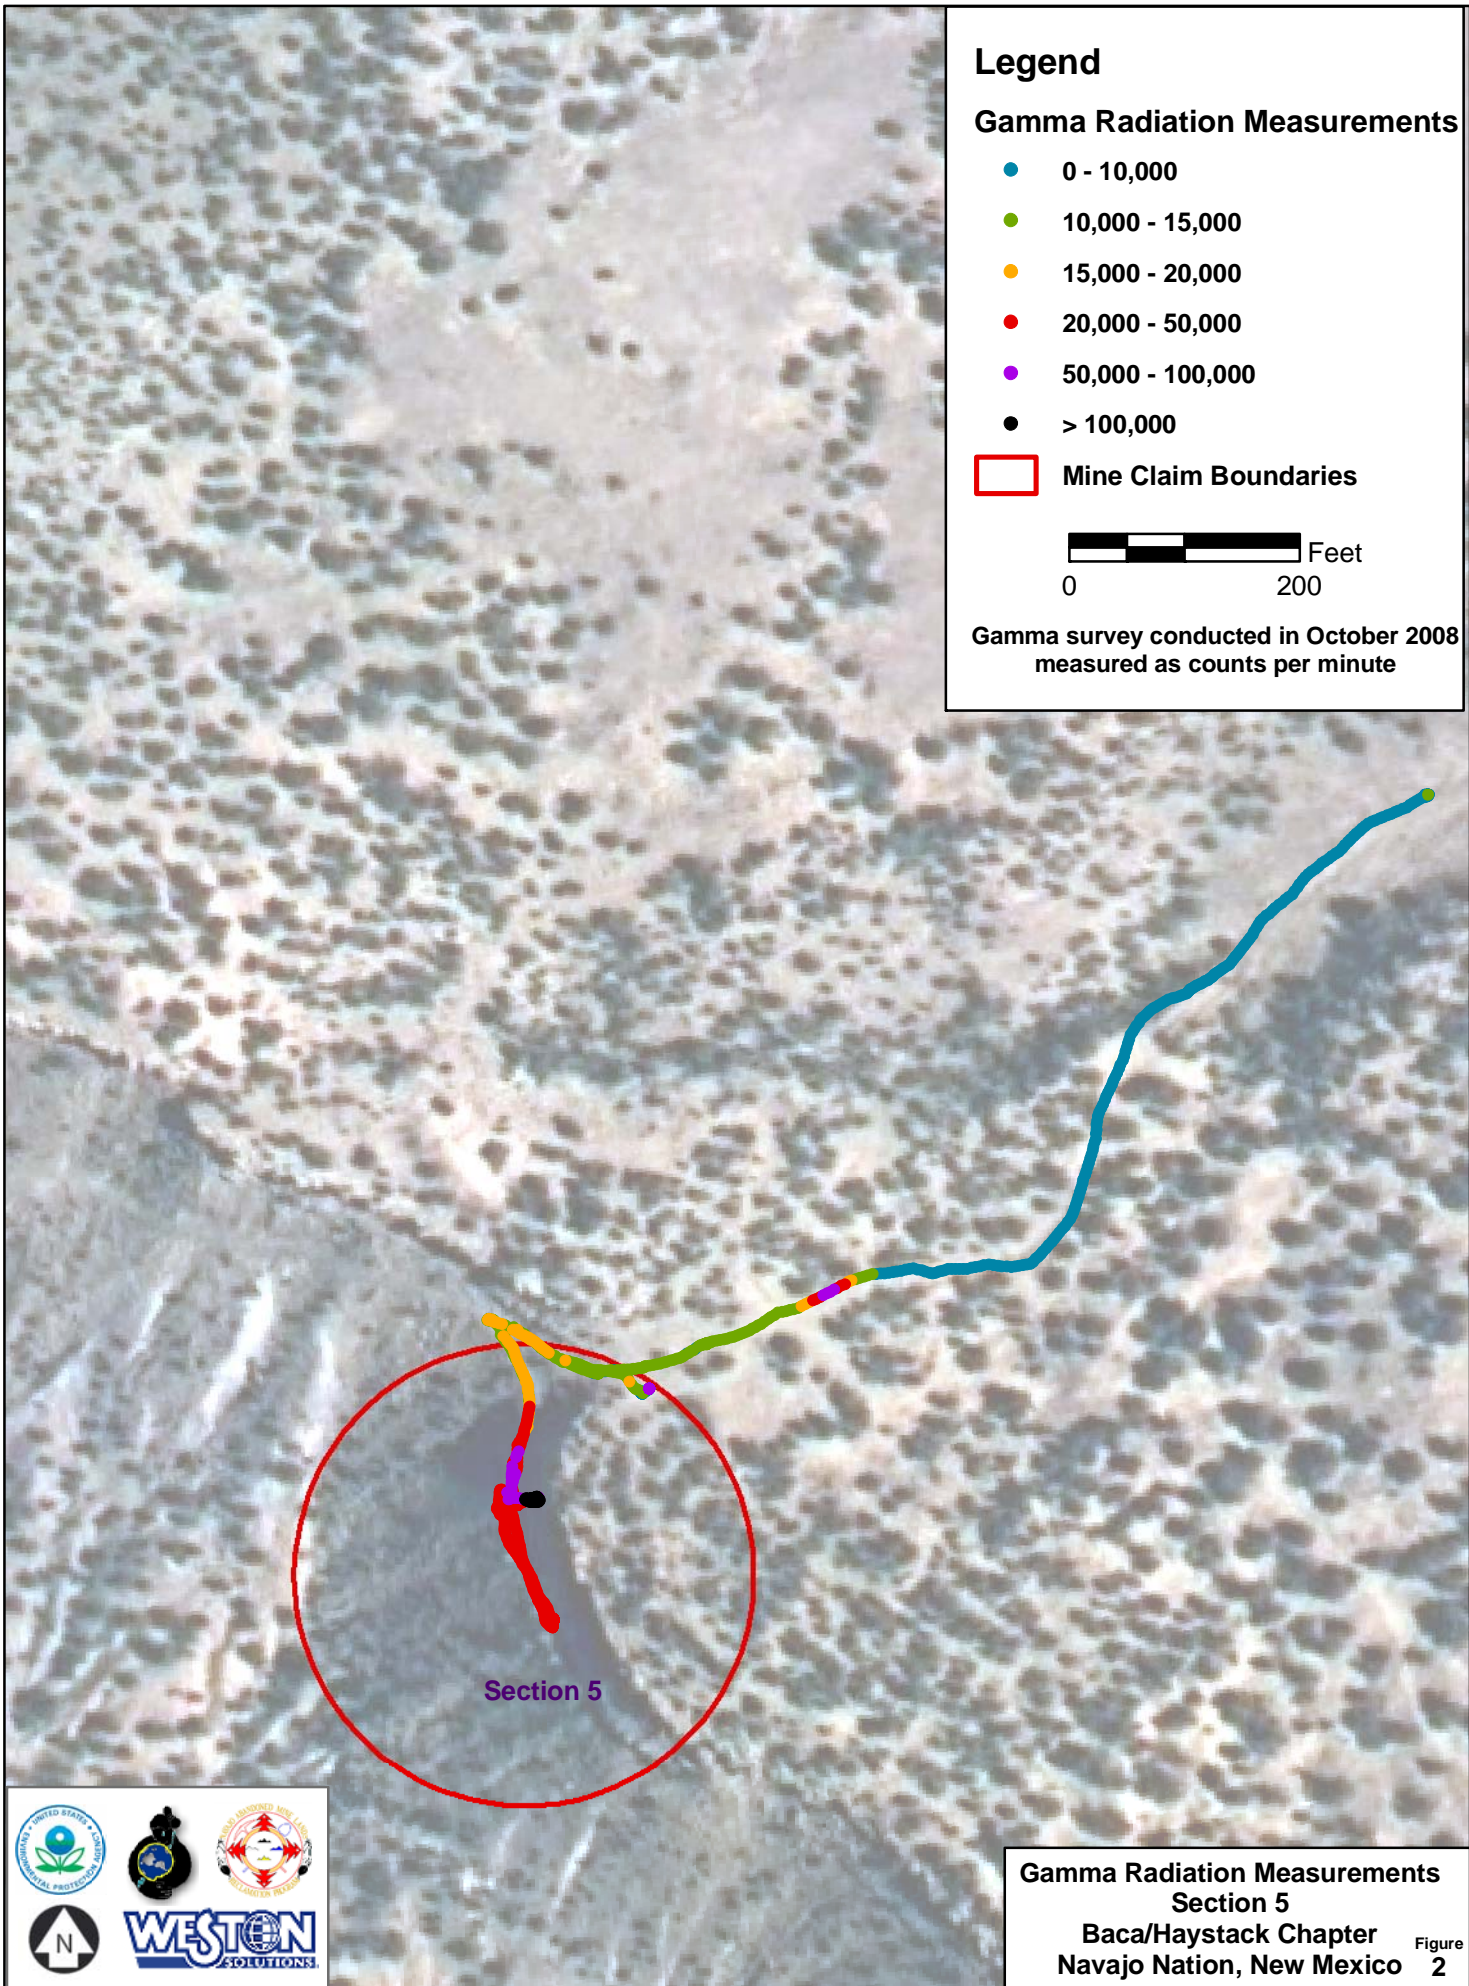
Gamma Radiation Measurements Above Two Times Background Section 5
Baca/Haystack Chapter Navajo Nation, New Mexico Figure 1

A total of 1,367 gamma radiation measurements were collected from mine sites, ranging from 6,137 cpm to 319,350 cpm. The measurements are represented in Figures 1 and 2. Gamma radiation measurements collected at the adit were greater than 100,000 cpm. The New Mexico Mining and Minerals Division identified radiological measurements with background levels 50 counts per second (cps); adit 800 cps.
