Navajo Abandoned Uranium Mine Site Screen Report

Dakota AUM Site

Navajo AUM Eastern Region

May 2009

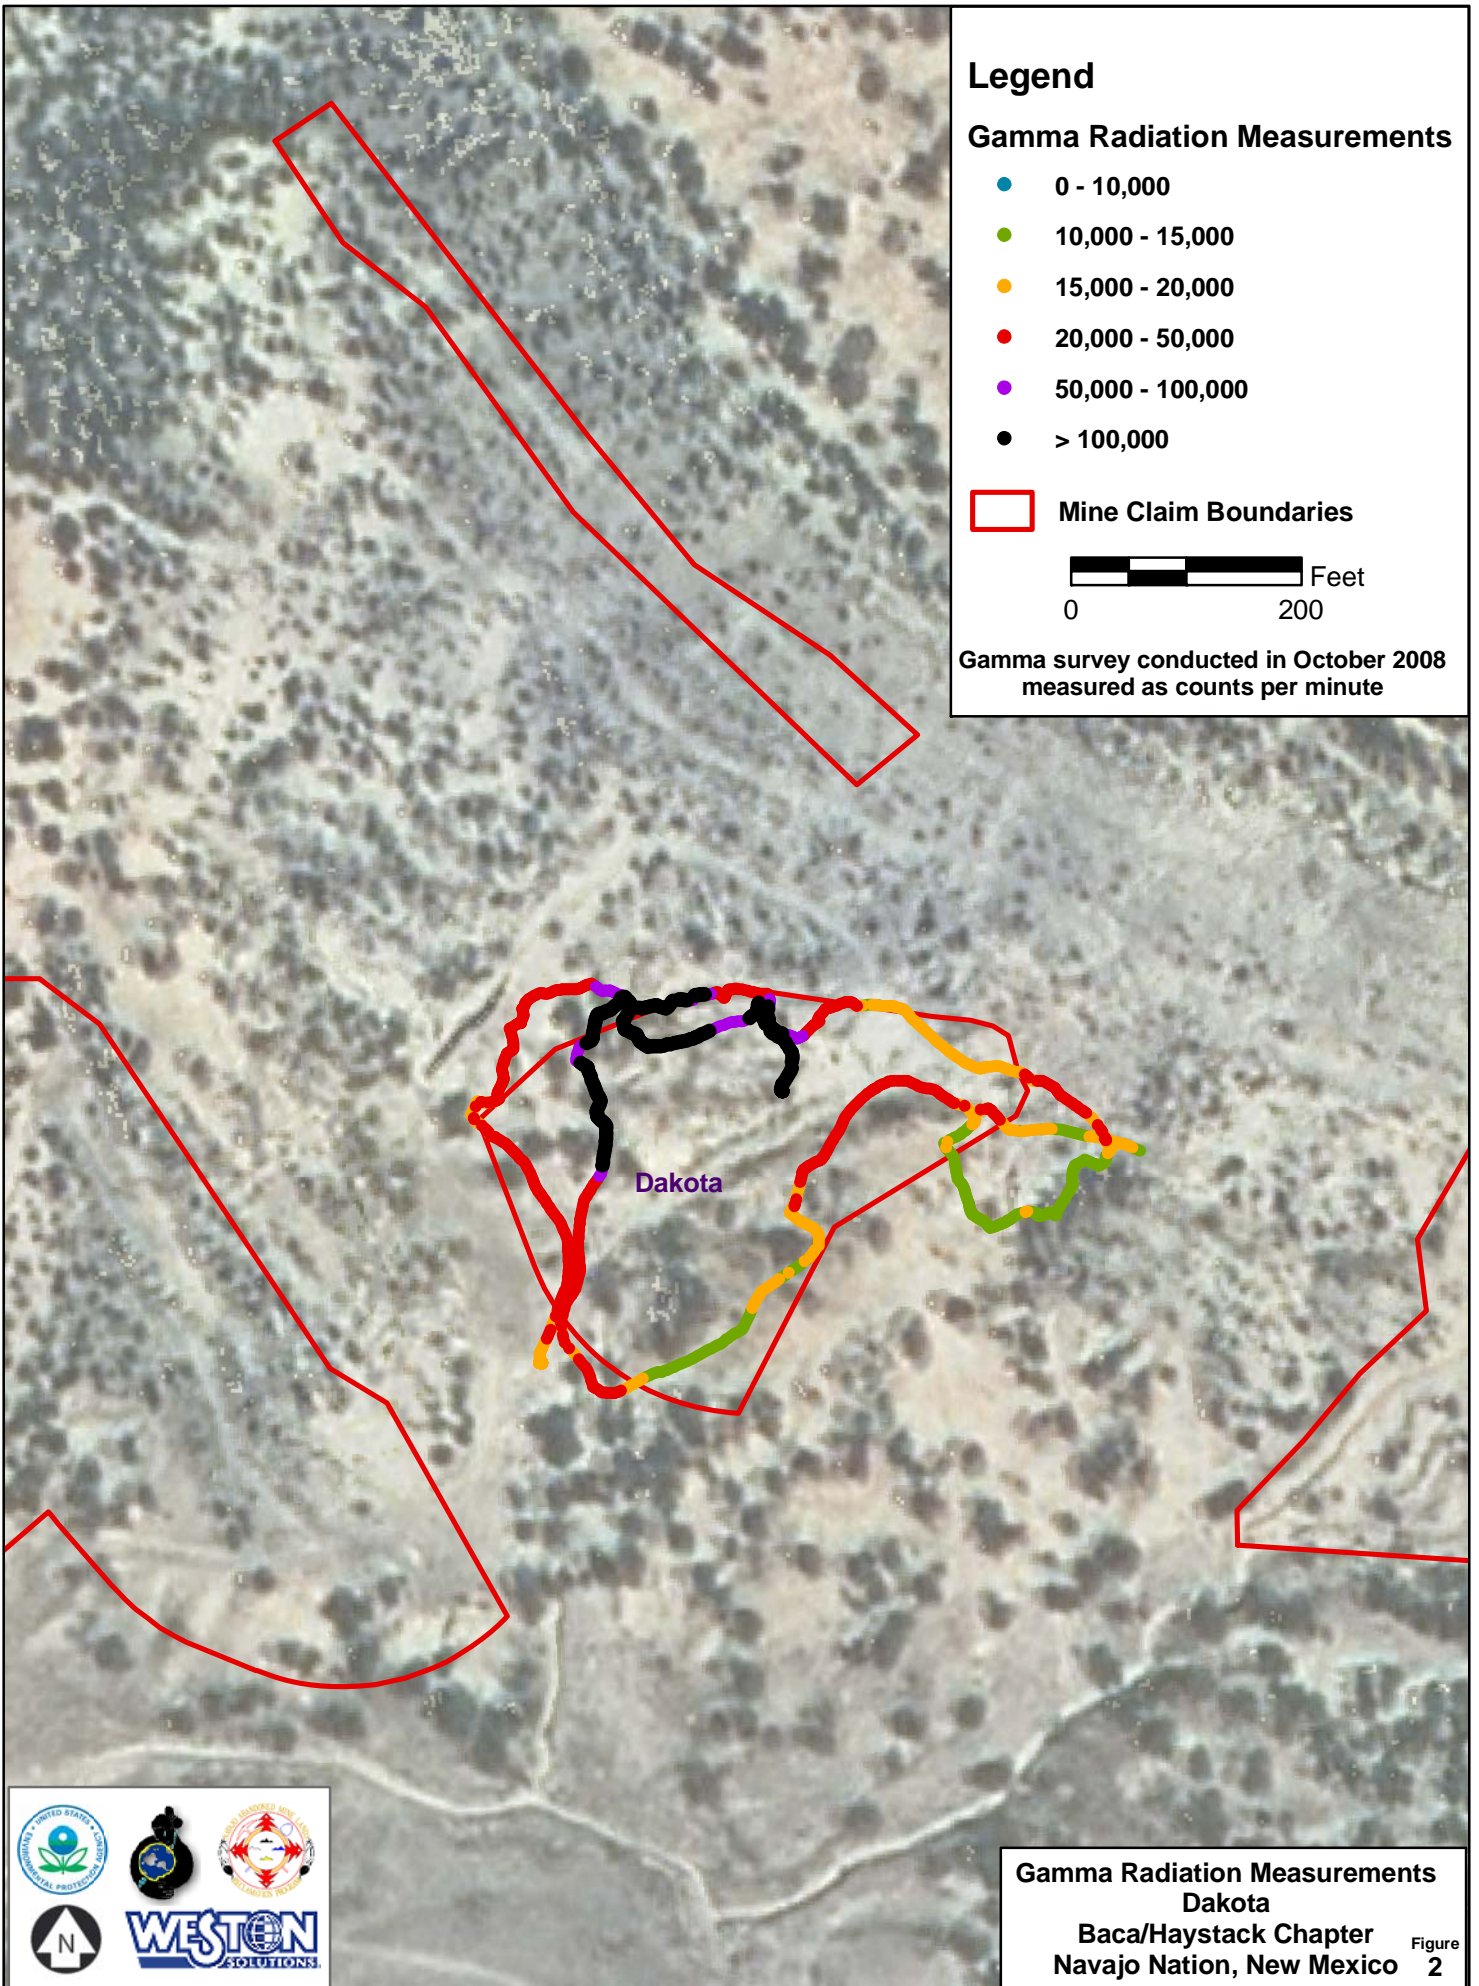
Gamma Radiation Measurements Above Two Times Background Dakota
 Baca/Haystack Chapter Navajo Nation, New Mexico Figure 1

A total of 1,178 gamma radiation measurements were collected from the mine site, ranging from 9,810 cpm to 292,715 cpm. Gamma radiation measurements at the mine adits were as great as 650,000 cpm. The measurements are represented in Figures 1 and 2. The New Mexico Mining and Minerals Division identified radiological measurements with background levels 50 counts per second (cps); and a high of 500 cps.
