Navajo Abandoned Uranium Mine

Site Screen Report

Harvey Begay 3 AUM Site

August 2010

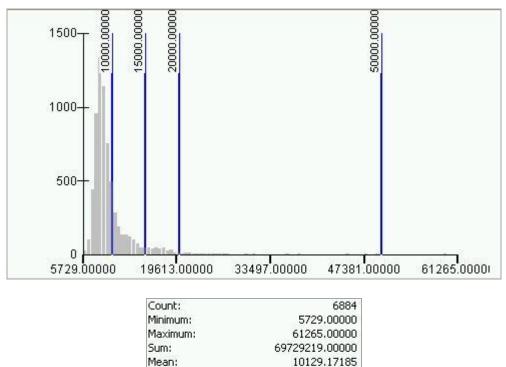
The following chart and statistics were generated by ESRI ArcGIS 9.3.1, and show the general distribution of the site gamma radiation measurements. The horizontal X axis represents the gamma radiation reading levels in cpm (lowest levels to the left). The vertical Y axis represents the frequency of each gamma radiation level.

Median: 8784.00000 Standard Deviation: 5186.61902
