**UNITED STATES ENVIRONMENTAL PROTECTION AGENCY**  
**REGION 5**  
**77 WEST JACKSON BOULEVARD**  
**CHICAGO, IL 60604-3590**

Subject: February 24, 2021 and February 25, 2021 SSO Reconnaissance Inspection Report

**Purpose:** Commonfields of Cahokia – SSO Reconnaissance Inspection Trip Report

**Facility:** Commonfields of Cahokia Sewer District

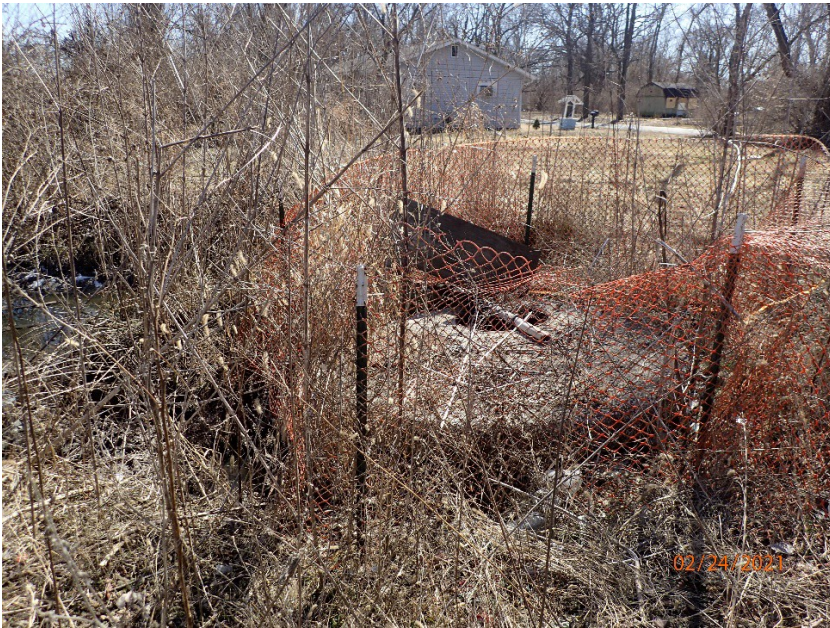
5: P2240058

Description: Lauralee and Violet Lift Station is located near residences.

EPA and IEPA discussed several of the other Commonfields lift stations. Mr. Traiteur stated that Lift Station #22, at Lauralee and Violet, was inoperable. He said that the manhole for this lift station had settled about four feet and that caused the manhole and piping to the lift station to fill with sand. There is a submersible pump in the lift station to pump the wastewater downstream. When flows come into the lift station from gas-powered pumps upstream, they come in at a higher rate than the submersible in the lift station is able to pump it out and it then overflows. Mr. Traiteur stated that the discharge doesn't go anywhere but stays in a depression near the station.

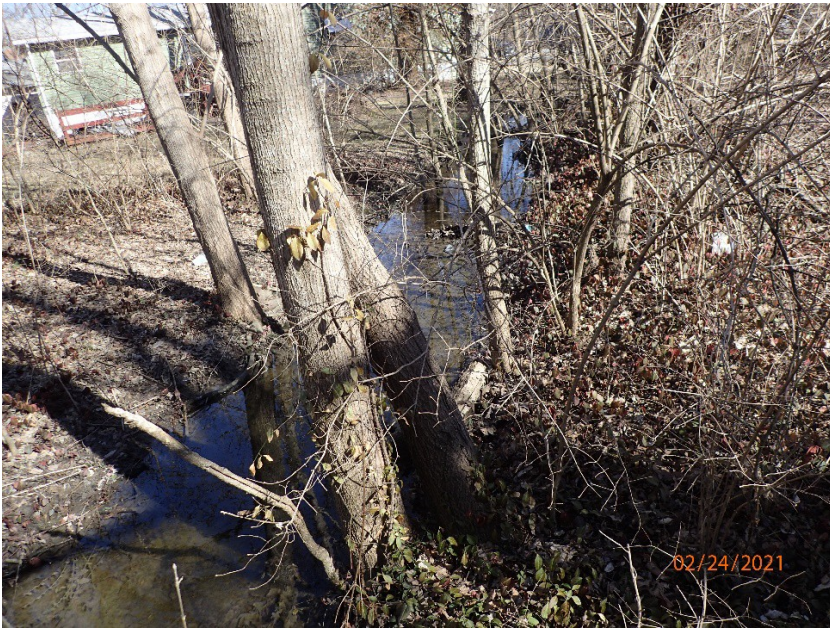
9: P2240062

Description: Flow pathway continues to the southwest behind the homes on North 82<sup>nd</sup> Street. Looking upstream.

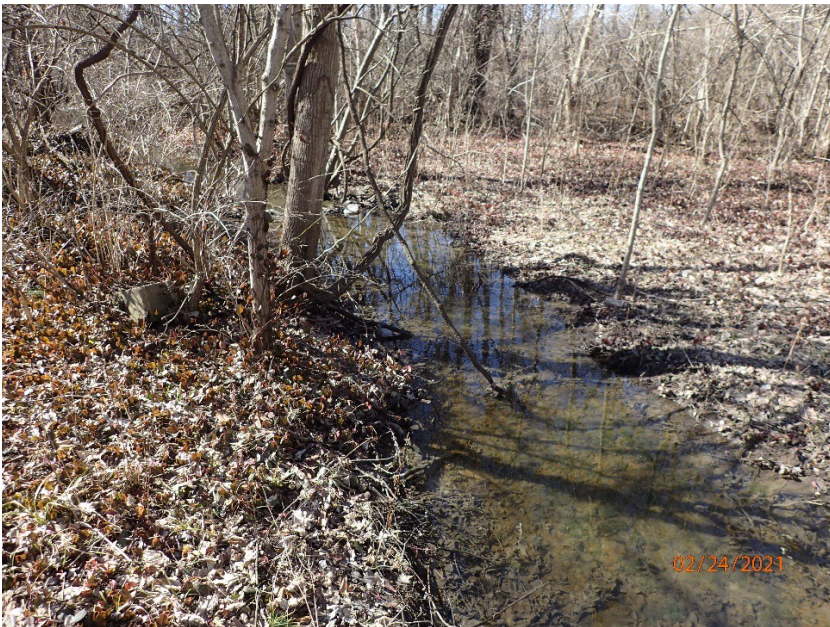
10: P2240063

Description: Flow pathway continues to the southwest behind the homes on North 82<sup>nd</sup> Street. Looking downstream.

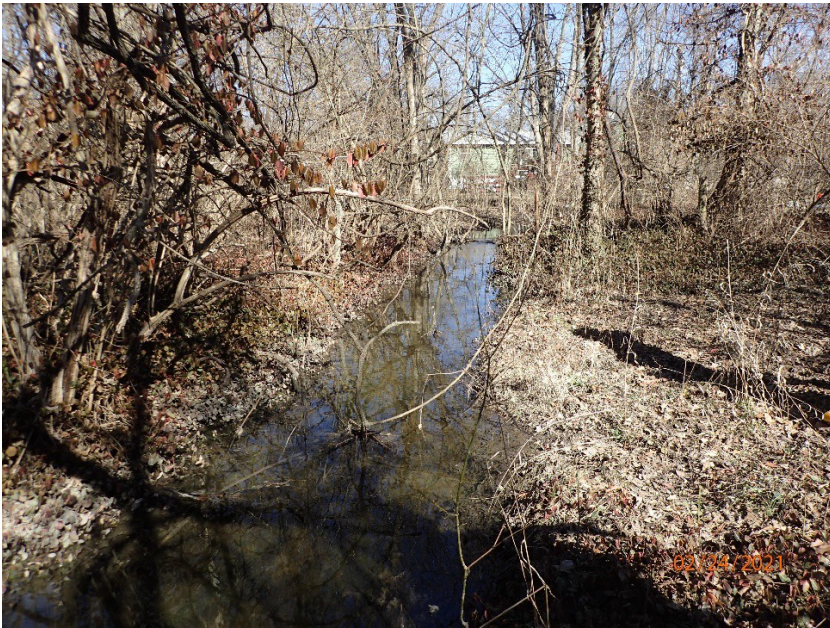
11: P2240064

Description: Looking upstream at the flow pathway which originated at the cleanout on North 82<sup>nd</sup> Street.  
Location: Between North 82<sup>nd</sup> Street and North 80<sup>th</sup> Street.

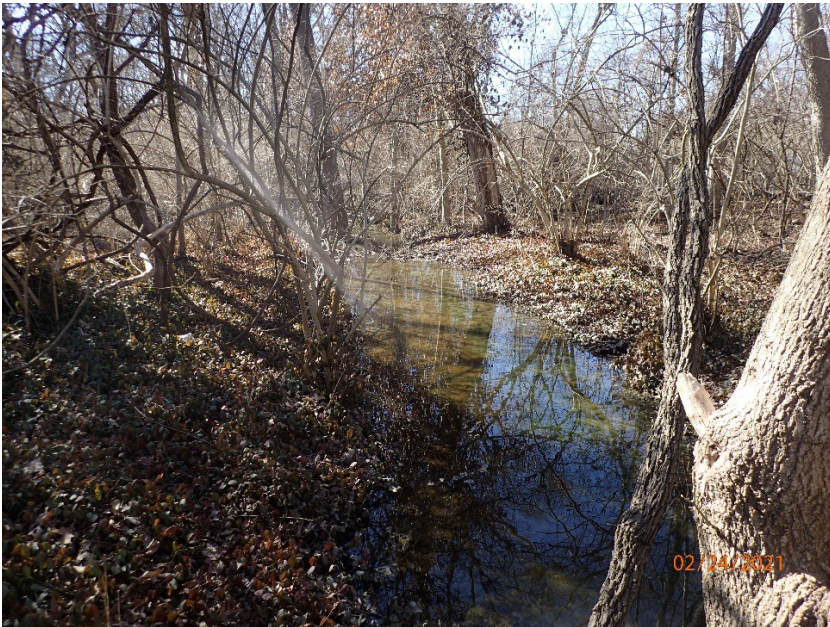
12: P2240065

Description: Looking downstream at the flow pathway which originated at the cleanout on North 82<sup>nd</sup> Street.  
Location: Between North 82<sup>nd</sup> Street and North 80<sup>th</sup> Street.

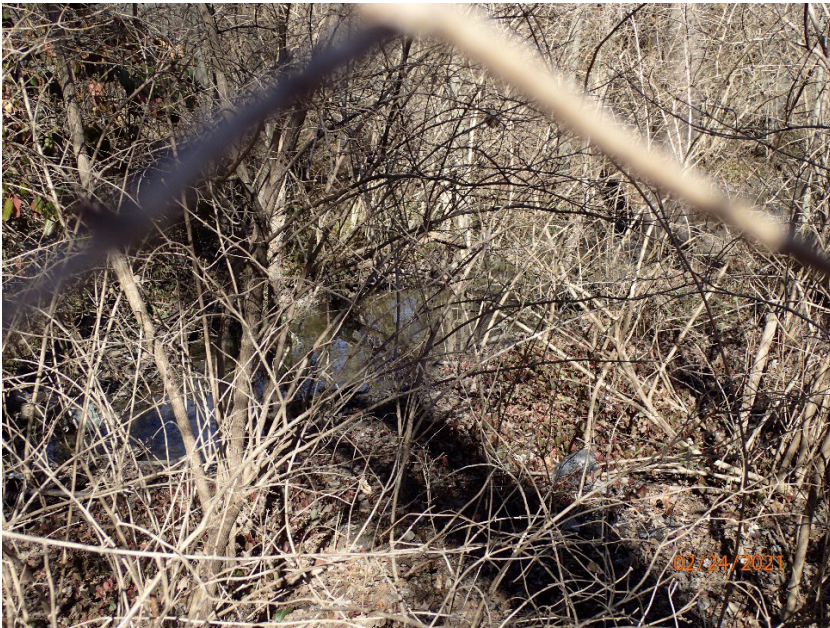
13: P2240066

Description: The flow pathway took a turn to the northwest. Looking upstream.

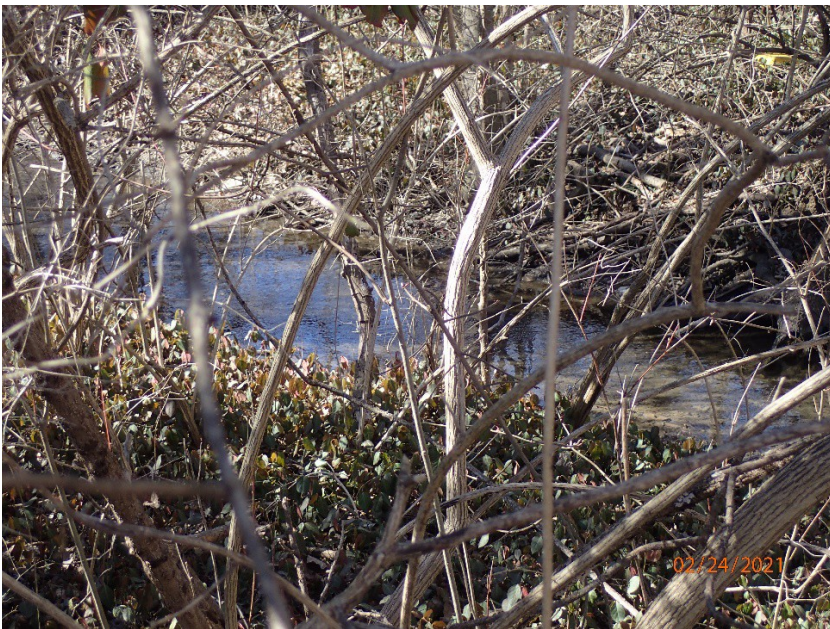
14: P2240067

Description: The flow pathway took a turn to the northwest. Looking downstream.

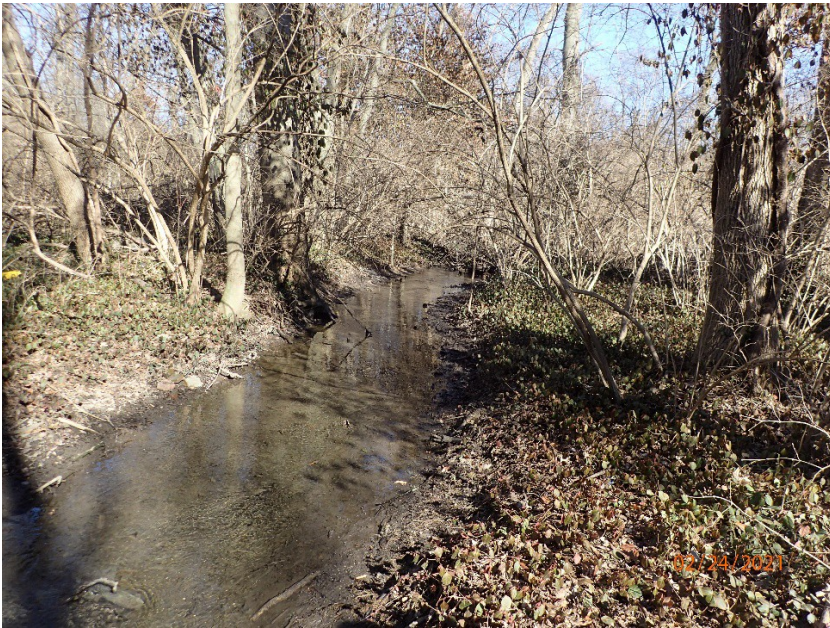
15: P2240068

Description: Looking upstream at the flow pathway that began at the cleanout on North 82<sup>nd</sup> Street.

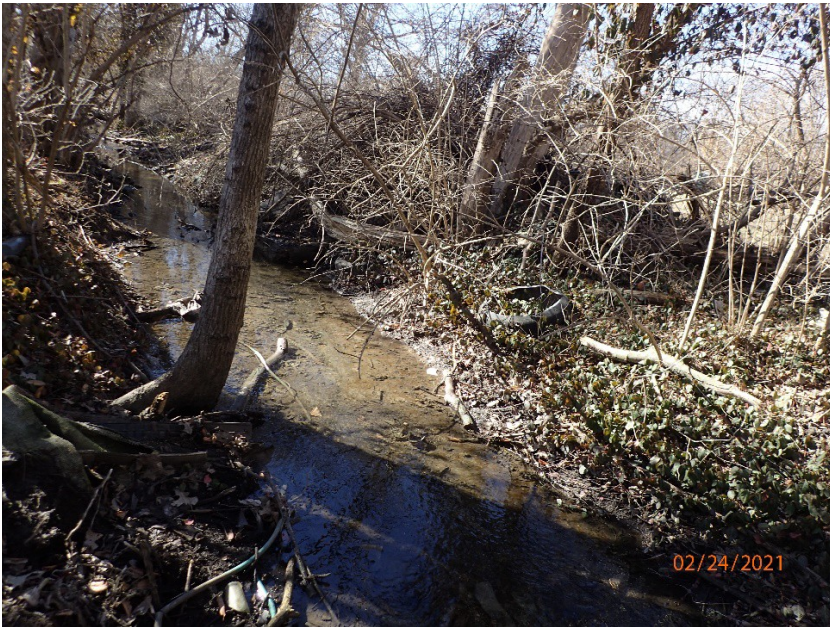
16: P2240069

Description: Looking downstream at the flow pathway that began at the cleanout on North 82<sup>nd</sup> Street.

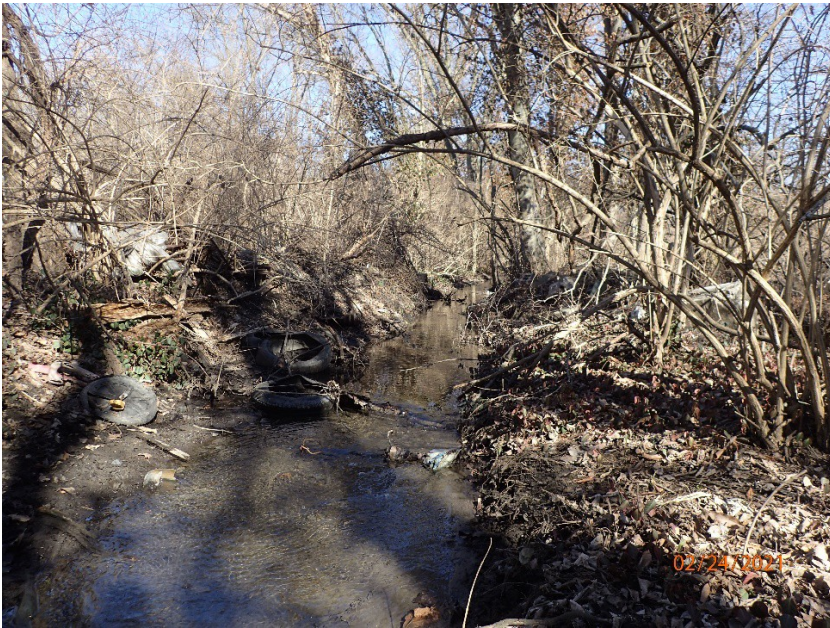
17: P2240070

Description: Looking upstream at the flow pathway that began at the cleanout on North 82<sup>nd</sup> Street.

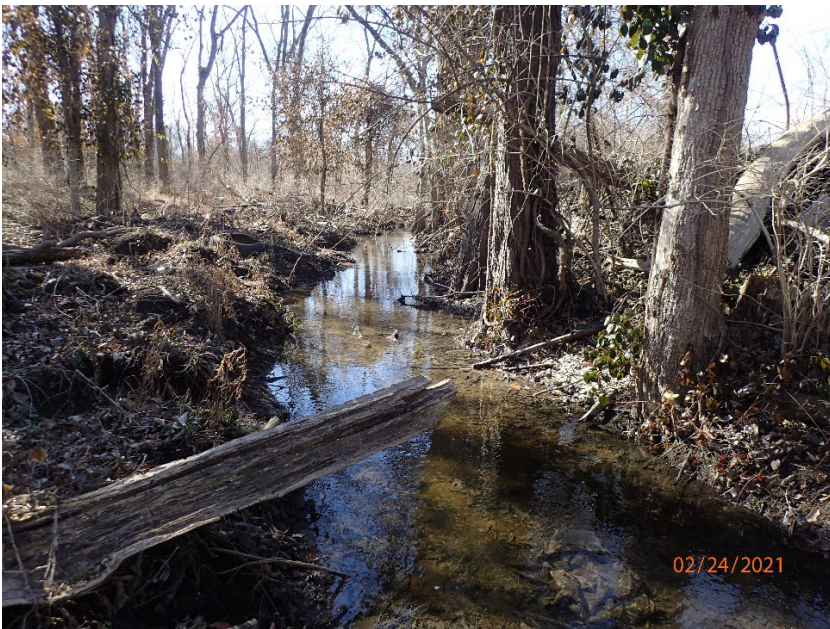
18: P2240071

Description: Looking downstream at the flow pathway that began at the cleanout on North 82<sup>nd</sup> Street.

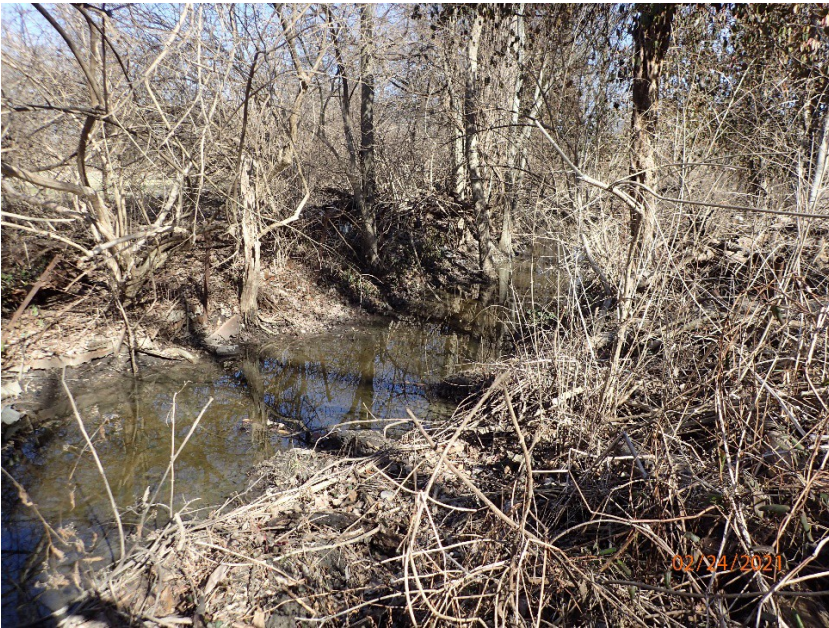
19: P2240072

Description: Flow turns to the northwest toward the bend in North 80th Street. Looking upstream.

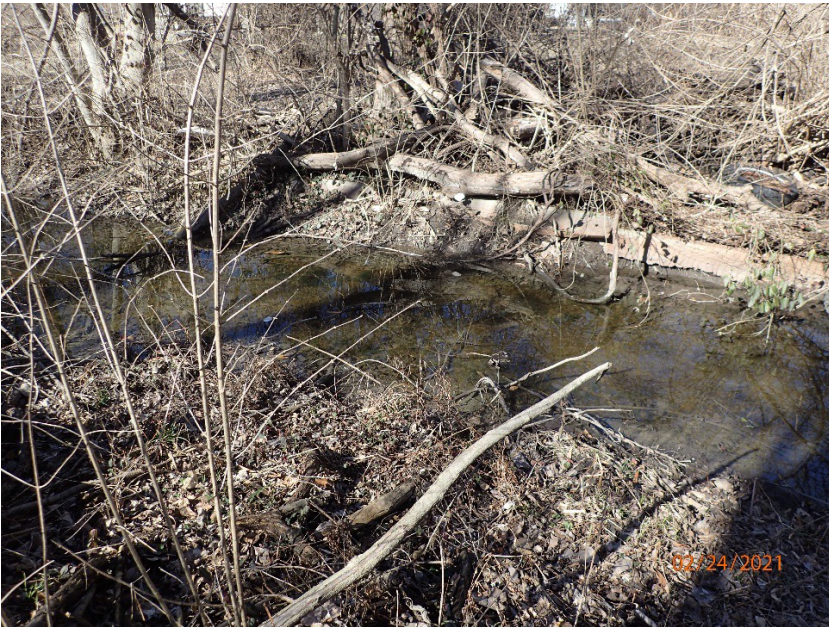
20: P2240073

Description: Looking downstream after flow turns toward the northwest.

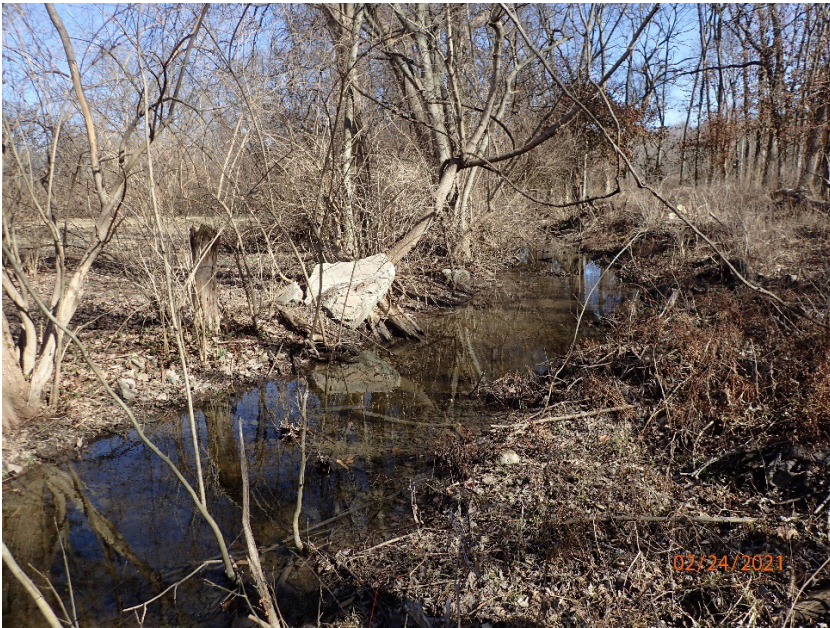
21: P2240074

Description: Looking upstream after flow turns toward the northwest.

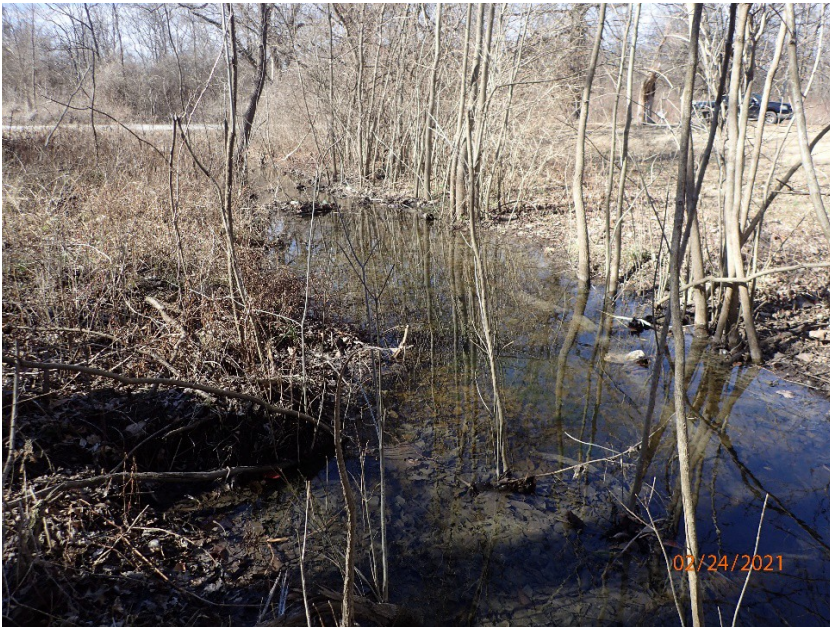
22: P2240075

Description: Looking downstream after flow turns toward the northwest. North 80<sup>th</sup> Street in background.

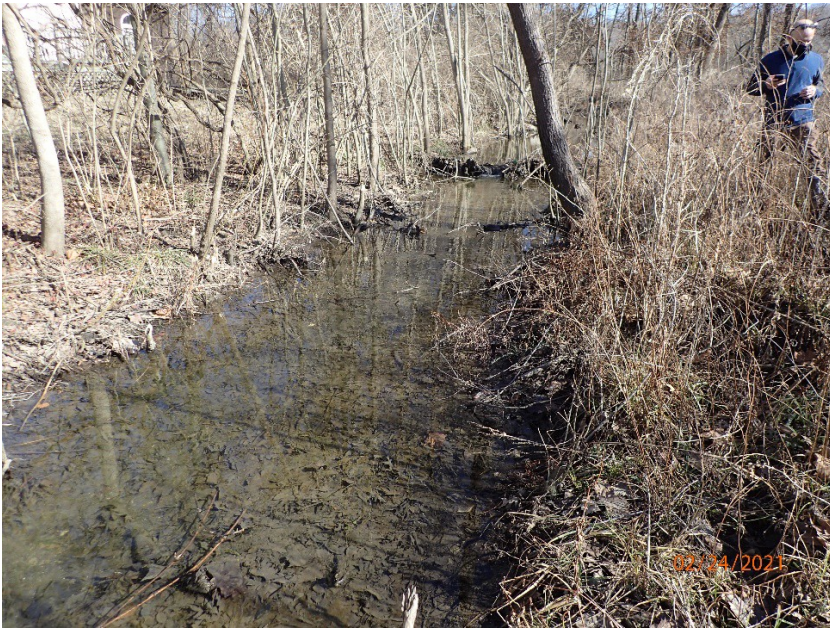
23: P2240076

Description: Looking upstream as flow approaches North 80<sup>th</sup> Street.

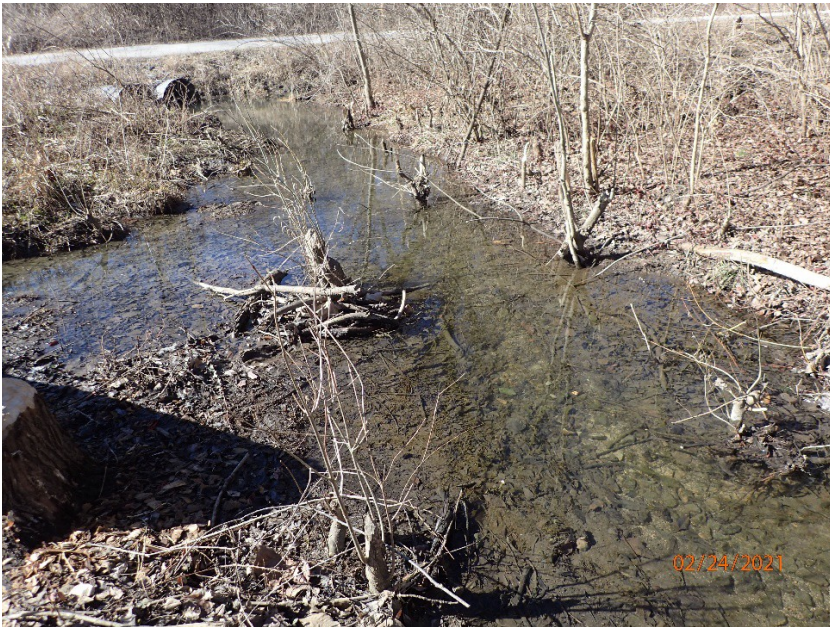
24: P2240077

Description: Looking downstream as flow approaches North 80<sup>th</sup> Street.

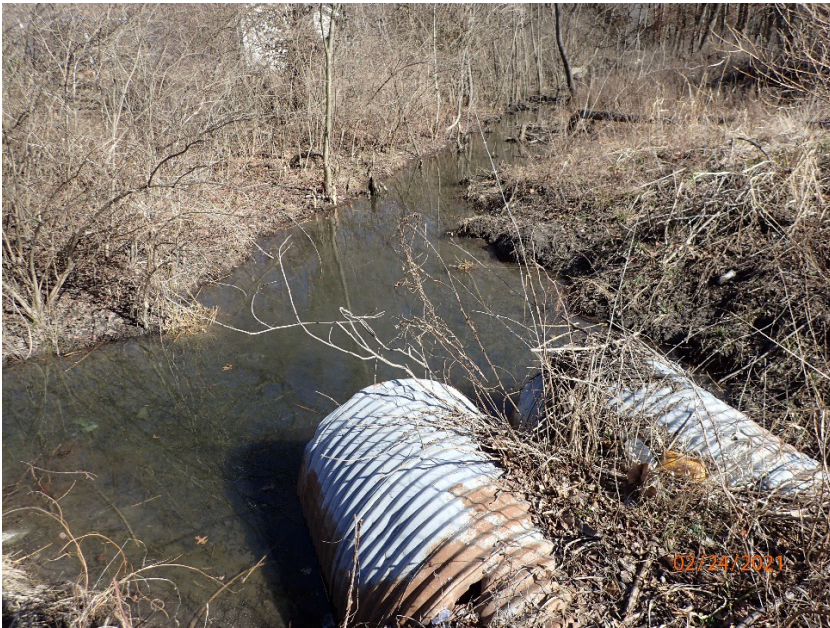
25: P2240078

Description: Looking upstream as flow approaches twin culverts under North 80<sup>th</sup> Street.

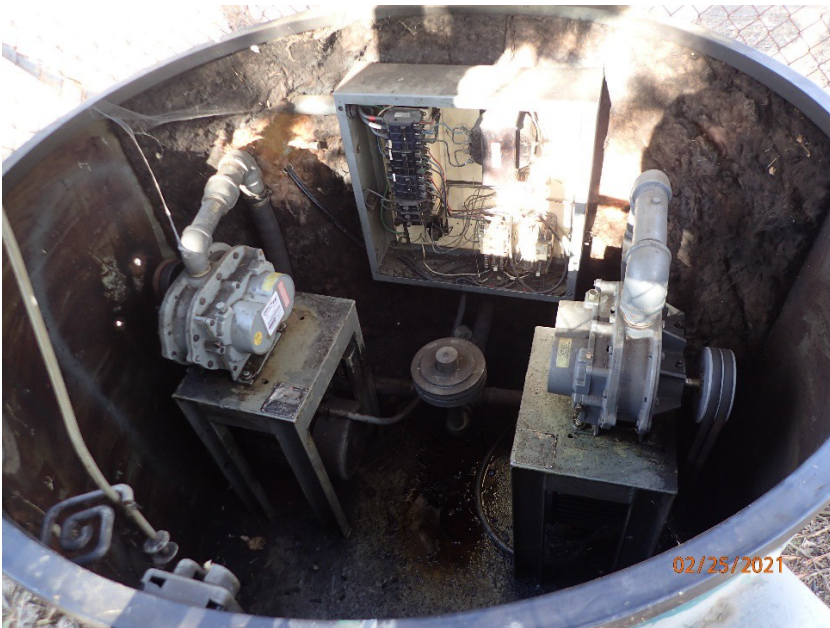
41: P2250086

Description: The inside of Lift Station #5.

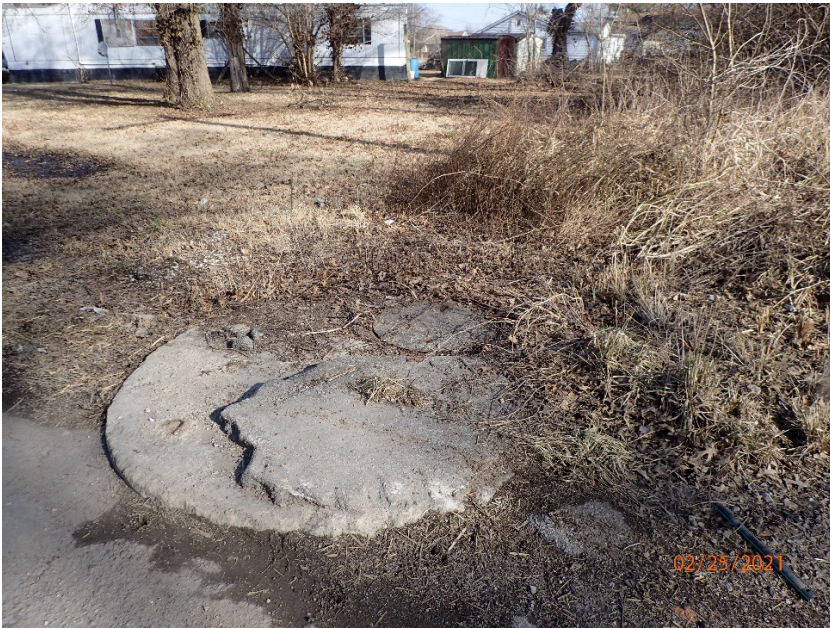
43: P2250088

Description: Wet well for Lift Station #6 is across the street.

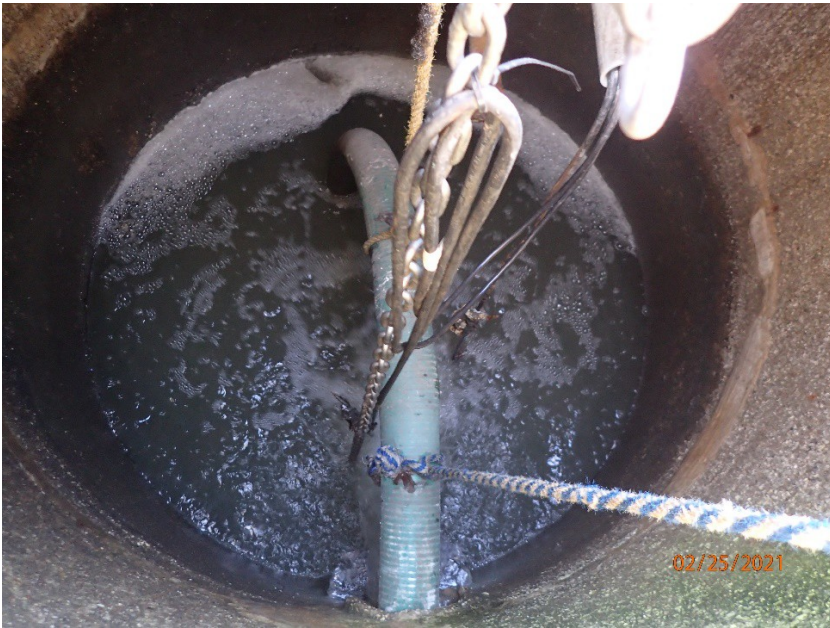
47: P2250092

Description: Lift Station #8 was not operational. The manhole across North 75<sup>th</sup> Street had a pipe across it from which a submersible pump was hanging. The manhole contained water.

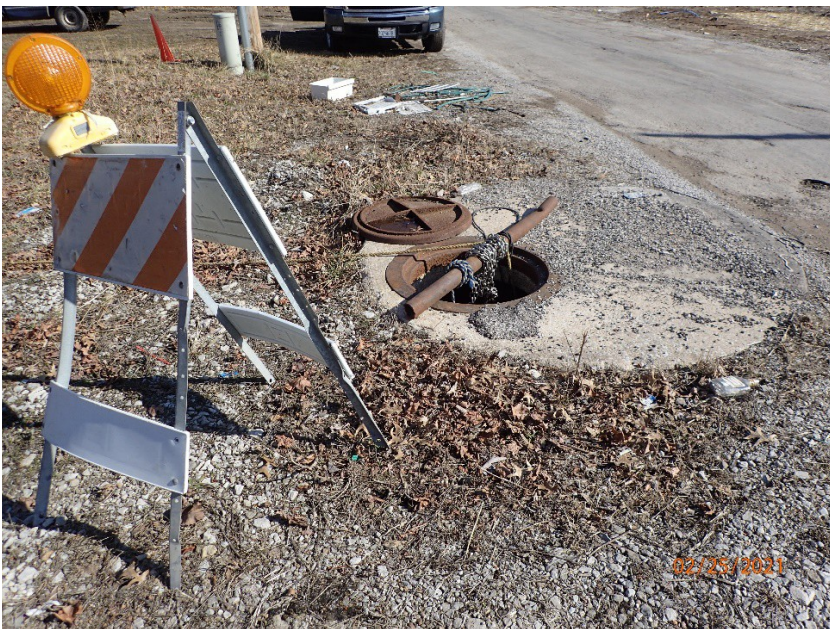
48: P2250093

Description: Manhole across North 75<sup>th</sup> Street from Lift Station #8 had a submersible pump hanging in the wet well. The manhole cover was laying next to the open manhole.

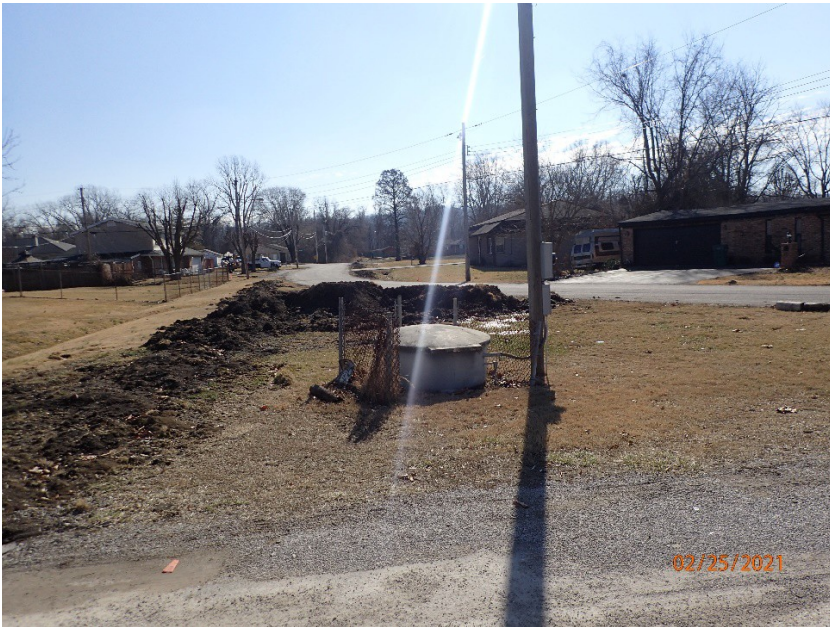
50: P2250095

Description: Lift Station #9 did not have any evidence that it had overflowed recently.

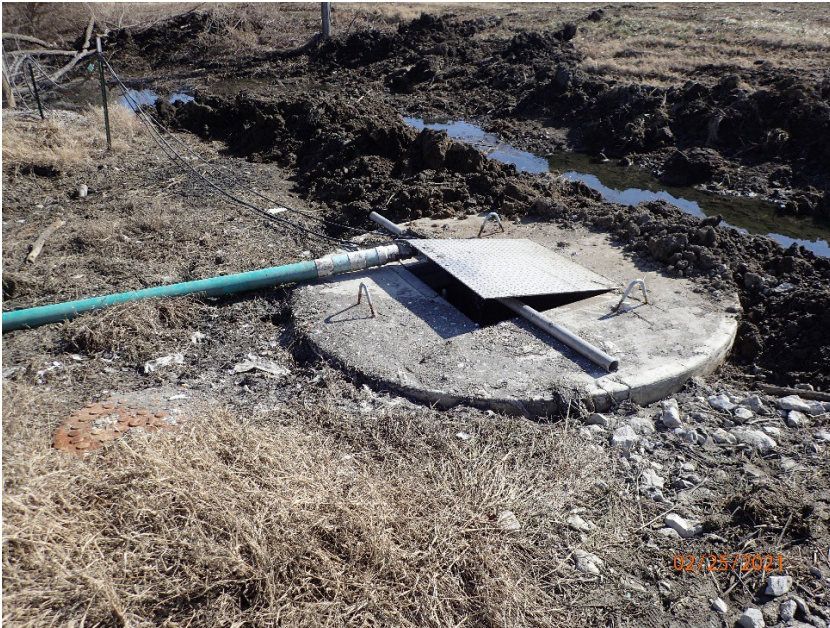
51: P2250096

Description: Lift Station #20 was being bypassed by piping that took it up to the street level and to a manole. This lift station is also known as Lady of Snows.

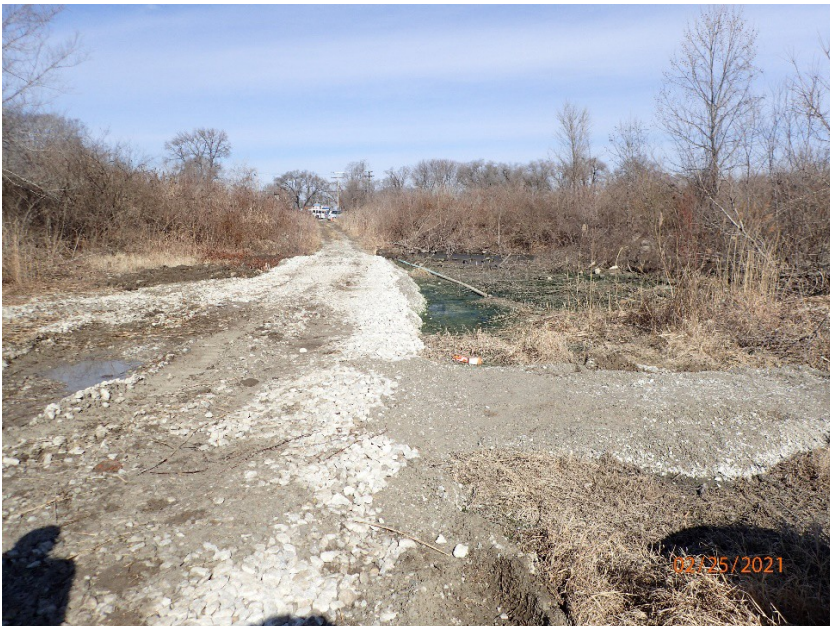
52: P2250097

Description: The hose to the right of the driveway takes the flow that is pumped from the lift station to a manhole at street level.

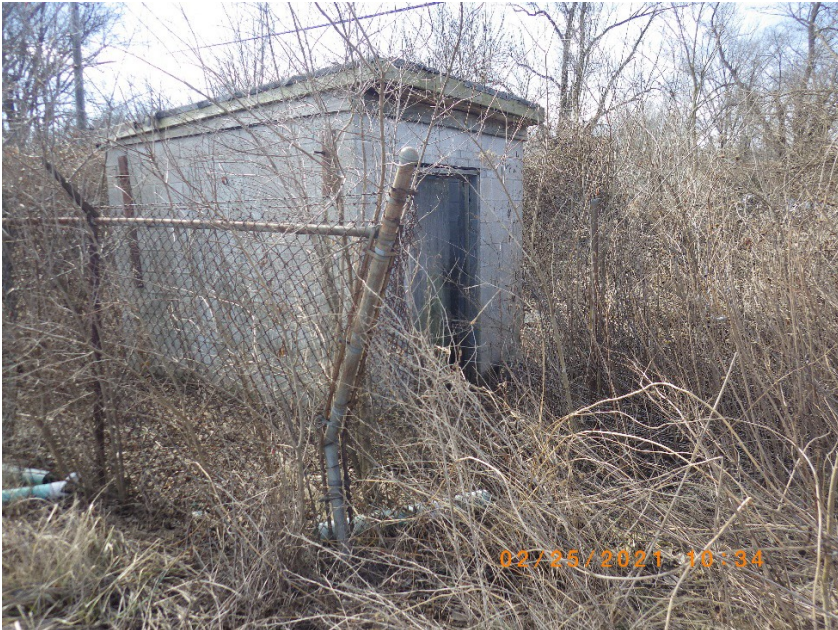
53: CFCD0006\_20210225

Together with Mr. Stitely, all three EPA inspectors drove back to Lift Station #22 at Lauralee Drive and Violet Drive. EPA and IEPA walked northwest to Lift Station # 13, also named the Block House. The Block House was in complete disrepair and was not functional. The roof of the Block House had fallen into the pump station, there was no cover on the wet well, and the station was not locked.

Description: Lift Station #13. Lift station building in disrepair and unlocked.

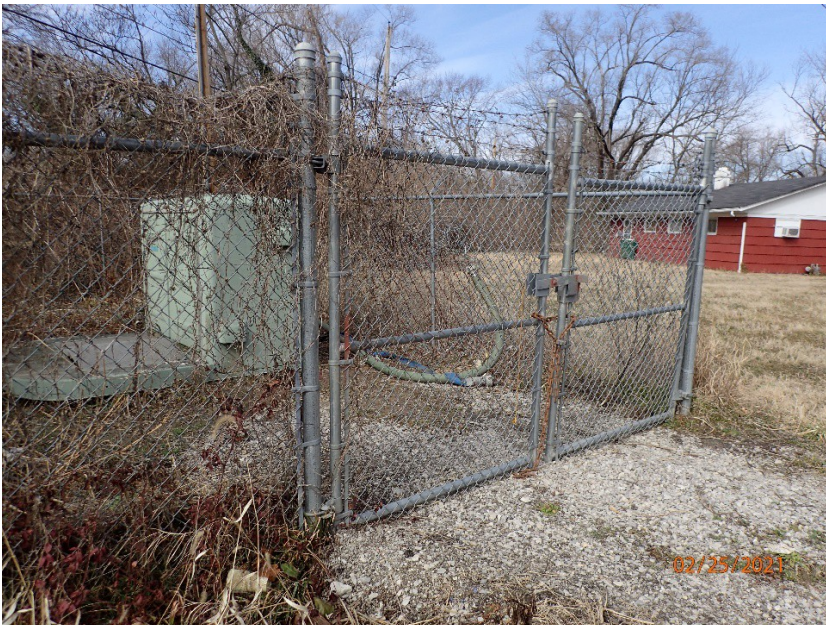
57: P2250098

Description: Lift Station #1 is behind a locked fence.

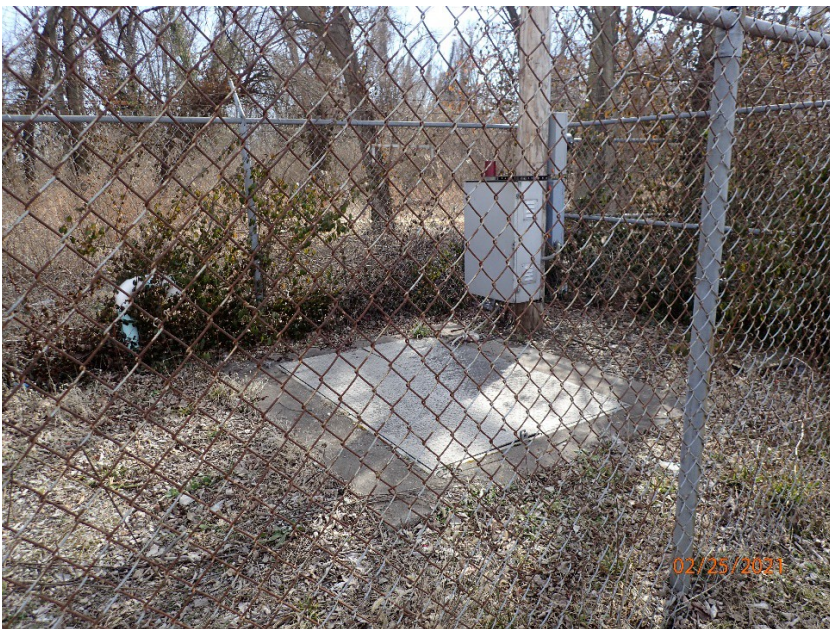
59: P2250100

Description: Lift Station #18 is behind the playground for the Greystone Apartments. There is no lock on the gate around the lift station.

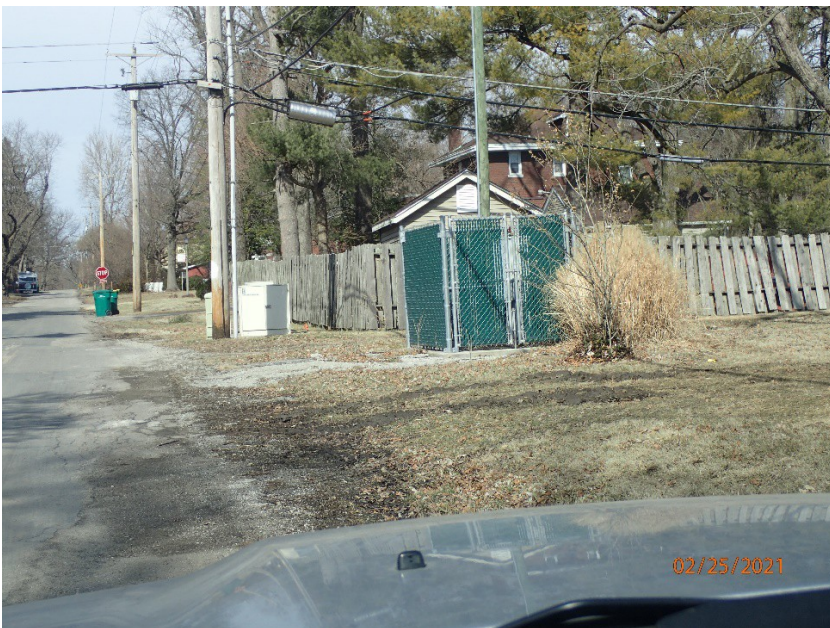
61: P2250102

Description: Lift Station #17 had locked fencing around it.

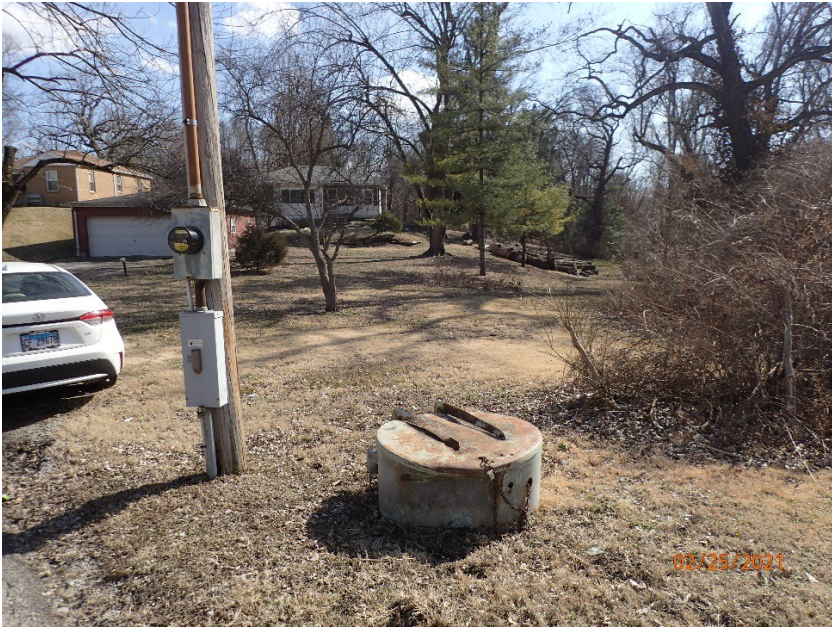
62: P2250103

Description: Lift Station #26 was locked and did not have any evidence of overflows.

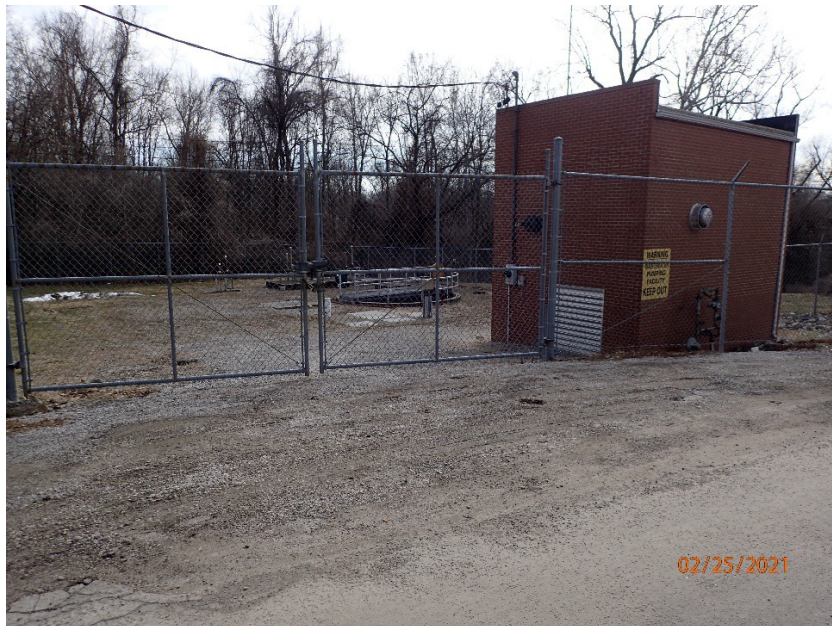
63: P2250104

Description: A neighborhood wastewater pump facility in the Signal Hill neighborhood. Location: Superior and South 88<sup>th</sup> Street.
