FOURTH FIVE-YEAR REVIEW REPORT

**SHARON STEEL SUPERFUND SITE
CERCLIS ID: UTD980951388**

**CITY OF MIDVALE
SALT LAKE COUNTY, UTAH**

Utah Department of Environmental Quality
Division of Environmental Response and Remediation

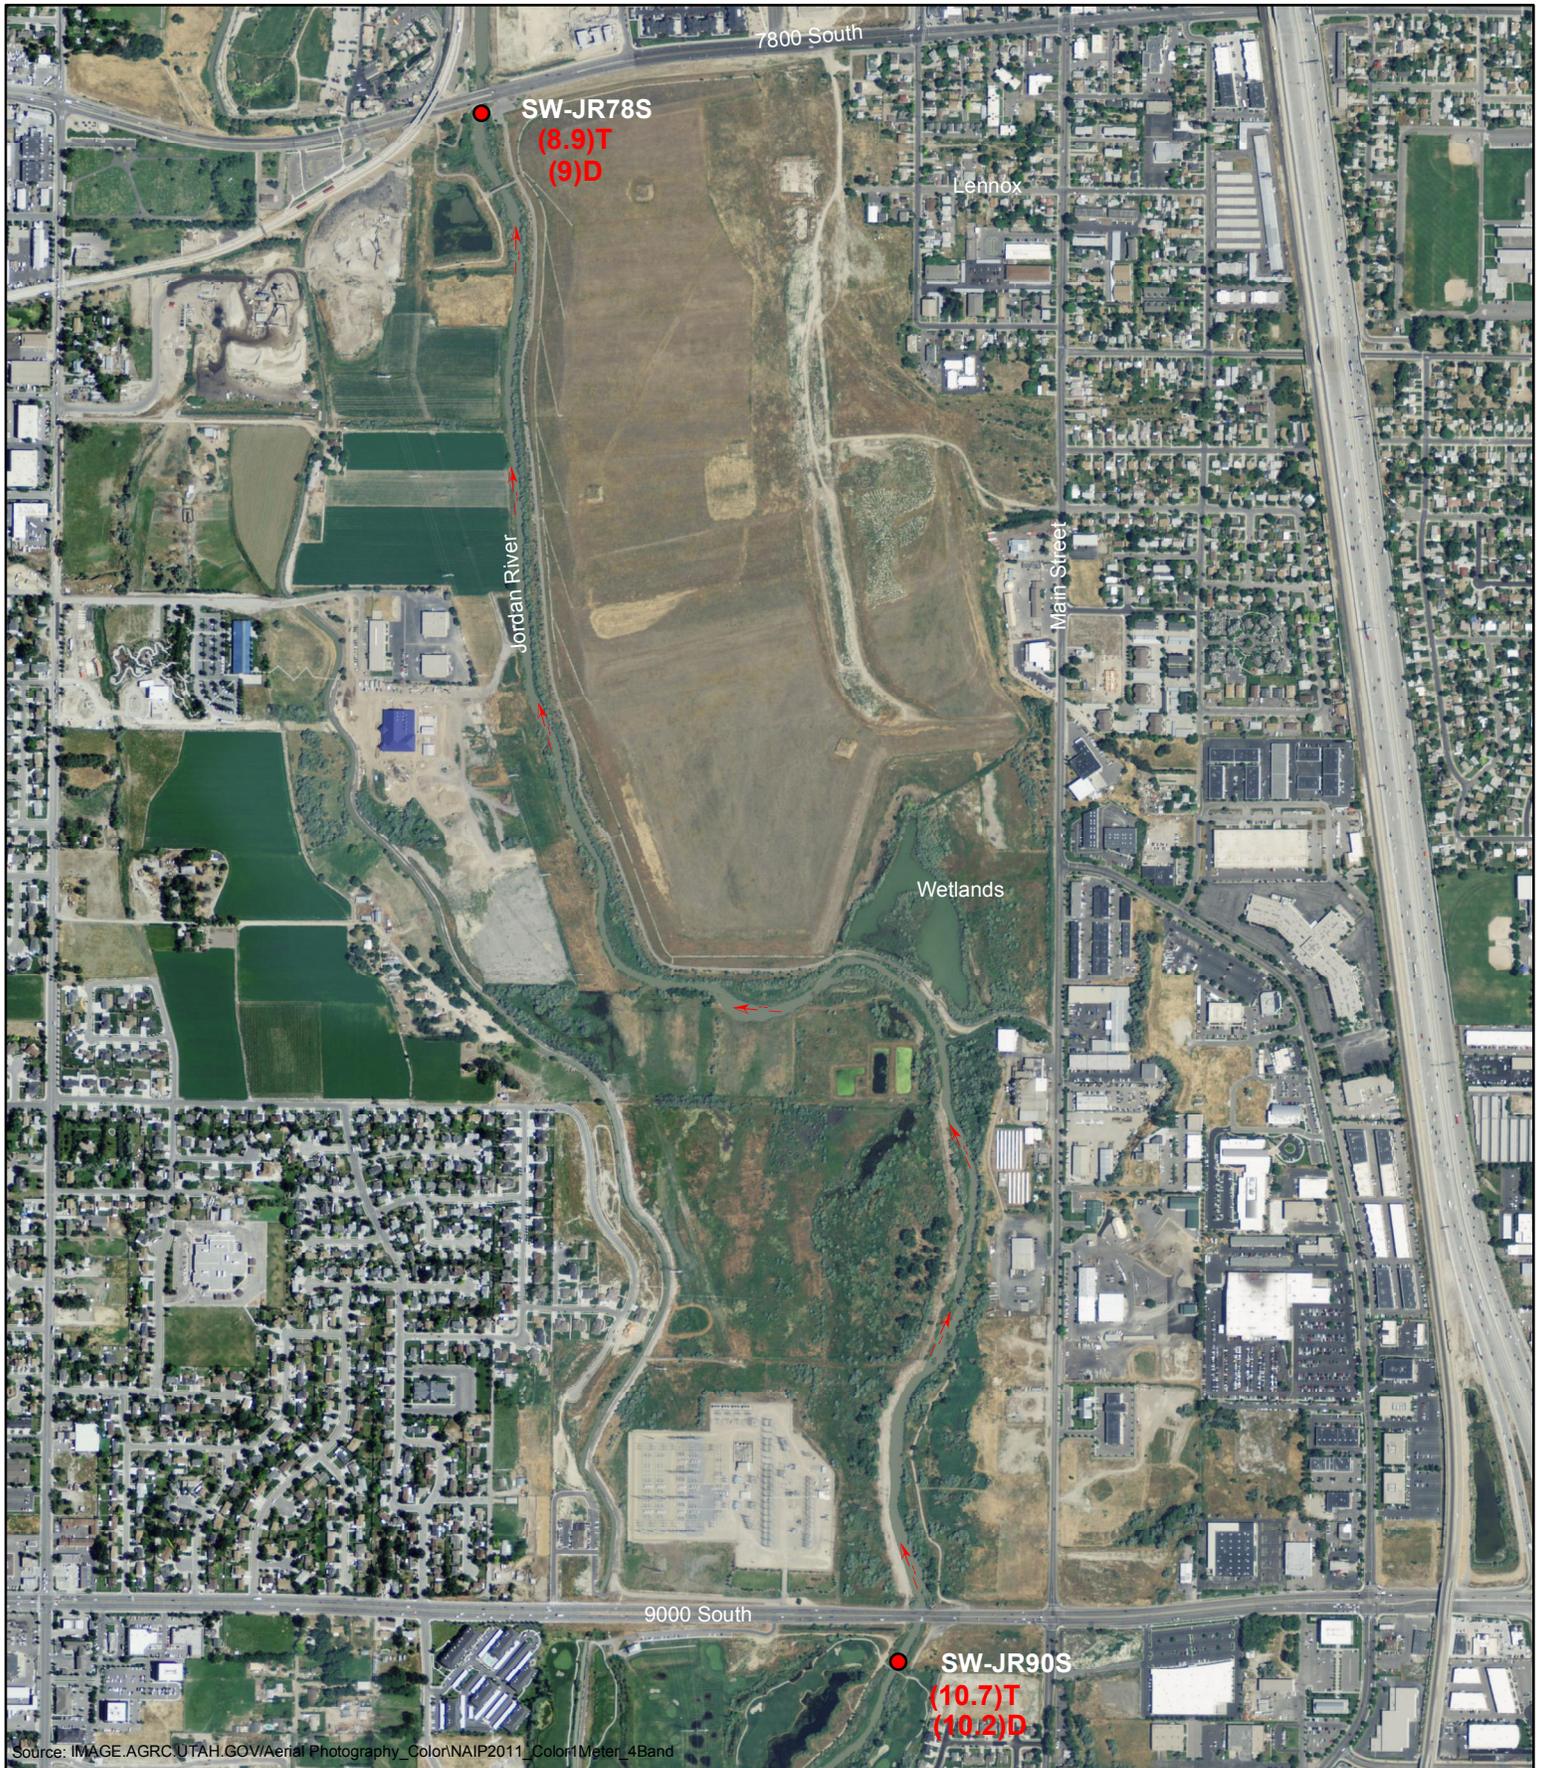
**Attachment F:
Figure of Arsenic Concentrations in Surface
Water**

- Surface Water Sample Location
 - (3)T Total Arsenic Concentration ppb
 - (3)D Dissolved Arsenic Concentration ppb
 - Surface Water Flow Direction
- Note: Action Level for Surface Water is 190 ppb

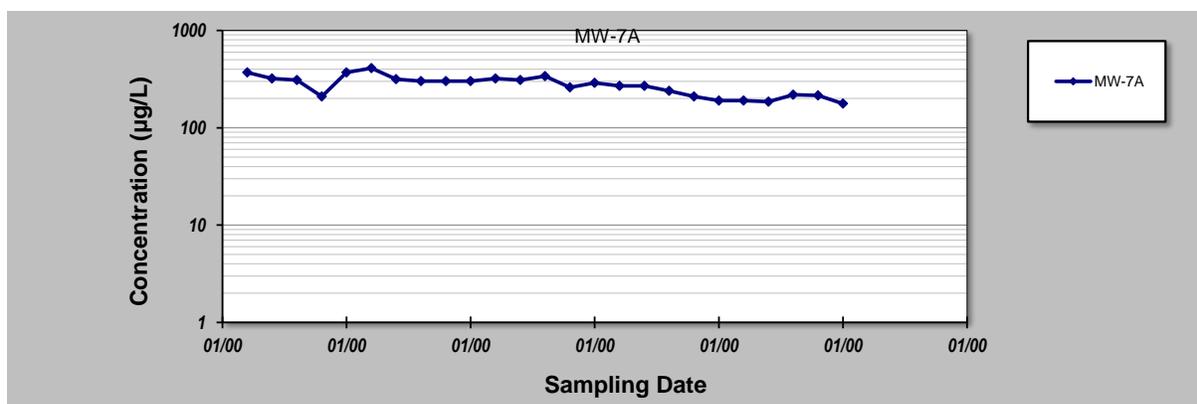
Coefficient of Variation:	0.23
Mann-Kendall Statistic (S):	-191
Confidence Factor:	>99.9%
Concentration Trend:	Decreasing
