**Second Five Year Review Report  
Hudson River PCBs Superfund Site**

**APPENDIX 10  
FIVE-YEAR REVIEW SITE INSPECTION  
CHECKLIST**

**APPENDIX 10-1  
FIVE-YEAR REVIEW SITE INSPECTION  
CHECKLIST  
OU-1**

## Five-Year Review Site Inspection Checklist – OU1

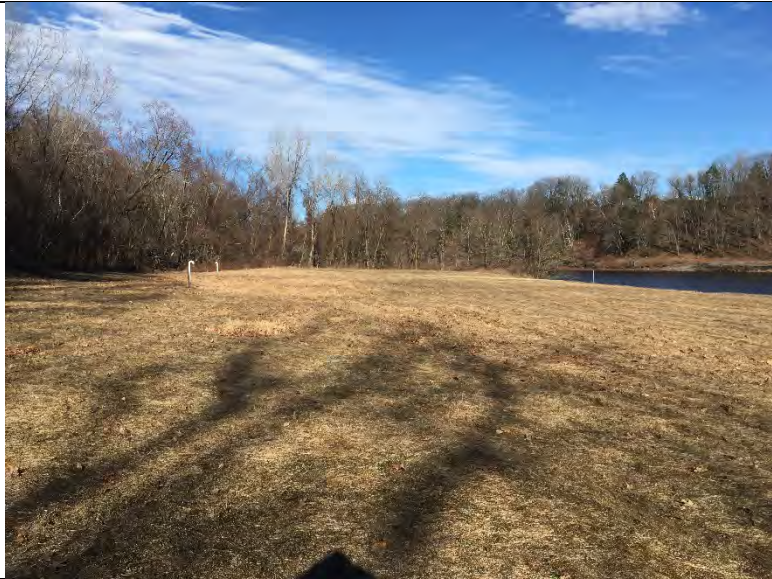
030217\_0201

030217_0512	1430	Western edge of Site 5	West	Mid extent of Site 4
030217_0513	1430	Western edge of Site 5	Northwest	Northern extent of Site 4
030217_0514	1430	Western edge of Site 5	West	Drainage swale on Site 4
030217_0201	1503	Middle of Site 2	Northeast	Northern extent of Site 2

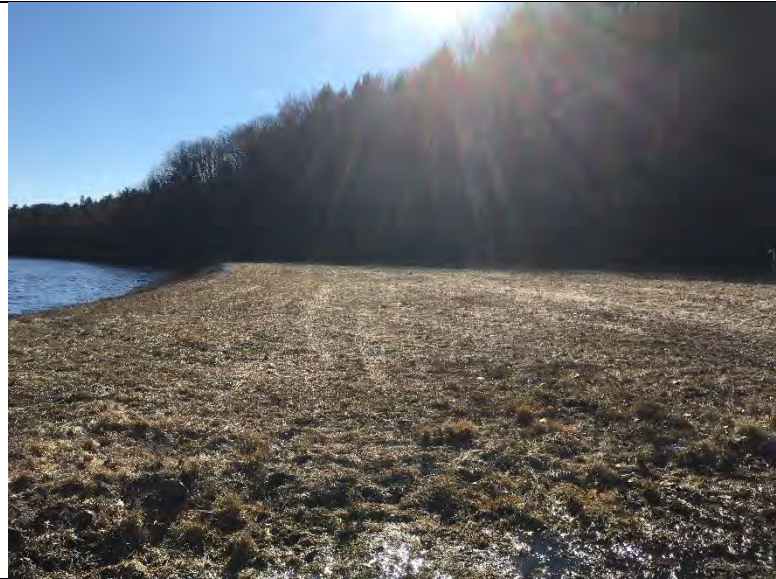
030217\_0204

Photo Name	Time Taken	Location of Photographer	Direction of Photo	Subject
030217_0202	1503	Middle of Site 2	North	Drainage swale on Site 2
030217_0203	1503	Middle of Site 2	Southeast	Drainage swale on Site 2
030217_0204	1503	Middle of Site 2	South	Southern extent of Site 2
030217_0205	1503	Middle of Site 2	Southeast	Southern extent of Site 2 and Southern extent of Site 3
