March 29, 2019

Project No. 30401358

**RE: POST-RESPONSE ACTION COMPLETION REPORT – 2018
UNION PACIFIC RAILROAD HOUSTON WOOD PRESERVING WORKS, HOUSTON, TEXAS
4910 LIBERTY ROAD, HOUSTON, HARRIS COUNTY, TEXAS
TCEQ SWR NO. 31547; TCEQ PERMIT/COMPLIANCE PLAN NO. 50343EPA ID NO. TXD000820266
CUSTOMER NO. CN600131098; REGULATED ENTITY NO. RN100674613**

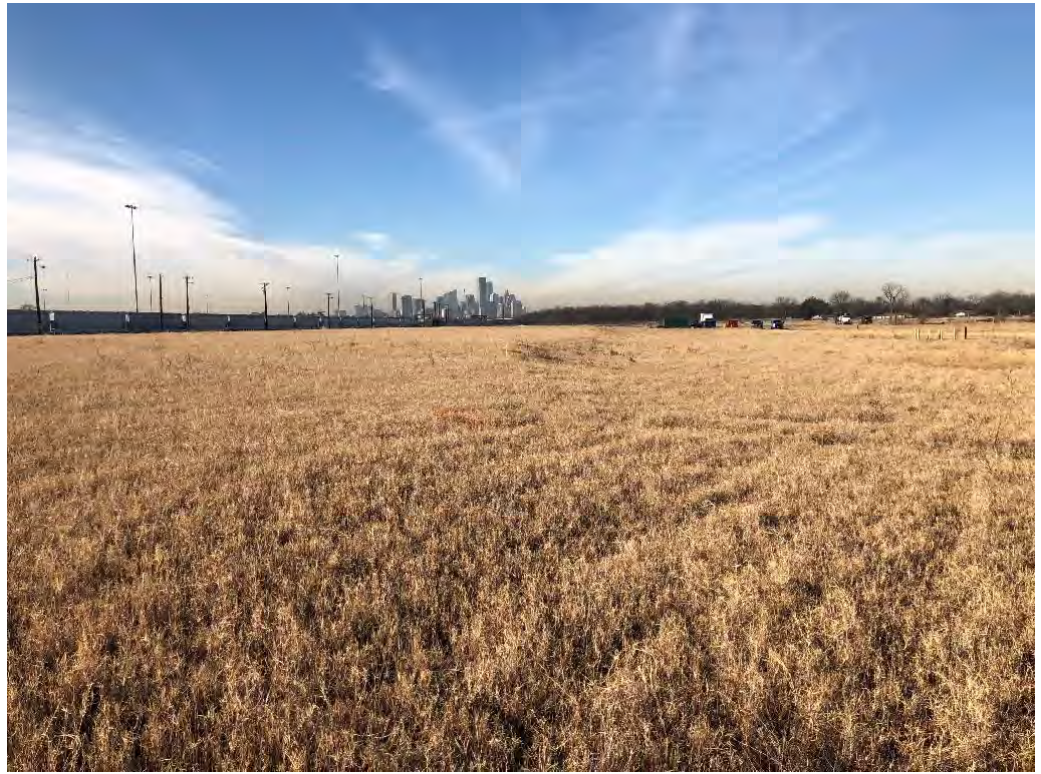
Photo No. 2	Date: 01/25/18
------------------------------	--------------------------

Soil Cap Area:
 Soil cap, facing northeast, Liberty Rd on left of photo

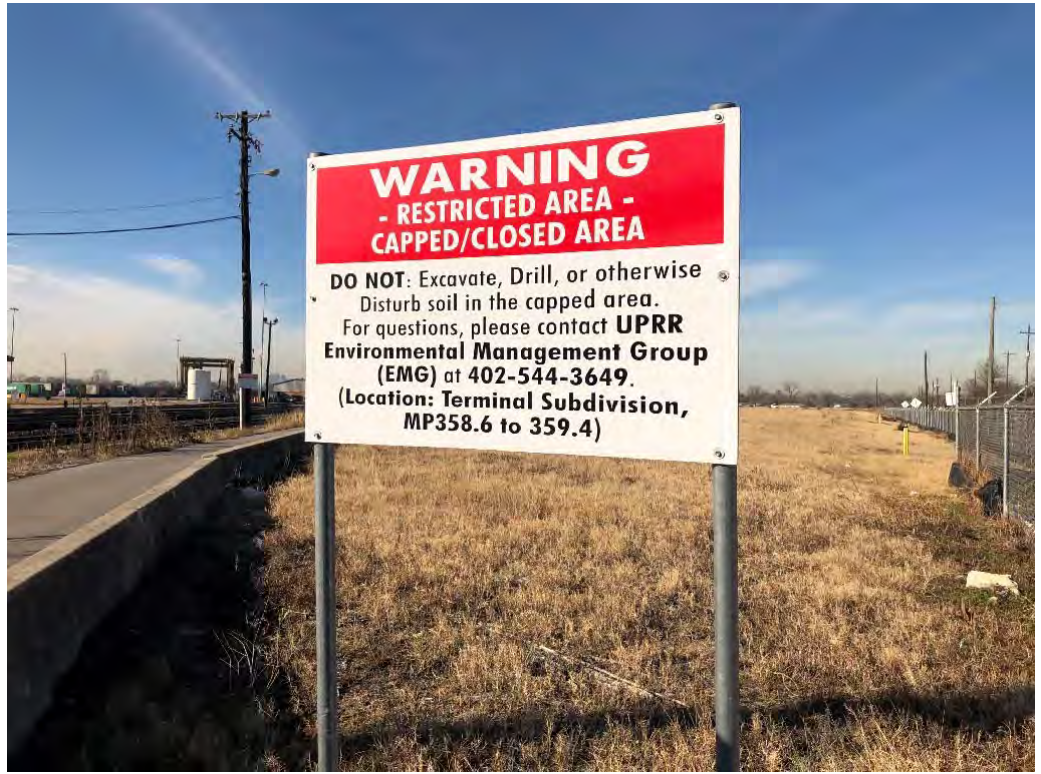
Photo No. 10	Date: 01/25/18
-------------------------------	--------------------------

Soil Cap Area:
 Southern edge of soil cap along asphalt road cap, looking southwest, vegetation cover in good shape.

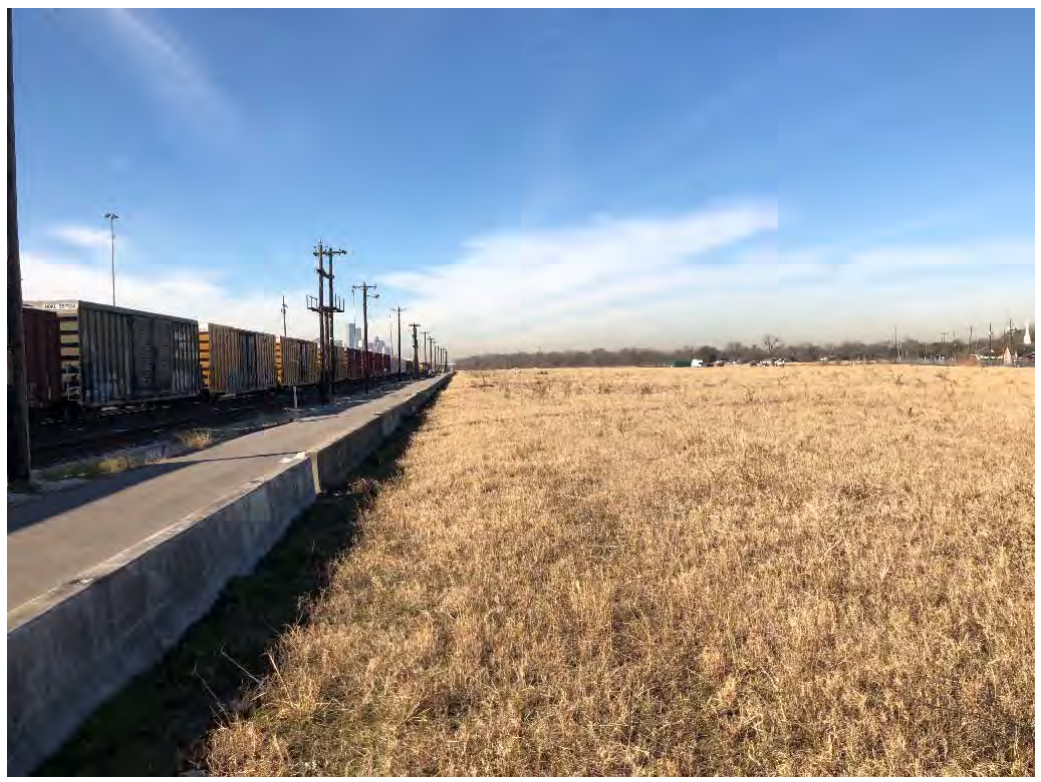
Photo No. 11	Date: 01/25/18
-------------------------------	--------------------------

Soil Cap Area:
 Soil cap area, looking north, vegetation cover in good shape.

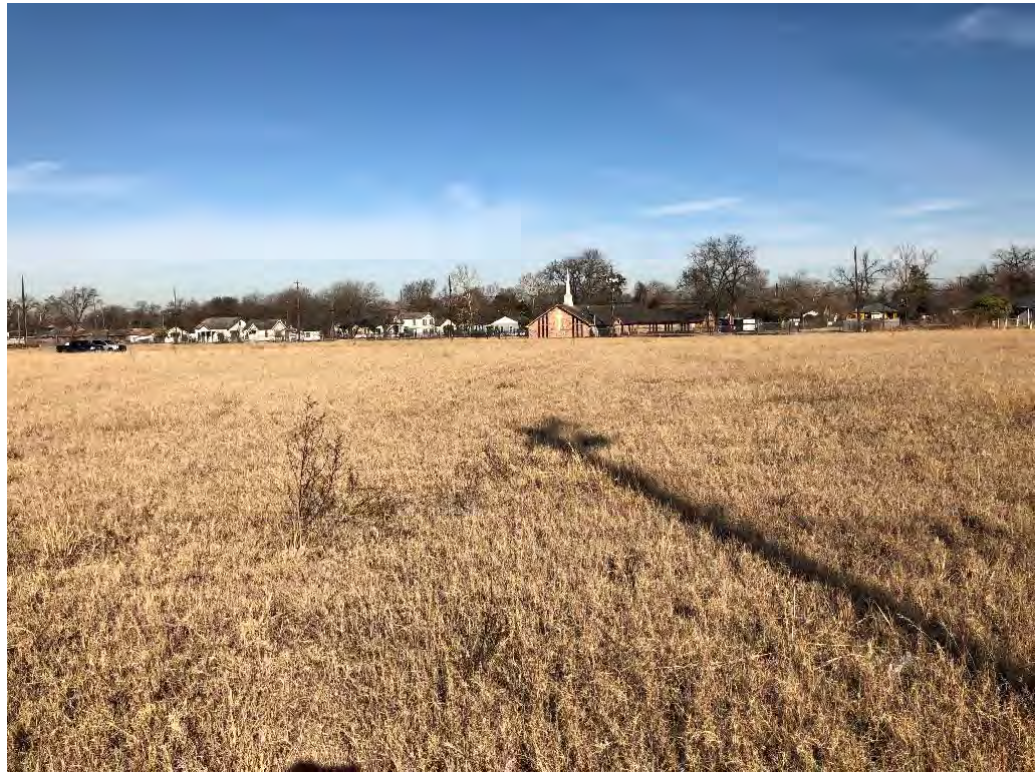
Photo No. 12	Date: 01/25/18
-------------------------------	--------------------------

Soil Cap Area:
 Bare area on southern portion of soil cap, vegetation starting to cover the area, looking southwest.

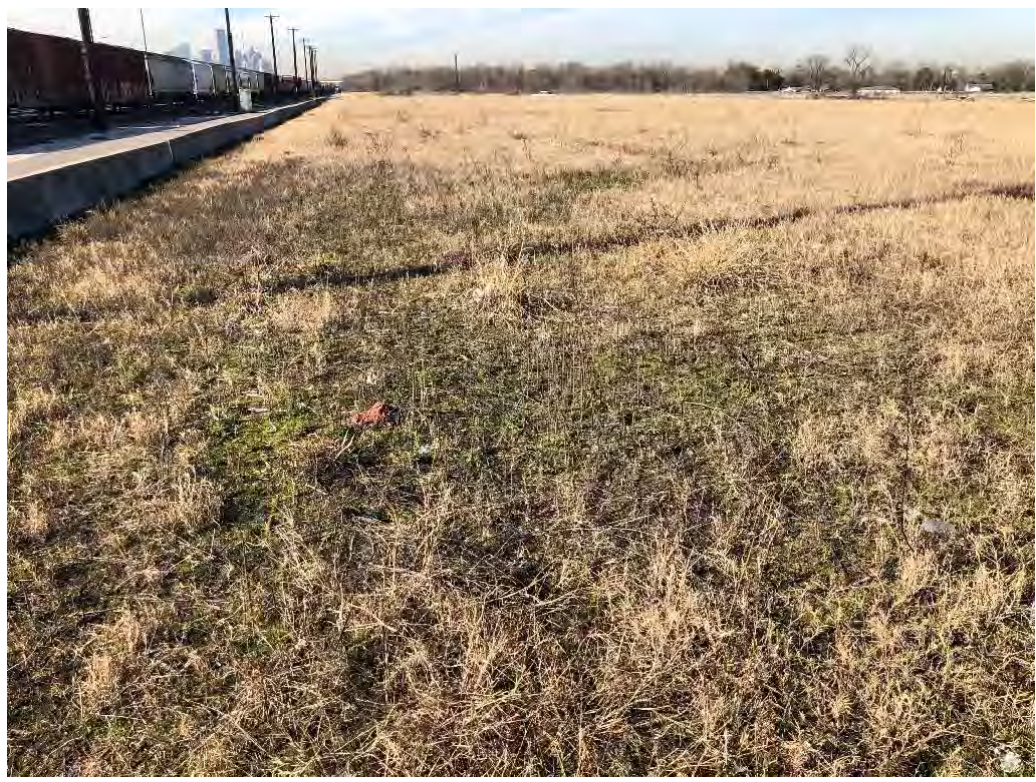
Photo No. 13	Date: 01/25/18
-------------------------------	--------------------------

Soil Cap Area:
Western edge of soil cap, looking east, erosion rill to be repaired.

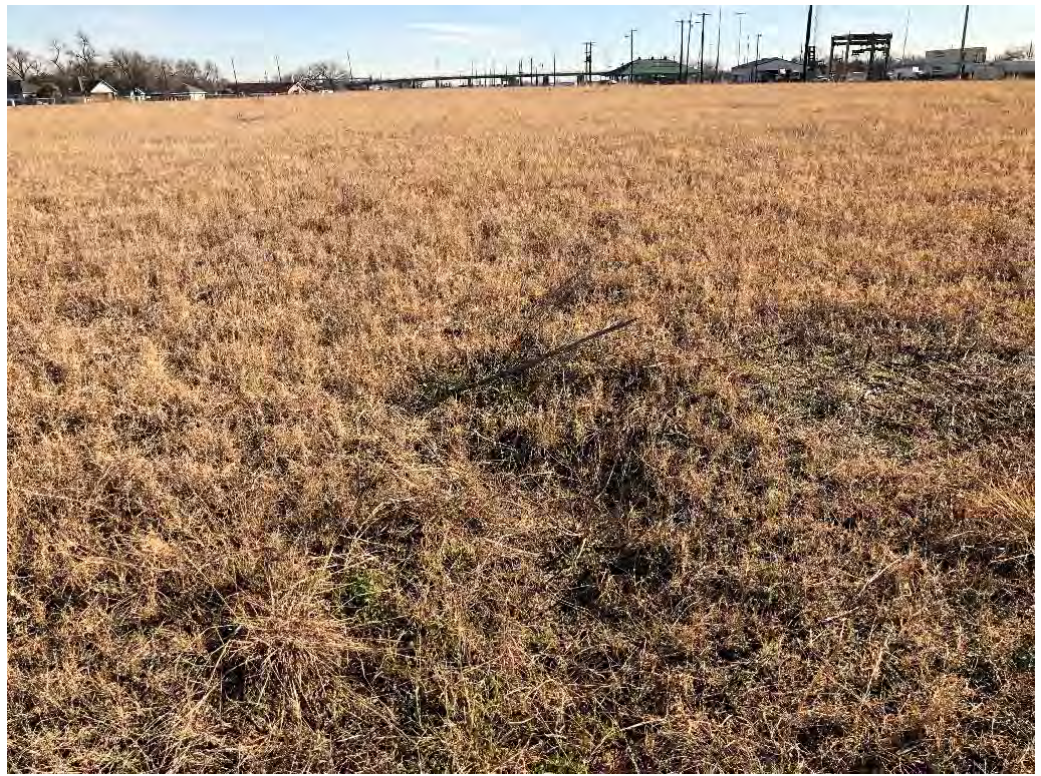
Photo No. 14	Date: 01/25/18
-------------------------------	--------------------------

Soil Cap Area:
Western edge of soil cap, looking east.

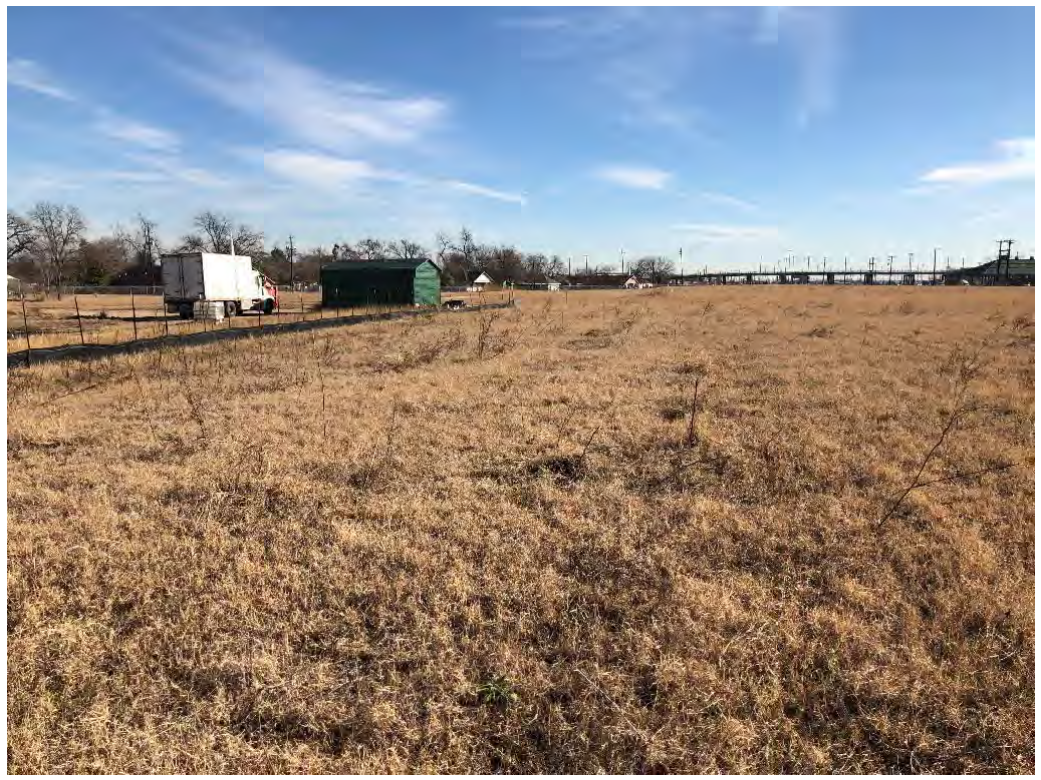
Photo No. 15	Date: 01/25/18
-------------------------------	--------------------------

• **Soil Cap** -The soil cap area did not appear to have any significant erosion, sloughing, or subsidence. Some minor erosion rills (see Photo Nos. 5 (Lat: 29.78753611, Long: -95.31826667), 6 (Lat: 29.78750556, Long: -95.31805556), 8 (Lat: 29.78758889, Long: -95.31713889) and 15 (Lat: 29.78686111, Long: -95.319502779)) and a few bare spots (Photo No. 12 (Lat: 29.78635278, Long: -95.31948056)) were noted along the slopes of the soil cap, but the cap appeared to be functioning as designed. A few minor depression areas were also noted along the concrete barriers on the south side of the capped area (see Photo Nos. 21 and 22 (Lat: 29.78668333, Long: -95.318627779, Lat: 29.78586944, Long: -95.32038056))

Soil Cap Area:
 Northern edge of soil cap, looking southeast, erosion/slough area to be repaired.

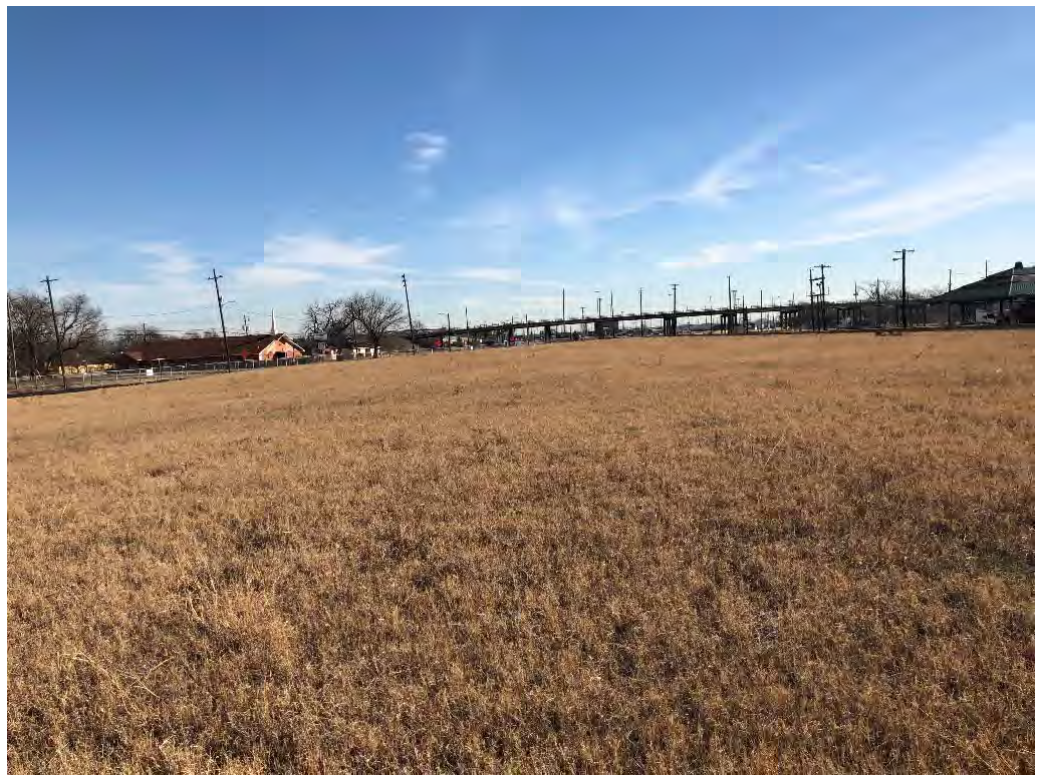
Photo No. 17	Date: 01/25/18
-------------------------------	--------------------------

Soil Cap Area:
 Northern edge of soil cap, looking southwest, erosion/slough area to be repaired.

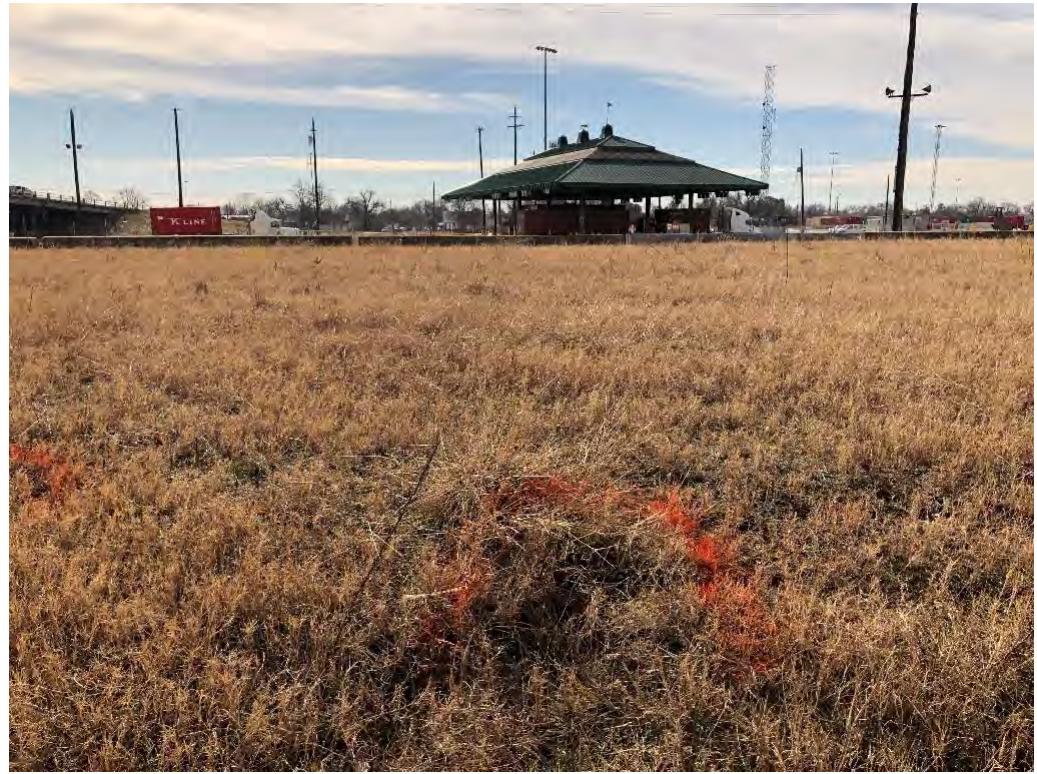
Photo No. 20	Date: 01/25/18
-------------------------------	--------------------------

Soil Cap Area:
 Southern edge of soil cap along concrete barriers, looking south, orange paint outlining depression to be repaired.

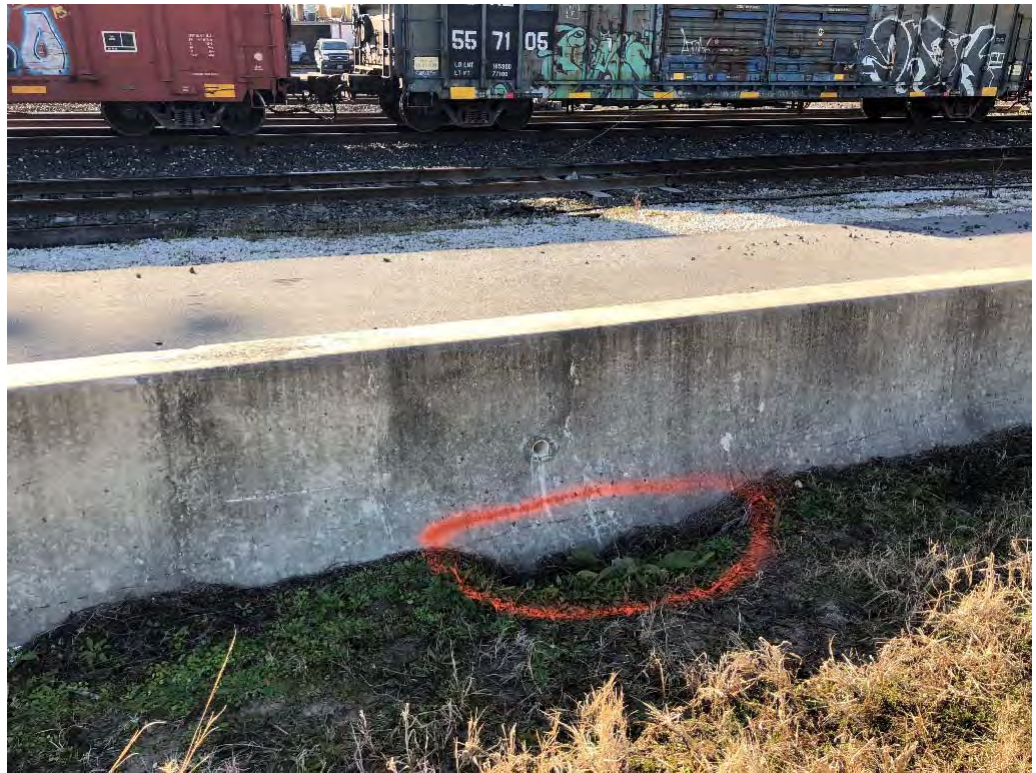
Photo No.
22

Southern edge of soil cap along concrete barriers, looking southwest, orange paint outlining depression to be repaired.

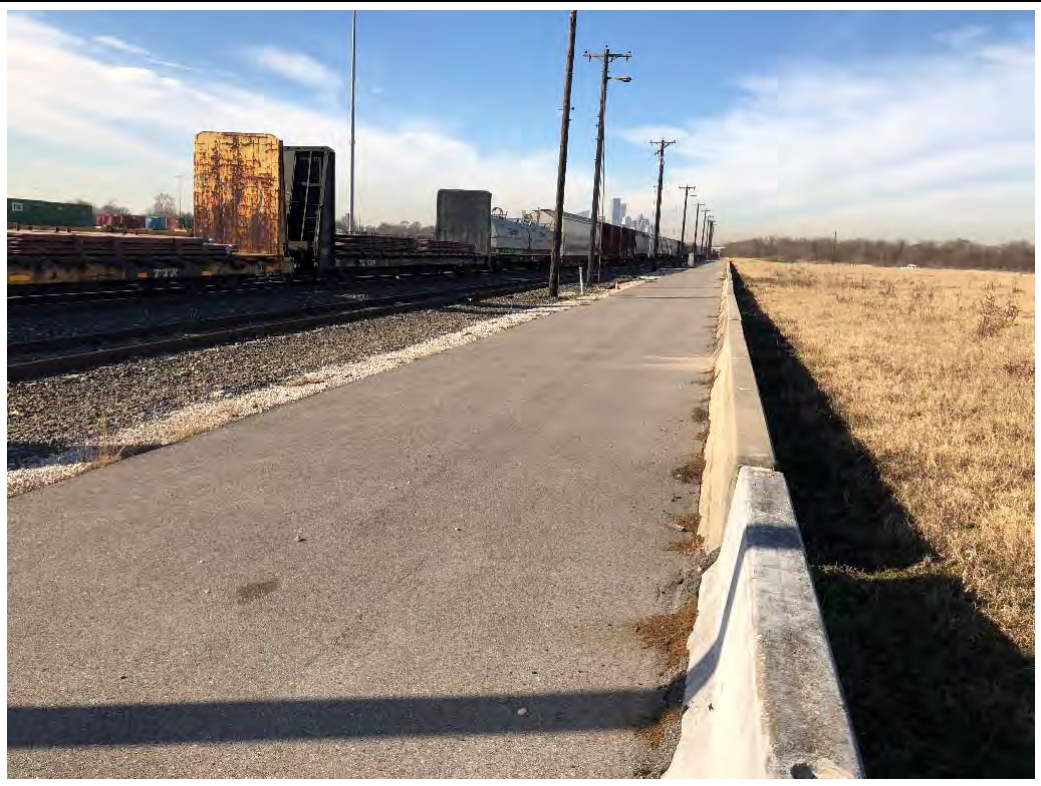
Asphalt Cap Area:
View of asphalt cap area, looking southwest. Note small oily stains on pavement, appear the same compared to Oct 2017 inspection.

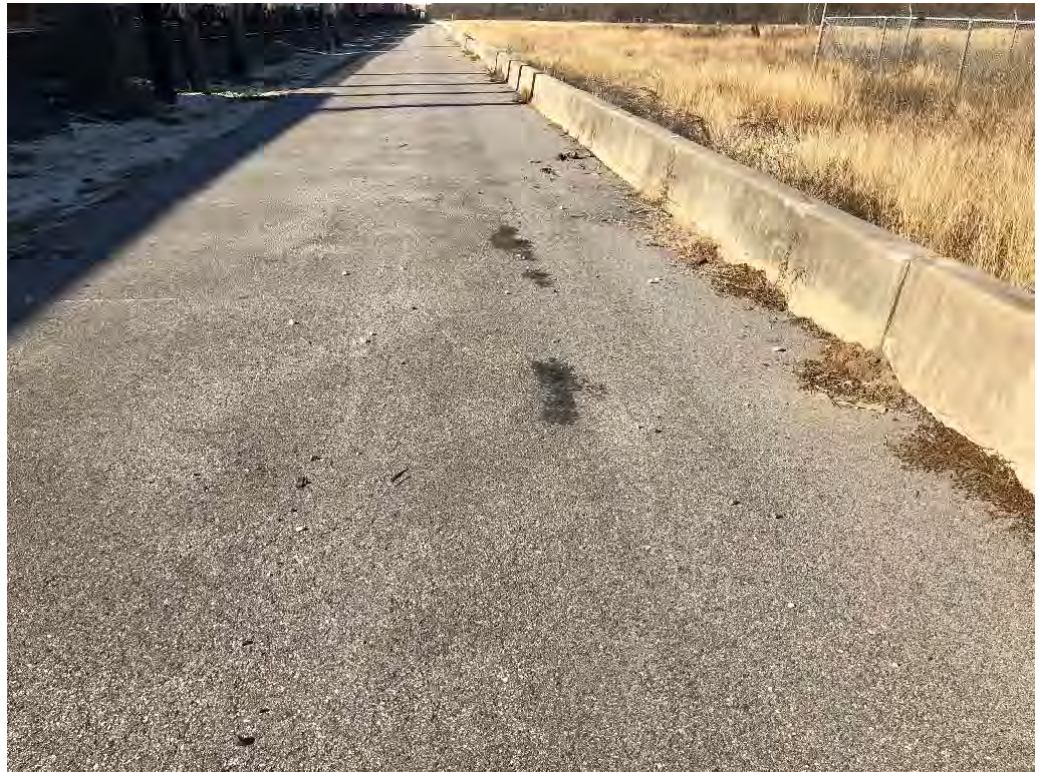
Photo No.
28

Asphalt Cap Area:
View of asphalt cap area. Note small oily stains on pavement, appear the same compared to Oct 2017 inspection.

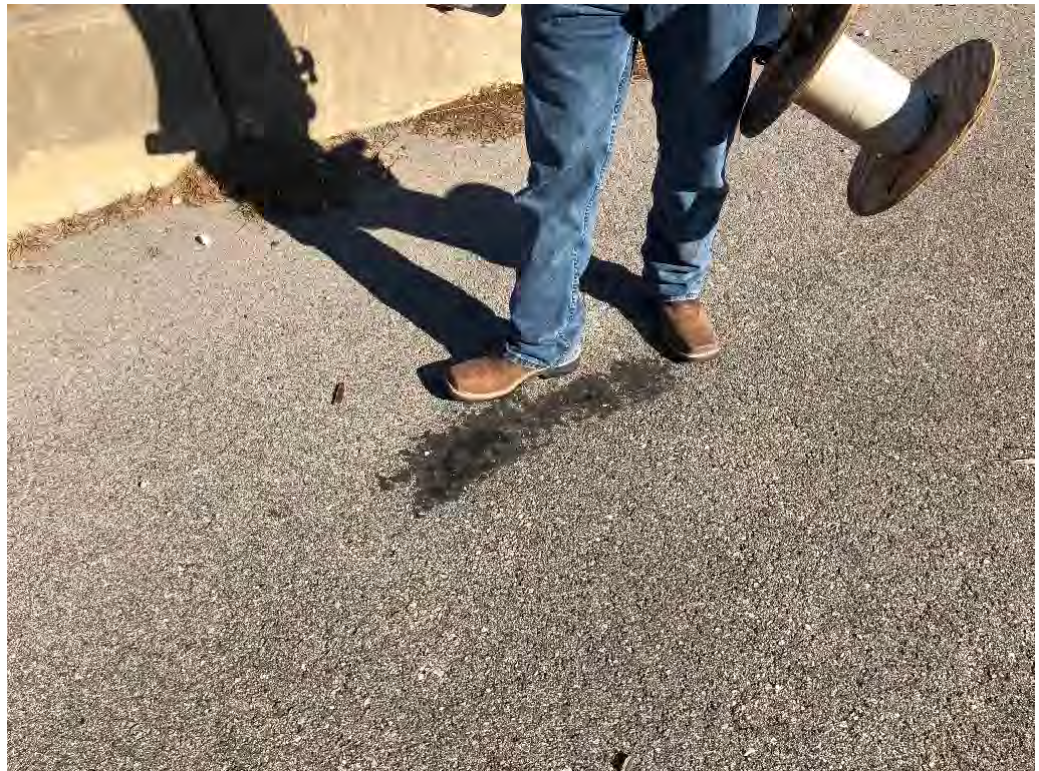
Photo No. 29	Date: 01/25/18
-------------------------------	--------------------------

Asphalt Cap Area:
 View of asphalt cap area, looking northeast. Note small oily stains on pavement, car key chain for scale.

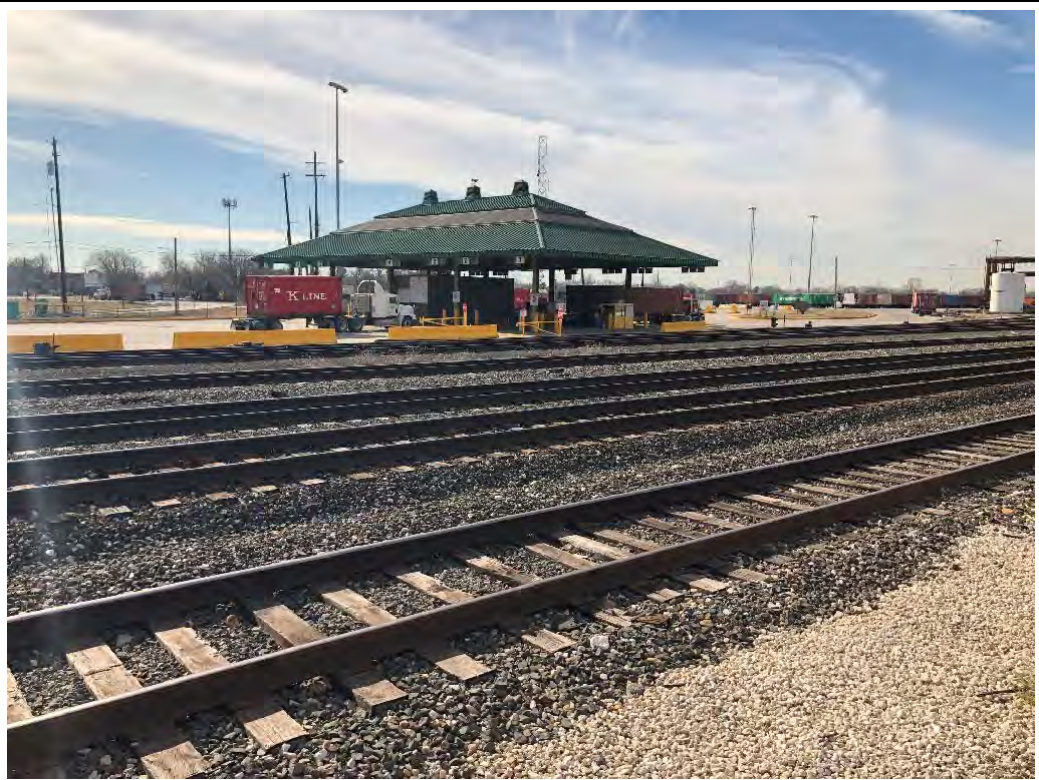
Photo No. 31	Date: 01/25/18
-------------------------------	--------------------------

• **Railroad Ballast Cap** – The railroad ballast cap area appeared to be in good shape, with some vegetation growth within the ballast area (Photo No. 31 (Lat: 29.787425, Long: -95.31681111)).

Asphalt Cap/Ballast Cap Area:
 View of ballast cap area, looking southwest. Some vegetation within the ballast area, no soil exposed.

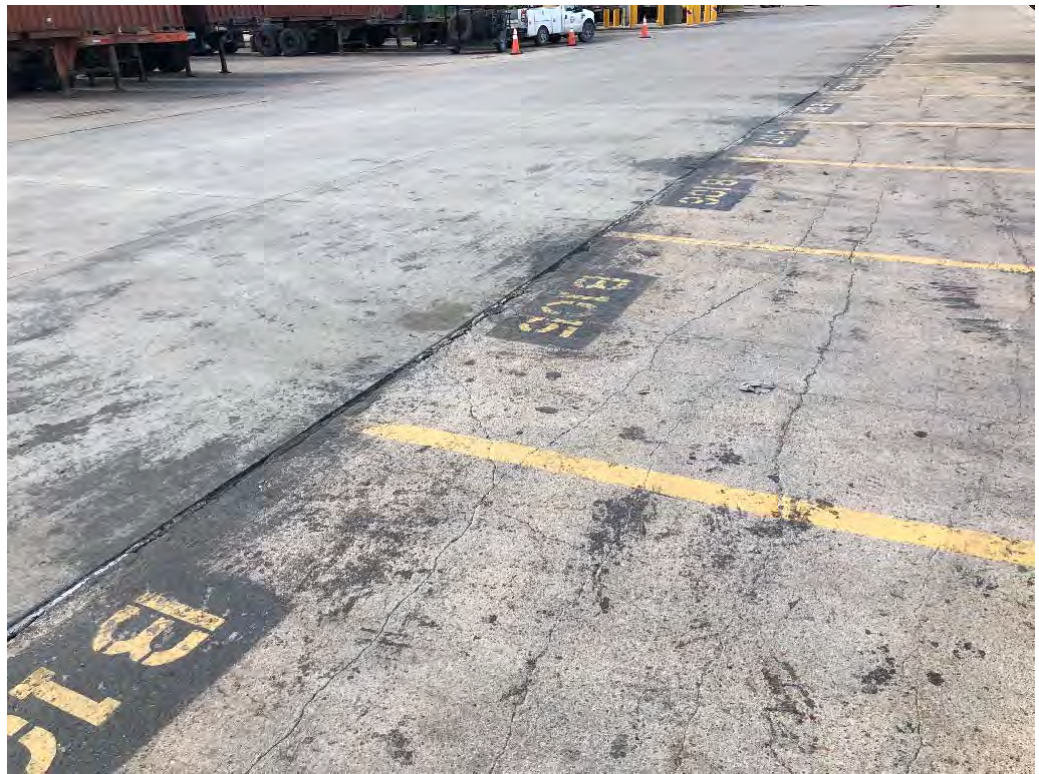
Photo No.
40

Concrete Cap Area:
Remnants of tar-like material seeps near B103, no active seeping noted.

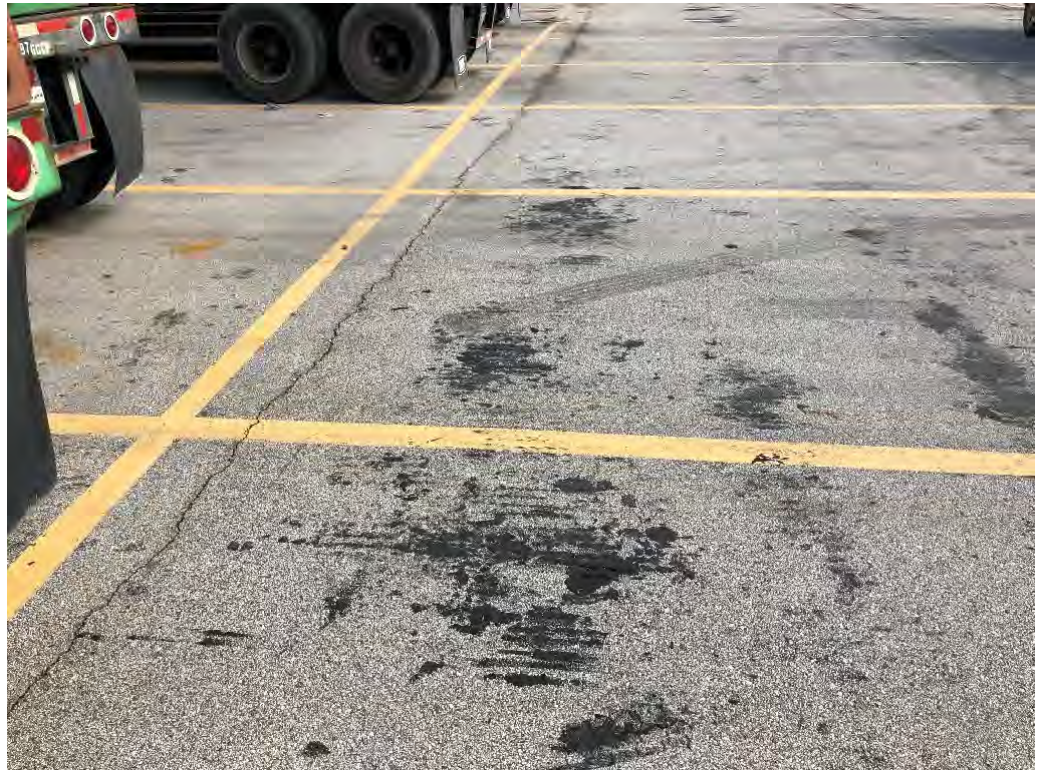
Photo No.
44

Concrete Cap Area:
Remnants of tar-like material seeps near B109, no active seeping noted

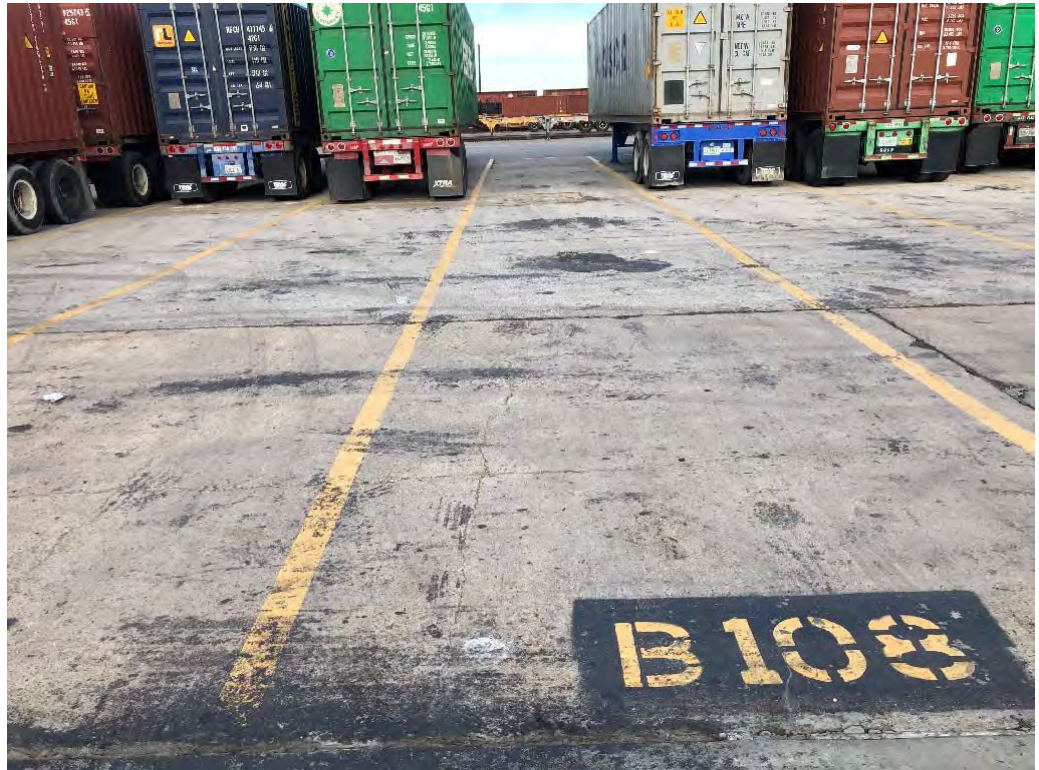
Photo No.
46

Remnants of tar-like material seeps near B107, no active seeping noted

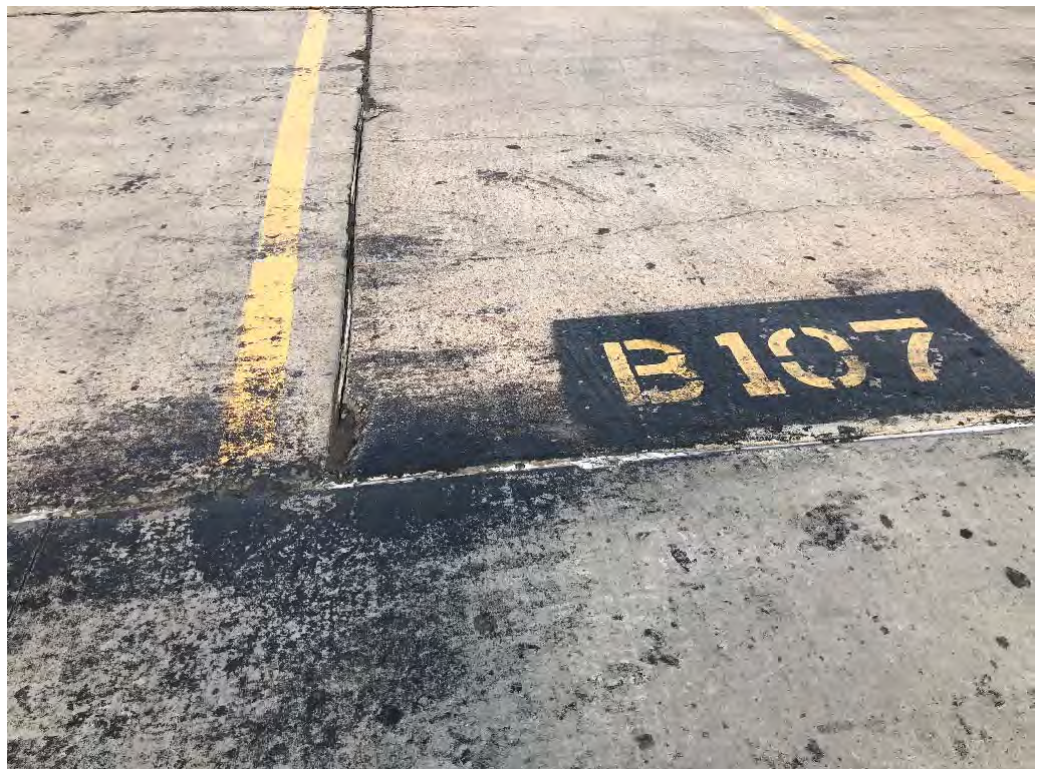
Photo No. 47	Date: 01/25/18
------------------------	--------------------------

Concrete Cap Area:
Remnants of tar-like material seeps near B105, no active seeping noted

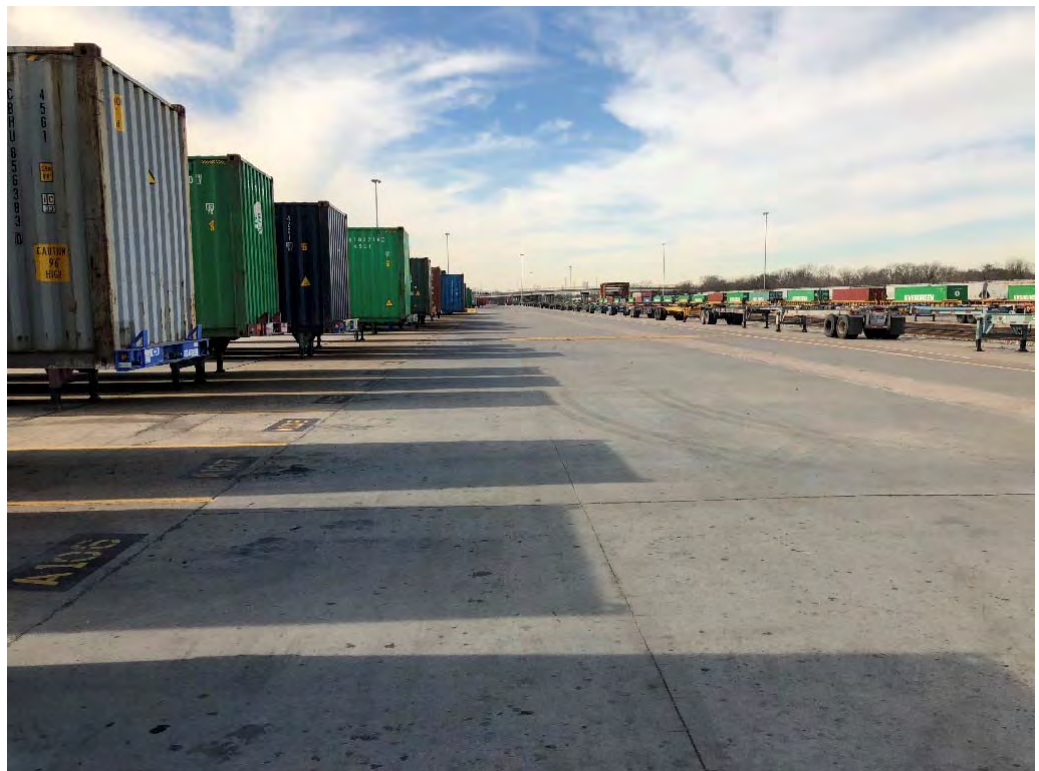
Concrete Cap Area:
Area north of A-Row, concrete appears in good shape, looking southwest.

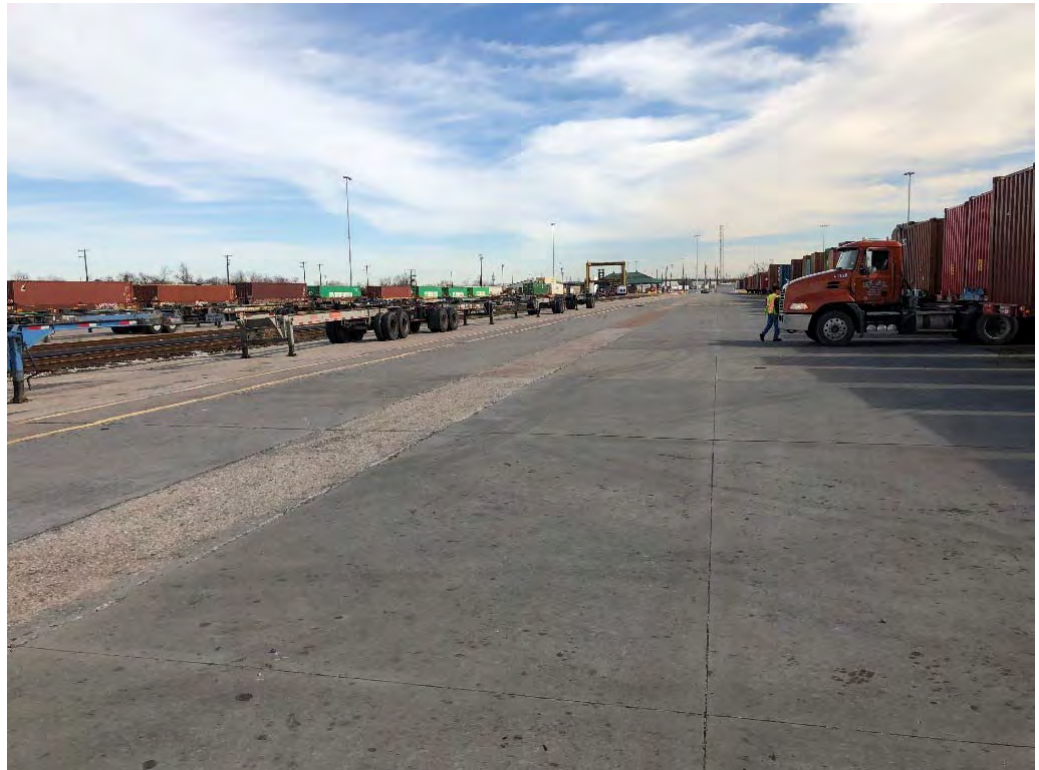
Photo No. 49	Date: 01/25/18
-------------------------------	--------------------------

Concrete Cap Area:
Area north of A-Row, concrete appears in good shape, looking northeast.

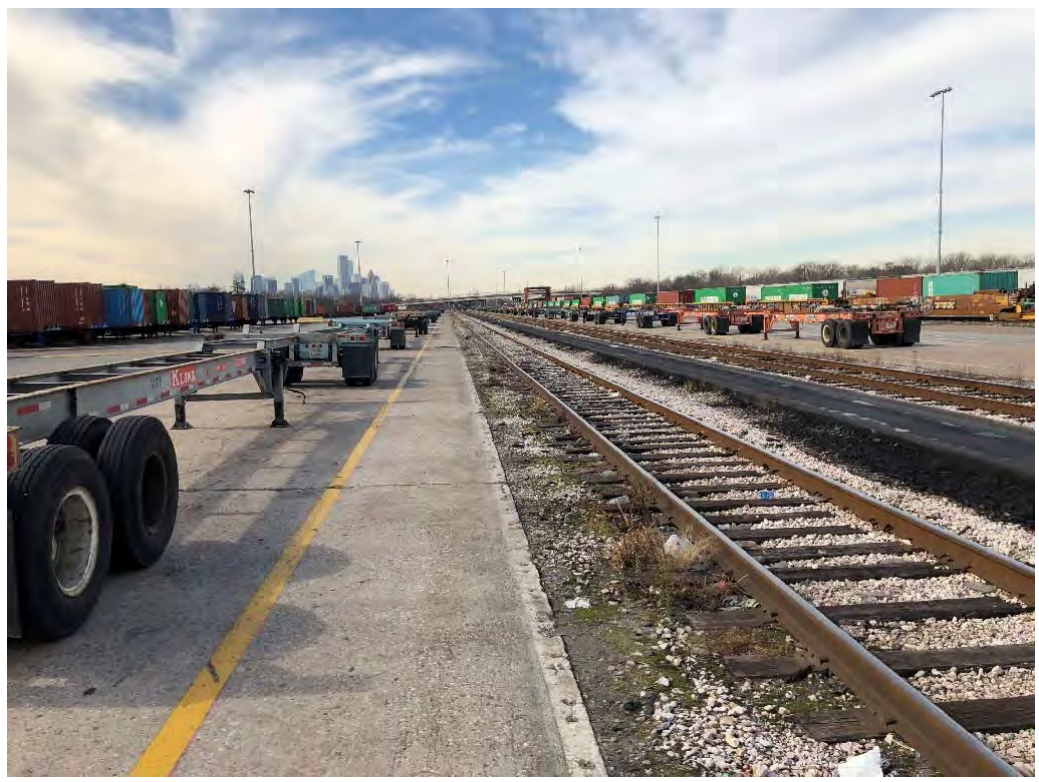
Photo No. 50	Date: 01/25/18
-------------------------------	--------------------------

Concrete Cap/Ballast Cap Areas:
Rail container box loading/unloading area, looking southwest.

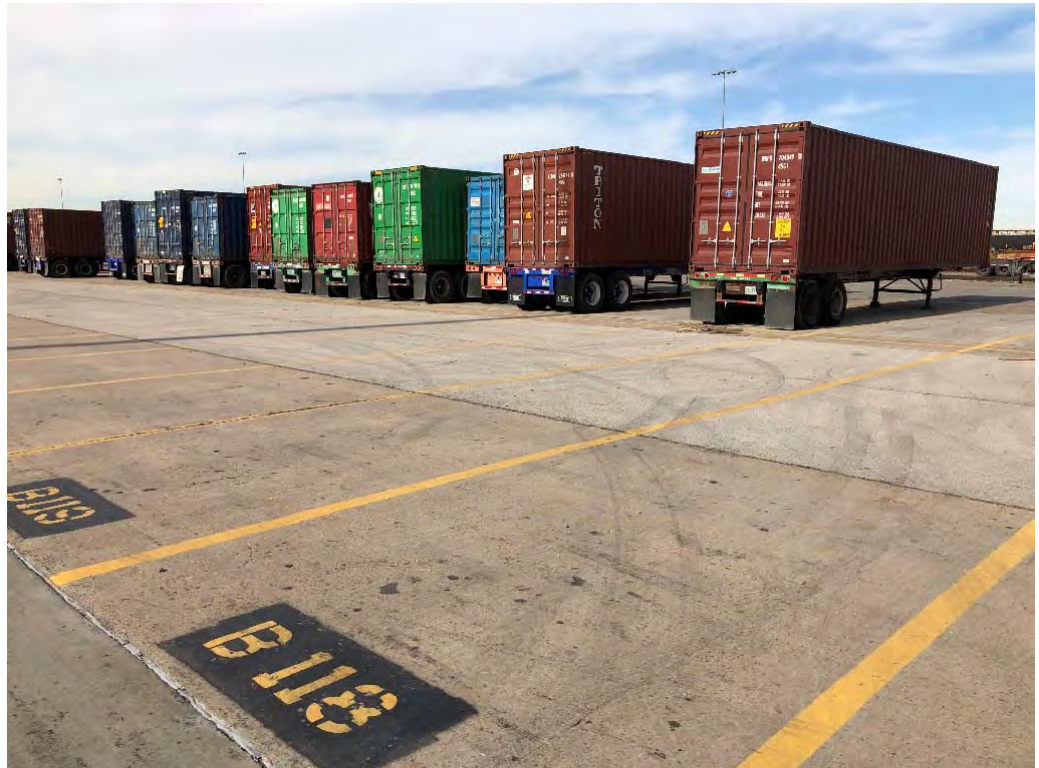
Area within B-Row, concrete appears in good shape, looking west.

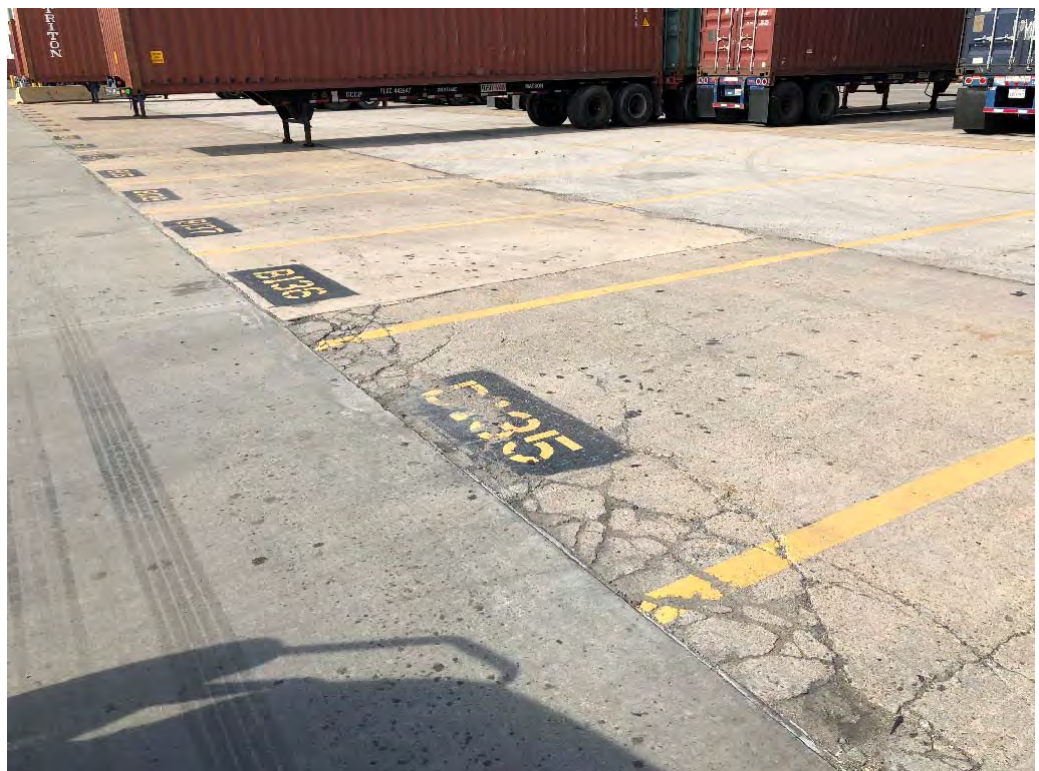
Photo No.
52

• **Concrete Cap (Englewood Intermodal Yard)** – Cracks in the pavement were noted, but no soil appeared to be exposed (Photo No. 52 (Lat: 29.78380556, Long: -95.32174722)). In the area of parking slots B100 to B109, a tar-like substance had been observed in the joints and cracks in the concrete and asphalt surfaces in the area shown on the attached Figure 2, and Photo Nos 39 through 47 (Lat: 29.78418333, Long: -95.3209749)). Since the initial observation of the tar-like substance at the surface, weekly inspections of the affected area have been conducted. The amount of tar which surfaces each week varies. It generally is

Area within B-Row, cracks in the concrete but no exposed soils, looking west.

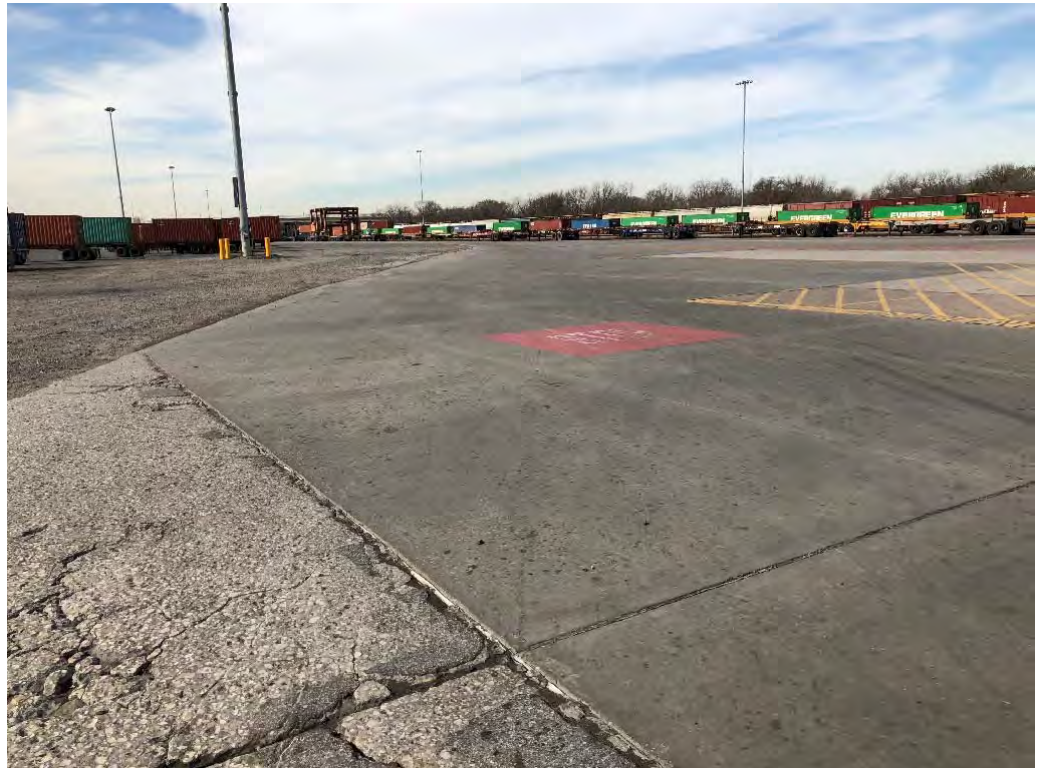
Concrete Cap Area:
Edge of concrete cap area at the west end of B-Row, concrete appears in good shape with some cracks, looking west.

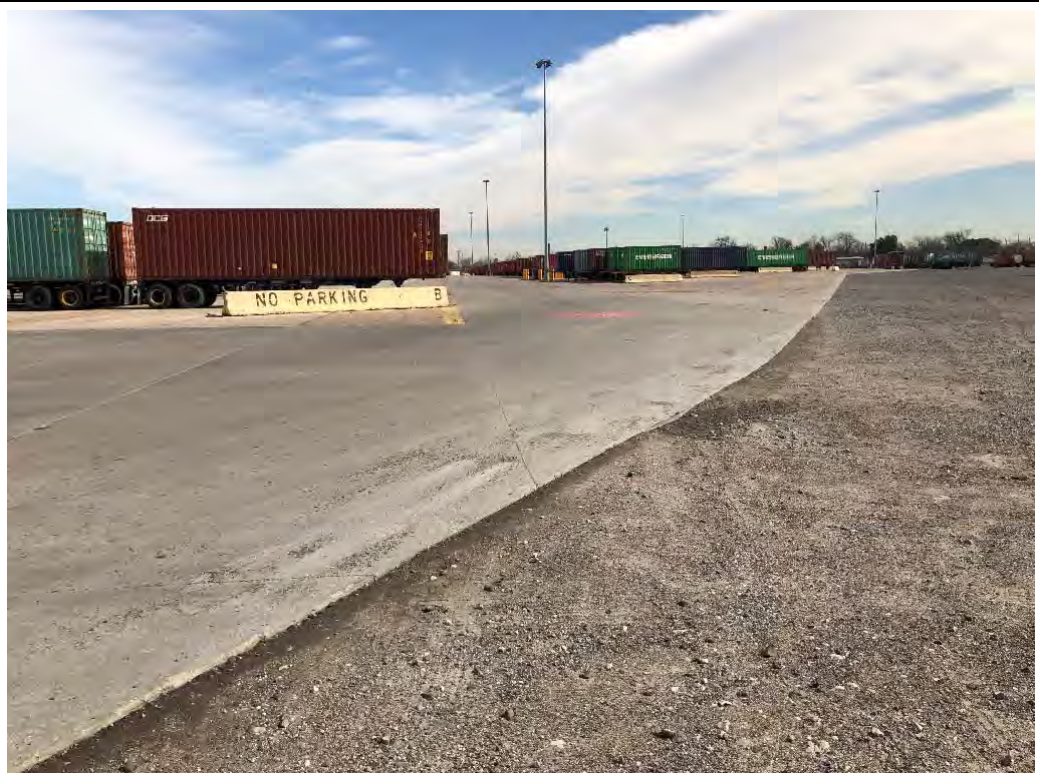
Photo No.
54

Concrete Cap Area:
Edge of concrete cap area at the west end of A and B-Rows, concrete appears in good shape, looking east.

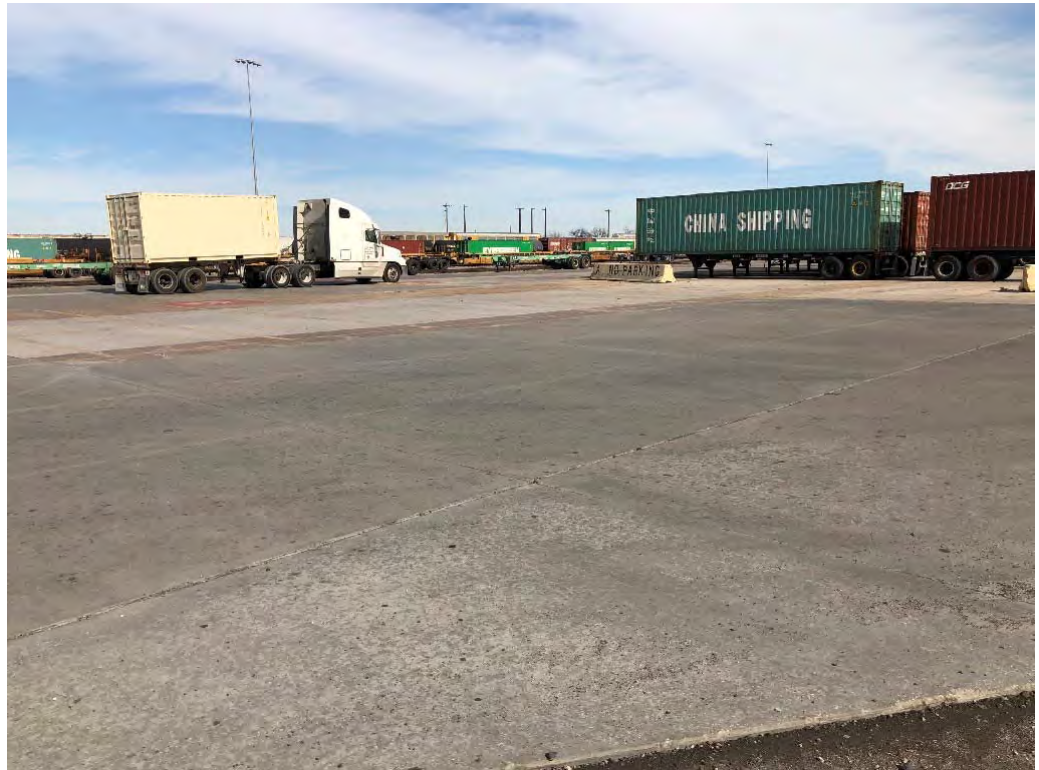
Concrete Cap Area:
Edge of concrete cap area at the west end of A and B-Rows, concrete appears in good shape, looking north.
