March 29, 2019

Project No. 30401358

**RE: POST-RESPONSE ACTION COMPLETION REPORT – 2018
UNION PACIFIC RAILROAD HOUSTON WOOD PRESERVING WORKS, HOUSTON, TEXAS
4910 LIBERTY ROAD, HOUSTON, HARRIS COUNTY, TEXAS
TCEQ SWR NO. 31547; TCEQ PERMIT/COMPLIANCE PLAN NO. 50343EPA ID NO. TXD000820266
CUSTOMER NO. CN600131098; REGULATED ENTITY NO. RN100674613**

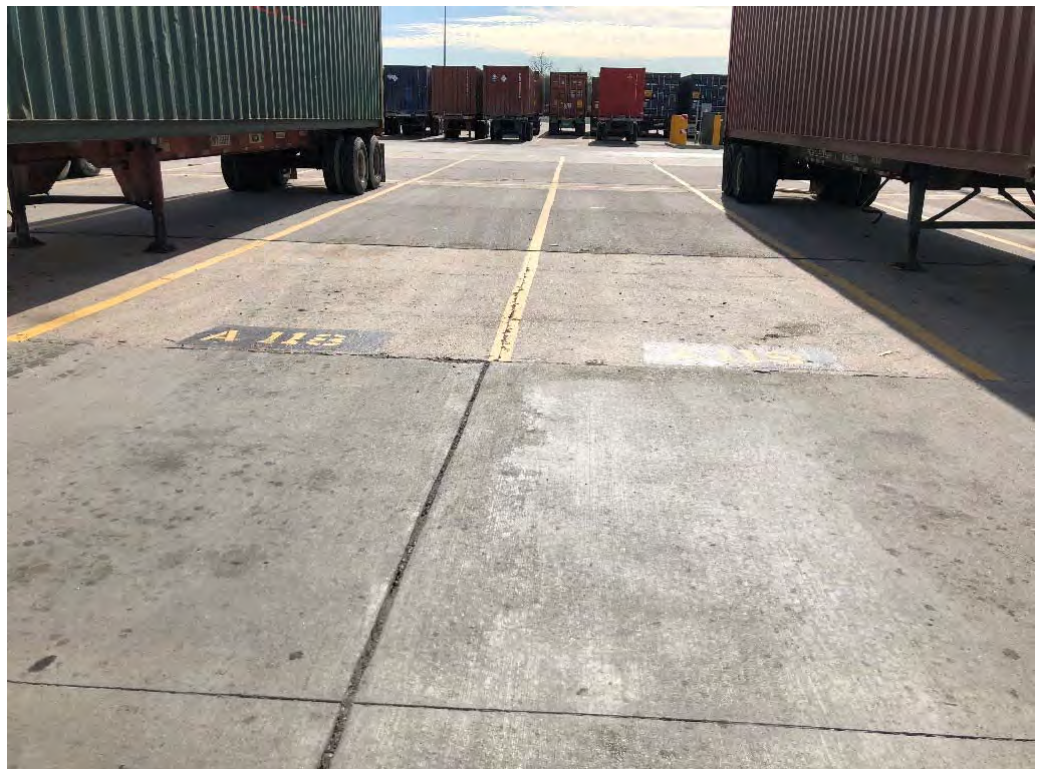
Photo No.
56

Concrete Cap Area:
Area within A-Row, concrete appears in good shape, looking south.

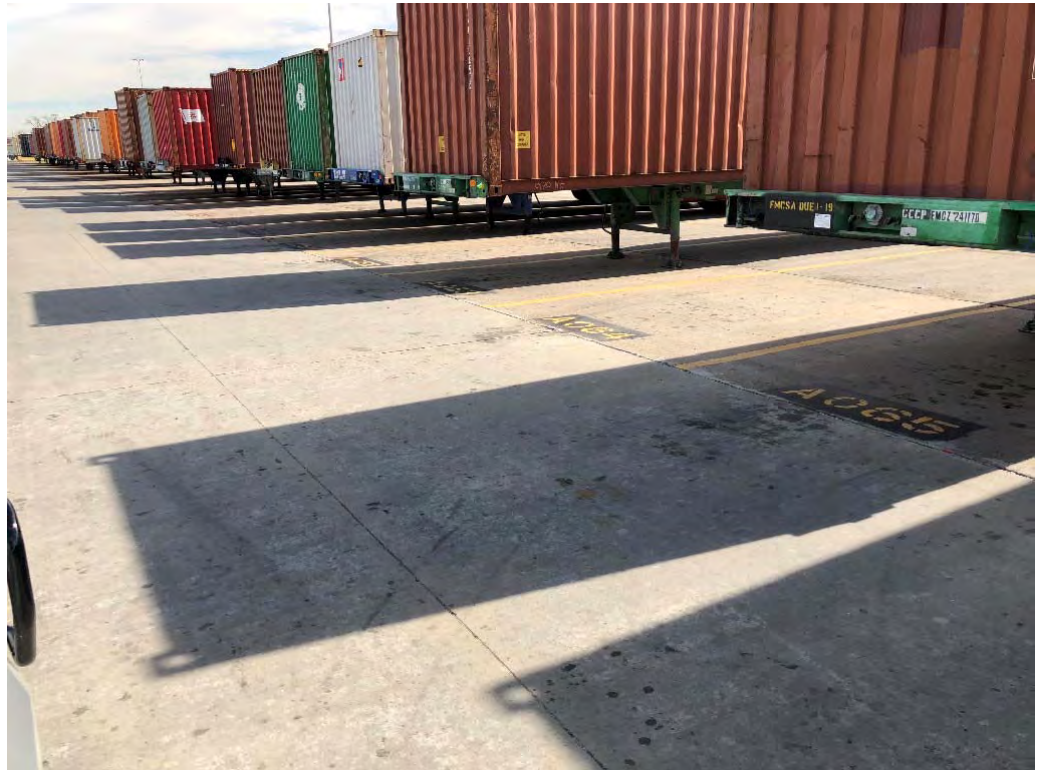
Photo No.: 57	Date: 01/25/18
-------------------------	--------------------------

Concrete Cap Area:
Area within A-Row, concrete appears in good shape, looking east.

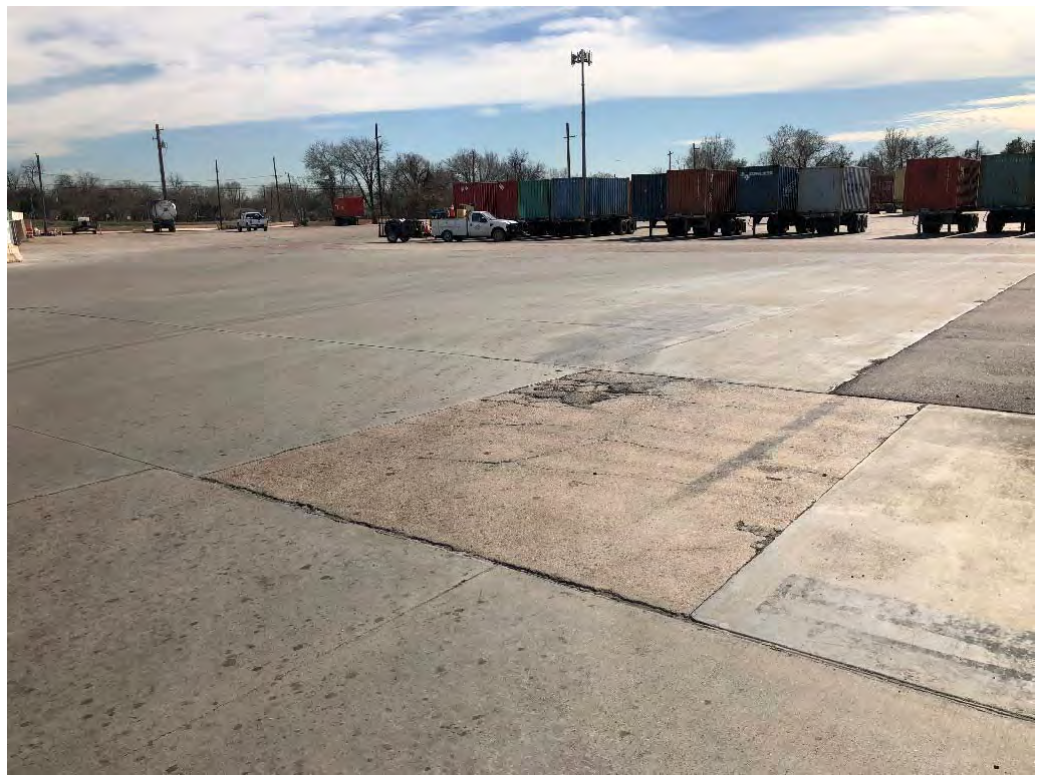
Photo No.: 58	Date: 01/25/18
-------------------------	--------------------------

Concrete Cap Area:
Area east of A-Row, concrete appears in good shape, looking south.

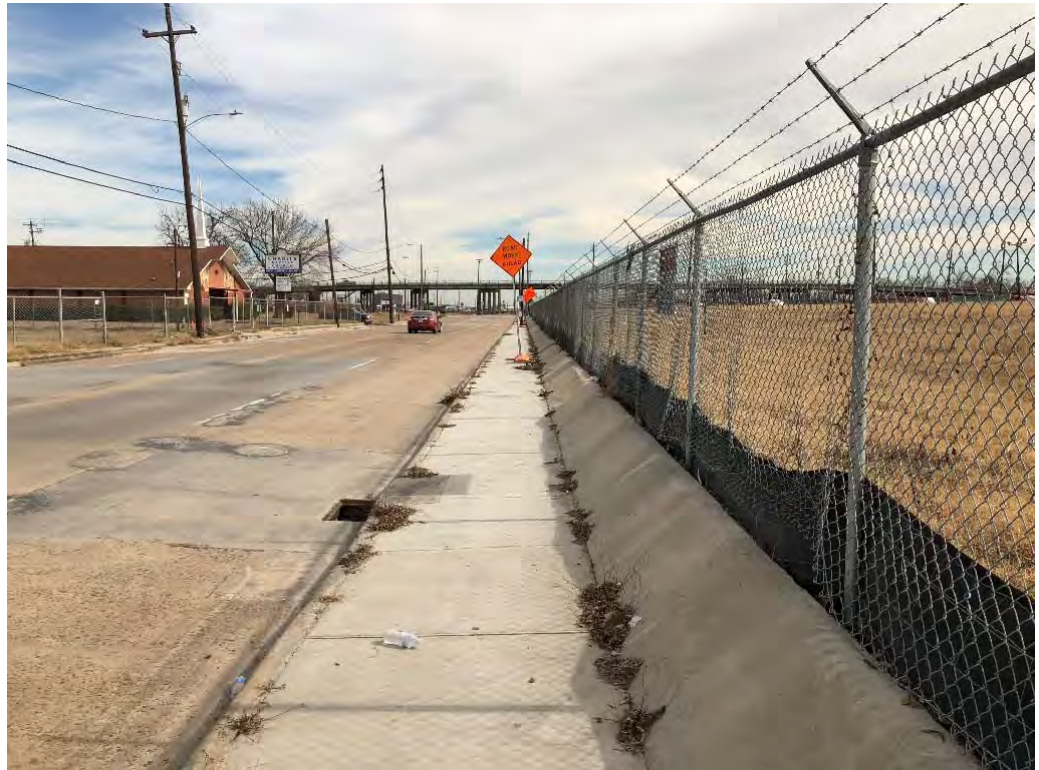
View of the sidewalk
cap area, looking east
along Liberty Road.

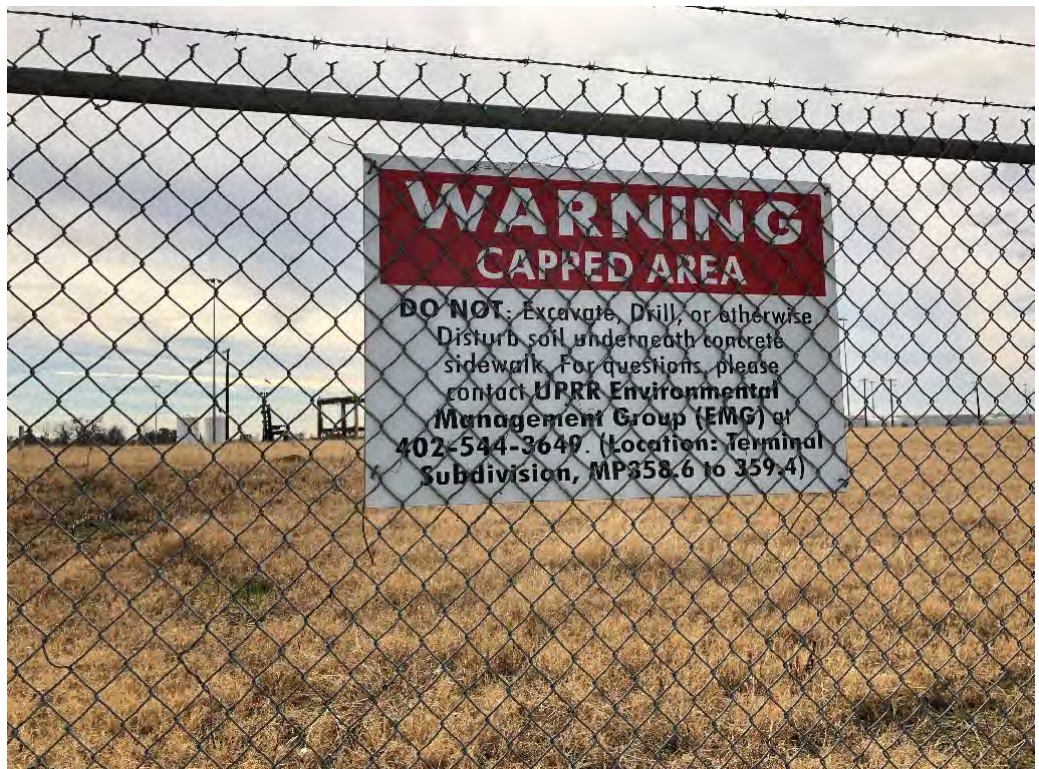
Photo No.
64

Warning sign on the
northern perimeter
fence.

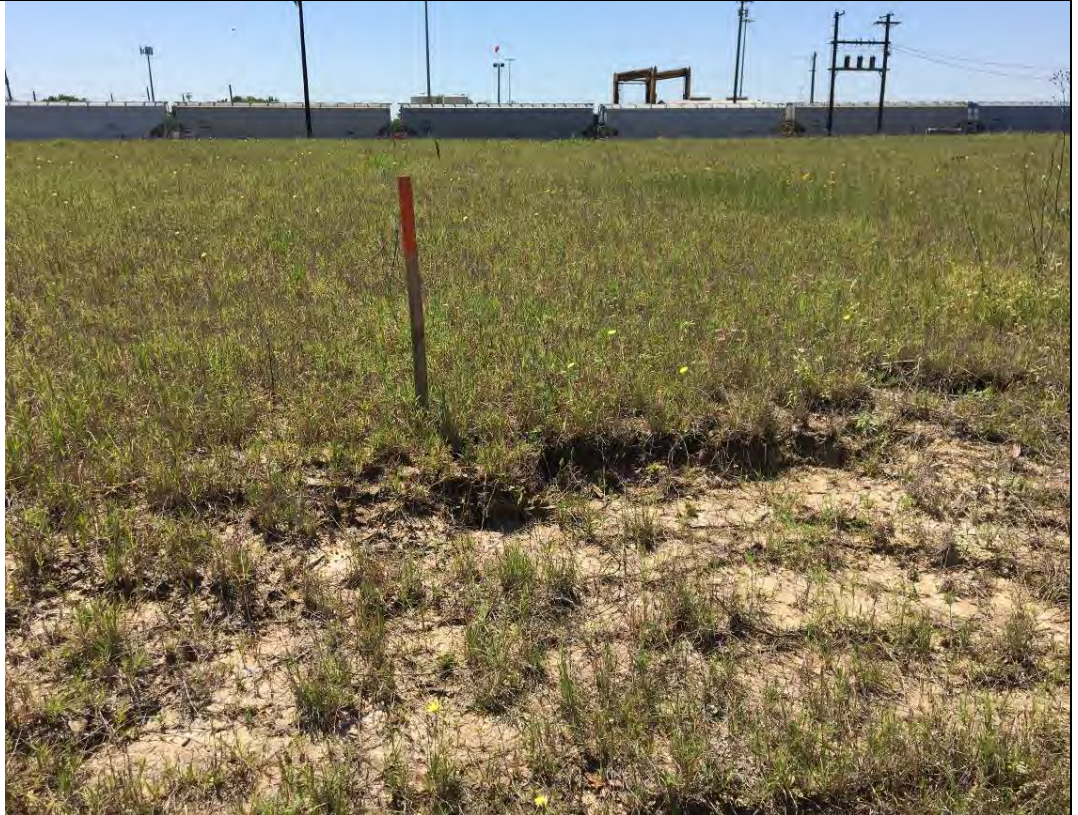
Northern edge of soil cap,
looking south, stake near
erosion rill to be repaired

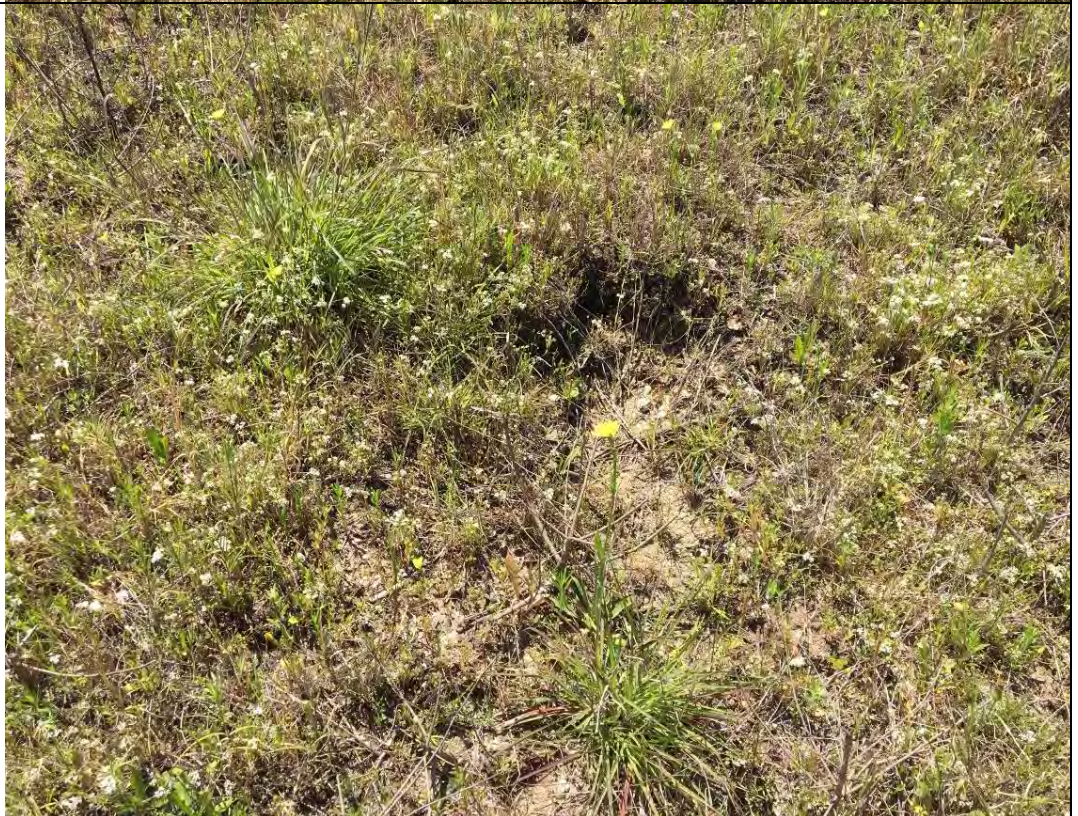
Photo No.
4

Northern edge of soil cap,
looking south, bare area and
erosion rill to be repaired

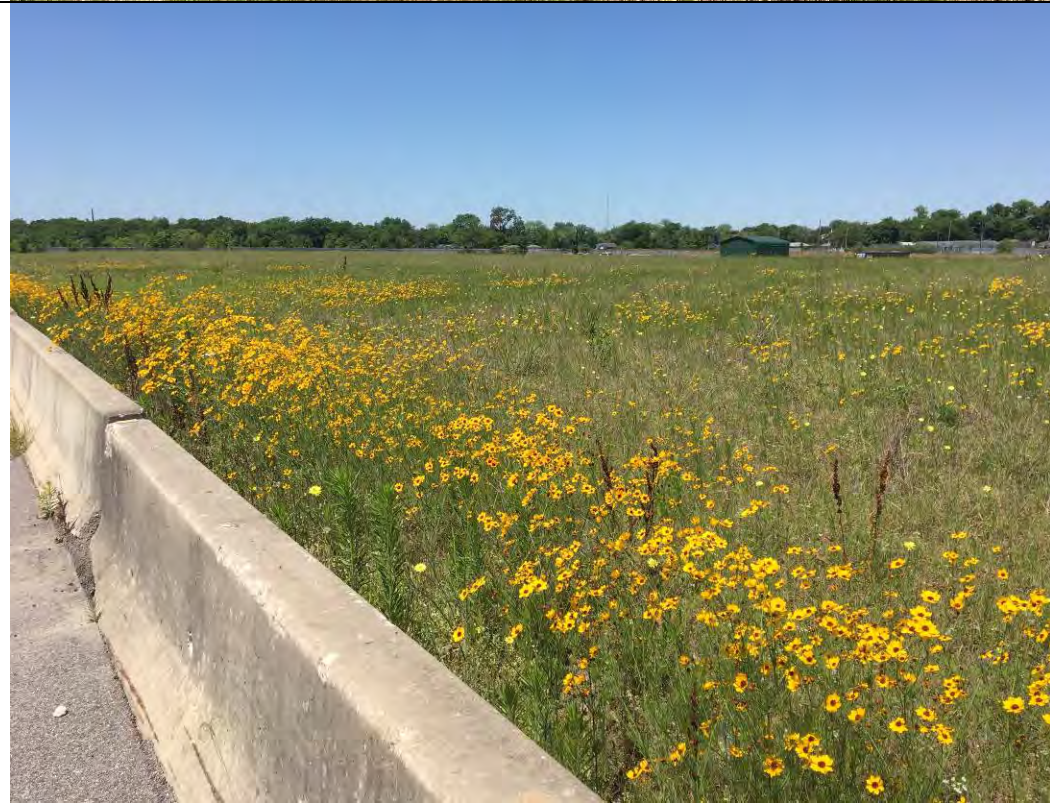
Photo No. 6	Date: 04/26/18
Description: Soil Cap Area: Flowering plants at southern edge of cap in full bloom, looking northwest. Lat: 29.78573056 Long: -95.32070832999999

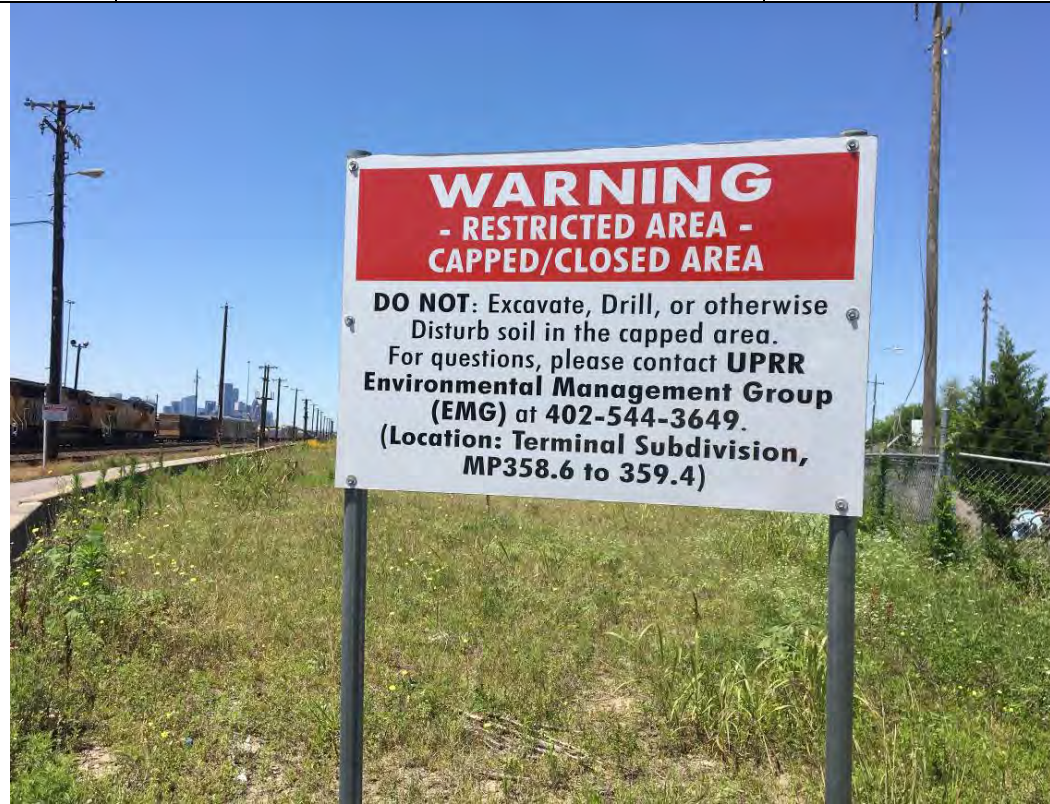
Photo No.: 7	Date: 04/26/18
------------------------	--------------------------

Soil Cap Area:
Warning sign at northeast corner of soil cap area, looking west

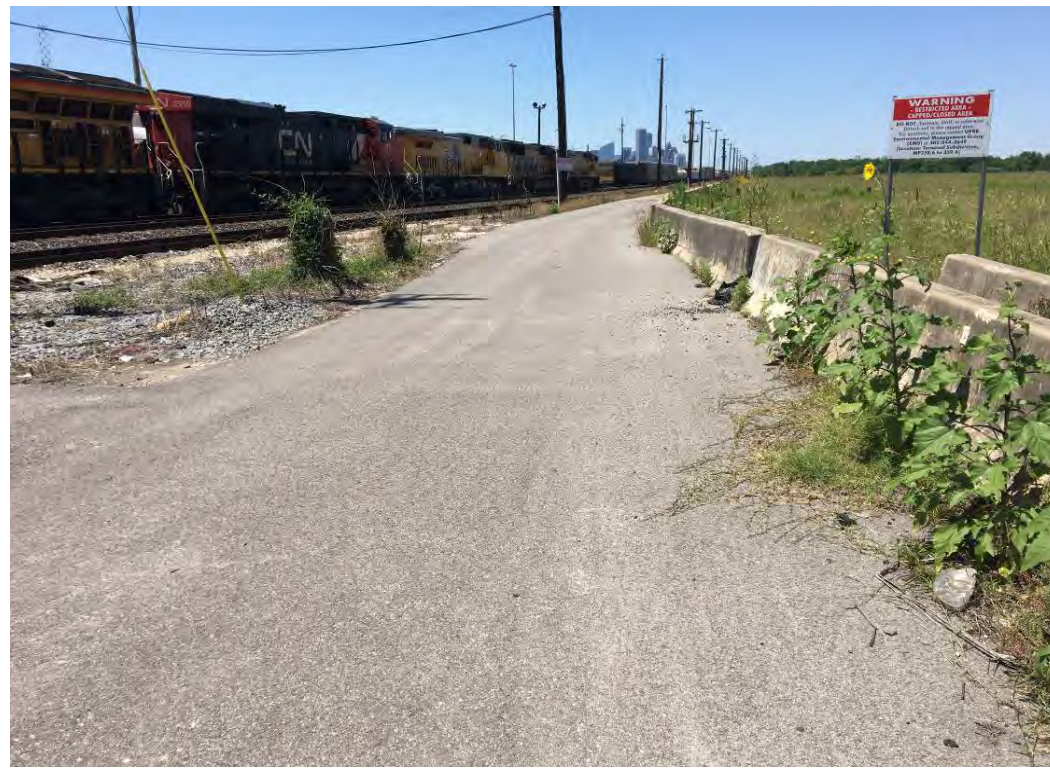
Soil Cap Area:
Southern edge of soil cap along asphalt road cap, looking southwest, vegetation cover in good shape, weeds growing along the concrete barriers.

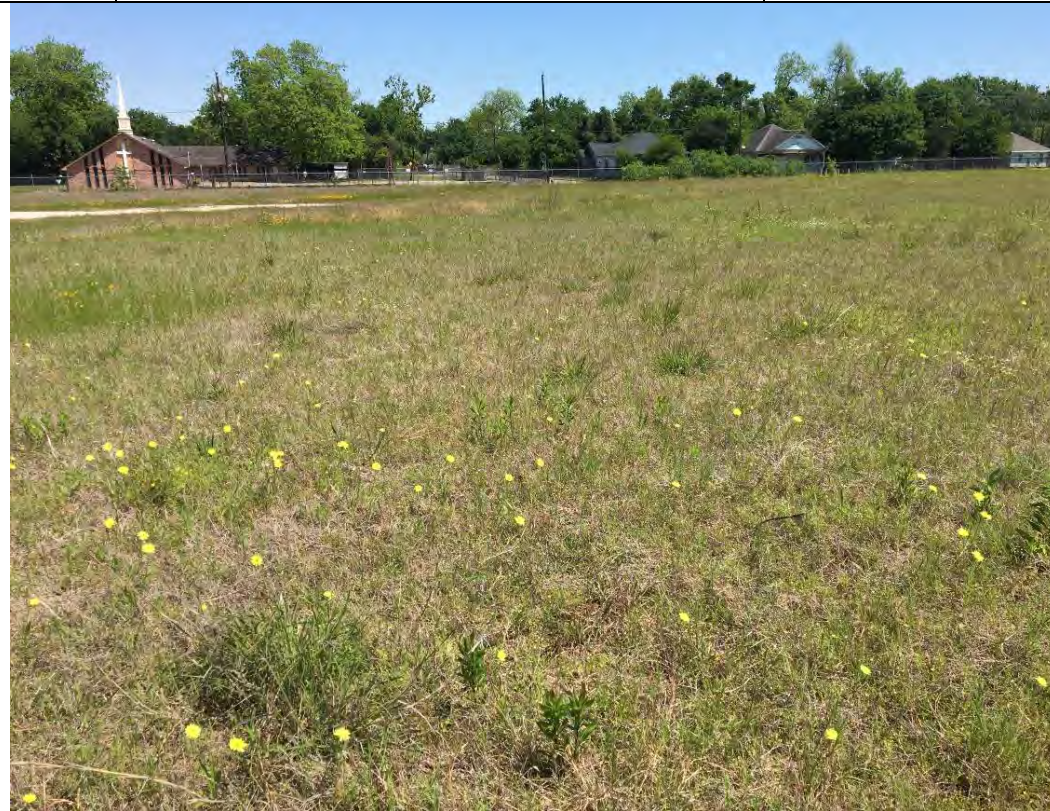
Photo No. 9	Date: 04/26/18
Description: Soil Cap Area: Soil cap area, looking north, vegetation cover in good shape. Lat: 29.78663889 Long: -95.31975556

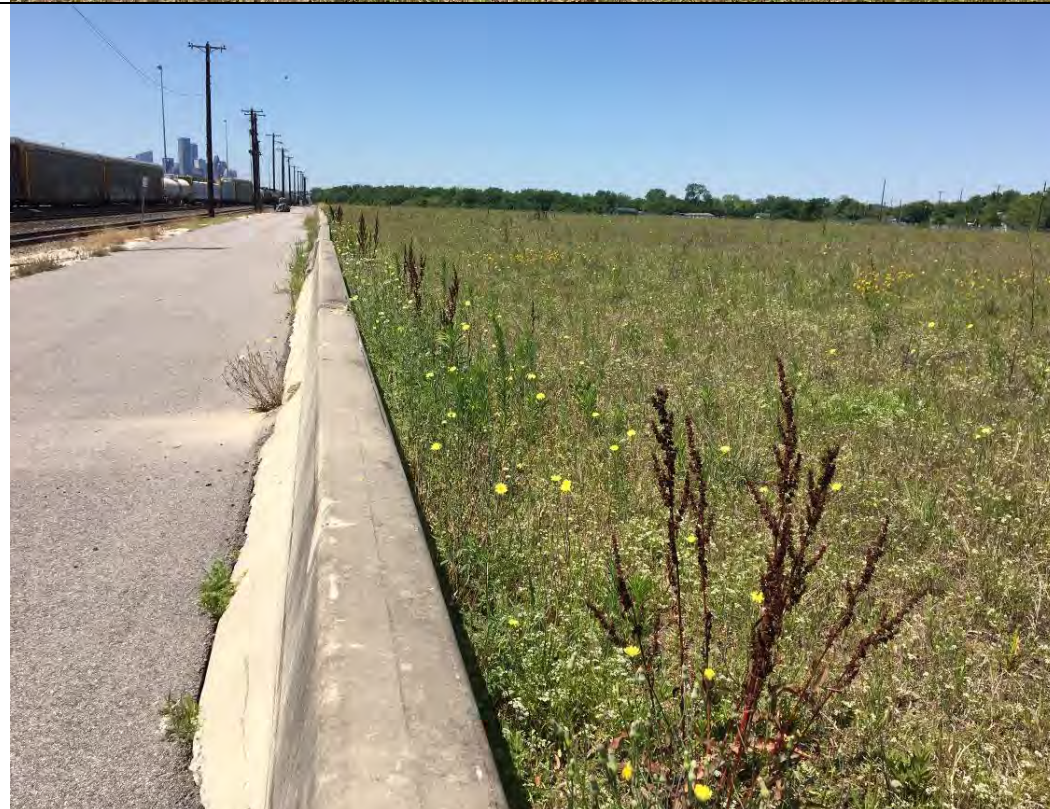
Photo No. 10	Date: 04/26/18
Description: Soil Cap Area: Healthy vegetation cover on southeastern portion of soil cap, looking southwest. Lat: 29.78706111 Long: -95.31761943999999

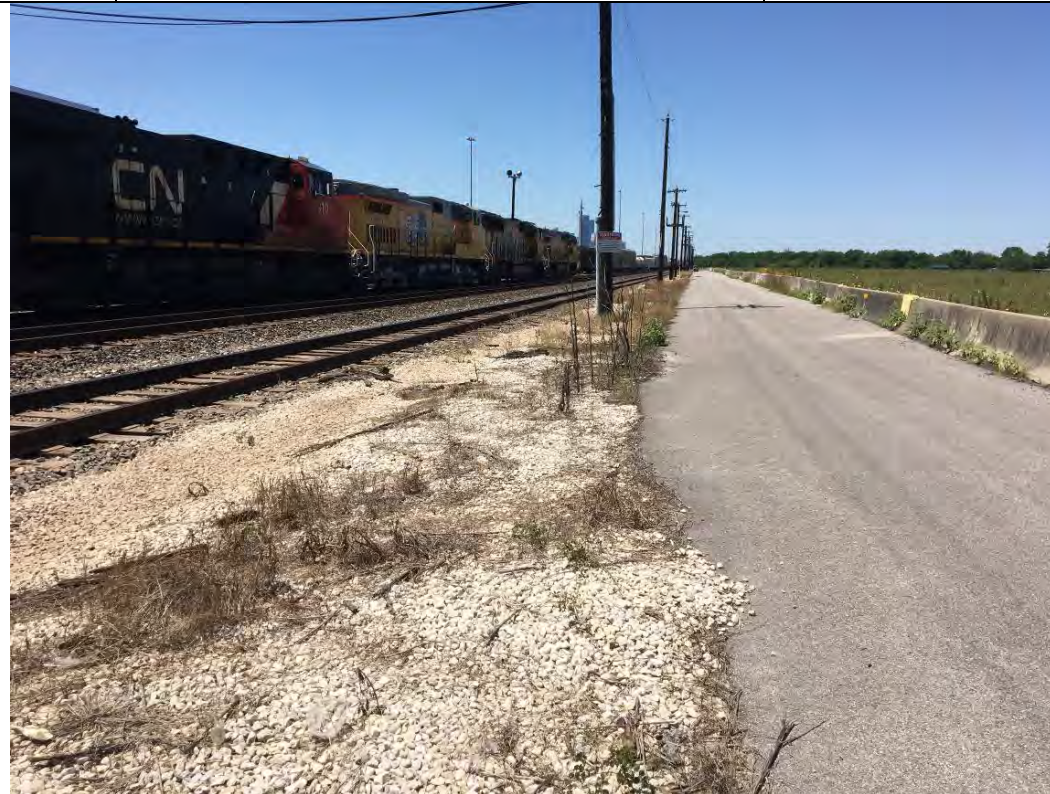
Photo No. 15	Date: 04/26/18
Description: Asphalt Cap Area: View of asphalt road cap, looking southwest, warning sign on left in ballast cap area, soil cap area to the right. Some vegetation within ballast cap area. Lat: 29.787475 Long: -95.31654999999999

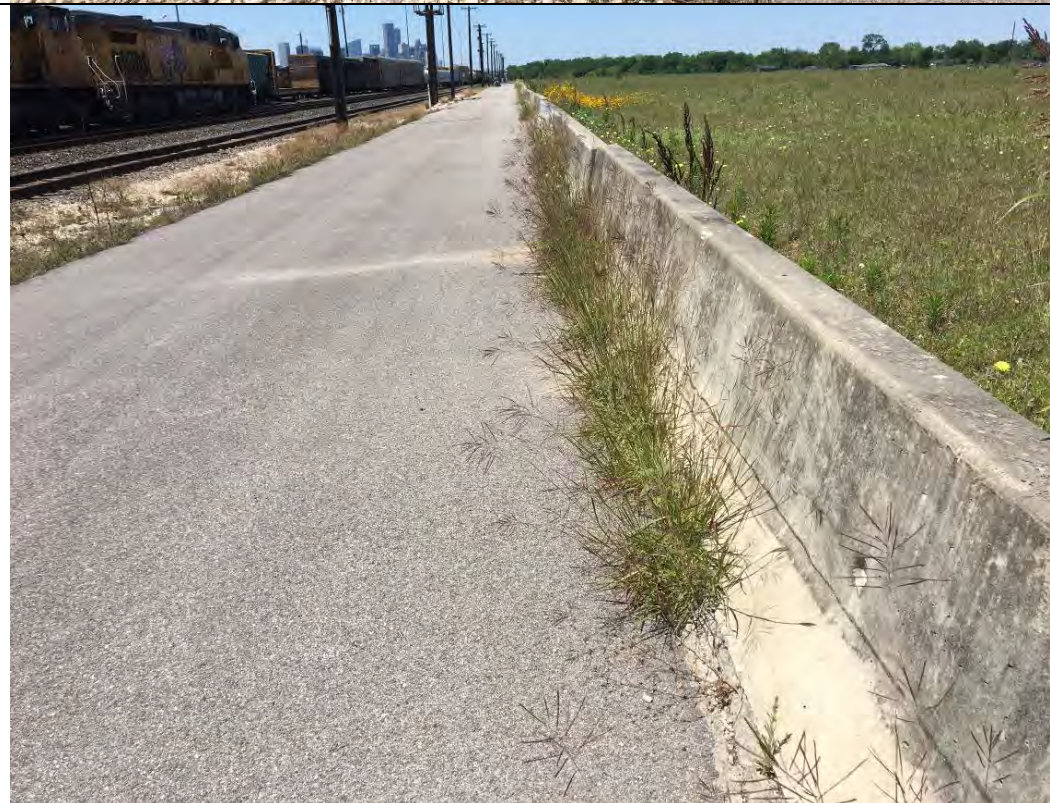
Photo No. 16	Date: 04/26/18
Description: Asphalt Cap Area: View of asphalt road cap, looking southwest. Vegetation growing beneath the concrete barriers Lat: 29.78735833 Long: -95.31691111000001

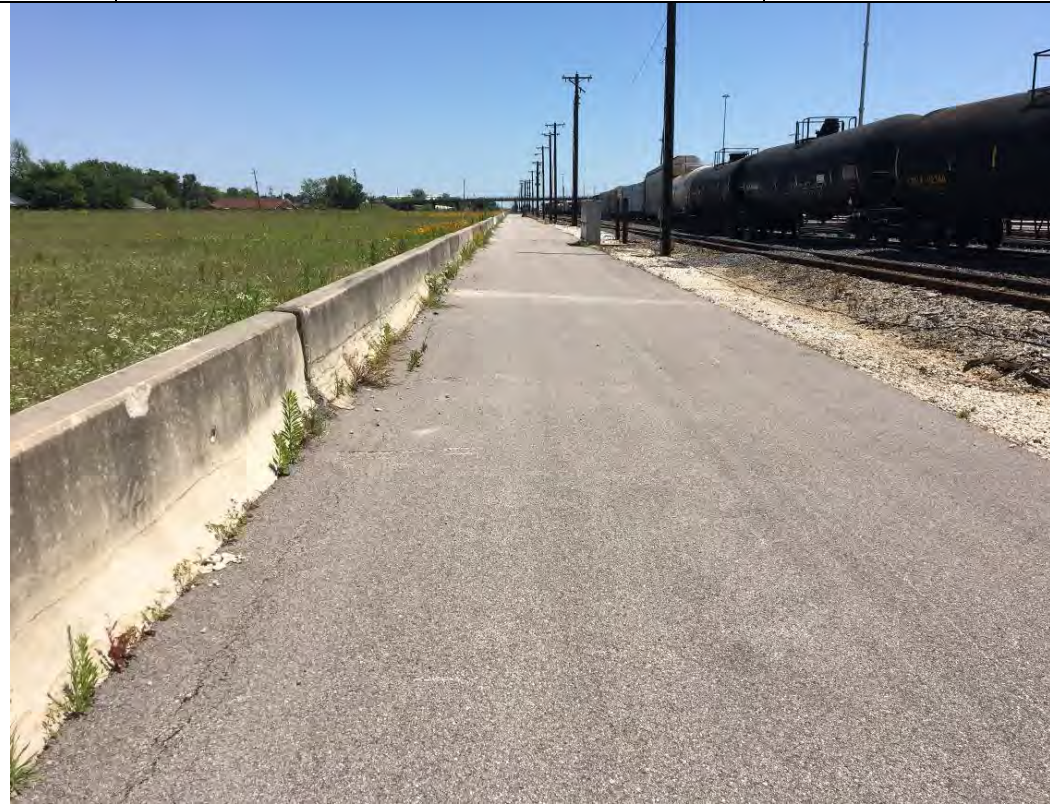
Photo No. 17	Date: 04/26/18
Description: Asphalt Cap Area: View of asphalt road cap, looking northeast. Lat: 29.78578056 Long: -95.32058056

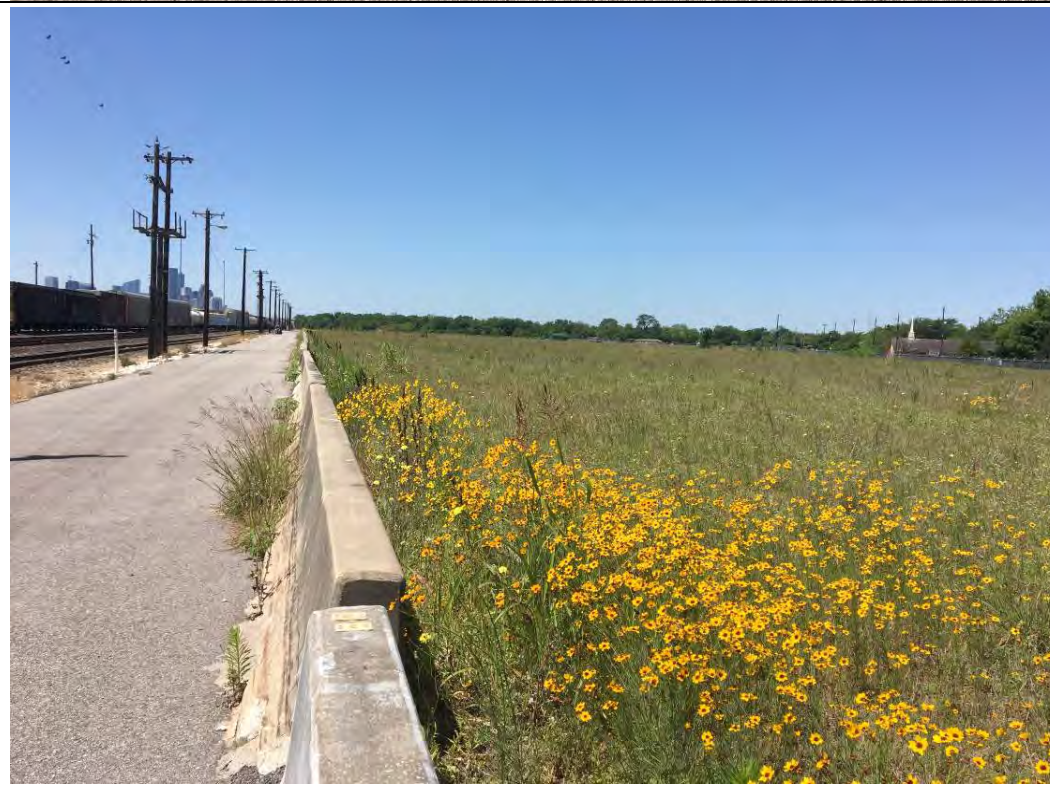
Photo No. 18	Date: 04/26/18
Description: Asphalt Cap Area: View of asphalt road cap, looking southwest, railroad ballast cap area to the left, soil cap area to the right. Flowering plants in soil cap appear healthy. Lat: 29.787275 Long: -95.31714722

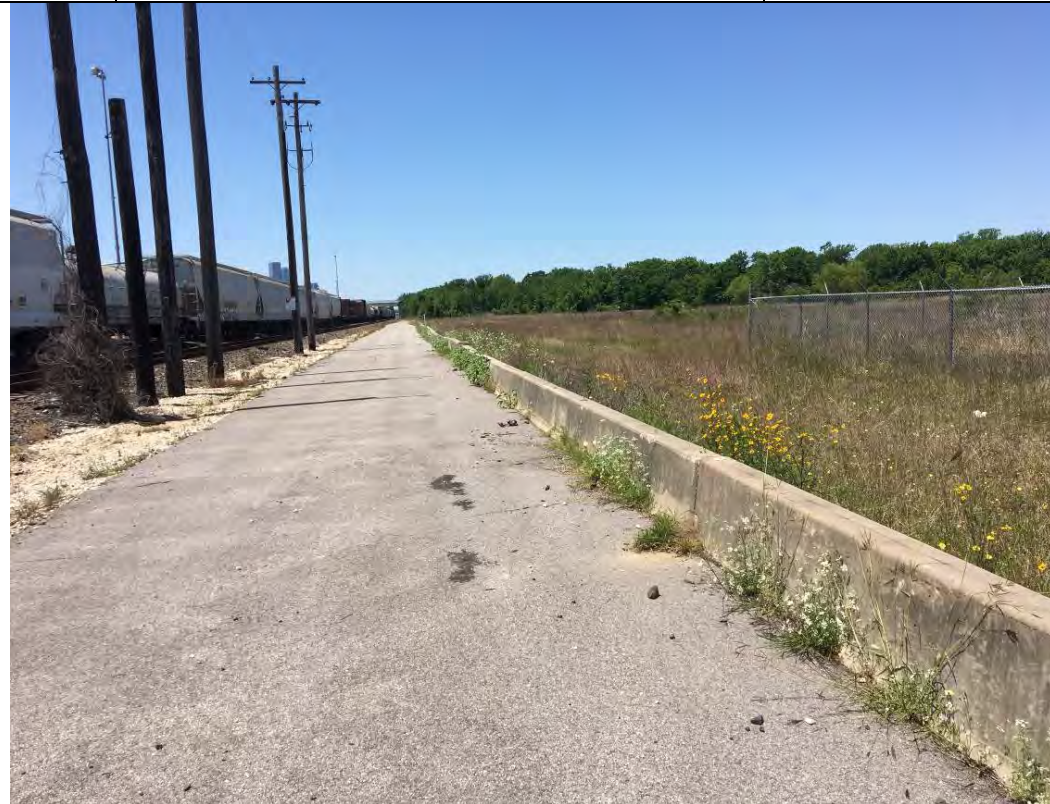
Photo No. 19	Date: 04/26/18
-------------------------------	--------------------------

Asphalt Cap Area:
 View of asphalt cap area, looking southwest. Note small oily stains on pavement, appear the same compared to Jan 2018 inspection.

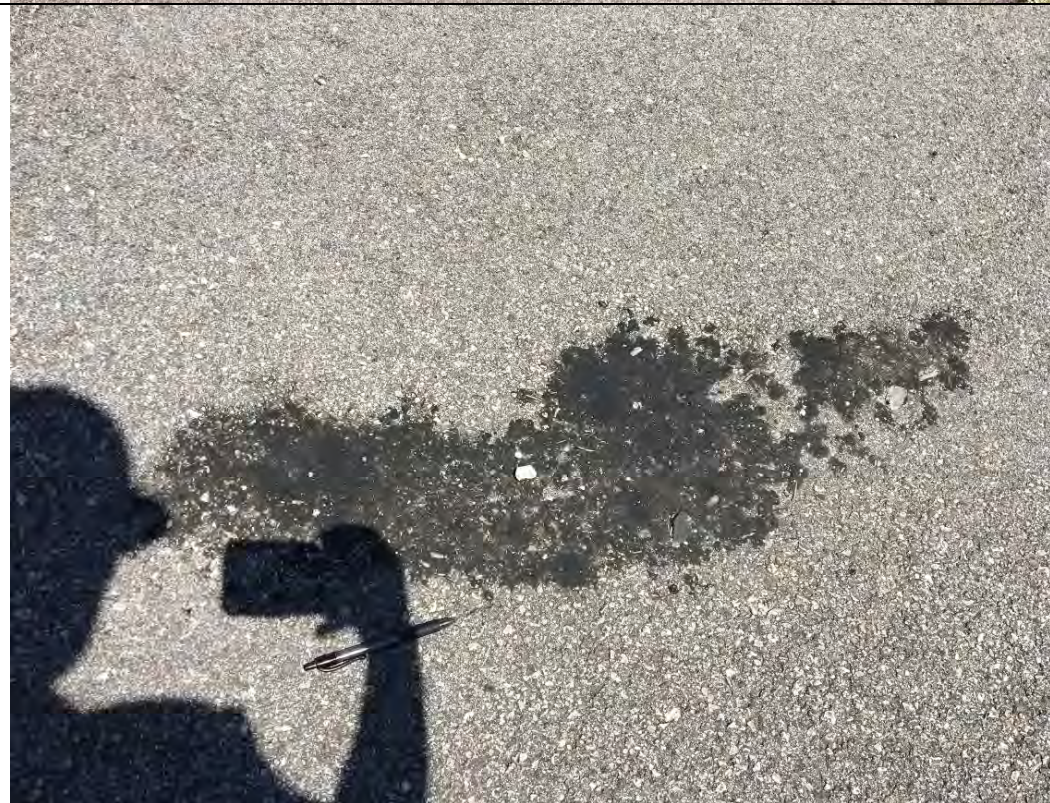
Photo No. 20	Date: 04/26/18
-------------------------------	--------------------------

Asphalt Cap Area:
 View of asphalt cap area. Note small oily stains on pavement, appear the same compared to Jan 2018 inspection. Pen for scale.

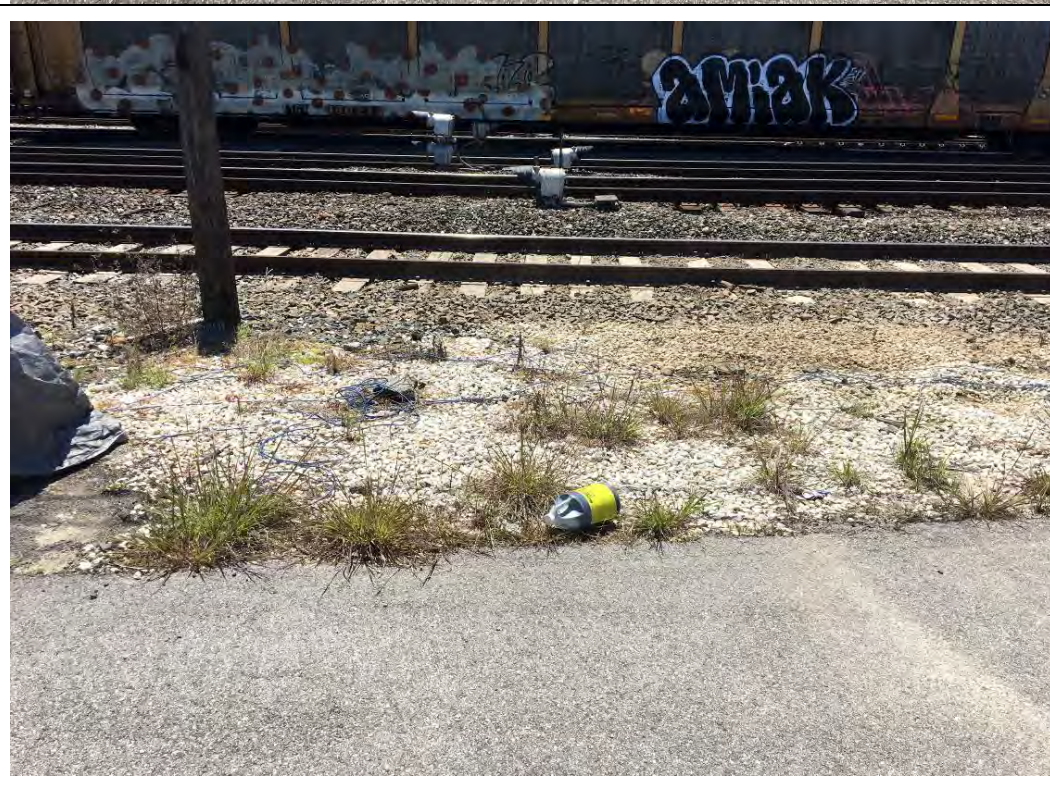
Photo No. 22	Date: 04/26/18
Description: Ballast Cap Area: View of ballast cap area, looking south-southwest. Trash and vegetation present. Lat: 29.78655 Long: -95.318825

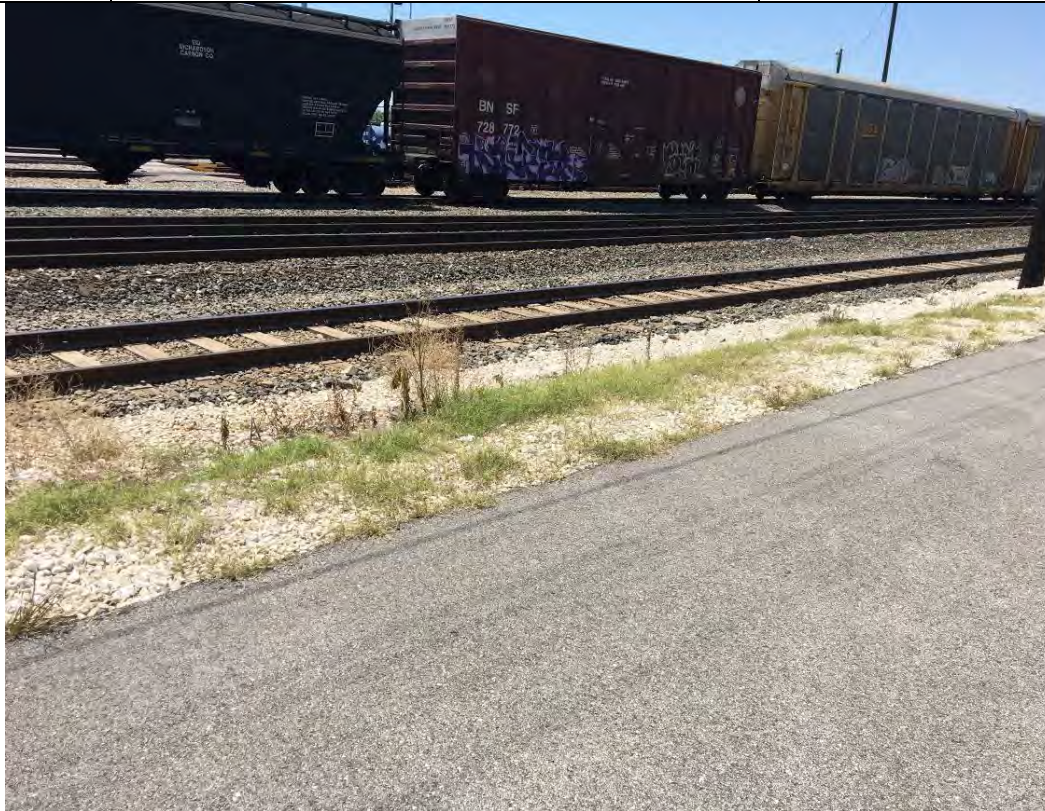
Photo No. 23	Date: 04/26/18
Description: Asphalt Cap/Ballast Cap Area: View of ballast cap area, looking southwest. Some vegetation within the ballast area, no soil exposed. Lat: 29.78685278 Long: -95.31810833

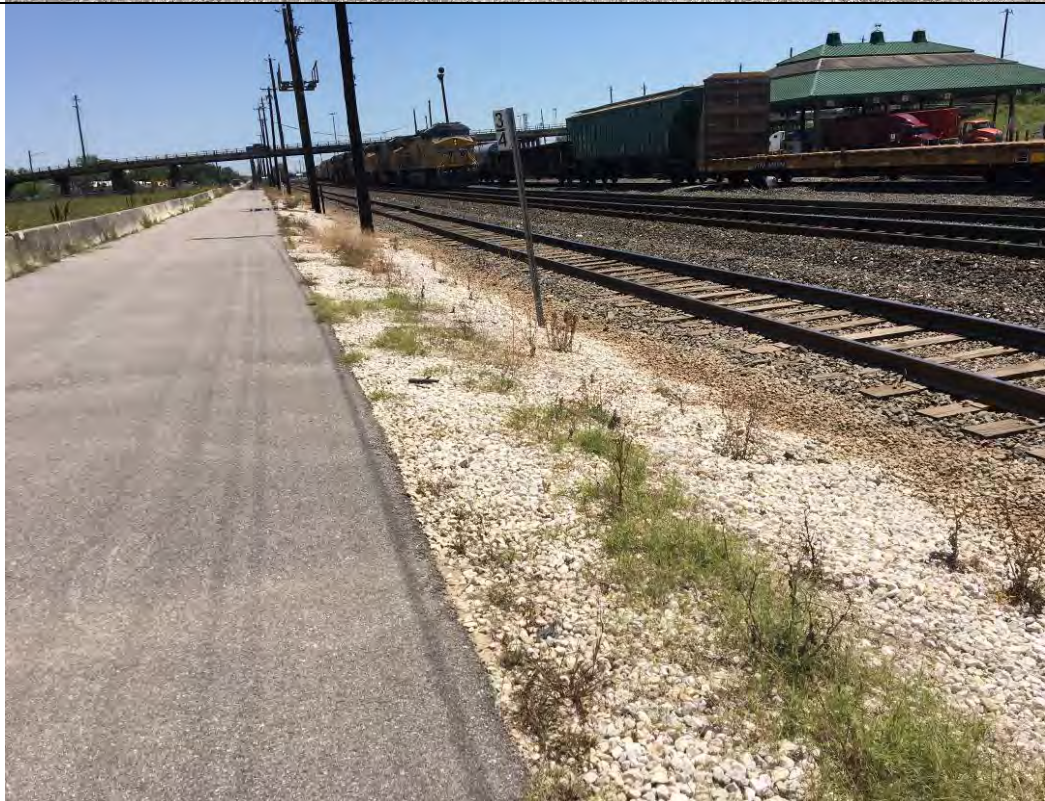
Photo No. 24	Date: 04/26/18
Description: Asphalt Cap/Ballast Cap Area: View of ballast cap area, looking southeast. Ballast area cover in good shape. Some vegetation in ballast cap. Lat: 29.78682778 Long: -95.3181

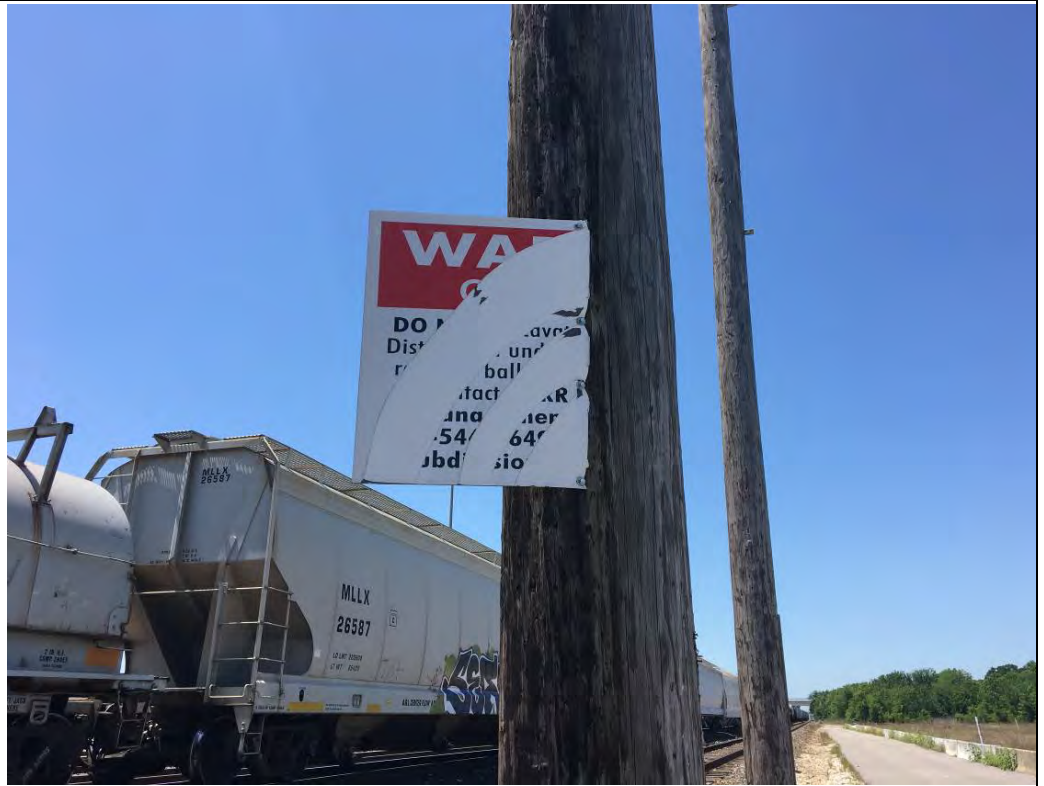
Damaged warning sign in ballast cap area. Looking west.

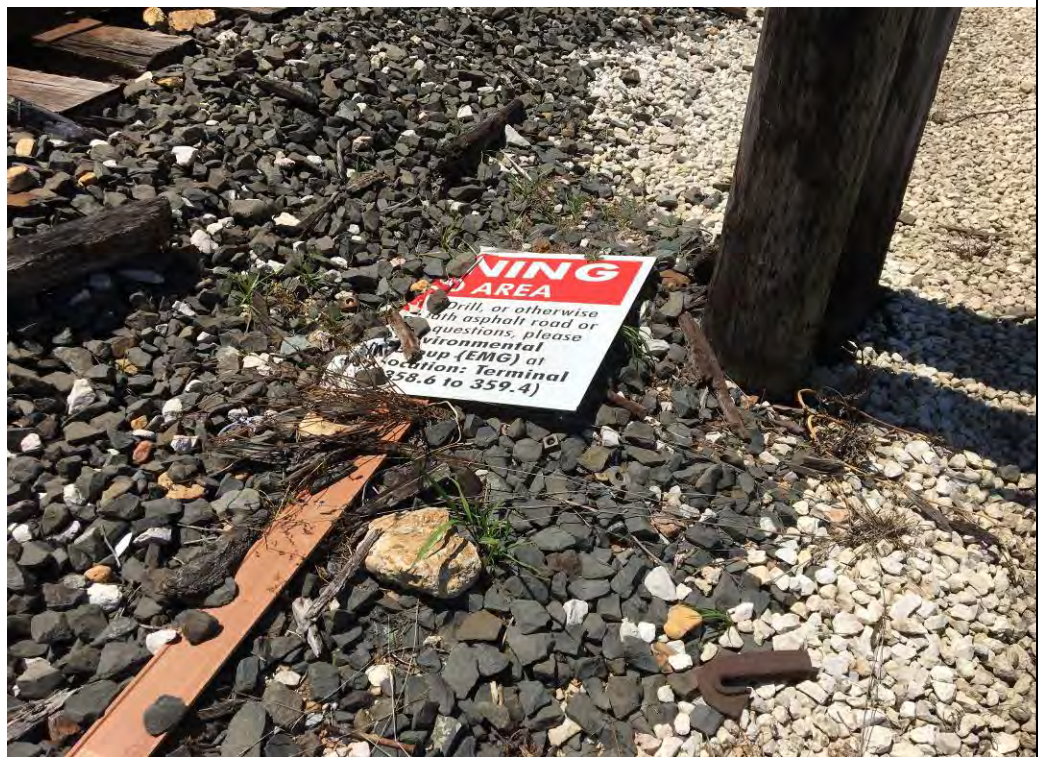
Photo No.
26

Damaged warning sign in ballast cap area. Looking west.

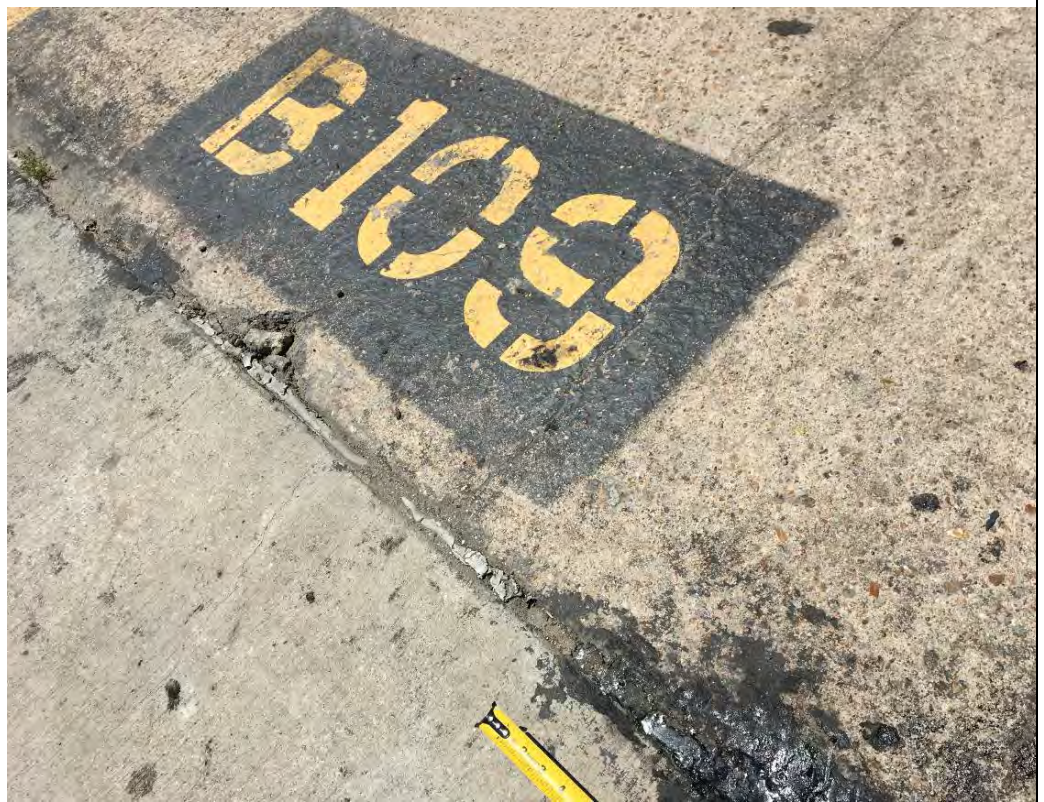
Concrete Cap Area:
Fresh tar-like material and staining around parking spot B109. Looking west.

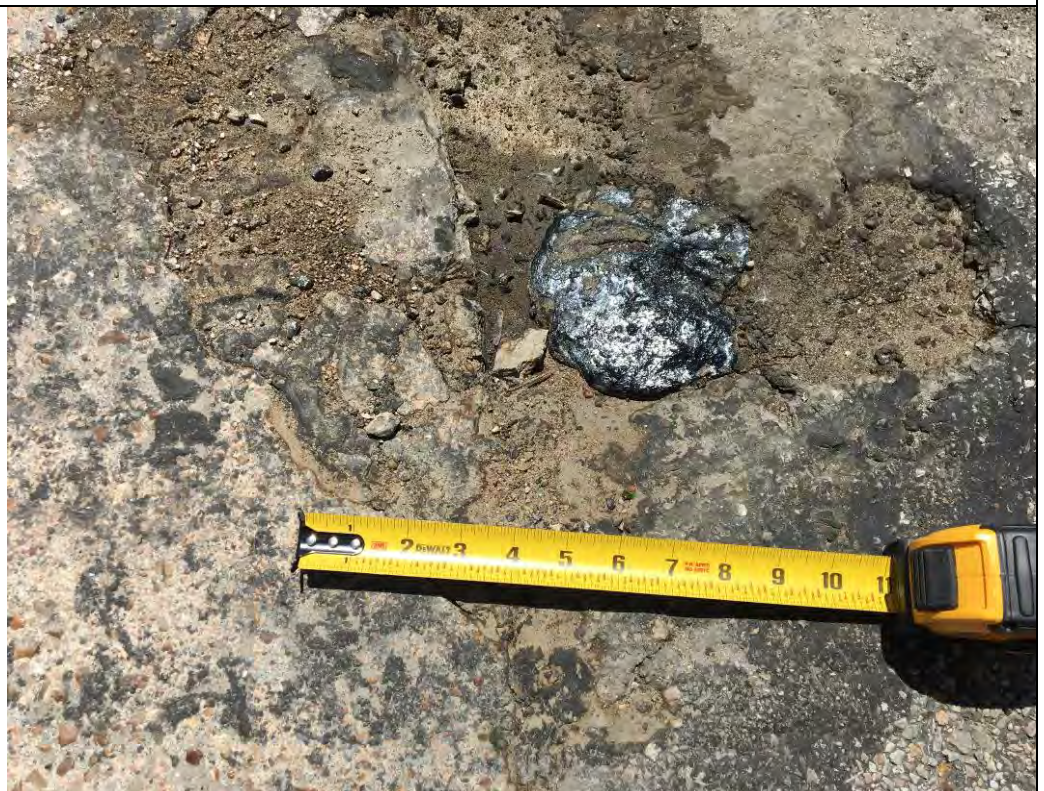
Concrete Cap Area:
Fresh tar-like product in parking spot B100. Tape measure for scale.

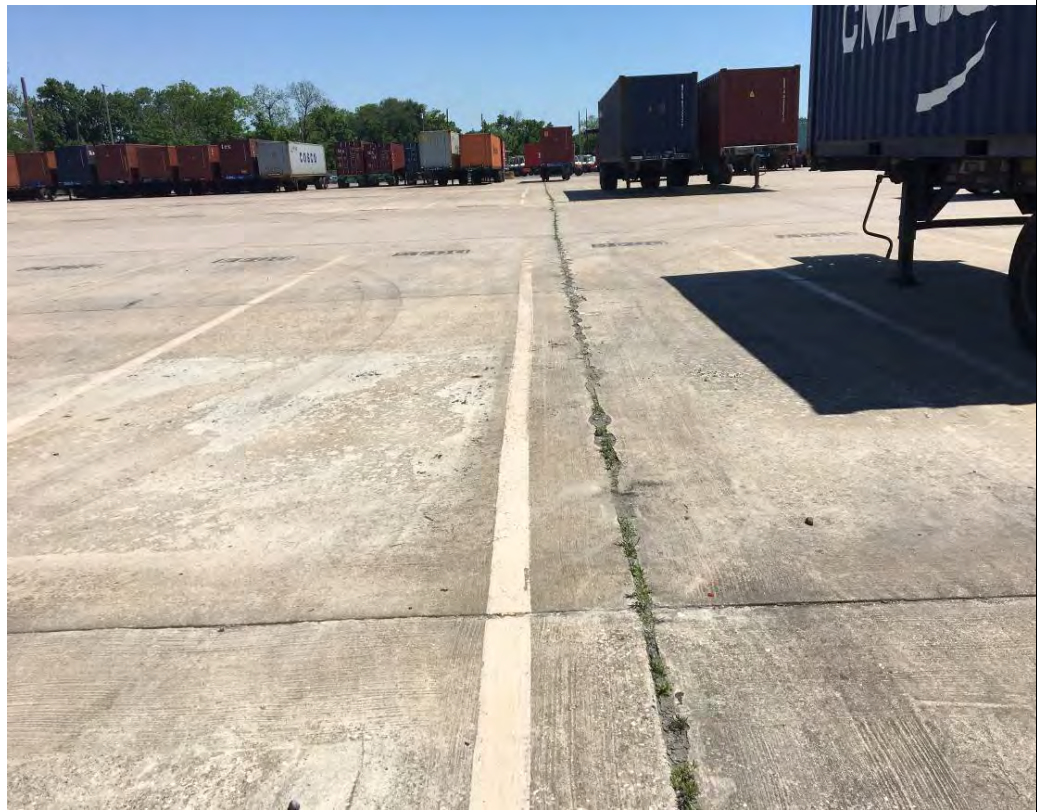
Photo No. 33	Date: 04/26/18
-------------------------------	--------------------------

Concrete Cap Area:
Area of B-Row and C-Row concrete appears in good shape, some vegetation growing in the joint, looking south.
