March 29, 2019

Project No. 30401358

**RE: POST-RESPONSE ACTION COMPLETION REPORT – 2018
UNION PACIFIC RAILROAD HOUSTON WOOD PRESERVING WORKS, HOUSTON, TEXAS
4910 LIBERTY ROAD, HOUSTON, HARRIS COUNTY, TEXAS
TCEQ SWR NO. 31547; TCEQ PERMIT/COMPLIANCE PLAN NO. 50343EPA ID NO. TXD000820266
CUSTOMER NO. CN600131098; REGULATED ENTITY NO. RN100674613**

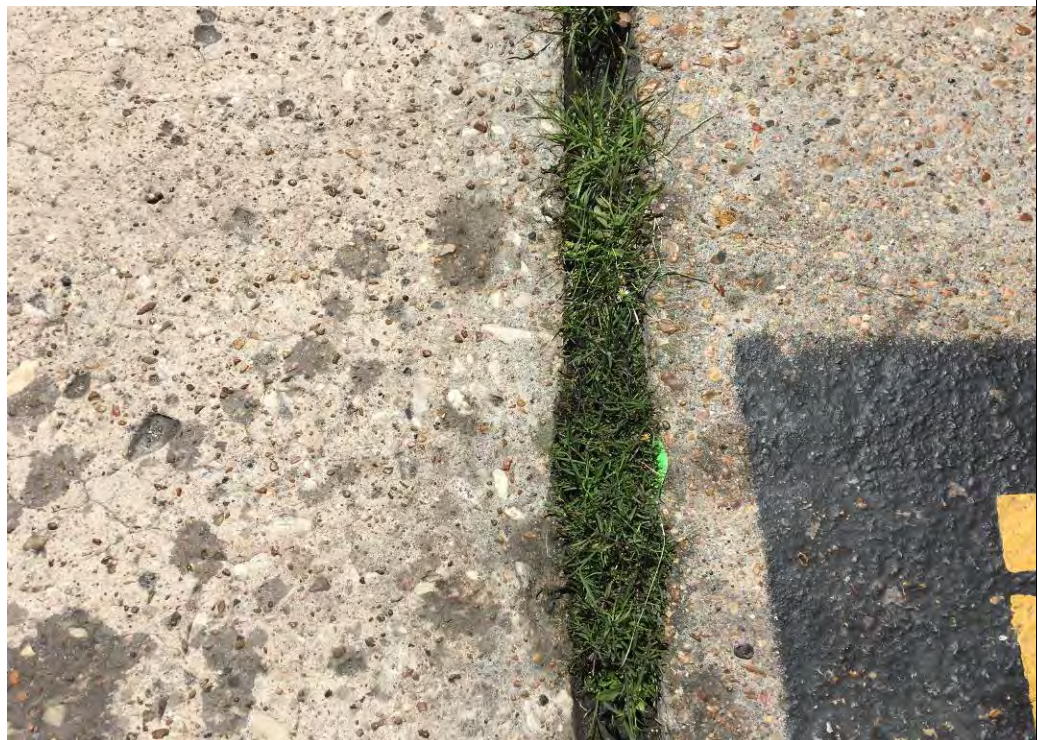
Photo No. 34	Date: 04/26/18
-------------------------------	--------------------------

Concrete Cap/Ballast Cap Areas:
Vegetation growing in a joint in the A-Row.

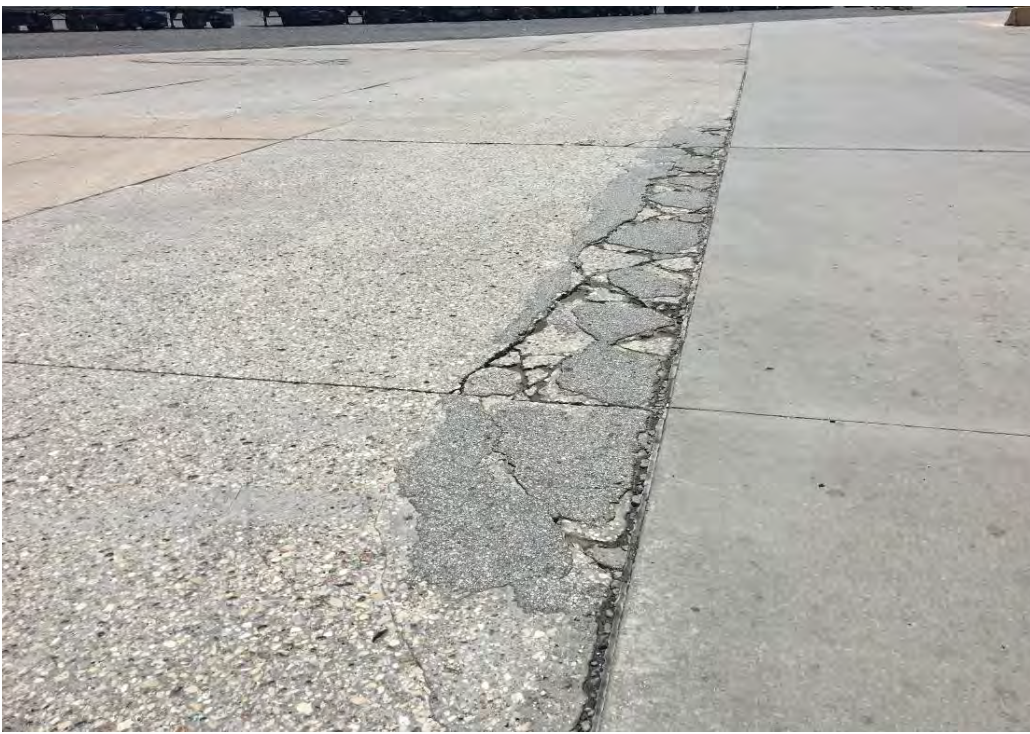
Photo No. 38	Date: 04/26/18

Description: <u>Concrete Cap Area:</u> North edge of concrete cap near A-Row, some cracking in concrete cap, looking east. Lat: 29.78605278 Long: -95.32102222

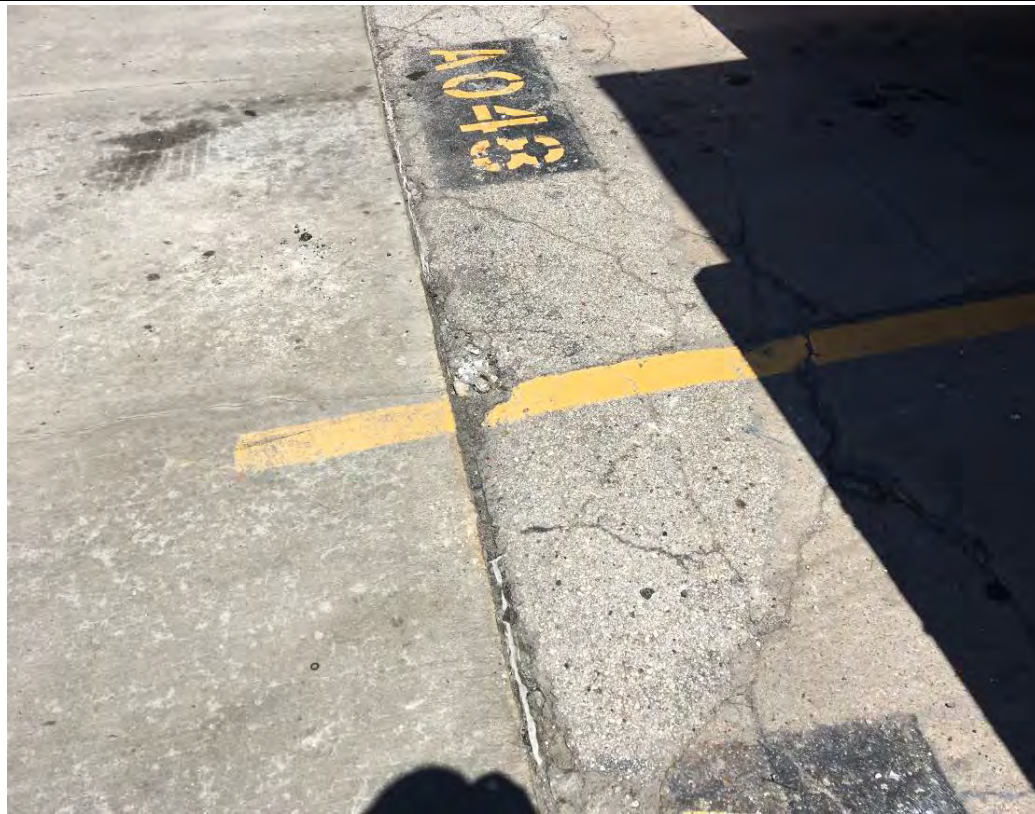
Concrete Cap Area:
Cracking in concrete near A-Row spot A048, looking east.

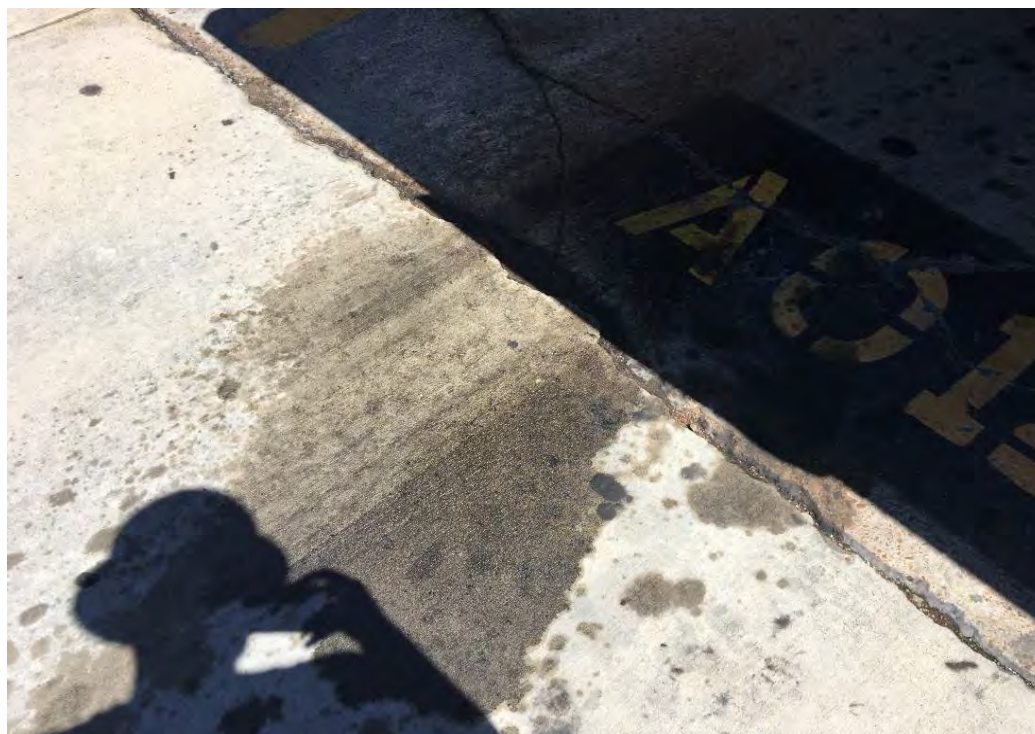
Photo No. 40	Date: 04/26/18
------------------------	--------------------------

Concrete Cap Area:
Oily staining on concrete in A-Row spot A012, looking southeast.

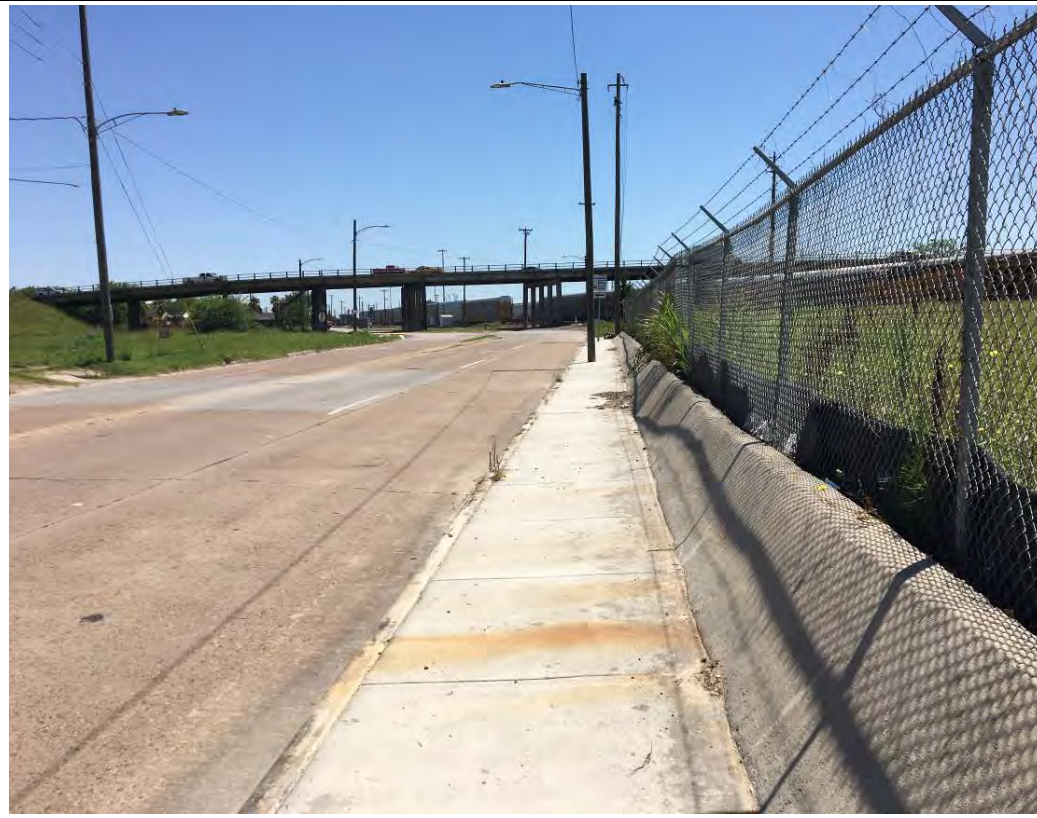
Photo No. 45	Date: 04/26/18
-------------------------------	--------------------------

Perimeter Fence/ Concrete Sidewalk Cap Area:
View of the sidewalk cap area, looking east along Liberty Road.

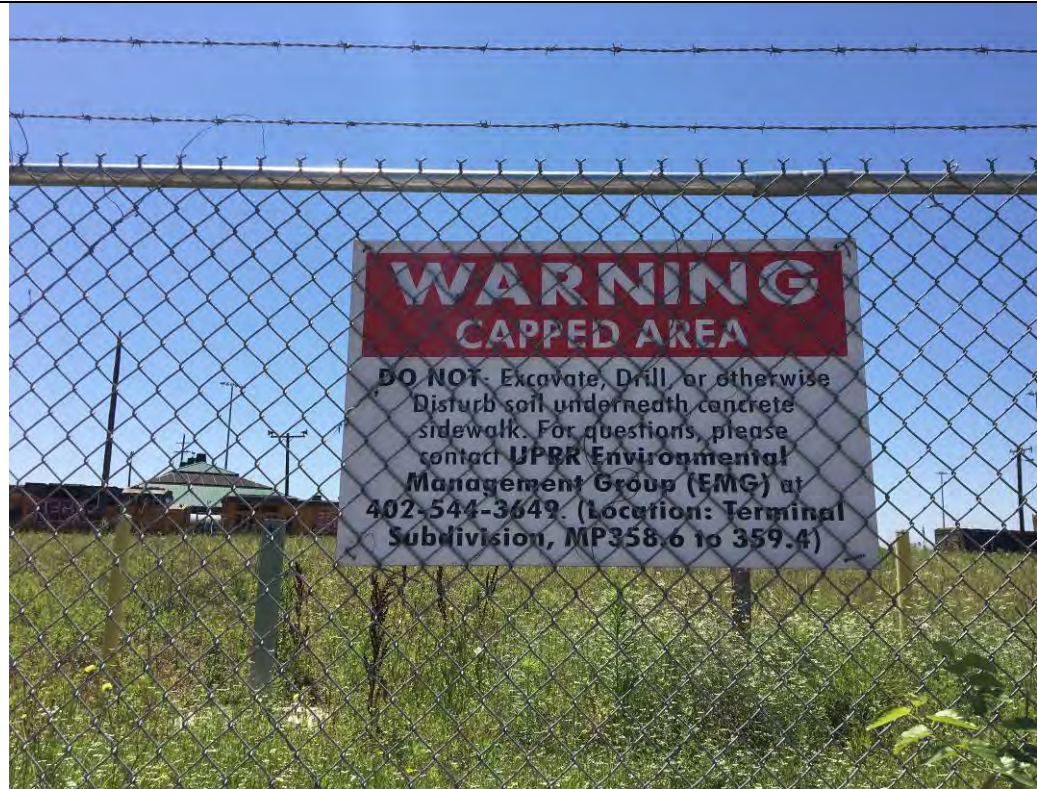
Photo No. 46	Date: 04/26/18
-------------------------------	--------------------------

Perimeter Fence/ Concrete Sidewalk Cap Area:
Warning sign on the northern perimeter fence.

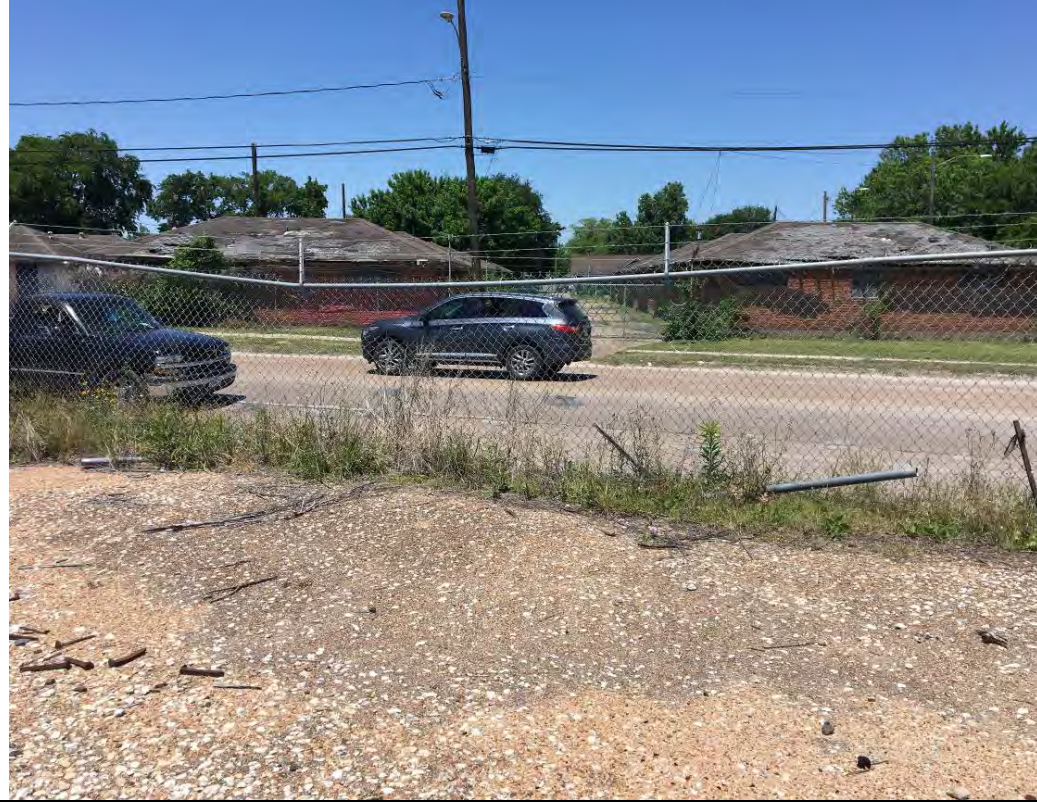
Photo No. 47	Date: 04/26/18
-------------------------------	--------------------------

Perimeter Fence:
 Perimeter fence with sagging mesh and two missing posts. Looking northwest.

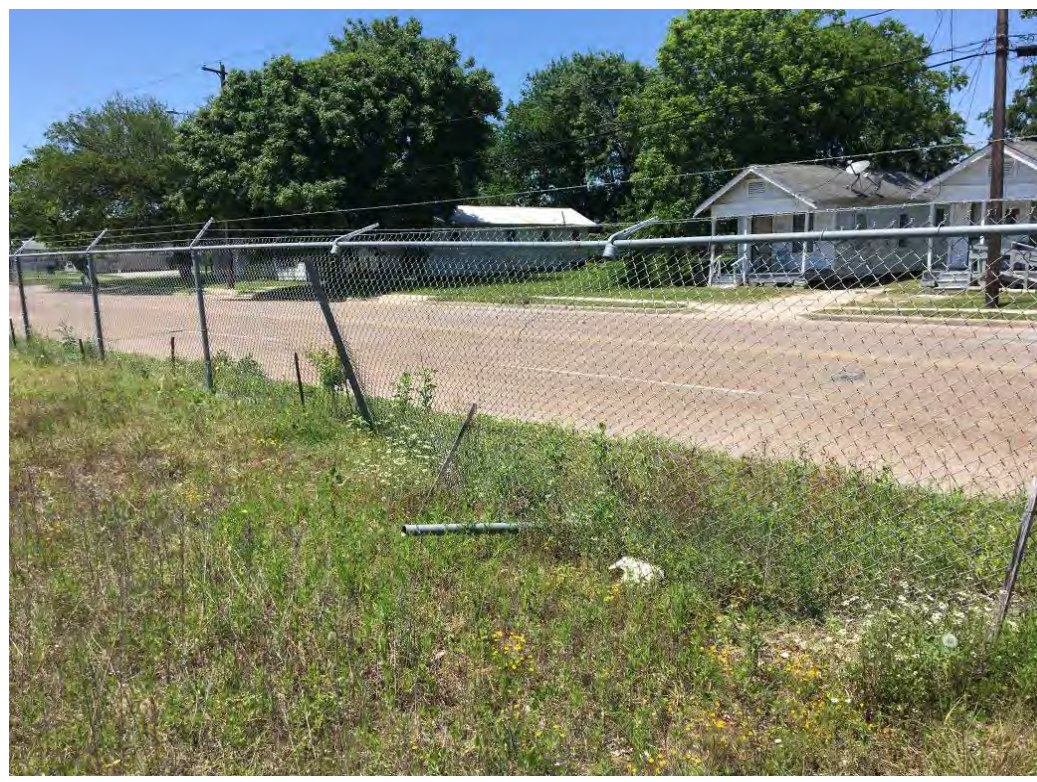
Photo No. 48	Date: 04/26/18
-------------------------------	--------------------------

Perimeter Fence:
 Perimeter fence with missing posts and damaged mesh. Fence appears to have been impacted by a vehicle. Looking northwest.

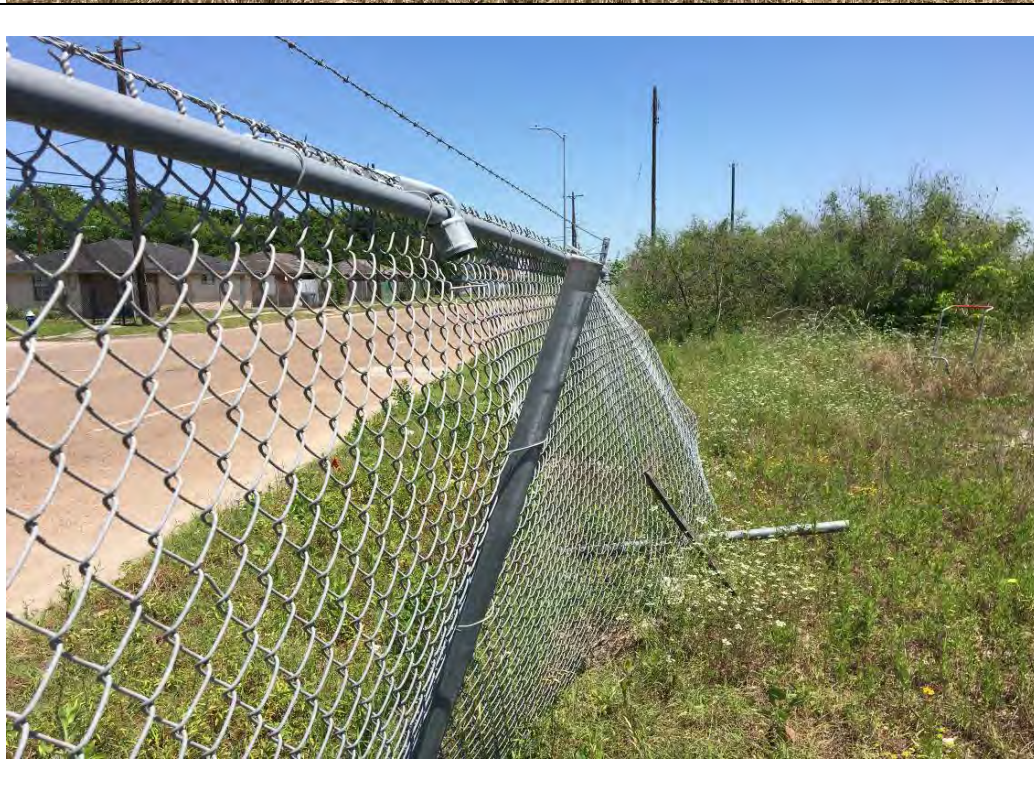
Photo No. 50	Date: 04/26/18
Description: <u>Perimeter Fence:</u> Perimeter fence bending outward at point of collision. Looking east Lat: 29.7876 Long: -95.32228056000001

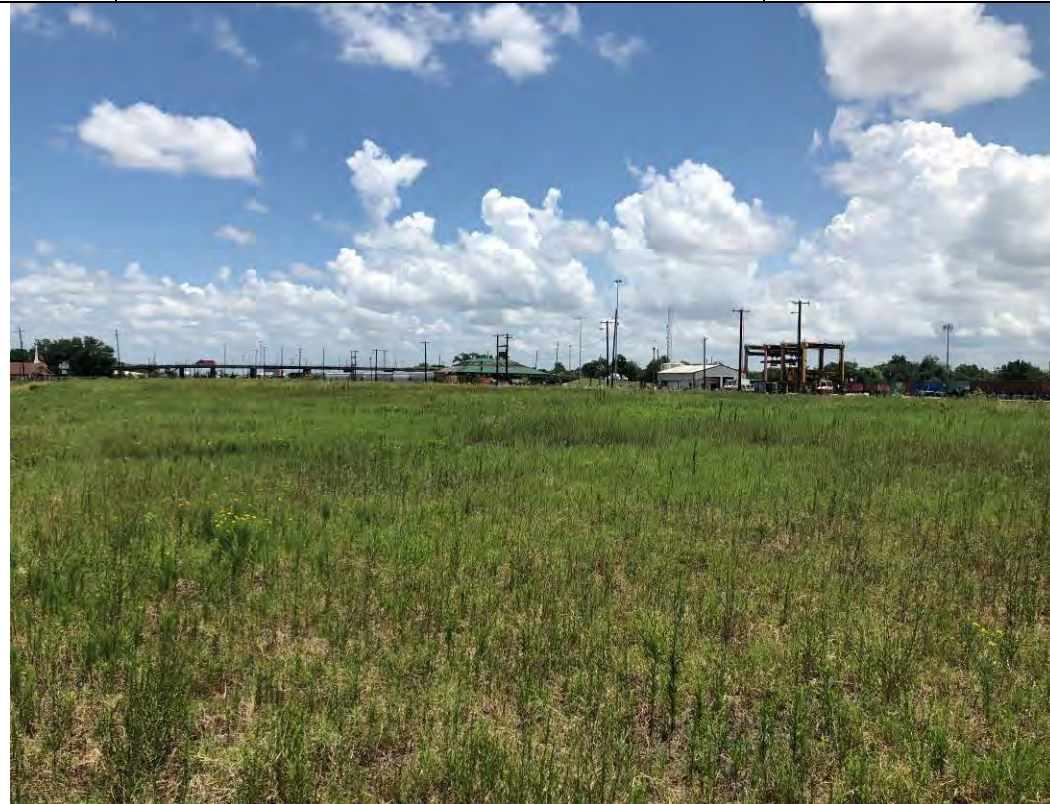
Photo No. 1	Date: 07/05/18
Description: Soil Cap Area: Soil cap facing southeast, vegetation cover in good shape Lat: 29.7879 Long: -95.31986111

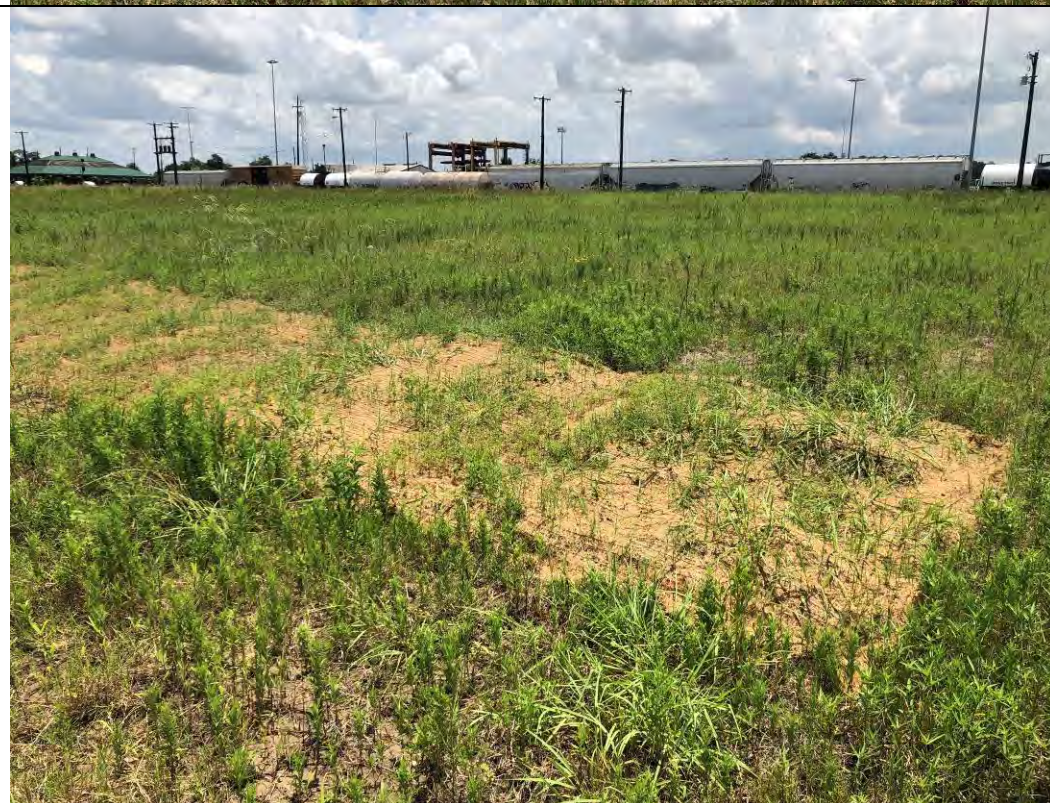
Photo No. 2	Date: 07/05/18
Description: Soil Cap Area: Soil cap, facing southeast. Repair intact, vegetation and pollinator plants are growing as intended. Lat: 29.78175556 Long: -95.31781110999998

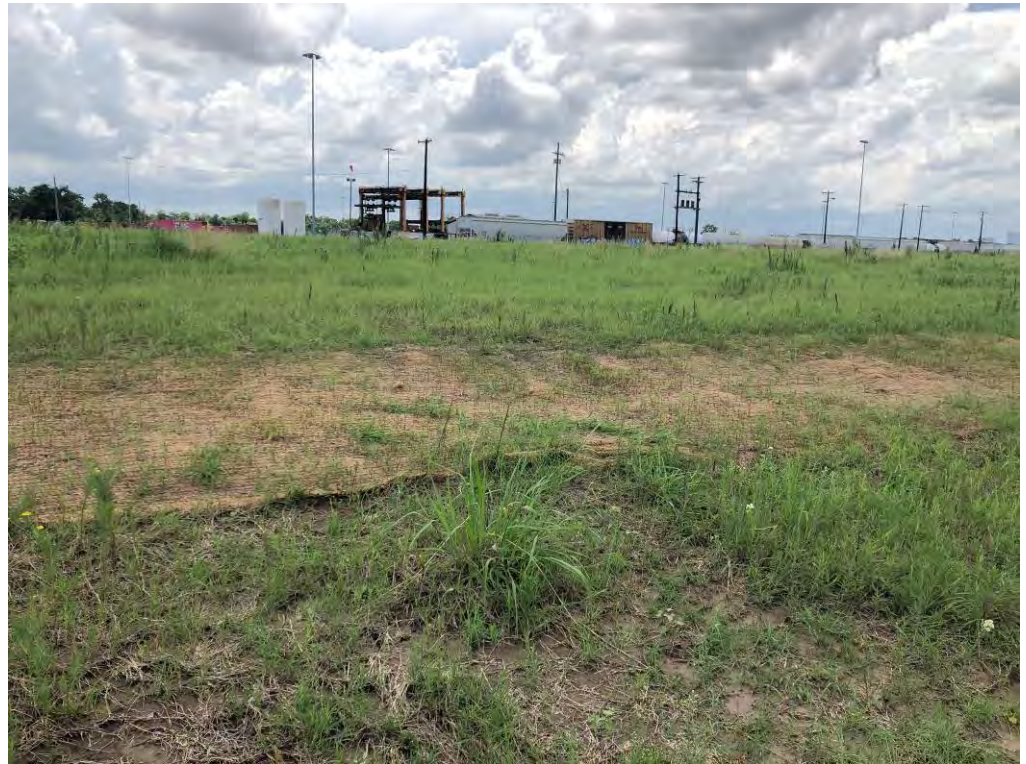
Soil cap, facing southeast.
Repair intact, vegetation and
pollinator plants are growing
as intended

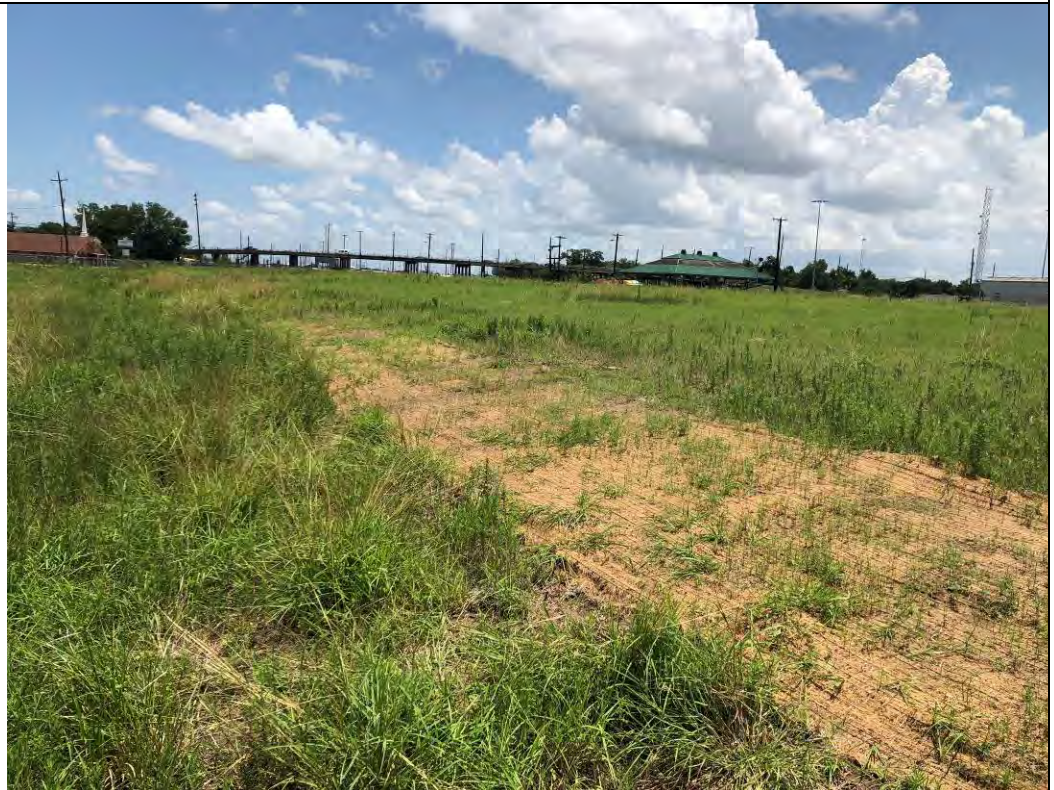
Photo No.
4

Soil cap, facing southeast.
Repair intact, vegetation and
pollinator plants are growing
as intended

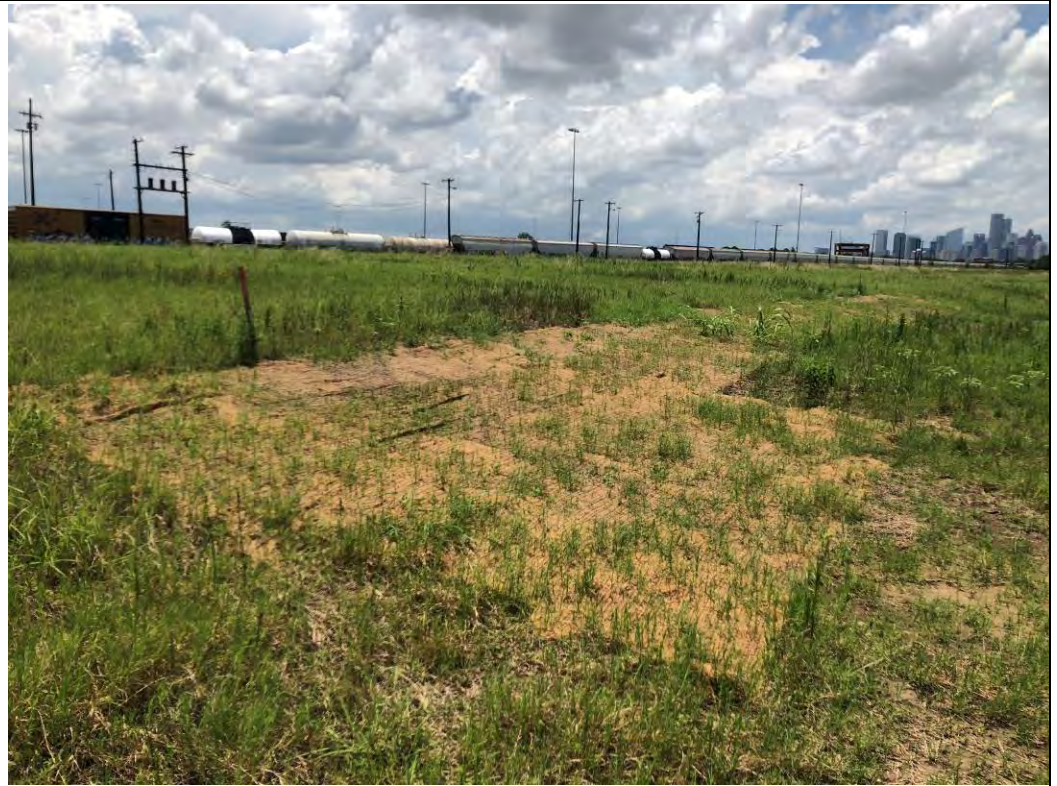
Soil cap, facing southwest.
Repair intact, vegetation and
pollinator plants are growing
as intended.

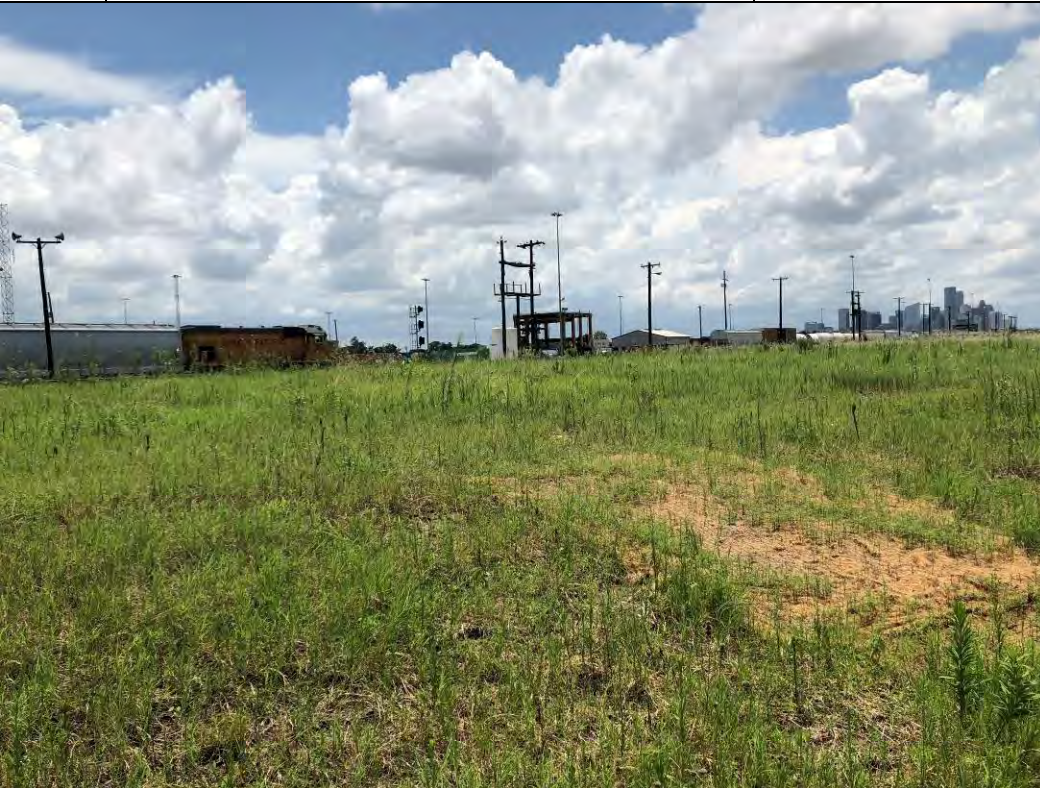
Photo No. 7	Date: 07/05/18

Description: Soil Cap Area: Soil cap, facing southwest. Repair intact, vegetation and pollinator plants are growing as intended. Lat: 29.78778611 Long: -95.31663611000001

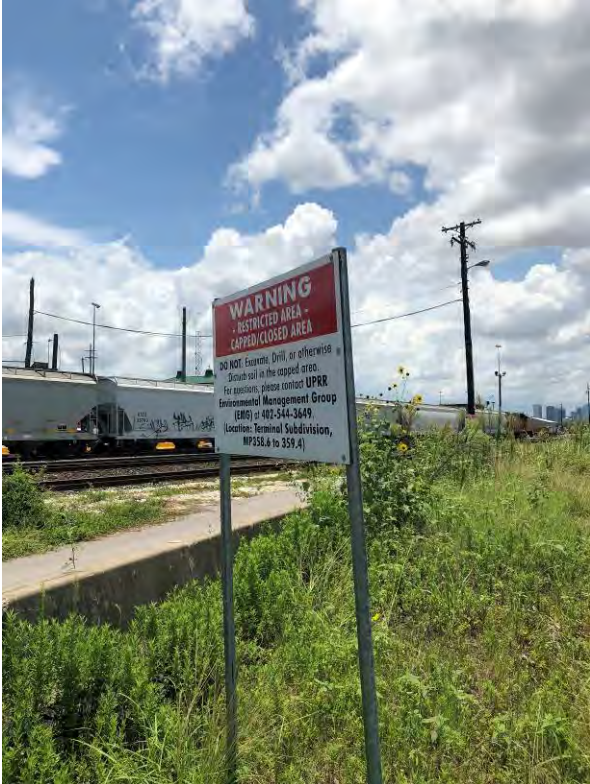
Description: Soil Cap Area: Warning sign at northeast corner of soil cap area, looking west. Lat: 29.78764444 Long: -95.31646667					
Photo No. 10	Date: 07/05/18

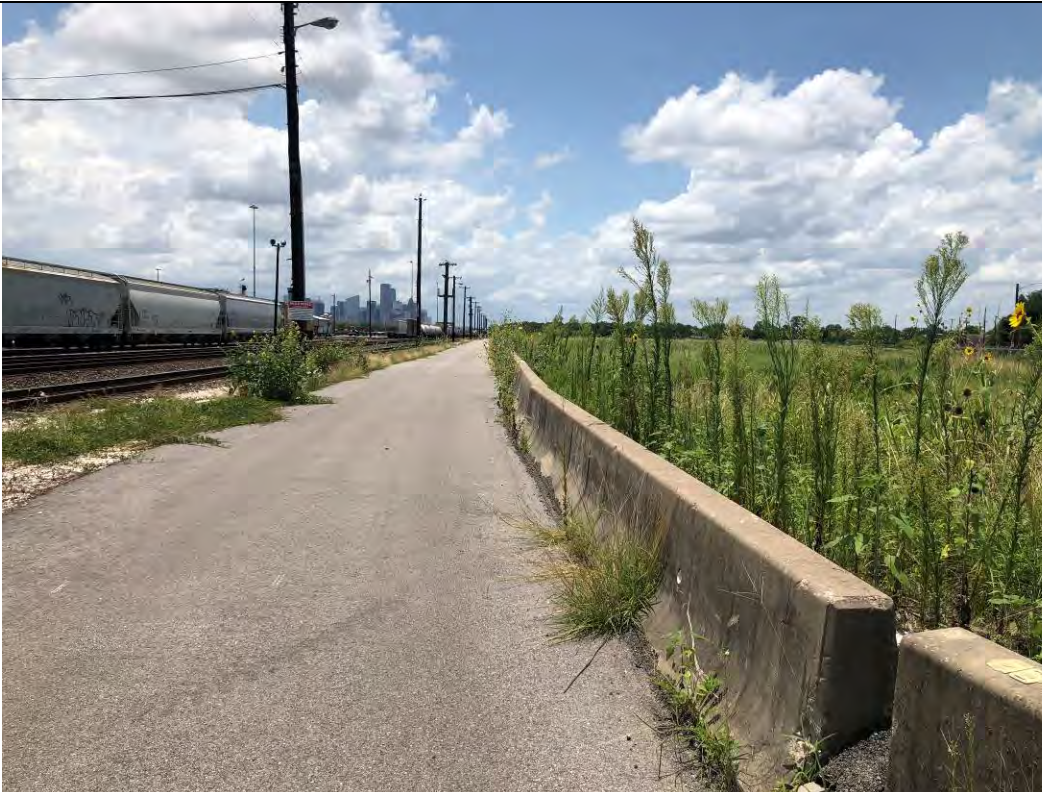
Description: Soil / Asphalt Cap Area: Southern edge of soil cap along asphalt road cap, looking southwest, vegetation cover in good shape, weeds growing along the concrete barriers and on ballast. Lat: 29.78755 Long: -95.31657500000001

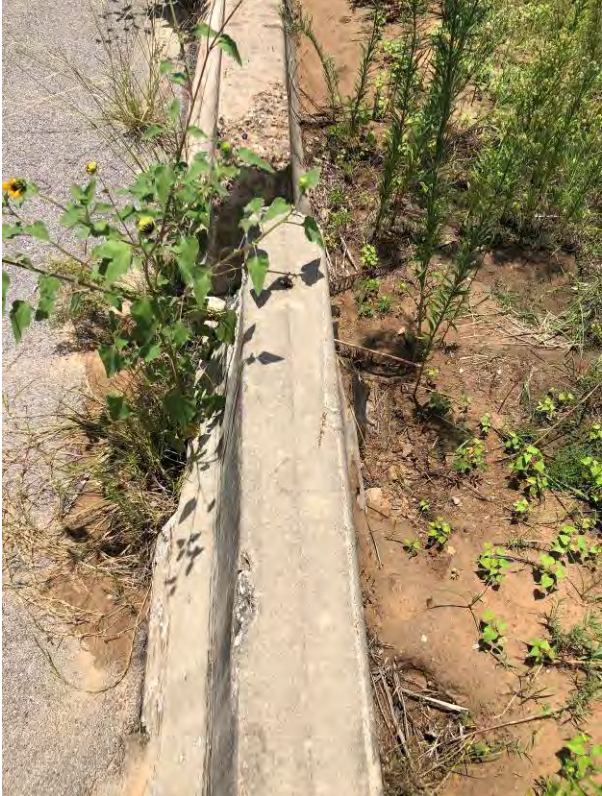
Photo No. 14	Date: 07/05/18

Description: Soil Cap Area: Southern edge of soil cap, viewing washout of soil beneath concrete barrier Lat: 29.78715 Long: -95.31744444

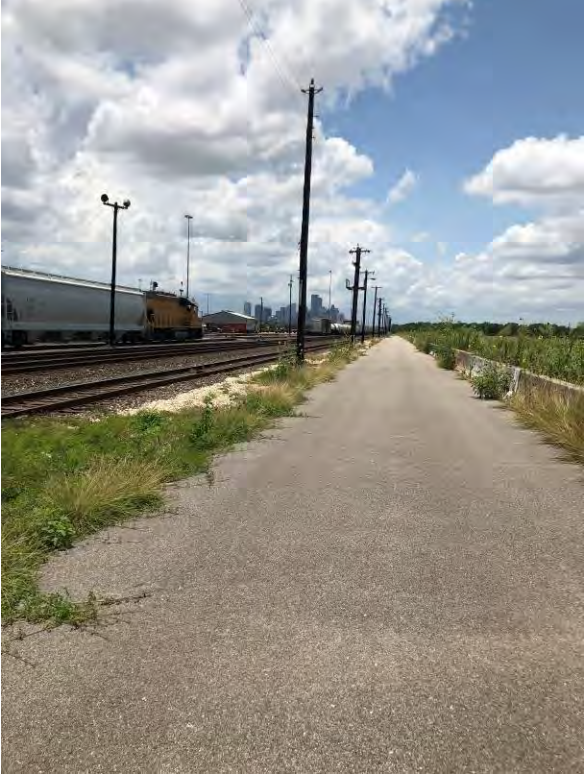
Photo No. 17	Date: 07/05/18

Description: <u>Asphalt / Ballast Cap Area:</u> View of asphalt road cap, looking west, ballast cap area to the left, and the soil cap area to the right. Some vegetation within ballast cap area and weeds along the concrete barrier. Lat: 29.78734722 Long: -95.31696943999999

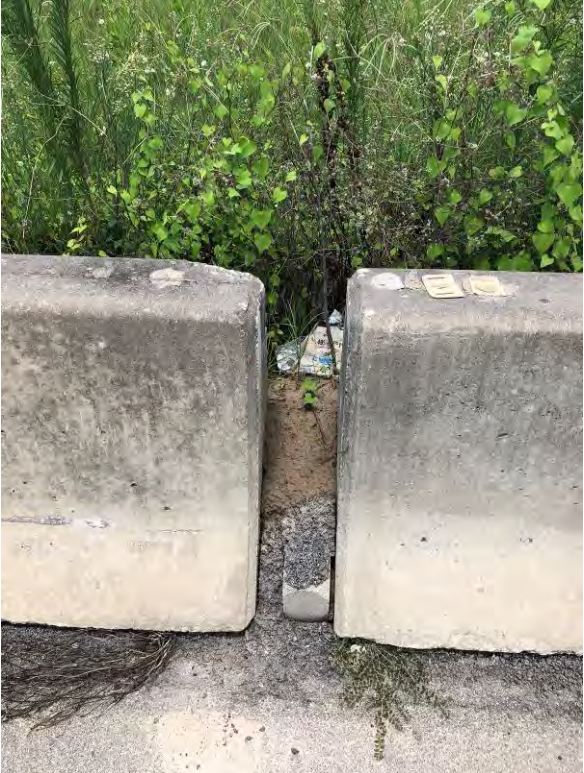
Photo No. 18	Date: 07/05/18

Description: <u>Asphalt Cap Area:</u> View of small ant hill and trash between two concrete barriers along the south side of the cap. Lat: 29.78735278 Long: -95.31783333

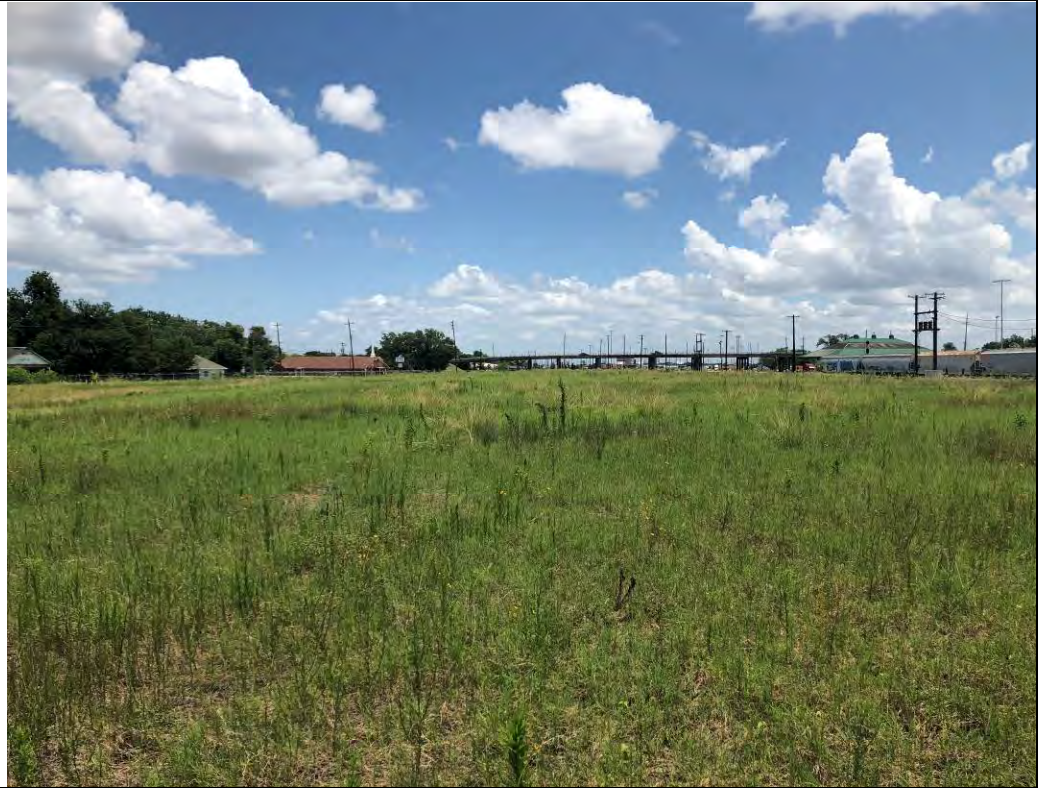
View of soil cap area, looking east with the Lockwood Overpass in the background. Vegetative cover appears in good condition

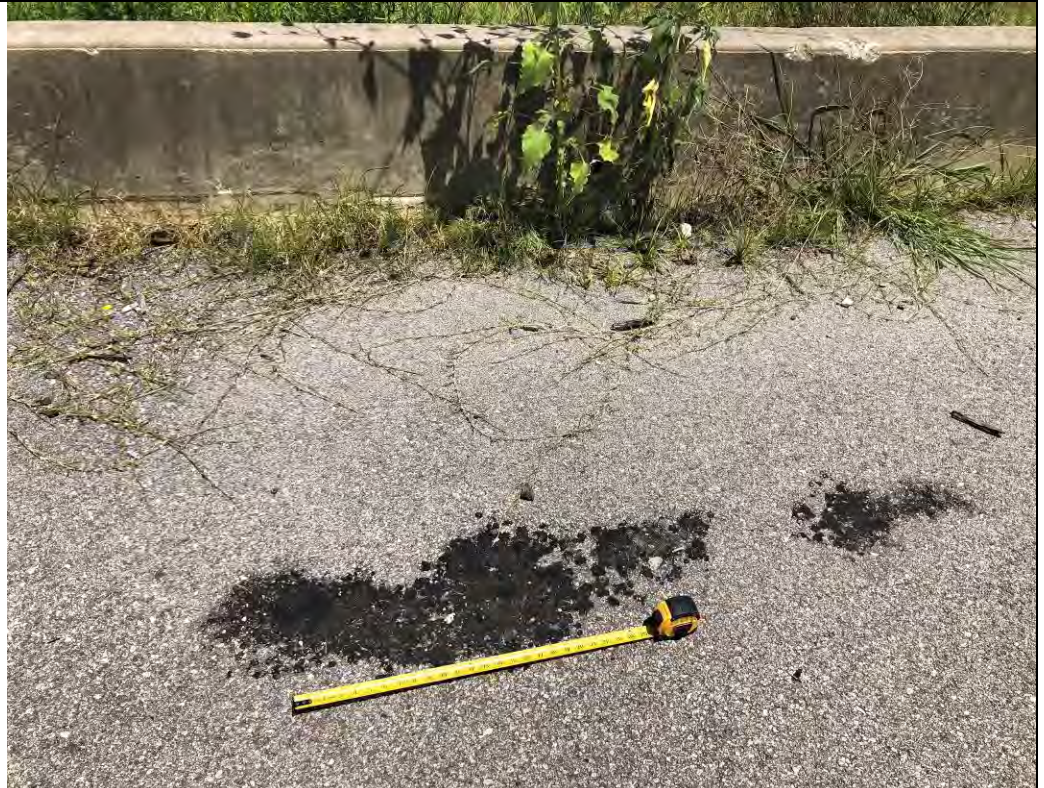
Photo No.
22

View of asphalt cap area. Note small oily stains on pavement, appear similar to the April 2018 inspection. Tape measure for scale

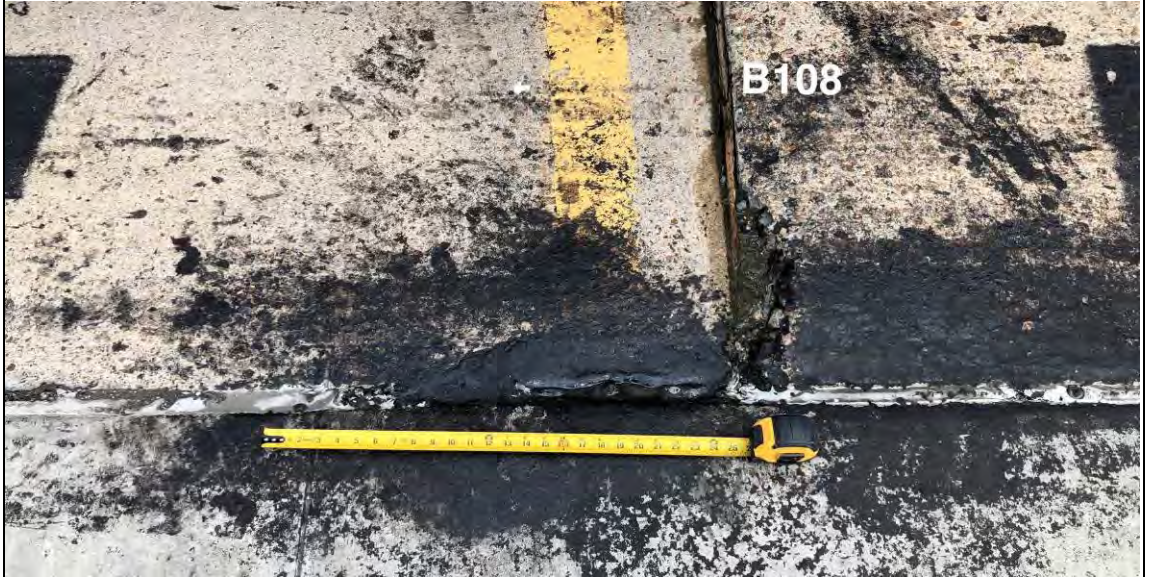
Concrete Cap Area:
Active tar-like seeps in
the joint at B108

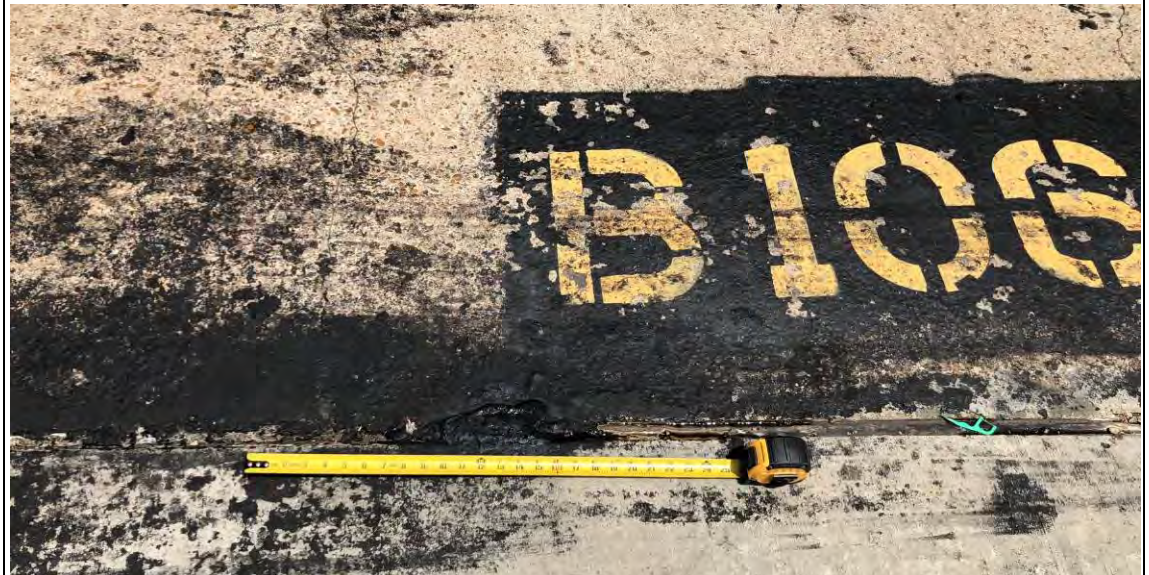
Photo No.
26

Concrete Cap Area:
Active tar-like seeps in
the joint at B106

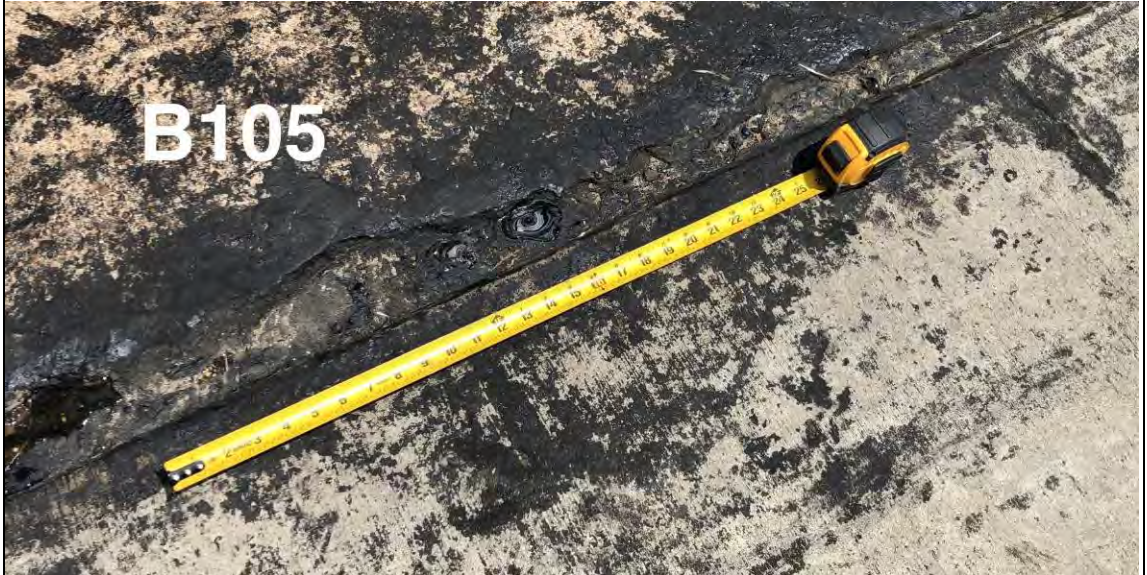
Concrete Cap Area:
Active tar-like seeps in
the joint at B105

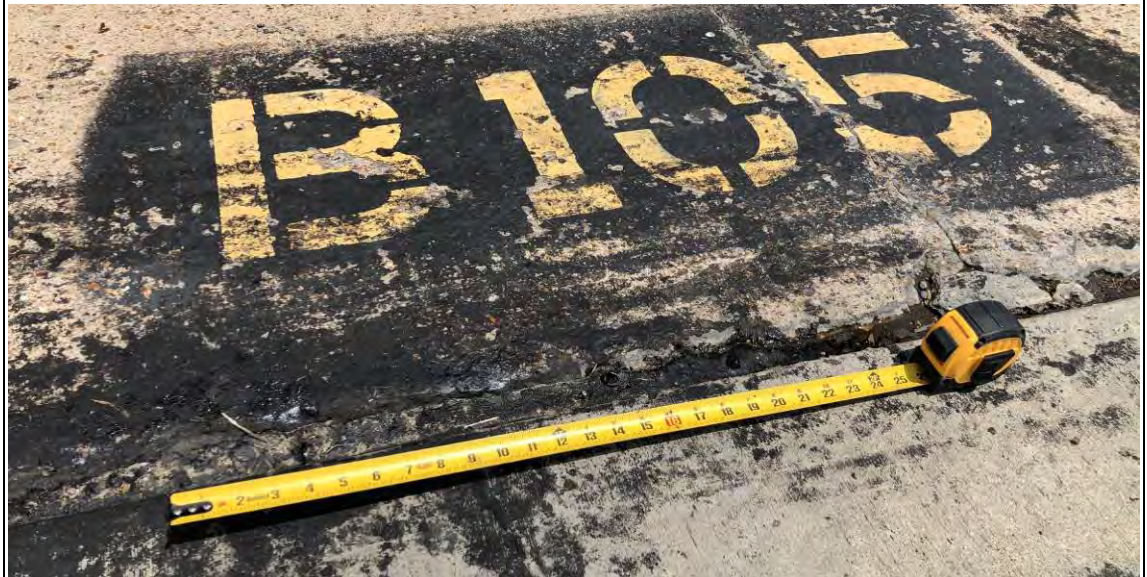
Concrete Cap Area:
Active tar-like seeps in
the joint at B105

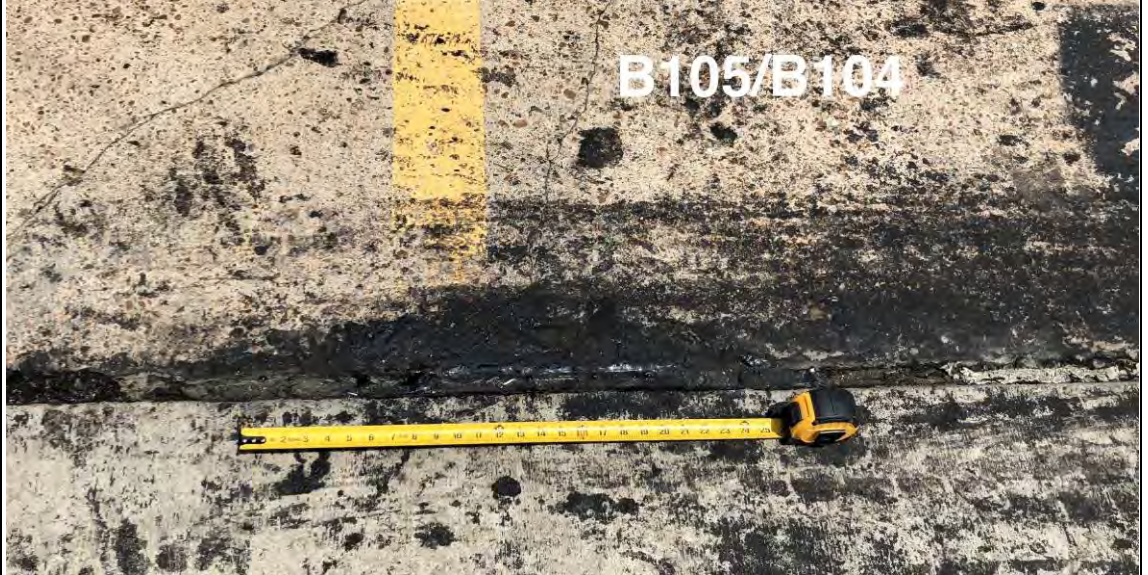
Concrete Cap Area:
Active tar-like seeps in
the joint at B105 and
B104

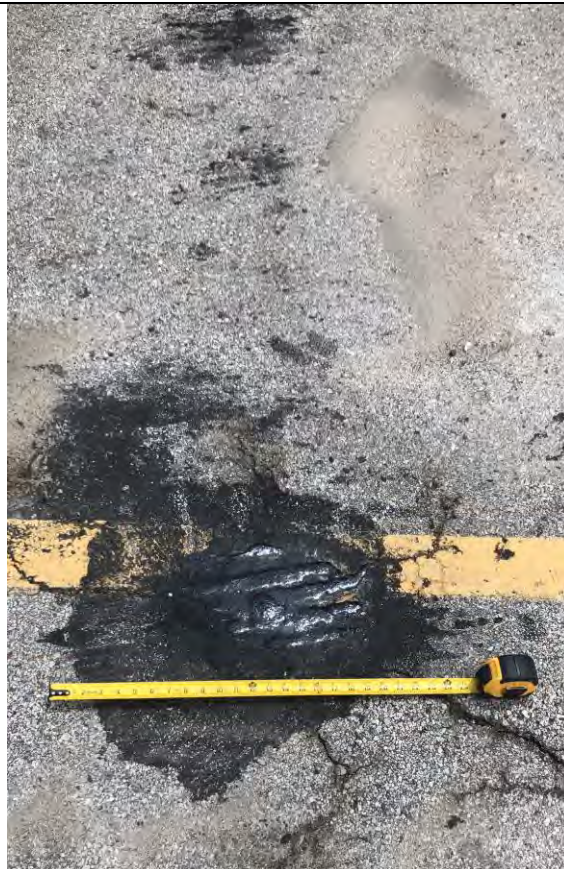
Photo No.
30

Concrete Cap Area:
Fresh tar-like product in
a crack in parking spot
B101

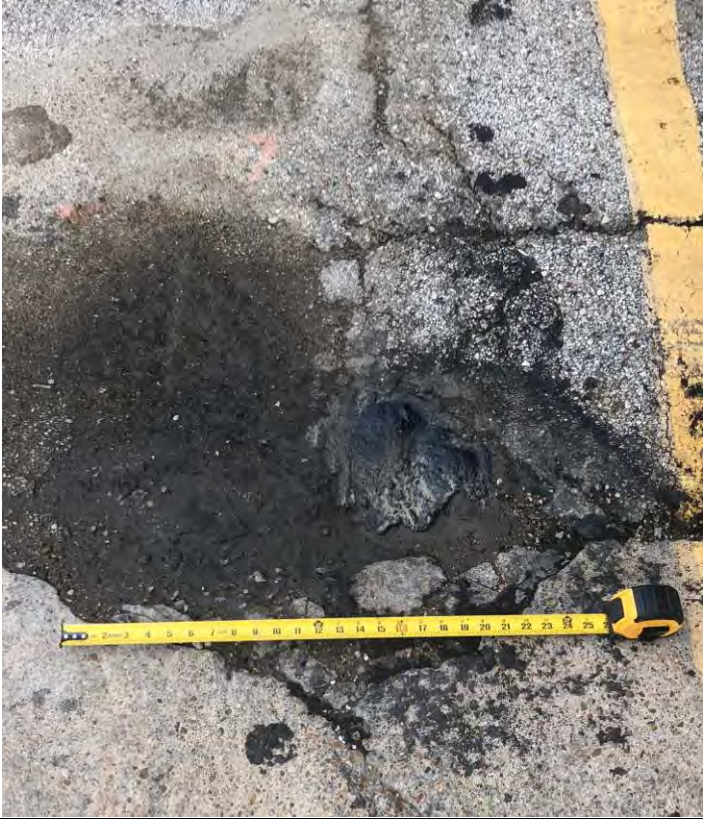
Description: Concrete Cap Area: Fresh tar-like product in the joint at B100. Tape measure for scale Lat: 29.78434 Long: -95.3208			
Photo No. 32	Date: 07/05/18

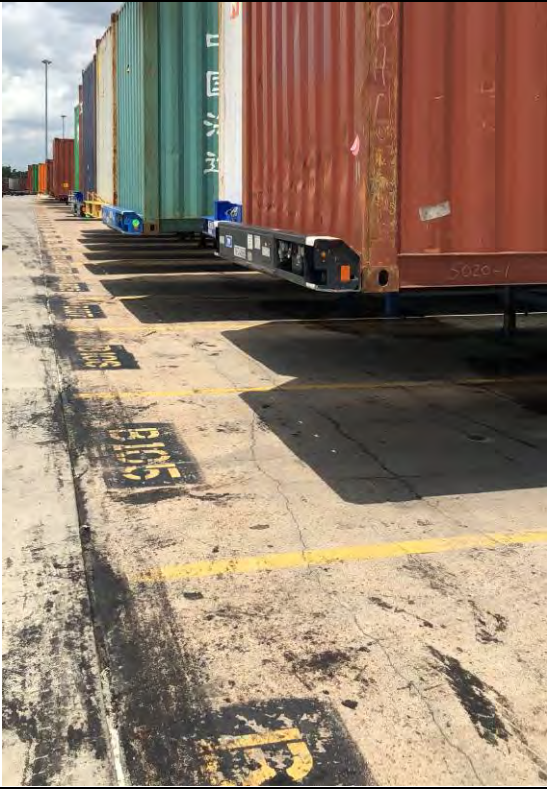
Description: Concrete Cap Area: Fresh tar like product residue in B Row Lat: 29.78384 Long: -95.3213

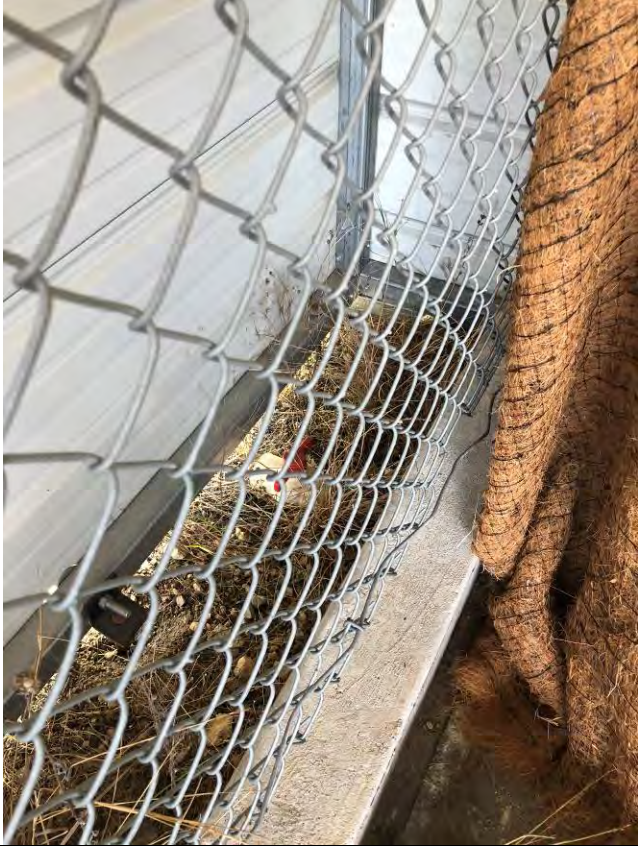
Description: Container Storage Area: Valve in closed position and functioning within the container storage area Lat: 29.78861944 Long: -95.32327222			
Photo No. 34	Date: 07/05/18
