March 29, 2019

Project No. 30401358

**RE: POST-RESPONSE ACTION COMPLETION REPORT – 2018
UNION PACIFIC RAILROAD HOUSTON WOOD PRESERVING WORKS, HOUSTON, TEXAS
4910 LIBERTY ROAD, HOUSTON, HARRIS COUNTY, TEXAS
TCEQ SWR NO. 31547; TCEQ PERMIT/COMPLIANCE PLAN NO. 50343EPA ID NO. TXD000820266
CUSTOMER NO. CN600131098; REGULATED ENTITY NO. RN100674613**

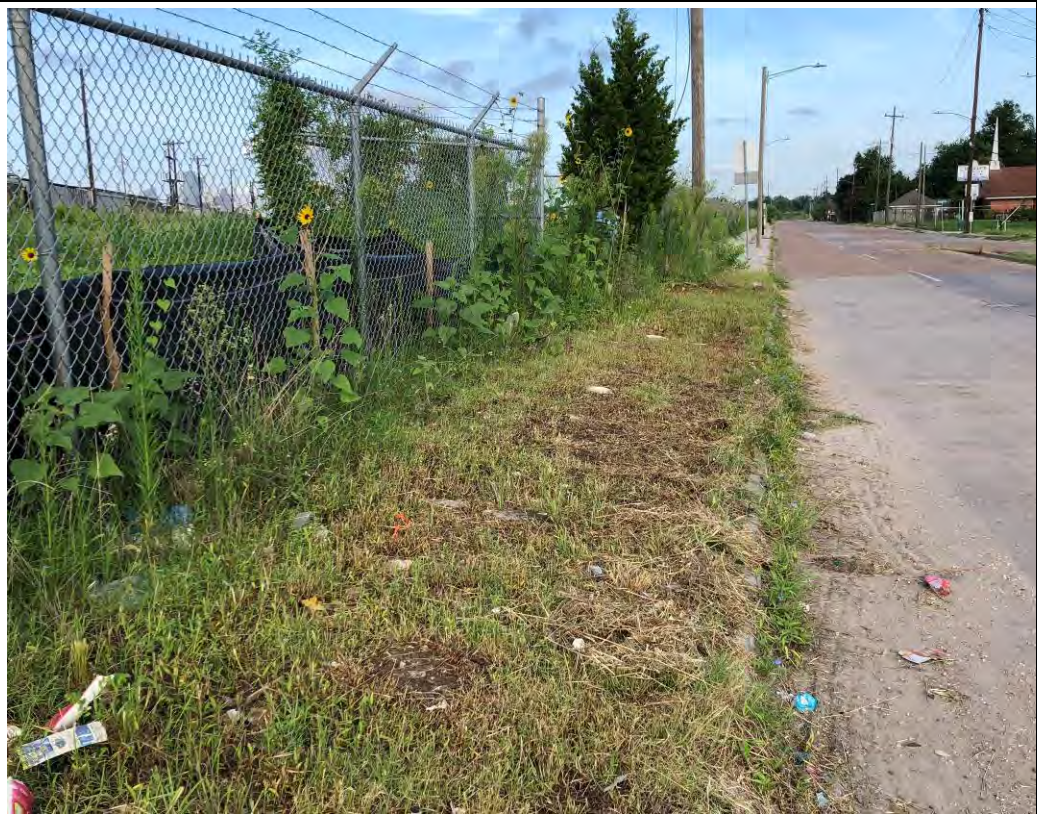
Perimeter Fence/ Concrete Sidewalk Cap Area:
View of the sidewalk cap area, looking west along Liberty Road. Note the trash that is accumulating along the sidewalk.

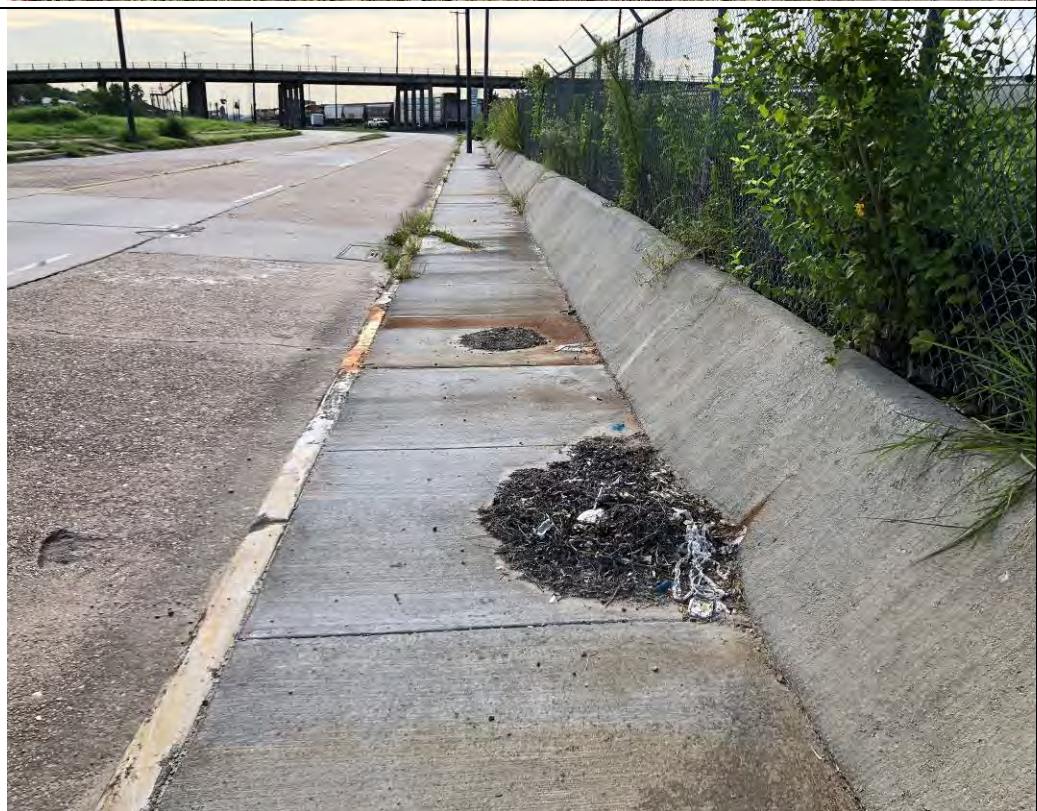
Photo No. 38	Date: 07/12/18
-------------------------------	--------------------------

Perimeter Fence/ Concrete Sidewalk Cap Area:
View of the sidewalk cap area, looking southeast along Liberty Road, small areas where debris has built up along sidewalk.

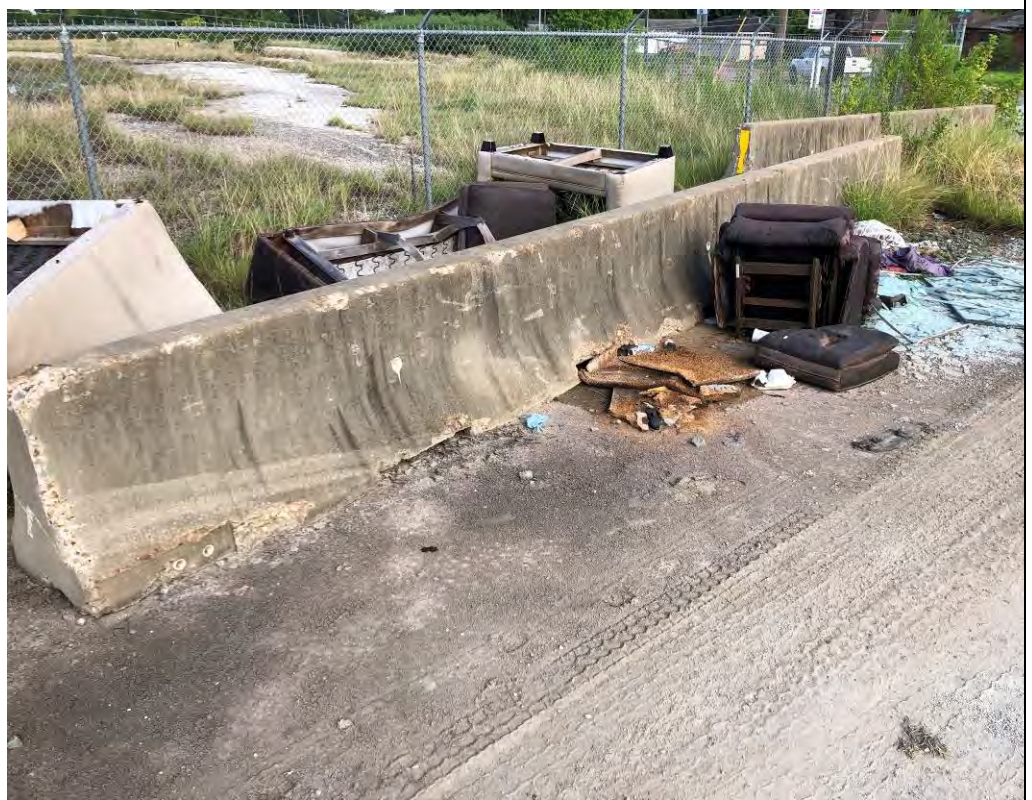
Perimeter Fence/ Concrete Sidewalk Cap Area:
Furniture, trash, and broken glass dumped at entrance of the soil cap.

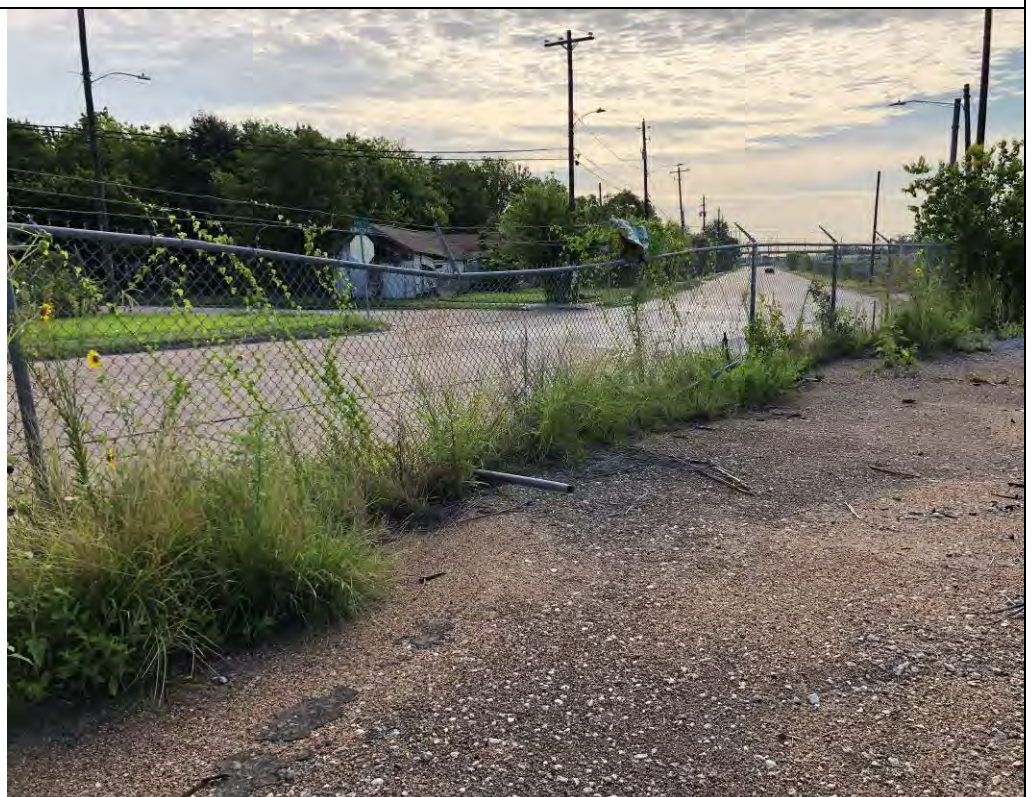
Photo No.
42

Perimeter Fence/ Concrete Sidewalk Cap Area:
Perimeter fence with sagging mesh and two missing posts. Looking northeast.

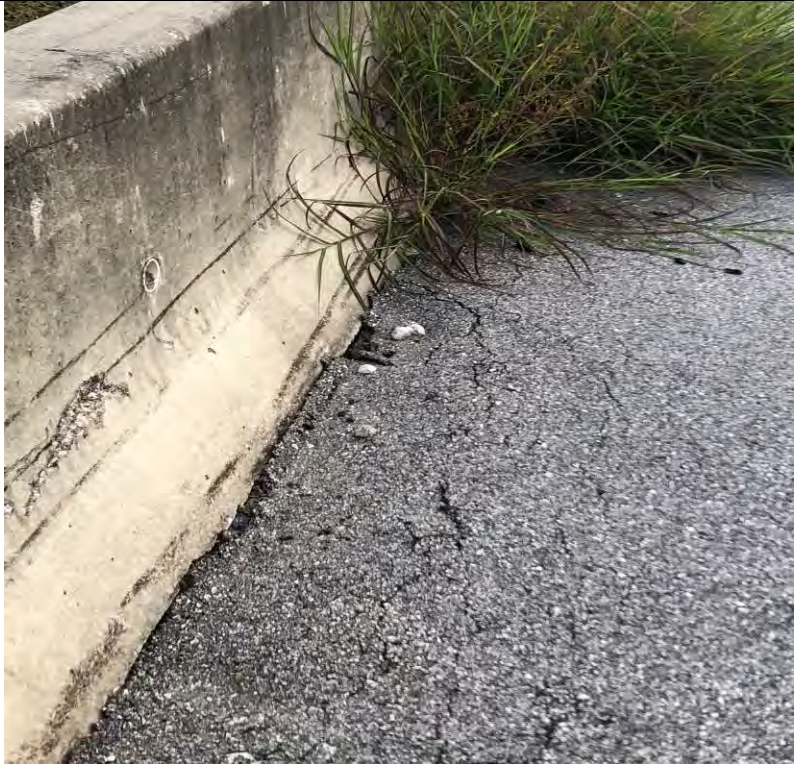
Cracks in the asphalt roadway along concrete barrier (only location of significant cracking). Facing east.

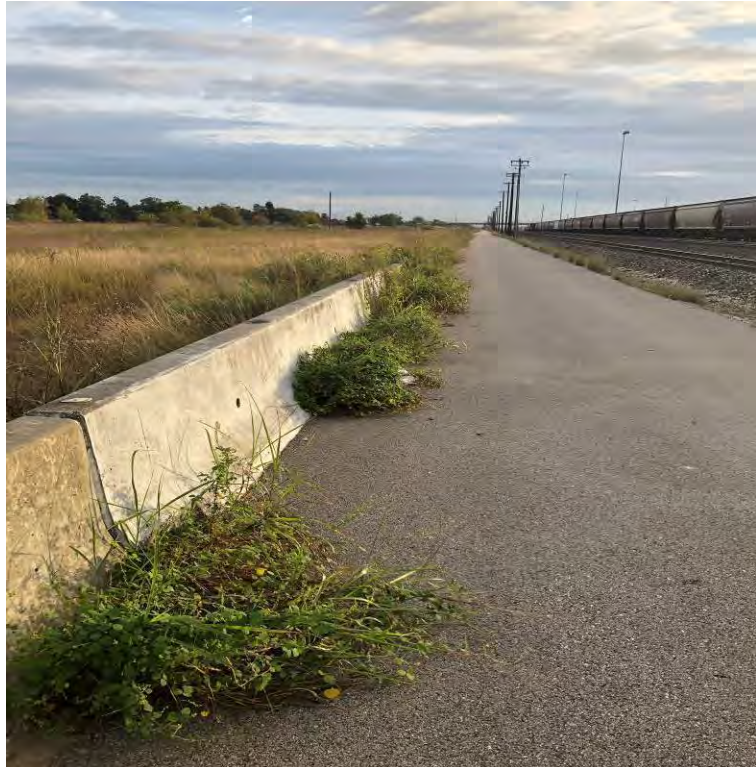
Photo No.
2

Weeds growing under the concrete barriers and along the edge of the ballast cap. Soil Cap's vegetative cover in good shape, facing east. Facing east.

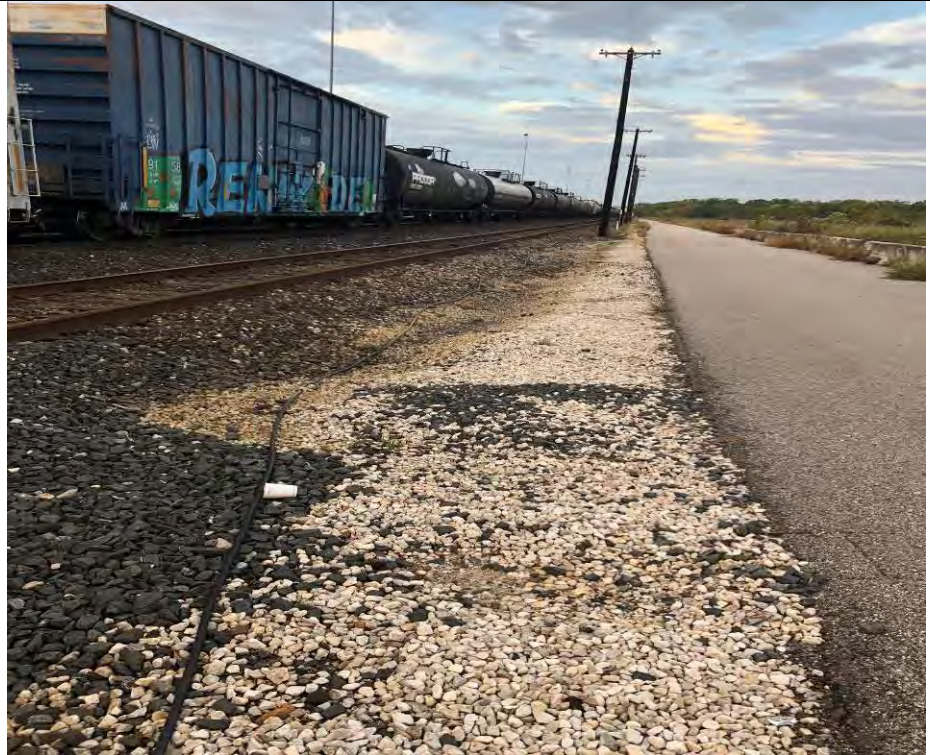
Ballast cap area in good condition. Vegetation growing under the concrete barricades. Asphalt roadway in good condition. Facing west.

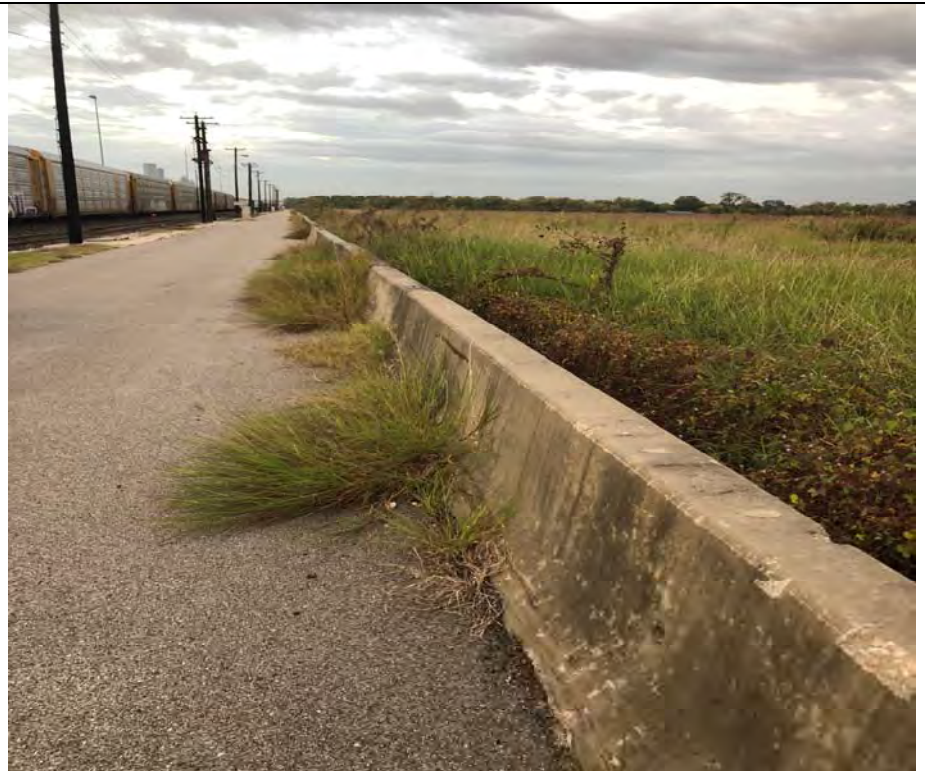
Photo No.
4

Weeds growing under the concrete barriers and in the ballast cap. Soil Cap's vegetative cover in good shape, facing west. Facing west.

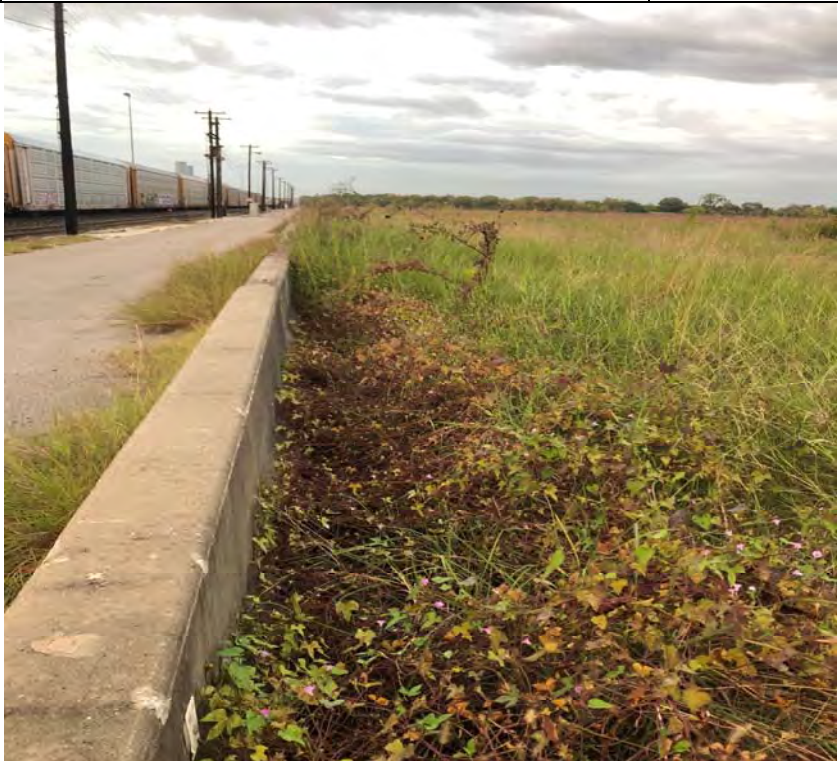
Photo No. 5	Date: 10/31/18
Description: <u>Ballast Cap, Asphalt Road, and Soil Cap Vegetative Cover:</u> Weeds growing under the concrete barriers and in the ballast cap. Soil Cap's vegetative cover in good shape. Facing west. Lat:29.47129700 Long: -95.19490999

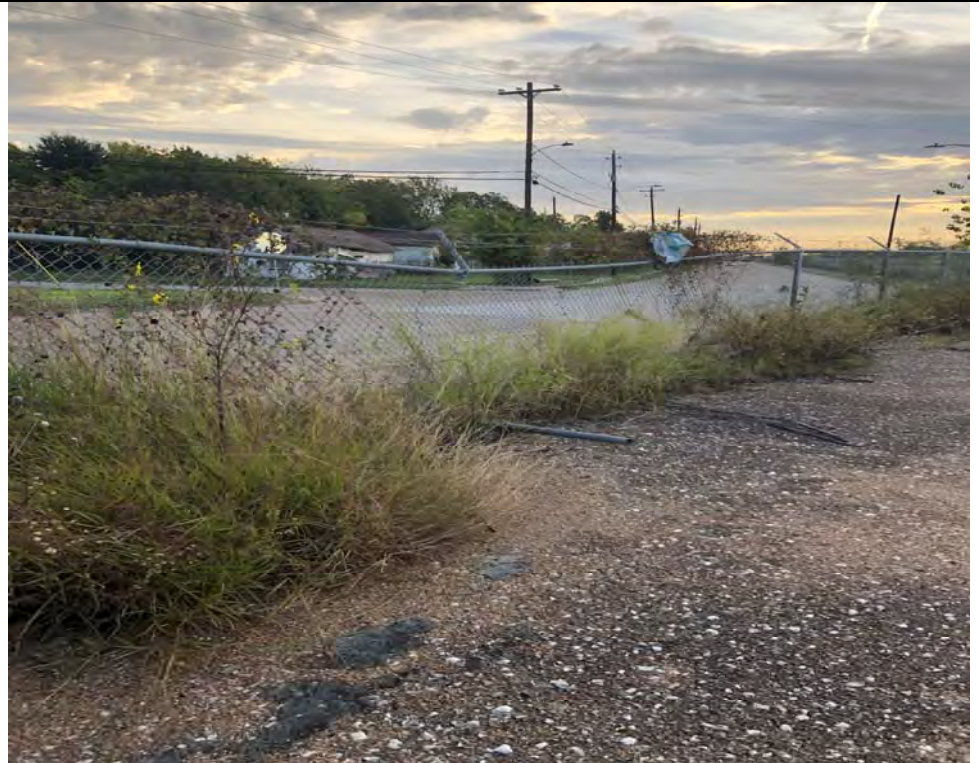
Photo No.
8

1 of 2 knocked over post and damaged chain link. 150' west of main entrance. Facing northeast.

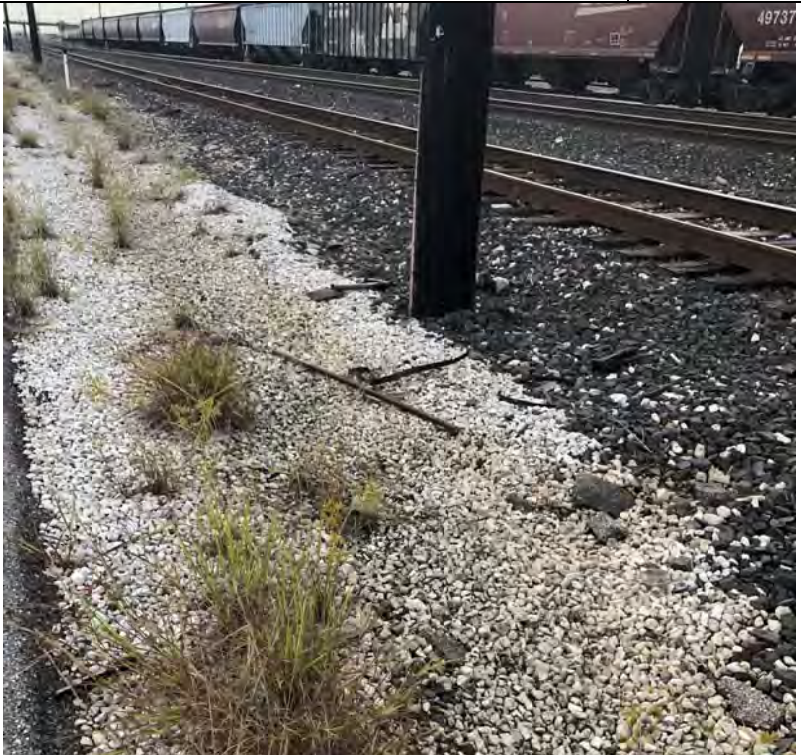
Photo No. 9	Date: 10/31/18
Description: Ballast Cap: Ballast cap area, with some vegetation growing within the gravel. Facing east. Lat: 29.4791600 Long -95.1913099

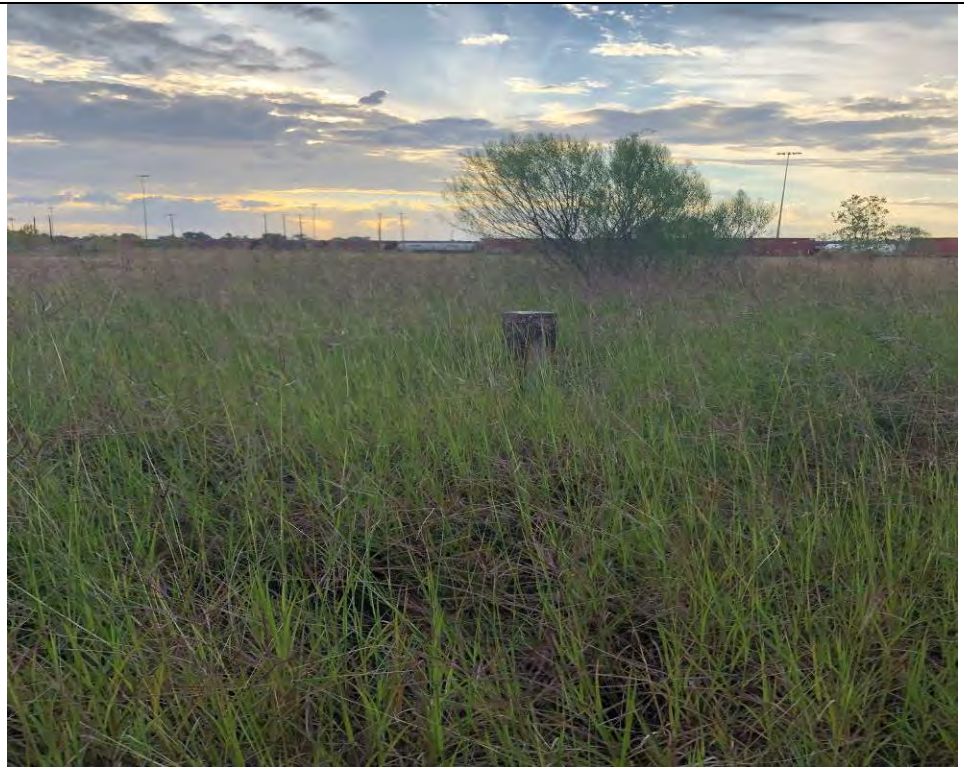
Photo No. 10	Date: 10/31/18
Description: Monitoring Well: Vegetation growth around monitoring well. Facing northeast (mowing in progress during inspection). Lat: 29.47972999999999601 Long: -95.19257000000000115

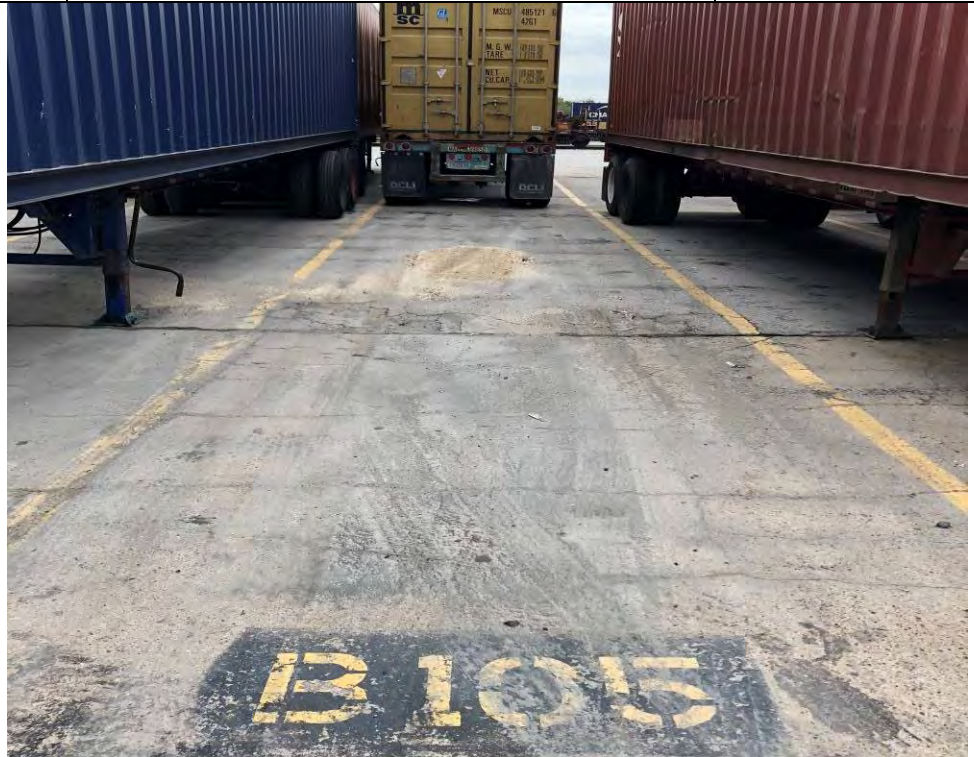
**Concrete Cap Area
(Englewood Yard):**
B105 Stall & Test Pit. No
evidence of recent NAPL
seepage. Facing north.

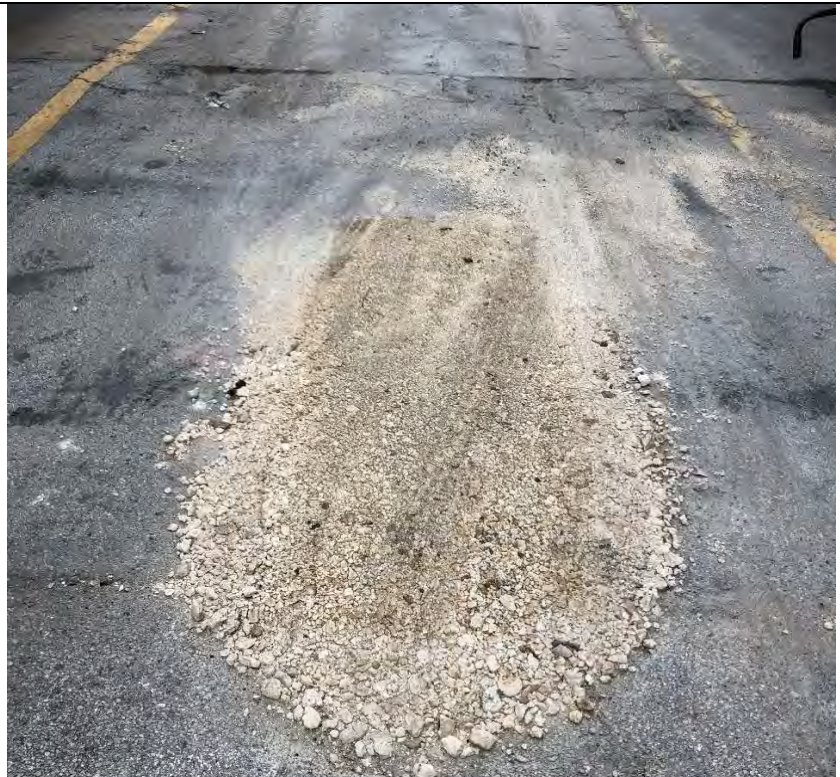
Photo No.
14

**Concrete Cap Area
(Englewood Yard):**
B105 Stall & Test Pit. Evidence
of recent minor NAPL
seepage
through the road base. Facing
south.

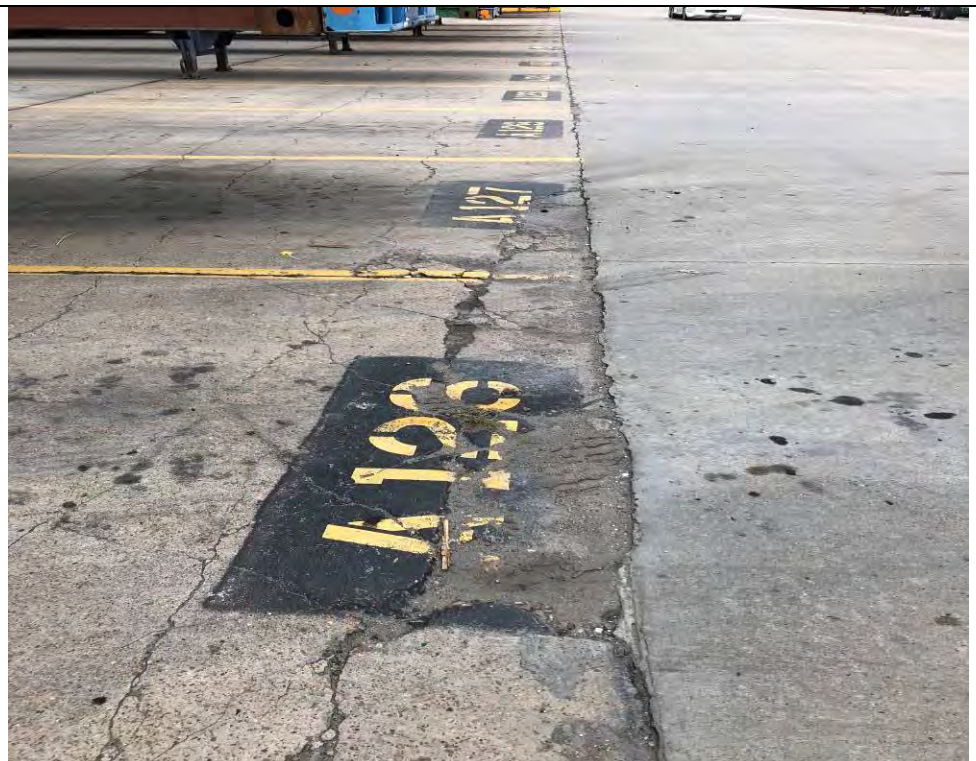
Photo No.
16

Heavy cracking in A Row strip. Facing west.

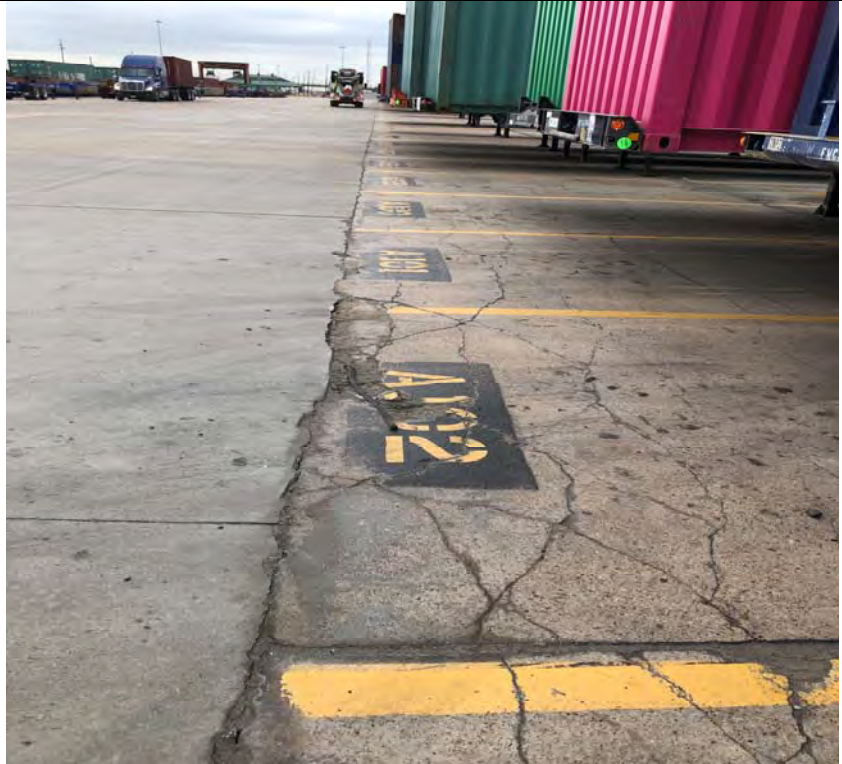
Heavy cracking in A Row strip.
Facing east.

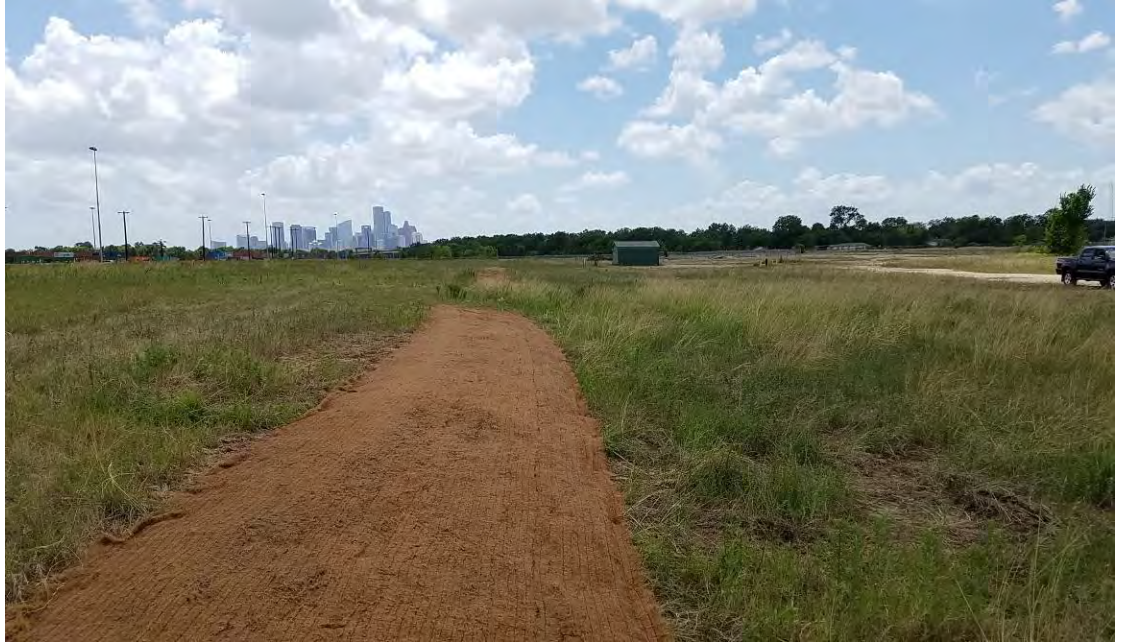
Repairs to the soil cap facing southwest, after placement of topsoil and erosion mats.

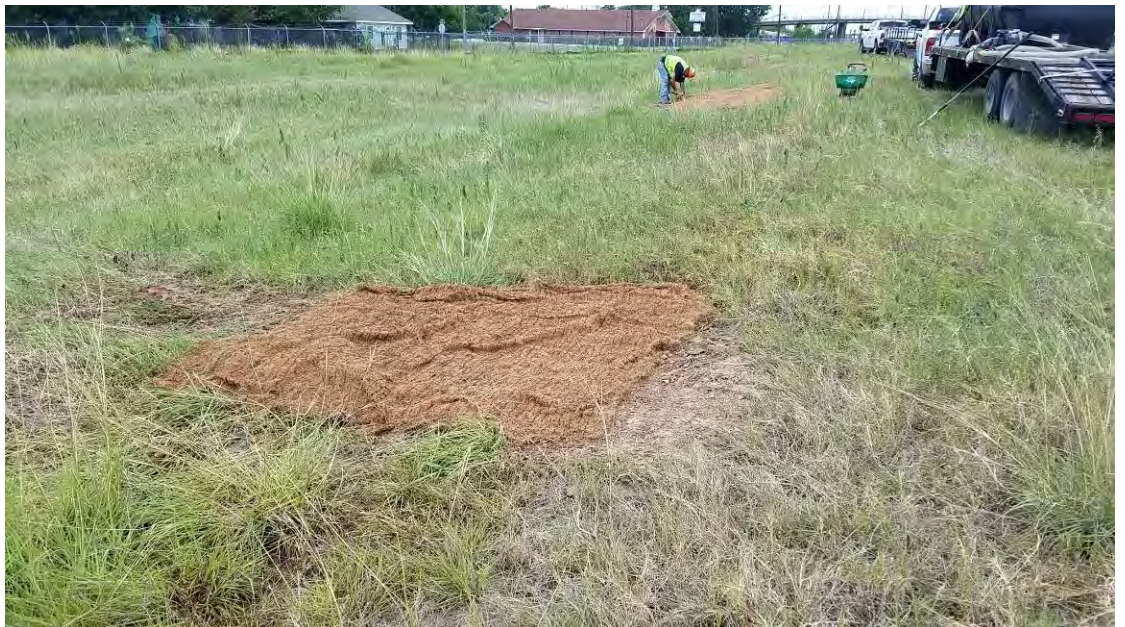
Photo No.
2

Soil cap, facing northeast, view of repaired area, topsoil and erosion mat.

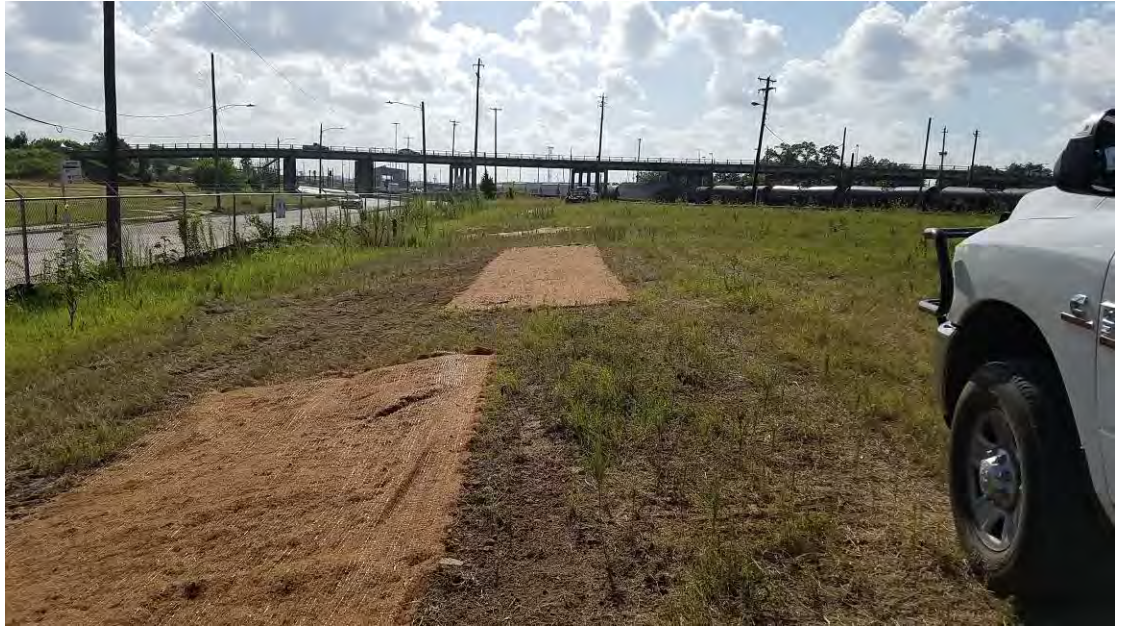
Soil cap, facing east, view of repaired area, topsoil and erosion mat, Liberty Rd to the left, soil cap area to the right.

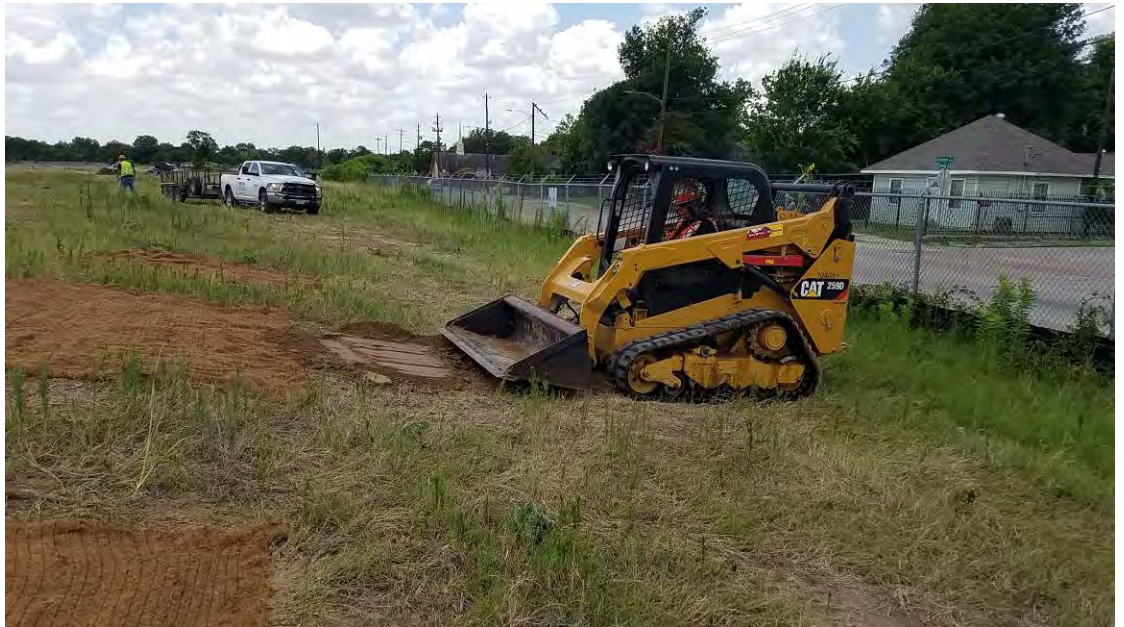
Photo No.
4

Repairs to soil cap, facing west, view of area being repaired, placing topsoil and erosion mat, Liberty Rd to the right.

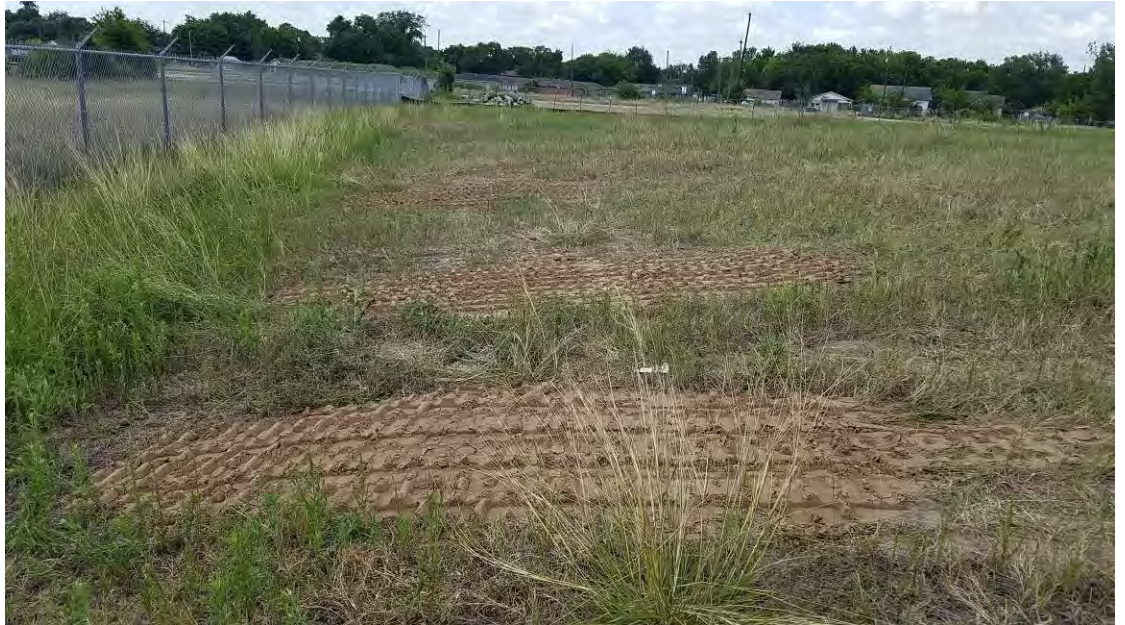
Photo No.
5

Repairs to the west side of the soil cap facing north, after placement of topsoil.

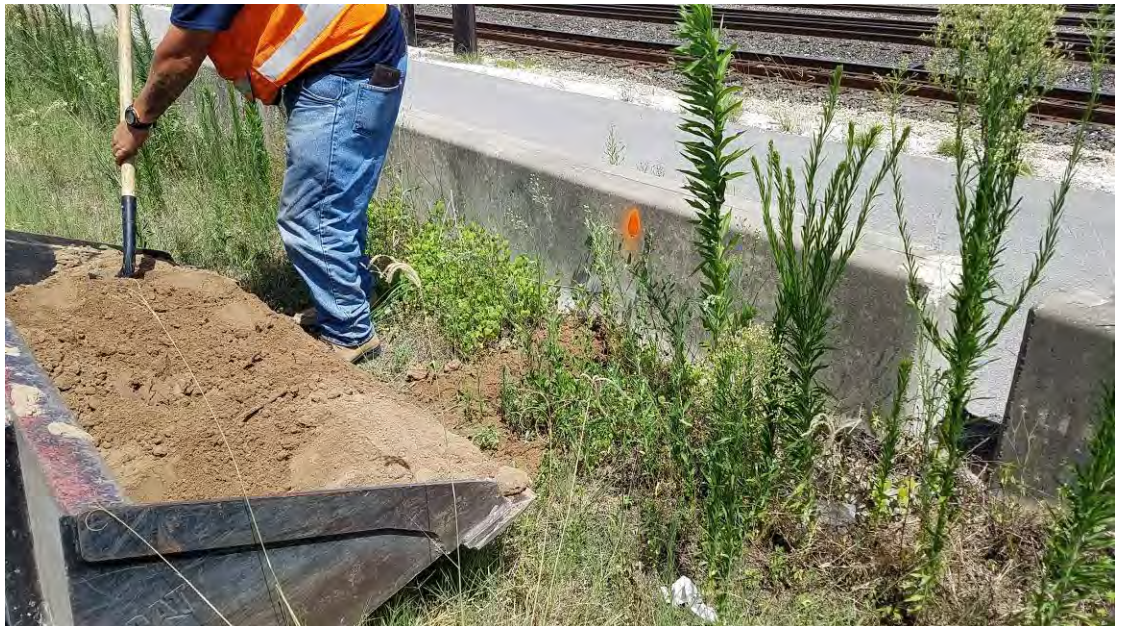
Photo No.
6

Placement of topsoil in areas of settlement along the concrete barriers, facing east-southeast.
