March 31, 2020

Project No. 19119232

**RE: POST-RESPONSE ACTION COMPLETION REPORT – 2019  
UNION PACIFIC RAILROAD HOUSTON WOOD PRESERVING WORKS, HOUSTON, TEXAS  
4910 LIBERTY ROAD, HOUSTON, HARRIS COUNTY, TEXAS  
TCEQ SWR NO. 31547; TCEQ PERMIT/COMPLIANCE PLAN NO. 50343EPA ID NO. TXD000820266  
CUSTOMER NO. CN600131098; REGULATED ENTITY NO. RN100674613**

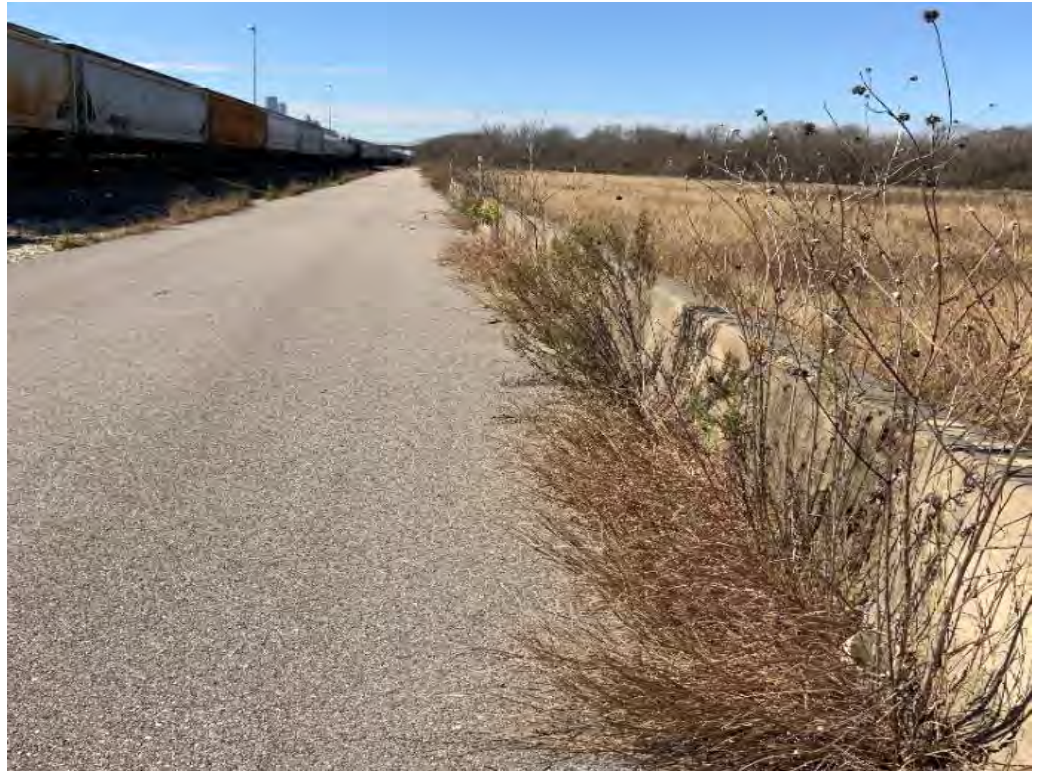
Heavy vegetative growth along concrete barrier and asphalt road. Facing West.

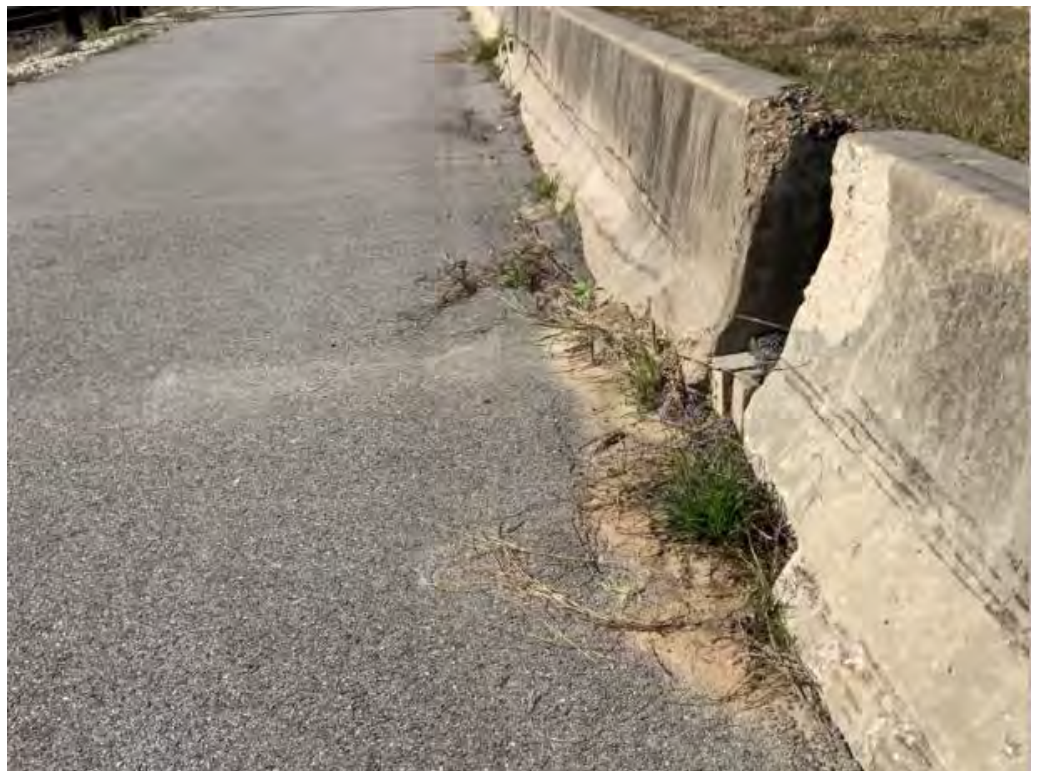
**Photo No.**  
**6**

Minor ant hills and some eroded soil along concrete barrier. Facing southwest.

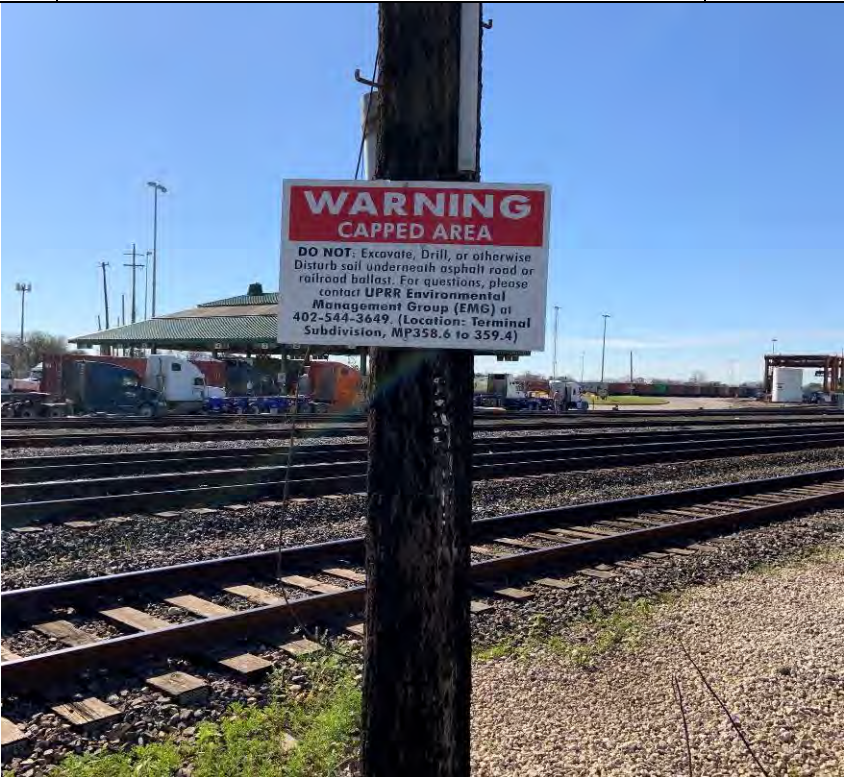
**Asphalt Road and Ballast Cap:**  
View of warning sign within ballast cap area. Facing south.

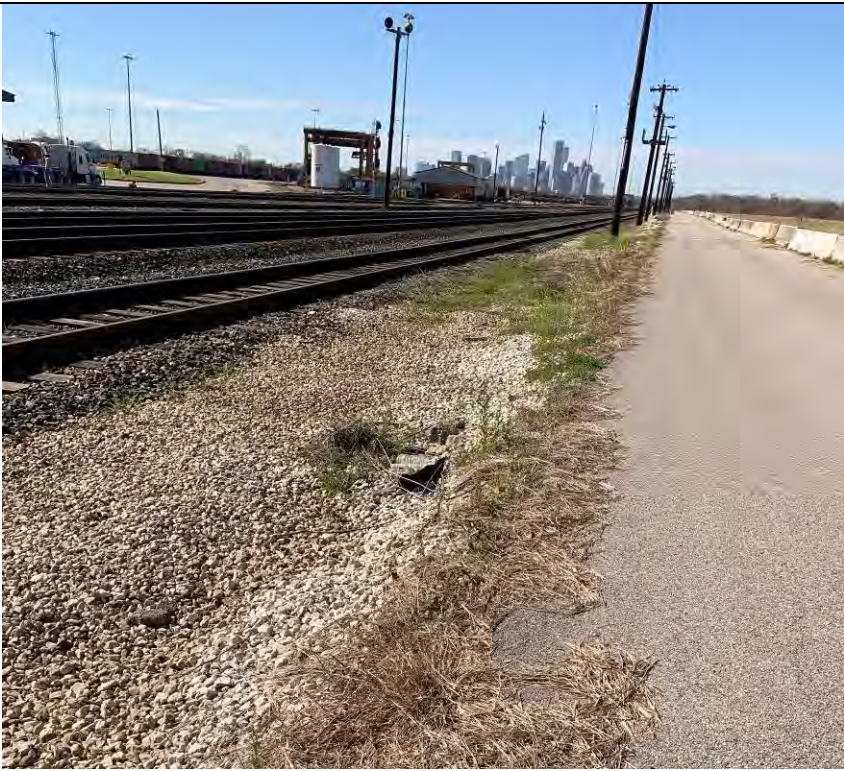
<b>Photo No.</b> <b>10</b>	<b>Date:</b> 1/11/19
-------------------------------	-------------------------

**Asphalt Road and Ballast Cap:**  
Vegetation growth in ballast cap area. Facing west.

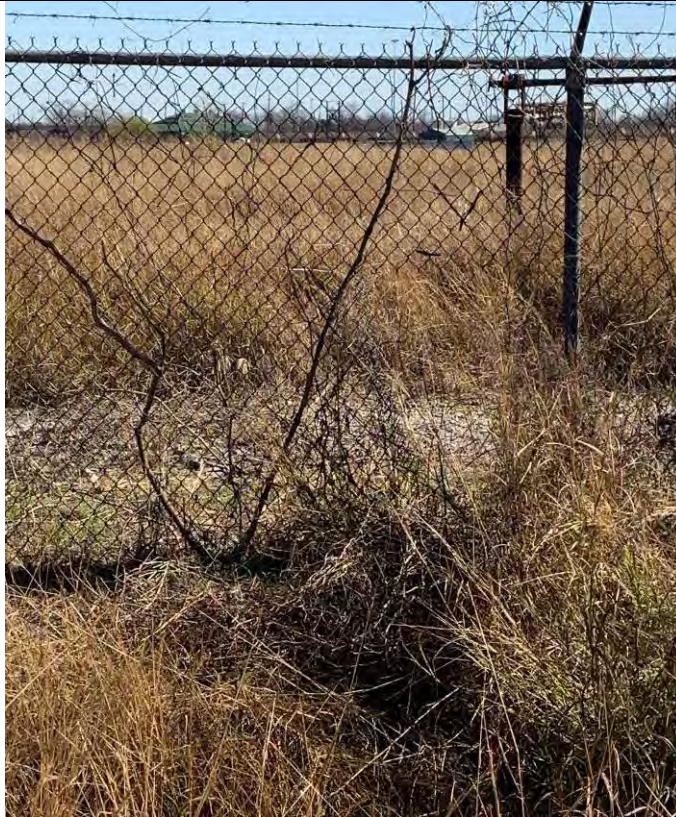
Fence mesh breached along Kashmere St.  
Facing east.

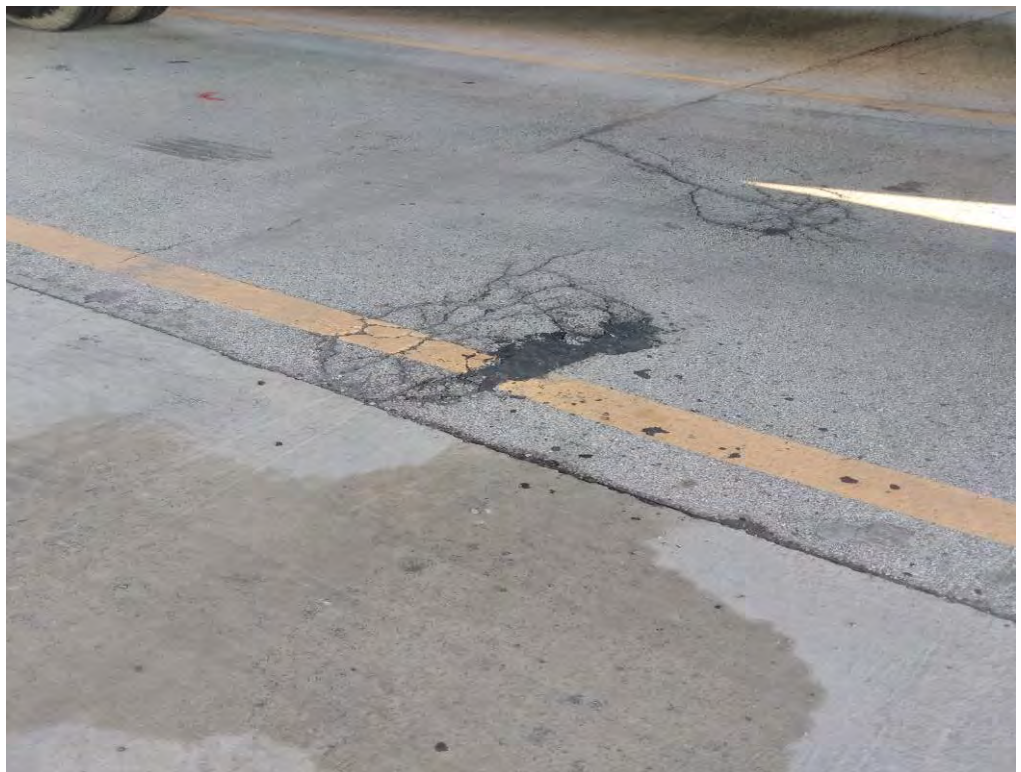
**Concrete Cap Area**  
**(Englewood Yard):**  
Slot B057. Evidence of  
recent NAPL seepage.  
Facing east.

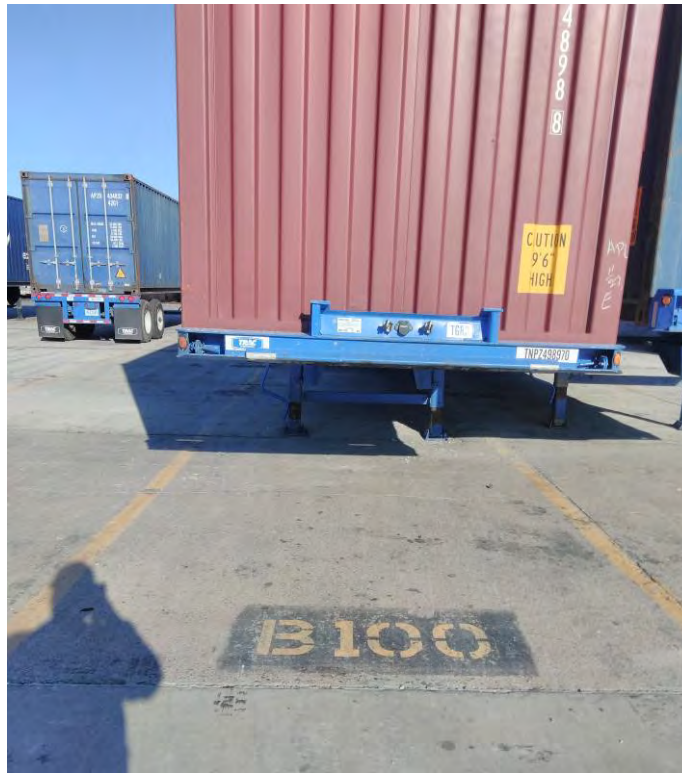
Slot B100. Some  
cracking along joint.  
Facing northeast.

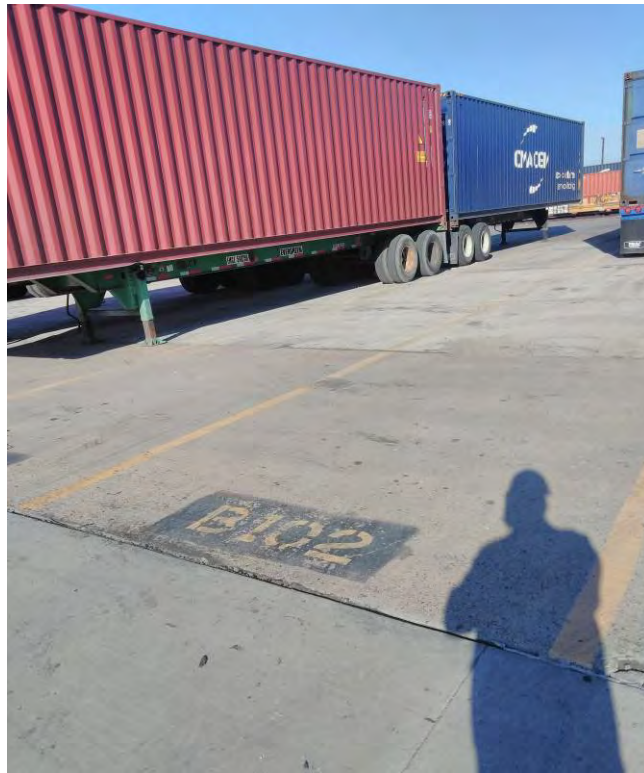
Slot B102. No observed  
seeps. Facing  
northwest.

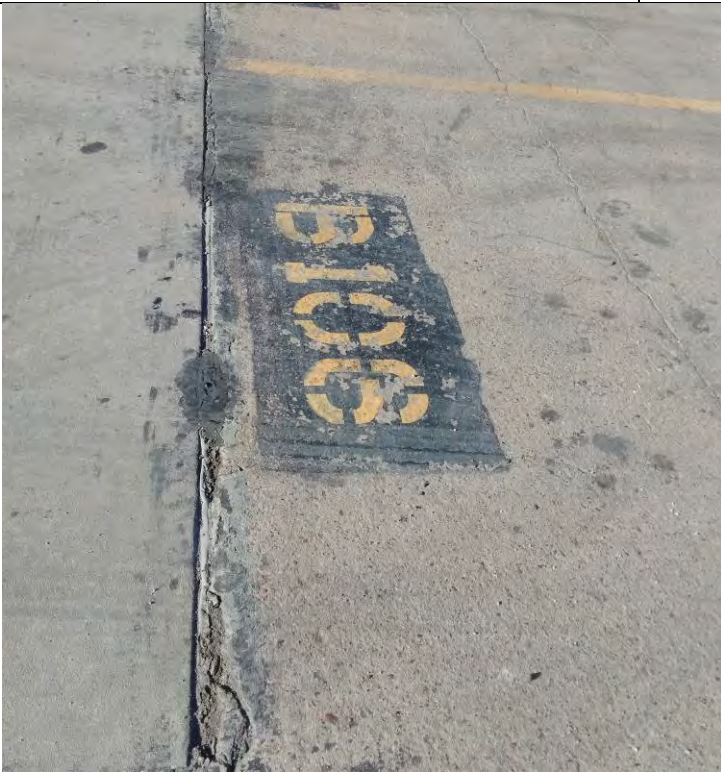
**Concrete Cap Area (Englewood Yard):**  
Slot B106. Evidence of recent NAPL seepage. Facing west.

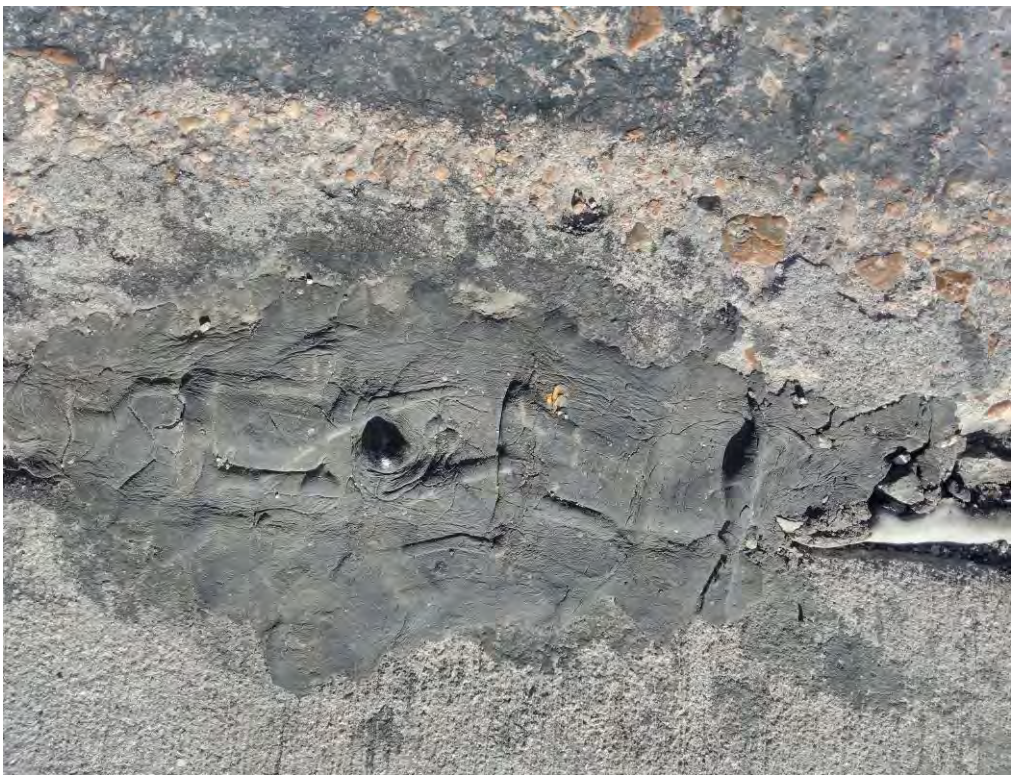
<b>Photo No.</b> <b>24</b>	<b>Date:</b> 1/11/19
-------------------------------	-------------------------

**Concrete Cap Area (Englewood Yard):**  
Slot B106 Evidence of recent NAPL seepage. Facing south.

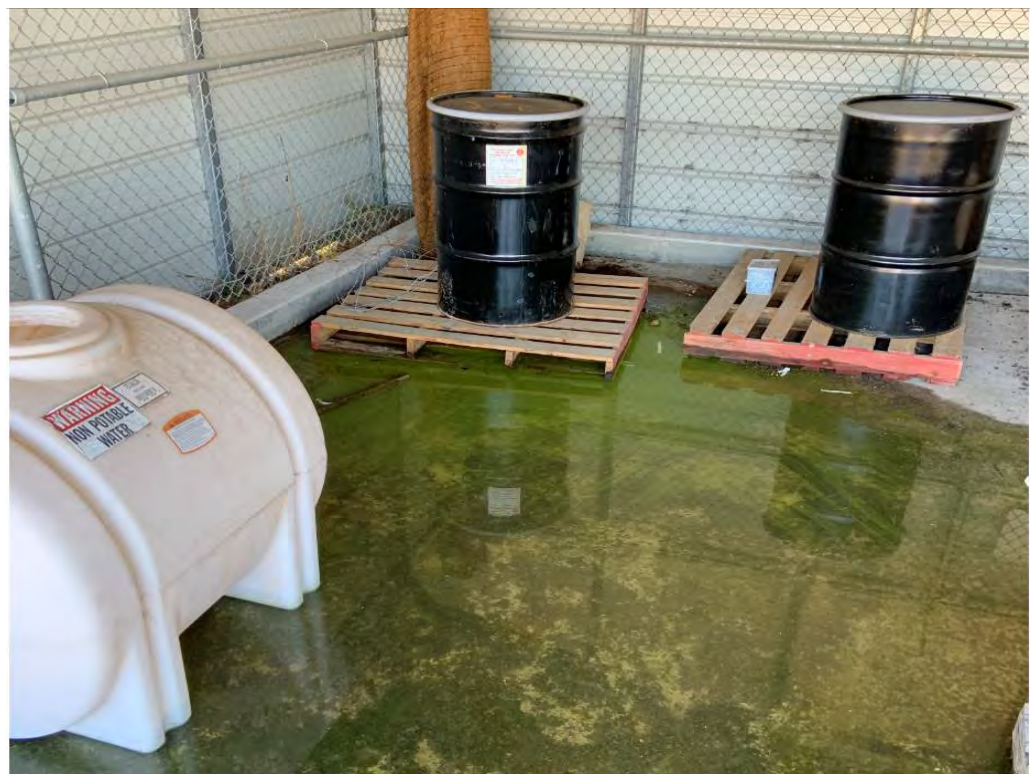
**Photo No.**  
**26**

**Container Storage Area:**  
Shallow ponding rainwater inside shed,  
with algae growing.  
Facing south.

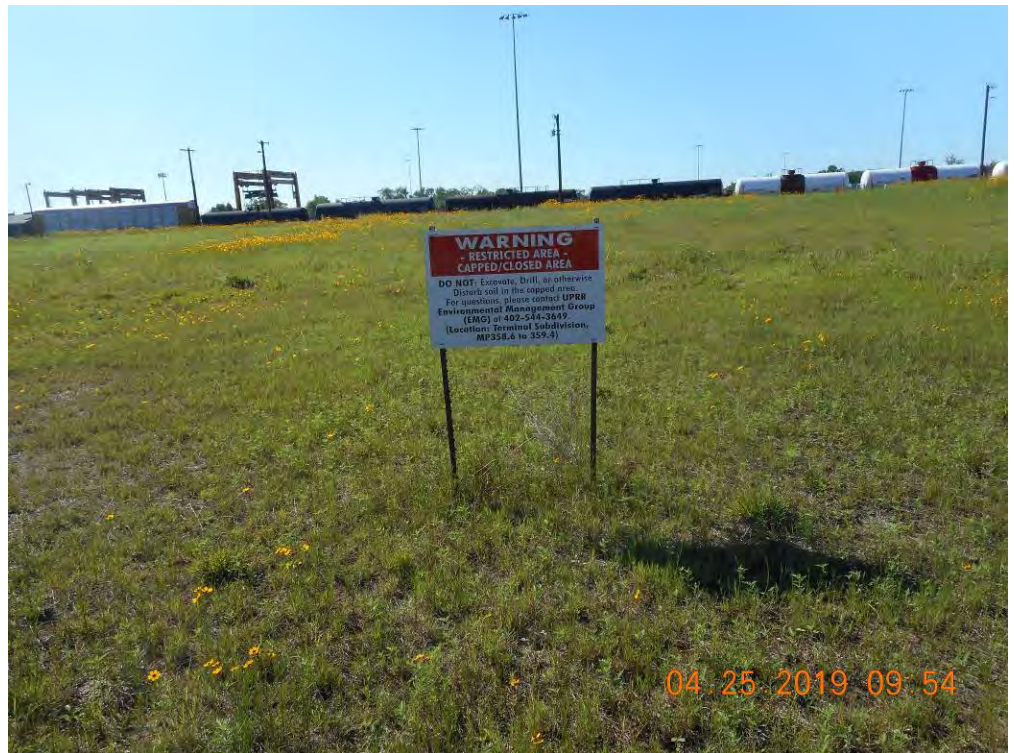
Signage on north side of soil cap. The majority of signage is comparably unobstructed by vegetation and can be easily read. Pollinator plants Facing south.

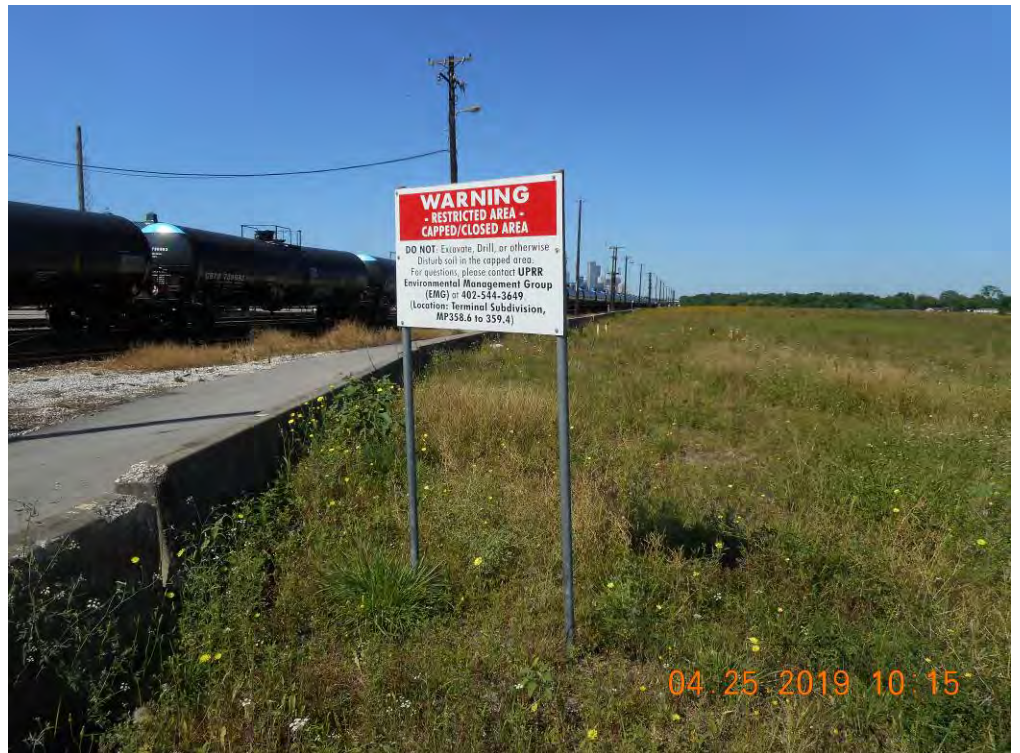
Signage on east side of soil cap.  
Pollinator plants present on soil  
cap area. Facing southwest.

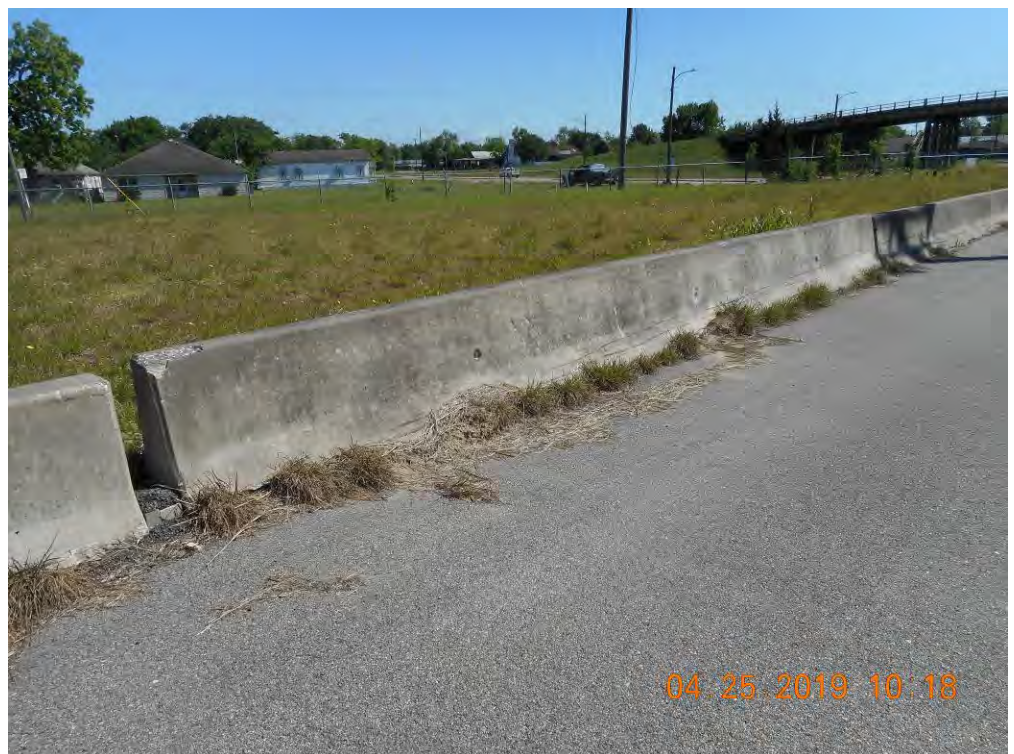
Weeds growing under the concrete barriers and along the edge of the ballast cap in some areas. Soil cap's vegetative cover in good shape. Facing north.

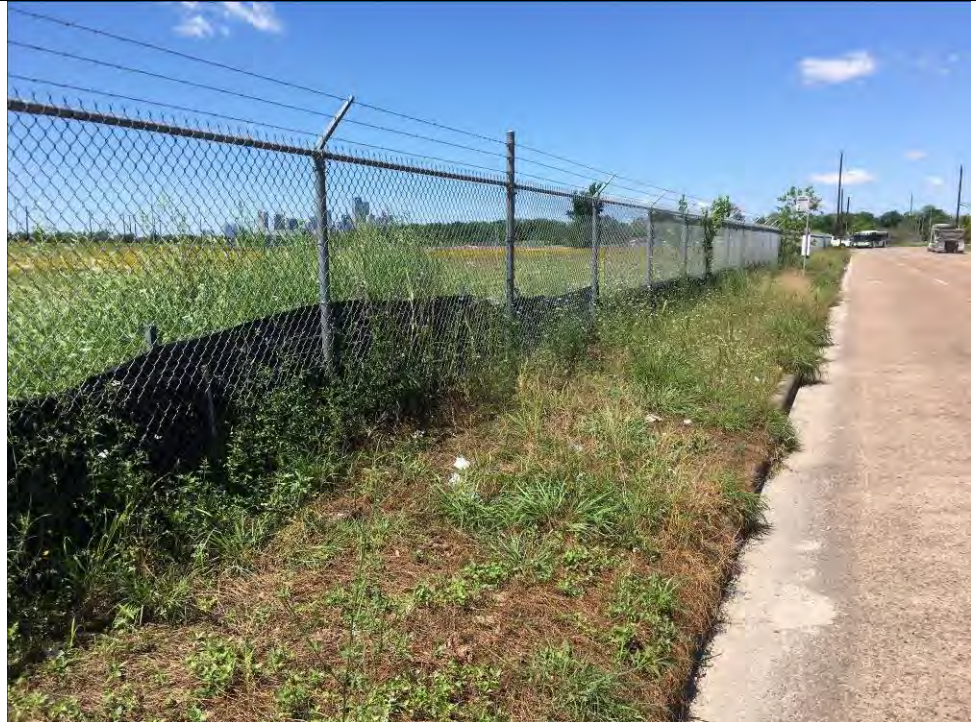
**Security Fence:**  
Security fence in good shape  
along north side of the Site.  
Facing west.

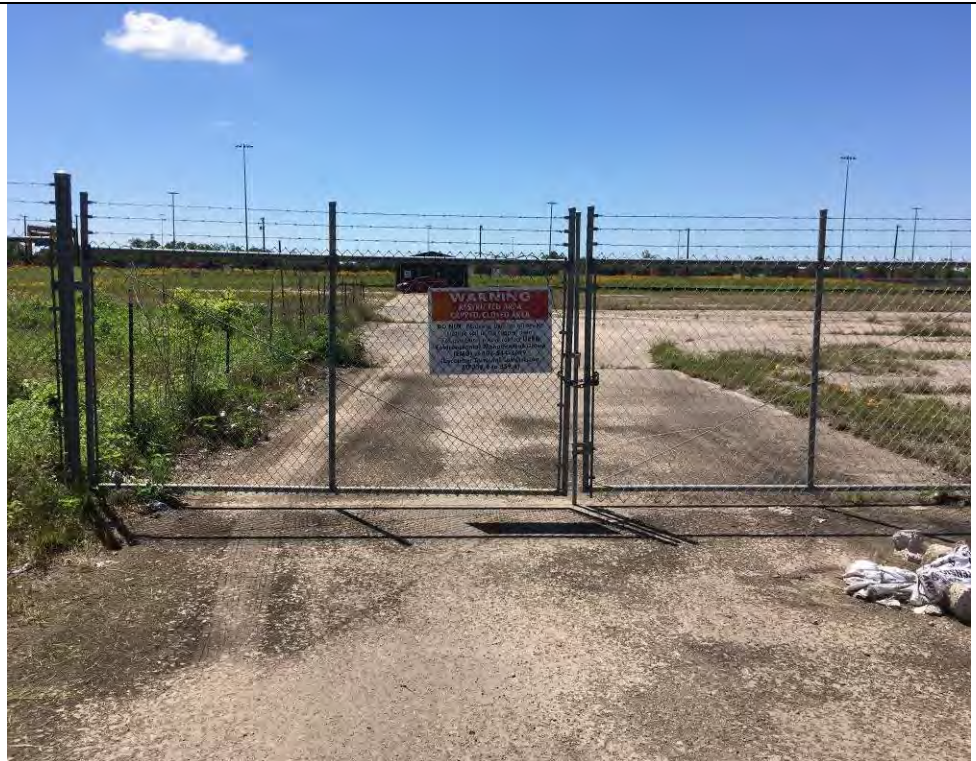
**Photo No.**  
**16**

**Security Fence (Entrance Gate):**  
Gate in good shape, some  
barbed wire atop security fence  
tacked down on west side of  
entrance area. Facing south.

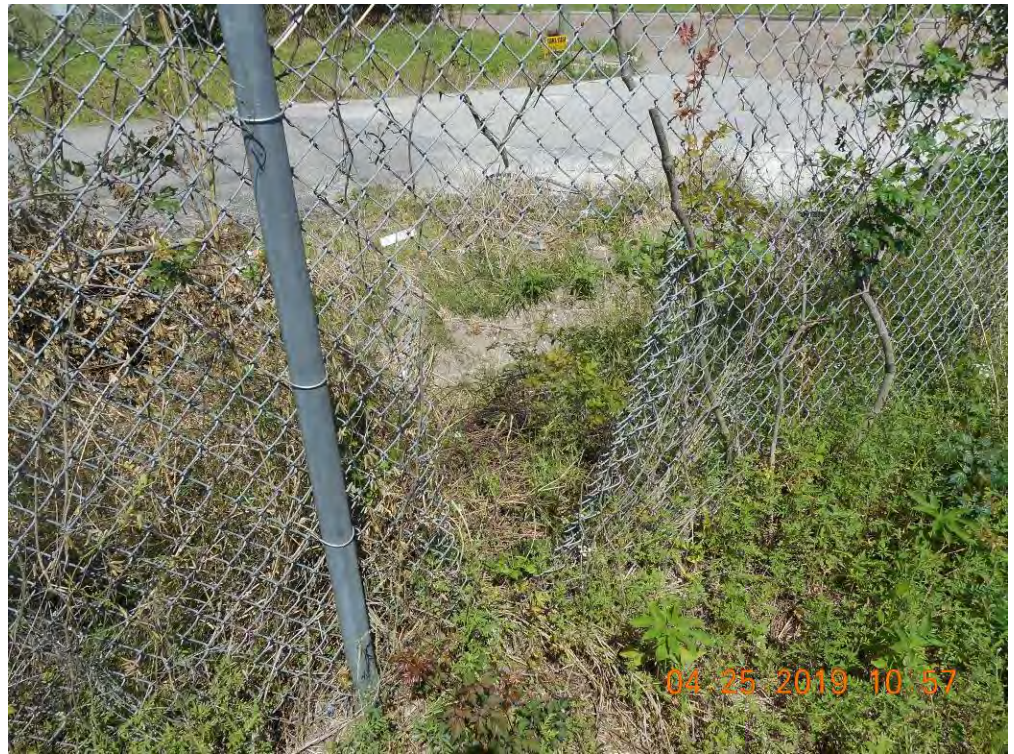
**Security Fence:**  
Hole in security fence in northwest corner of yard at intersection of Liberty Rd and Kashmere St. Facing west.

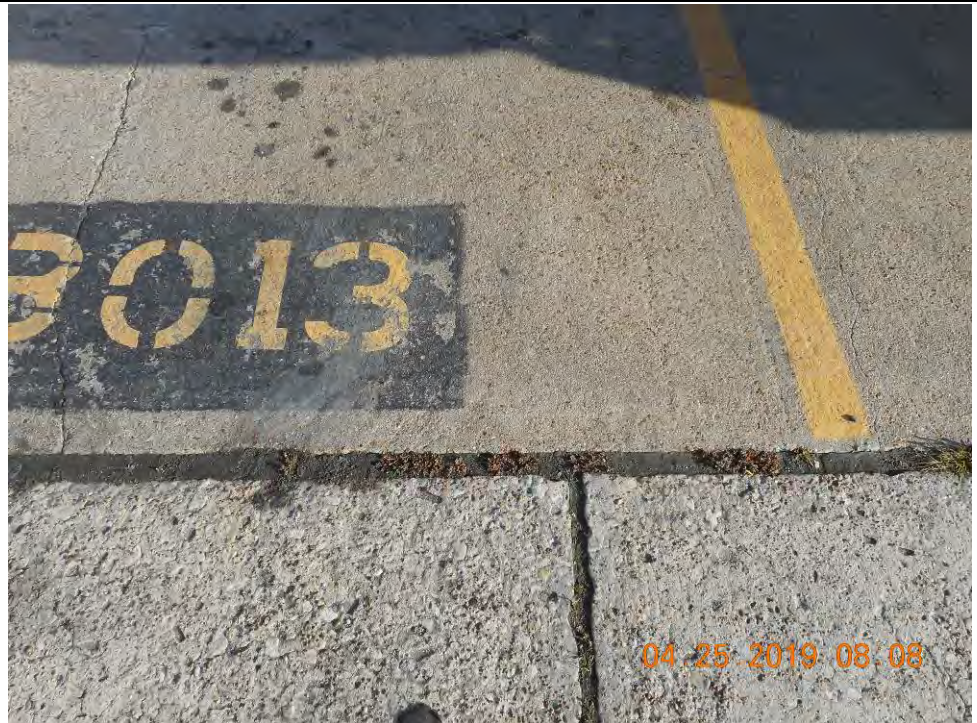
**Photo No.**  
**18**

**Concrete Cap Area**  
**(Englewood Yard):**  
No evidence of tar seeps in Slot B013. Facing north.

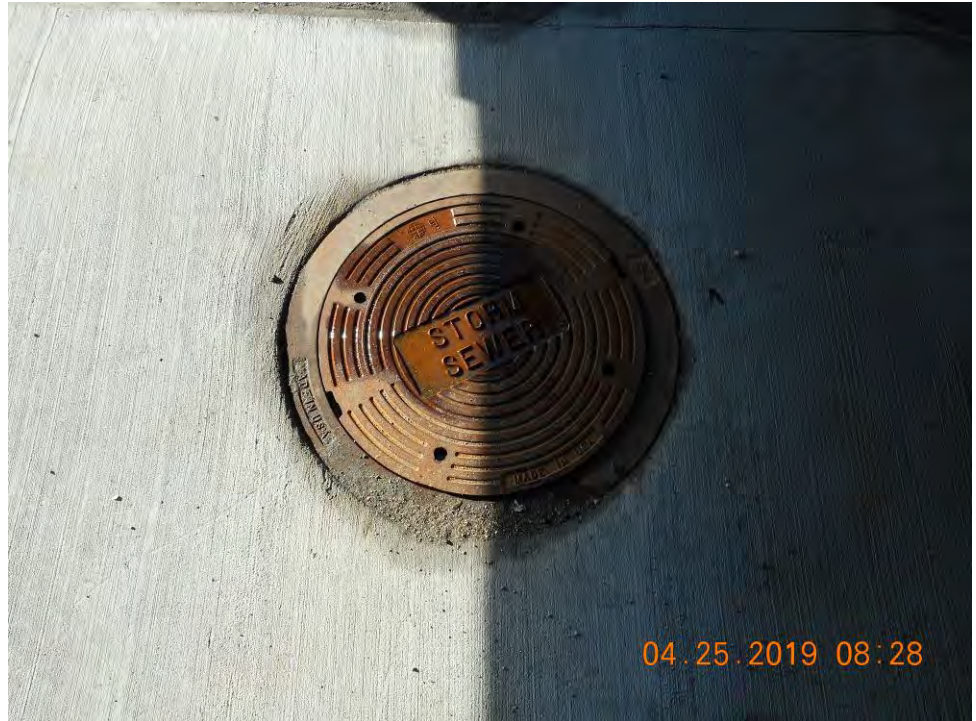
**Concrete Cap Area  
(Englewood Yard):**  
View of the manhole at NAPL  
Collection Sump B099/B100.

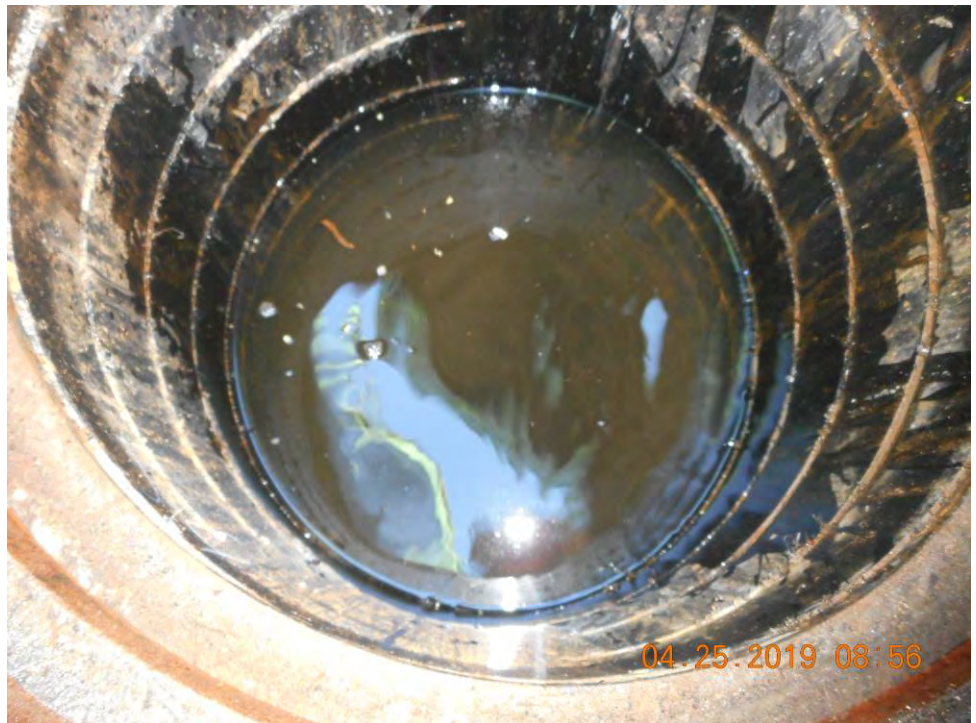
**Photo No.**  
**20**

**Concrete Cap Area  
(Englewood Yard):**  
View of the sump water in NAPL  
Collection Sump B099/B100.

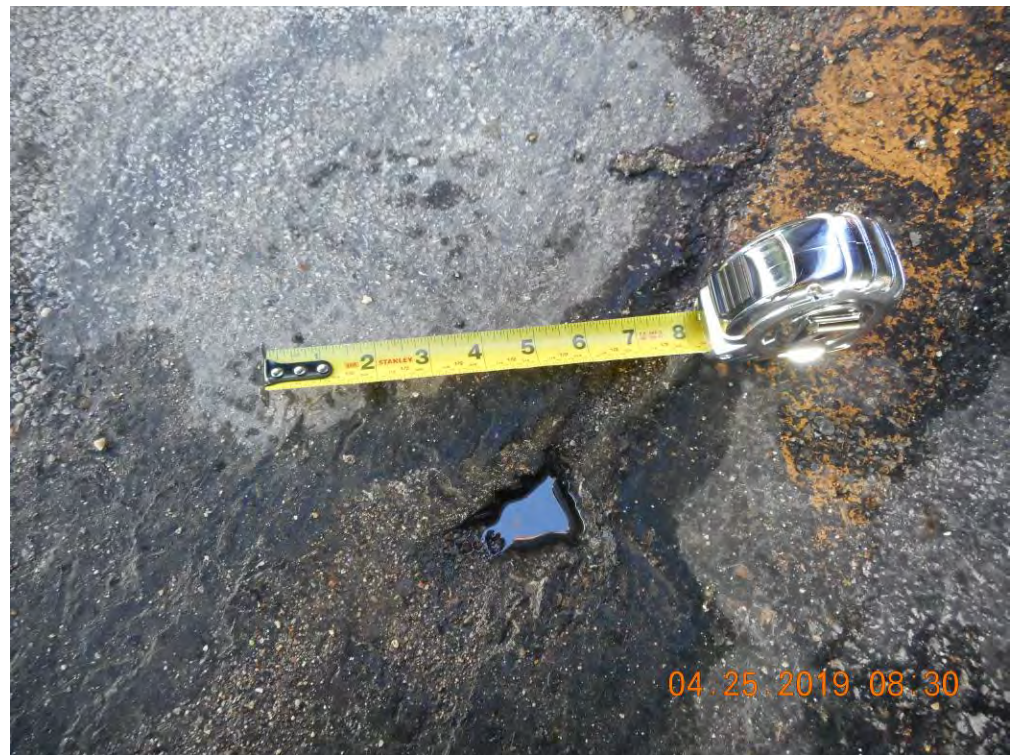
Slot B101. Evidence of recent NAPL seepage. Facing west.

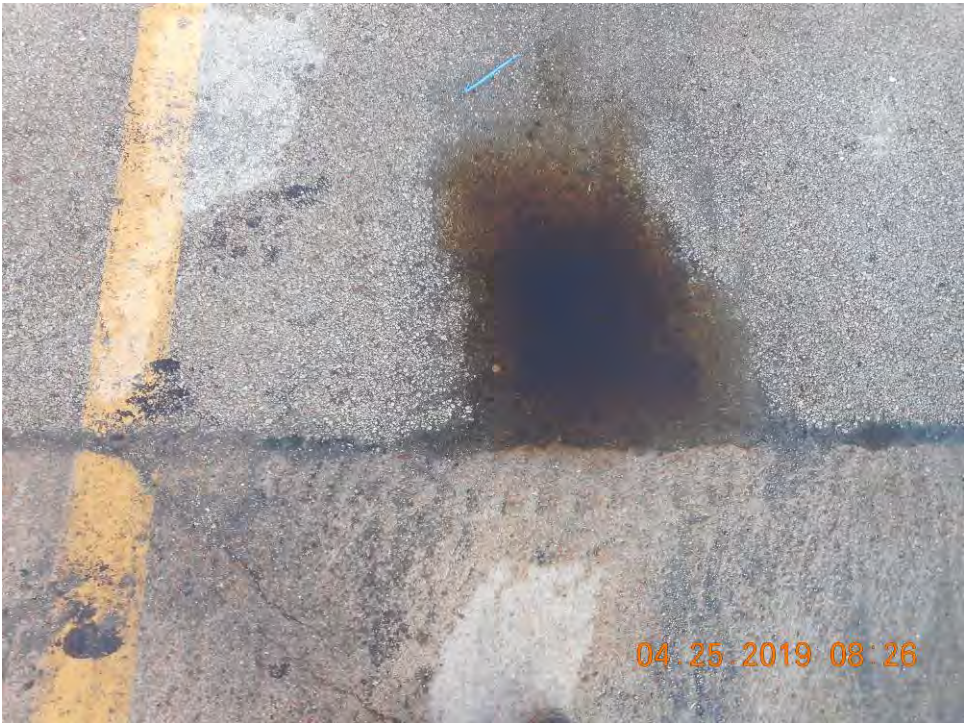
<b>Client Name:</b> <b>Union Pacific Railroad</b>		<b>Site Location:</b> Houston Wood Preserving Works, 4910 Liberty Road, Houston, Texas	<b>Project No.</b> 19119232
<b>Photo No.</b> <b>29</b>	<b>Date:</b> 04/25/19

<b>Description:</b>  <b>Concrete Cap Area (Englewood Yard):</b> Slot B097. Puddles of brown water in low-lying area. Facing north.  Lat: 29.784267 Long: -95.320706			
<b>Photo No.</b> <b>30</b>	<b>Date:</b> 04/25/19

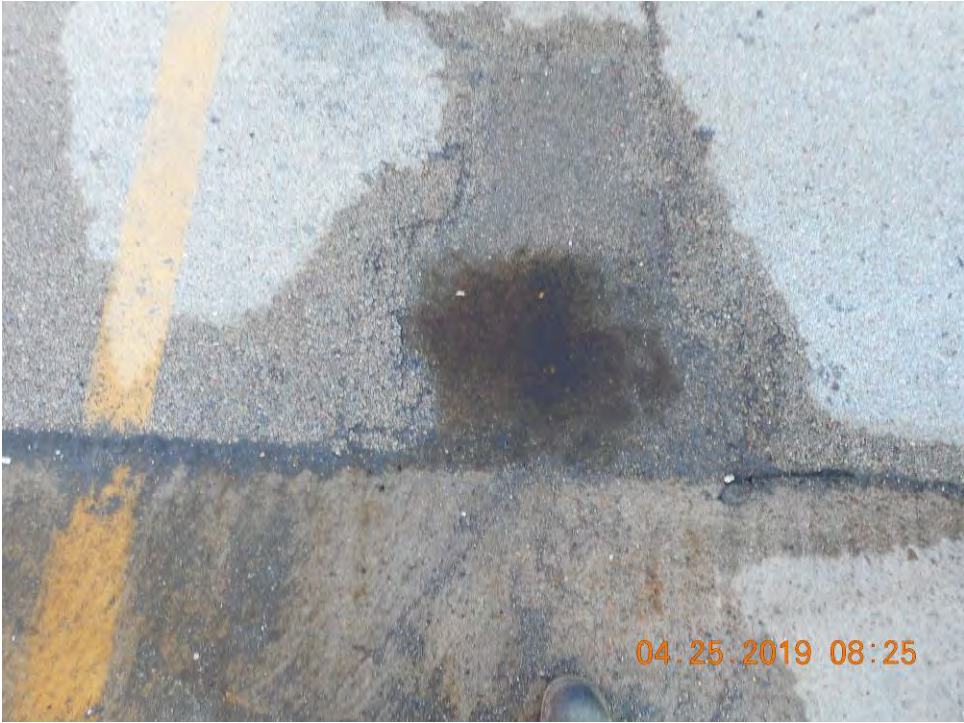
<b>Description:</b>  <b>Concrete Cap Area (Englewood Yard):</b> Slot B096. Puddles of brown water in low-lying area. Facing north.  Lat: 29.784300 Long: -95.320677

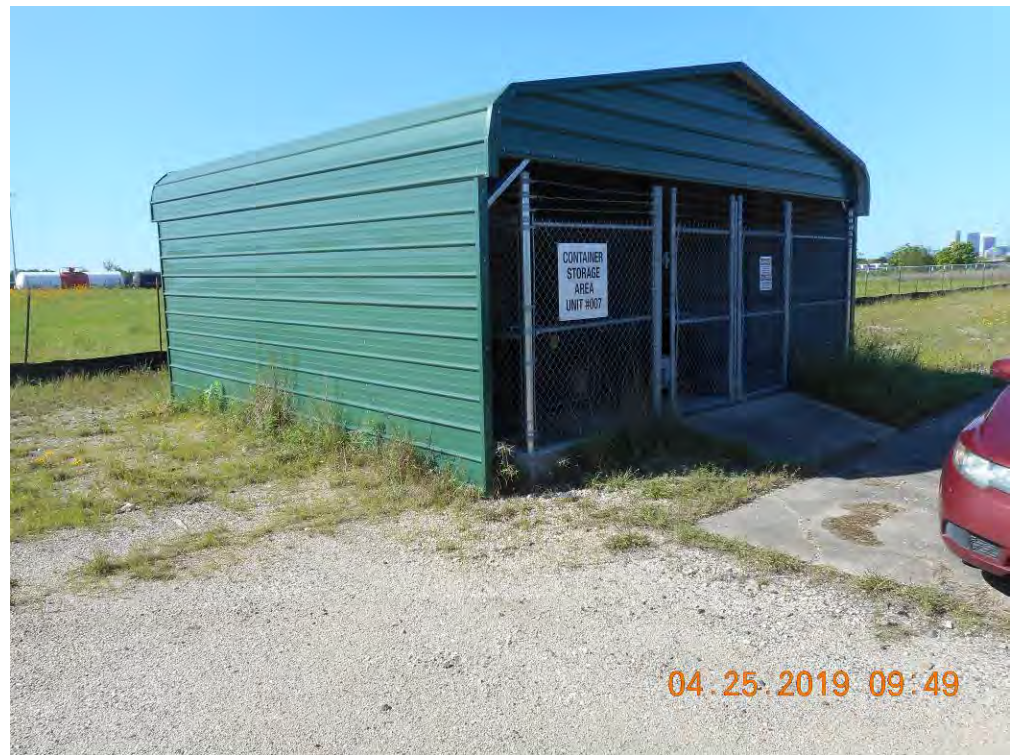
Valve in closed position and  
functioning within the container  
storage area. CSA in good  
condition, free of major dents  
and other damage.

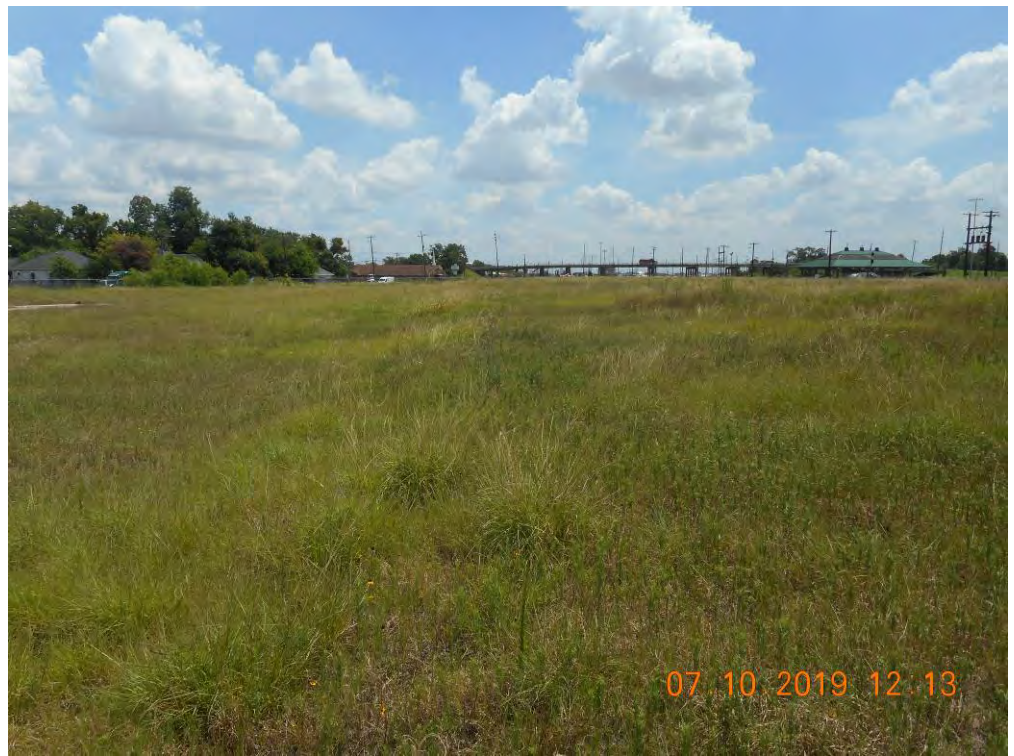
Soil cap well-vegetated in most areas with a low risk of erosion. No major rills observed during inspection. Facing northeast.

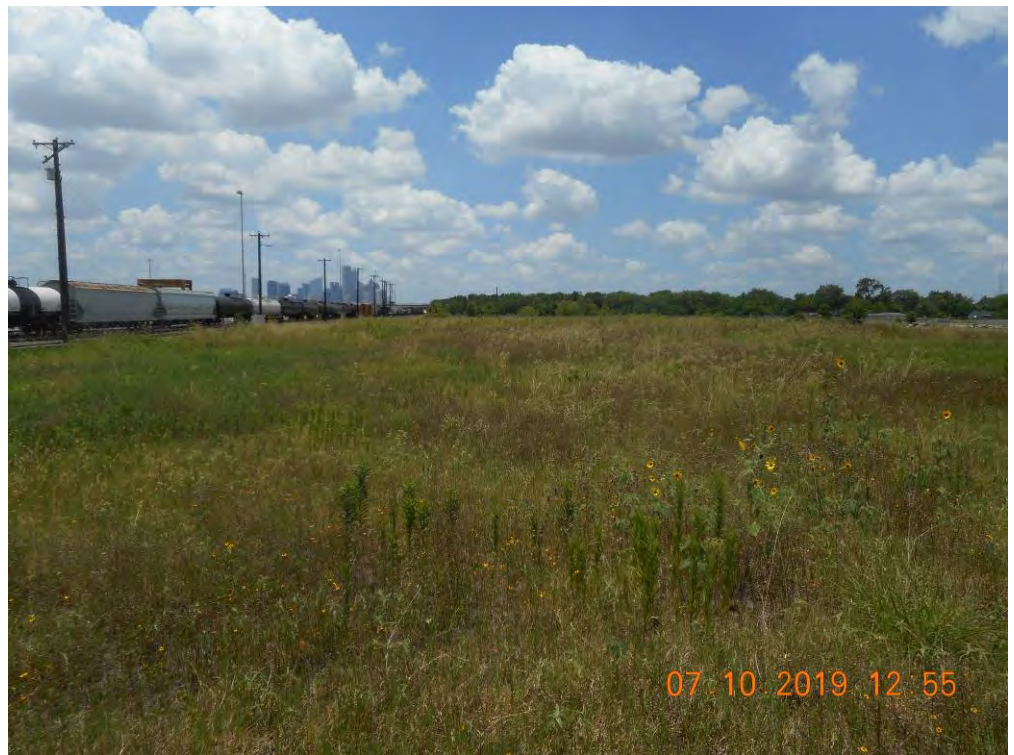
**Photo No.**  
**2**

Vegetative growth (pollinator plants and grasses) can be observed along the length of the soil cap, preventing future erosion. Facing west.

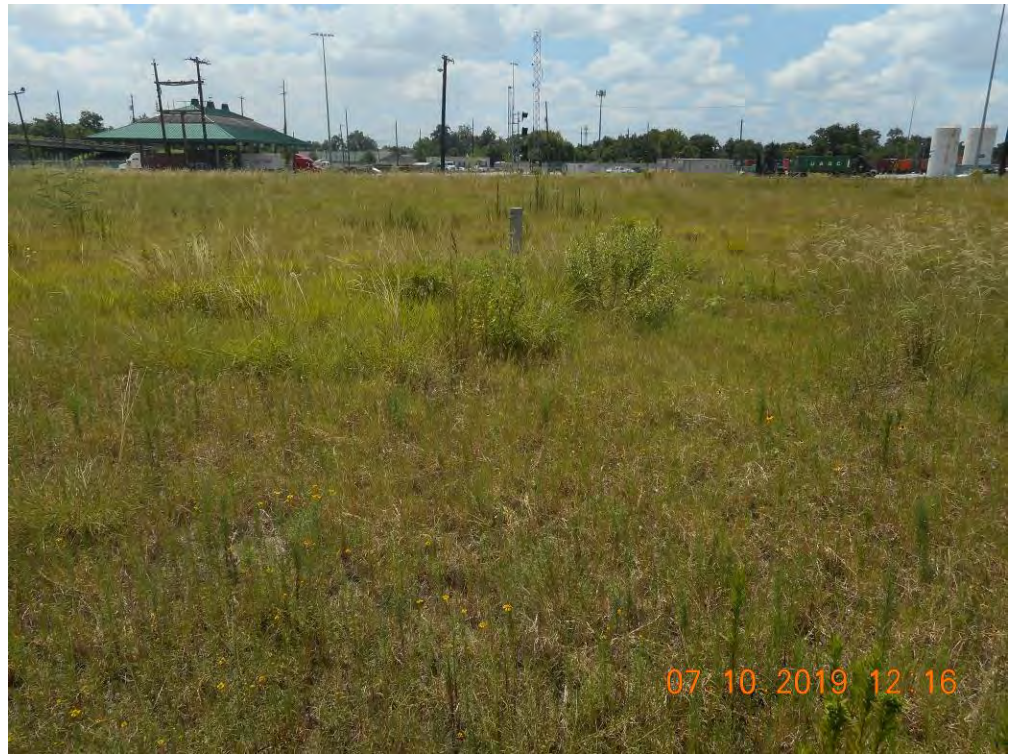
Soil cap well-vegetated (pollinators/grasses) in most areas with a low risk of erosion. No major rills observed during inspection. View of monitoring well MW-72B in center of photo. Facing south.

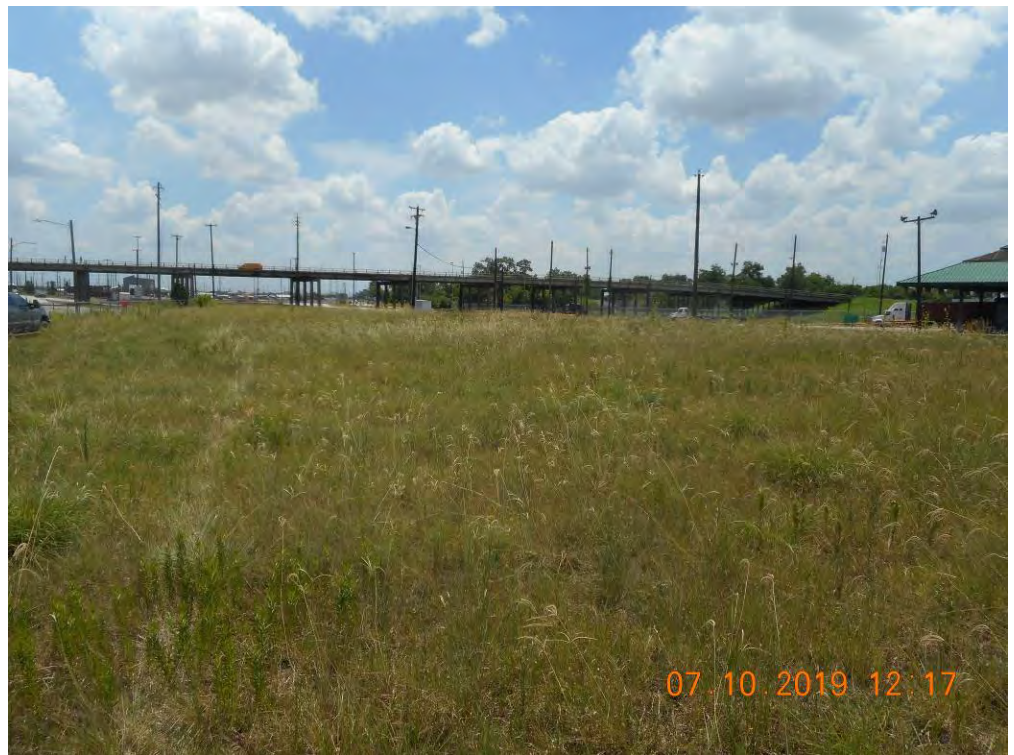
**Photo No.**  
**4**

View on northeast area of soil cap, heavy vegetative growth (grasses). View of Lockwood Bridge in background. Facing east.

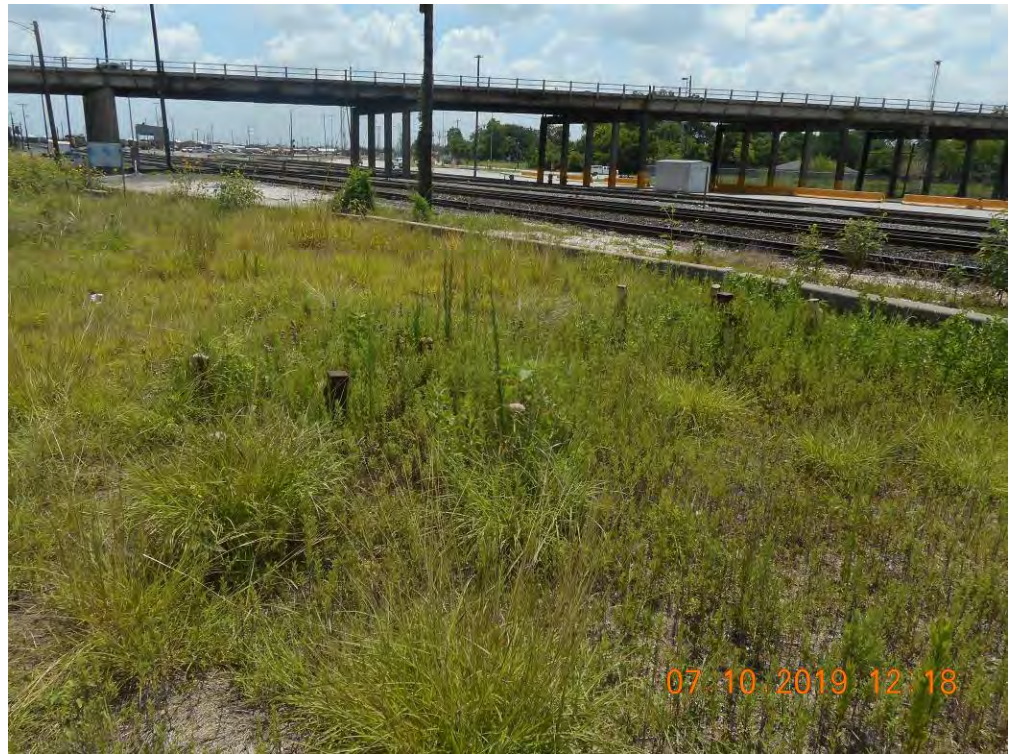
View of northeast corner of the soil cap some pollinators plant present. No major rills observed during inspection. A few bare spots in foreground of photo. View of monitoring wells MW-18A and MW-18C. Facing southeast.

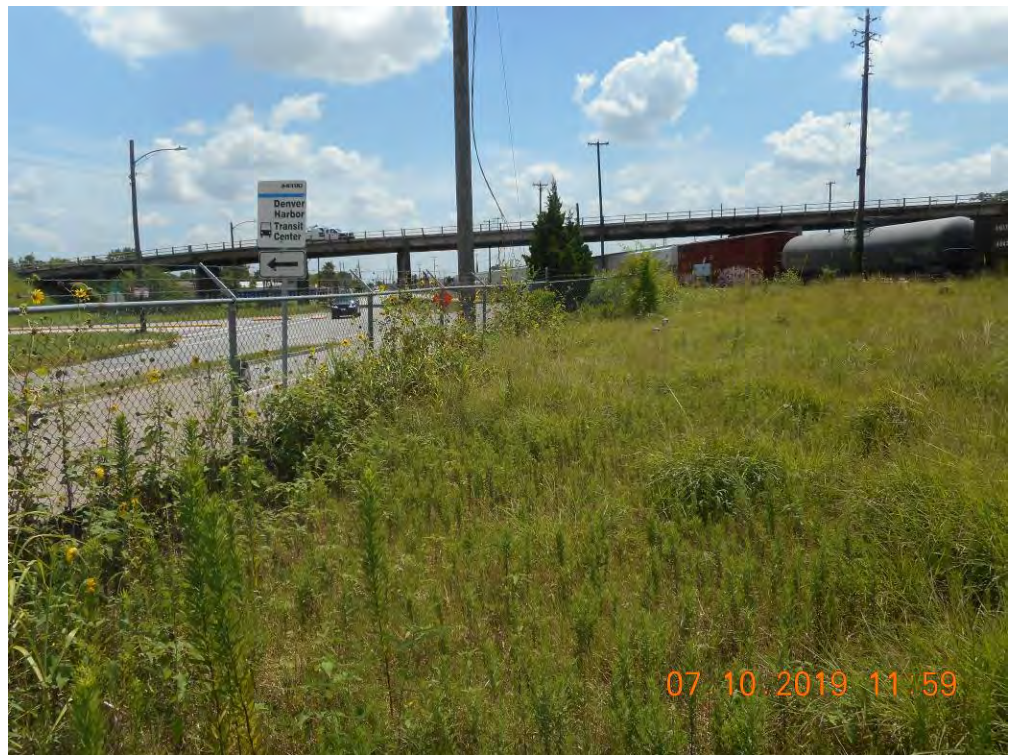
**Photo No.**  
**6**

View on northeast corner of soil cap, heavy vegetative growth (pollinators/grasses) can be observed along the length of the soil cap. View of security fence along northern boundary. Facing east.
