March 31, 2020

Project No. 19119232

**RE: POST-RESPONSE ACTION COMPLETION REPORT – 2019  
UNION PACIFIC RAILROAD HOUSTON WOOD PRESERVING WORKS, HOUSTON, TEXAS  
4910 LIBERTY ROAD, HOUSTON, HARRIS COUNTY, TEXAS  
TCEQ SWR NO. 31547; TCEQ PERMIT/COMPLIANCE PLAN NO. 50343EPA ID NO. TXD000820266  
CUSTOMER NO. CN600131098; REGULATED ENTITY NO. RN100674613**

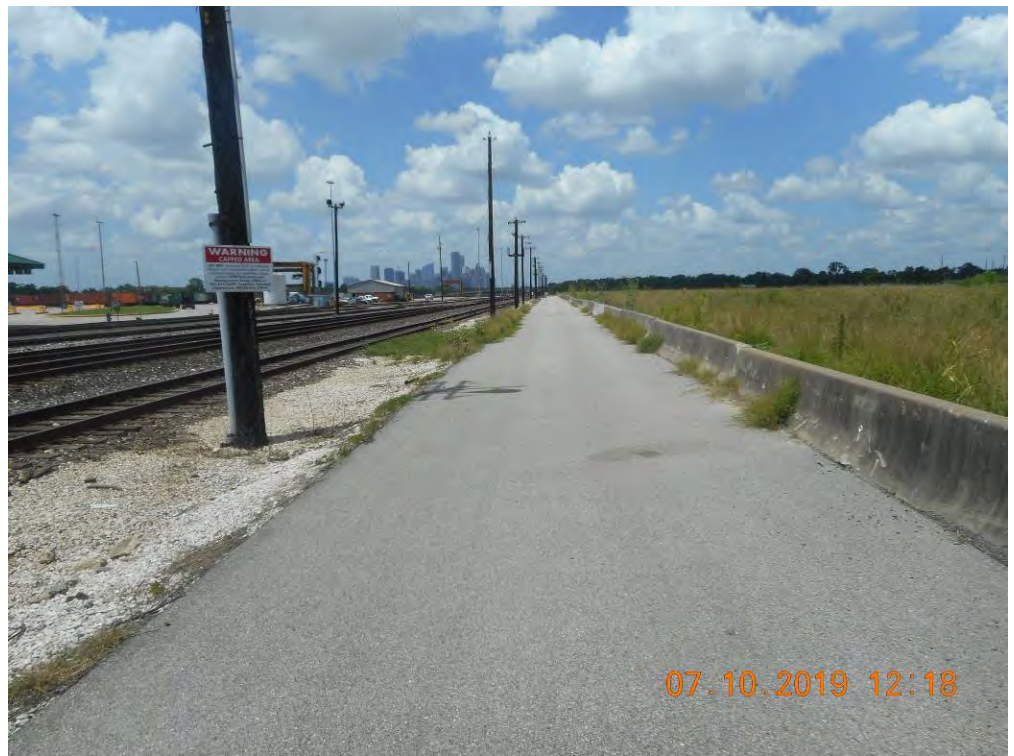
Asphalt roadway in good condition, free of major cracking/damage. Some weeds observed along concrete barrier and within the ballast cap area. Signage visible and in good condition. Facing southwest.

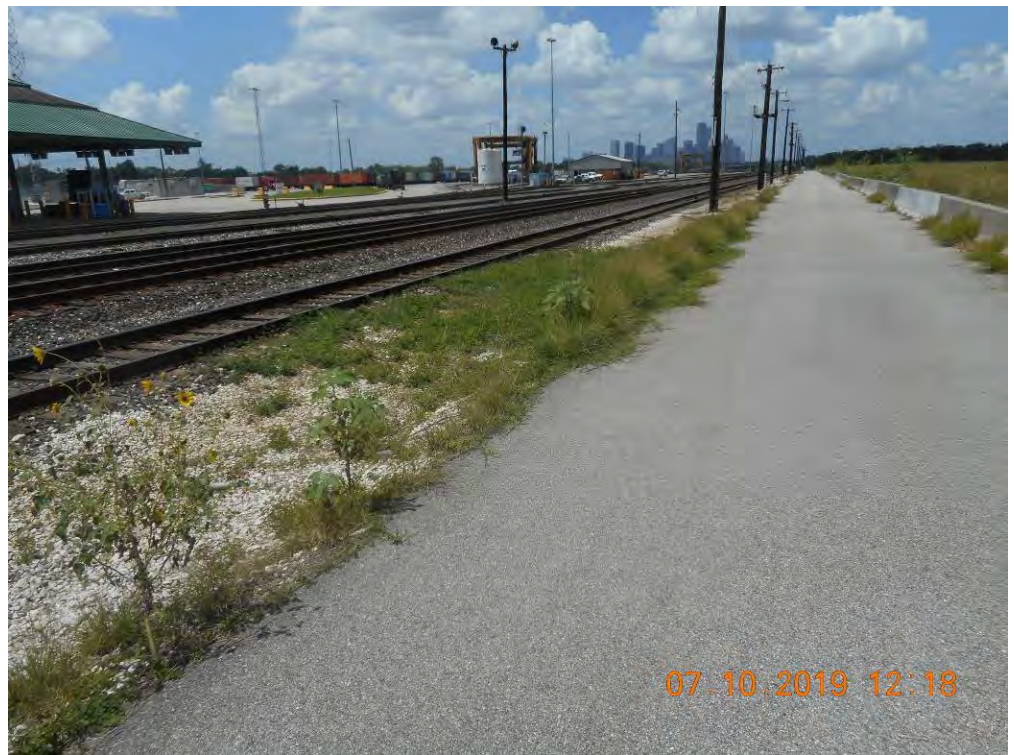
**Photo No.**  
**8**

Weeds growing along the ballast cap in some areas. Ballast material in good condition. Facing southwest.

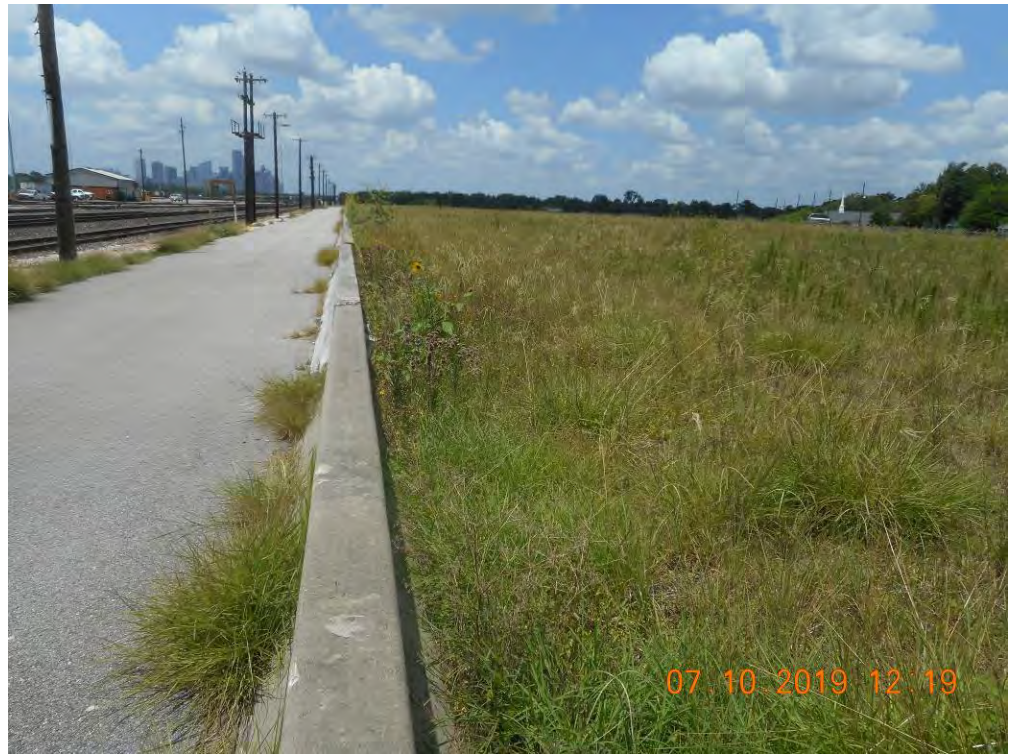
Asphalt roadway in good condition, with some weeds growing along concrete barriers. Soil cap in good condition, some pollinator plants observed. Facing southwest.

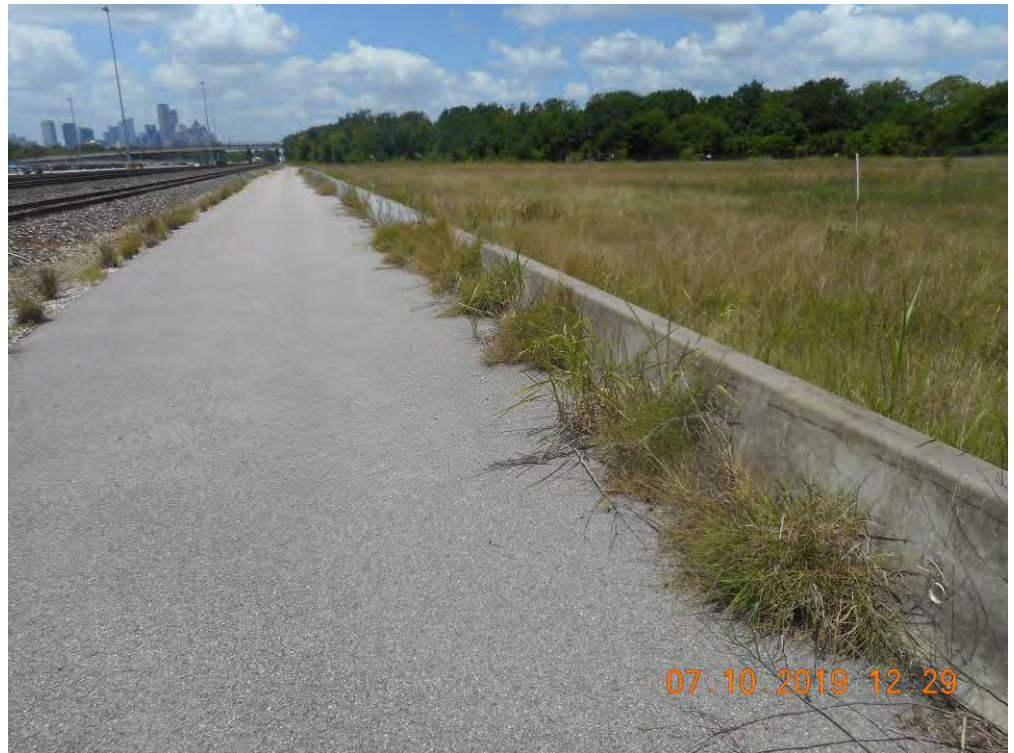
**Photo No.**  
**10**

Weeds growing under the concrete barriers and along the edge of the ballast cap in some areas. Facing southwest.

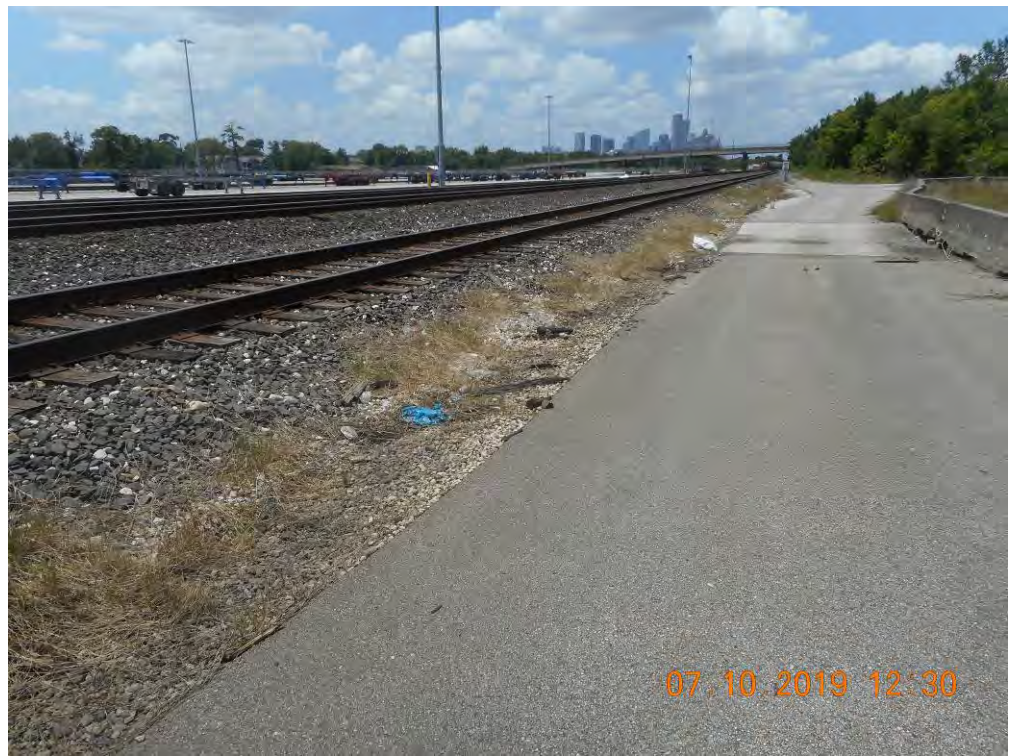
Some vegetation and debris including trash and lumber was observed in the ballast area. Facing southwest.

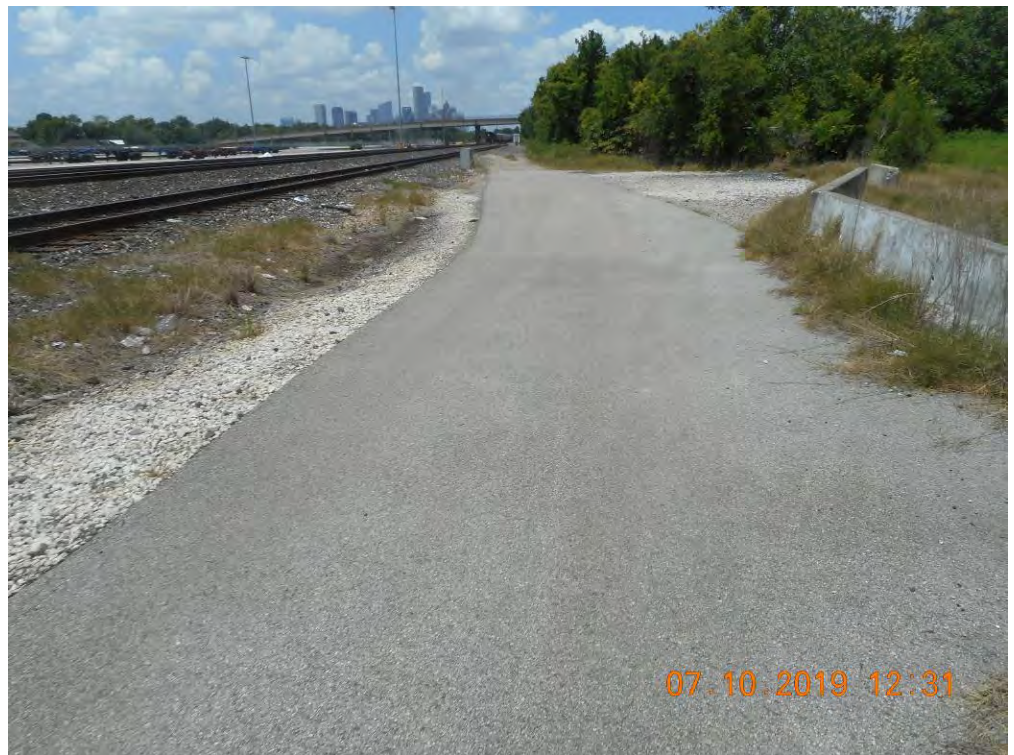
**Photo No.**  
**12**

View of southern end of asphalt roadway cap, vegetation along concrete barrier. Ballast cap has some grasses/weeds observed. Facing southwest.

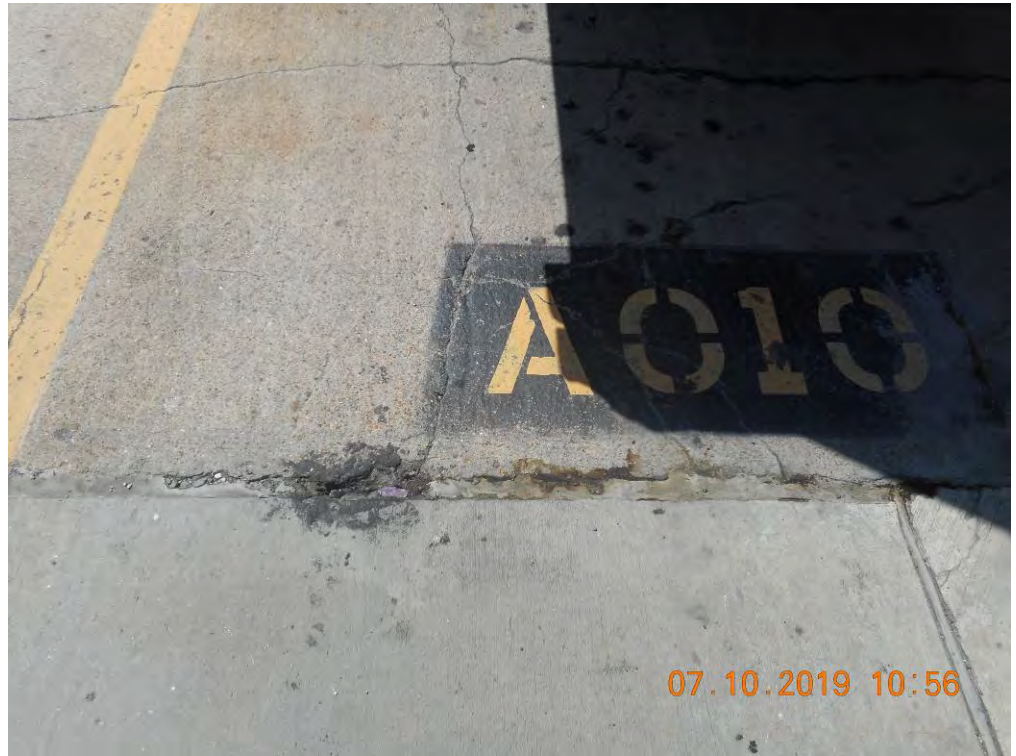
Small amount of tar seep in concrete joint, Slot A010, Englewood Yard area. Facing southeast.

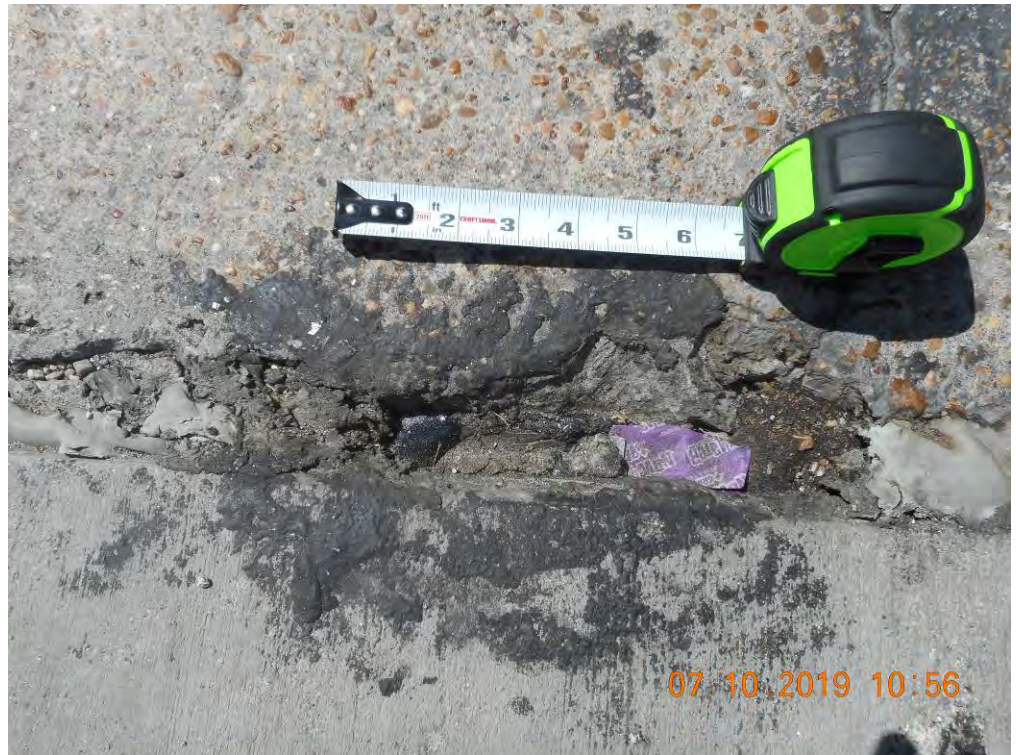
**Photo No.**  
**14**

Small amount of tar seep in concrete joint, Slot A010. Facing southeast.

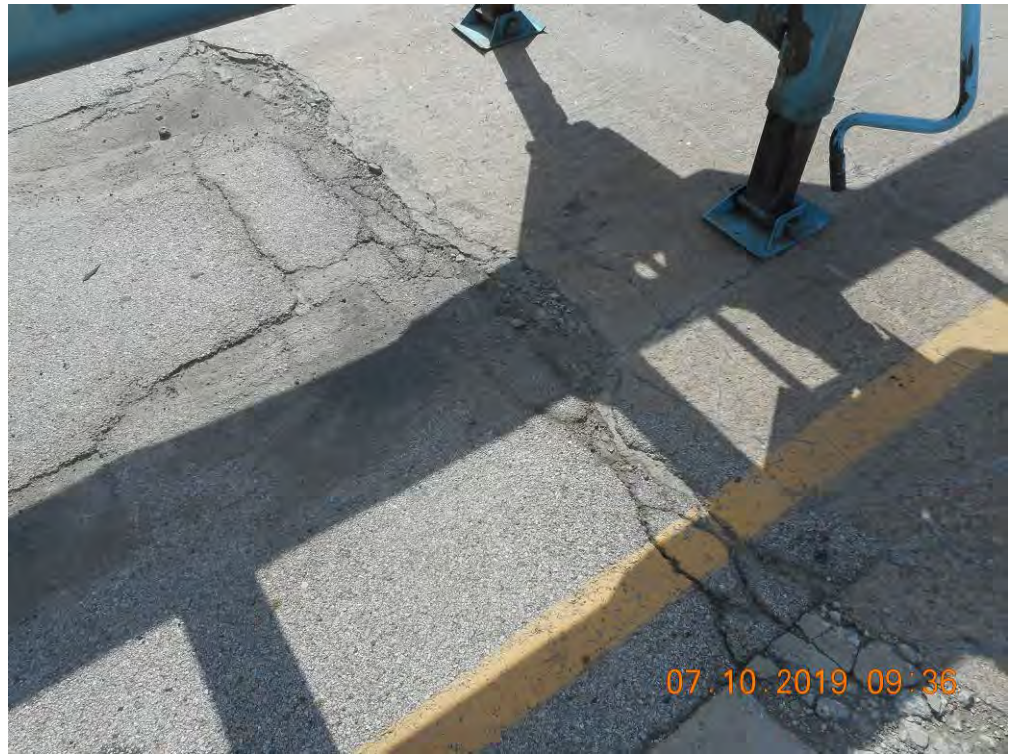
Some cracking/cratering in the pavement can be observed in the B Row of the Englewood Yard area, no soil exposed Facing east.

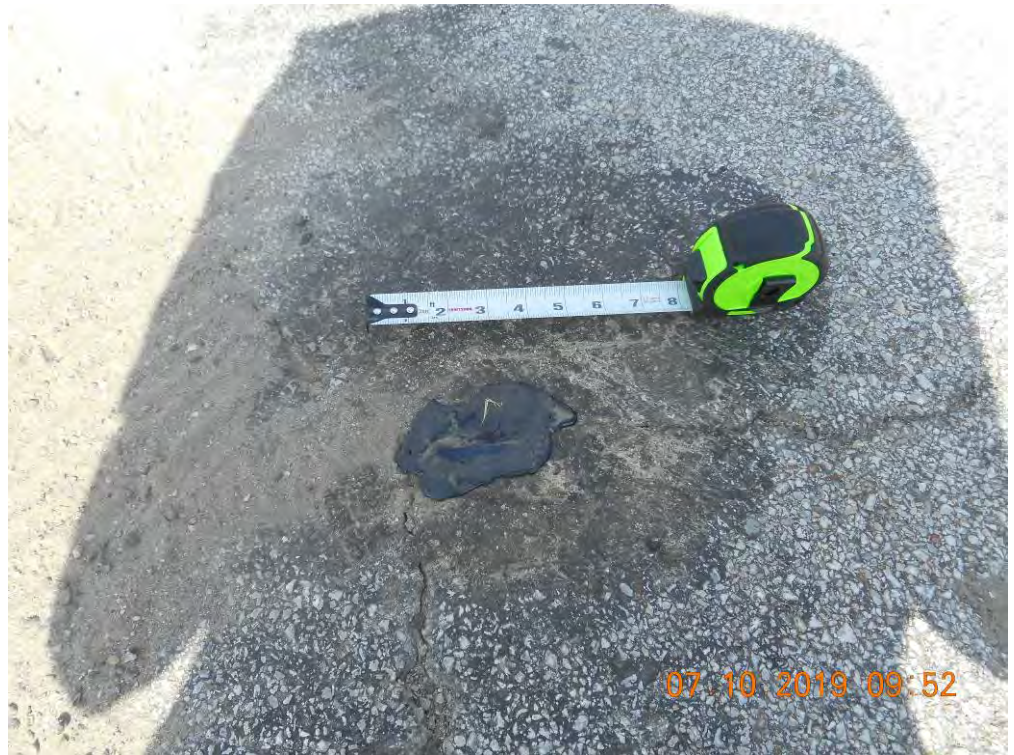
**Photo No.**  
**16**

Slot B105. Evidence of recent NAPL seepage and minor cracking. Facing southwest.

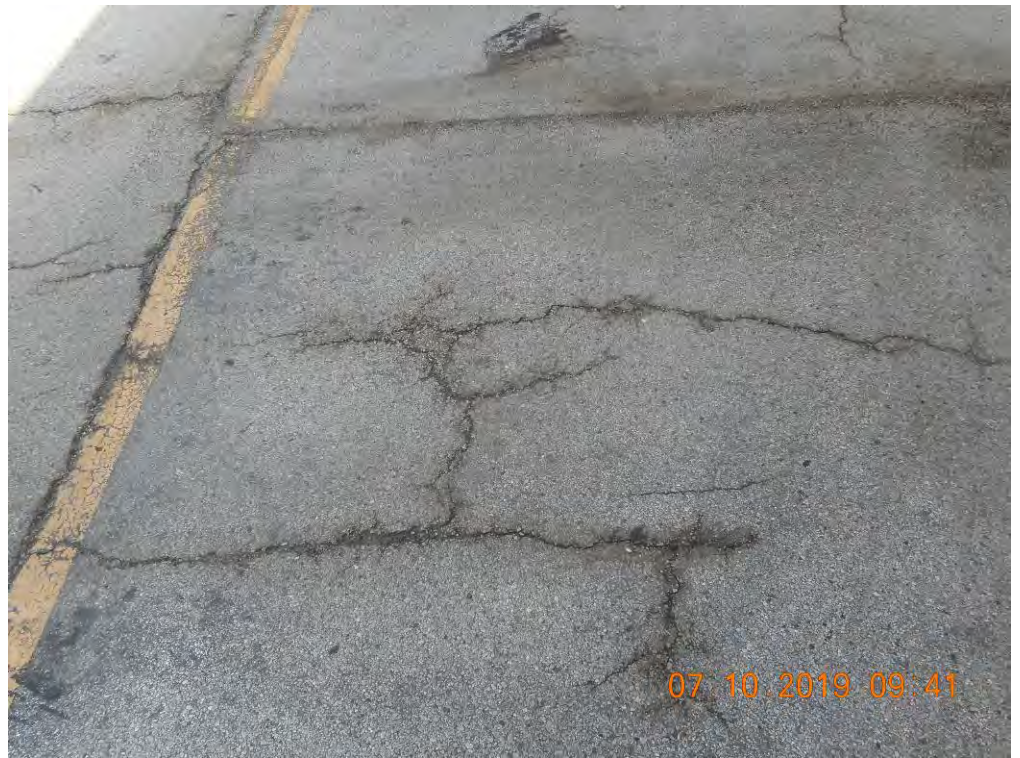
Some cracking/cratering in the pavement can be observed in the B Row (Slot B098) of the Englewood Yard area, no soil exposed Facing north.

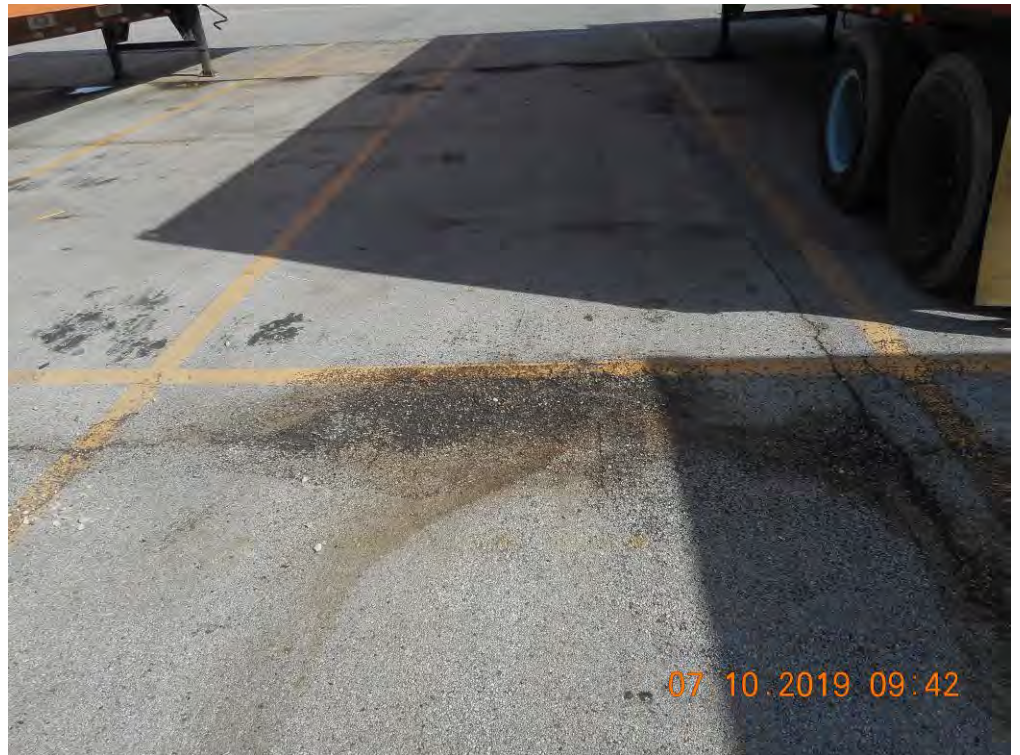
**Photo No.**  
**18**

Slot B099. Evidence of recent brown water seepage and staining along cracking in asphalt. Facing north.

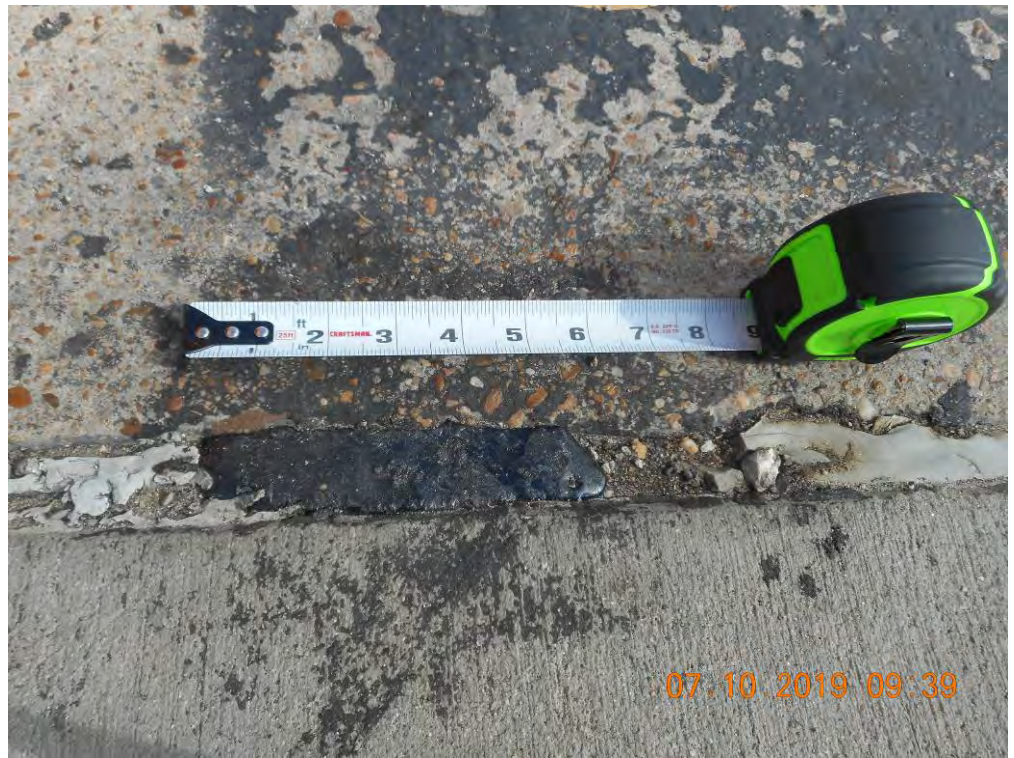
Slot B096. Evidence of recent NAPL seepage along front of stall. Evidence of missing joint sealant can be observed in the Yard Area along the front of some stalls. Facing northwest.

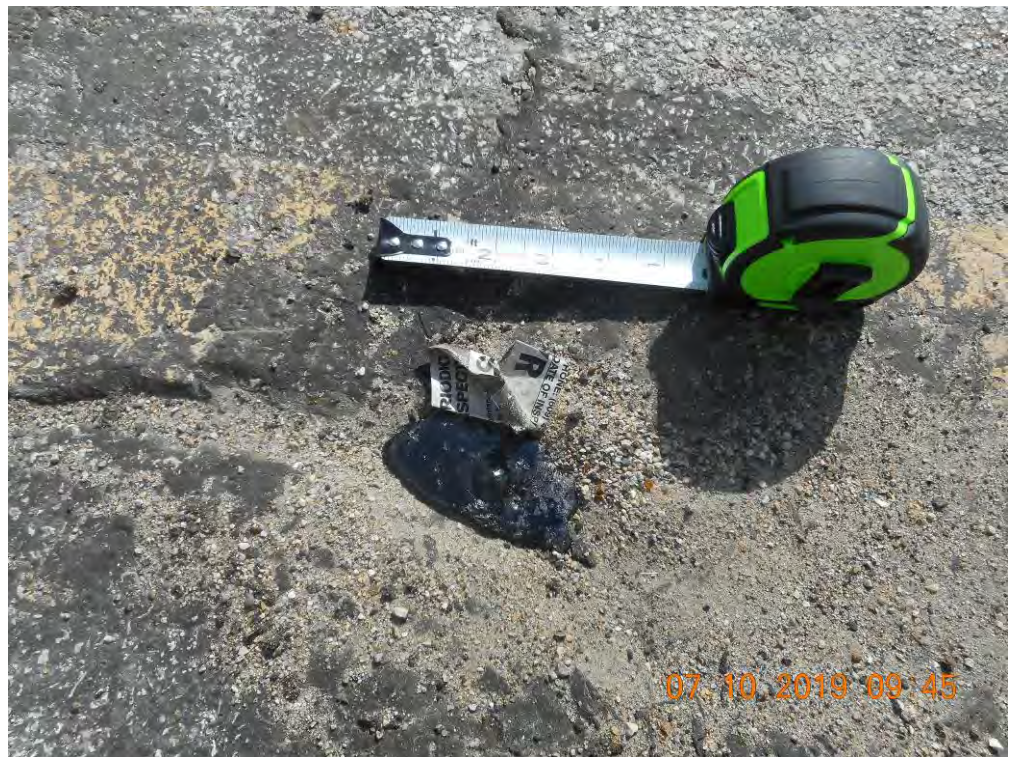
**Photo No.**  
**20**

Slot B101. Evidence of recent NAPL seepage. Facing southwest.

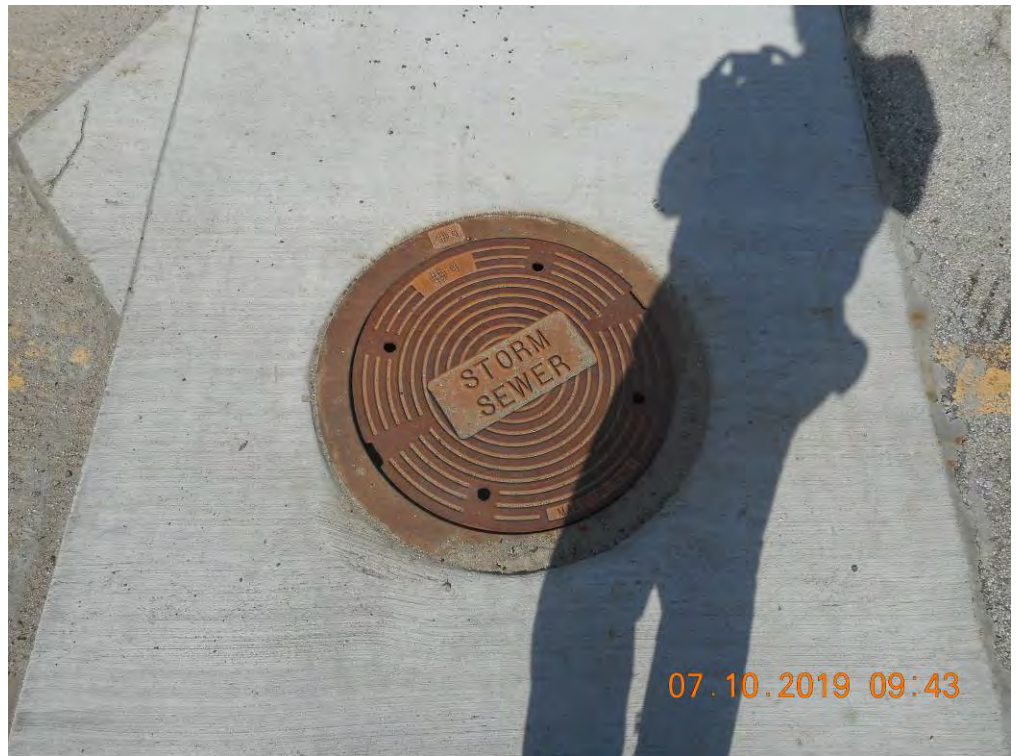
Sump B099/B100. Recently installed NAPL Collection System in stalls B099-B110 in good condition with little evidence of cracking, stains, etc. Facing north.

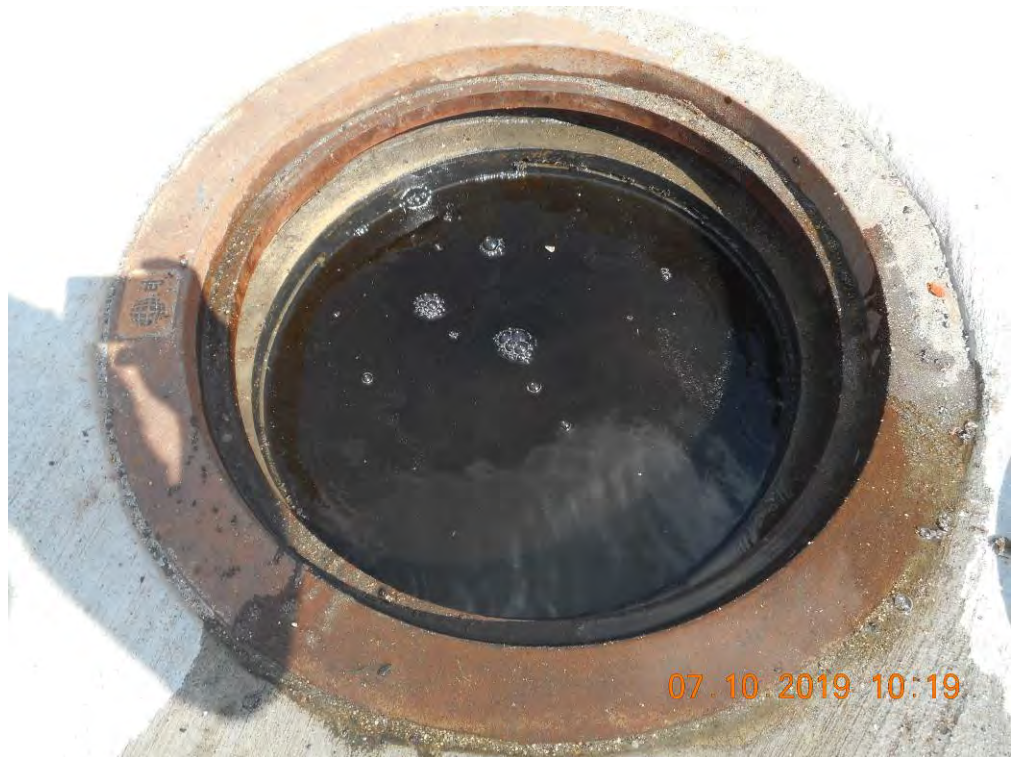
**Photo No.**  
**22**

Sump B099/B100. Sump filled with water. Facing north.

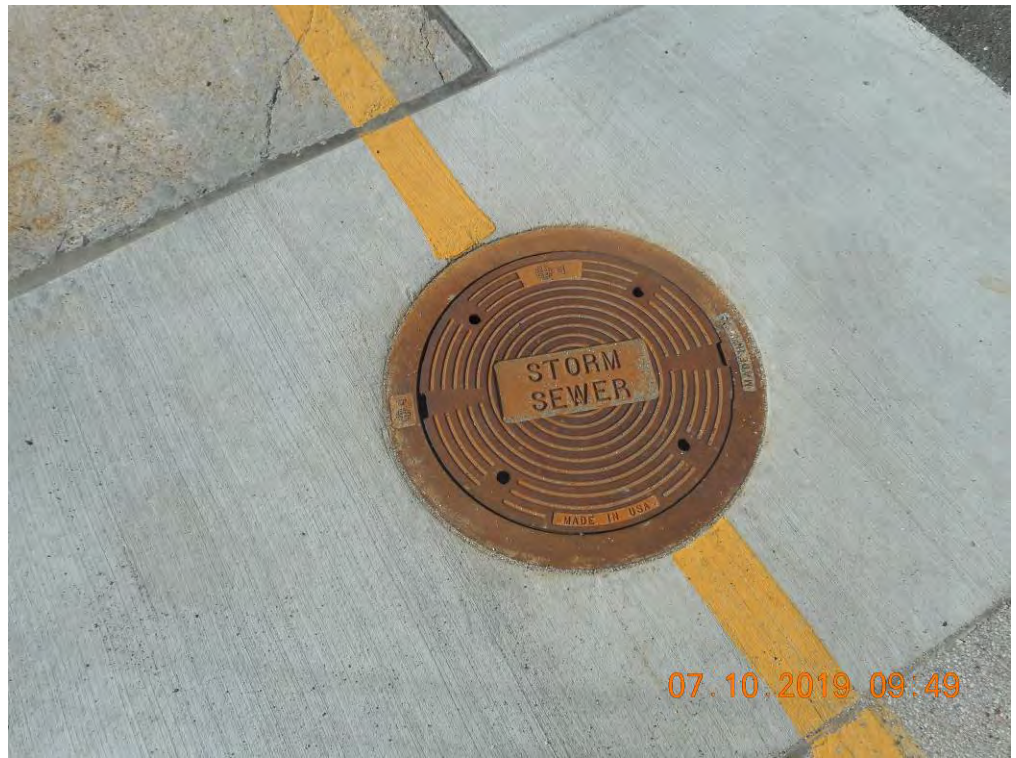
Sump B103/B104. Recently installed NAPL Collection System in stalls B103/B104 in good condition with little evidence of cracking, stains, etc. Facing north.

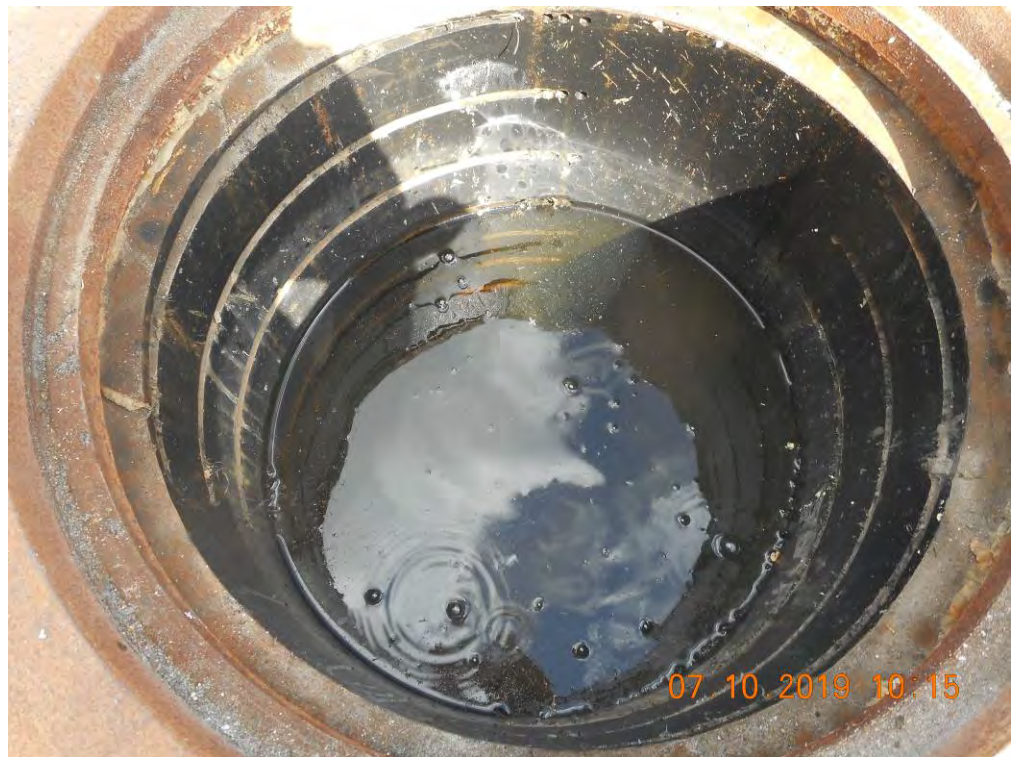
**Photo No.**  
**24**

Sump B103/B104. Sump half-filled with water. Facing north.

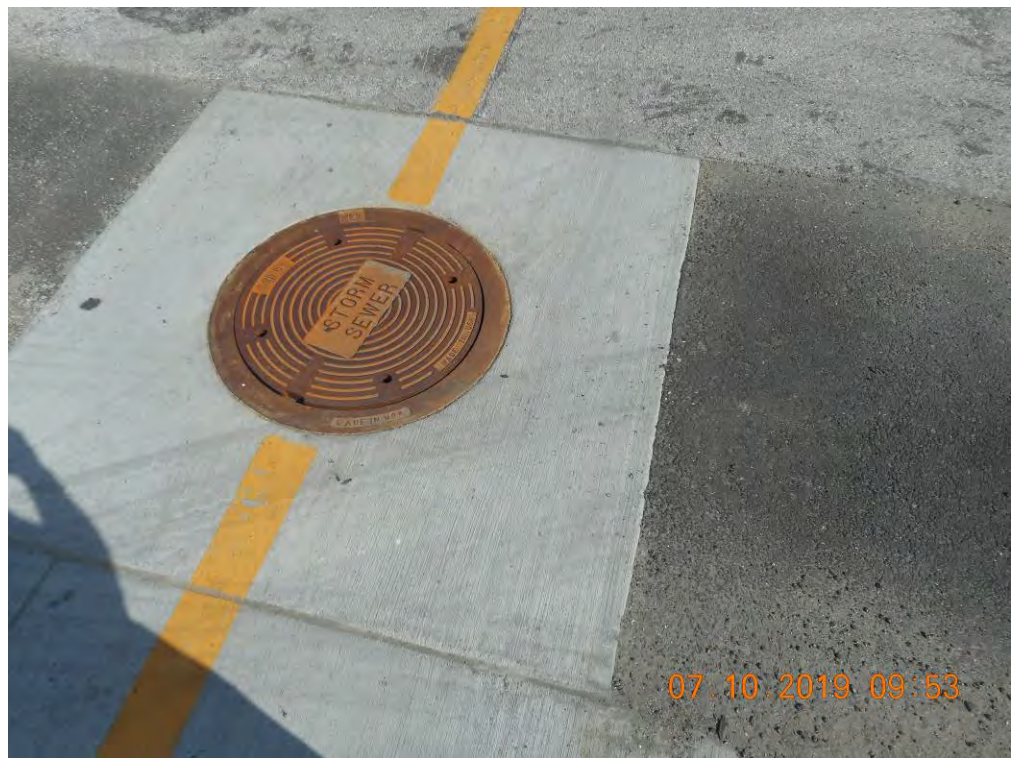
Sump B107/B108. Recently installed NAPL Collection System in stalls B107/B108 in good condition with little evidence of cracking, stains, etc. Facing north.

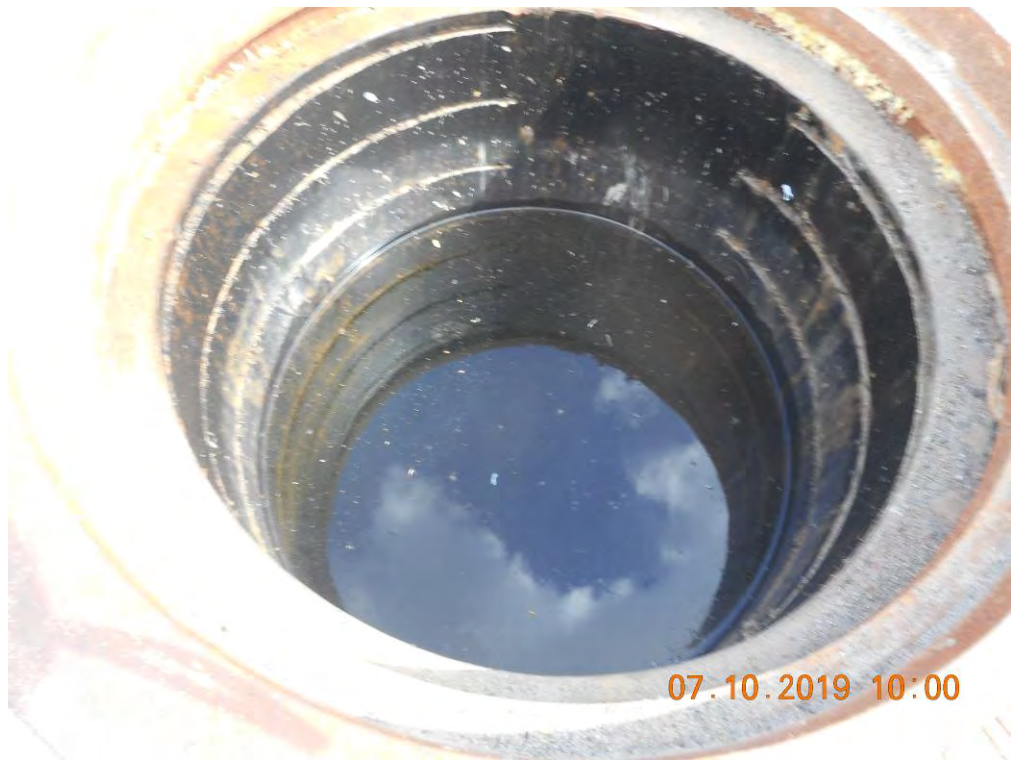
**Photo No.**  
**26**

Sump B107/B108. Sump half-filled with water. Facing north.

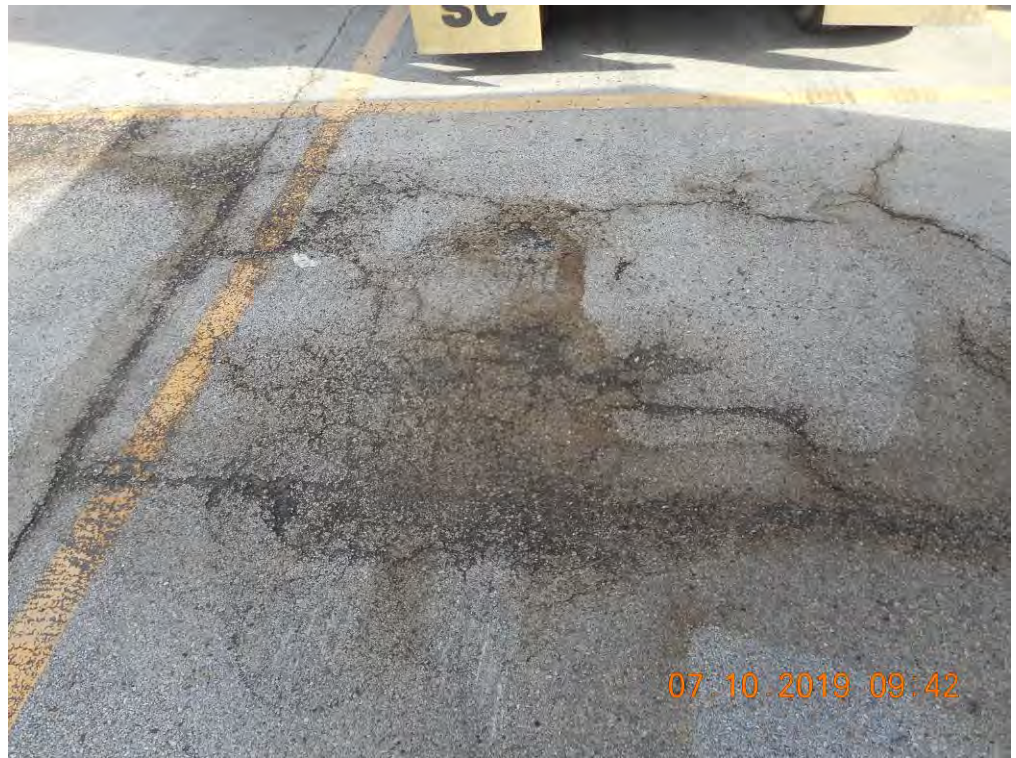
Some residual staining from brown water seeps in the cracks in the pavement can be observed in the B Row (Slot B098) of the Englewood Yard area, no soil exposed Facing north.

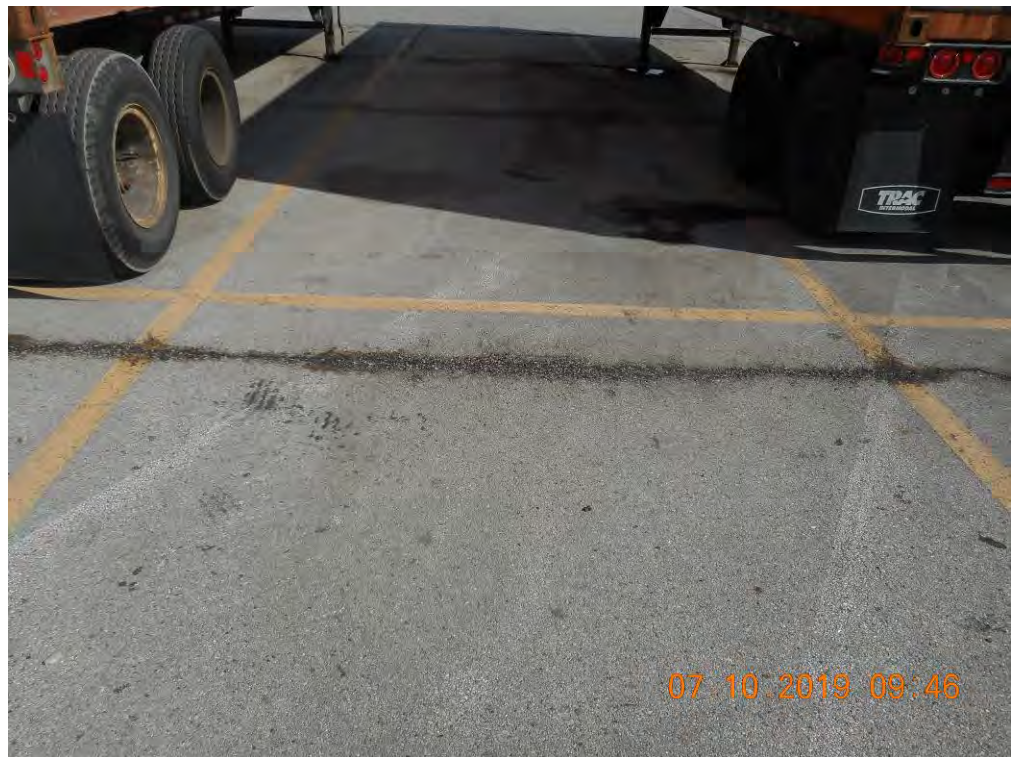
**Photo No.**  
**30**

Some residual staining from brown water seeps in the cracks in the pavement can be observed in the B Row (Slot B102) of the Englewood Yard area, no soil exposed Facing north.

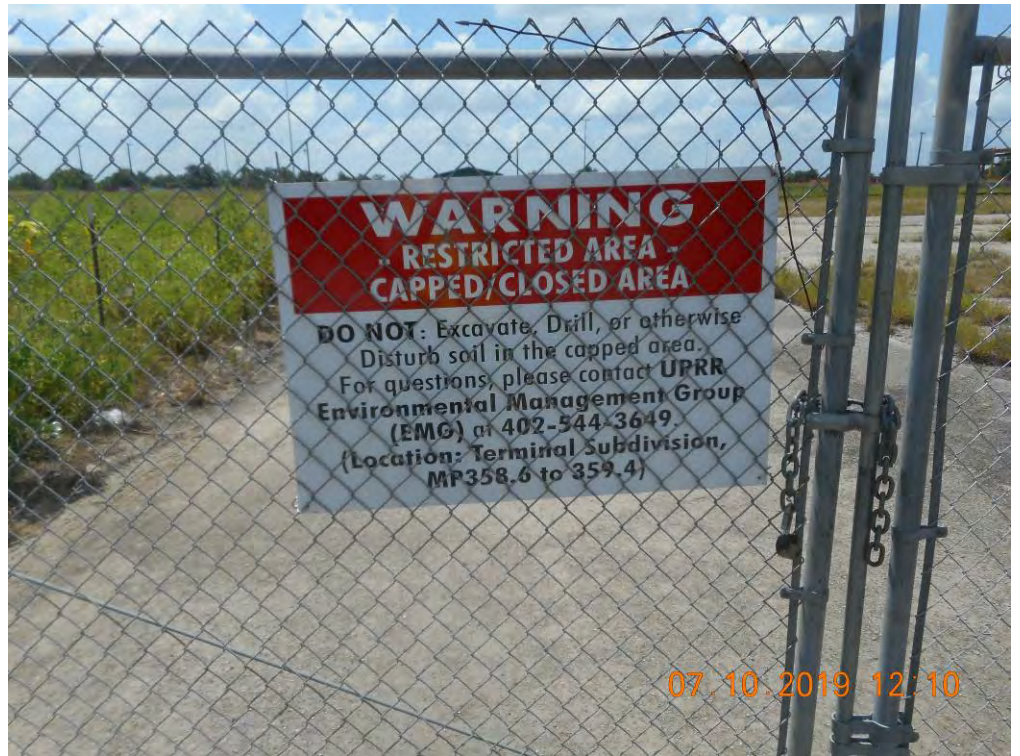
Front gate and signage in good condition. Facing south.

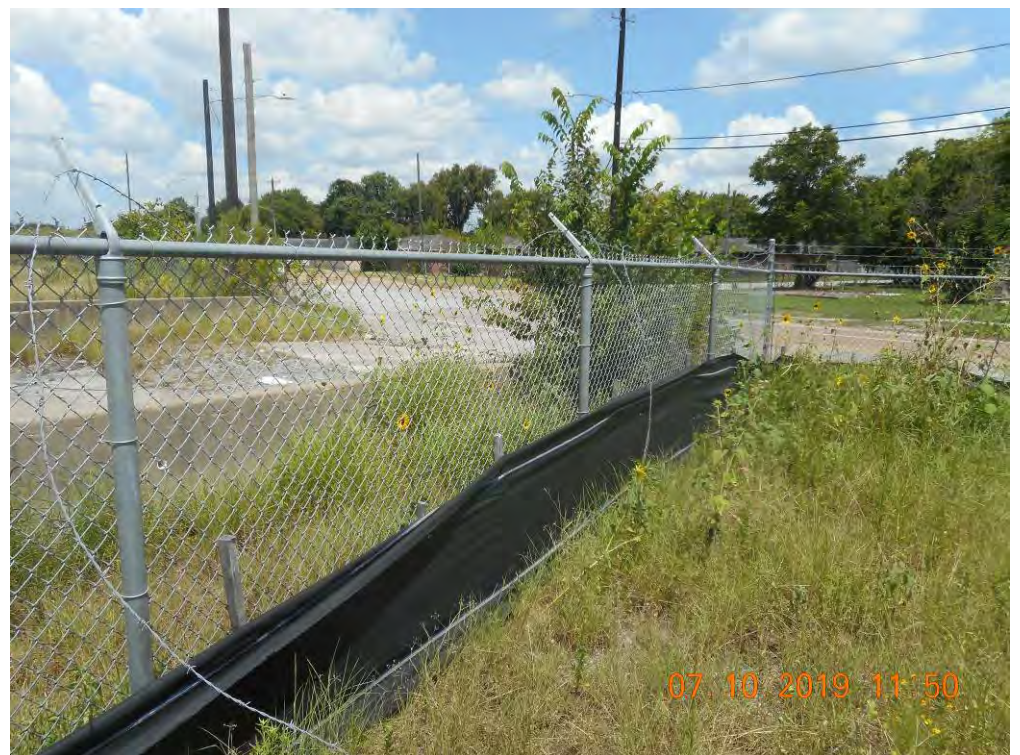
**Photo No.**  
**36**

Barbed wire atop security fence broken on east side of entrance area. Facing northwest.

Additional Comments or Observations: Mowing for site and sidewalk suggested, repairs to fence suggested in listed areas

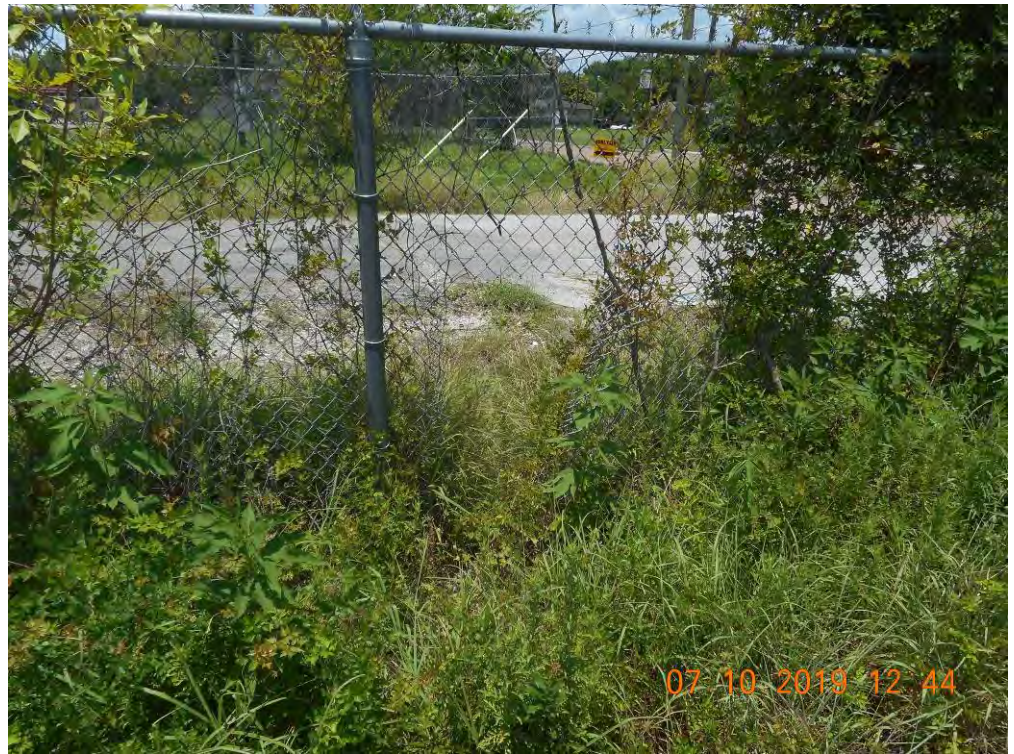
**Security Fence:**  
Hole in security fence in northwest corner of yard at intersection of Liberty Rd and Kashmere St. Facing west.

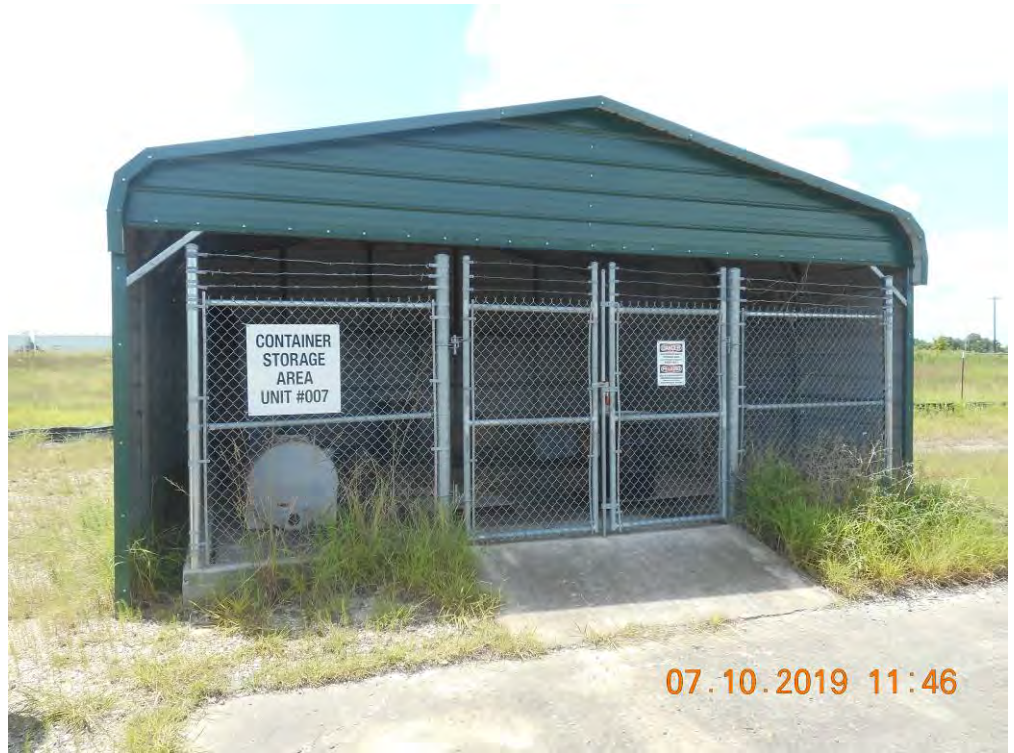
**Photo No.**  
**38**

**Container Storage Area:**  
Valve in closed position and functioning within the container storage area. CSA in good condition, free of major dents and other damage. Facing south.

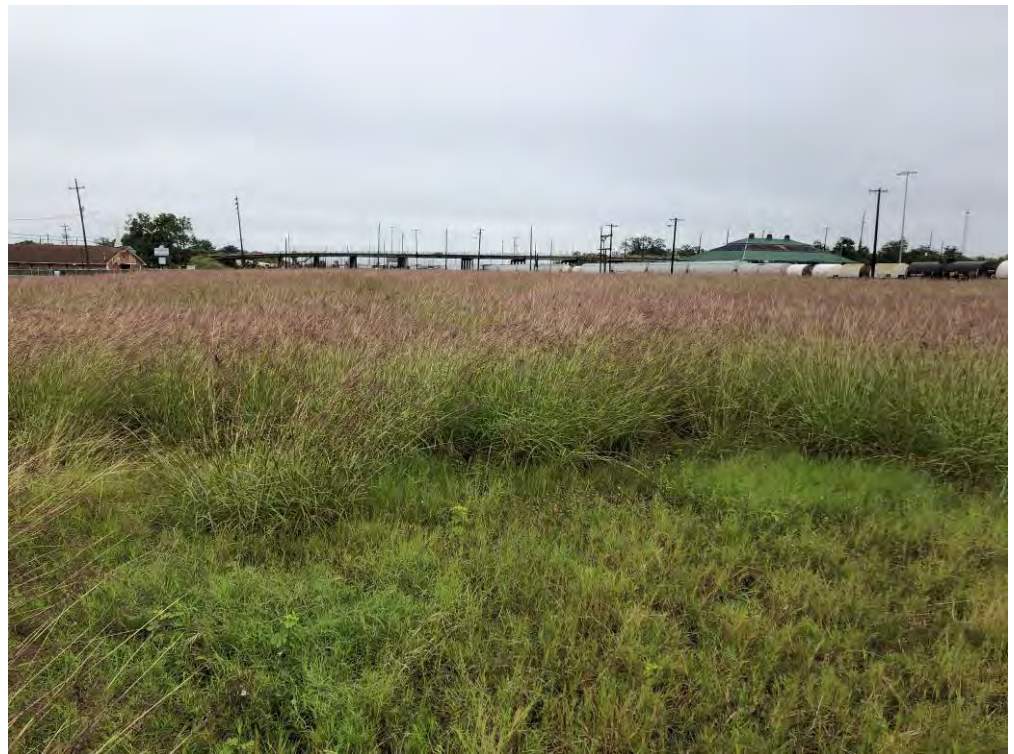
Soil cap well-vegetated in most areas with a low risk of erosion. No major rills observed during inspection. Facing east.

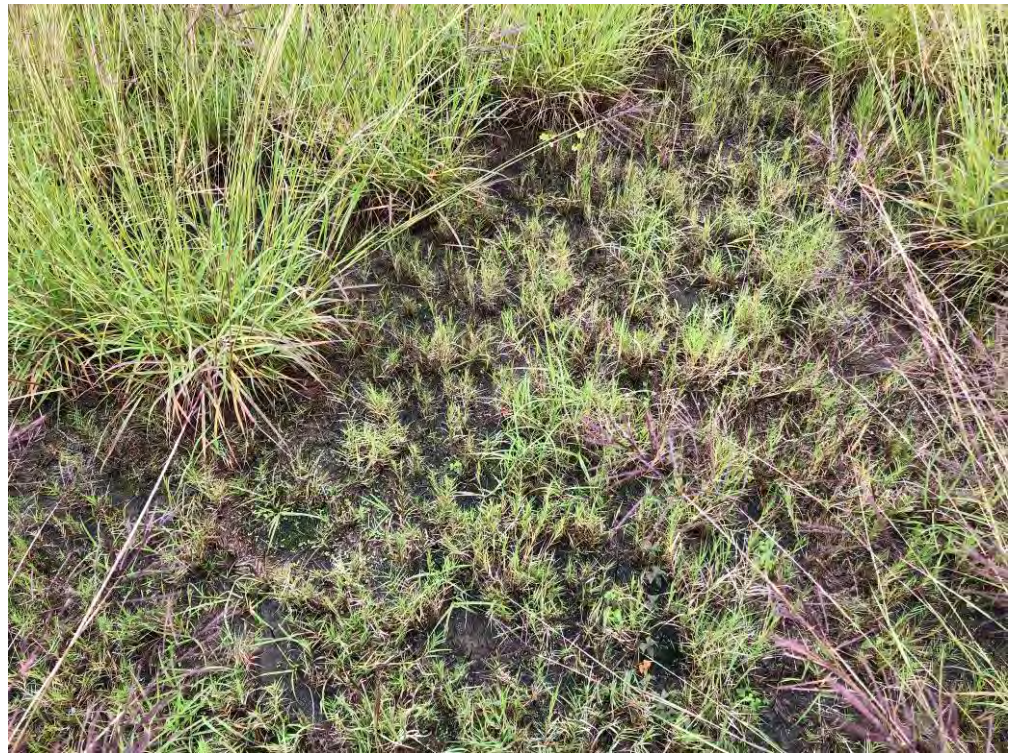
**Photo No.**  
**2**

Vegetative growth (brushes and grasses in particular) can be observed along the length of the soil cap, preventing future erosion. Facing west.
