March 31, 2020

Project No. 19119232

**RE: POST-RESPONSE ACTION COMPLETION REPORT – 2019  
UNION PACIFIC RAILROAD HOUSTON WOOD PRESERVING WORKS, HOUSTON, TEXAS  
4910 LIBERTY ROAD, HOUSTON, HARRIS COUNTY, TEXAS  
TCEQ SWR NO. 31547; TCEQ PERMIT/COMPLIANCE PLAN NO. 50343EPA ID NO. TXD000820266  
CUSTOMER NO. CN600131098; REGULATED ENTITY NO. RN100674613**

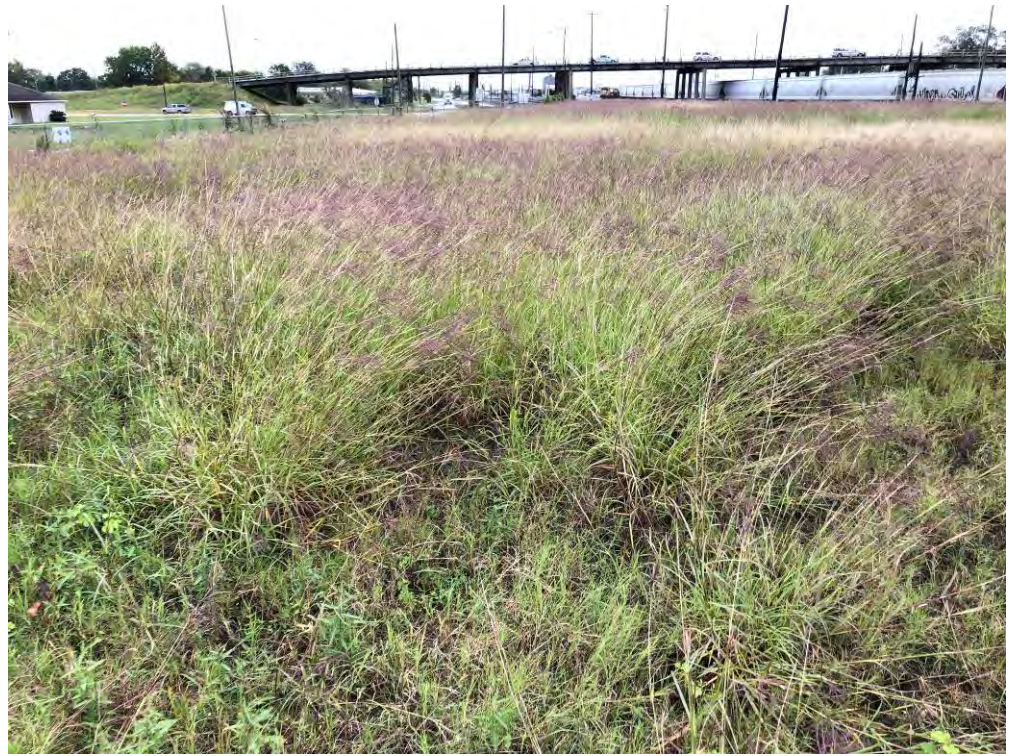
Vegetative growth (brushes and grasses in particular) can be observed along the length of the soil cap, preventing future erosion. Facing west.

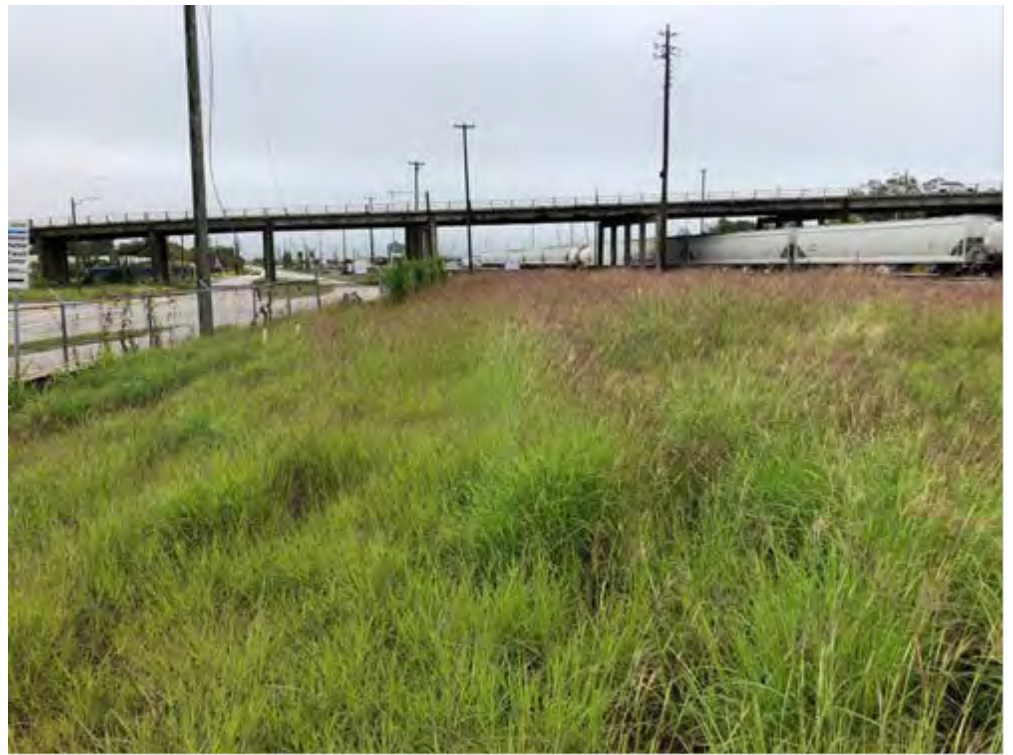
**Photo No.**  
**4**

Vegetative growth (brushes and grasses in particular) can be observed along the length of the soil cap, preventing future erosion. Facing west.

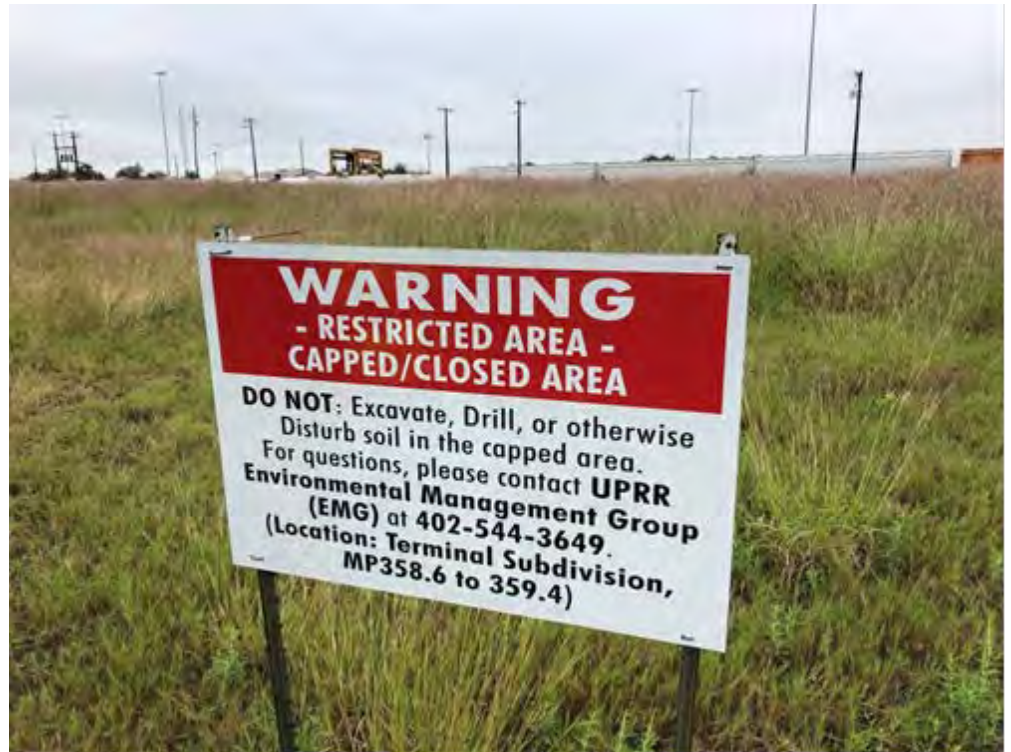
Sign in yard area. The majority of signage is comparably unobstructed by vegetation and can be easily read. Facing south.

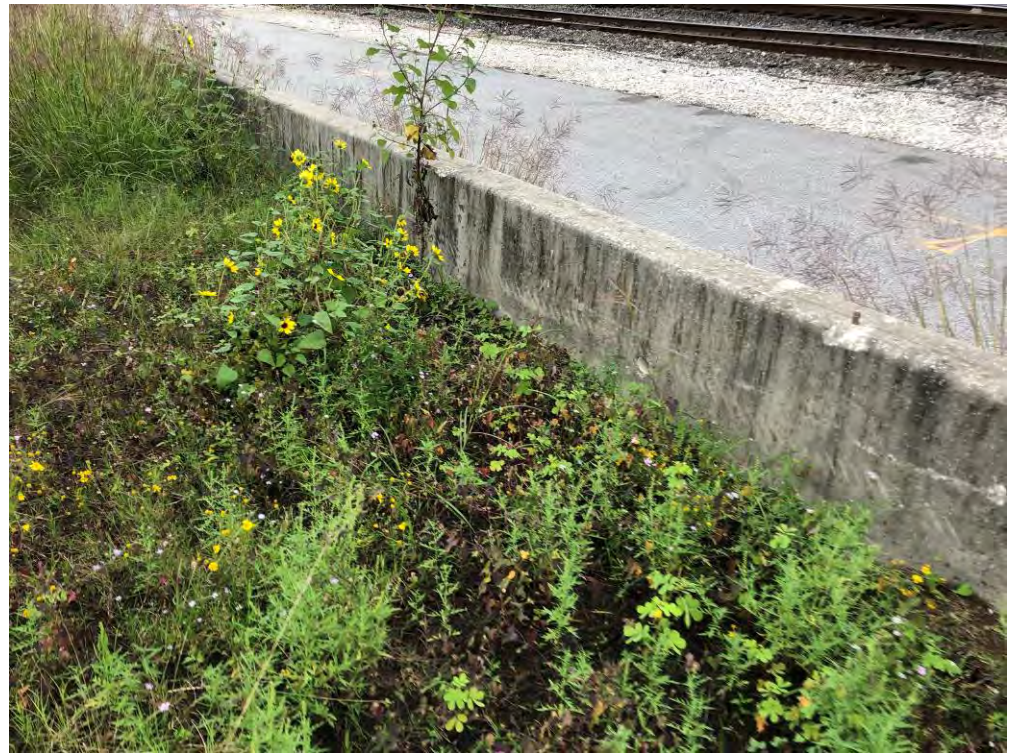
**Photo No.**  
**6**

Some weeds growing under the concrete barriers. Soil Cap's vegetative cover in good shape. Facing east.

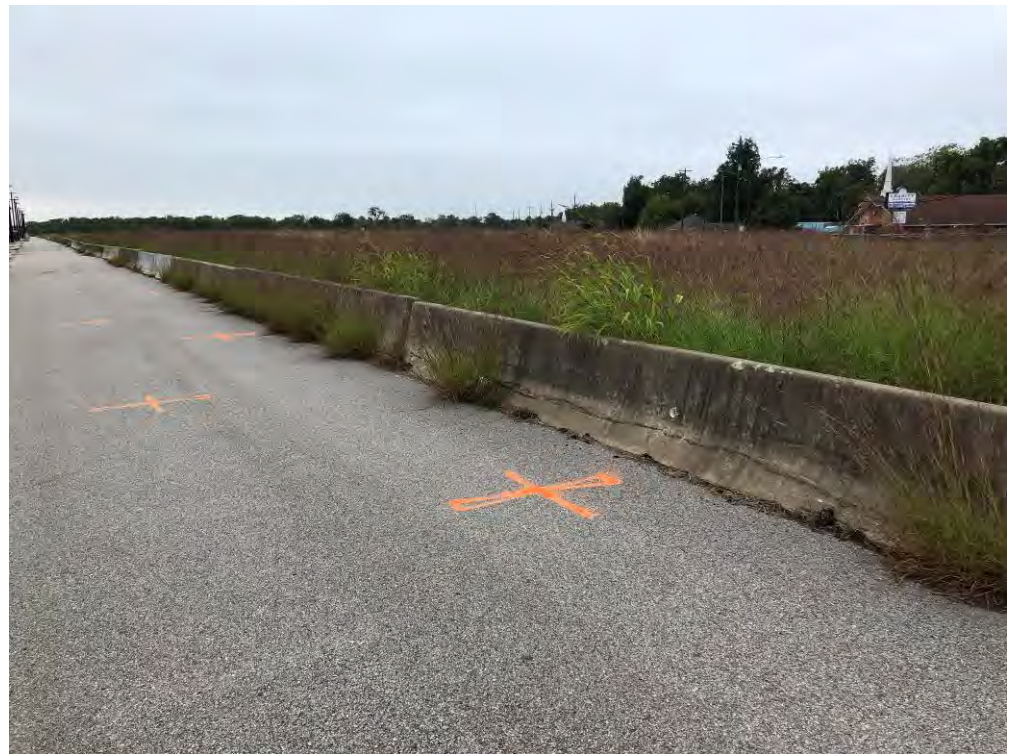
Weeds growing under the concrete barriers and along the edge of the ballast cap in some areas. Soil cap's vegetative cover in good shape. Facing west.

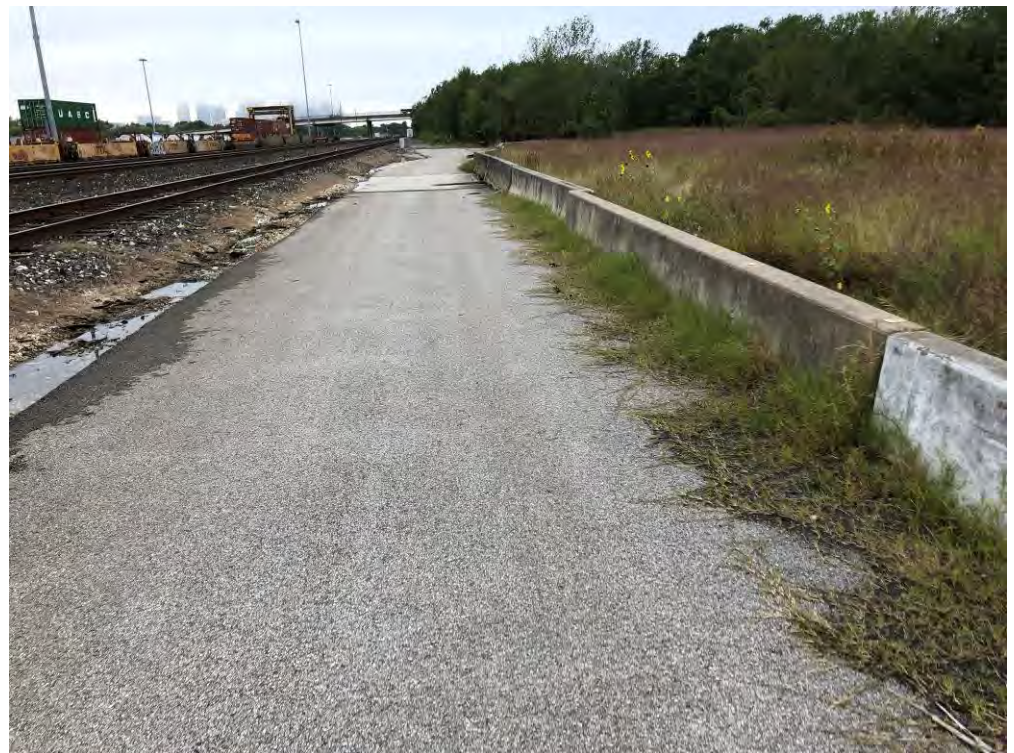
**Photo No.**  
**8**

Weeds growing under the concrete barriers and along the edge of the ballast cap in some areas. Soil cap's vegetative cover in good shape. Residual water from recent rain event noted. Facing west.

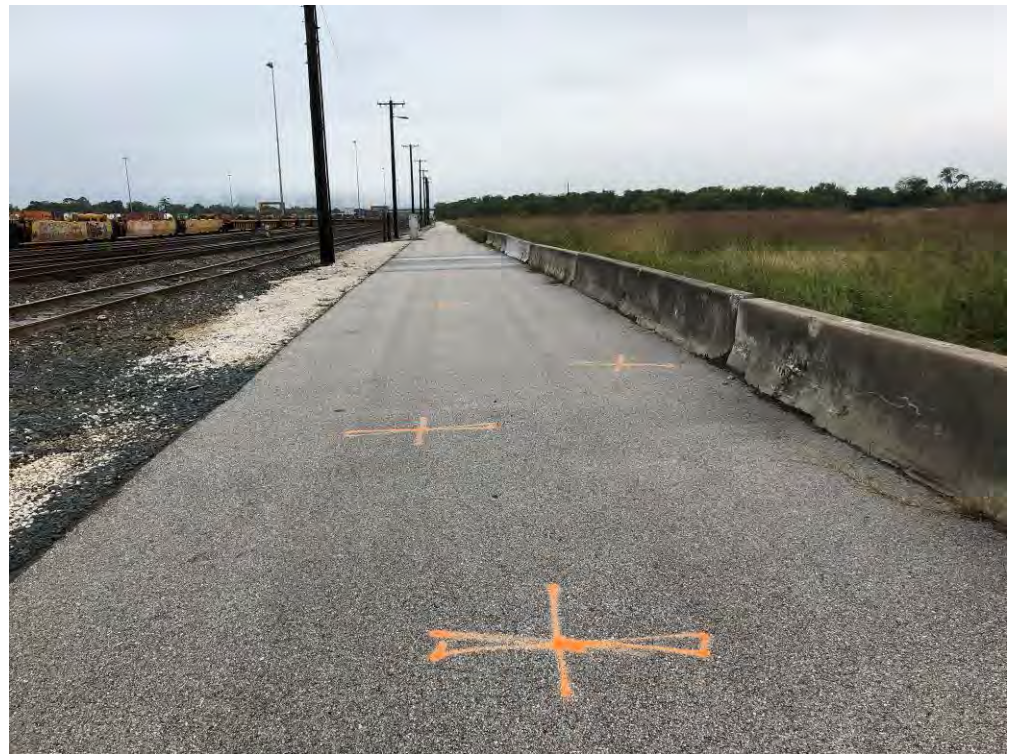
Asphalt roadway in good condition, free of major cracking/damage. Facing southwest.

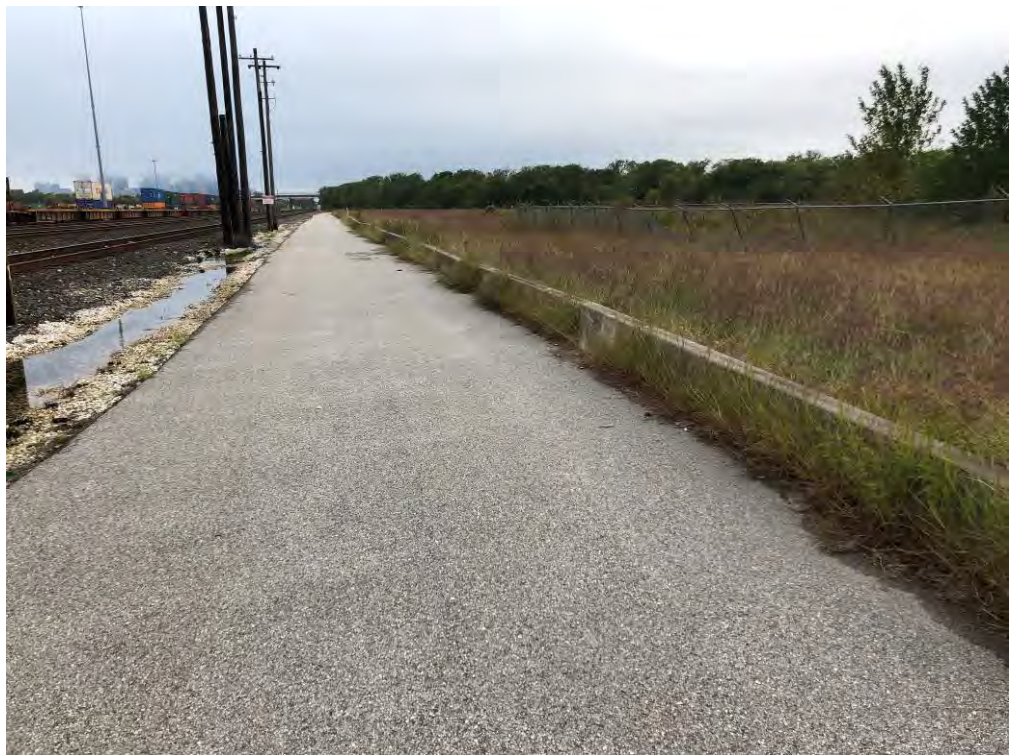
**Photo No.**  
**10**

Weeds growing under the concrete barriers and along the edge of the ballast cap in some areas. Residual water from recent rain event noted. Facing west.

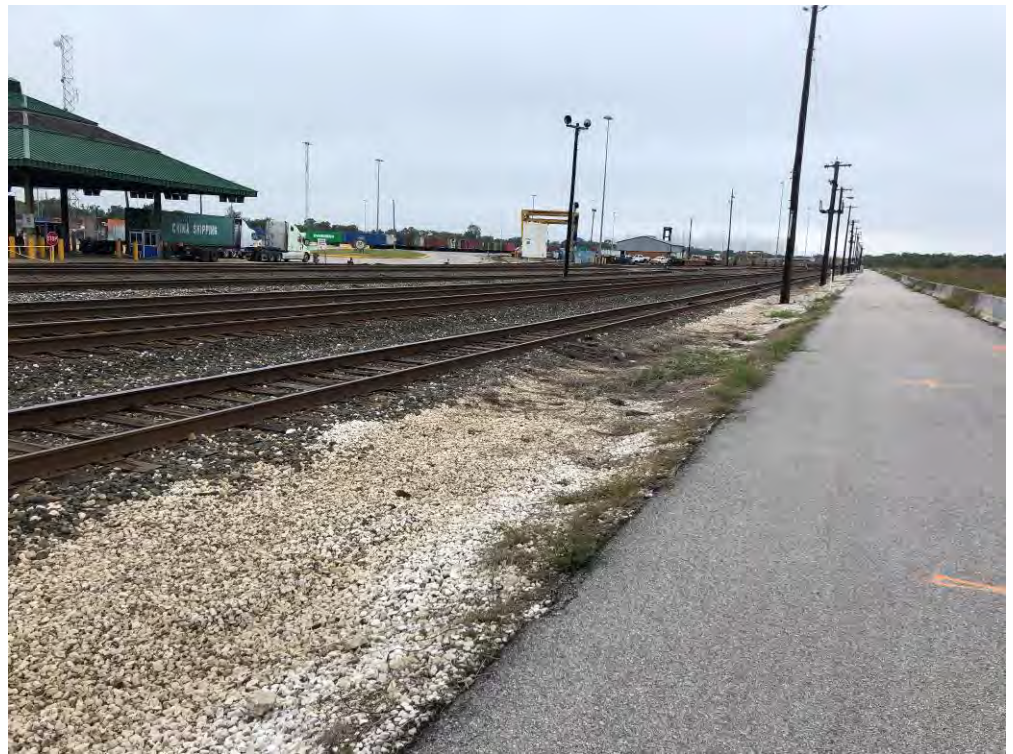
Ballast cap area in good condition with some areas of vegetative growth. Asphalt roadway in good condition. Facing southwest.

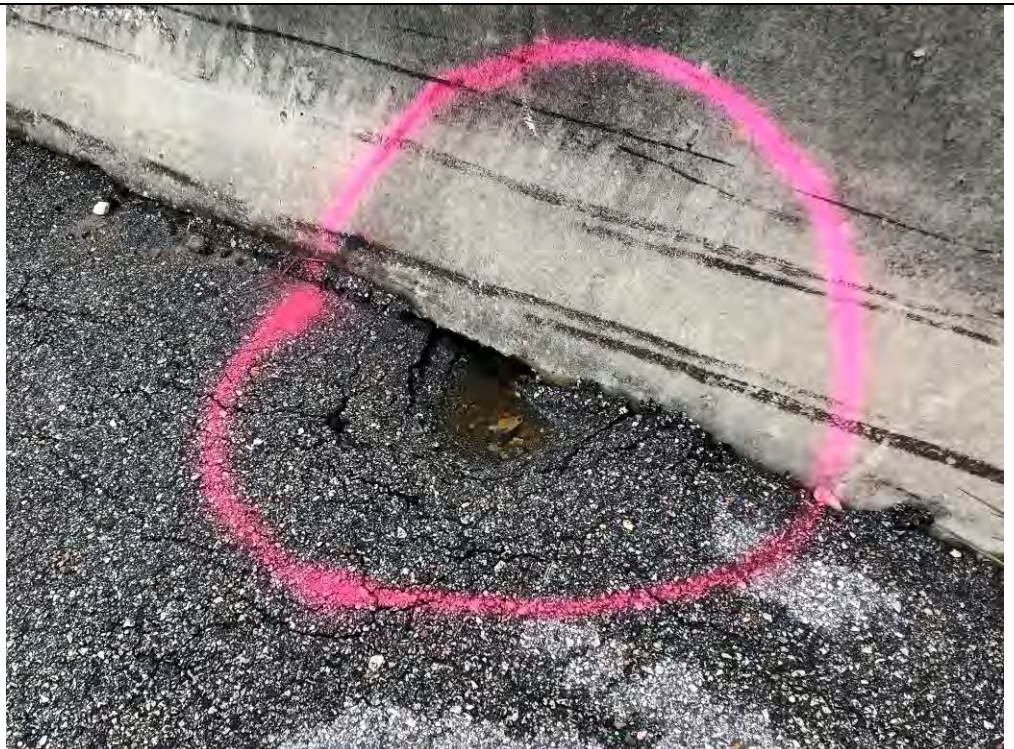
**Photo No.**  
**12**

Some minor gaps noted between soil cap and roadway. Facing west.

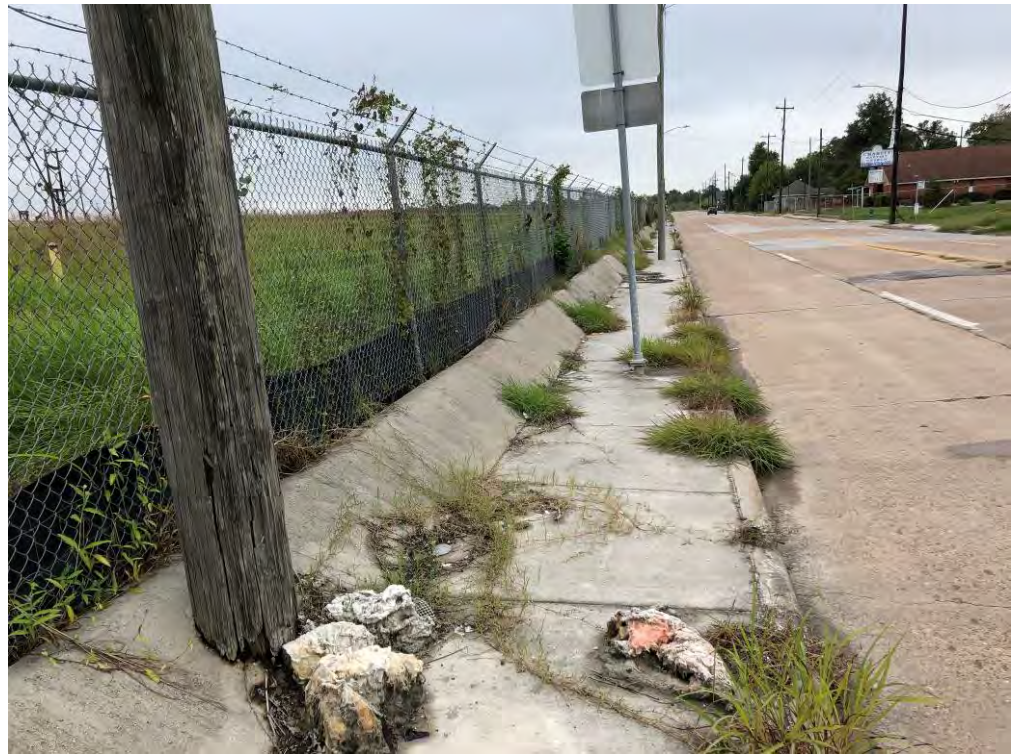
Sidewalk outside security fence in good condition. Some areas have significant vegetative growth and require mowing event. Some areas of damage/silt fencing ripped can be seen. Facing west.

Additional Comments or Observations: Mowing for site and sidewalk suggested, repairs to fence suggested in listed areas

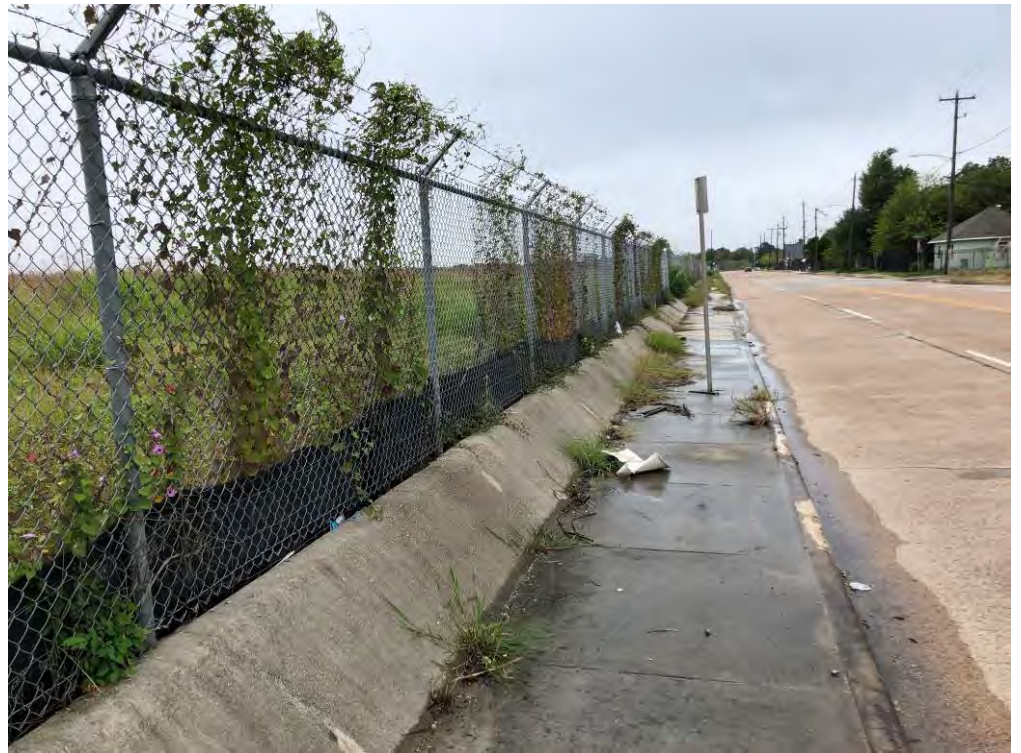
**Photo No.**  
**14**

Sidewalk outside security fence in good condition. Some areas have significant vegetative growth and require mowing event. Some areas of damage/silt fencing ripped can be seen. Residual water from recent rain event noted. Facing west.

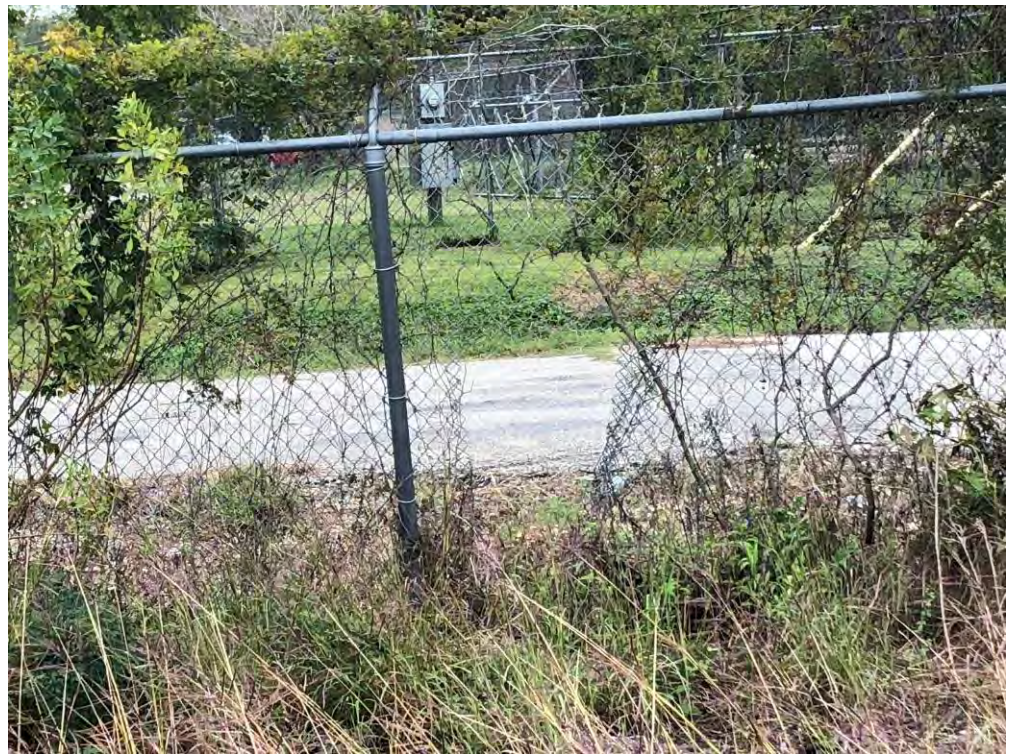
**Security Fence:**  
Hole in security fence in northwest corner of yard at intersection of Liberty Rd and Kashmere St. Facing west.

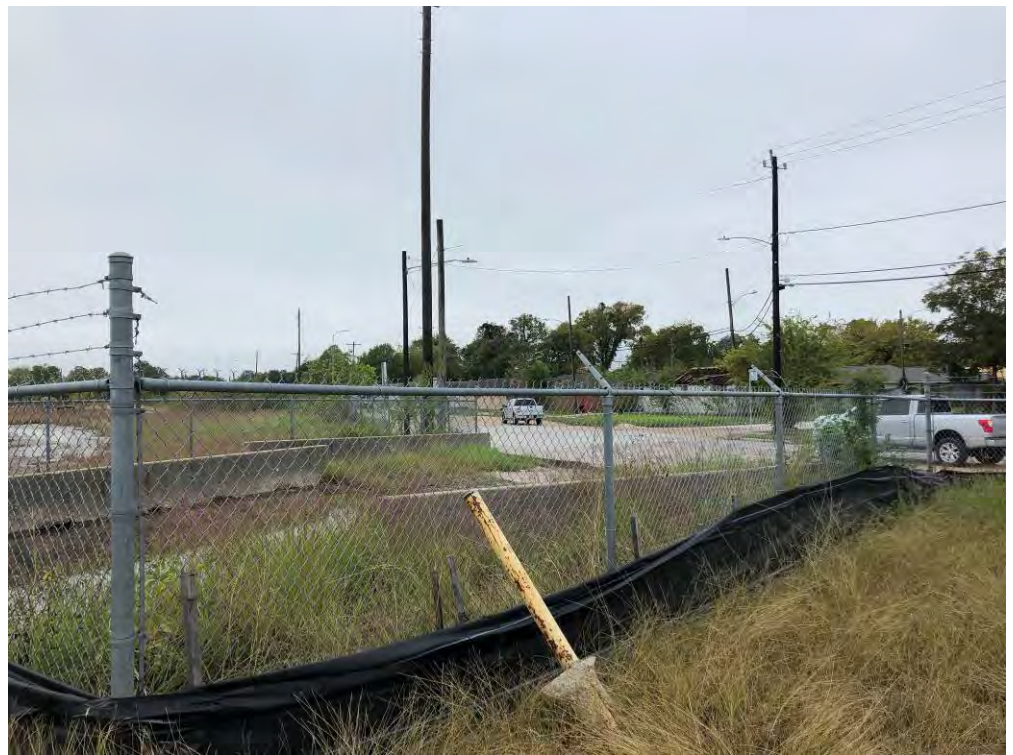
**Photo No.**  
**16**

**Security Fence (Entrance Gate):**  
Barbed wire atop security fence broken on east side of entrance area. Facing northwest.

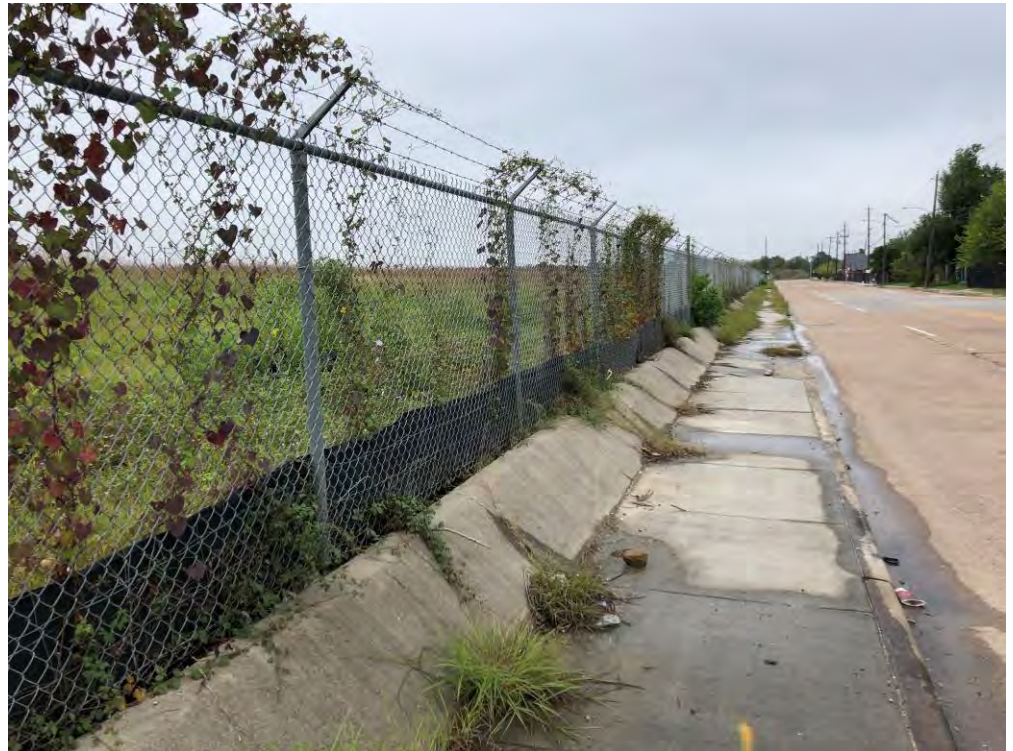
Sidewalk outside security fence in good condition. Some areas have significant vegetative growth and require mowing event. Some areas of damage/silt fencing ripped can be seen. Water from recent rain event. Facing west.

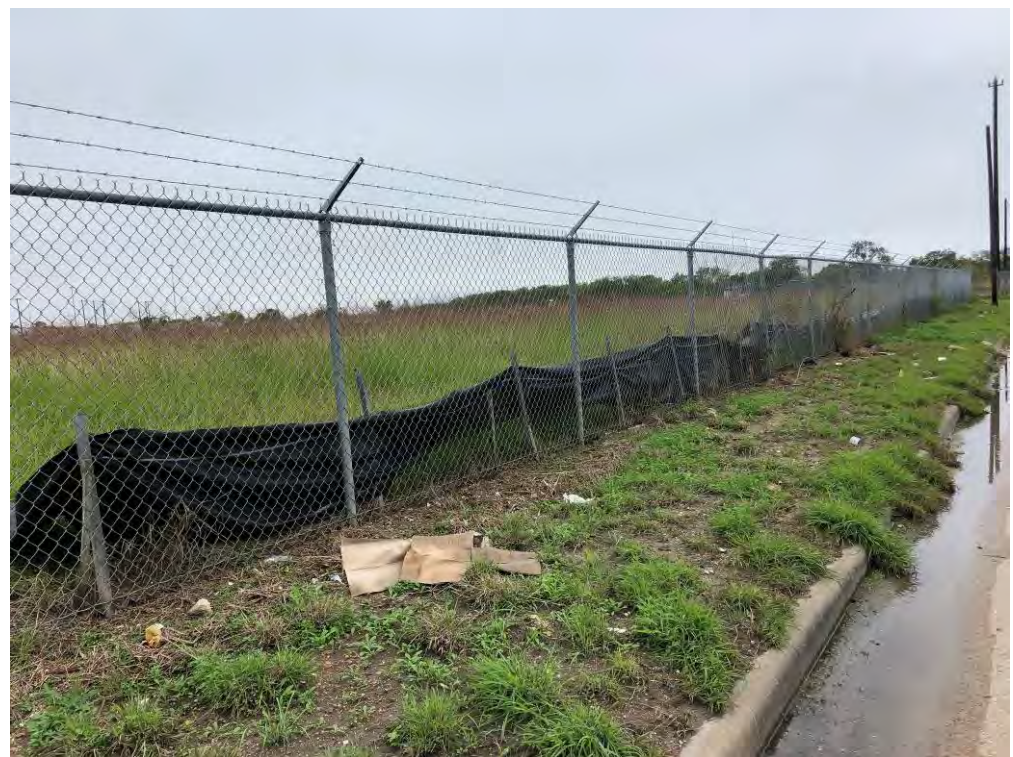
**Photo No.**  
**18**

Security fence in good shape along north side of the Site. Residual water from recent rain event noted. Facing west.

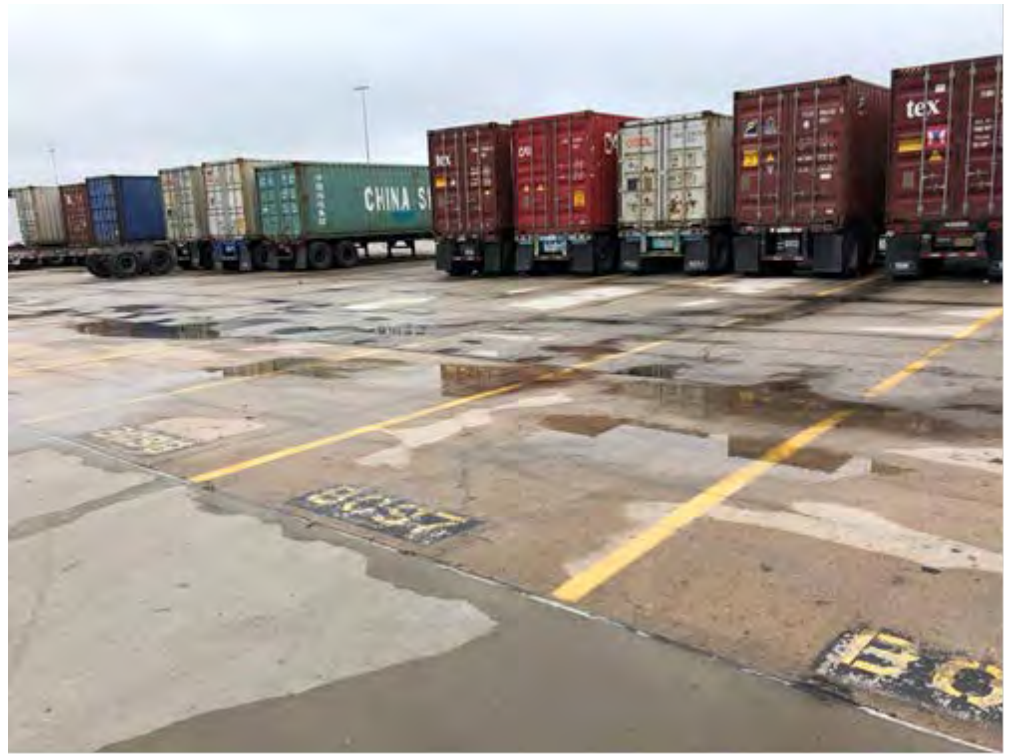
Some cracking/cratering in the pavement can be observed in the B Row of the Englewood Yard area. Residual water from recent rain event noted. Facing west.

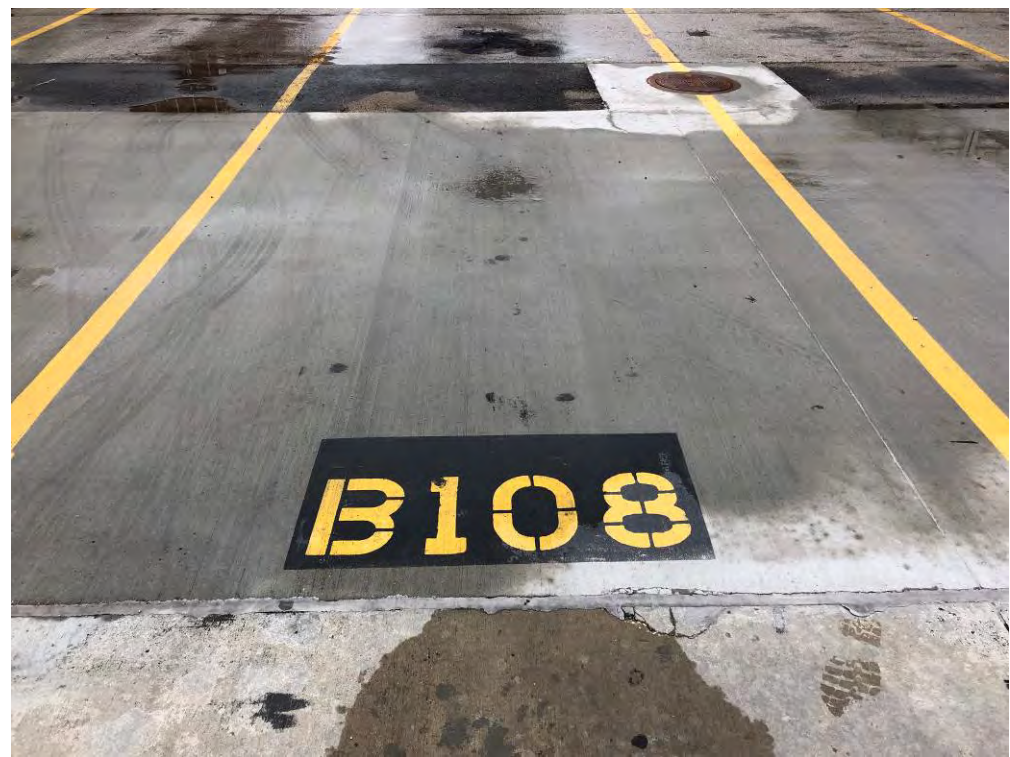
**Photo No.**  
**20**

B108 slot. NAPL seep remediation system in good condition. No major cracks/stains issues with concrete, sumps, or asphalt area. Residual water from recent rain event noted. Facing northwest.

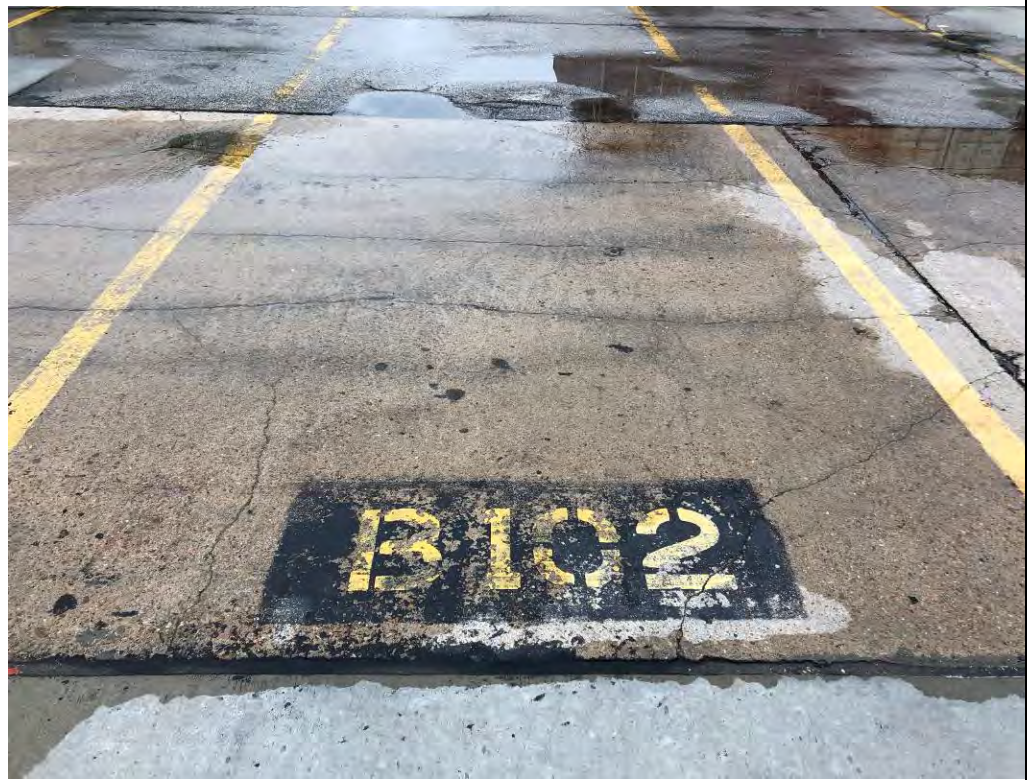
**Photo No.**  
**22**

Slot B102. No evidence of recent  
NAPL seepage. Evidence of  
missing joint sealant can be  
observed in the Yard Area along  
the front of some stalls. Residual  
water from recent rain event  
noted. Facing north.

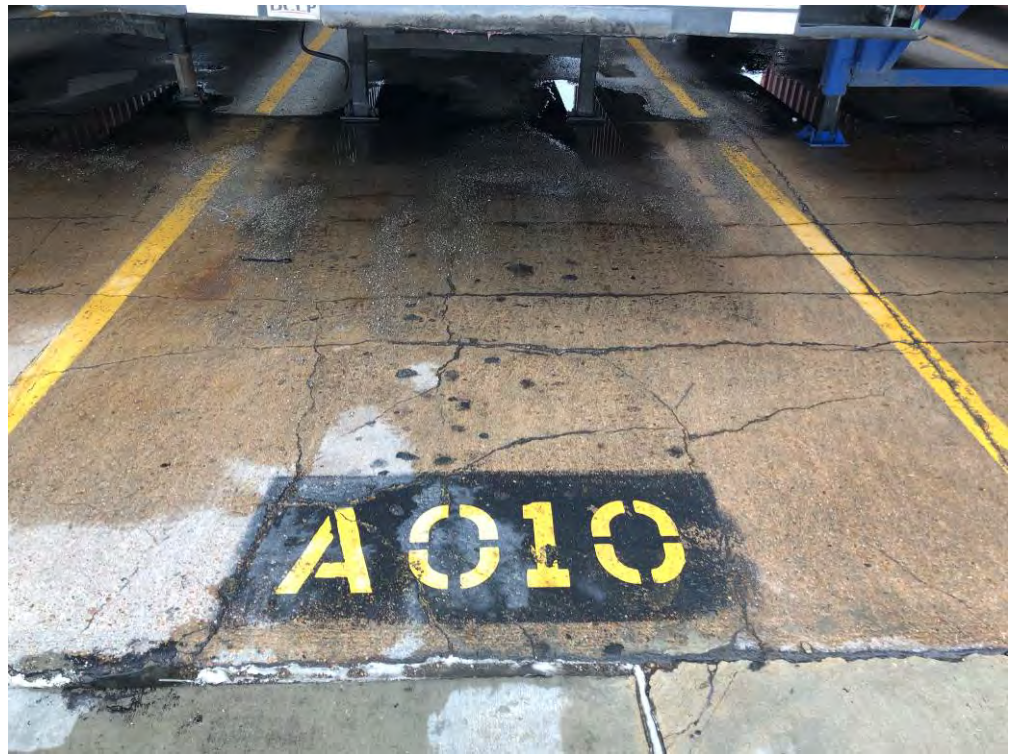
Slot A010. No evidence of recent NAPL seepage. Residual water from recent rain event noted. Facing west.

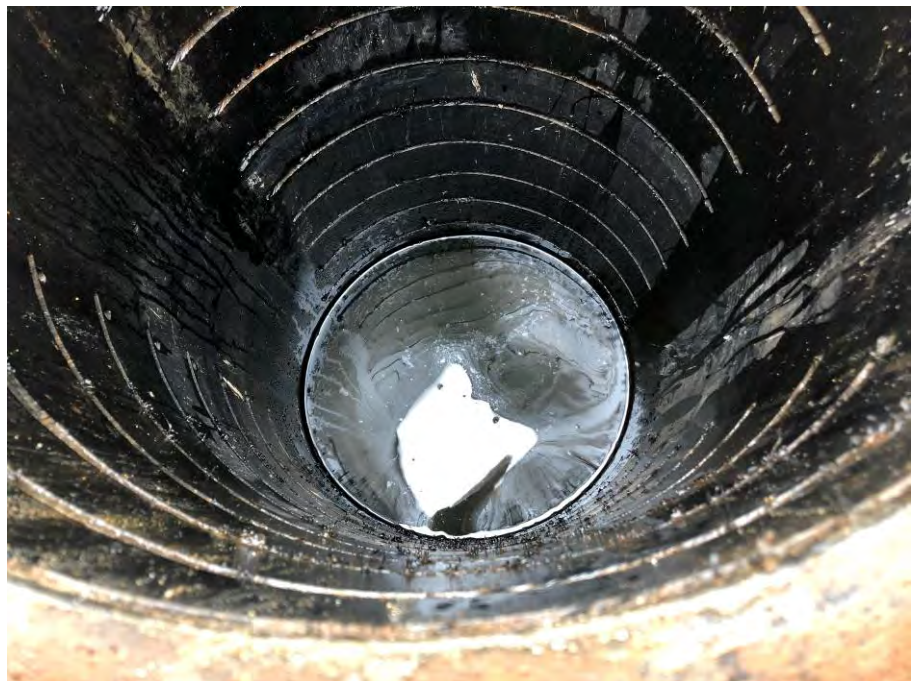
**Photo No.**  
**24**

View of the sump water in manhole at NAPL Collection Sump B107/B108.

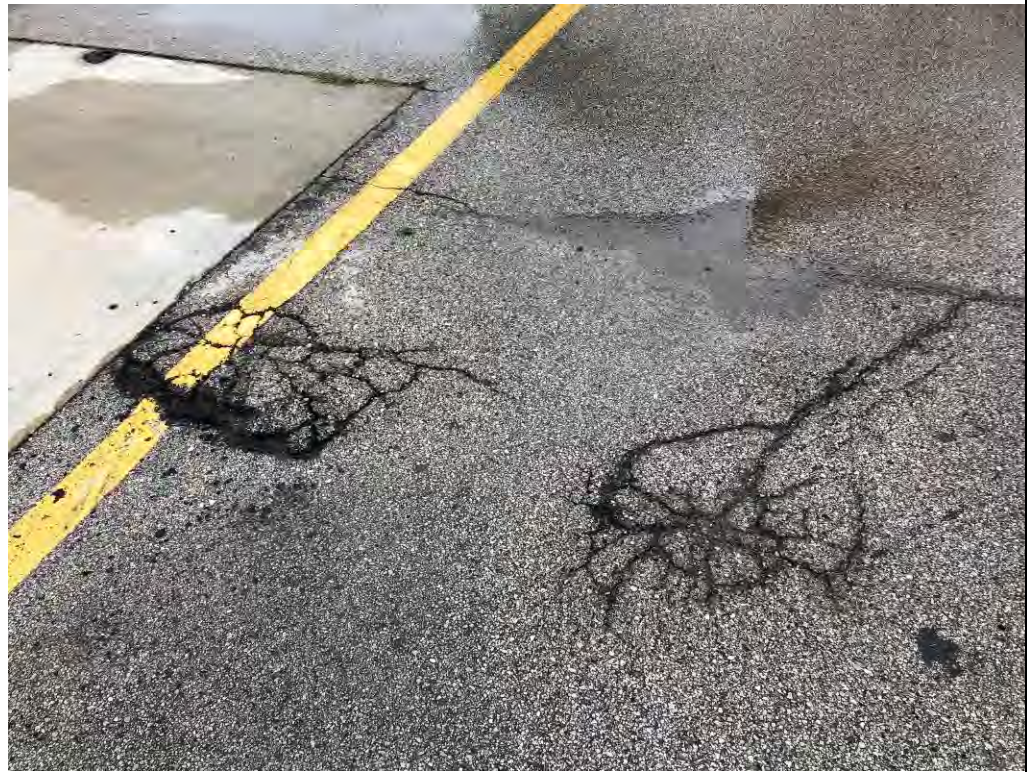
Slot B057. No evidence of recent NAPL seepage. Some cracking in the pavement. Residual water from recent rain event noted. Facing north.

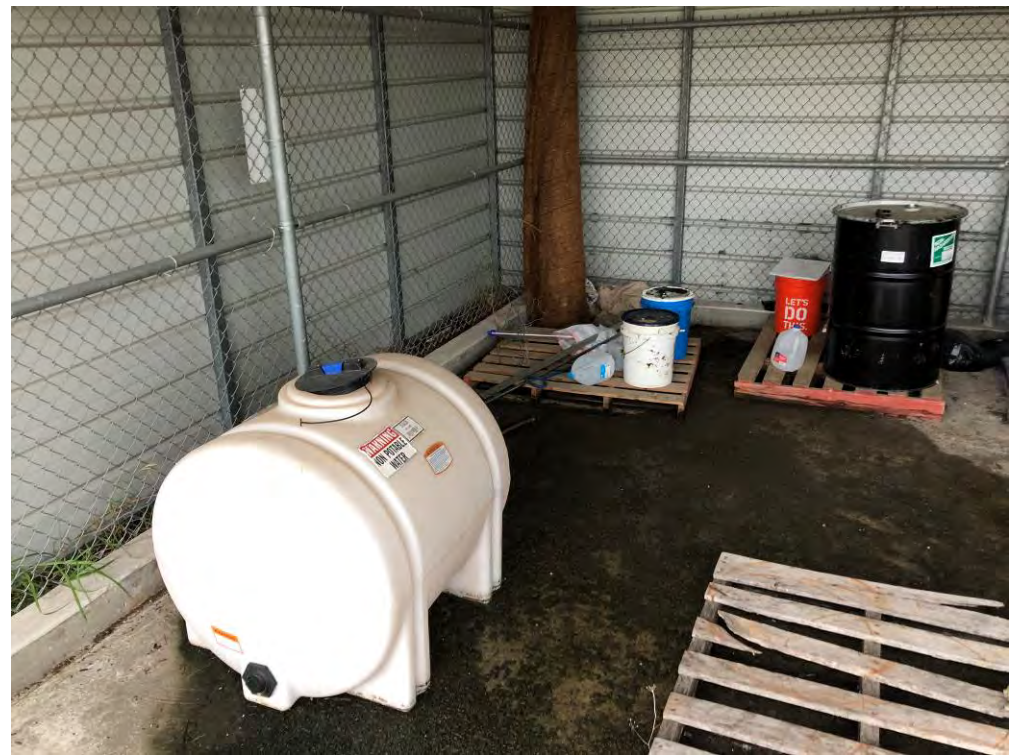
**Photo No.**  
**26**

Valve in closed position and functioning within the container storage area. CSA in good condition, free of major dents and other damage. Minor water on floor. Facing southeast.

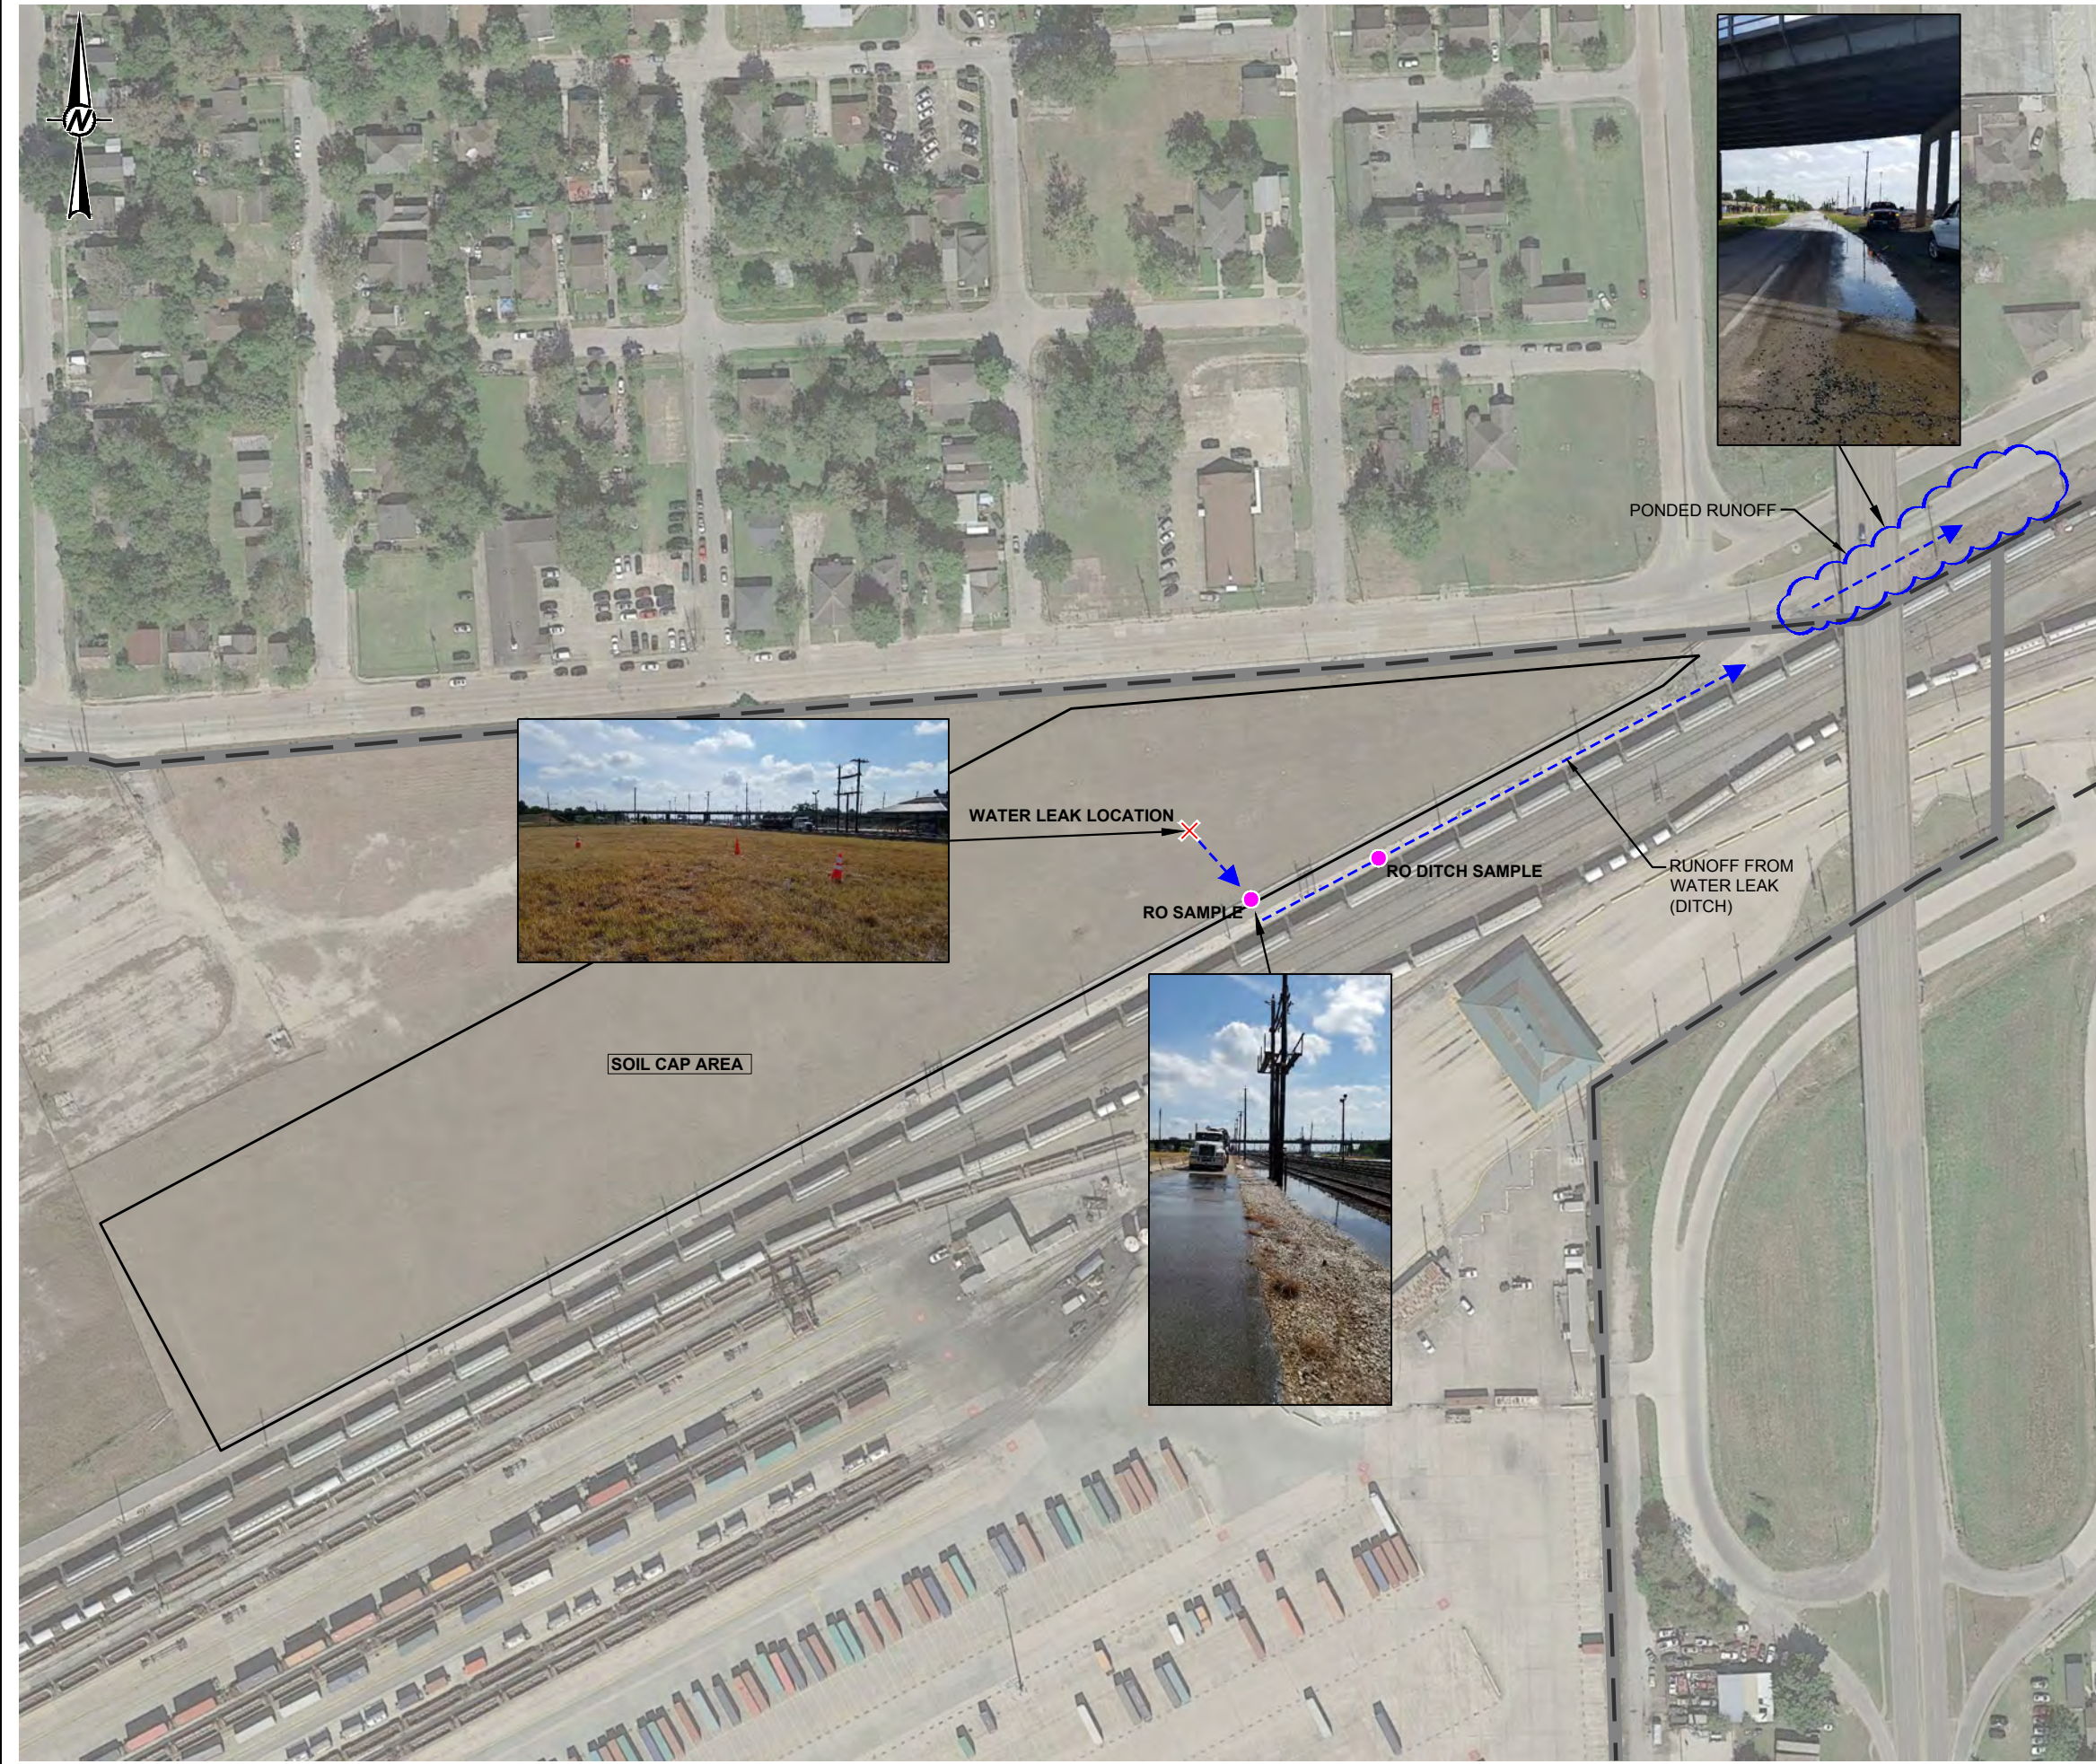
PROJECT NO. 19119232      REV. 0      FIGURE 1

The runoff flow direction is illustrated in Figure 1.

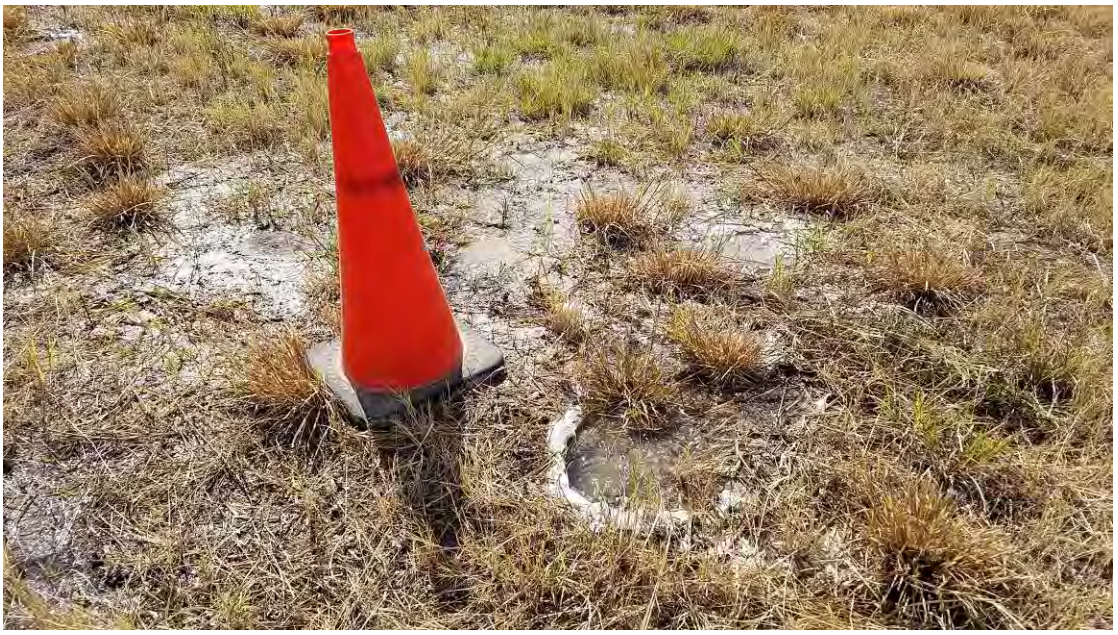
Location of the source of water emanating from the soil cap.
