March 31, 2020

Project No. 19119232

**RE: POST-RESPONSE ACTION COMPLETION REPORT – 2019  
UNION PACIFIC RAILROAD HOUSTON WOOD PRESERVING WORKS, HOUSTON, TEXAS  
4910 LIBERTY ROAD, HOUSTON, HARRIS COUNTY, TEXAS  
TCEQ SWR NO. 31547; TCEQ PERMIT/COMPLIANCE PLAN NO. 50343EPA ID NO. TXD000820266  
CUSTOMER NO. CN600131098; REGULATED ENTITY NO. RN100674613**

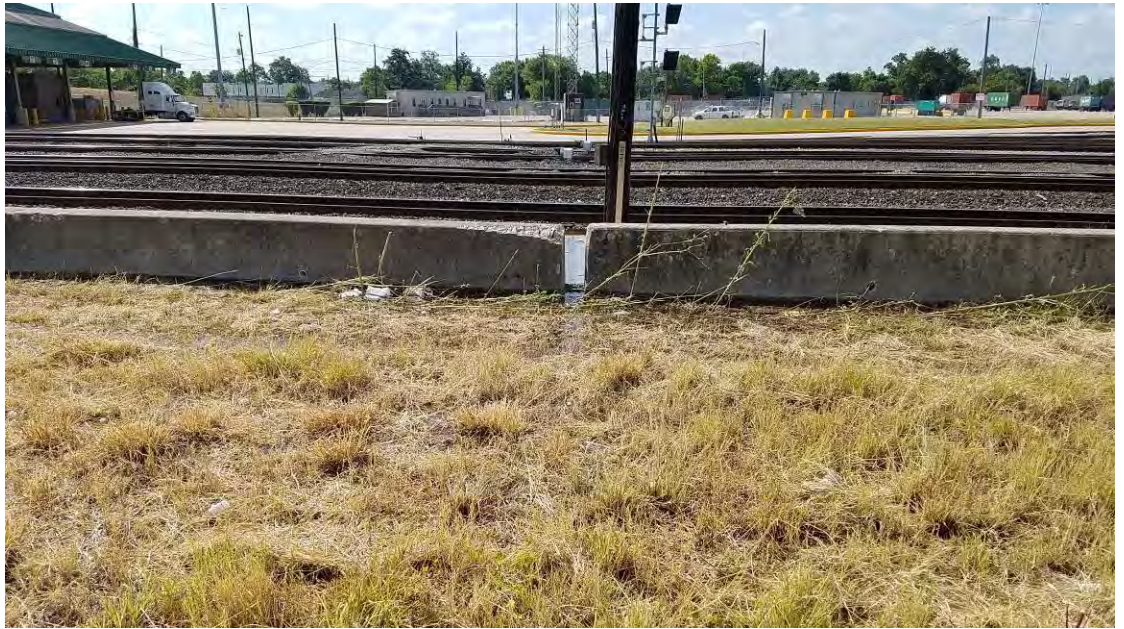
Runoff from soil cap toward asphalt road and railroad tracks, looking south.

Location of water runoff sample W-1620-RO-20190810.

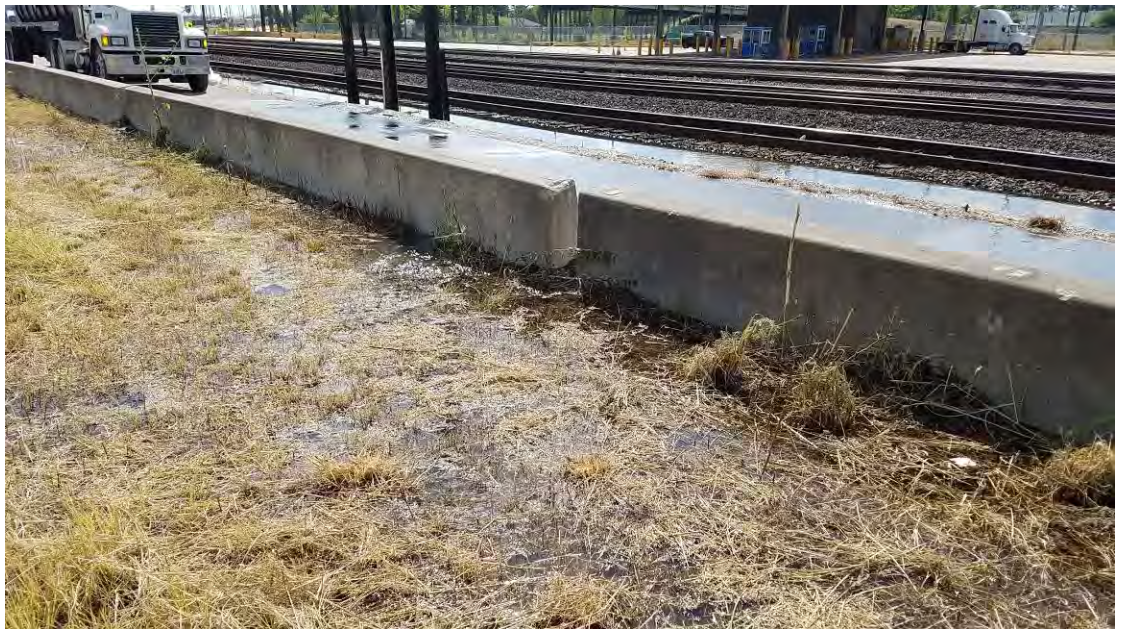
**Photo No.**  
**4**

Runoff from soil cap toward asphalt road and railroad tracks, looking southeast.

Location of water runoff sample W-1620-RO-20190810.

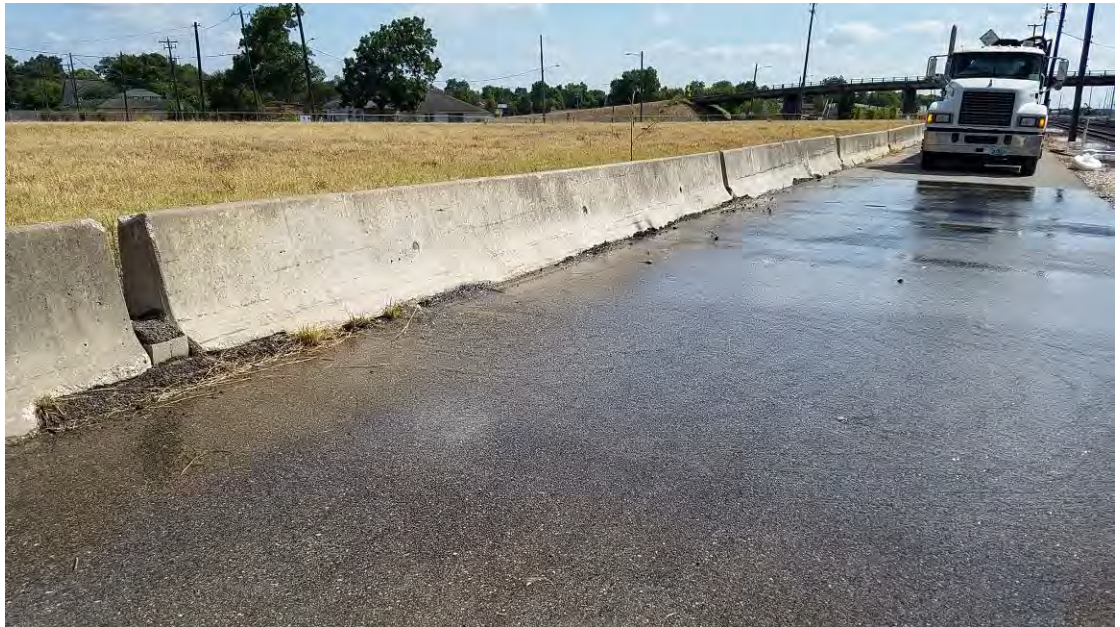
Water flowing across asphalt road toward railroad tracks from soil cap, looking northeast.

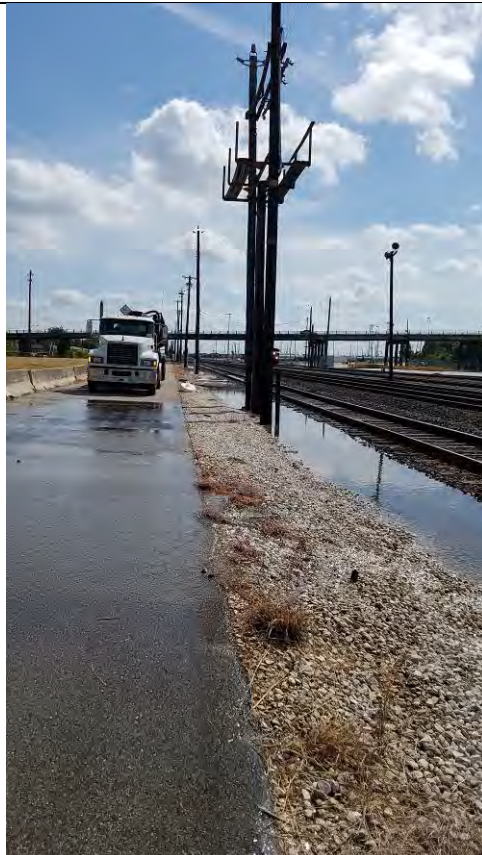
<b>Photo No.</b> 6	<b>Date:</b> 08/10/19
-----------------------	--------------------------

Water flowing across asphalt road toward railroad tracks from soil cap, looking northeast.

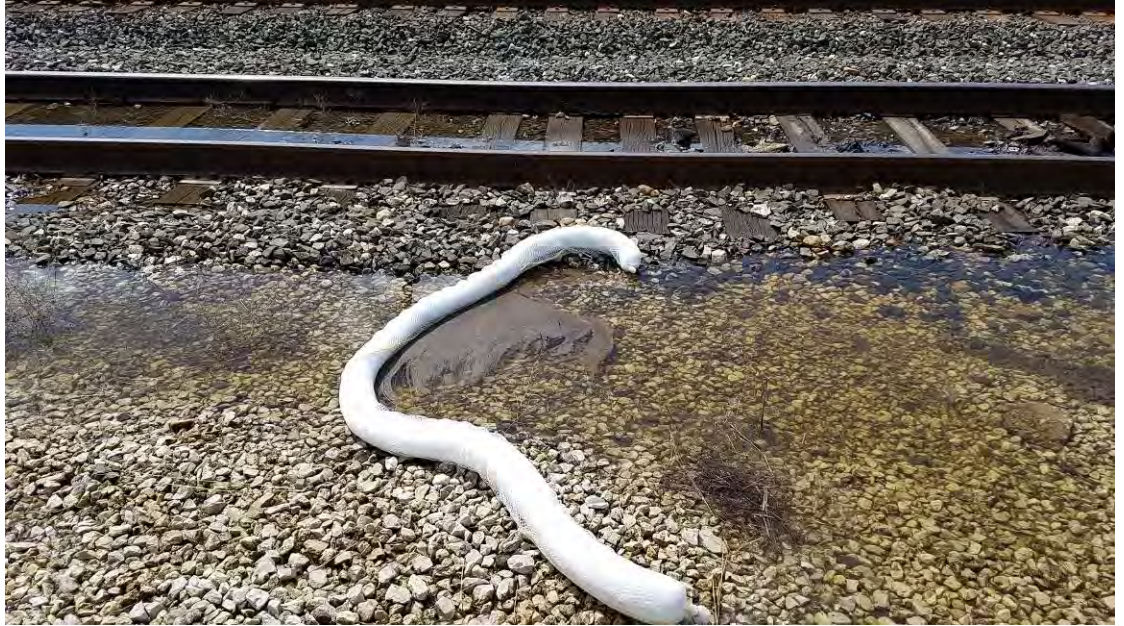
Absorbent boom placed in the ditch adjacent to railroad tracks, looking south. Note floating debris, no sheen observed.

Location of water run off sample W-1620-RO-Ditch-20190810.

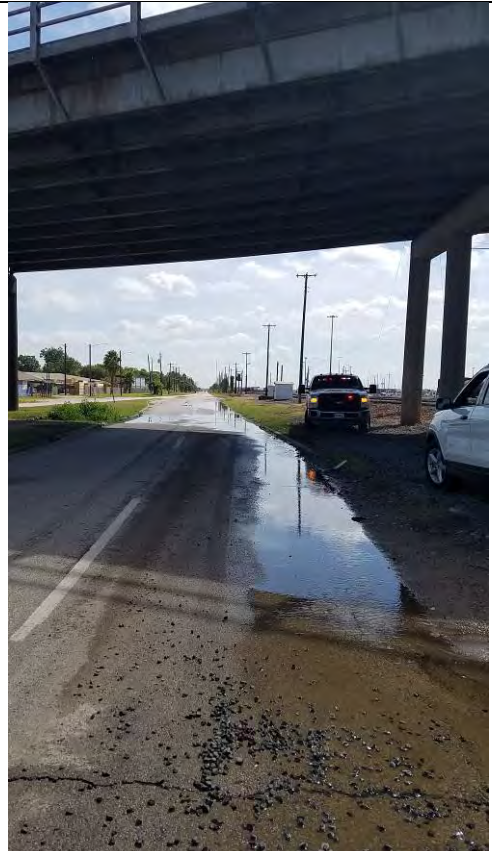
**Description:**  
Runoff under Lockwood Drive Bridge on Liberty Road, looking east.

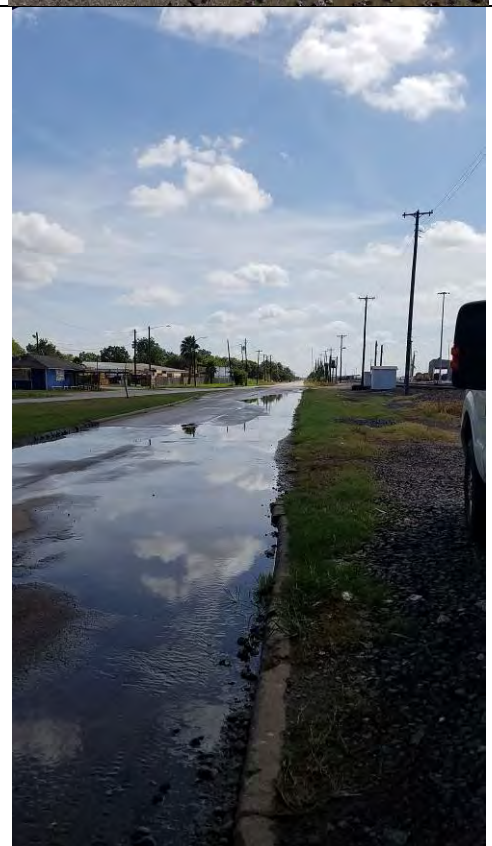
**Description:**  
Liberty Road past Lockwood Drive Bridge, looking east.

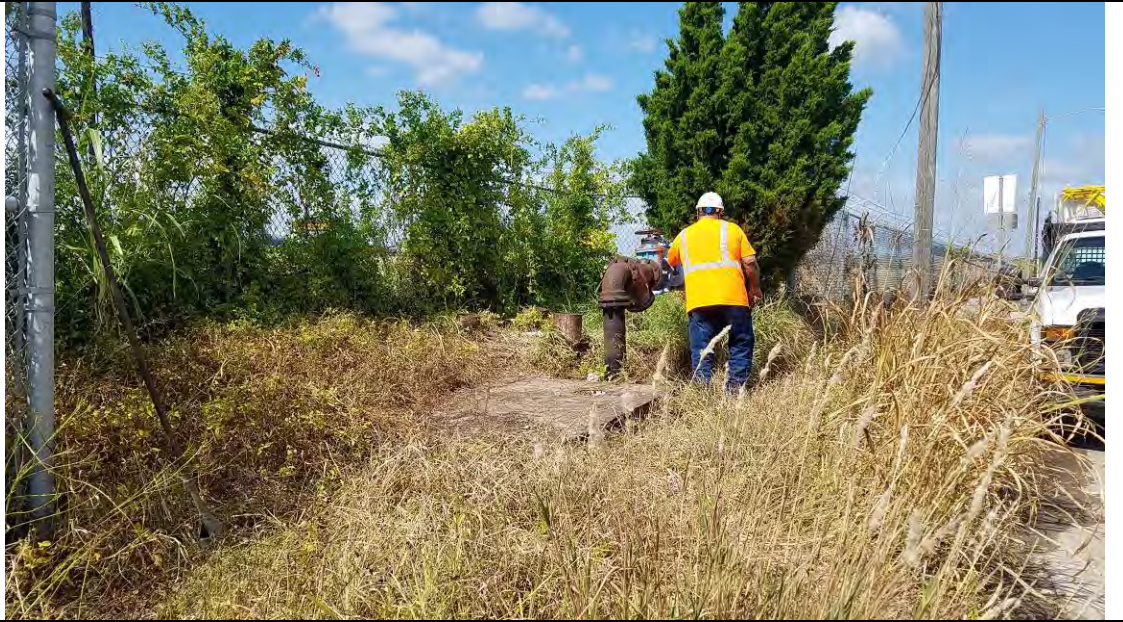
Location of water valve that was turned on at northeast corner of the property, looking west.
