**RE: POST-RESPONSE ACTION COMPLETION REPORT – 2020
UNION PACIFIC RAILROAD HOUSTON WOOD PRESERVING WORKS, HOUSTON, TEXAS
4910 LIBERTY ROAD, HOUSTON, HARRIS COUNTY, TEXAS
TCEQ SWR NO. 31547; TCEQ PERMIT/COMPLIANCE PLAN NO. 50343EPA ID NO. TXD000820266
CUSTOMER NO. CN600131098; REGULATED ENTITY NO. RN100674613**

TEXAS COMMISSION ON ENVIRONMENTAL QUALITY Post-Response Action Care Report (PRACR)

SECOND QUARTER 2020 (APRIL 28TH) INSPECTION RECORD AND PHOTOGRAPHIC LOG

THIRD QUARTER 2020 (JULY 23RD) INSPECTION RECORD AND PHOTOGRAPHIC LOGS

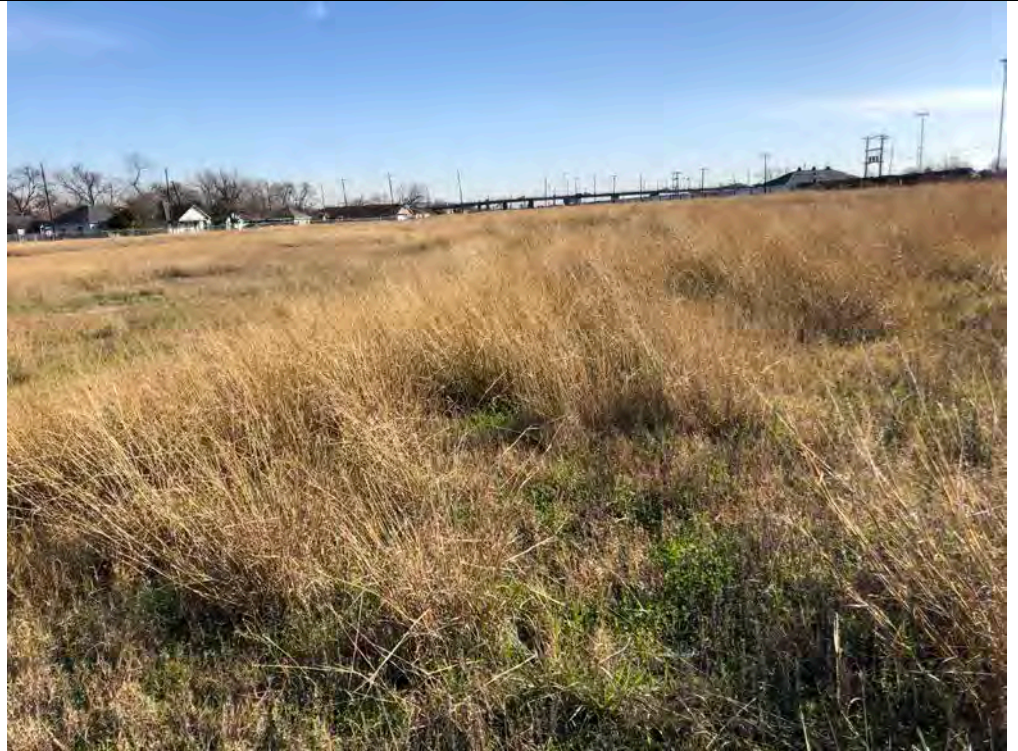
Photo No.
2

Vegetative growth (brushes and grasses in particular) can be observed along the length of the soil cap, preventing future erosion. Facing west.

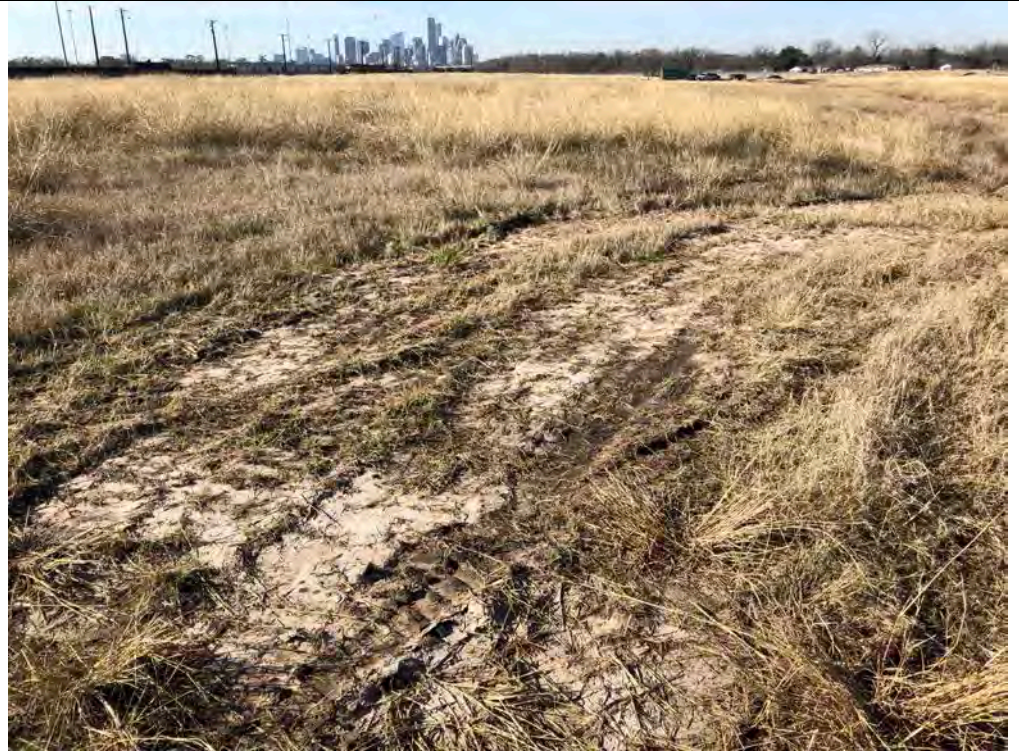
Photo No.
6

Soil cap well-vegetated in most areas with a low risk of erosion. Some damage to cap and slope due to trucks and rigs driving on it. Possible resodding needed in some areas. Facing west.

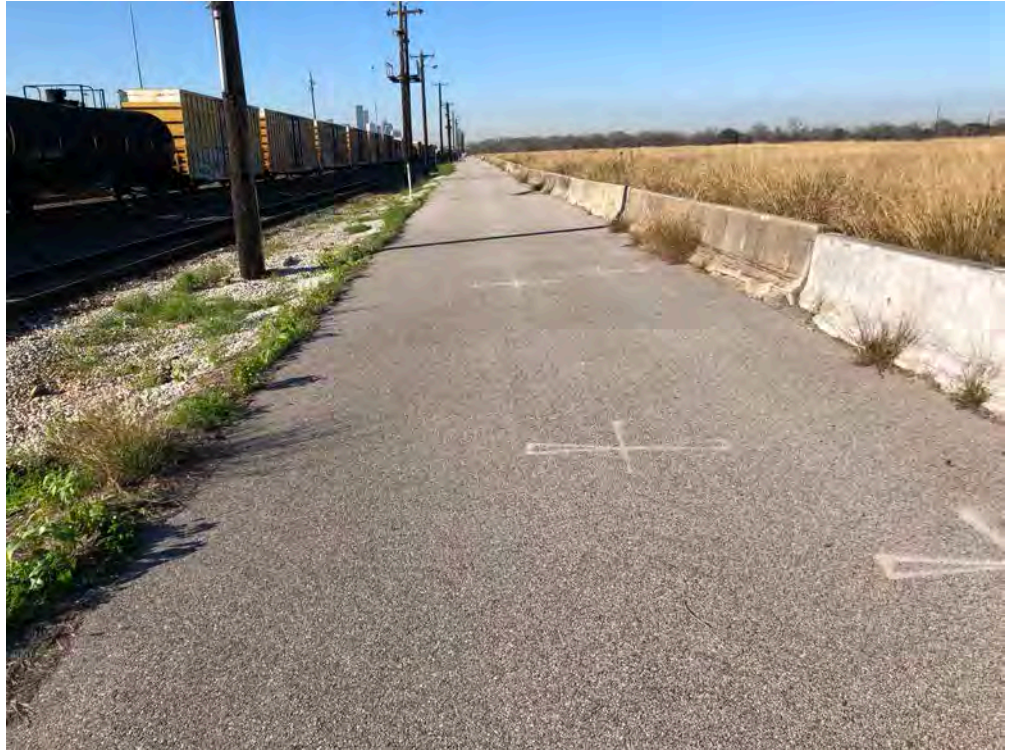
Photo No.
8

Weeds and vegetation can be observed growing under the concrete barriers. Facing west.

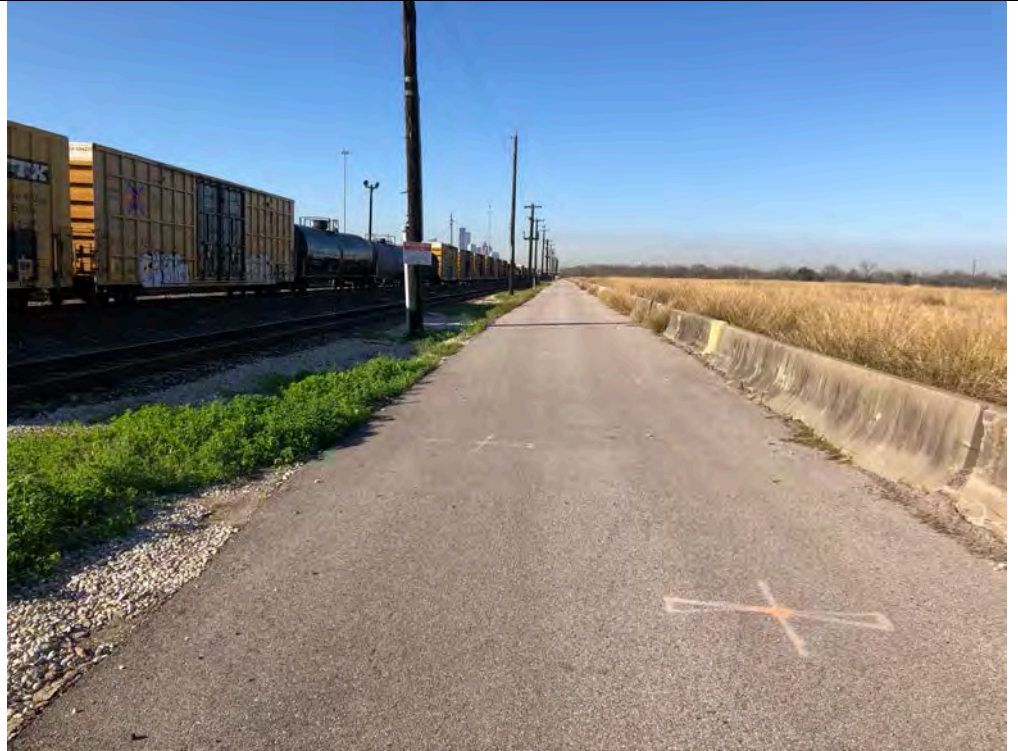
Photo No.
10

- Railroad Ballast Cap – The railroad ballast cap area appeared to be in good condition, with some vegetation growth within the ballast area (see Photo Nos. 7, 8, and 10). Some areas of bare soil were observed in the ballast cap near the edge of the asphalt road (Photo No. 10).

Some minor gaps noted between soil cap and roadway. Facing west.

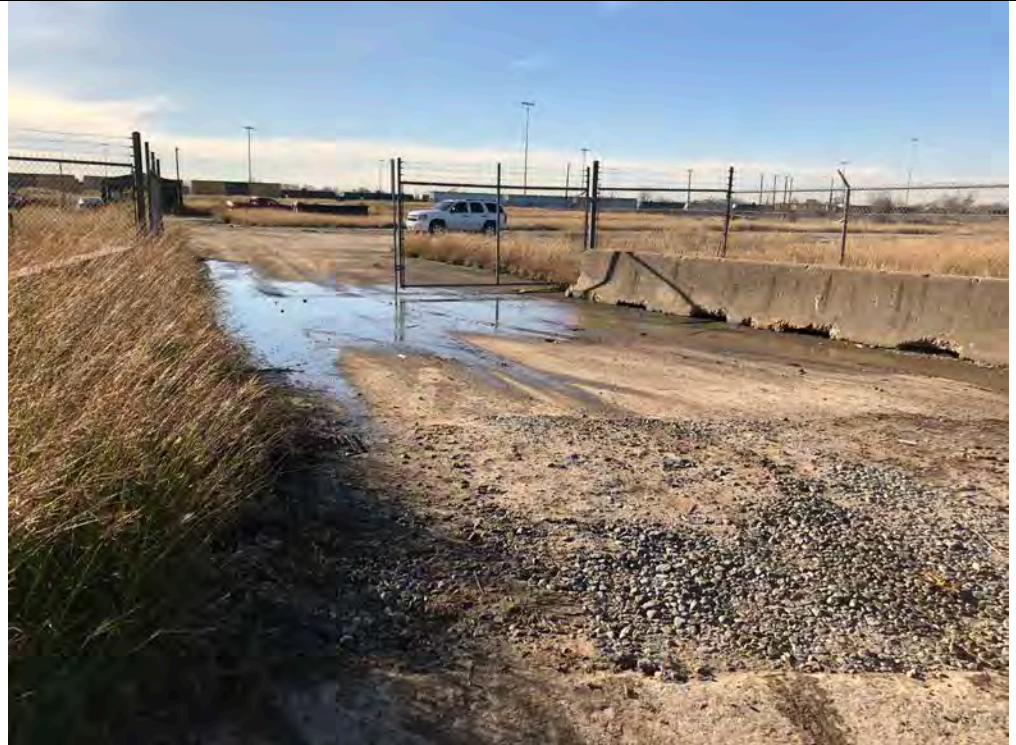
Photo No.
18

Barbed wire atop security fence tacked down on west side of entrance area. Barbed wire is broken on east side of fence as well. Facing southeast.

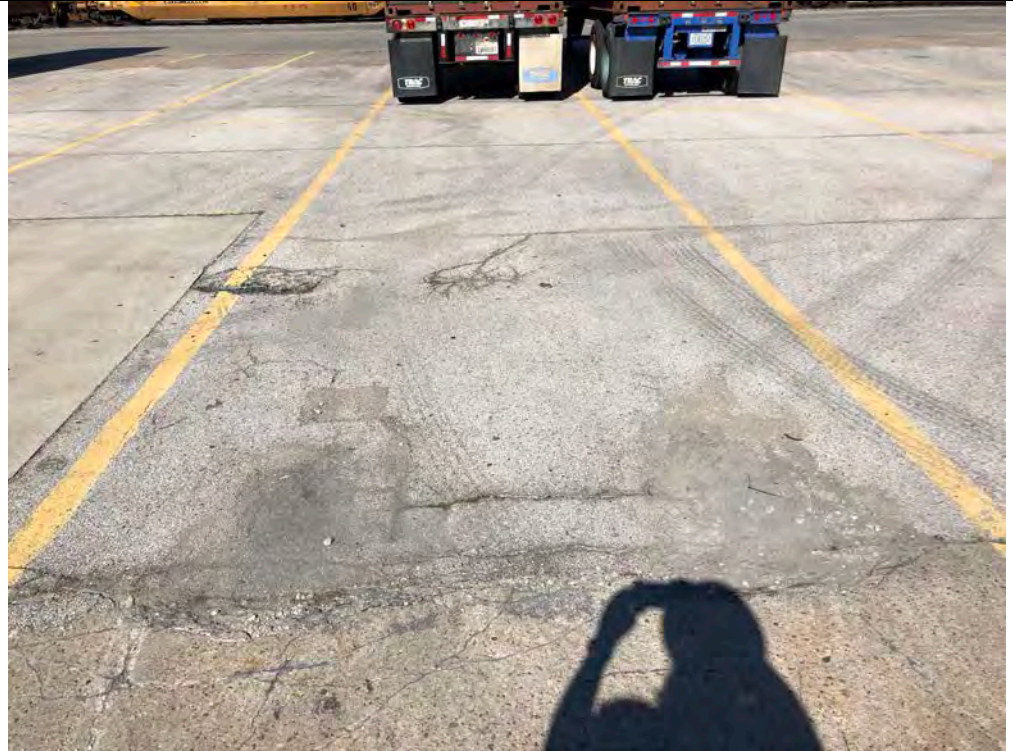
Photo No.
22

B057 stall. Evidence of minor cracking, sometimes producing NAPL seeps. Facing northwest.

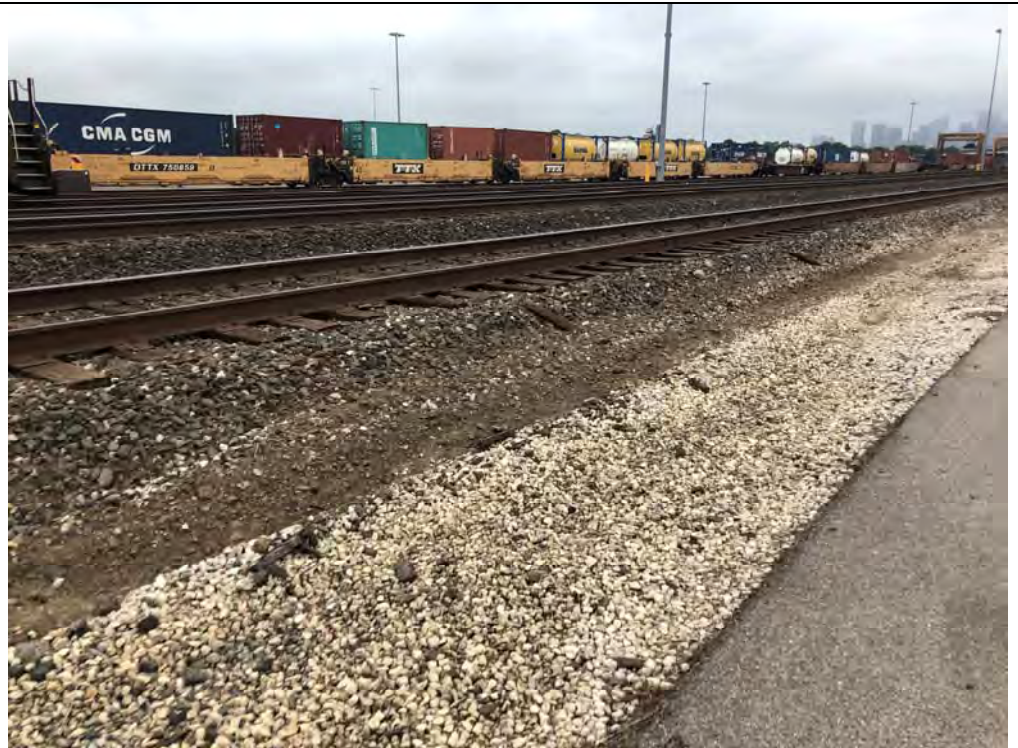
Exposed soil visible in ballast cap, likely brought up by equipment used on ballast. Facing southwest.

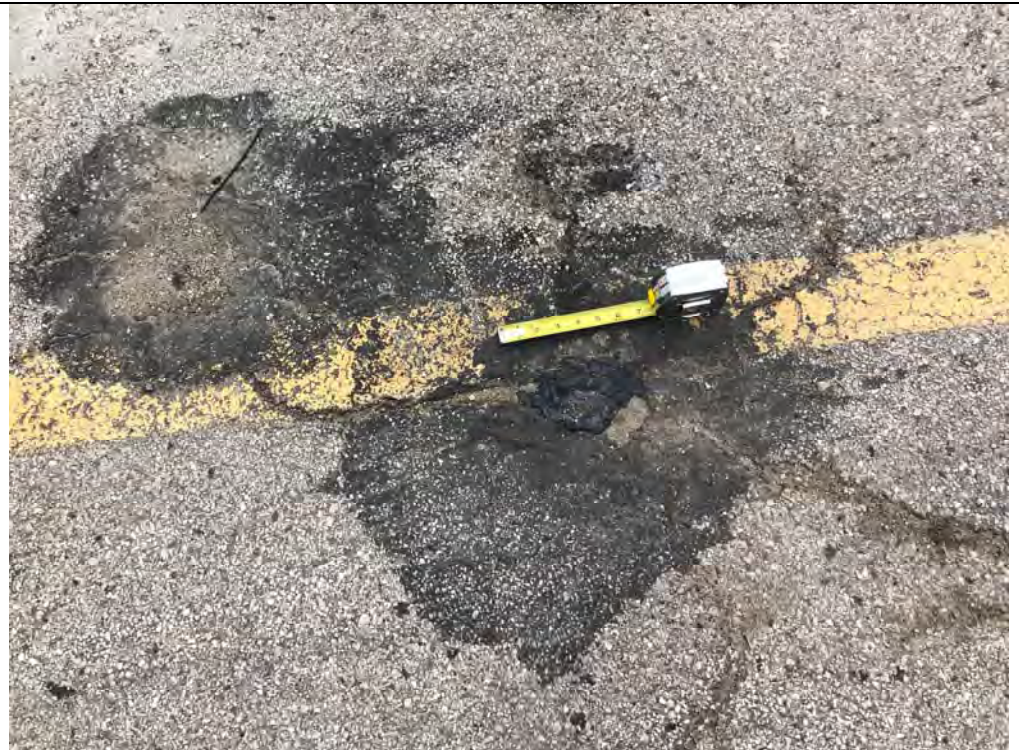
B100/101 stalls. Evidence of minor cracking and recent tar-like seepage (in asphalt), some present at time of inspection. Facing north.

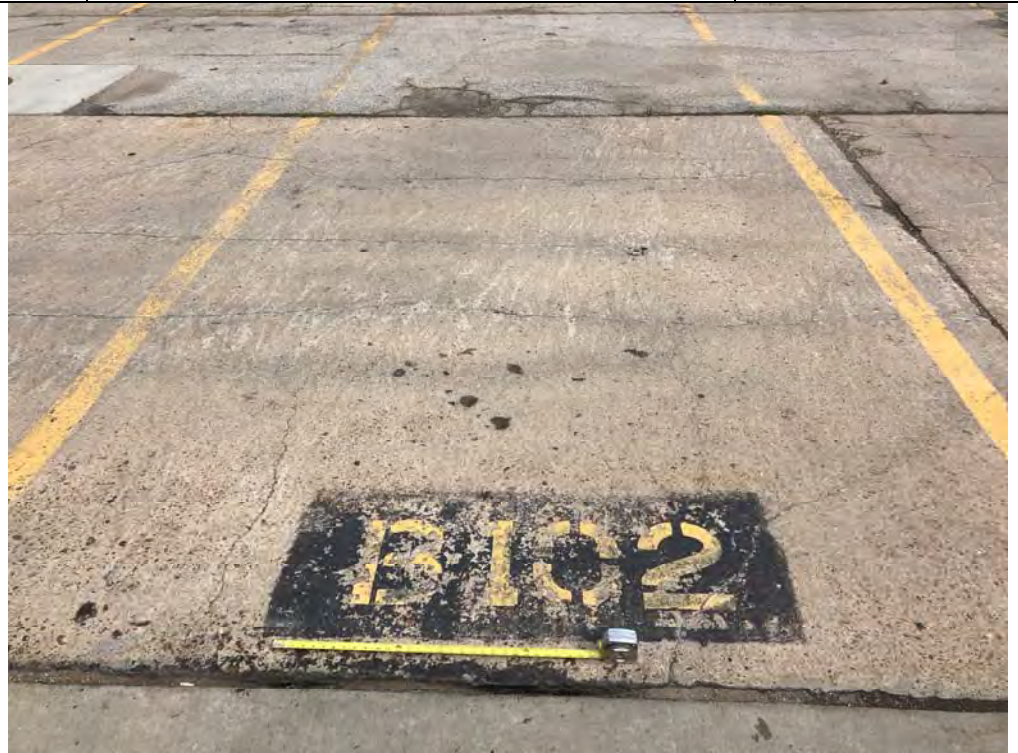
Photo No.
28

NAPL recovery system in B Row in good condition, free from major marking, cracking, or other issues. No visible vegetation or exposed soil was observed. Facing east.

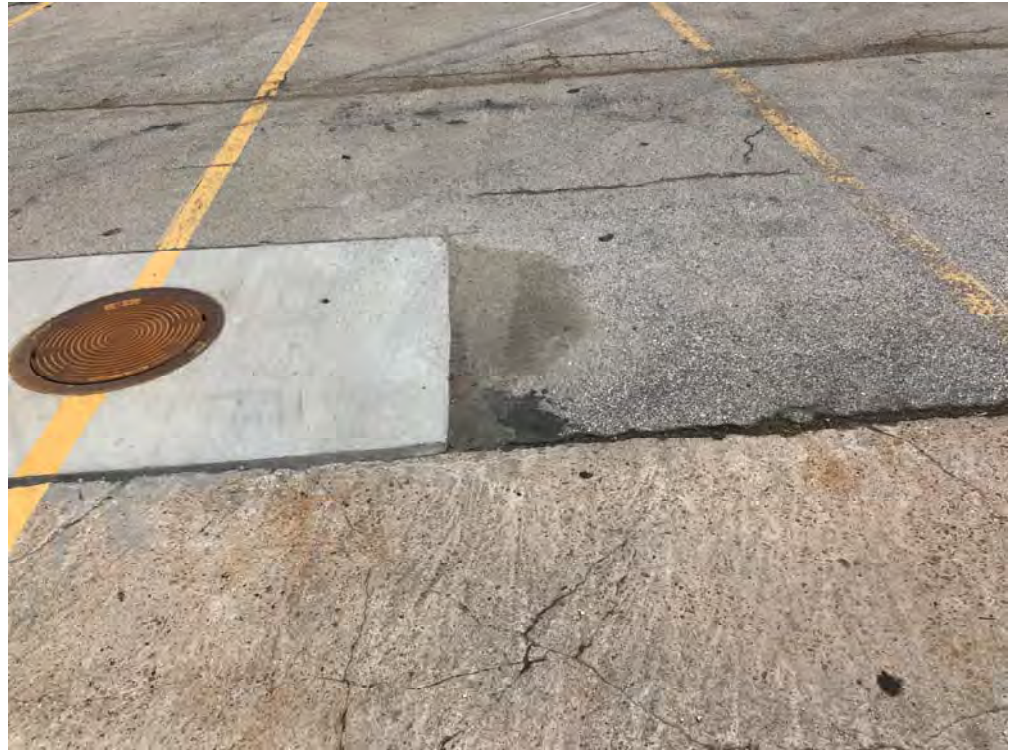
Photo No.
30

Sump B107/B108. NAPL Collection System in stalls B099-B110 in good condition with little evidence of cracking, stains, etc. Facing southwest.

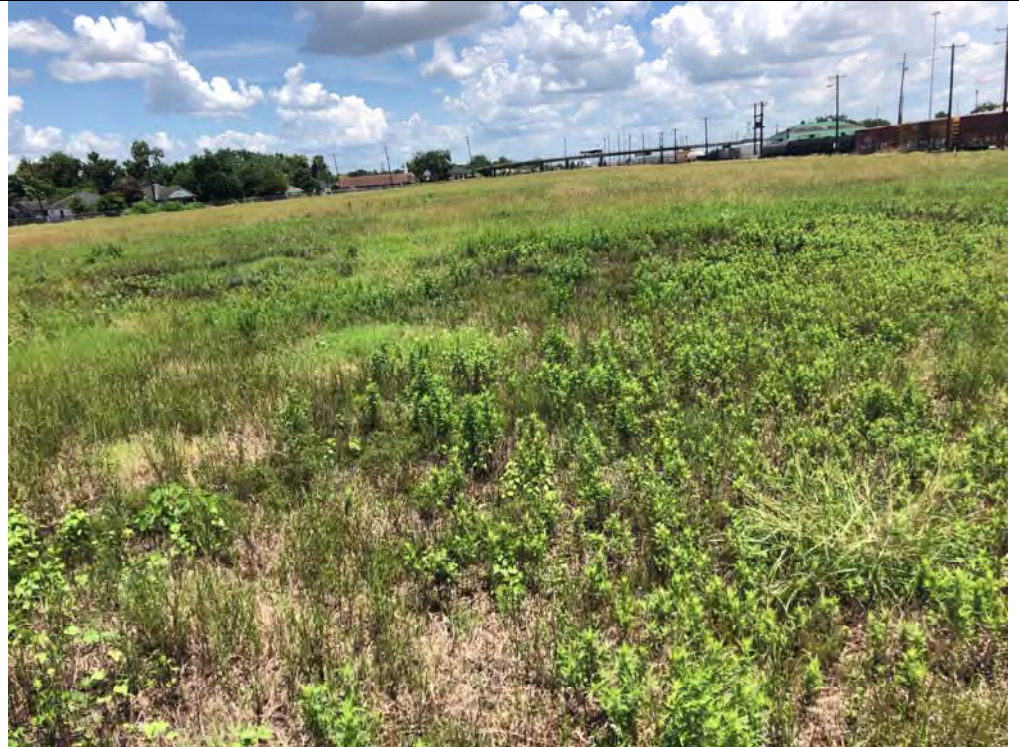
Soil cap well-vegetated in most areas with a low risk of erosion. Variety of plant species observed. Facing east.

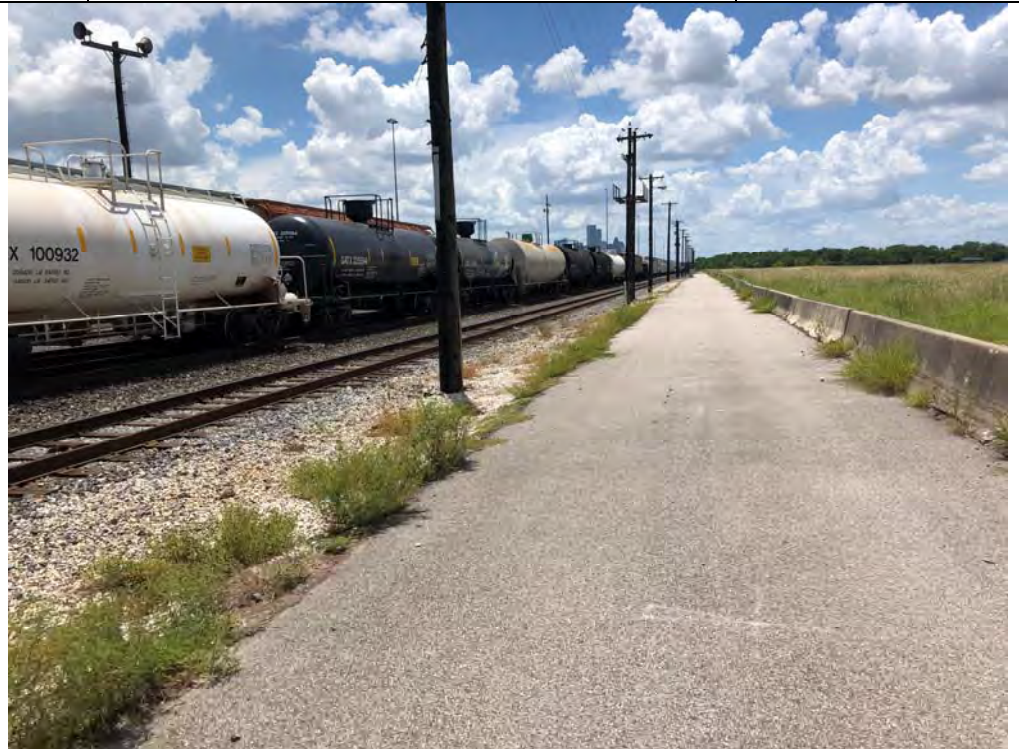
Asphalt roadway in good condition, free of major cracking/damage. Some vegetation can be noted growing within the ballast cap. Facing southwest.

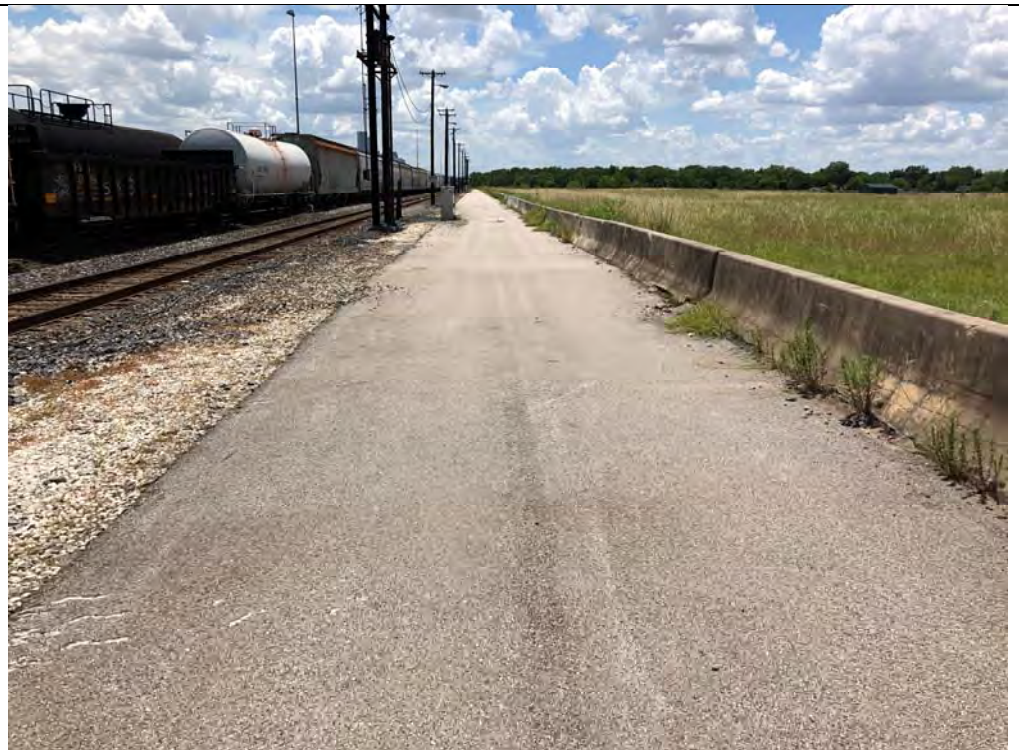
Photo No.
8

Weeds and vegetation can be observed growing under the concrete barriers. Soil cap's vegetative cover in good shape. Facing southwest.

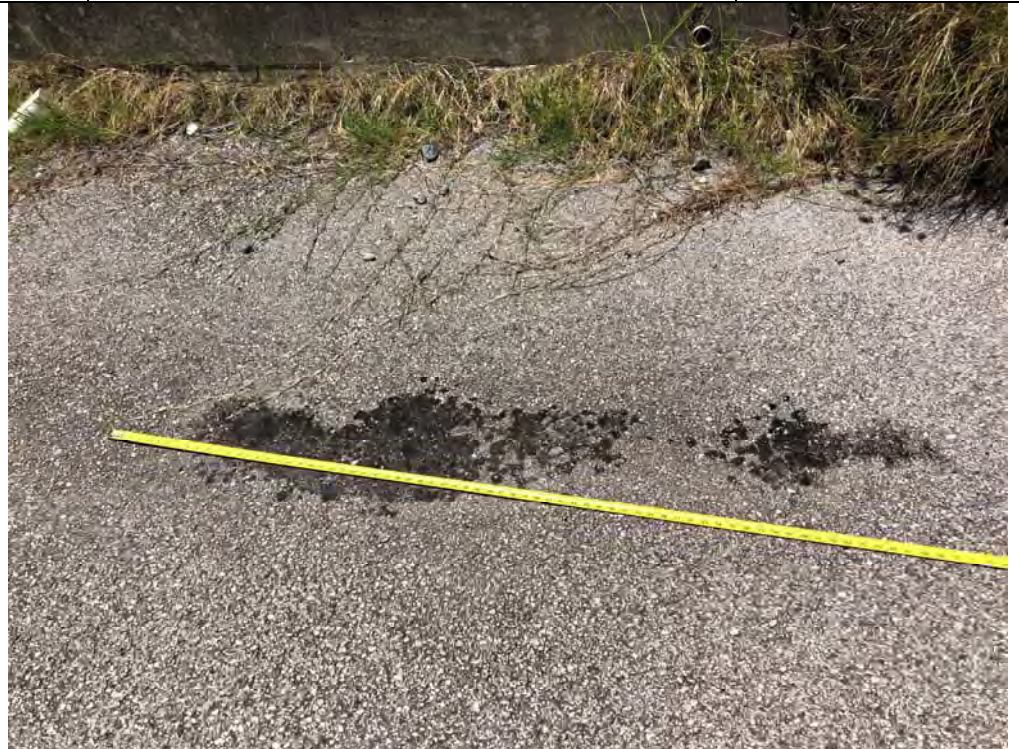
Asphalt roadway in good condition, free of major cracking/damage. Tar-like marks on road do not appear to have changed in size. Facing north.

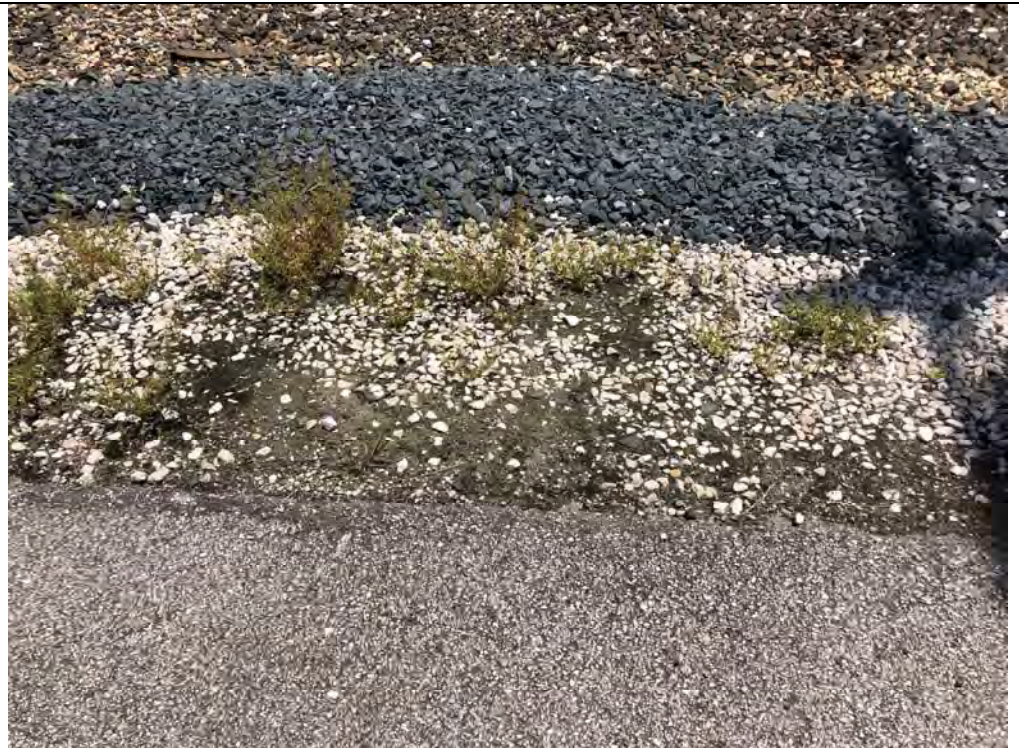
Photo No.
10

Some areas of bare soil can be observed in the ballast cap. Facing south.

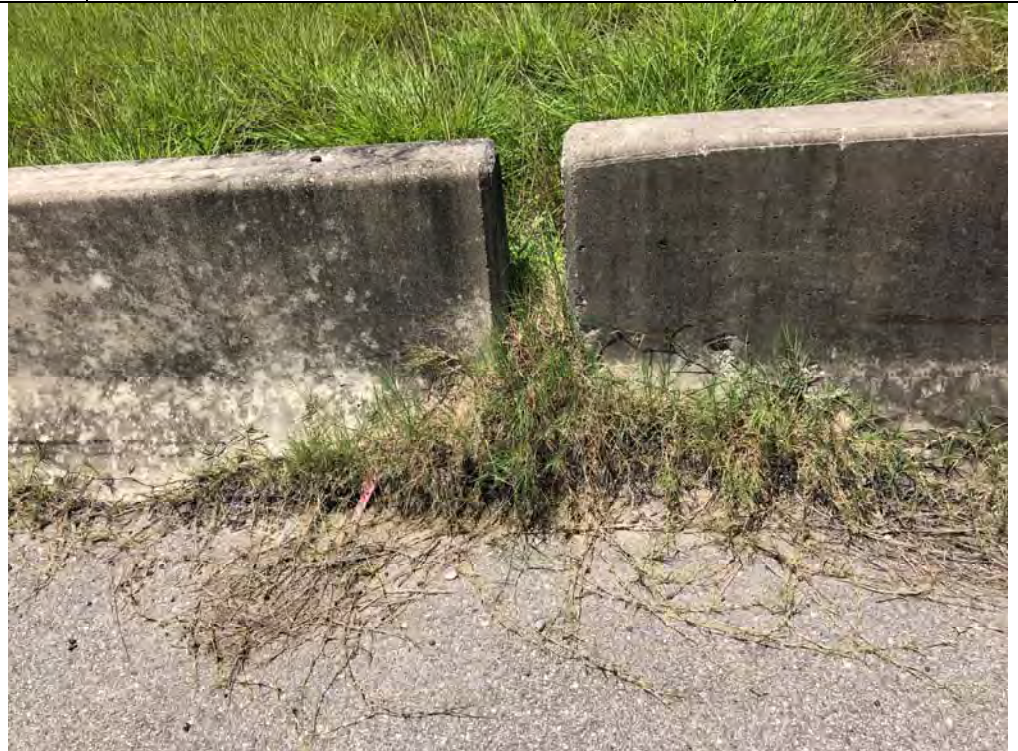
Anthills and small mounds of dirt observed on asphalt roadway between concrete barriers. Facing northwest.

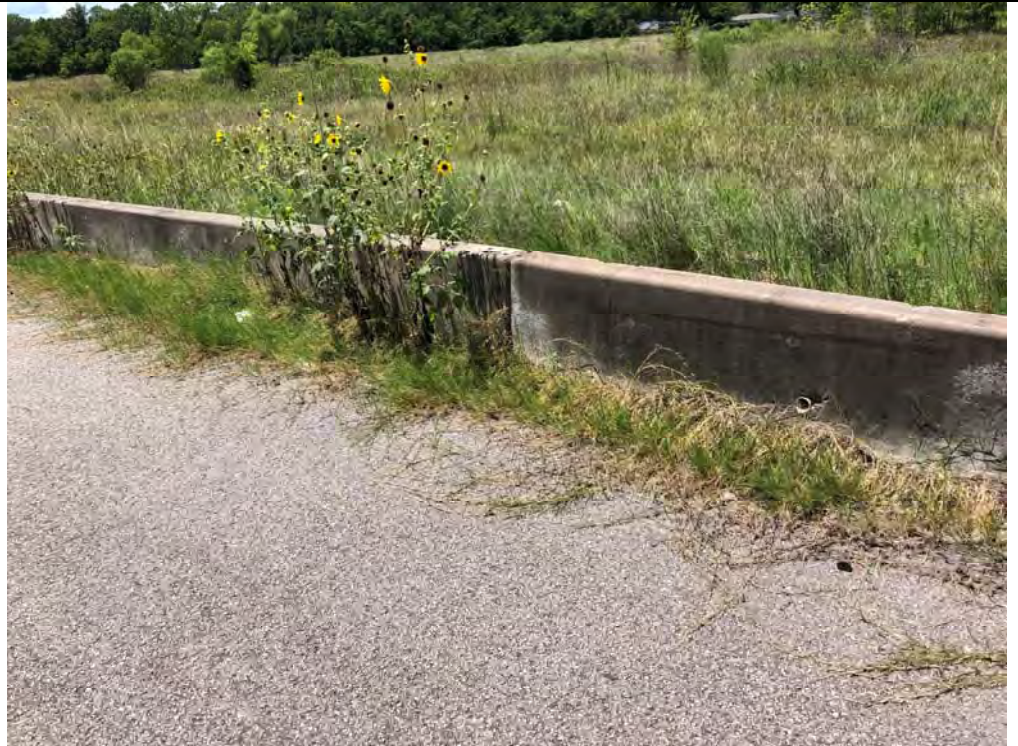
Photo No.
12

Weeds and vegetation can be observed growing under the concrete barriers. Facing west.

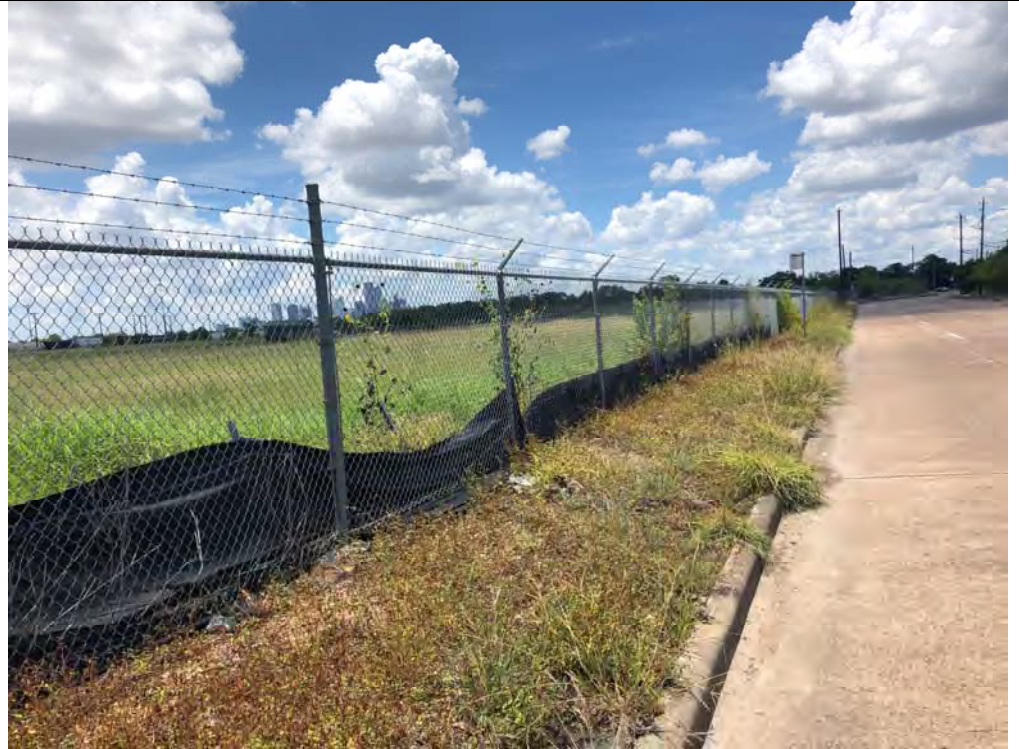
Fence in good condition. Some garbage and debris can be observed outside fence. Facing southwest.

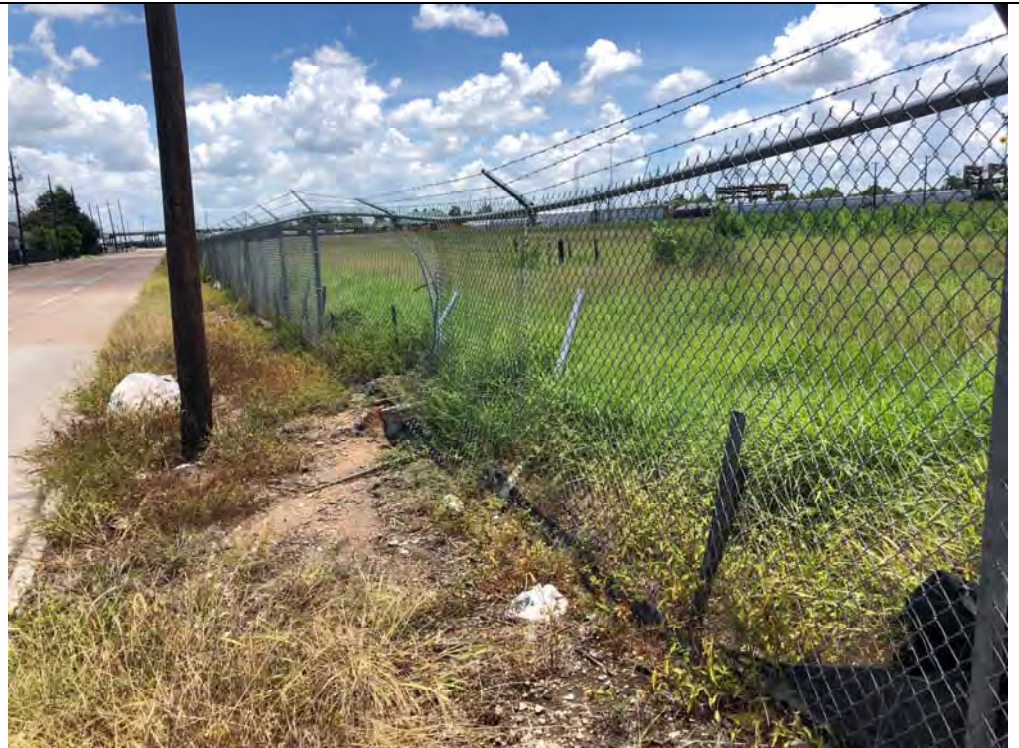
Photo No.
16

Fence damage from vehicle can be observed here, approximately 20' east of the main entrance gate. Facing east.

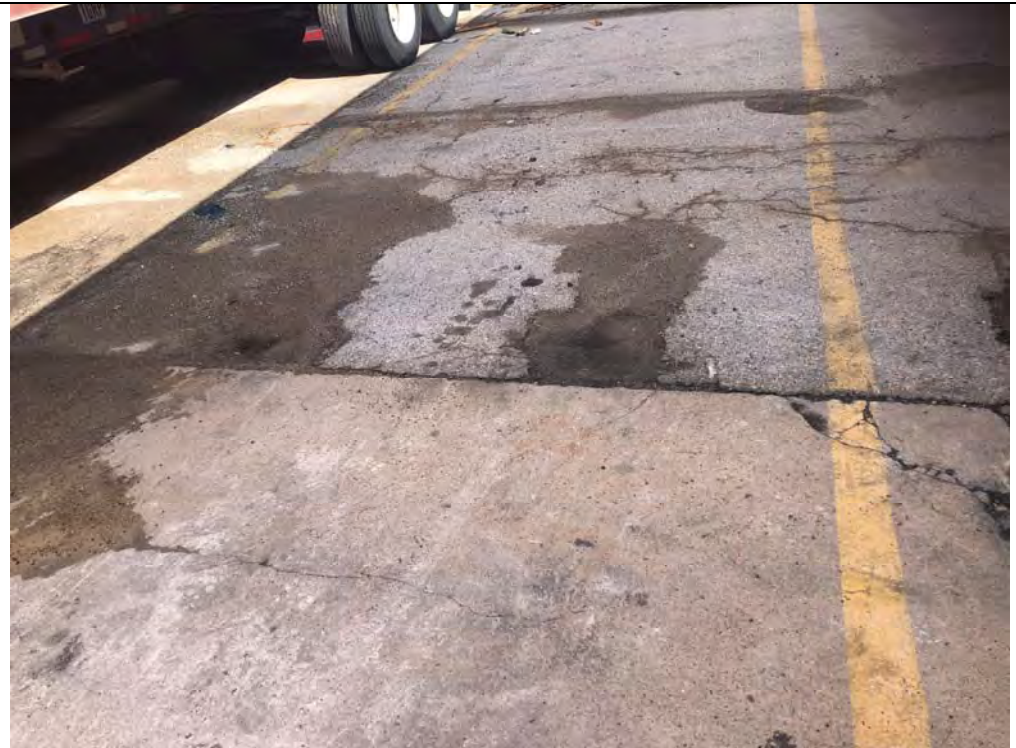
Photo No.
20

- Concrete Cap (Englewood Intermodal Yard) – Cracks in the pavement were noted, but no soil appeared to be exposed (Photo Nos. 20 through 22). Small amounts of the tar-like substance were observed during the inspection surfacing through the joints and cracks in the A Row (slot A022) and B Row (slots B100/101, B102 and B103) (Photo Nos. 21, 22, 23, and 26) in the concrete and asphalt surfaces in the area shown in the attached Figure 2. Weekly inspections and recovery of the tar-like substance continue to be conducted. The NAPL Collection System continued to be inspected weekly. Each sump of the NAPL Collection System was gaged during the weekly inspection using an interface probe. No NAPL was measured in any of the sumps. Less than 0.3 gallons of NAPL were recovered from the sumps during the 3rd Quarter 2020. Some brown staining was noted in the B Row (Photo No. 20).

Some mild cracking/cratering in the pavement can be observed in the B Row of the Englewood Yard area. No visible vegetation or exposed soil was observed. Some brown staining is also visible. Facing northwest.

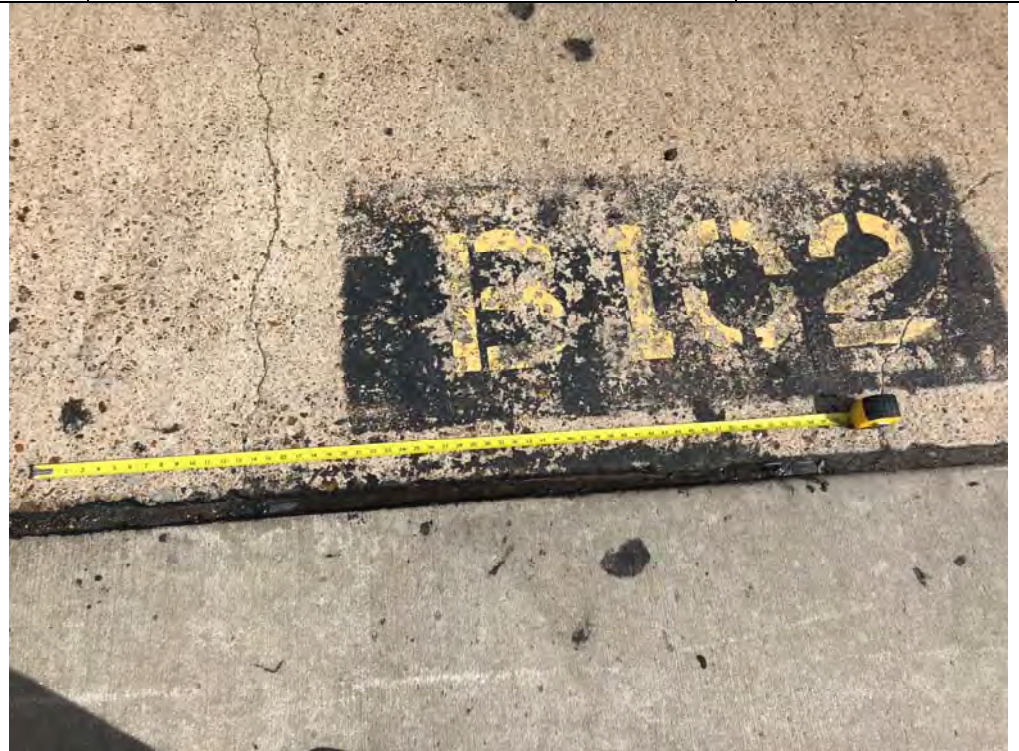
B102 stall. Evidence of recent tar-like substance seeping in joint. Routine in nearby B-Row stalls. Facing northwest.

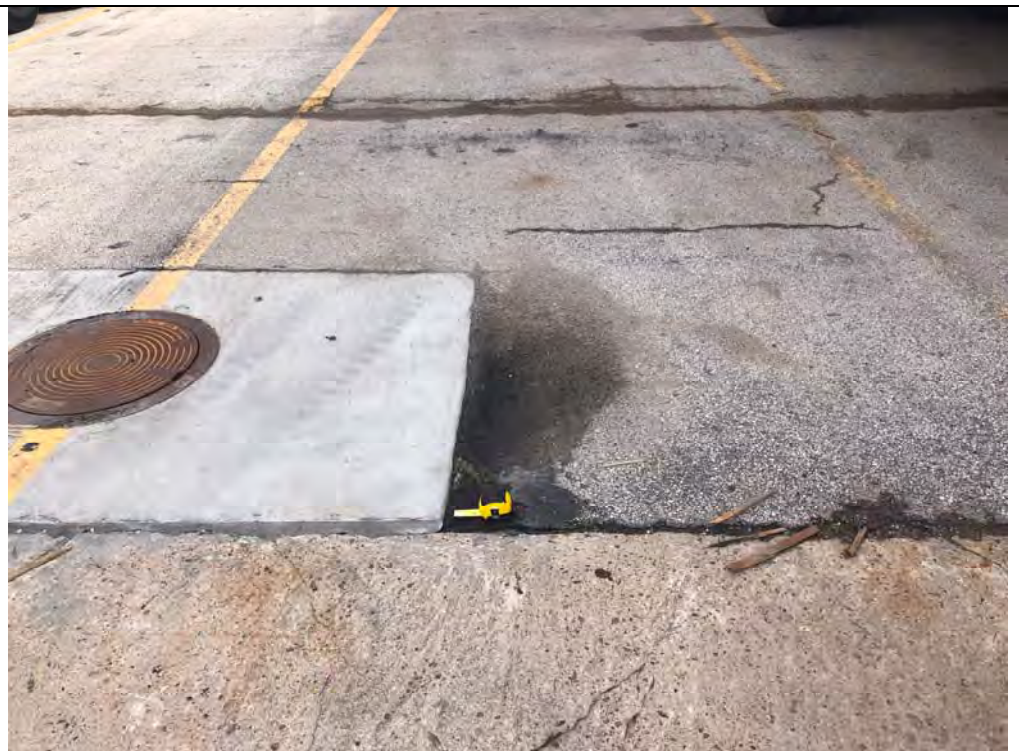
Photo No.
22

B103 stall. Evidence of recent tar-like substance seeping in joint. Routine in nearby B-Row stalls. Facing northwest.

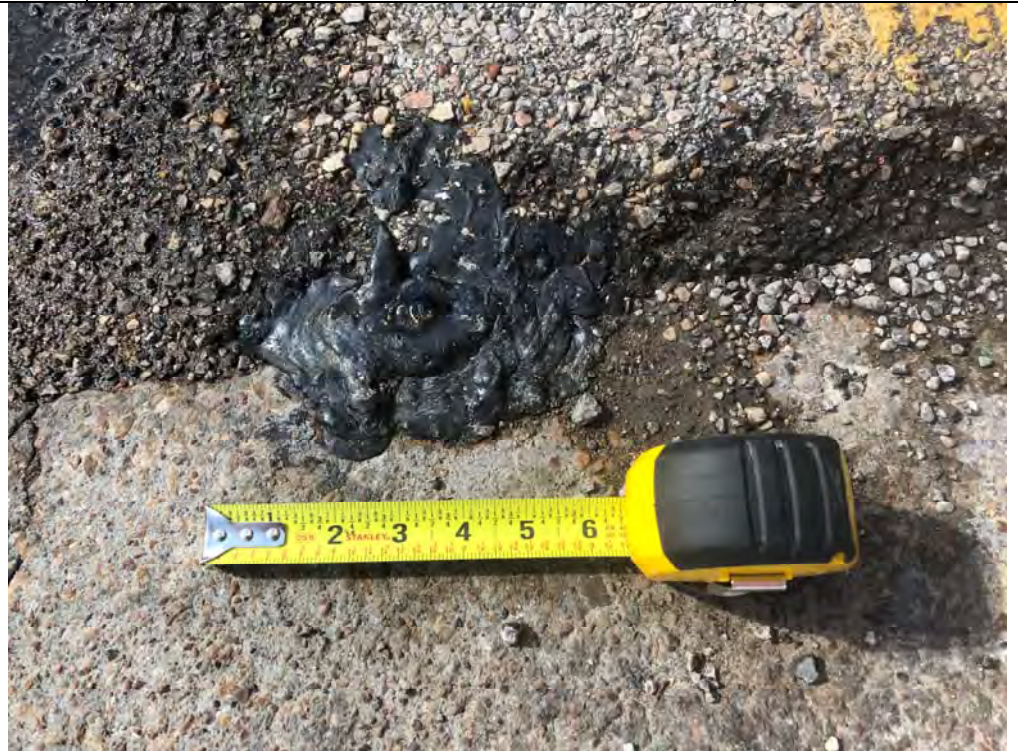
Stall A022. Evidence of recent tar-like substance surfacing evident in several spots in A and B rows. Facing southeast.

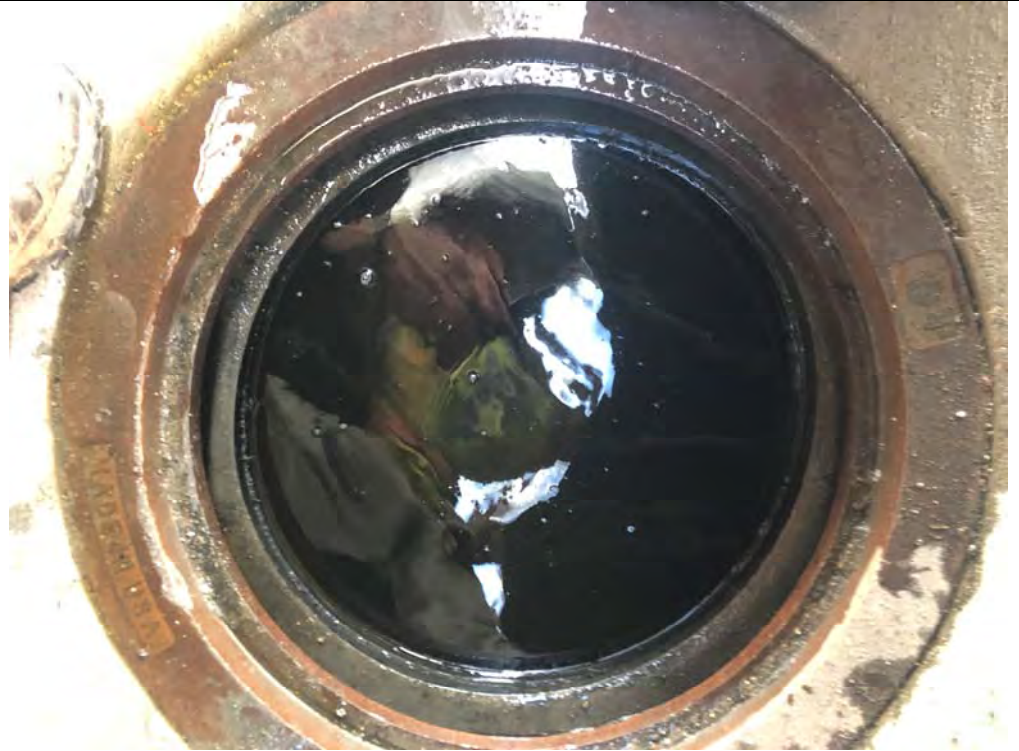
Sump B099/B100. Sump almost totally filled with water (brown in color, but with no sheen or odor). Facing north.

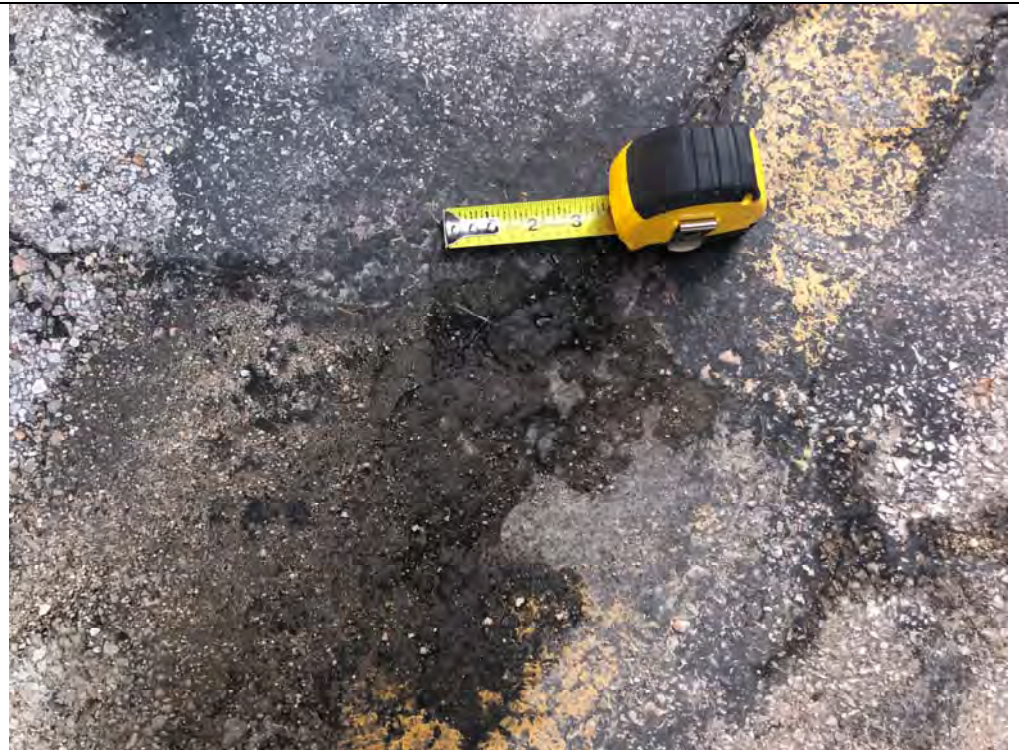
Photo No.
26

B100/101 stalls. Evidence of minor cracking and recent tar-like substance seepage (in asphalt), some present at time of inspection. Facing west.

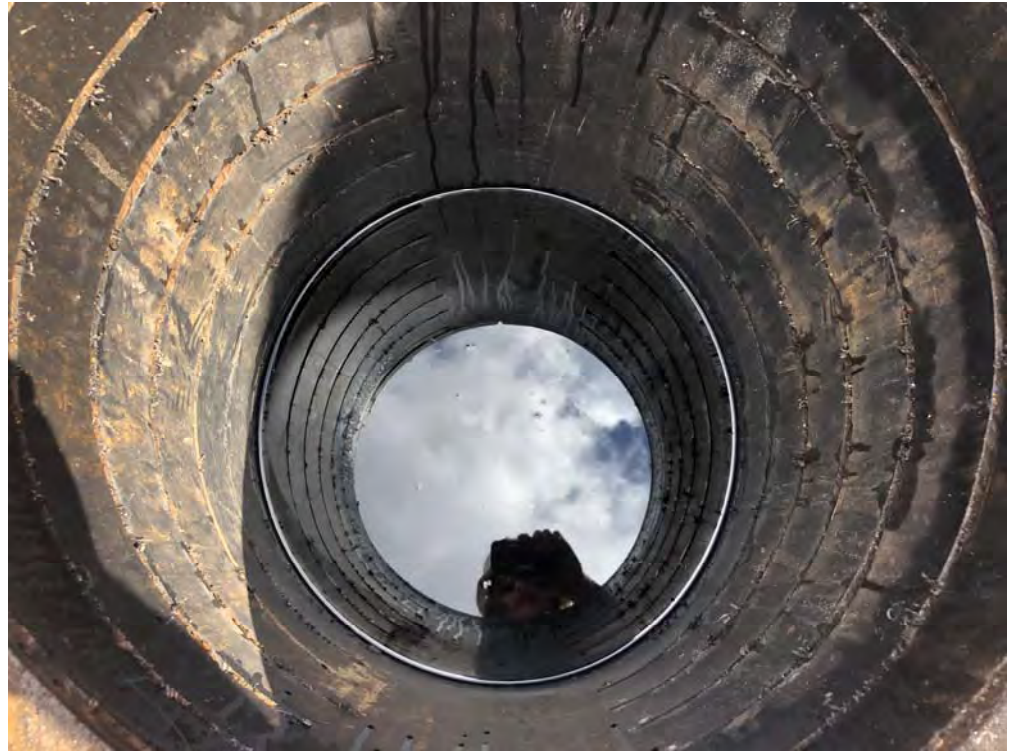
Sump B107/B108. Sump half-filled with water (no observable sheen on surface). Sump B103/B104 is filled similarly. Facing northeast.

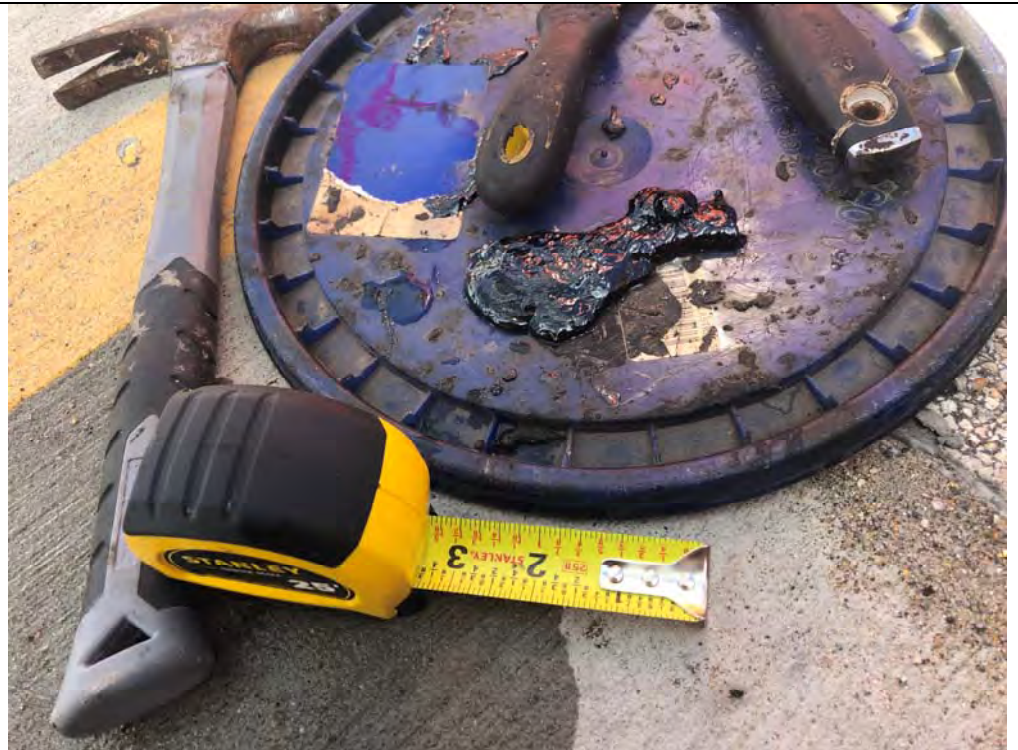
Photo No.
32

NAPL removed from B107/B108 sump. Sump produces similar amounts of NAPL on occasion. Facing southwest.

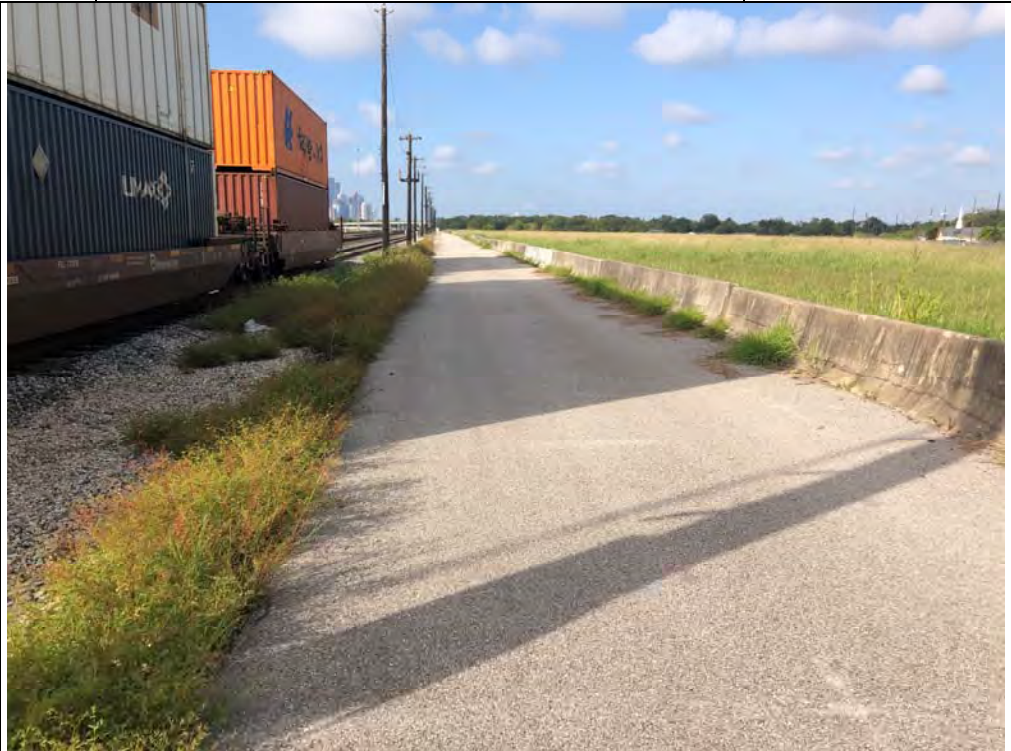
Asphalt roadway in good condition, free of major cracking/damage. Some vegetation can be noted growing within the ballast cap, and under the concrete barriers. Facing southwest.
