**RE: POST-RESPONSE ACTION COMPLETION REPORT – 2020
UNION PACIFIC RAILROAD HOUSTON WOOD PRESERVING WORKS, HOUSTON, TEXAS
4910 LIBERTY ROAD, HOUSTON, HARRIS COUNTY, TEXAS
TCEQ SWR NO. 31547; TCEQ PERMIT/COMPLIANCE PLAN NO. 50343EPA ID NO. TXD000820266
CUSTOMER NO. CN600131098; REGULATED ENTITY NO. RN100674613**

TEXAS COMMISSION ON ENVIRONMENTAL QUALITY Post-Response Action Care Report (PRACR)

SECOND QUARTER 2020 (APRIL 28TH) INSPECTION RECORD AND PHOTOGRAPHIC LOG

THIRD QUARTER 2020 (JULY 23RD) INSPECTION RECORD AND PHOTOGRAPHIC LOGS

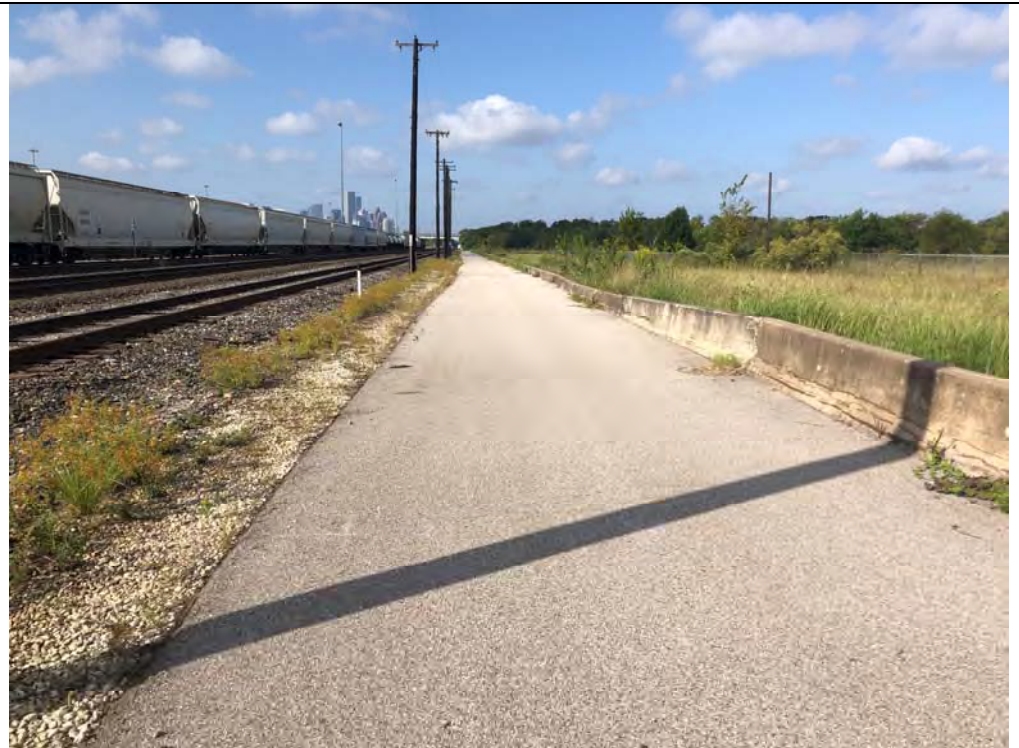
Photo No.
8

- Railroad Ballast Cap – The railroad ballast cap area appeared to be in good condition, with some vegetation growth within the ballast area (Photo No. 7 and 8). Some areas of bare soil were observed in the ballast cap (Photo No. 10).

Weeds and vegetation can be observed growing within the ballast cap. Facing southwest.

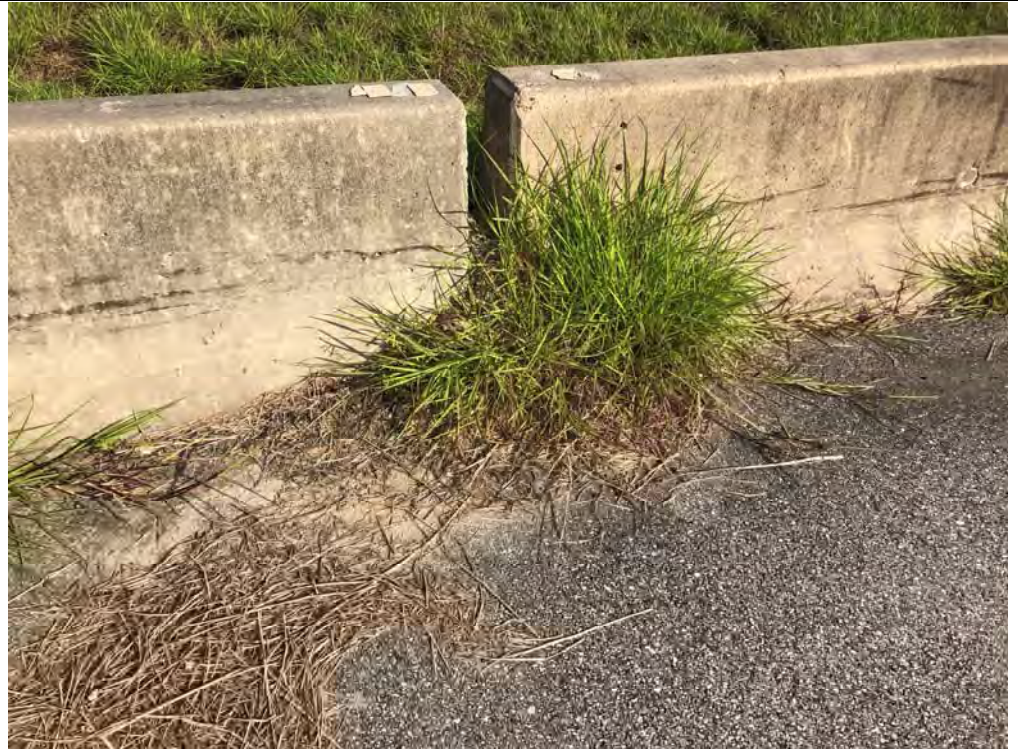
Anthills and small mounds of dirt observed on asphalt roadway between concrete barriers. Facing north.

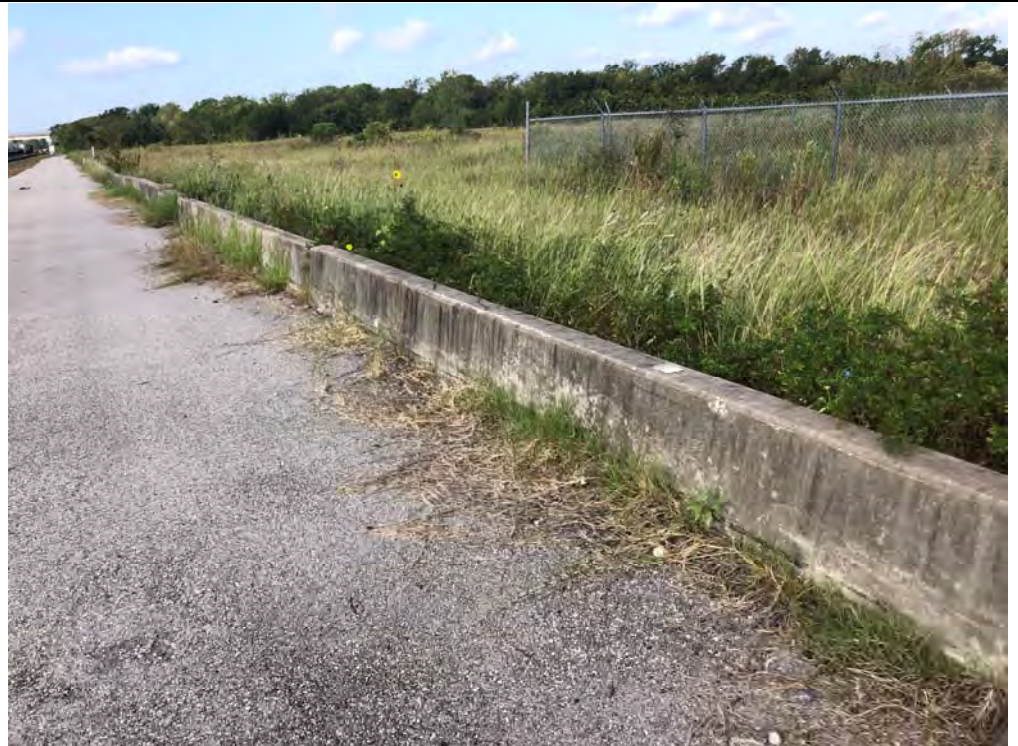
Weeds and vegetation can be observed growing under the concrete barriers. Facing west.

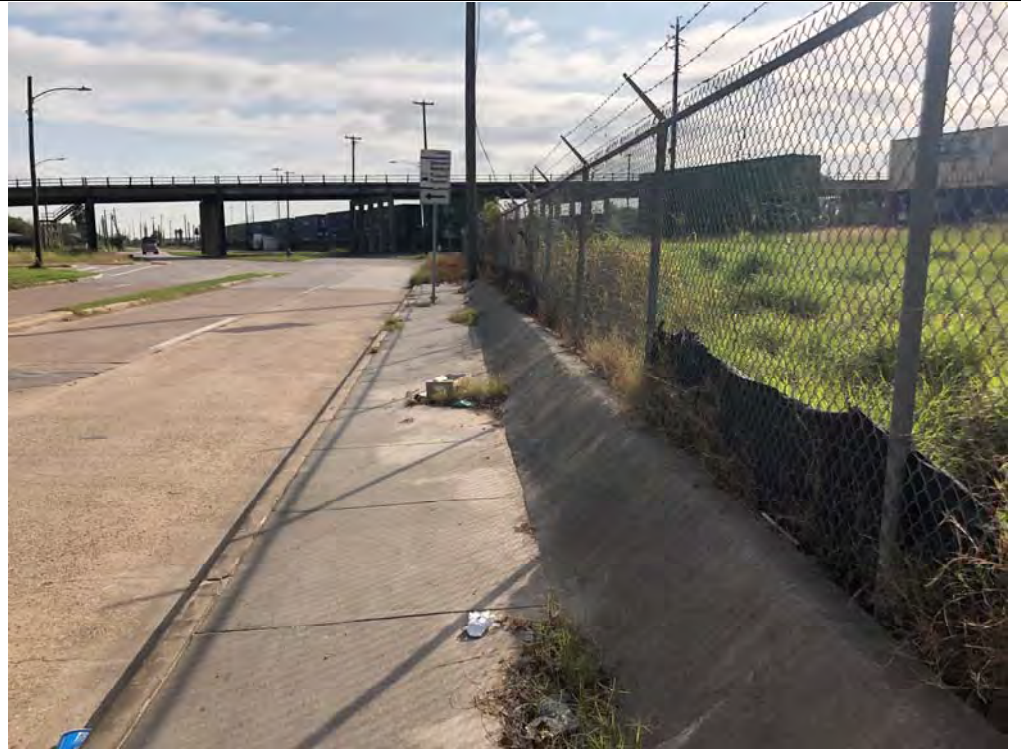
Security Fence/Sidewalk Area:
Sidewalk outside security fence in good condition. Some areas have minor vegetative growth. Facing east.

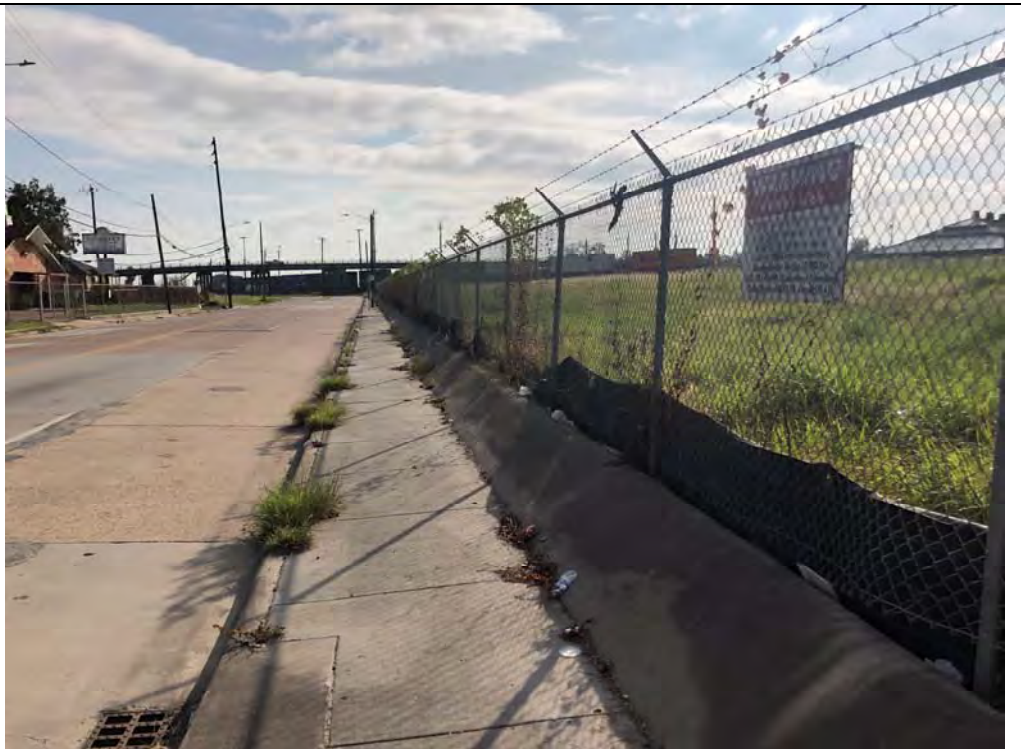
Photo No.
14

Security Fence/Sidewalk Area:
Sidewalk outside security fence in good condition. Some areas have minor vegetative growth. Facing east.

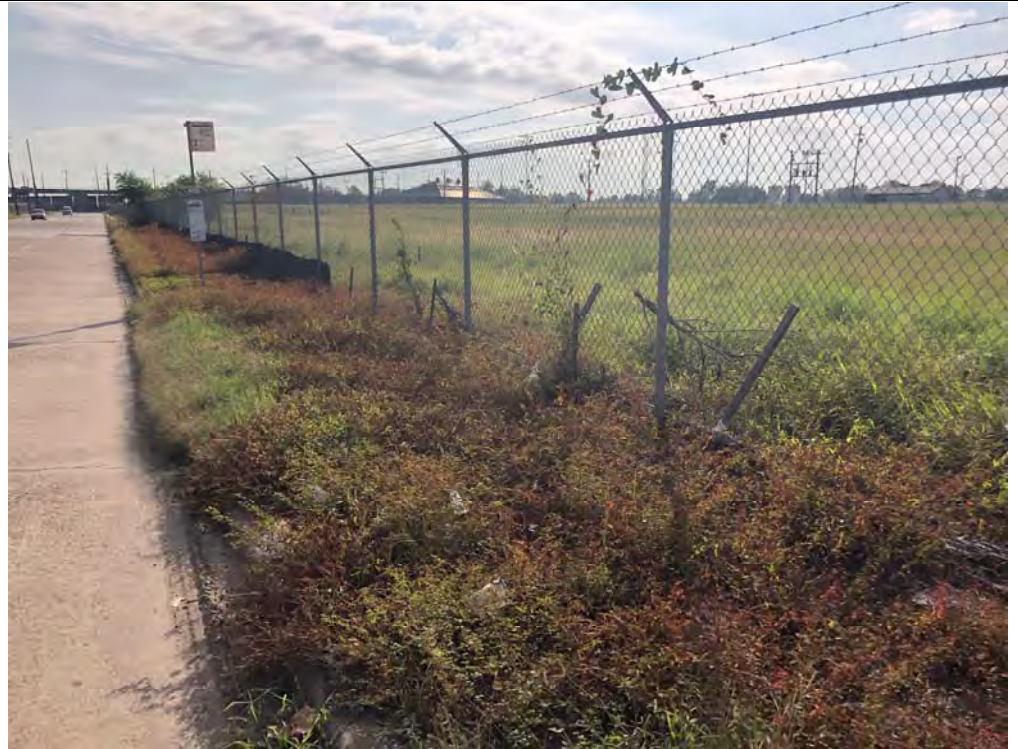
Security Fence:
Security fence in good condition. Some garbage and debris can be observed outside fenced area. Facing east.

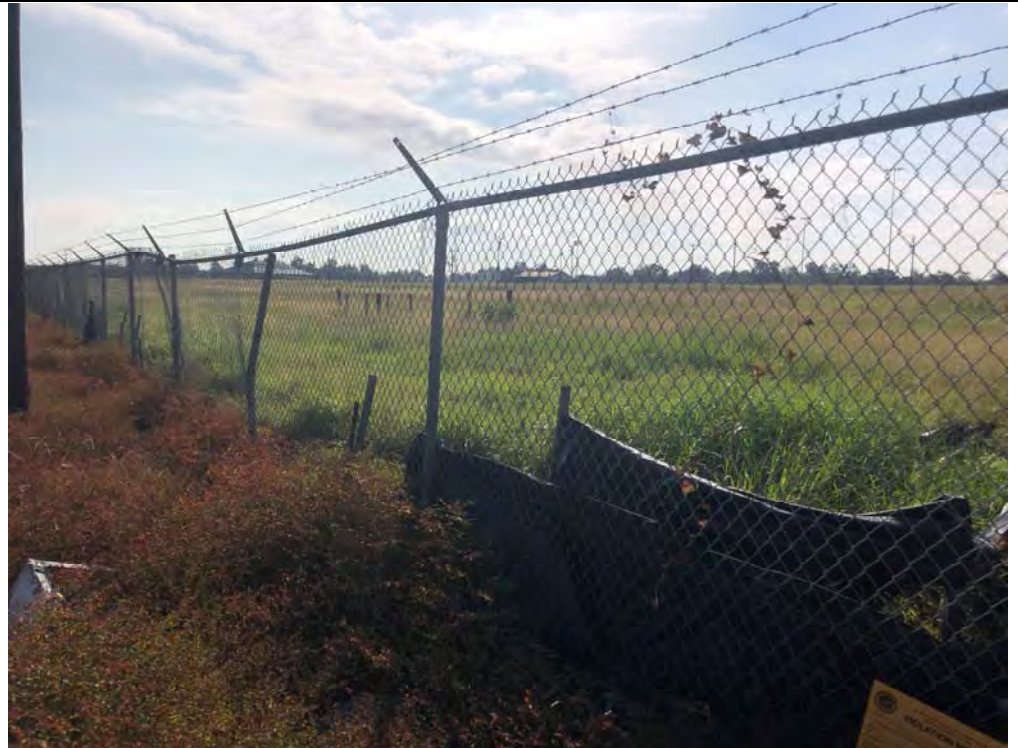
Photo No.
16

Security Fence:
Prior fence damage from vehicle has been repaired, approximately 20' east of the main entrance gate. Facing east.

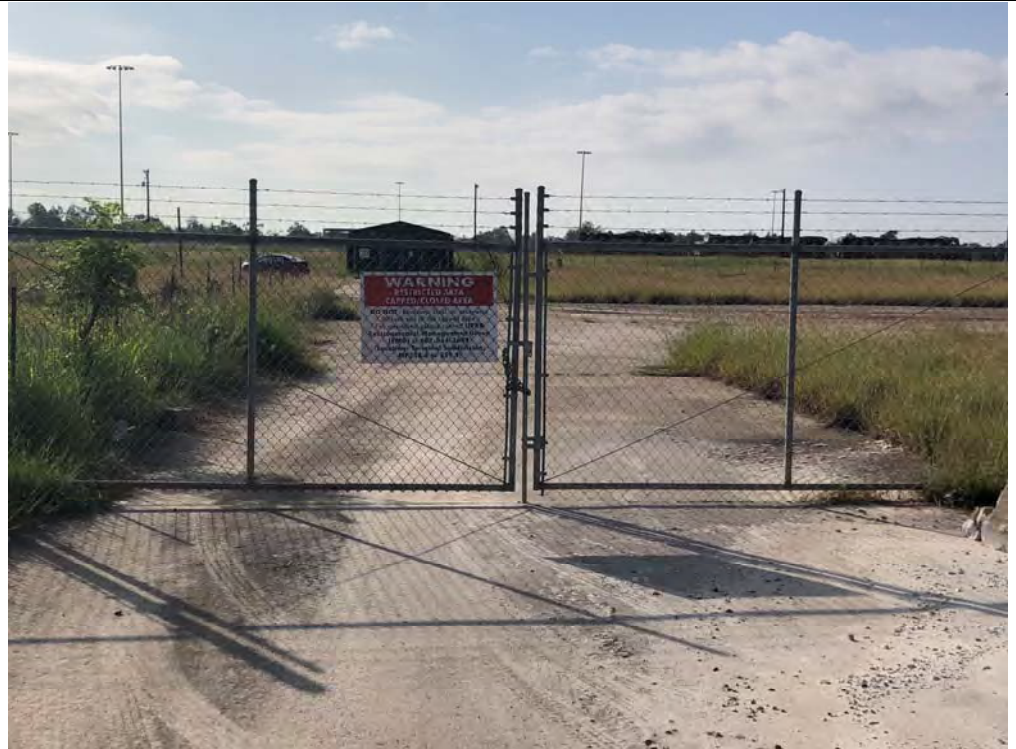
Front gate and signage in good condition. Facing south.

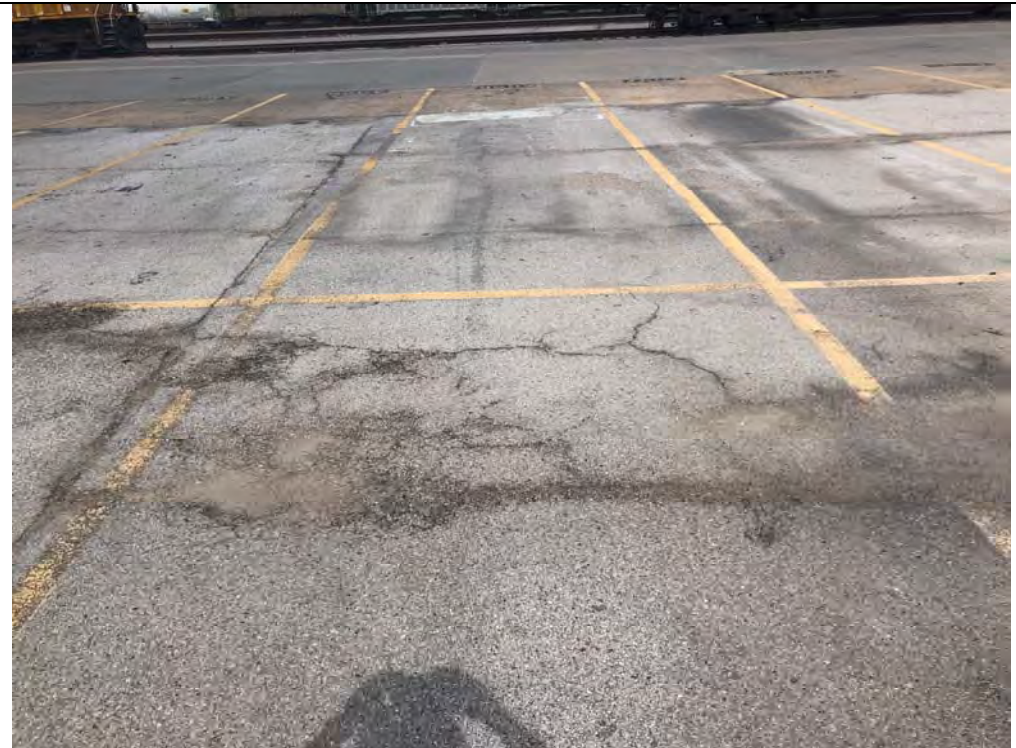
Photo No.
20

- Concrete Cap (Englewood Intermodal Yard) – Cracks in the pavement were noted, but no soil appeared to be exposed (Photo Nos. 20 and 30). Small amounts of the tar-like substance were observed during the inspection surfacing through the joints and cracks in the A Row (slot A022) and B Row (slots B100/101, B102 and B103) (Photo Nos. 21, 22, and 23) in the concrete and asphalt surfaces. Weekly inspections and recovery of the tar-like substance (upon reappearance) continue to be conducted. During the September 30, 2020 weekly inspection, oil staining and absorbents (sand and litter) were noted in the A-Row area (predominately in slots A008-A016). UPRR confirmed that the staining was from hydraulic oil from maintenance activities on a container crane and not related to the NAPL or water seeps. USES was called out to the site and added more absorbents to collect the residual oil. USES then removed the absorbents from the site. Some residual staining is visible on Photo 32. The NAPL Collection System continued to be inspected weekly. Each sump of the NAPL Collection System was gaged during the weekly inspection using an interface probe. No NAPL was measured in any of the sumps. Less than 0.1 gallons of NAPL were recovered from the sumps during the 4th Quarter 2020.

Minor cracking can be noted throughout the A and B rows in the concrete cap area, with some soil exposure evident. Facing northwest.

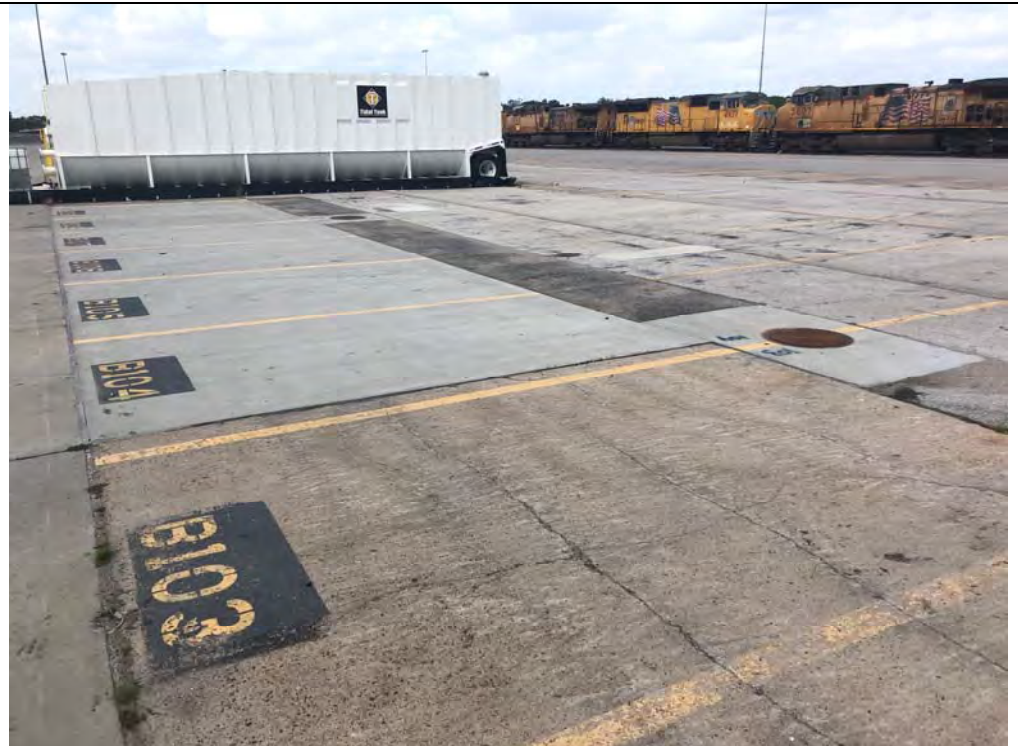
Photo No.
24

NAPL Collection System in stalls B099-B110 in good condition with little evidence of cracking, stains, etc. Facing west.

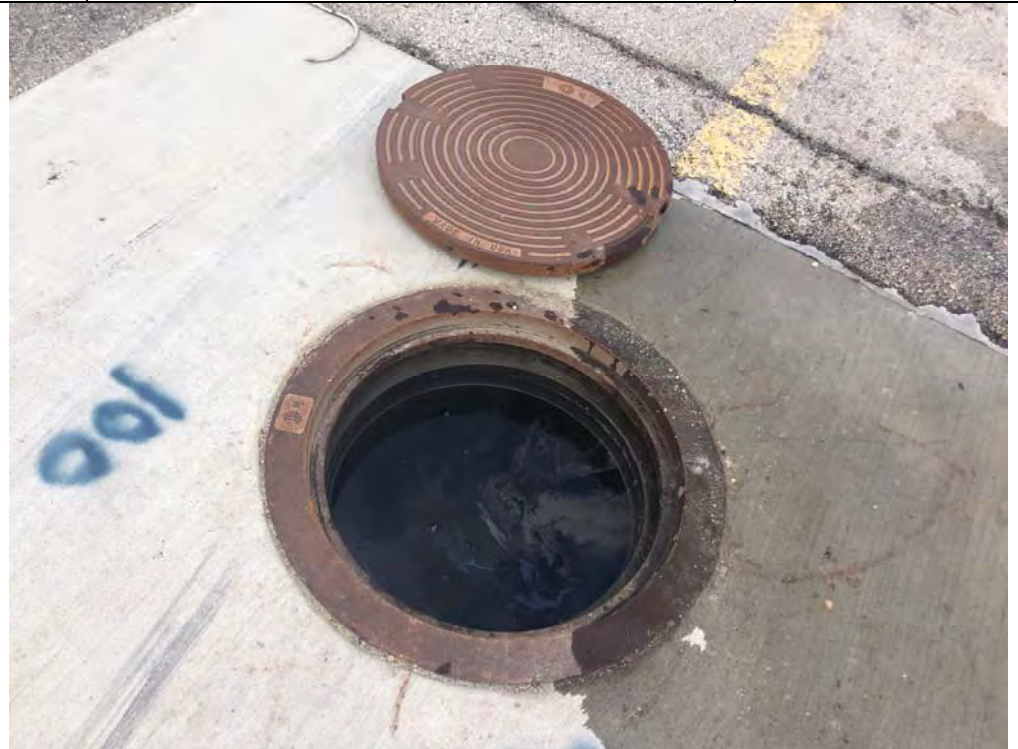
Sump B099/B100. Sump almost totally filled with water (brown in color, but with no sheen or odor). Facing northwest.

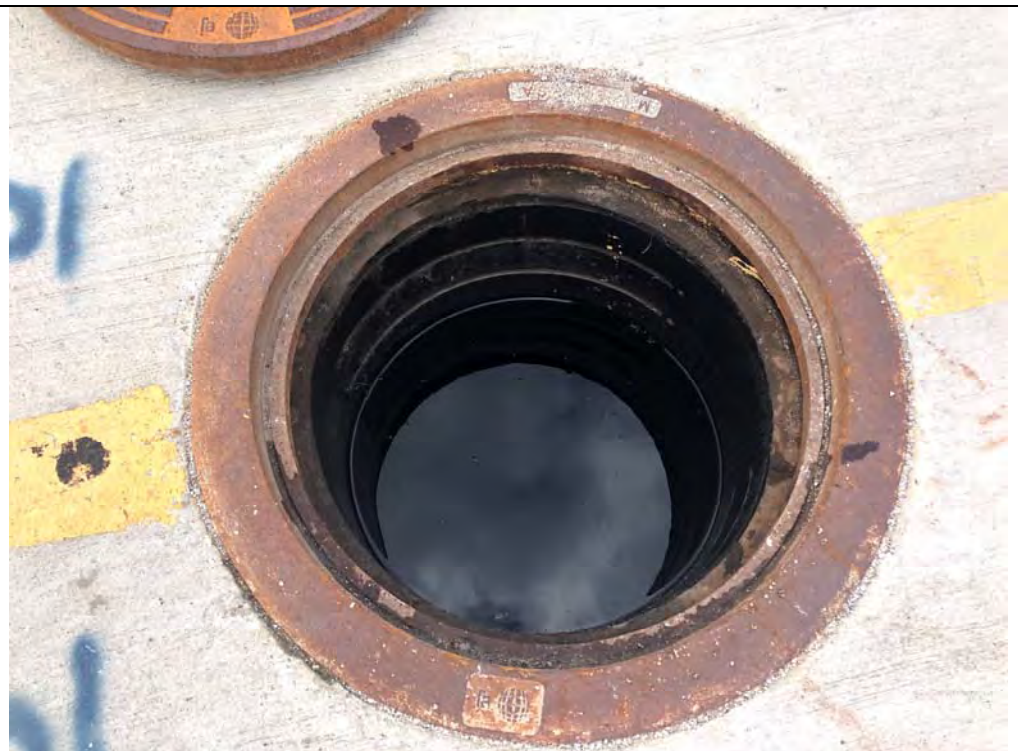
Photo No.
26

Sump B107/B108. This sump has historically not exhibited any LNAPL, other an occasional light sheen. Facing north.

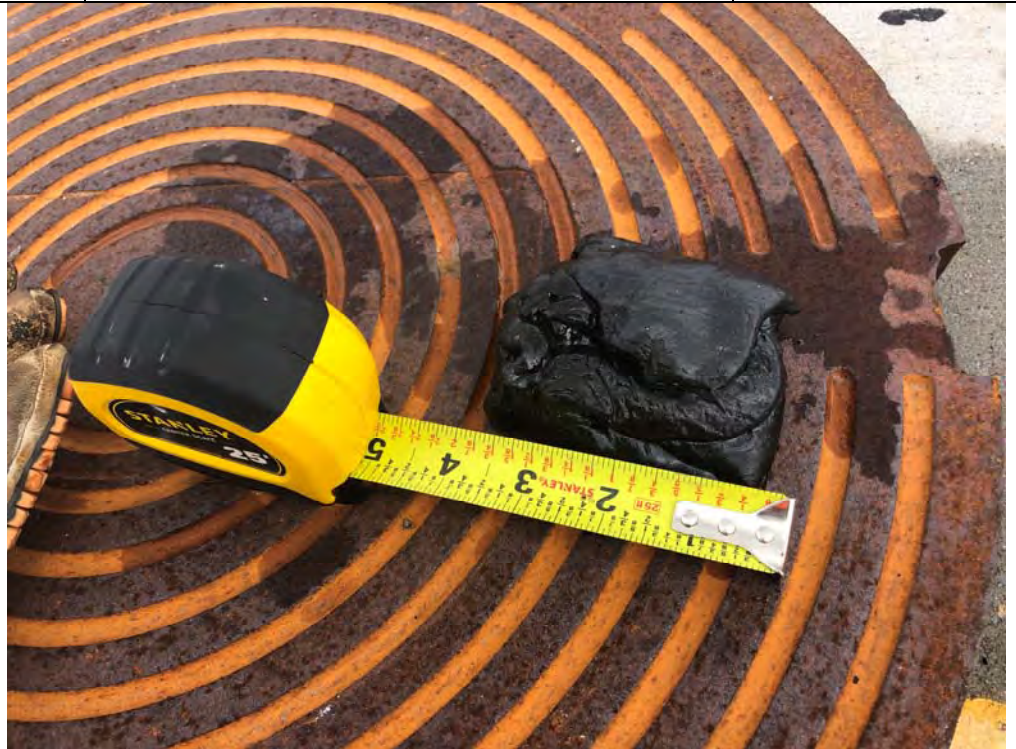
**Concrete Cap Area
(Englewood Yard):**
NAPL removed from Sump
B107/B108. Facing northwest.

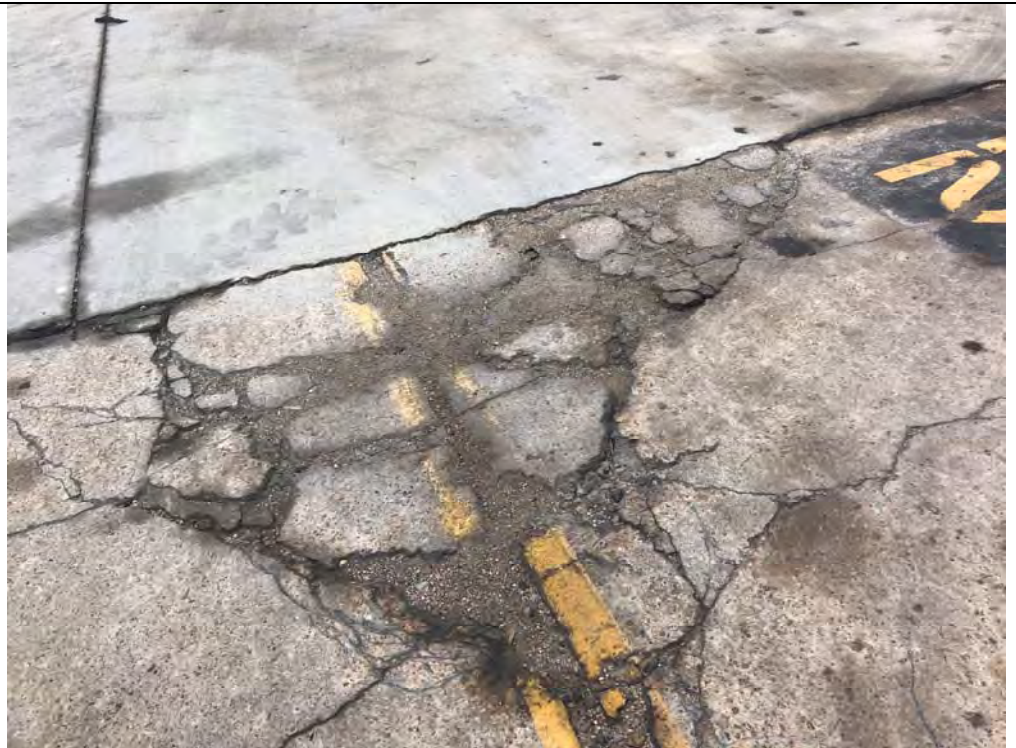
Photo No.
28

**Concrete Cap Area
(Englewood Yard):**
Some cracking evident within
concrete cap area, exposing
some fill/soil, particularly in the A
and B rows. No vegetation noted
anywhere in yard. Facing
southeast.

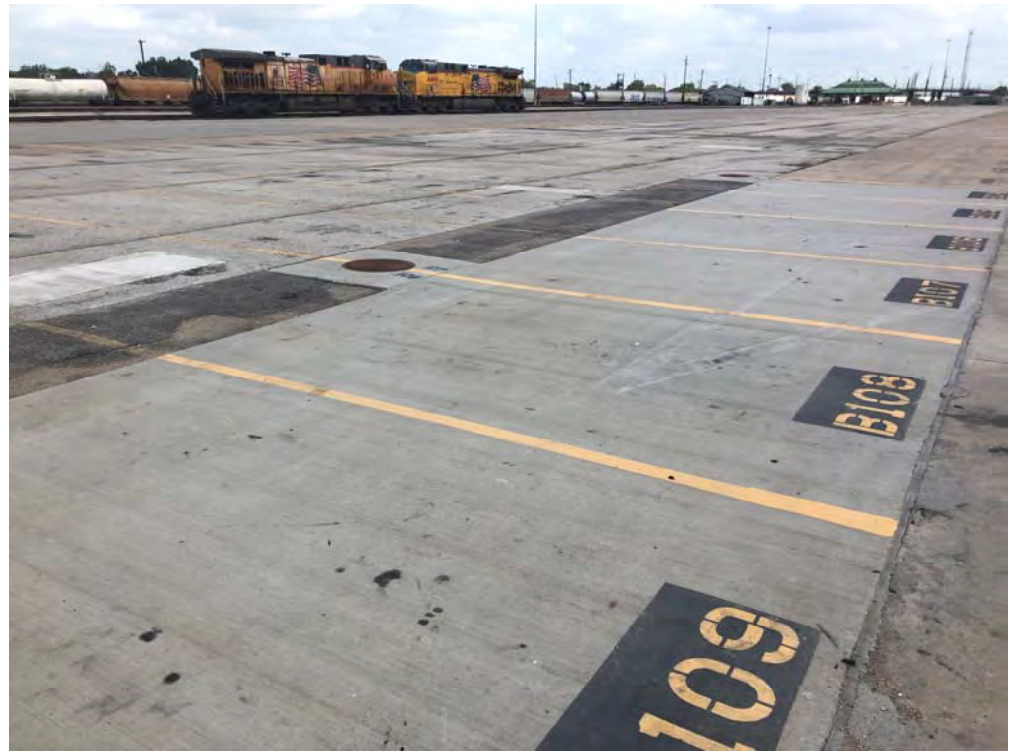
NAPL Collection System in stalls B099-B110 in good condition with little evidence of cracking, stains, etc. Facing east.

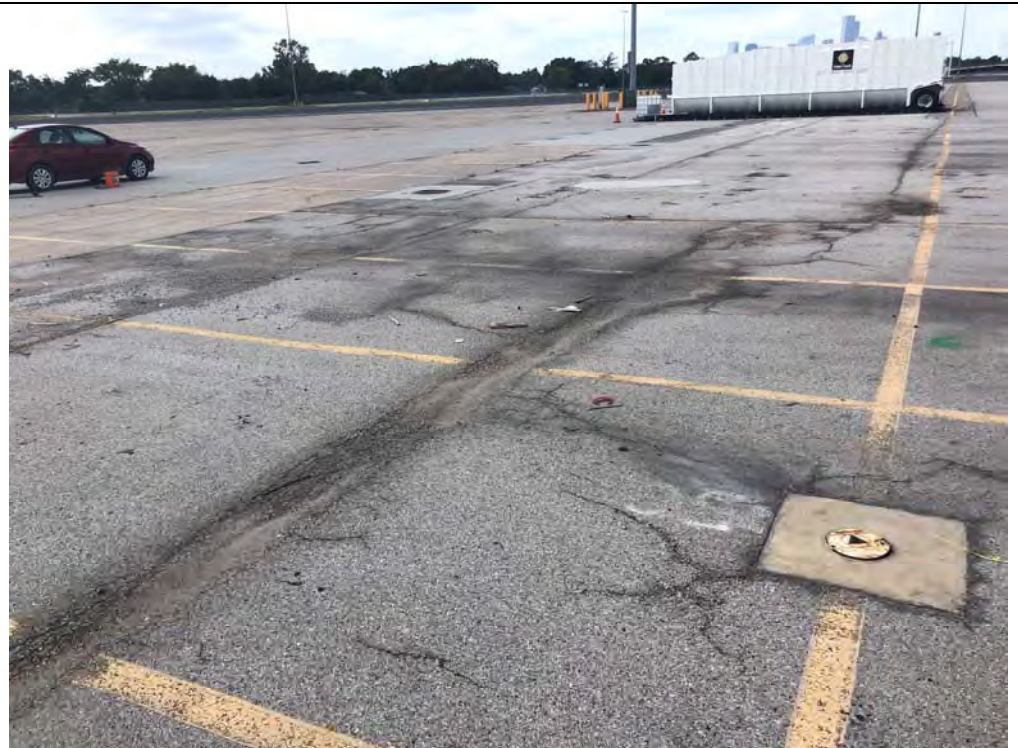
Photo No.
30

Concrete cap within yard in good condition, with minimal cracks/potential for soil exposure. Some cracking evident in B row, but with no evidence of vegetation growth. Facing west.

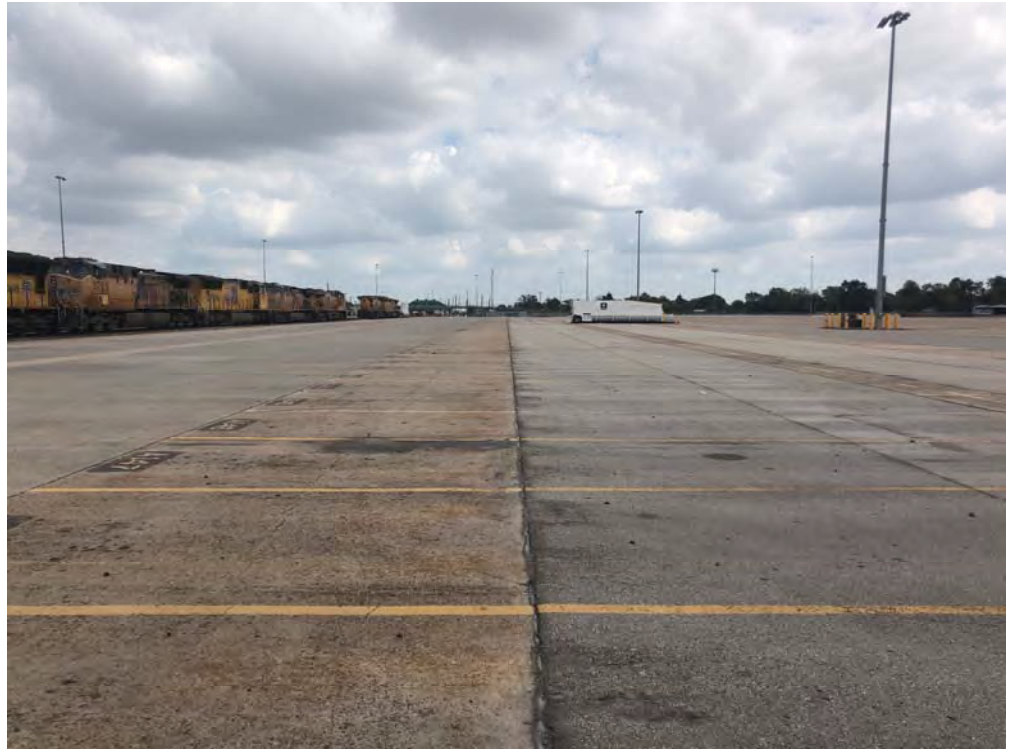
Concrete cap within yard in good condition, with minimal cracks/potential for soil exposure Facing northeast.

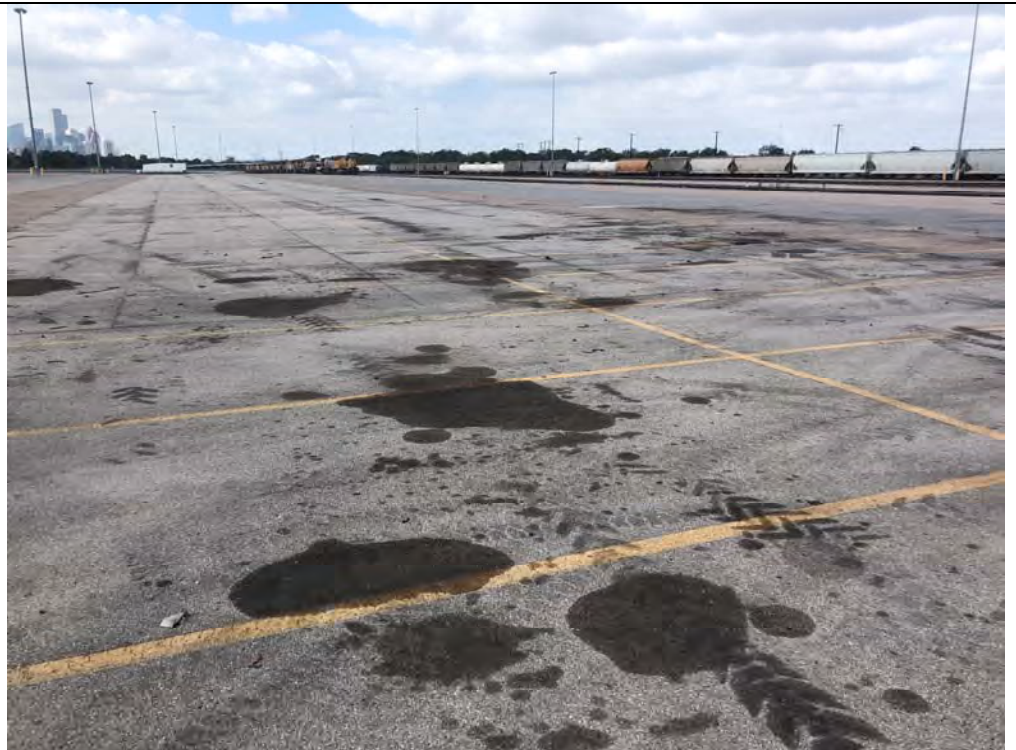
Photo No.
32

Concrete cap within yard in good condition, with minimal cracks/potential for soil exposure. Some surficial stains evident in A and B rows primarily. Facing west.

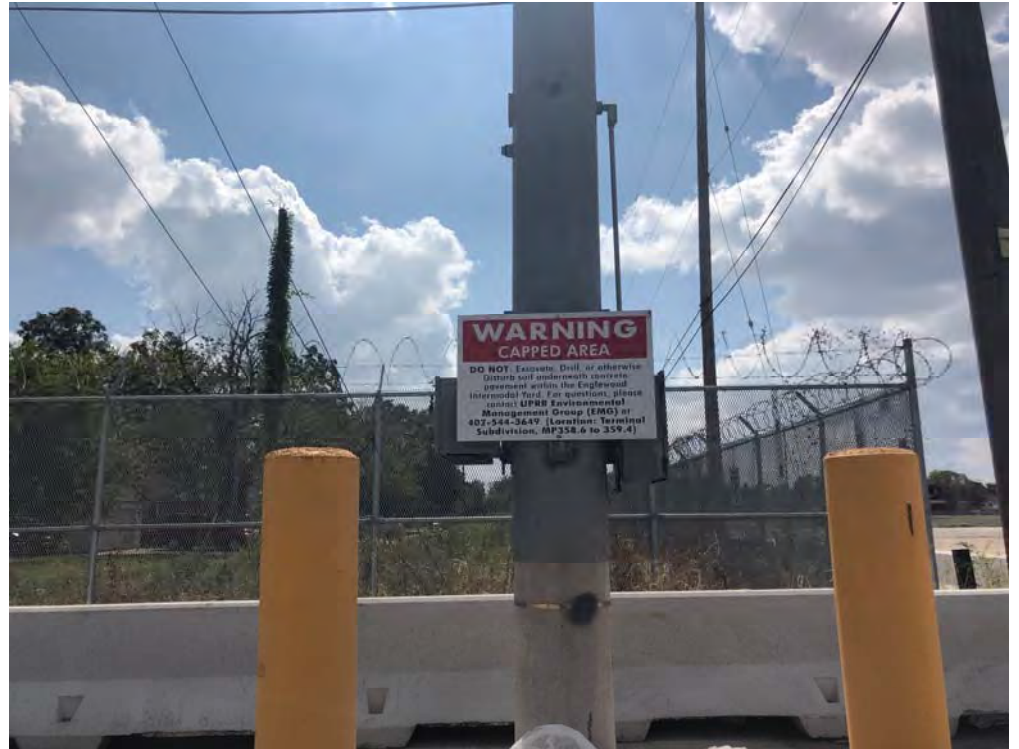
Signs and related warnings in concrete cap area and in HWPW area in good condition. Facing south.

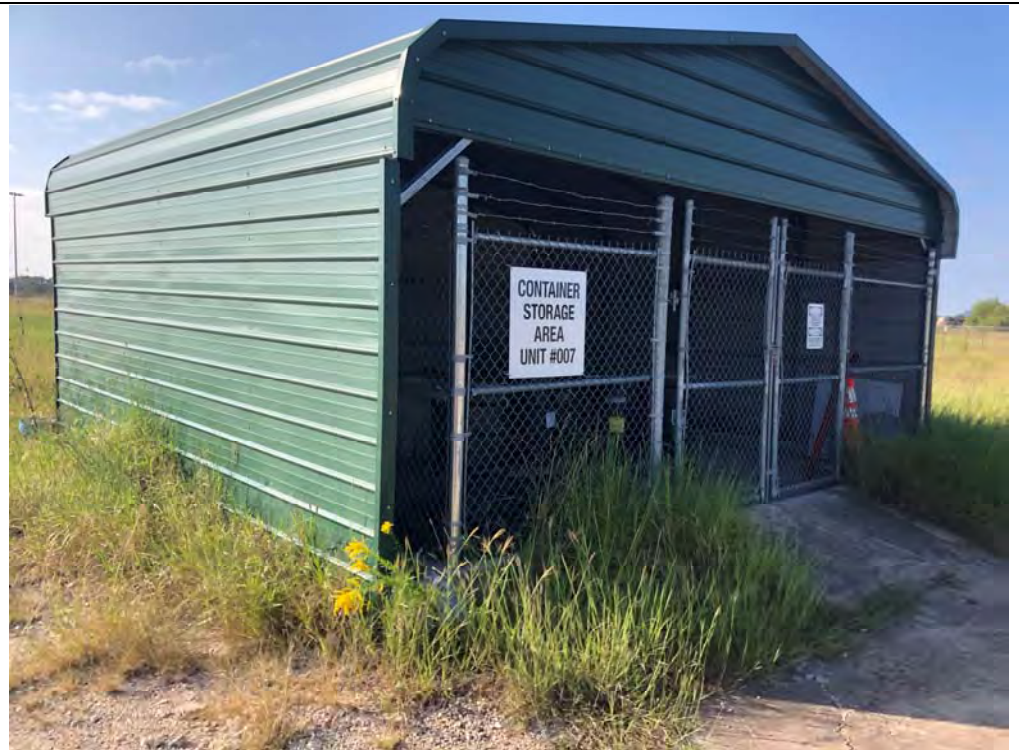
Photo No.
34

Valve in closed position and functioning within the container storage area. CSA in good condition, free of major dents and other damage. Minor water on floor. Facing southwest.
