June 2, 2020

**RE: MONTHLY STATUS UPDATE – ENGLEWOOD INTERMODAL YARD – NAPL COLLECTION SYSTEM/CONCRETE CAP REPAIRS
UNION PACIFIC RAILROAD HOUSTON WOOD PRESERVING WORKS FACILITY
4910 LIBERTY ROAD FACILITY, HOUSTON, TEXAS
POST-CLOSURE CARE PERMIT NO. HW-50343; INDUSTRIAL SWR NO. 31547**

Weekly Inspection Photolog

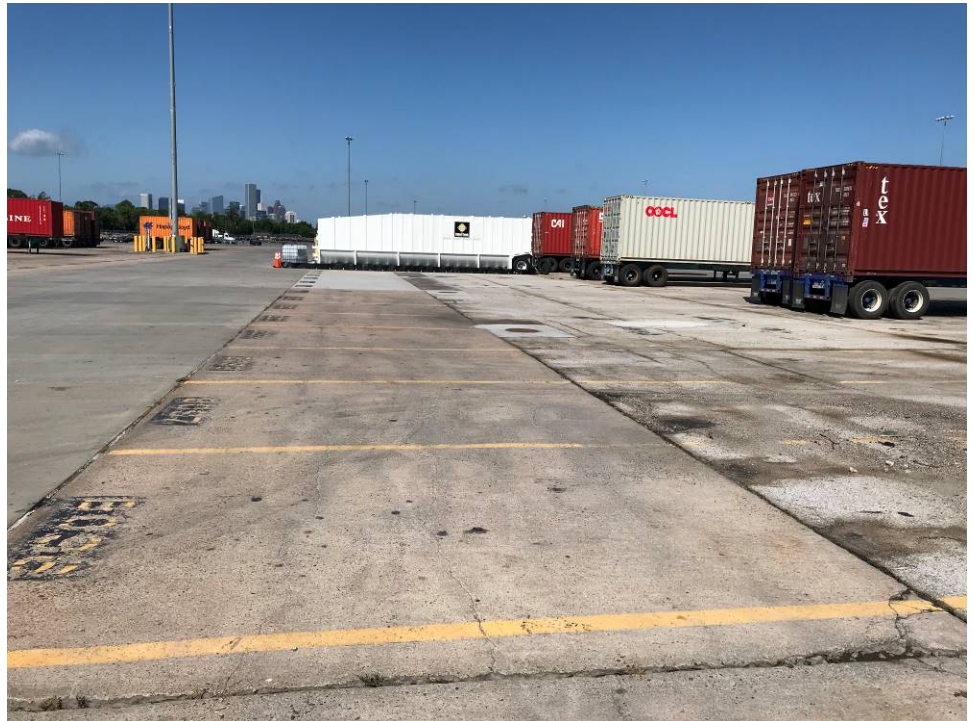
Photo No. 18	Date: 05/19/2020
-------------------------------	----------------------------

Slot B096, small amount of tar-like material seeping at joint, material was removed.

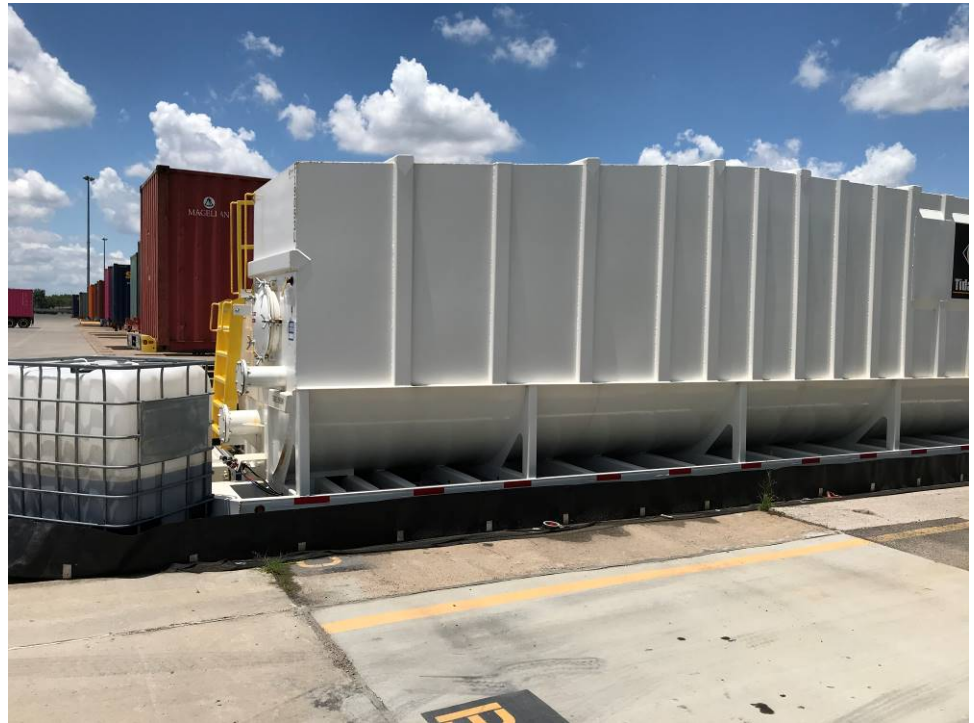
Photo No.
30

Slot B099, brown staining observed along asphalt cracks in slot B099 and surrounding slots, looking southeast.
