NONPOINT SOURCE SUCCESS STORY

Fish Return to Boulder Creek After Legacy Mine Remediation

EPA 841-F-22-001D
February 2022

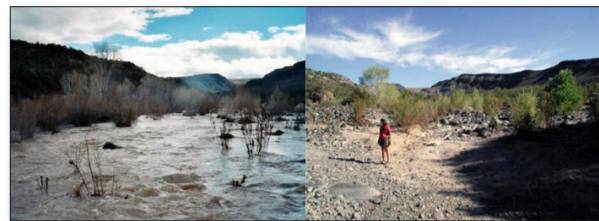
Figure 1. Boulder Creek's flow regimes are contrasted in these two pictures: high flows in February 2001 (left) and no flows in November 2001 (right).
