**Region 5 Enforcement and Compliance Assurance Division  
SDWA DRINKING WATER INSPECTION REPORT**

City of Benton Harbor  
Berrien County, Michigan

Inspection Date(s):	November 10, 2021		
Owner/Company Name:	City of Benton Harbor		
System Name	Benton Harbor PWS		
System Location	601 North Ridgeway Drive		
City, State, Zip Code	St. Joseph, Michigan 49085		
County	Berrien		
Mailing Address:	601 North Ridgeway Drive		
City, State, Zip Code	St. Joseph, Michigan 49085		
System Contact	Ellis Mitchell, City Manager		
	(269) 927-8457		
PWS ID No:	MI0000600		
Personnel Participating in Inspection:			
Jonathan Moody	Environmental Engineer, Lead	<a href="mailto:Moody.Jonathan@epa.gov">Moody.Jonathan@epa.gov</a>	312-886-7570
Abul Ahmed	Operator in Charge Treatment System	<a href="mailto:aahmed@fv-operations.com">aahmed@fv-operations.com</a>	616-588-2900
EPA Lead Inspector Signature/Date			
<b>Reviewed by:</b> Team Leader Signature/Date			
<b>Approved by:</b> Section Chief Signature/Date

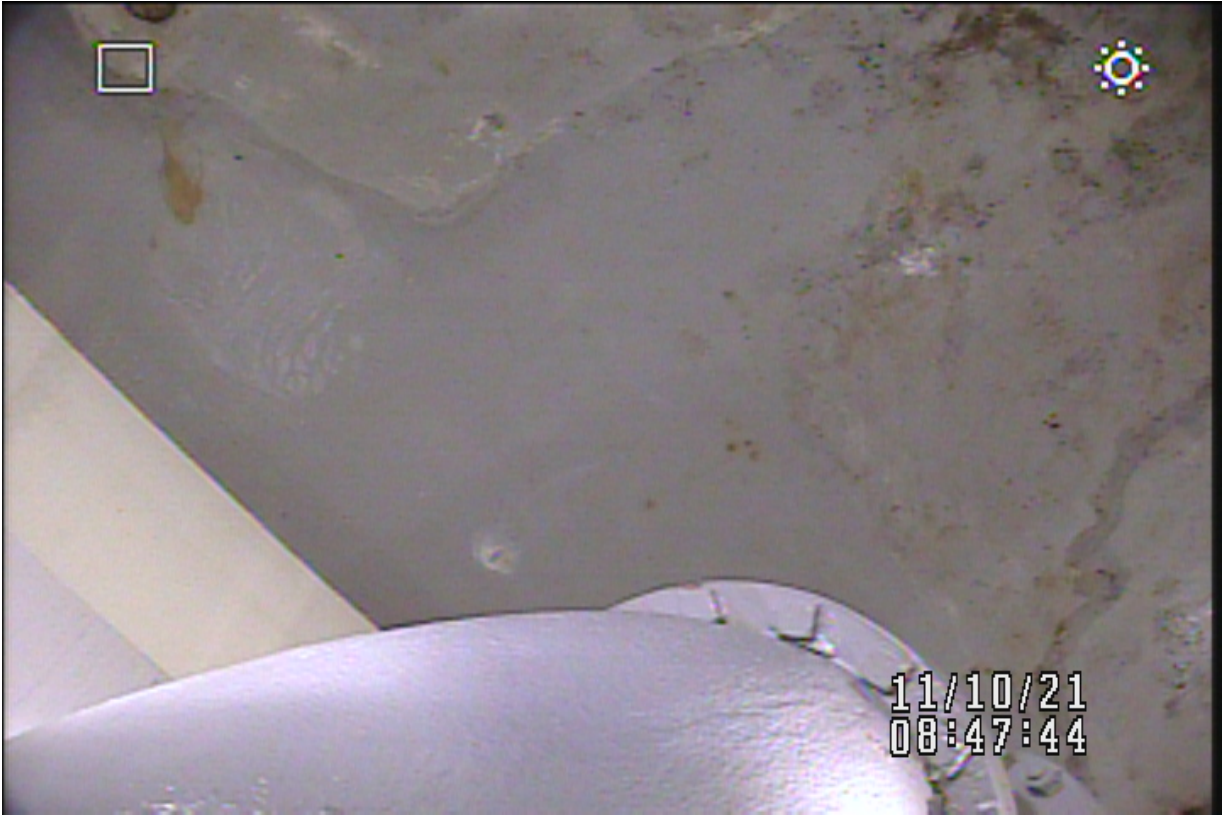
Description: At the concrete weir with the overflow from the high service suction well. Water was present in the bottom of the weir box. Both the upstream and downstream pipe flanges are visible in this image. The flow of water would be from the top of the photo to the bottom.
