## Third Party Assessment Final Presentation Meeting (100%)

# RED HILL - ASSESSMENT

FINAL ASSESSMENT PRESENTATION - 100%

## RED HILL UNDERGROUND STORAGE TANK FACILITY ASSESSMENT

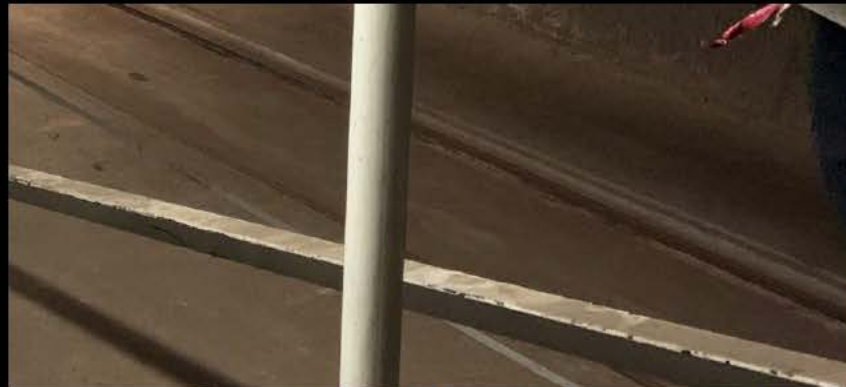
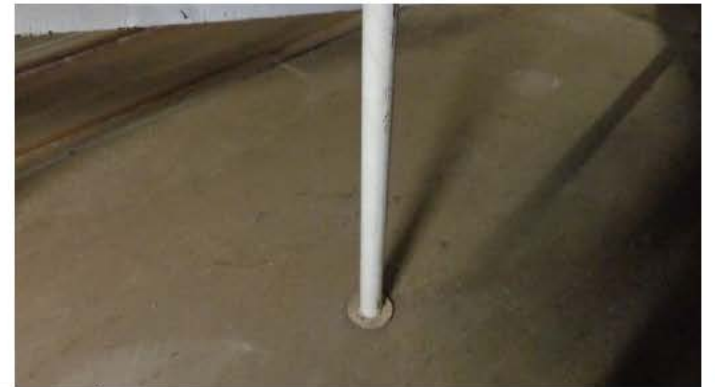
### Significantly Corroded Pipe Supports and Braces

- Retrofit required

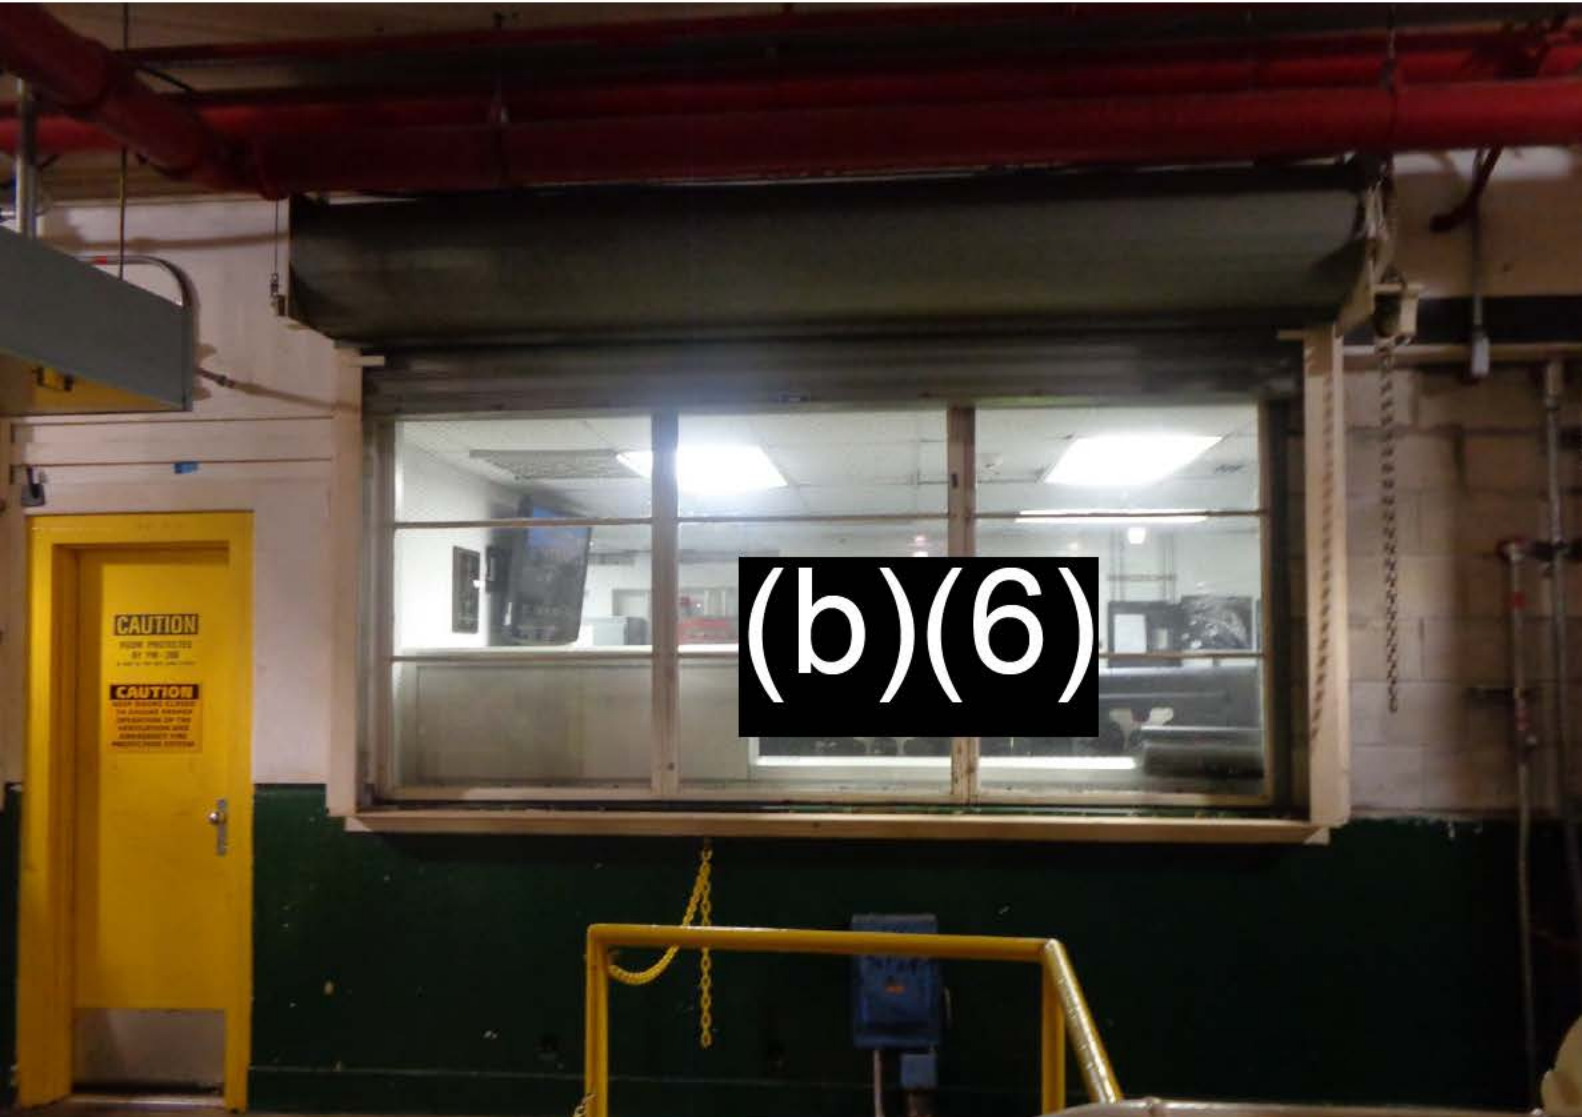
## Blast/Fire Resistant Window

- Operator viewing window and supporting framing within Pumphouse is not blast-resistant
- Control room door not blast or fire-resistant
- The control room is operationally critical and houses key personnel

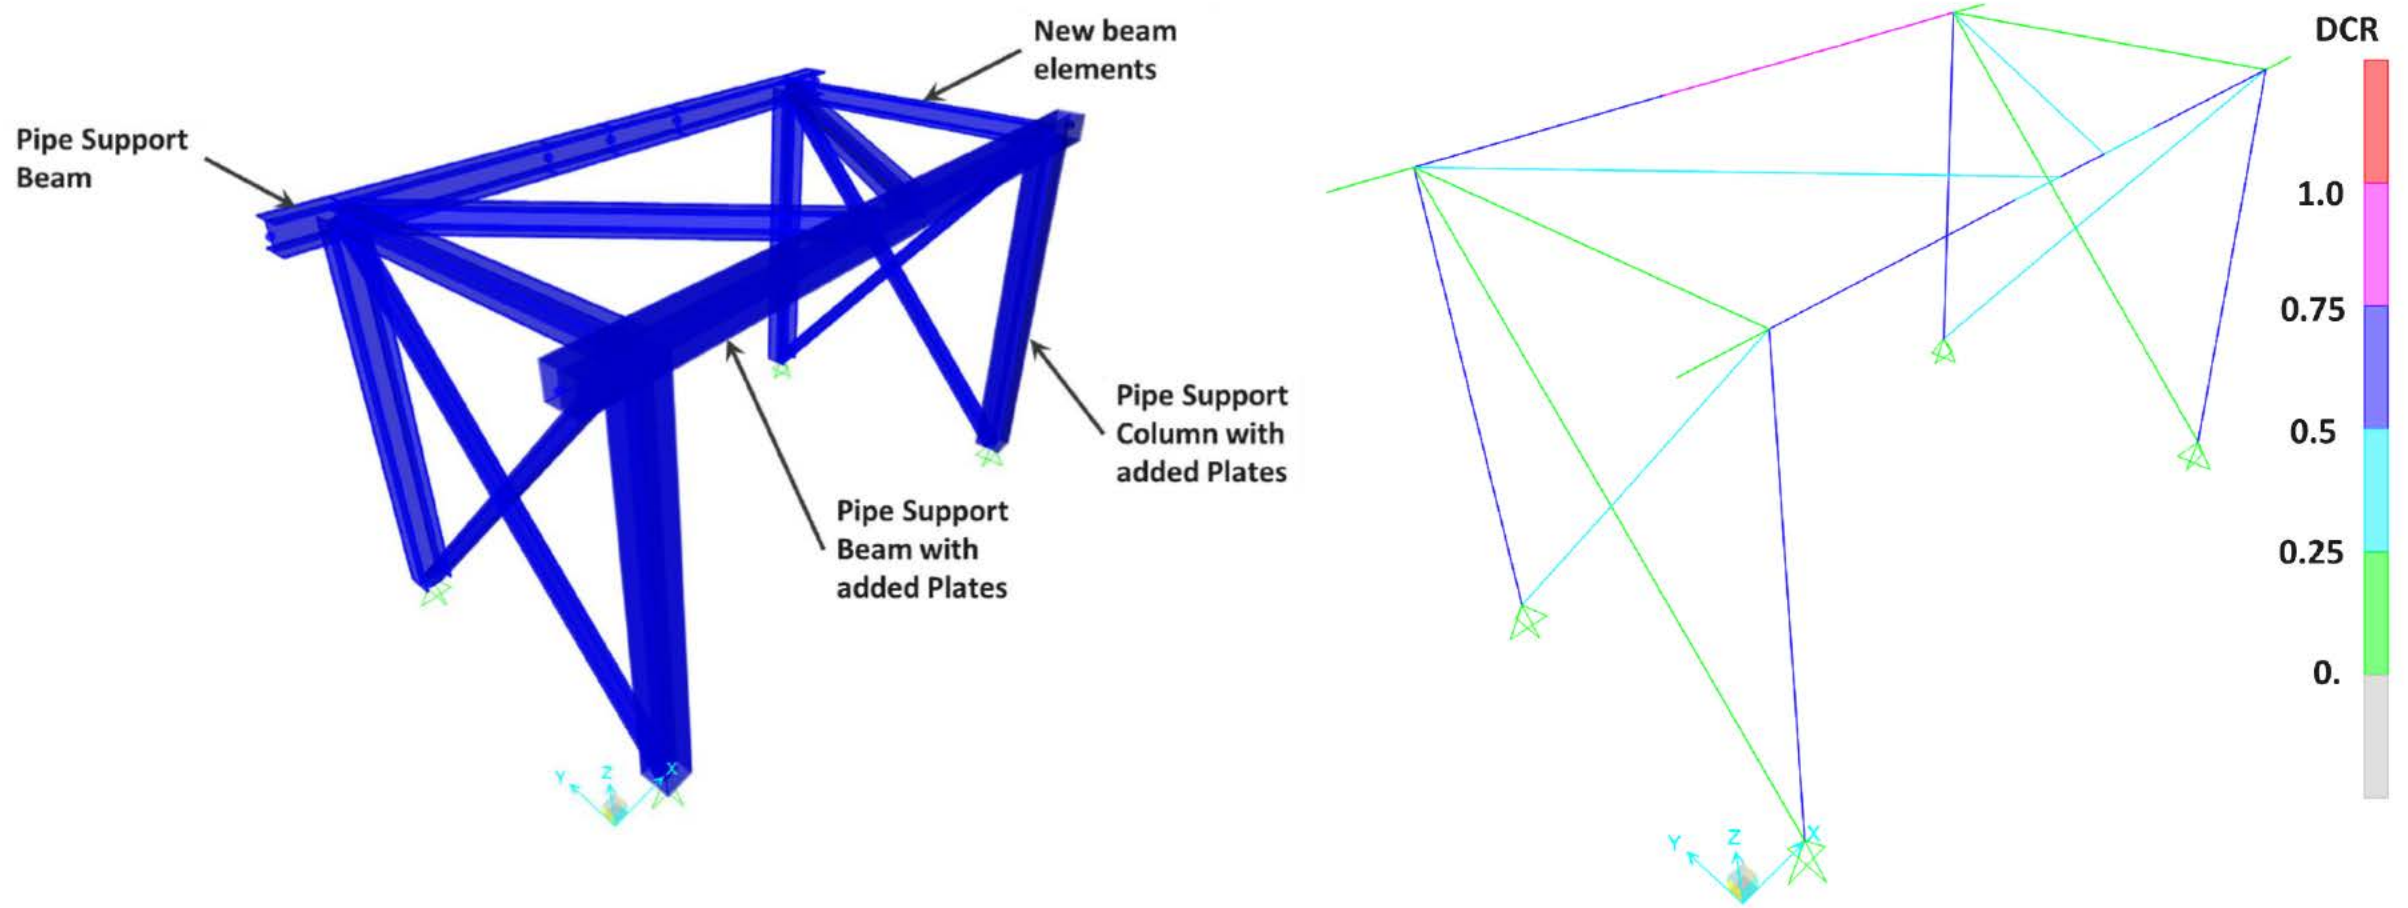
# Conceptual Axial Restraint (typical) and Frame Modifications at Tank 20

We recommend further investigation to determine the extent of the issue and potential mitigation for all tanks.

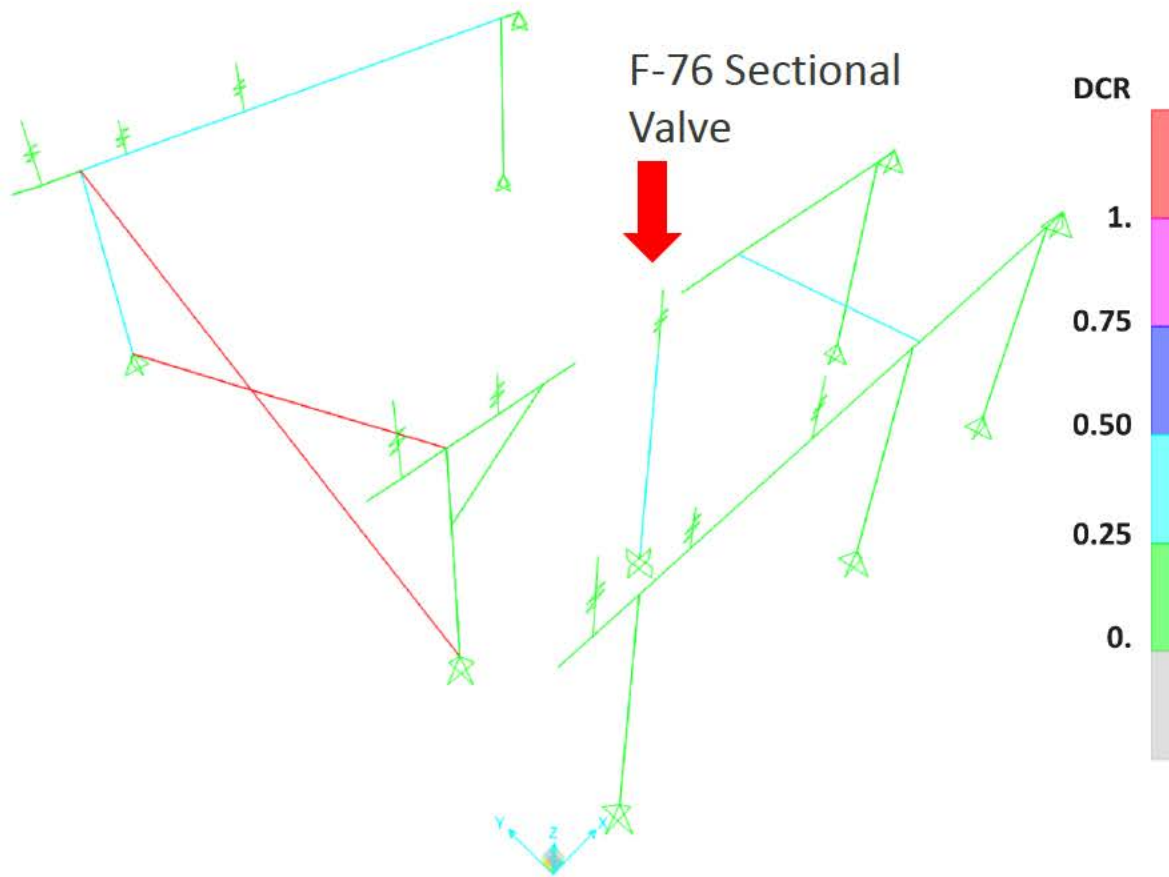
F-76 Sectional Valve

- Pipe Supports 46 to 48 – if corroded members are replaced

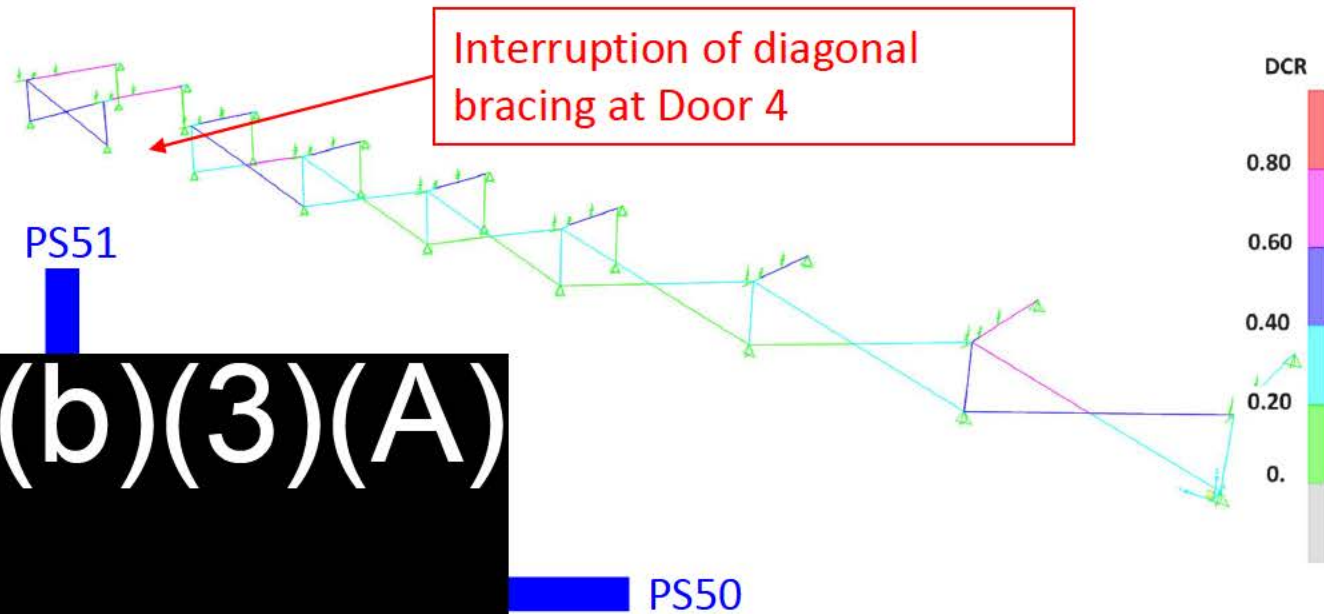
### Finite Element (FE) Analysis Results – Lower Access Tunnel

- Pipe Supports 49 to 57

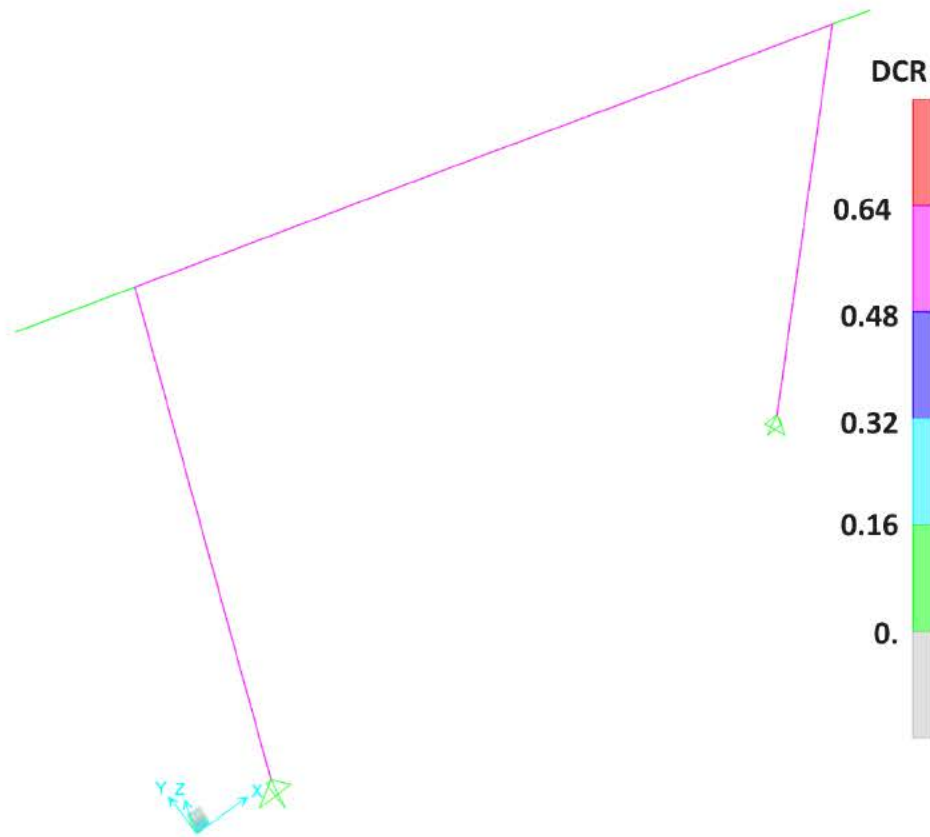
## Finite Element (FE) Analysis Results – Gallery at Tanks

- Pipe Support Tank Gallery 20

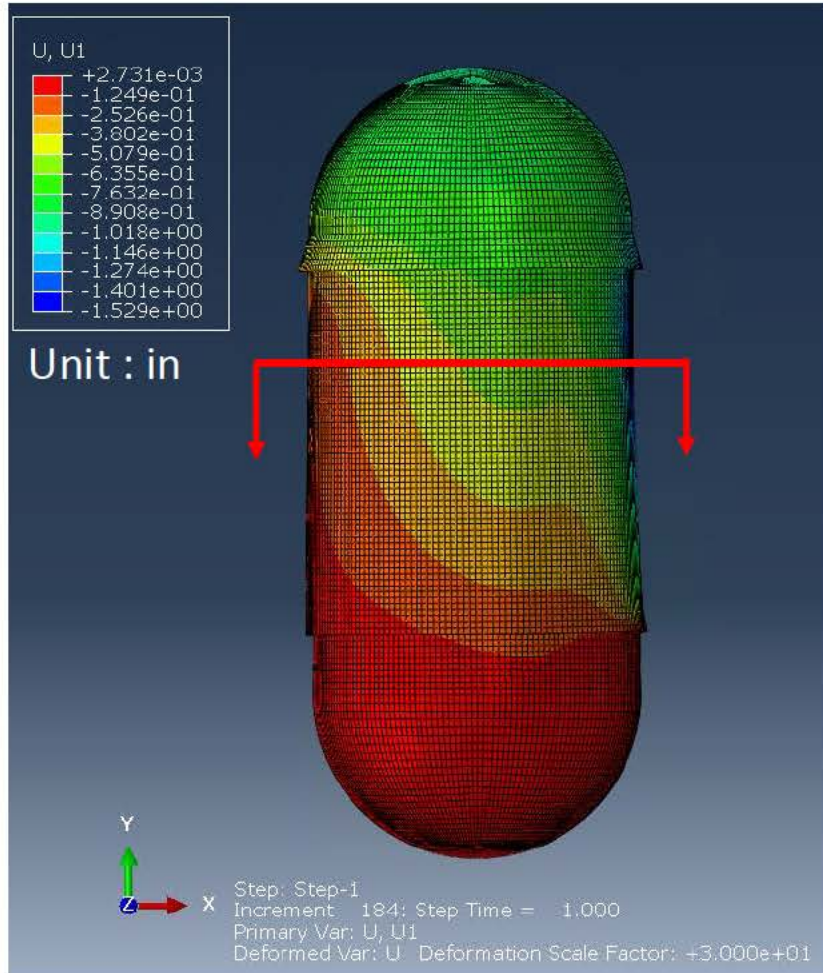
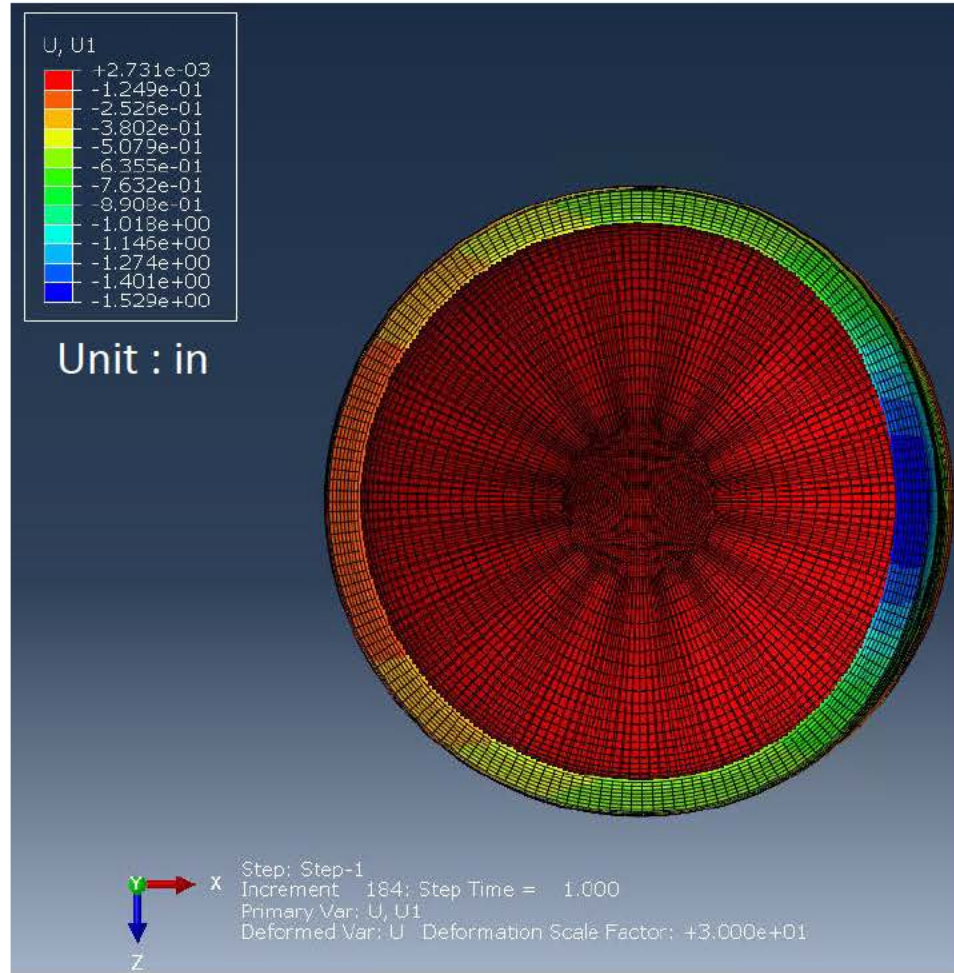
## Horizontal Deflections

- Maximum displacement for the global response (rigid body rotation) is less than 0.5 in
- Local bending of tank wall results in approximately 1.5 in deflection

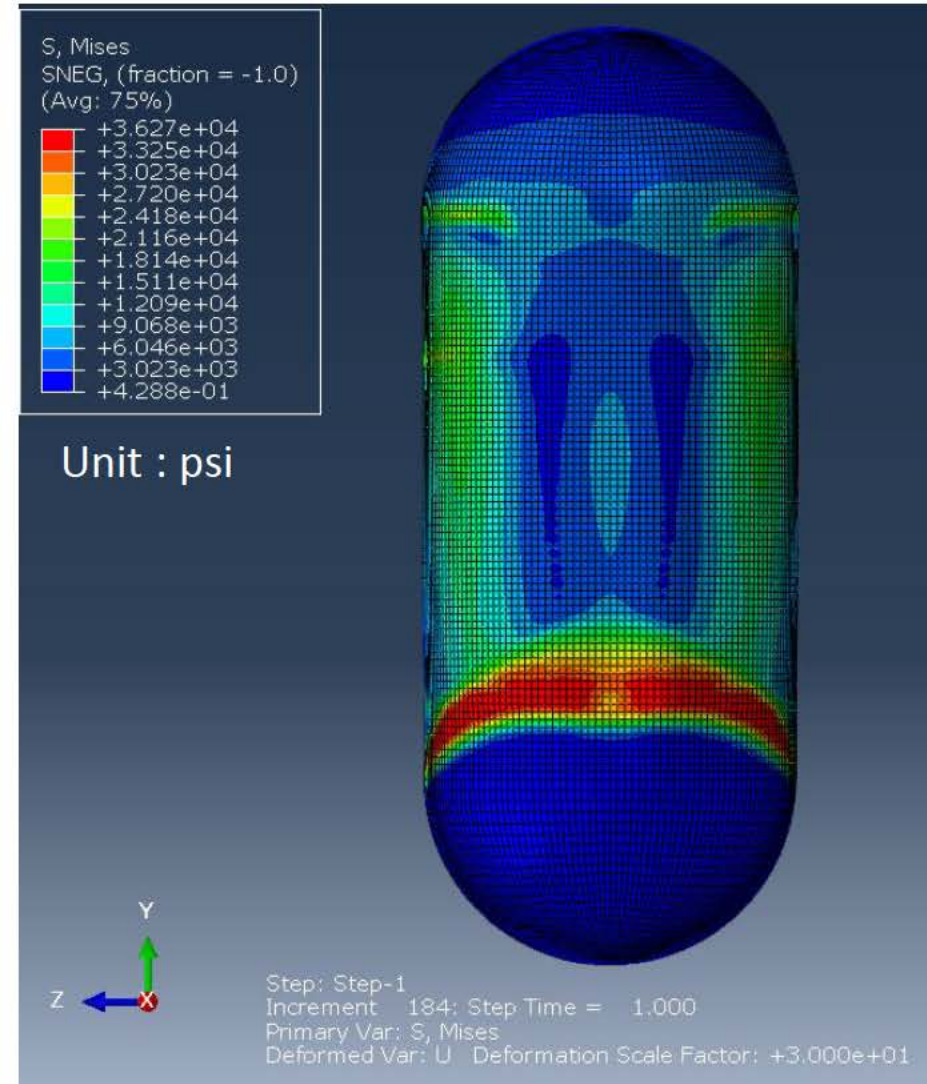
## Steel Liner Stresses

- Liner plate might be overstressed at the interface of the clinker layer and the solid rock around the tank
- The plastic strains are relatively small ( $\sim 0.004$ )
- Rupture of the liner highly unlikely due to a design level earthquake event

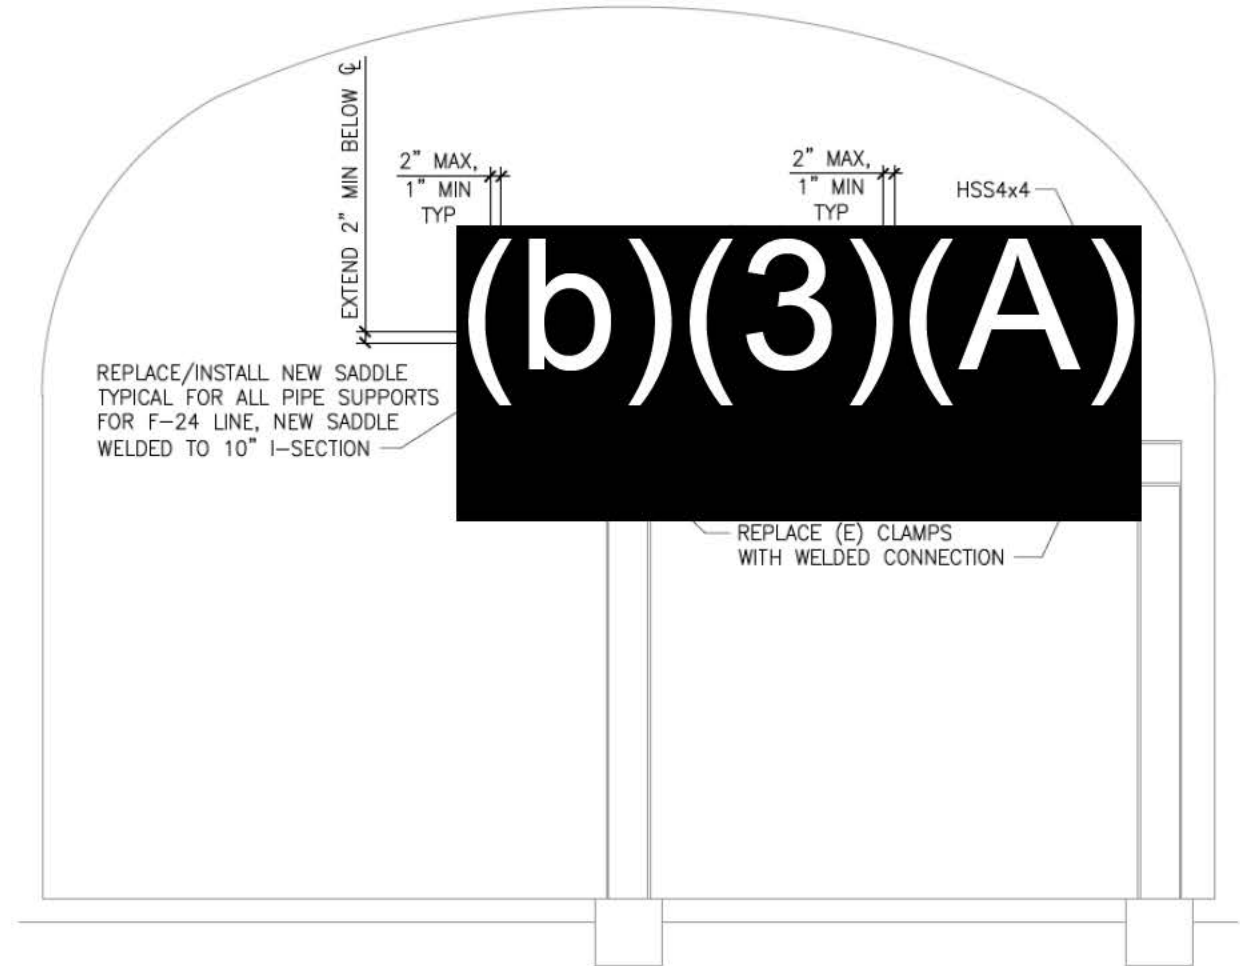
## Pipeline Lateral Restraints in the Red Hill Tunnels

- Increase lateral load resistance and redundancy of the pipe supports
- Lower the impact of surge loads on the piping systems
- In addition, restrain F-24 line at 20+ locations
