Ready for Reuse Basis of Decision Former FJ Doyle Salvage Transformers Facility EPA ID TXD980865109 Leonard, Fannin County, Texas

The United States Environmental Protection Agency (EPA) Region 6 has determined that the former FJ Doyle Salvage Transformers Facility, located at 905 North Poplar Street in Leonard, Texas (the "Property") is Ready for Reuse. The Property meets the criteria for the Ready for Reuse Determination since conditions on the Property are protective of human health and the environment, based on its current and future use, consistent with the deed notice filed in the Real Property Records in the Fannin County Clerk's Office.

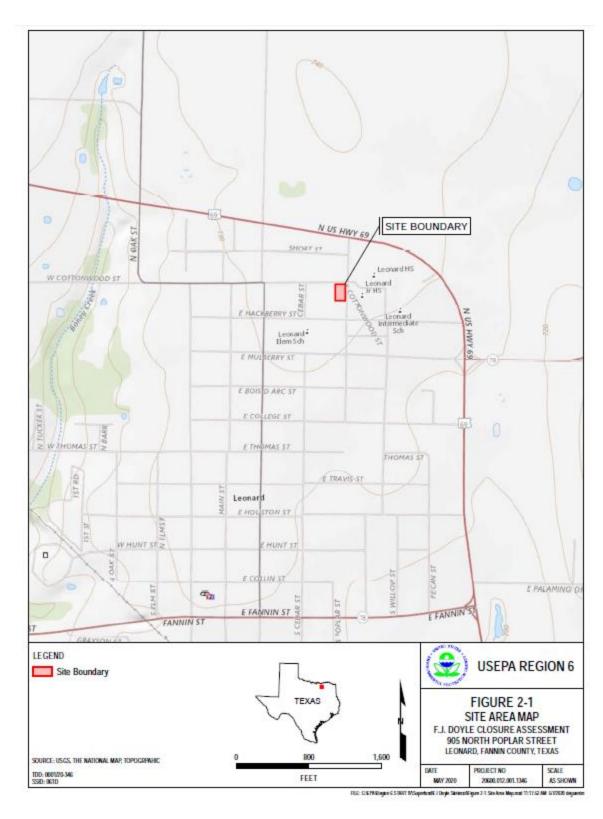
The EPA Ready for Reuse Determination is being issued for the Property, as shown on the Site Layout Map in Figure 2. The former F.J. Doyle site is 0.47 acres and located in Leonard, Texas. The Property is located within a residential neighborhood and bounded to the east by North Poplar Street, to the north by East Cottonwood Street, and to the south and west by residential properties. The site is directly bordered by residential properties and a Leonard Independent School District (LISD) daycare facility to the south, with LISD elementary schools just south of the daycare facility. Leonard Junior High School is located to the east of the site. Leonard High School is located north east of the site.

Figure 2: General site area map taken from F.J Doyle Salvage Closure Assessment (TDD No. 0001/20-346).

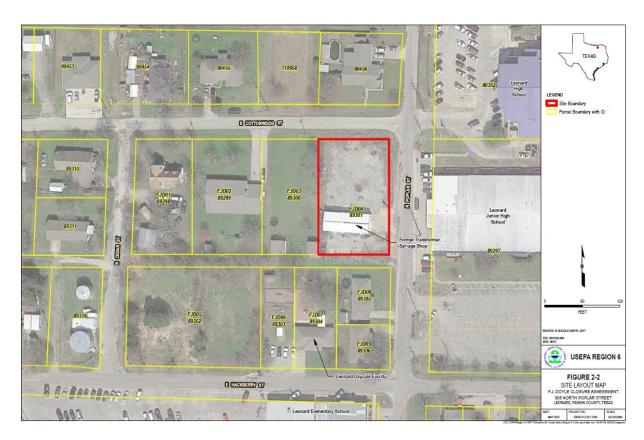
Figure 3: Former site layout map taken from F.J Doyle Salvage Closure Assessment (TDD No. 0001/20-346).

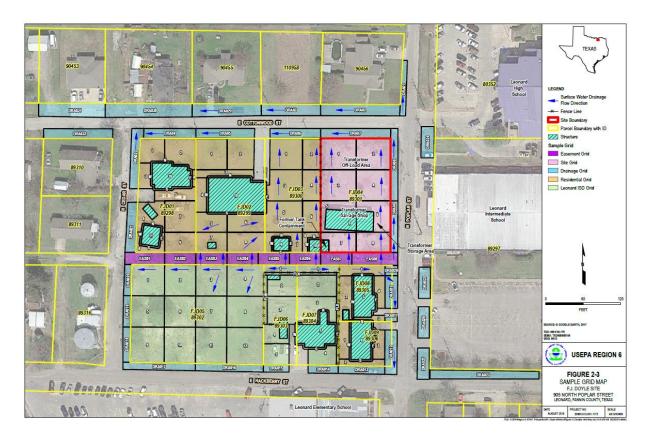
Figure 7: Sample grid map depicting site boundaries, residential boundaries, and surface drainage patterns. Taken from the F.J Doyle Salvage Site Removal Action Report (TDD No. 0001/18-175).
