UNITED STATES ENVIRONMENTAL PROTECTION AGENCY
REGION IX
75 Hawthorne Street
San Francisco, CA 94105-3901

Re: Transmittal of the Spill Prevention, Control and Countermeasure and Underground Storage Tank Inspection Reports for Joint Base Pearl Harbor-Hickam

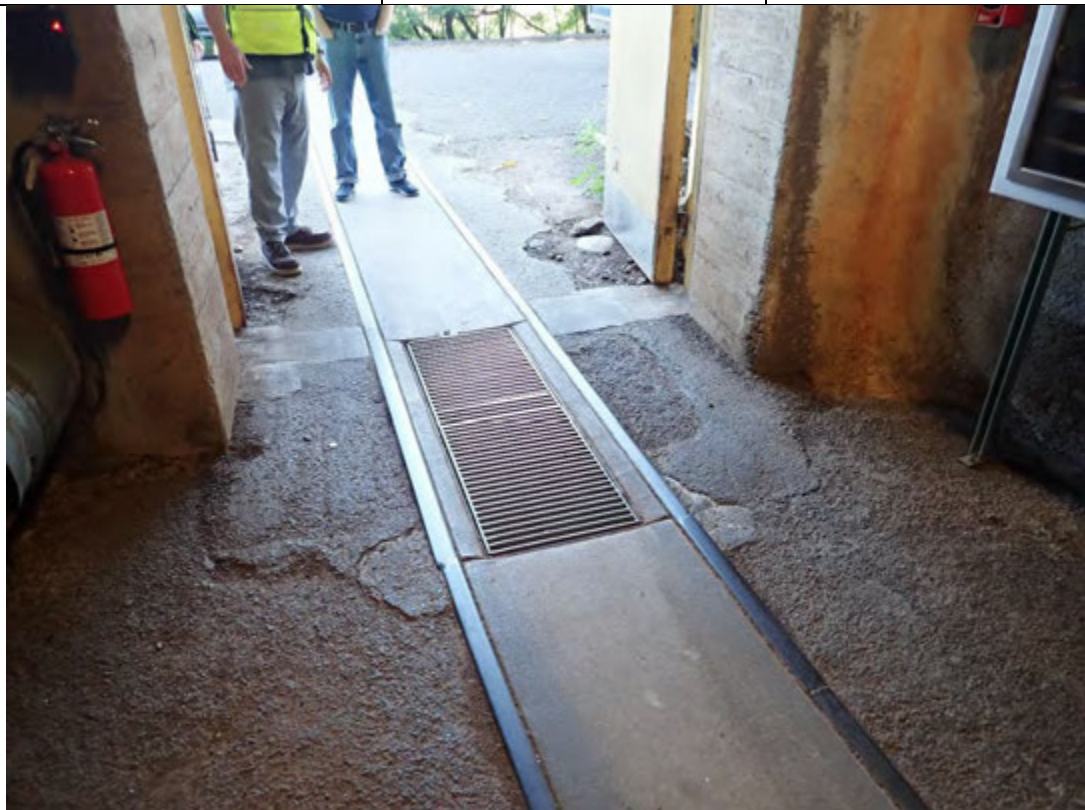
Grated drain at
entrance of Adit **REF**

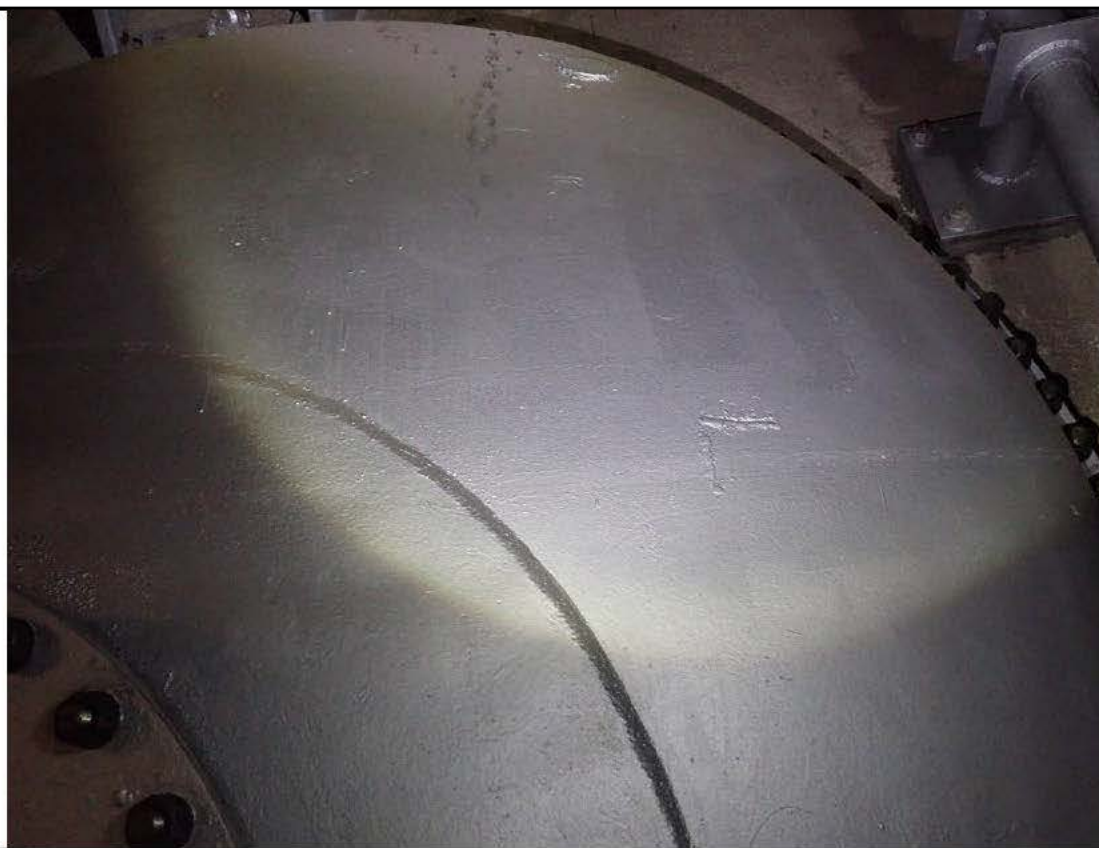
Photographer: WITUL	
Photo No. 11	Time: 0931
Direction Photo Taken: In Upper Tunnel	
Photo Description: Tank 17 hatch with possible welded or repaired areas.

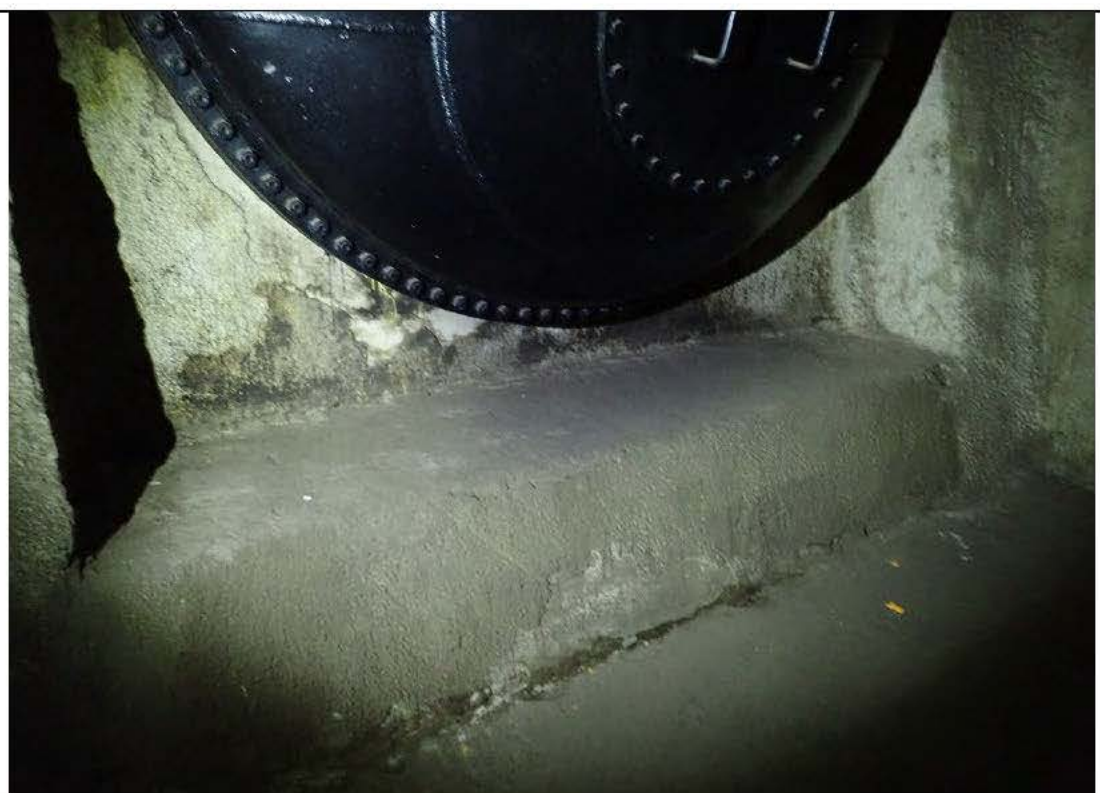
Photo No. 22	Time: 0958
Direction Photo Taken: In Upper Tunnel	
Photo Description: Tank 11 Upper hatch and manway with discoloration reminiscent of weeping below hatch and step. A strong odor was evident in this area.

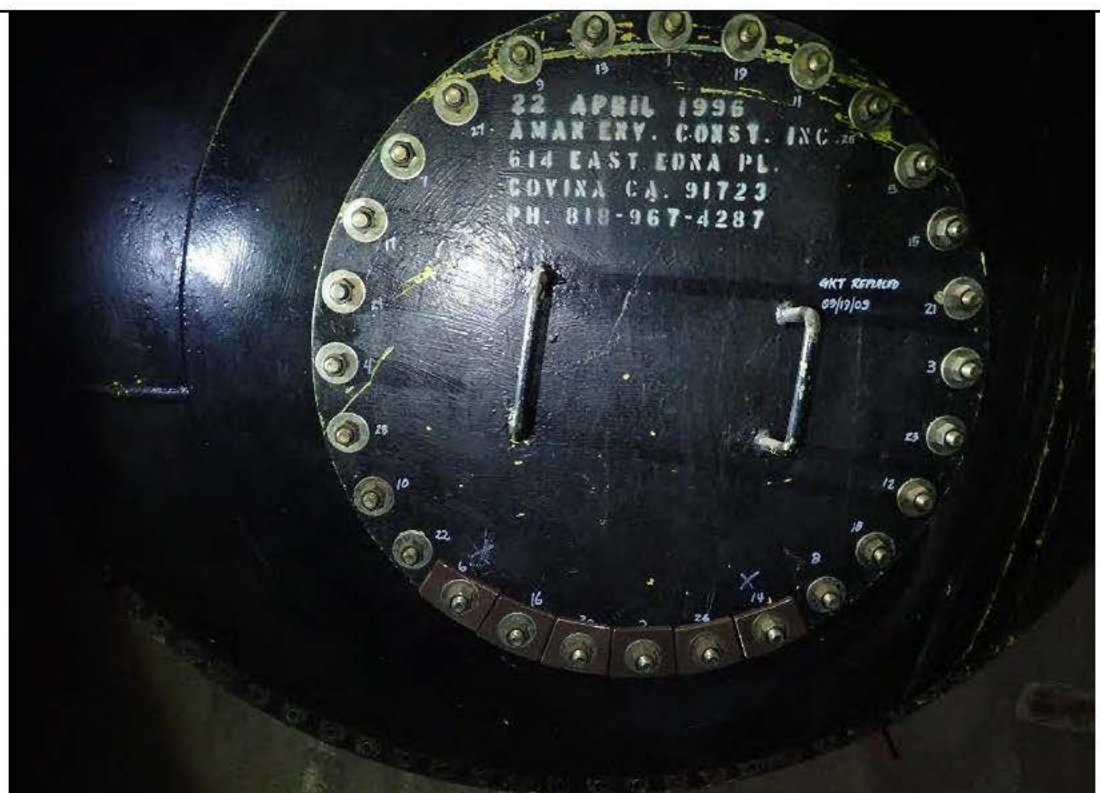
Photo No. 24	Time: 1001
Direction Photo Taken: In Upper Tunnel	
Photo Description: Tank 9 manway flange on hatch. Bottom six bolts have extra plate behind washers, reportedly for extra torque.

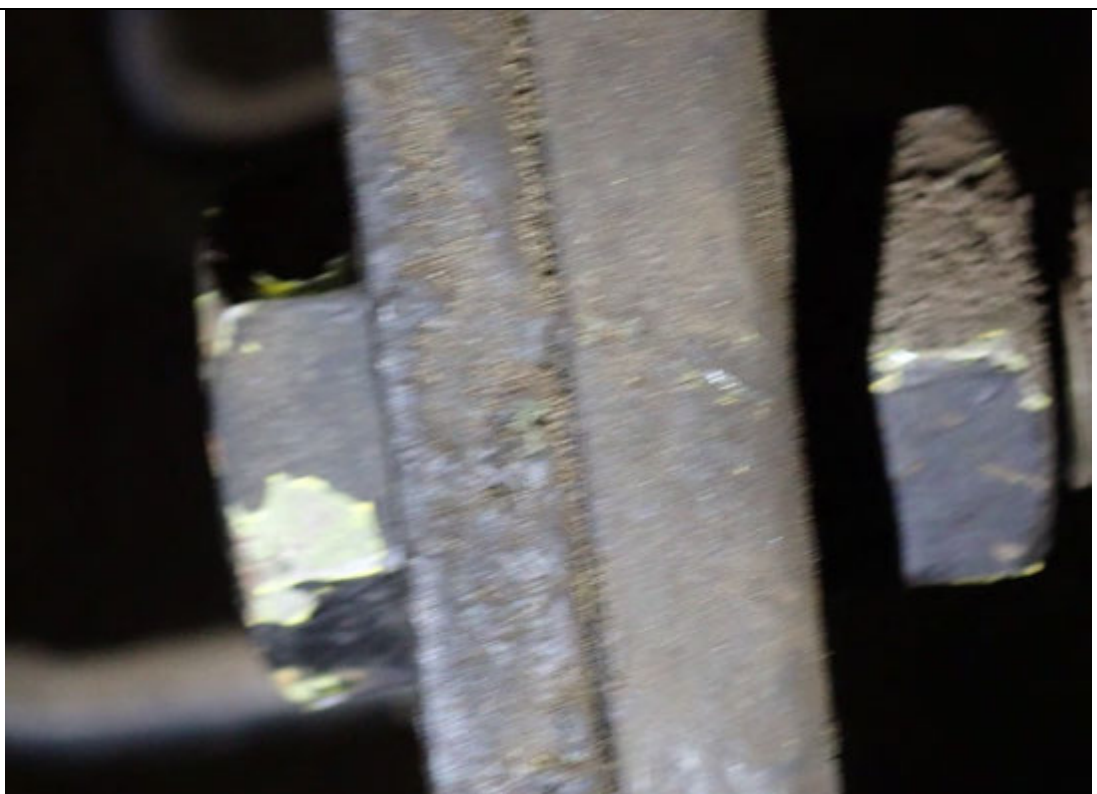
Photo No. 34	Time: 1012
Direction Photo Taken: In Upper Tunnel	
Photo Description: Tank 4 manway flange, no gasket visible.

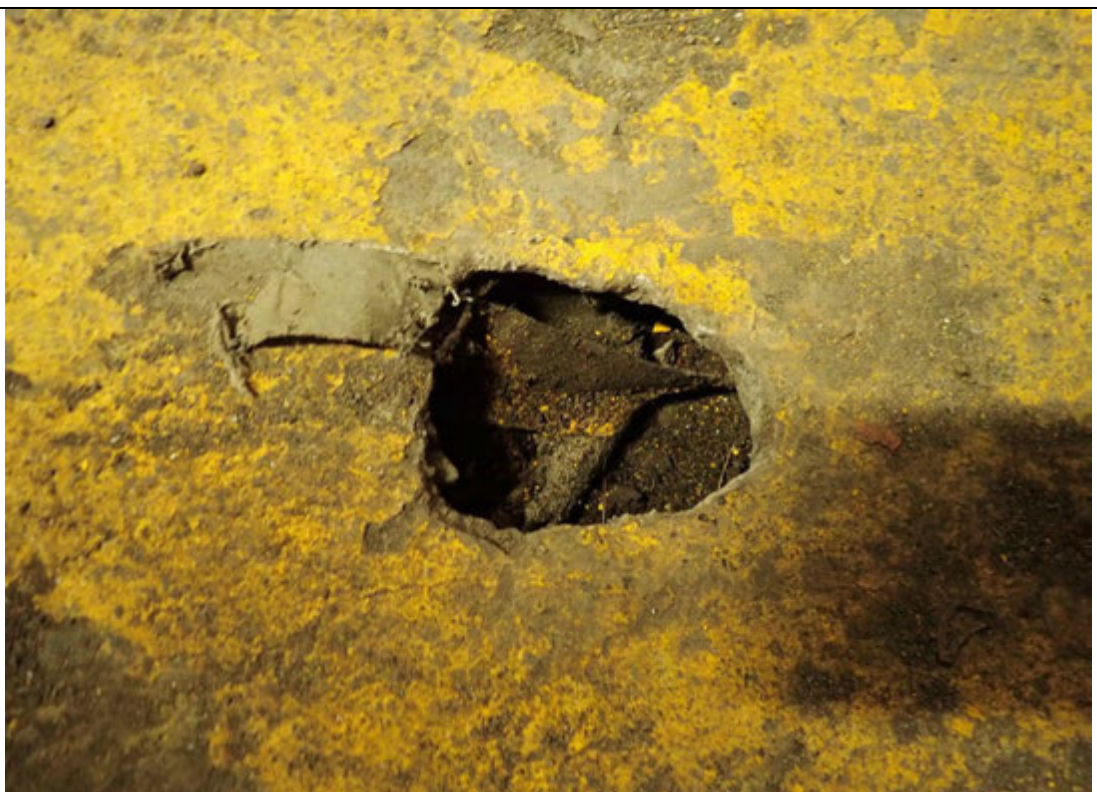
Photo No. 38	Time: 1031
Direction Photo Taken: In Upper Tunnel	
Photo Description: Hole in gunite floor between tracks by elevator.

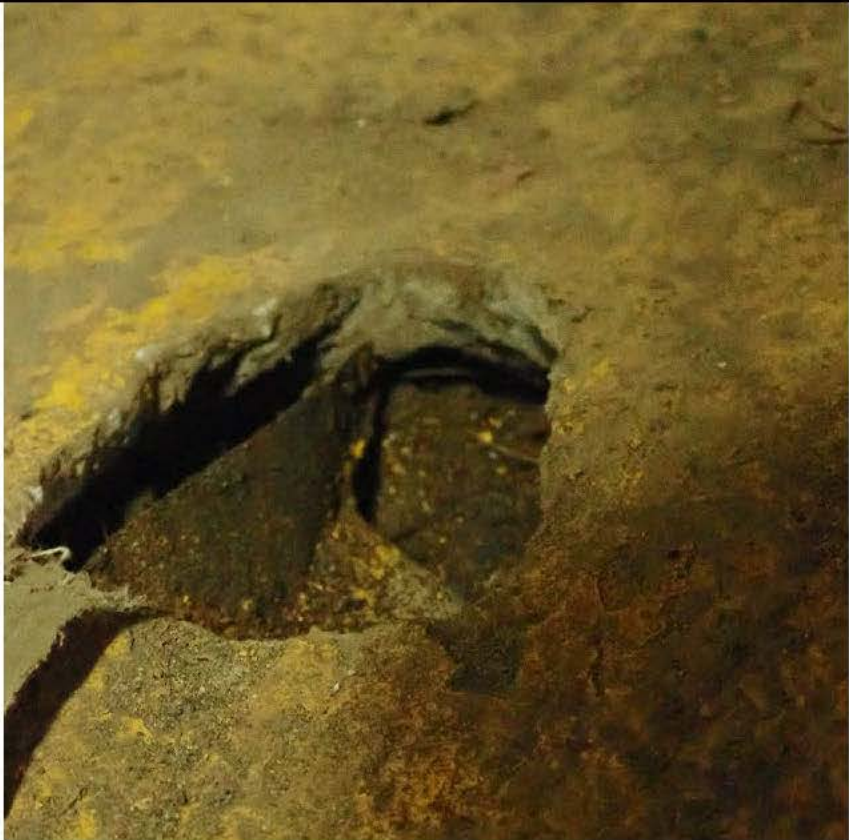
Photo No. 39	Time: 1031	
Direction Photo Taken: In Upper Tunnel		
Photo Description: Thickness of gunite visible at side of hole in floor.

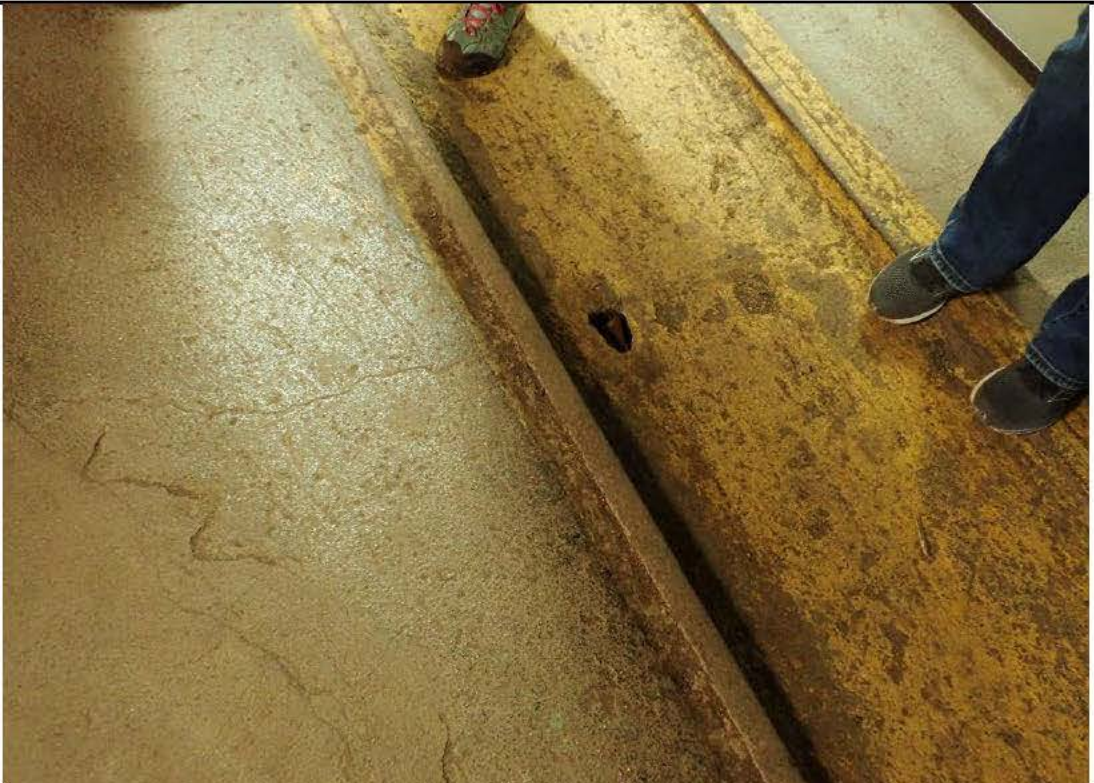
Direction Photo Taken: In Upper Tunnel		
Photo Description: Tracks and hole in floor, near tunnel elevator upper door.

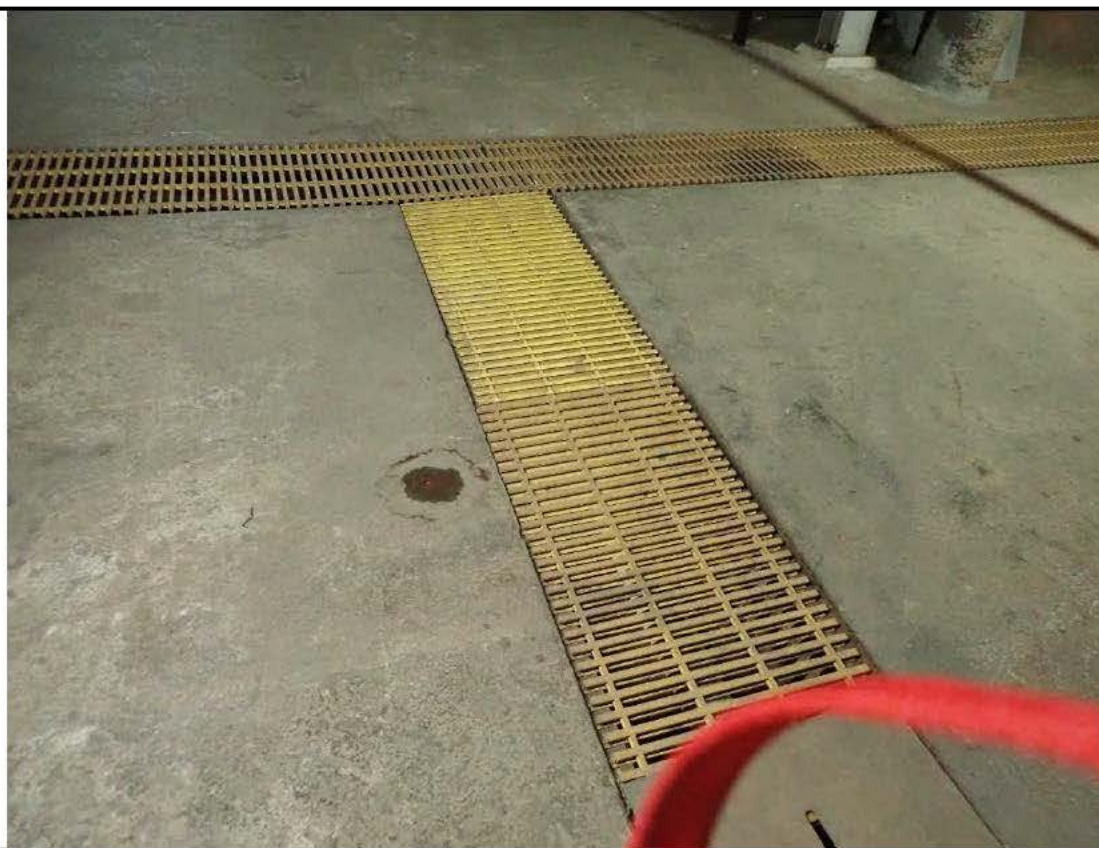
Photo No. 42	Time: 1041
Direction Photo Taken: In Lower Tunnel	
Photo Description: Sampling drain lines at Tank 19; not operative for exhibition tank.

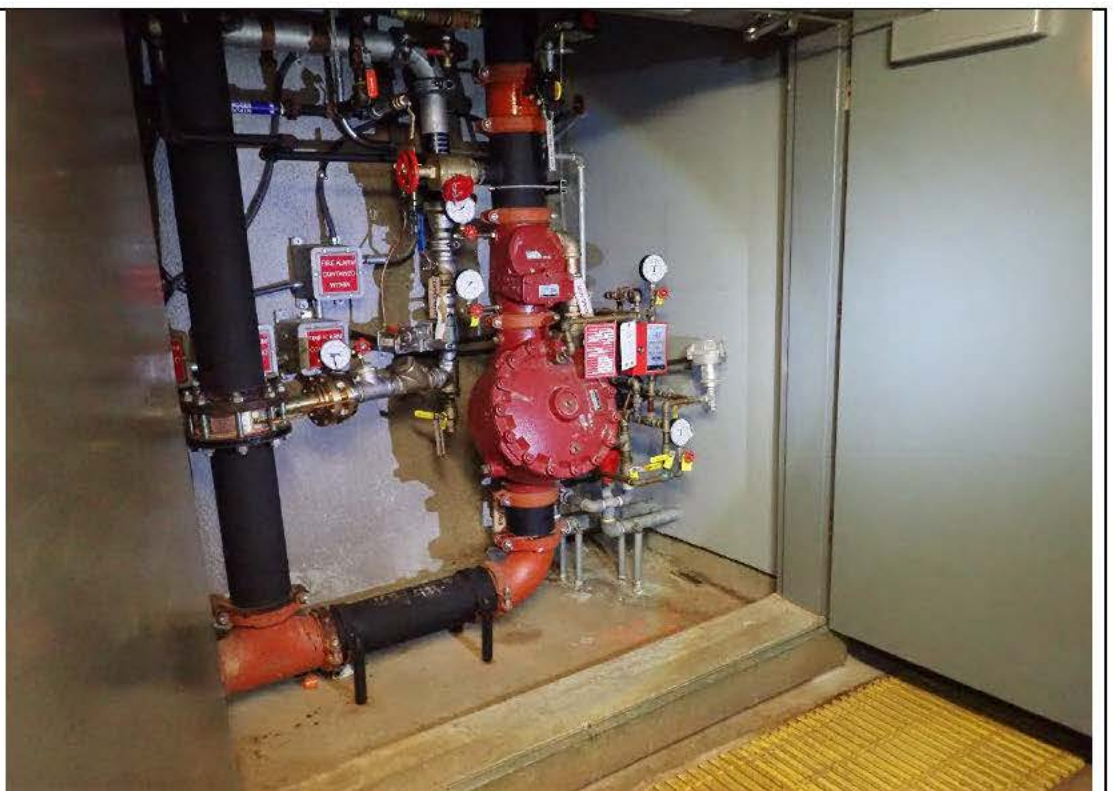
Photographer: WITUL	
Photo No. 49	Time: 1059
Direction Photo Taken: In Lower Tunnel	
Photo Description: Tank 18 end of line at left, where end was forced off during May 2021 incident.

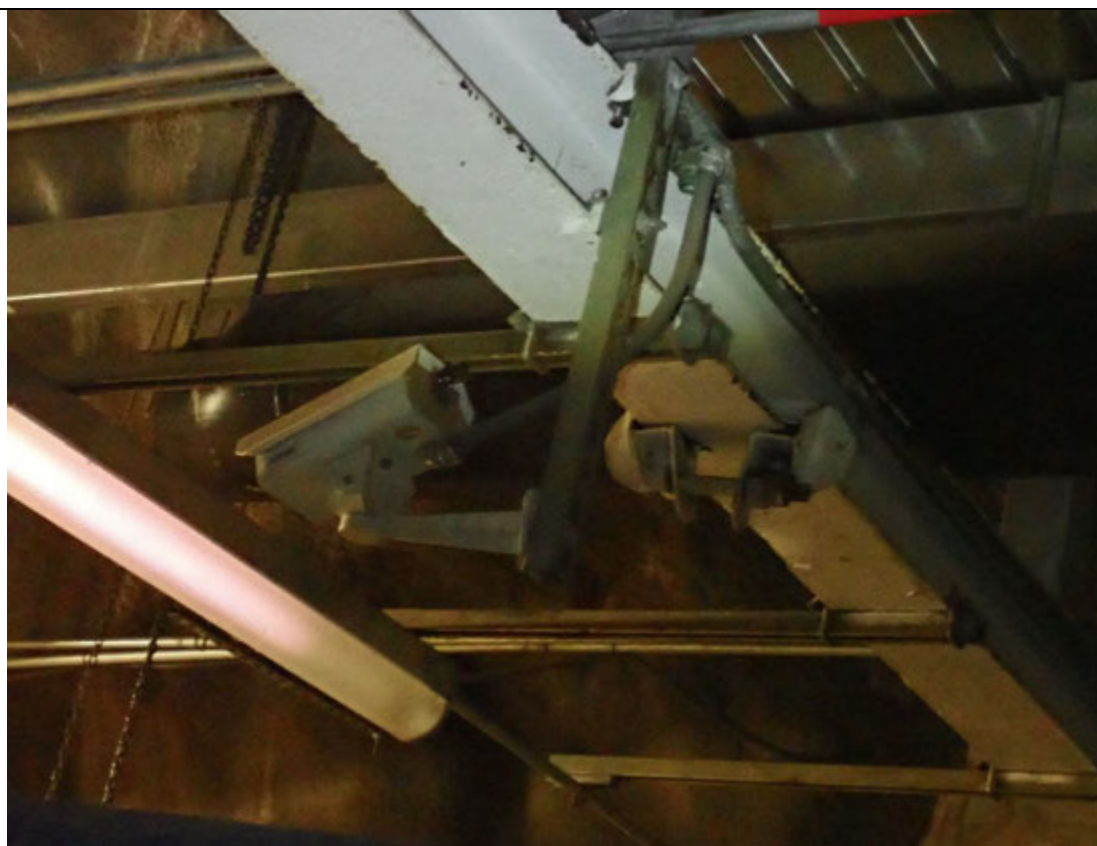
Photo No. 50	Time: 1101
Direction Photo Taken: In Lower Tunnel	
Photo Description: Two of four pumps visible below grate over AFFF fire water sump, at one of five such sumps in lower tunnel. Sump was full to grate in May 6 incident.

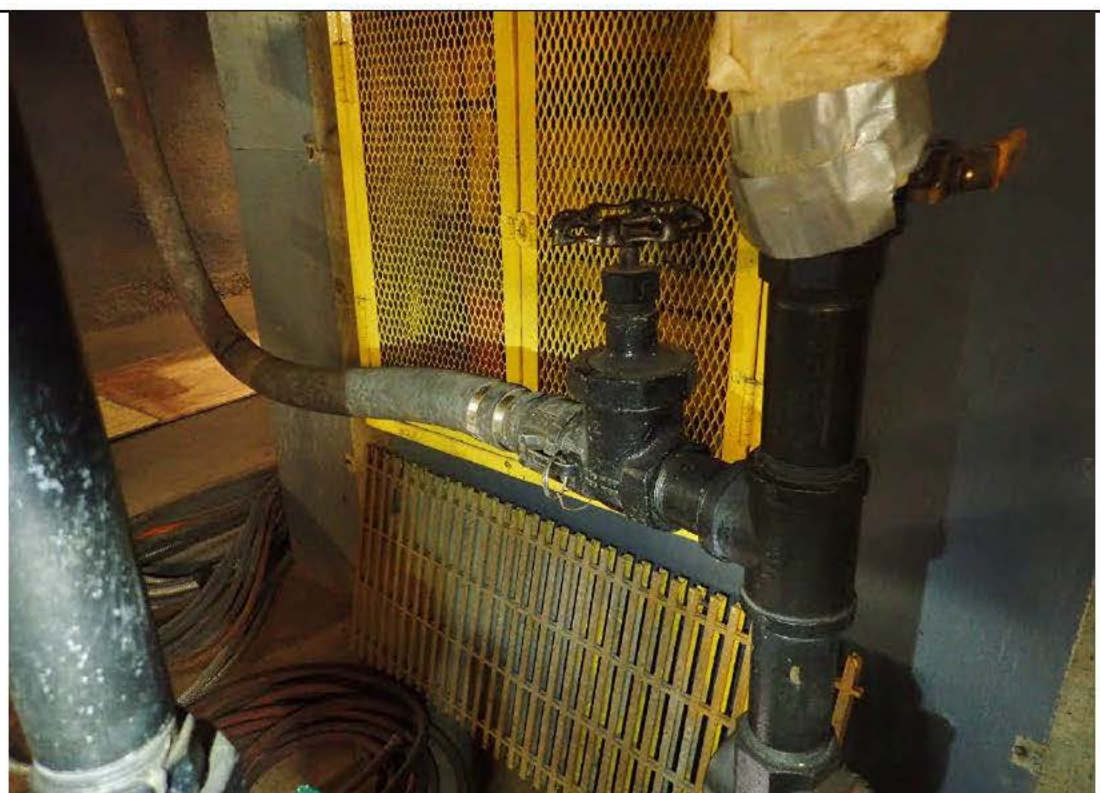
Photographer: WITUL	
Photo No. 65	Time: 1141
Direction Photo Taken: In Lower Tunnel	
Photo Description: Wet sample line end, typical of several seen.

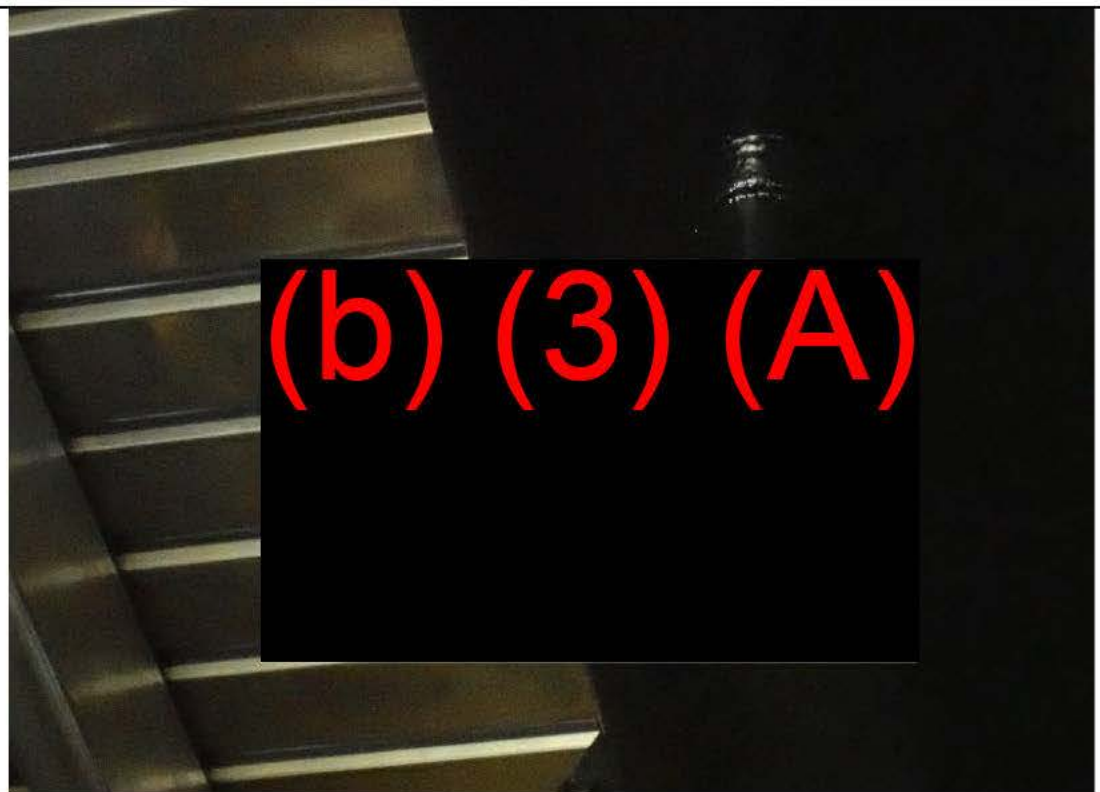
Photo No. 80	Time: 1210
Direction Photo Taken: In Lower Tunnel	
Photo Description: Tank 9 low point drain, close-up.

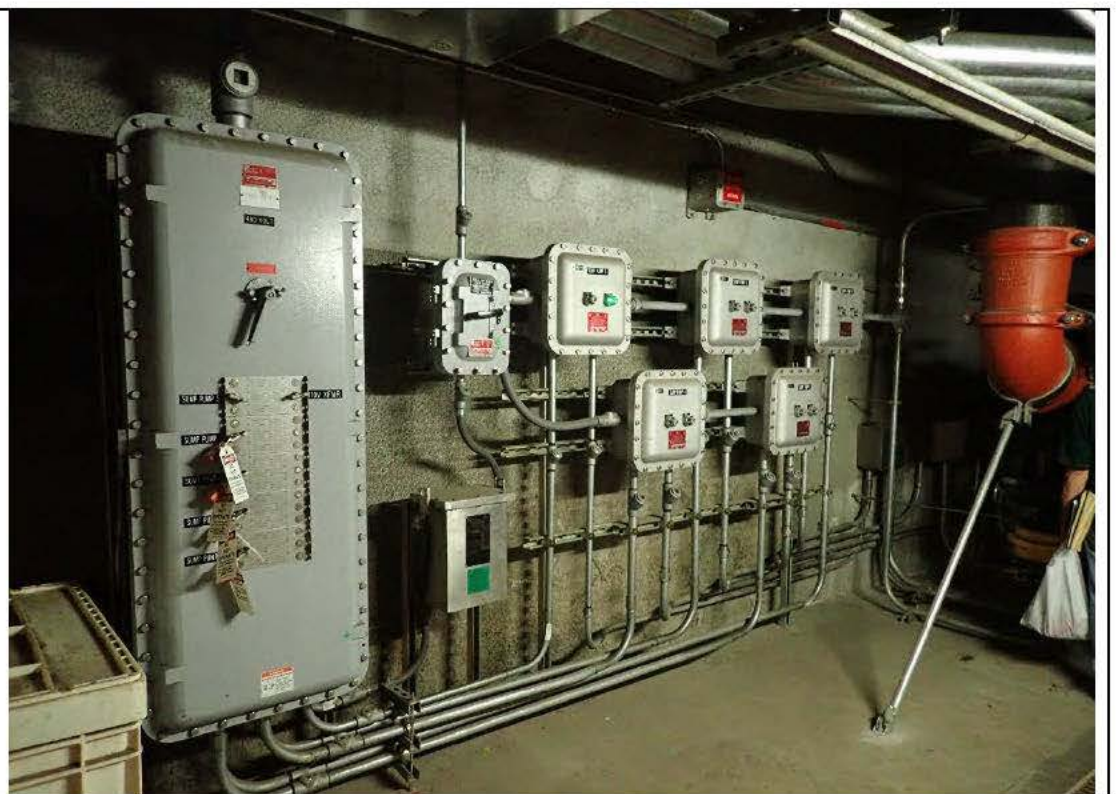
Photo No. 84	Time: 1223
Direction Photo Taken: In Lower Tunnel	
Photo Description: System sump controls.

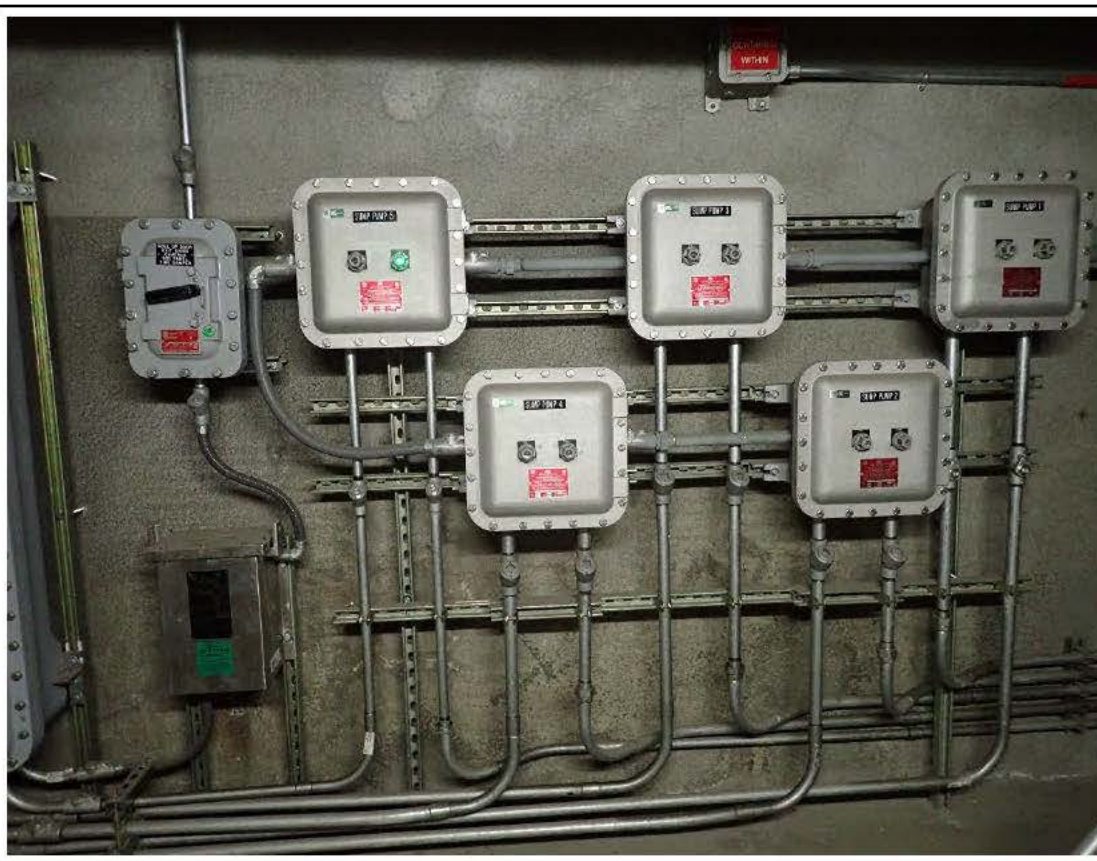
Photographer: WITUL	
Photo No. 85	Time: 1224
Direction Photo Taken: In Lower Tunnel	
Photo Description: Sump pump 5 lighted green.

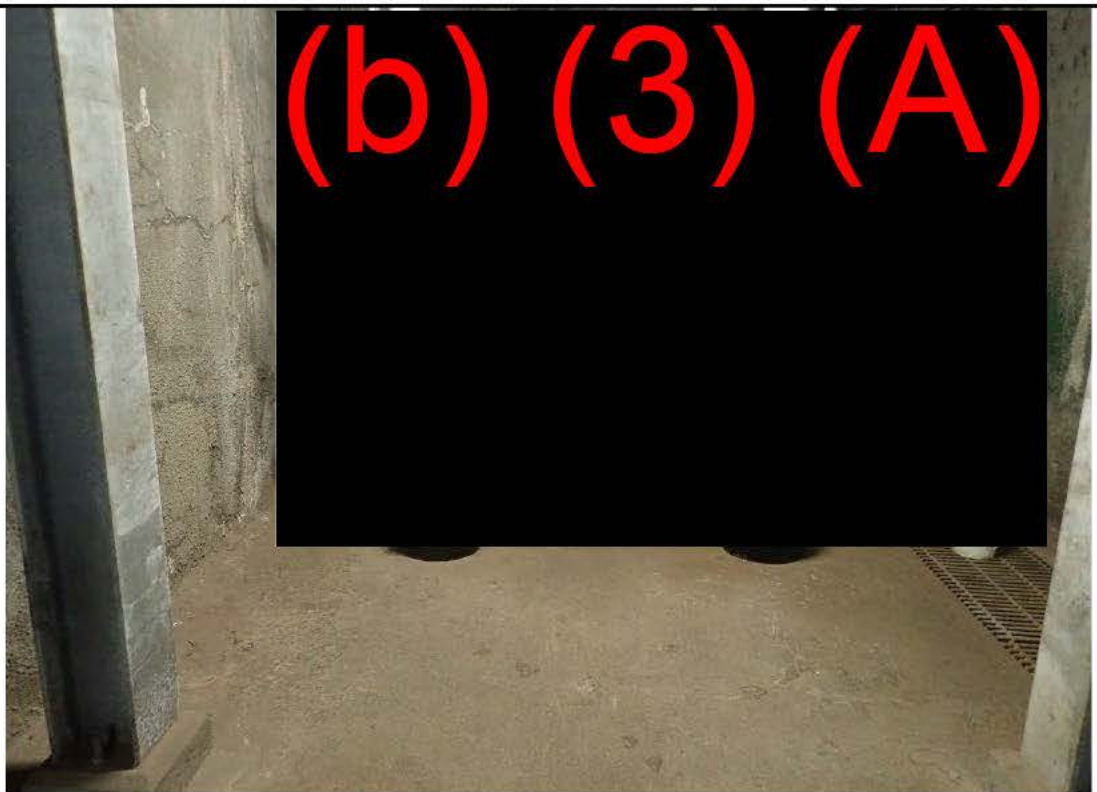
Photo No. 86	Time: 1226
Direction Photo Taken: In Lower Tunnel	
Photo Description: Tank 3, larger F76 piping tagged out-of-service. Pans placed below controls to contain possible drips.

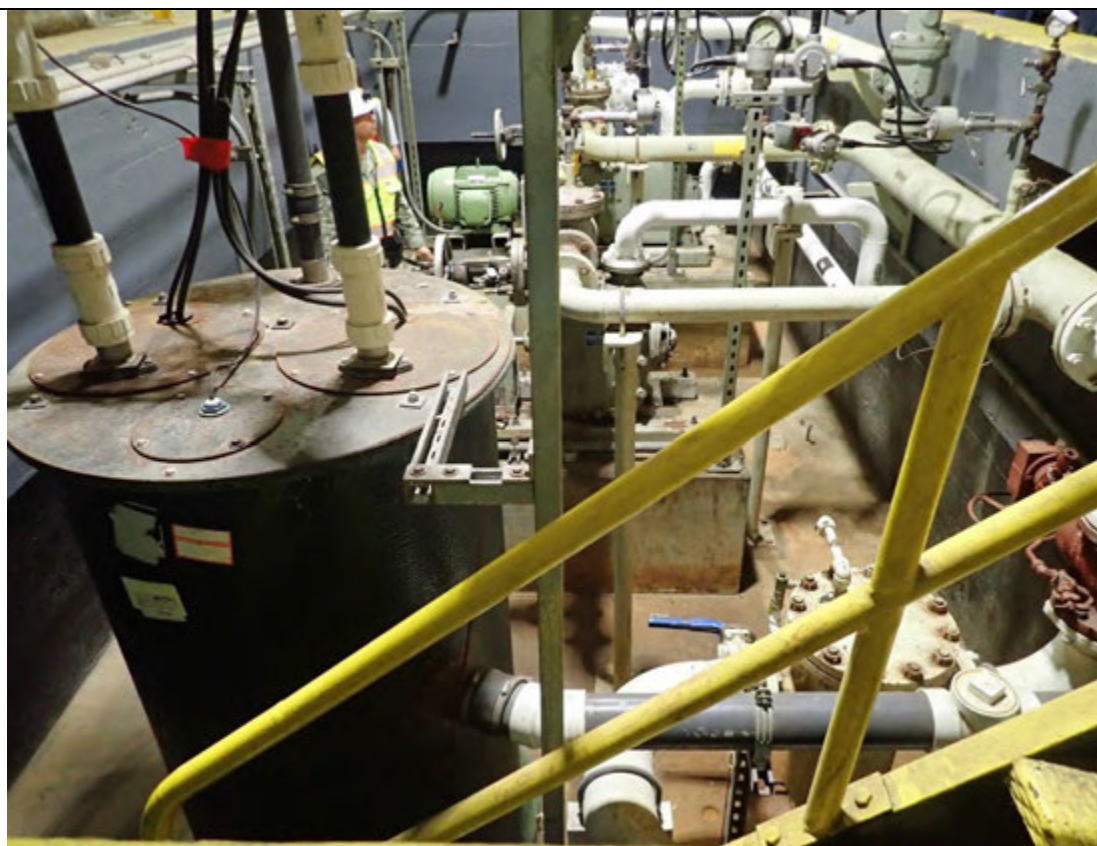
Photographer: WITUL	
Photo No. 89	Time: 1231
Direction Photo Taken: In Lower Tunnel	
Photo Description: Main sump tank, looking down and across.

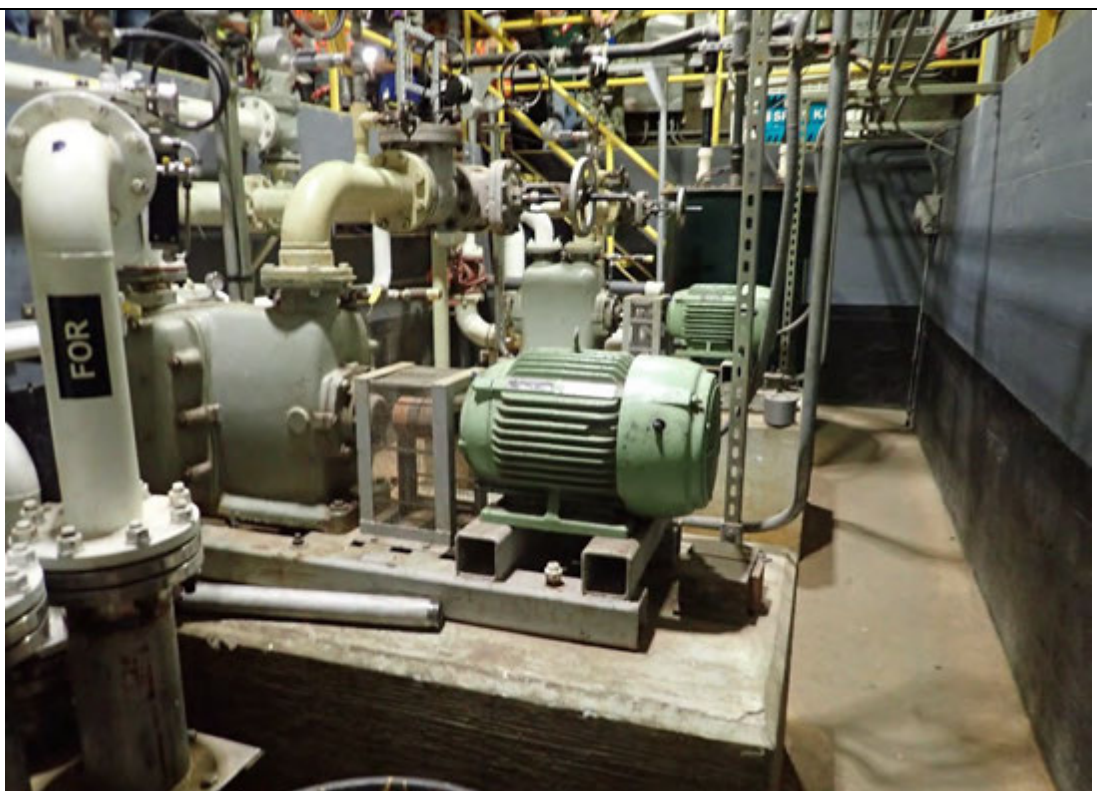
Photo No. 90	Time: 1232
Direction Photo Taken: In Lower Tunnel	
Photo Description: Main sump, pumps and piping.

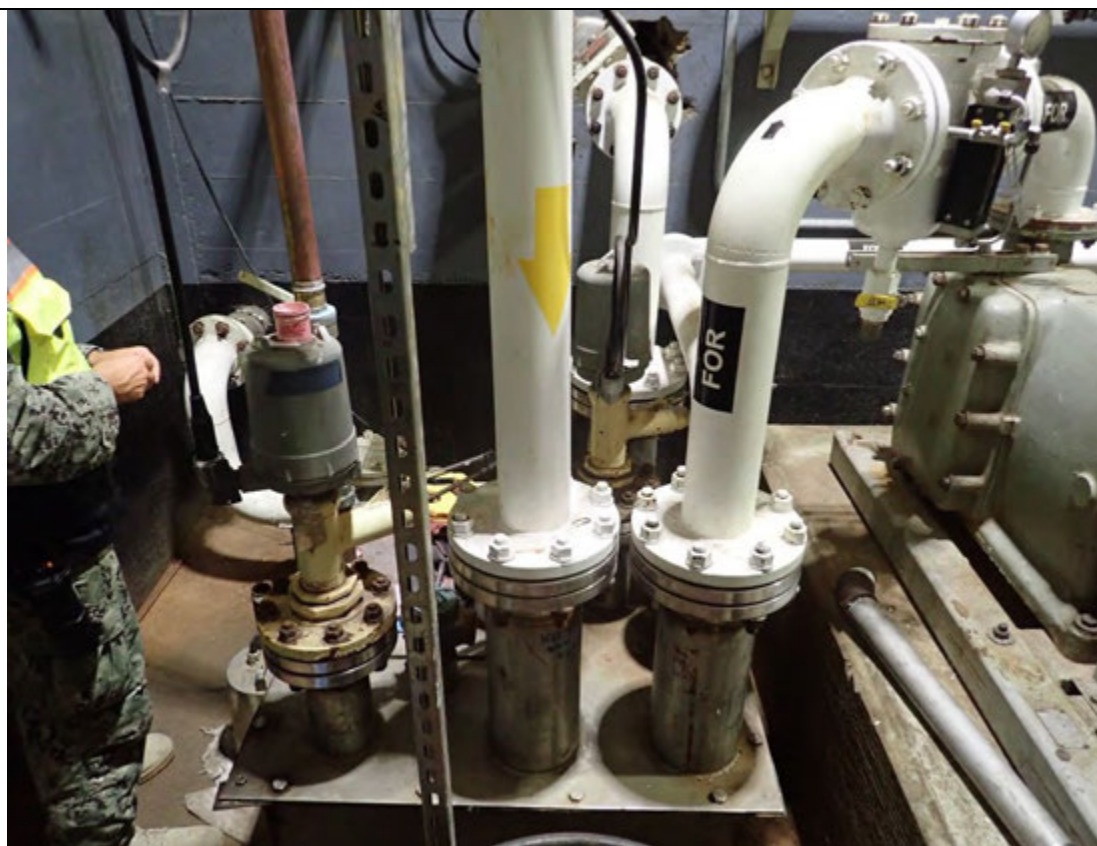
Photographer: WITUL	
Photo No. 91	Time: 1232
Direction Photo Taken: In Lower Tunnel	
Photo Description: 5000-gallon sump (or tank) pumps out to Fuel Oil Recovery Tank 311.

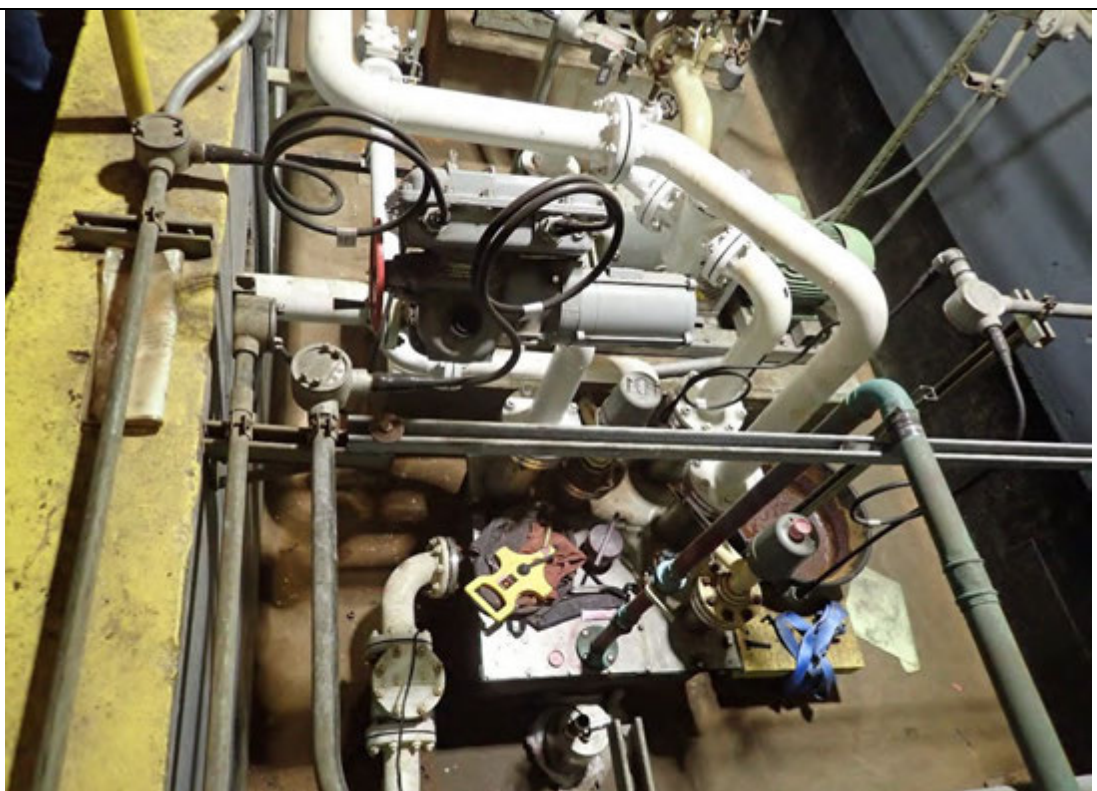
Photo No. 92	Time: 1236
Direction Photo Taken: In Lower Tunnel	
Photo Description: Main sump tank, view from above.

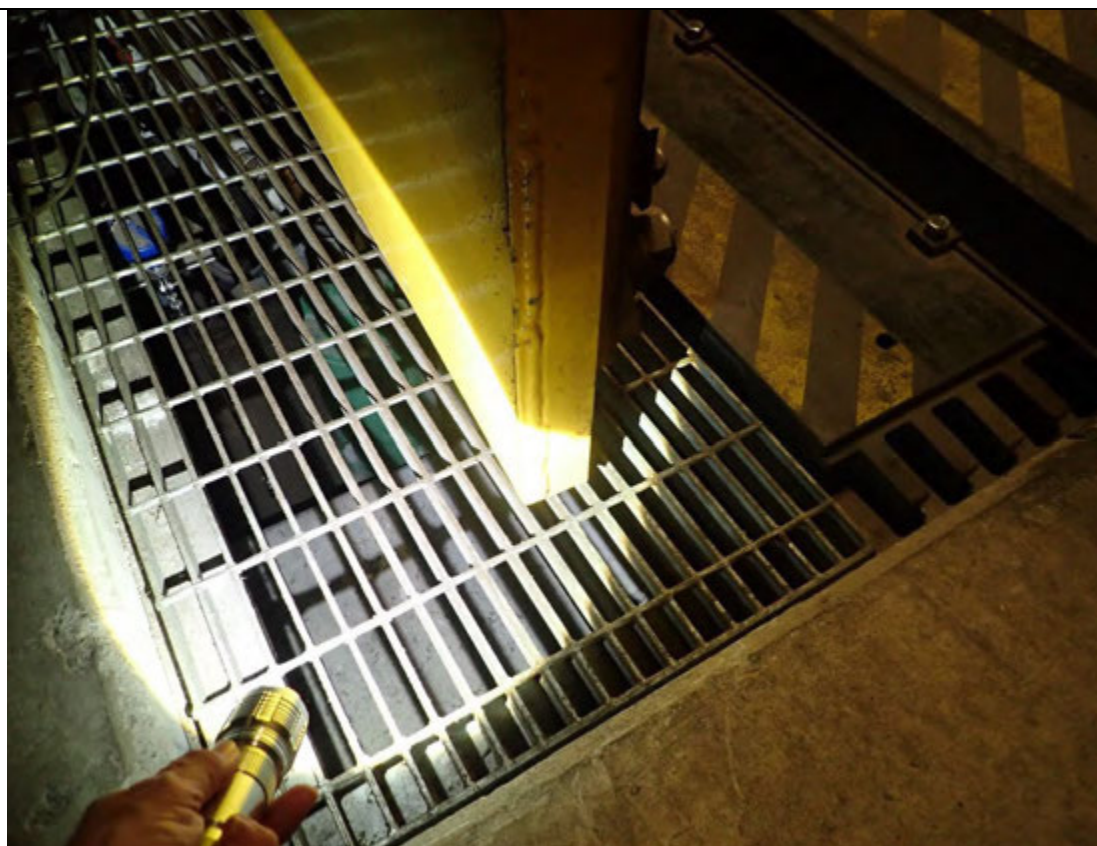
Photographer: WITUL	
Photo No. 93	Time: 1238
Direction Photo Taken: In Lower Tunnel	
Photo Description: Automated oil tight door sump #1099.

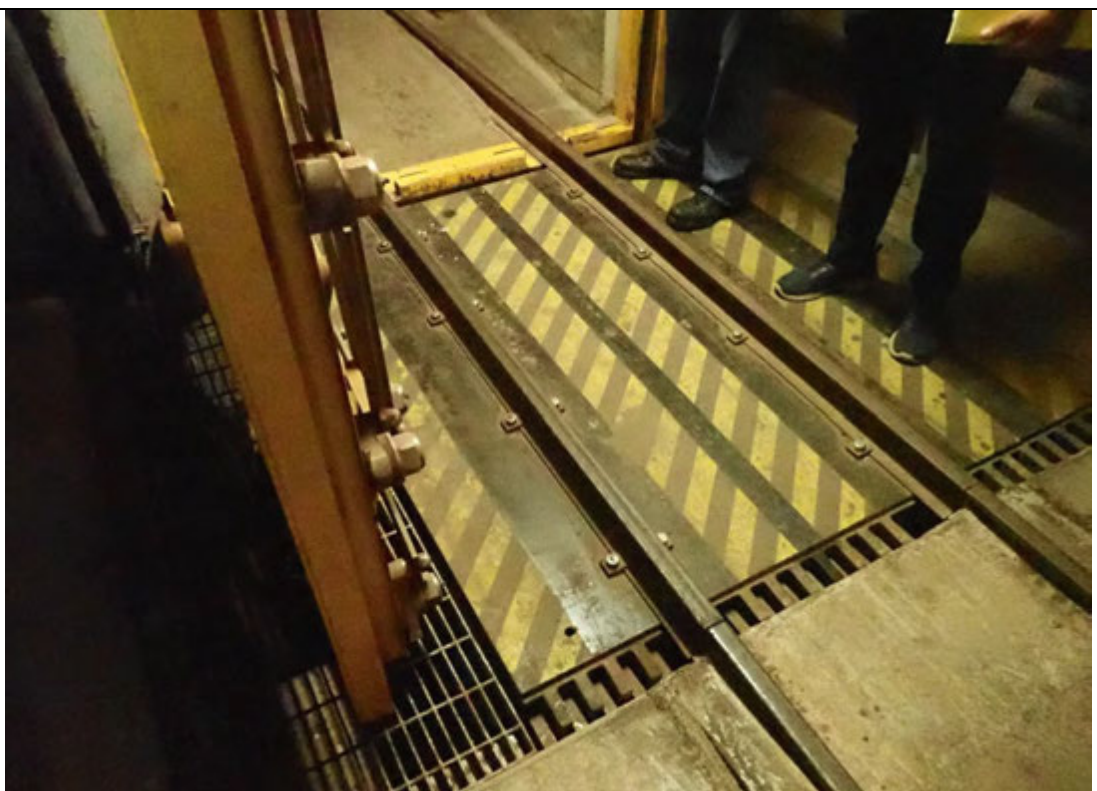
Photo No. 94	Time: 1238
Direction Photo Taken: In Lower Tunnel	
Photo Description: Grate lowers approximately 6 inches for closing door.

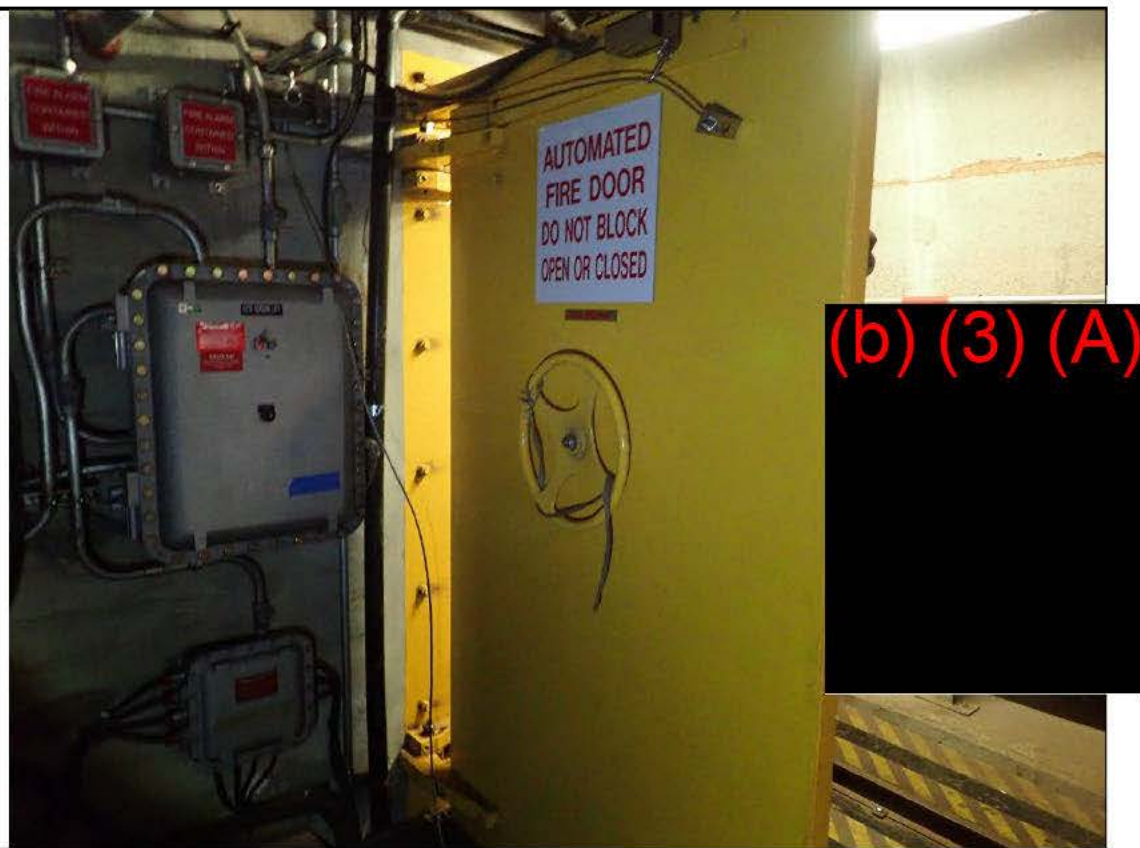
Photographer: WITUL	
Photo No. 95	Time: 1238
Direction Photo Taken: In Lower Tunnel	
Photo Description: Door view; from tank side.

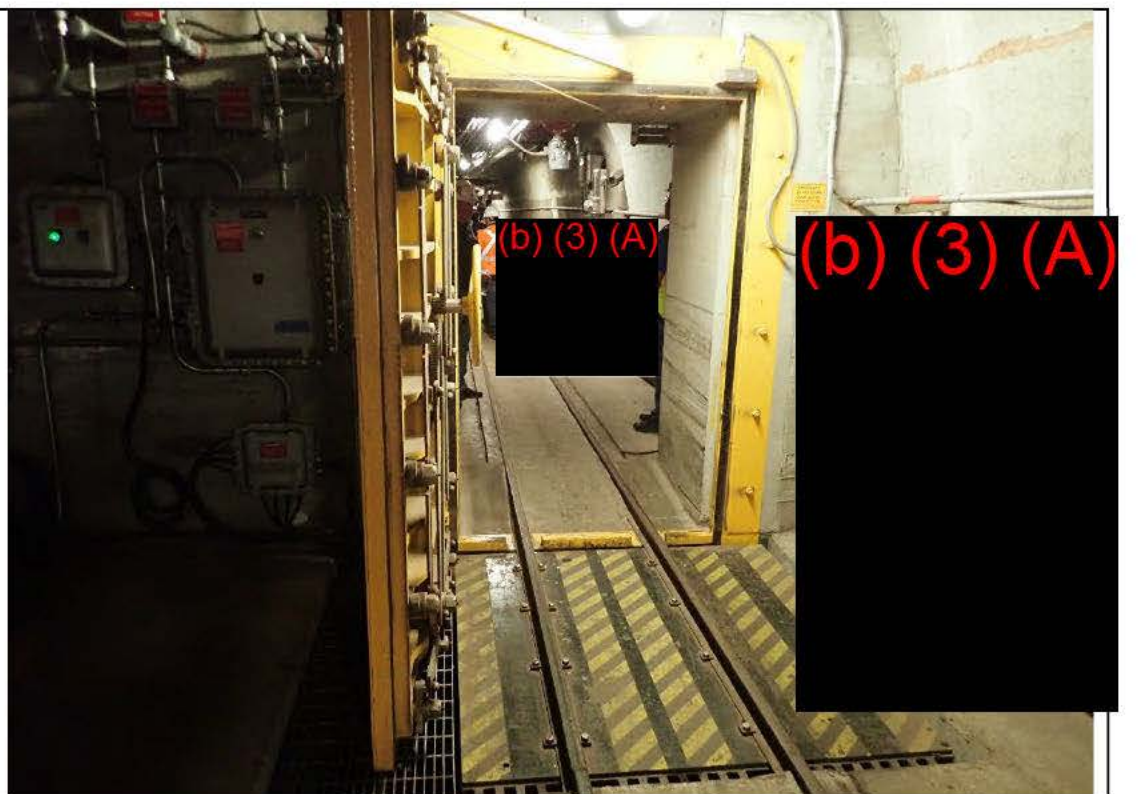
Photo No. 96	Time: 1239
Direction Photo Taken: In Lower Tunnel	
Photo Description: Entrance to piping tunnel, and out to Adit entrance.

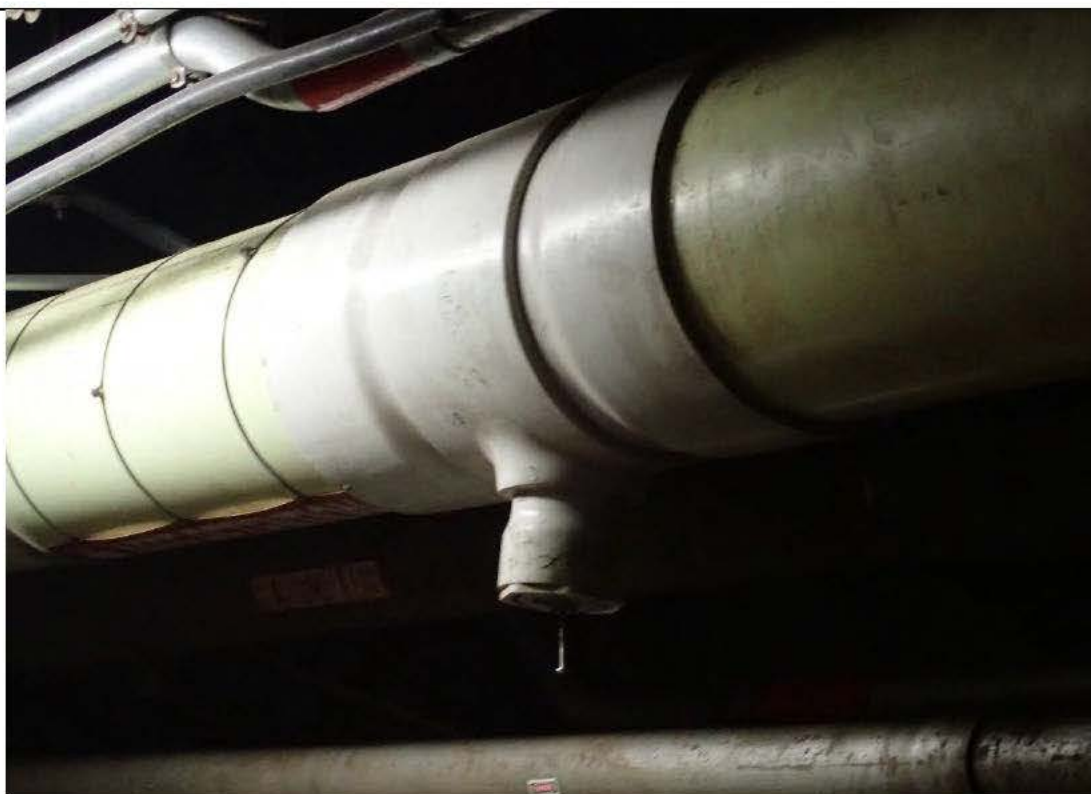
Photo No. 100	Time: 1253
Direction Photo Taken: In Lower Tunnel	
Photo Description: Location of November 20, 2021 break. PVC vertical section at bottom of pipe was knocked off by vehicle. Windy conditions in the area contributed to spread of fuel.
