UNITED STATES ENVIRONMENTAL PROTECTION AGENCY
REGION IX
75 Hawthorne Street
San Francisco, CA 94105-3901

Re: Transmittal of the Spill Prevention, Control and Countermeasure and Underground Storage Tank Inspection Reports for Joint Base Pearl Harbor-Hickam

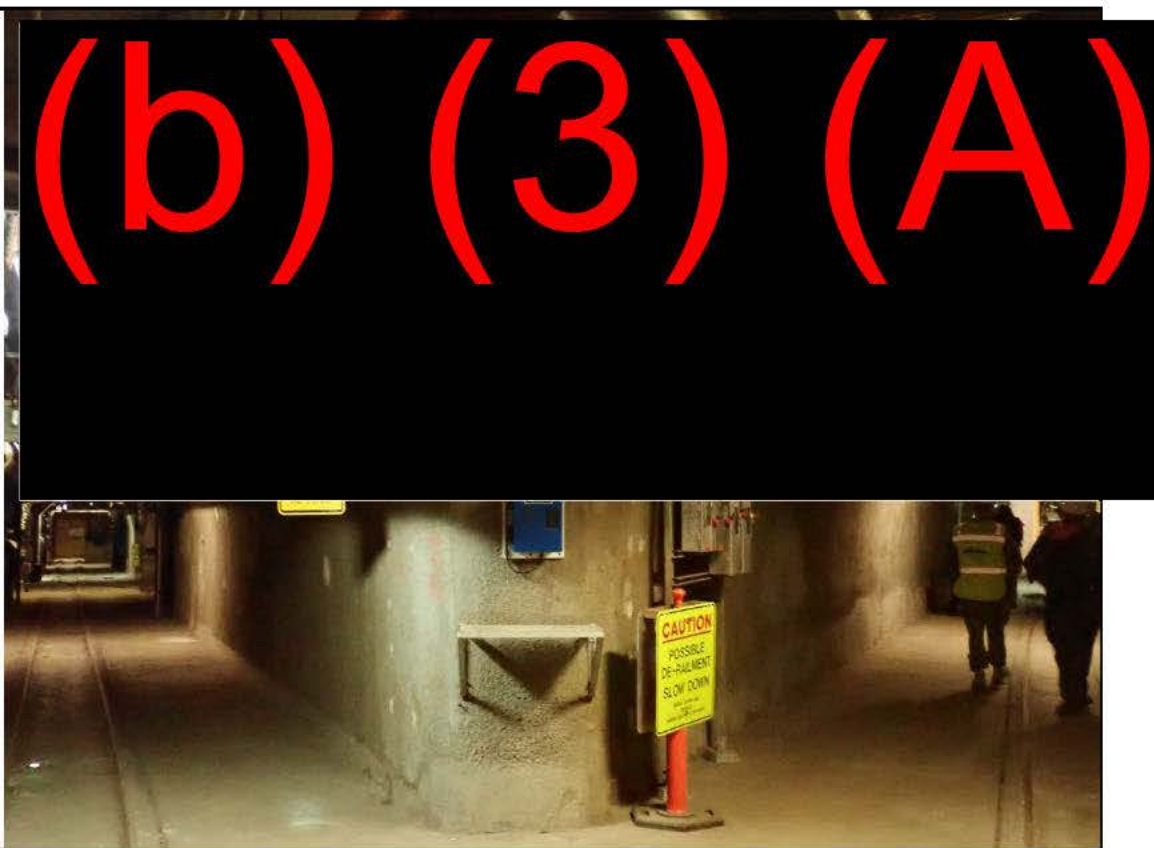
Photographer: WITUL	
Photo No. 101	Time: 1255
Direction Photo Taken: In Lower Tunnel	
Photo Description: Fuel piping continues to Underground Pump House via tunnel to left. AFFF retention line and fuel oil recovery line continue to Adit 3 via tunnel to right.

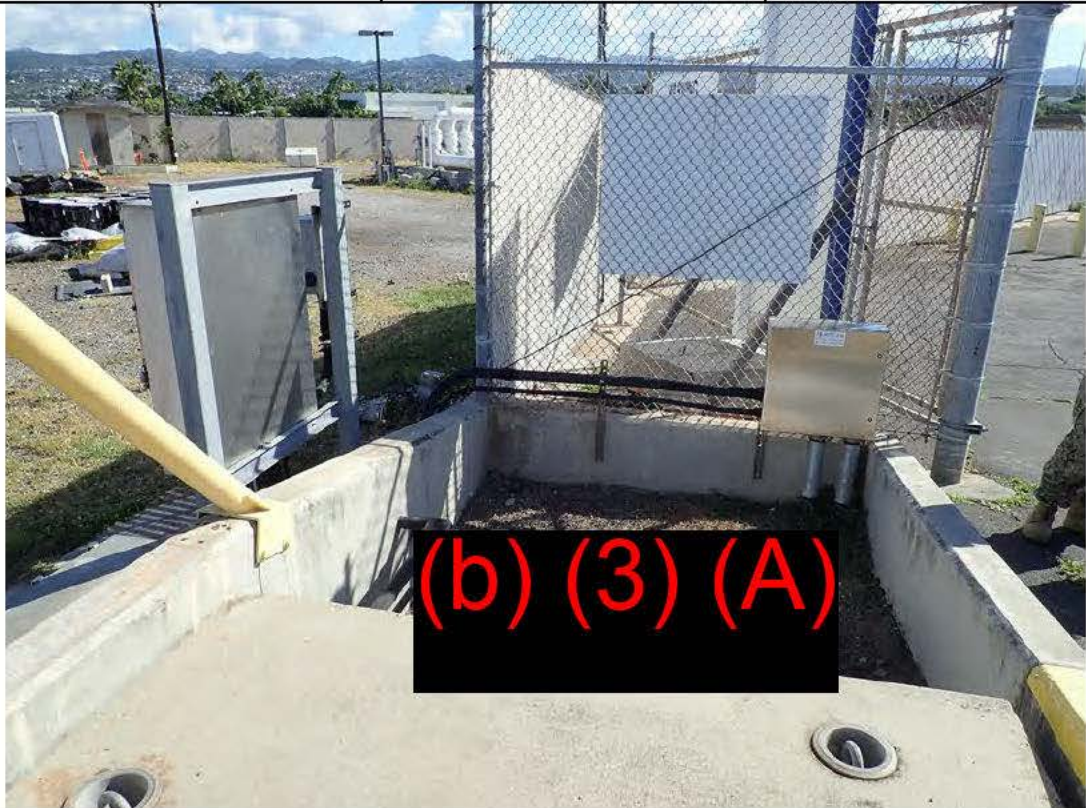
Fuel lines from Hotel
Pier going
underground.
Middle line is non-
operational.

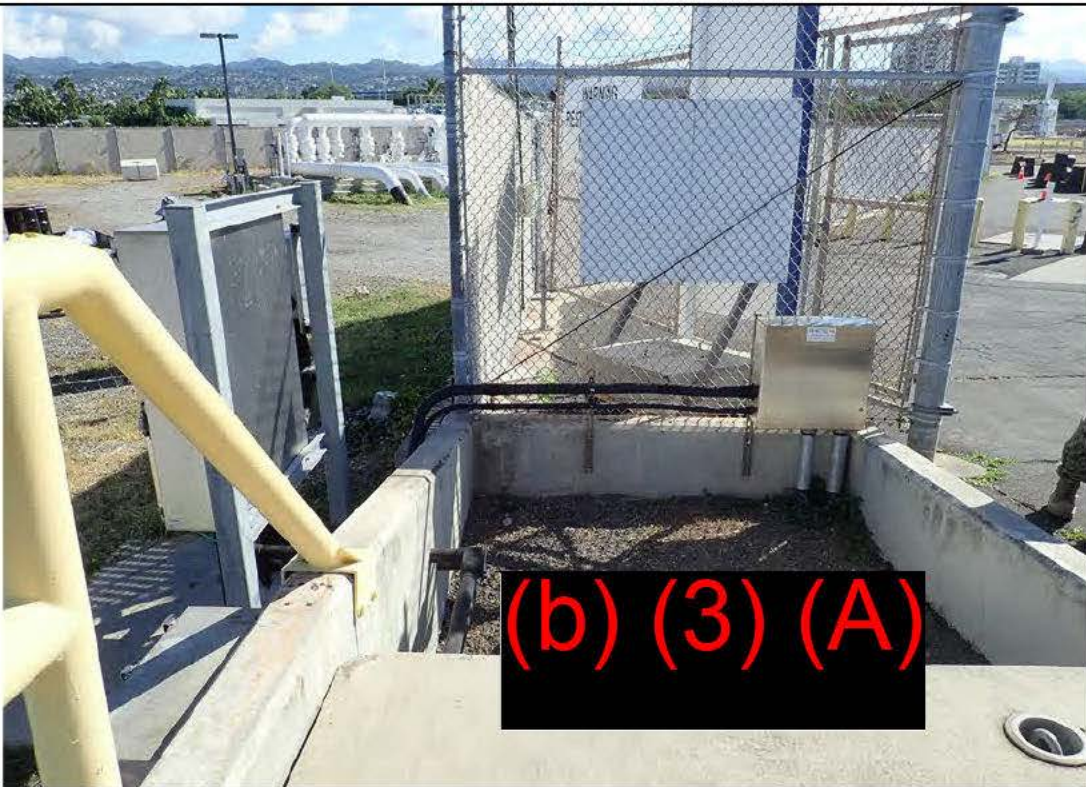
Fuel lines from Hotel
Pier going
underground, additional
view.

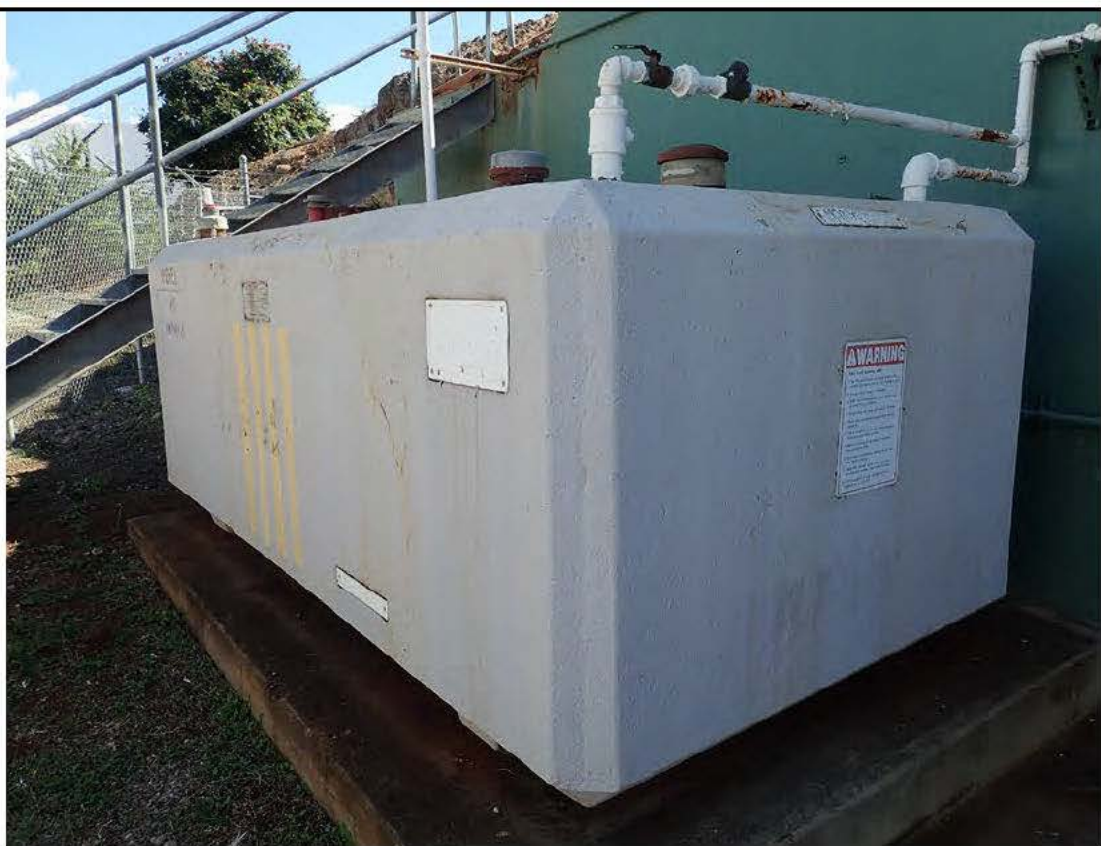
. Indicator gauge exhibits aging, corrosion visible on piping. No containment measures for piping or transfers (such as spill kit) evident in area.

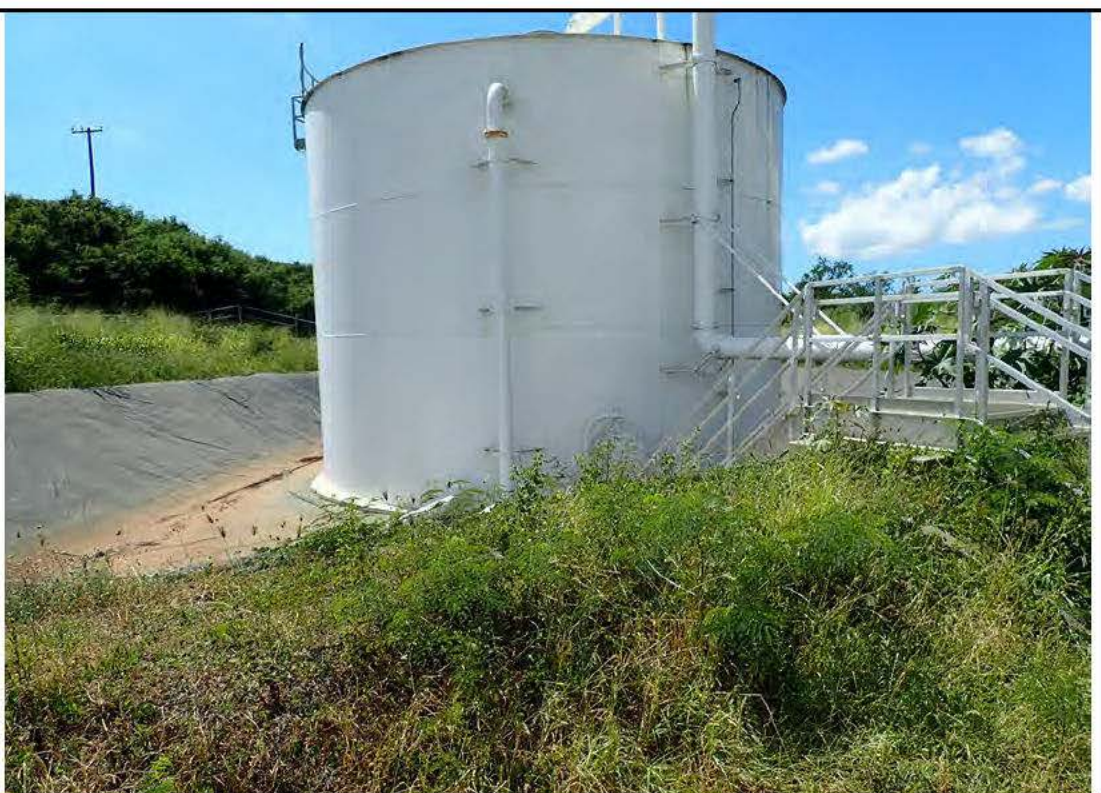
Photo No. 14	Time: 1322
Direction Photo Taken: SW	
Photo Description: Aqueous Film Forming Foam (AFFF) Retention Tank with lined containment area.

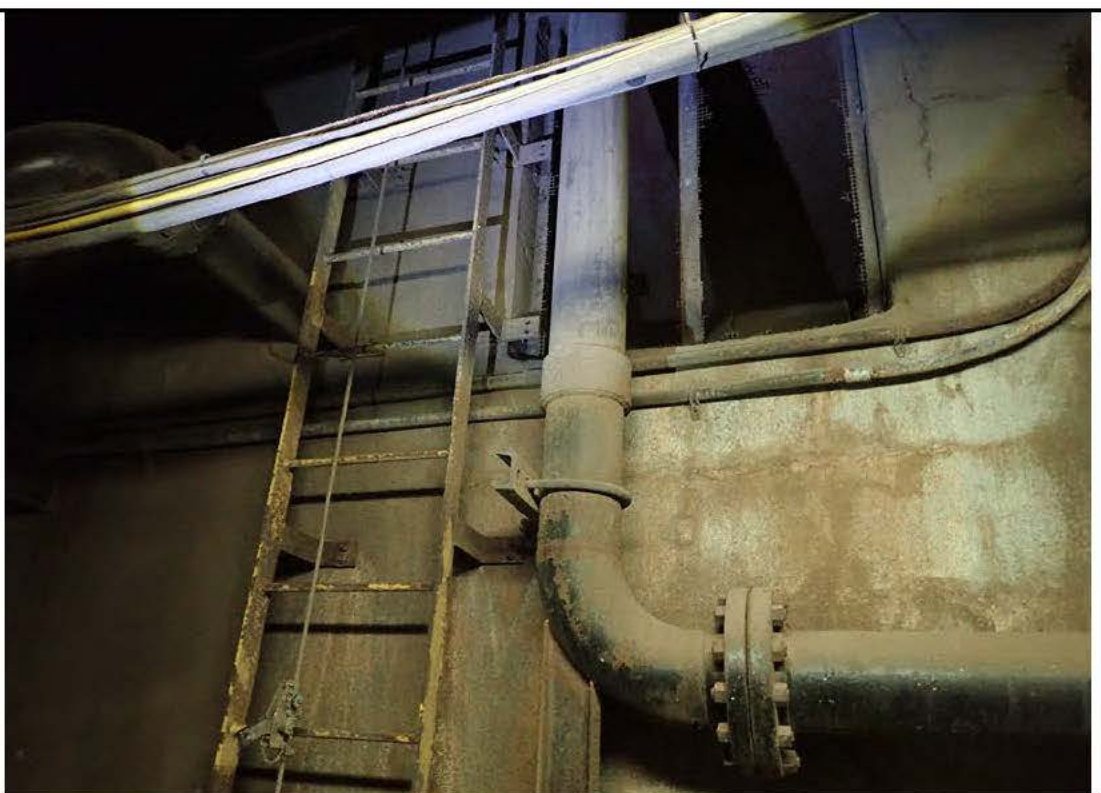
Photo No. 36	Time: 1410
Direction Photo Taken: In Red Hill tunnel	
Photo Description: Piping system - reportedly an obsolete fire suppression system, not associated with fuel.

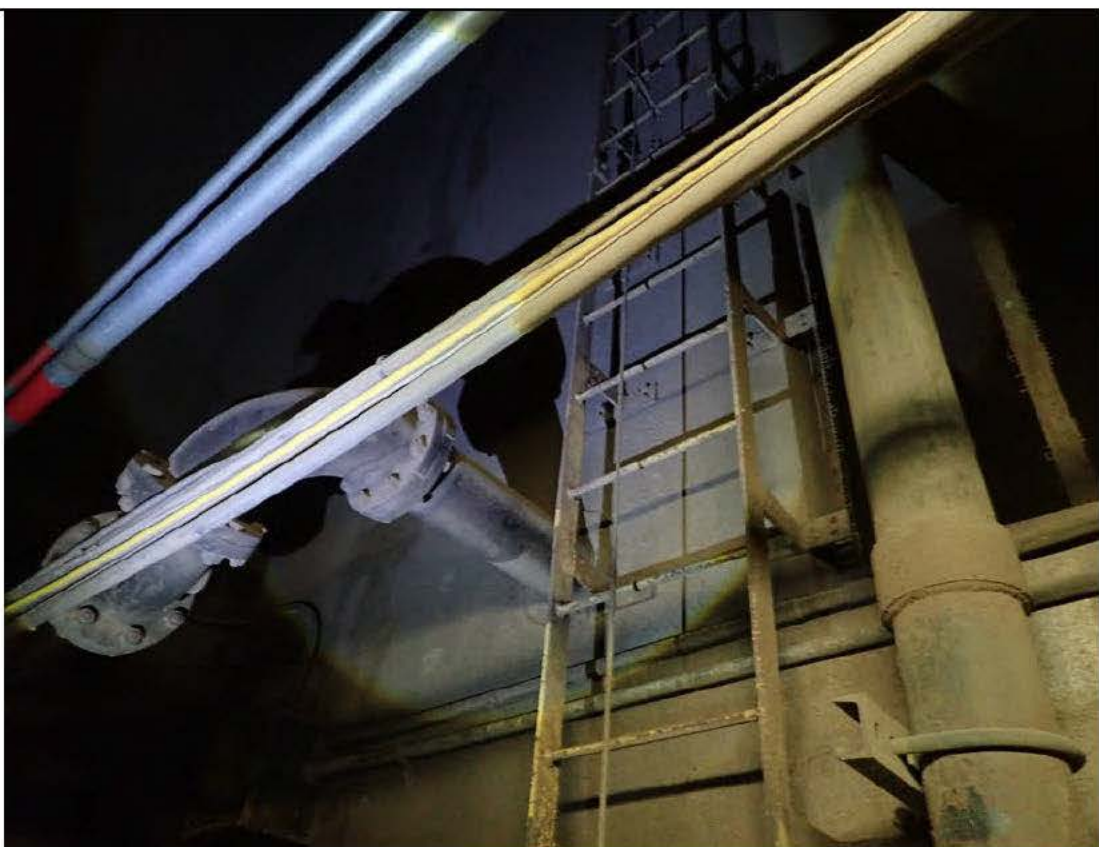
Photographer: WITUL	
Photo No. 37	Time: 1410
Direction Photo Taken: In Red Hill tunnel	
Photo Description: Piping system thought to be obsolete fire suppression system, additional view.

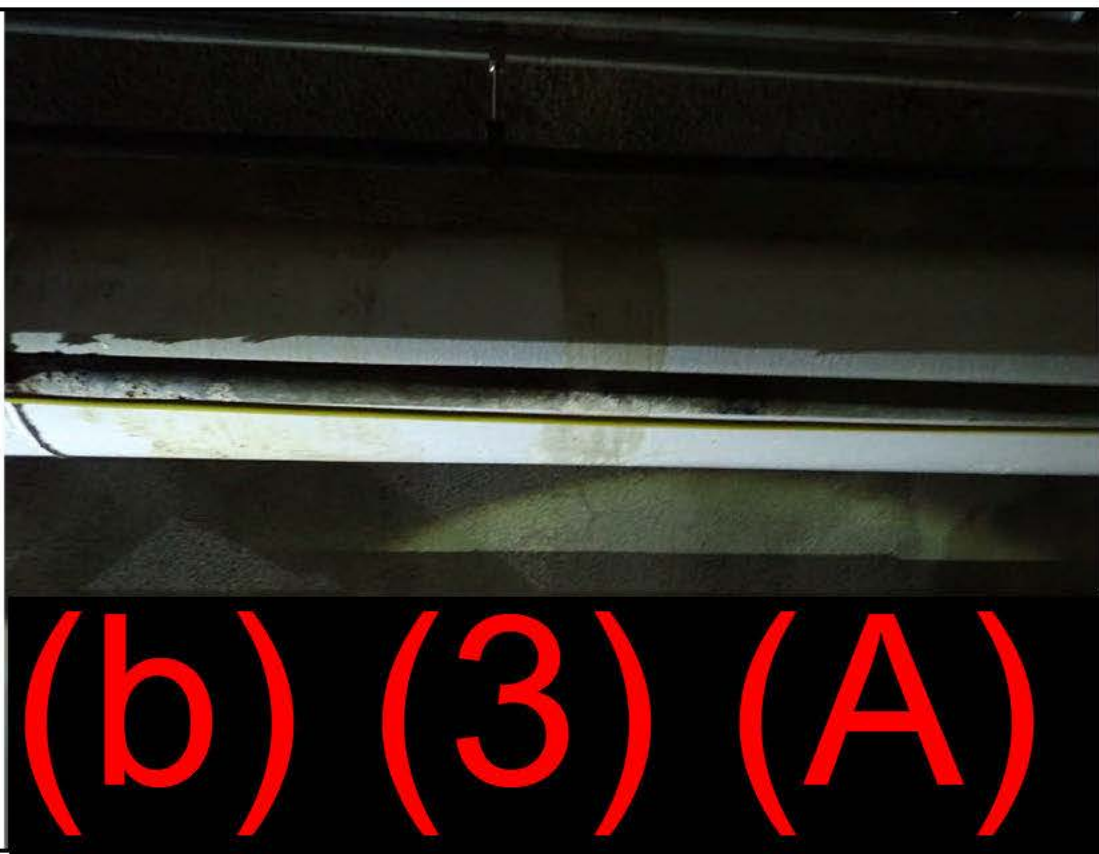
Photographer: WITUL	
Photo No. 43	Time: 1419
Direction Photo Taken: In Red Hill tunnel	
Photo Description: Creosote stains on wall.

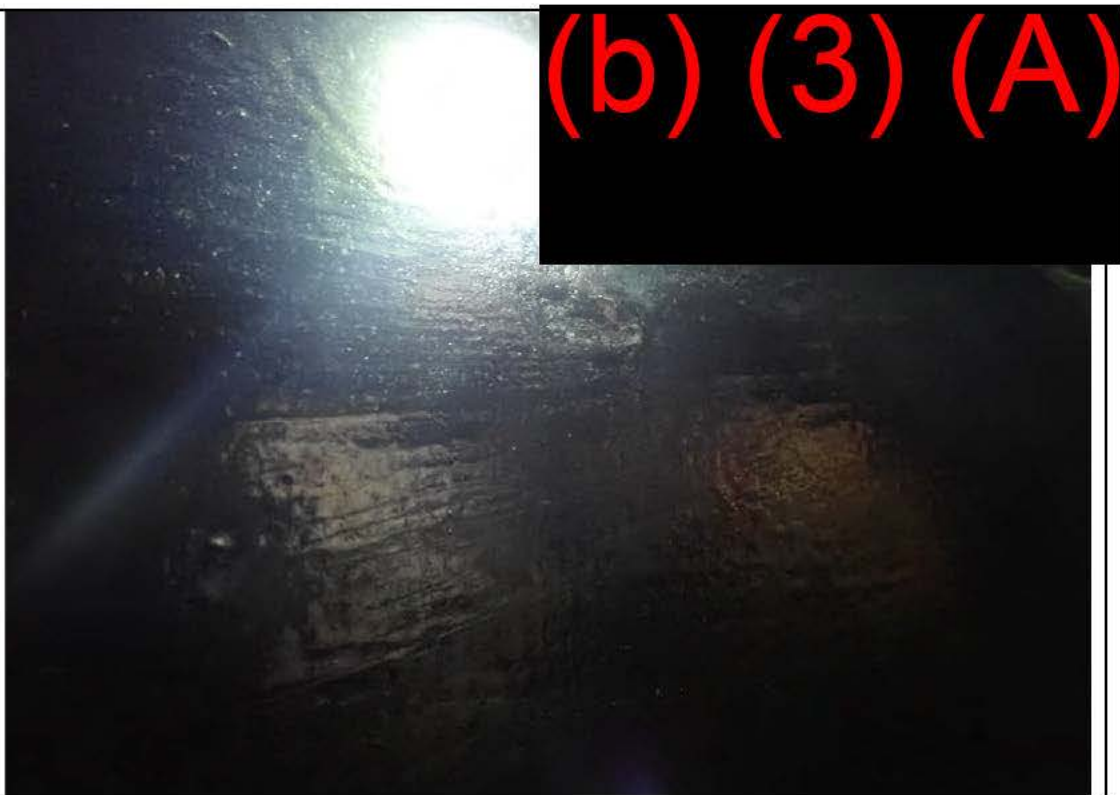
Photo No. 56	Time: 1446
Direction Photo Taken: In Red Hill tunnel	
Photo Description: Depressions in (b) (3) (A) pipe, near support (b) (3) (A) additional view.

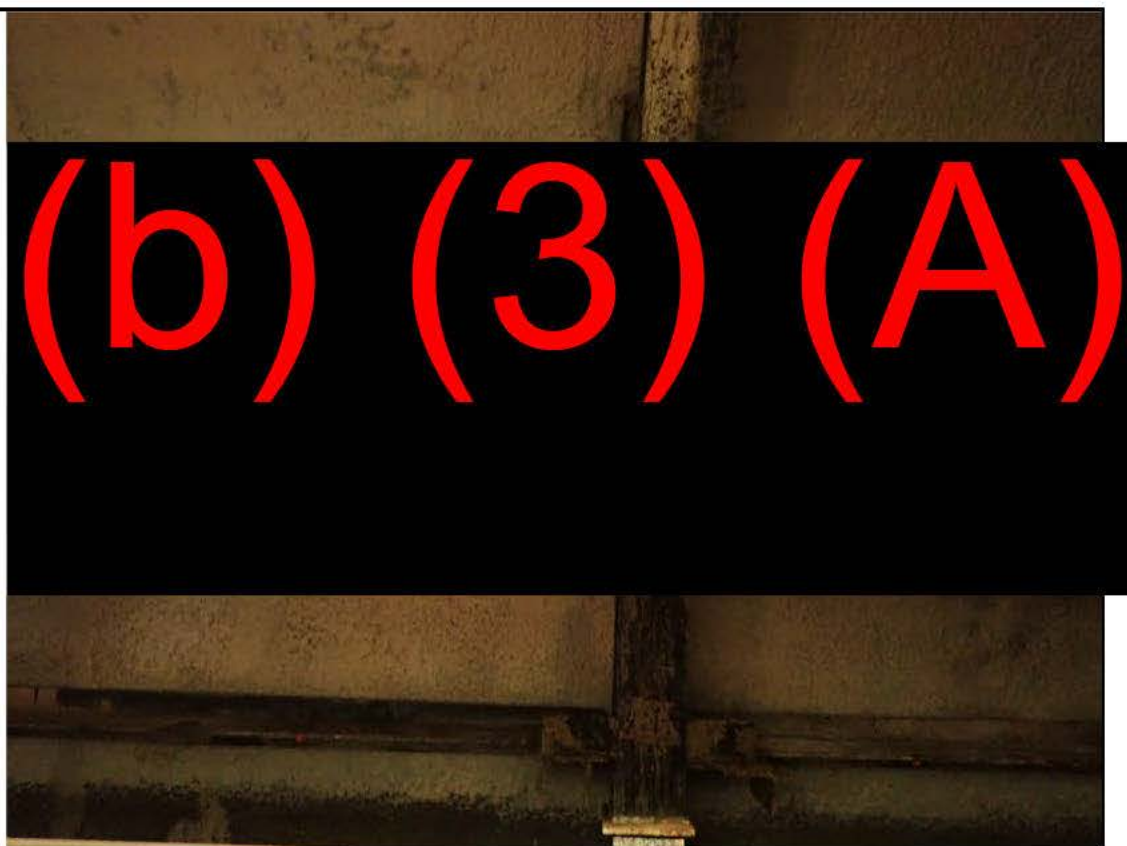
Photographer: WITUL	
Photo No. 61	Time: 1453
Direction Photo Taken: In Red Hill tunnel	
Photo Description: Dents and gouges in [REDACTED] pipe, marked - Dent [REDACTED] Dent [REDACTED] Dent/Gouge [REDACTED]

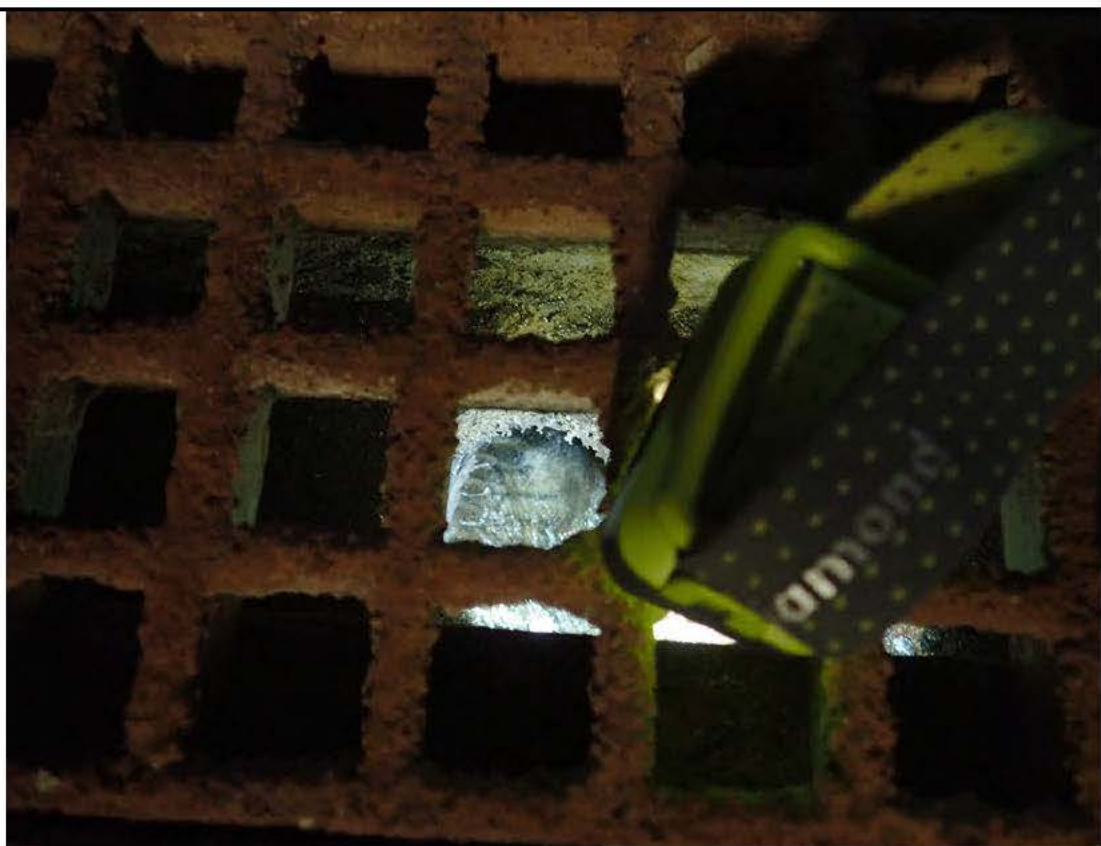
Photographer: WITUL	
Photo No. 77	Time: 1520
Direction Photo Taken: In Red Hill tunnel	
Photo Description: Grated drain at support 548, flowing water visible in hole – additional view.

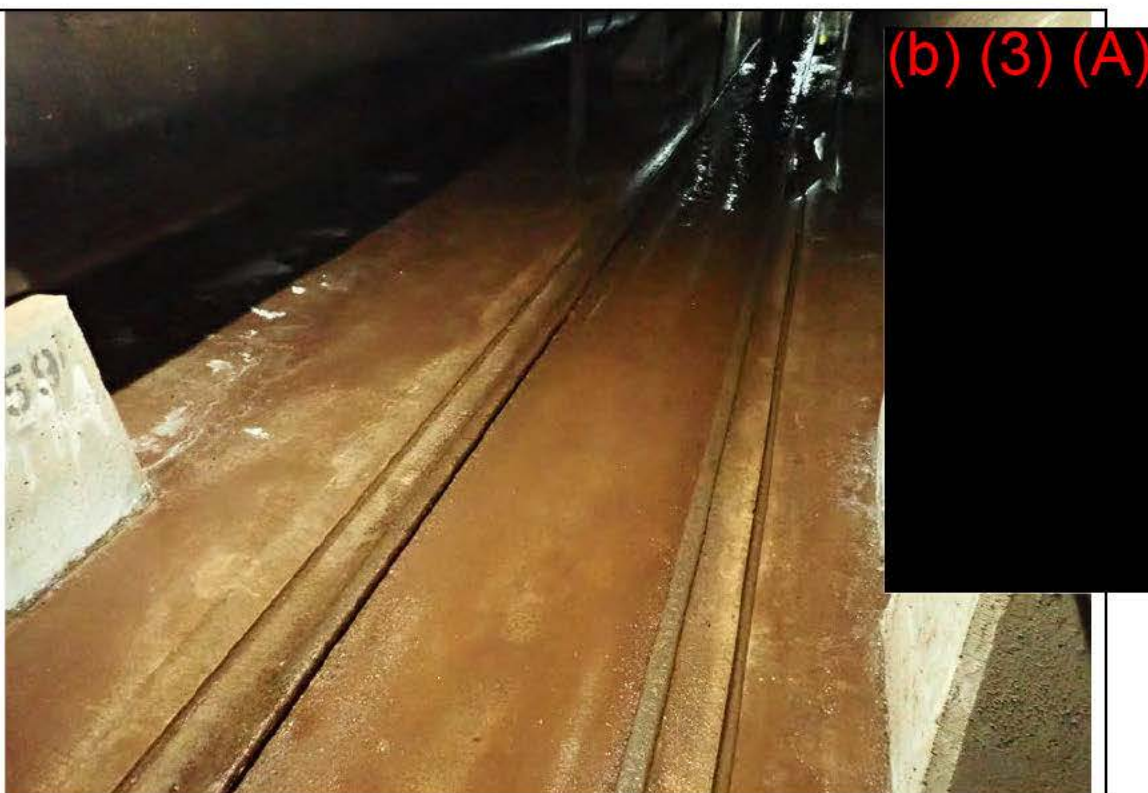
Photo No. 78	Time: 1521
Direction Photo Taken: In Red Hill tunnel	
Photo Description: Flooding in tunnel, starting near support 550; reportedly due to blockage in French Drain system.

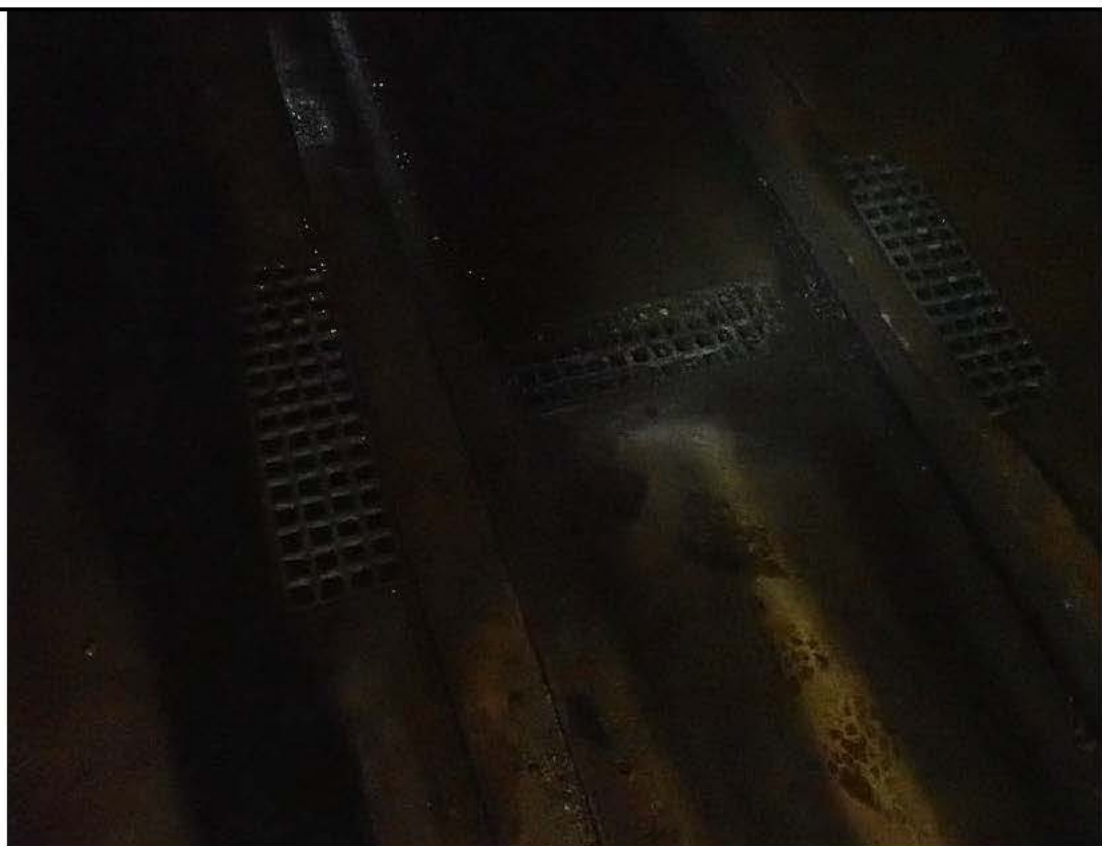
Photographer: WITUL	
Photo No. 79	Time: 1524
Direction Photo Taken: In Red Hill tunnel	
Photo Description: Water returning (from flooded area) to drain under grates, near support 567.

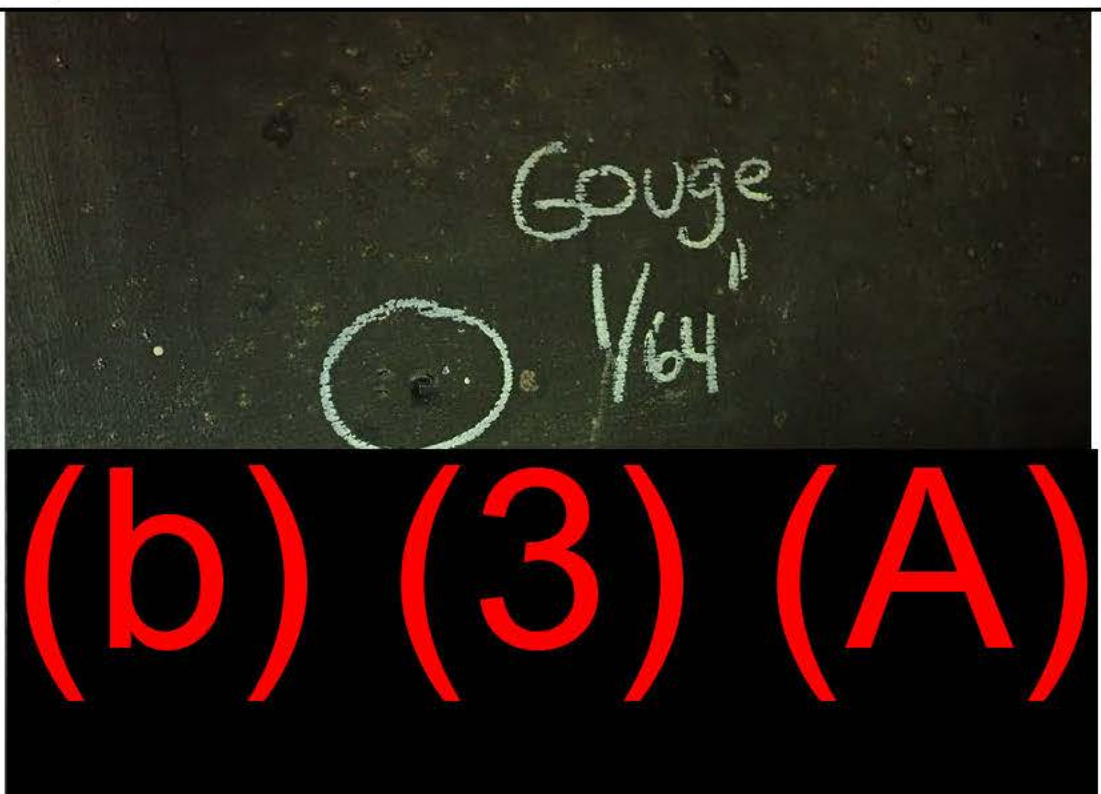
Photo No. 86	Time: 1535
Direction Photo Taken: In Red Hill tunnel	
Photo Description: Gouge in (b) (3) (A) pipe at support (b) (3) (A) marked Gouge (b) (3) (A)

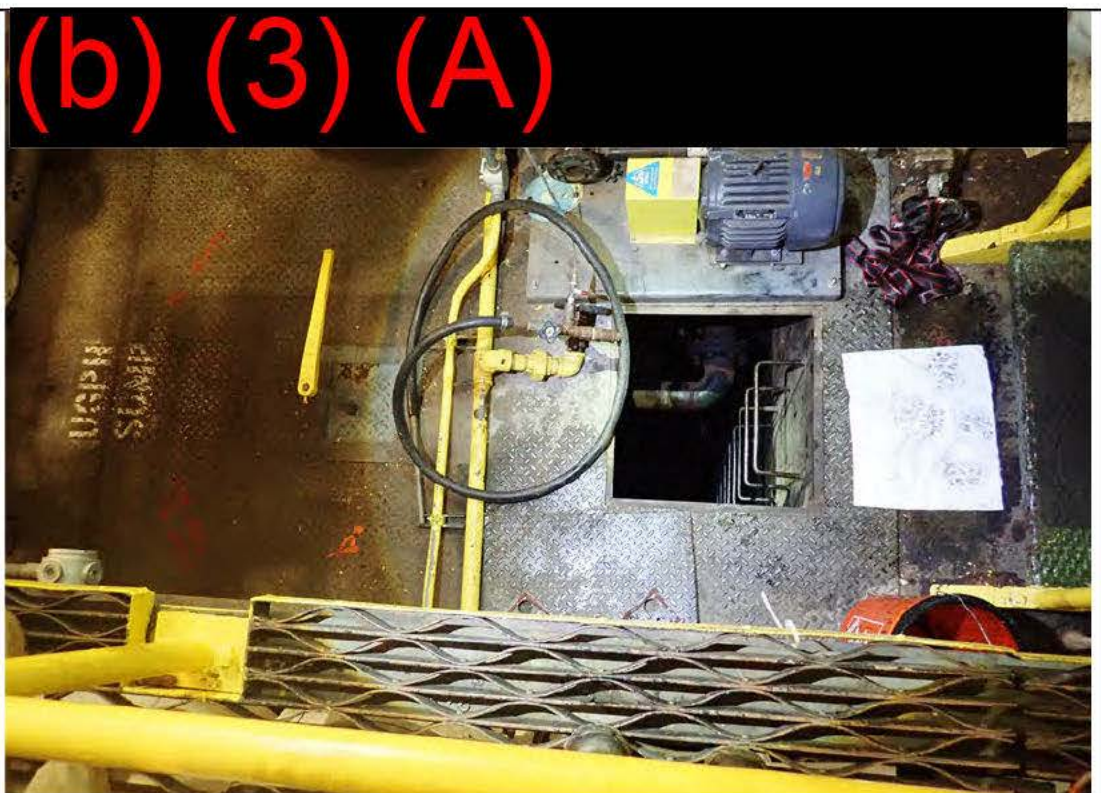
Photo No. 98	Time: 1558
Direction Photo Taken: Inside UGPH	
Photo Description: Approximately 6,000-gallon capacity fuel oil recovery (FOR) sump. Unit could be considered partially buried tank.

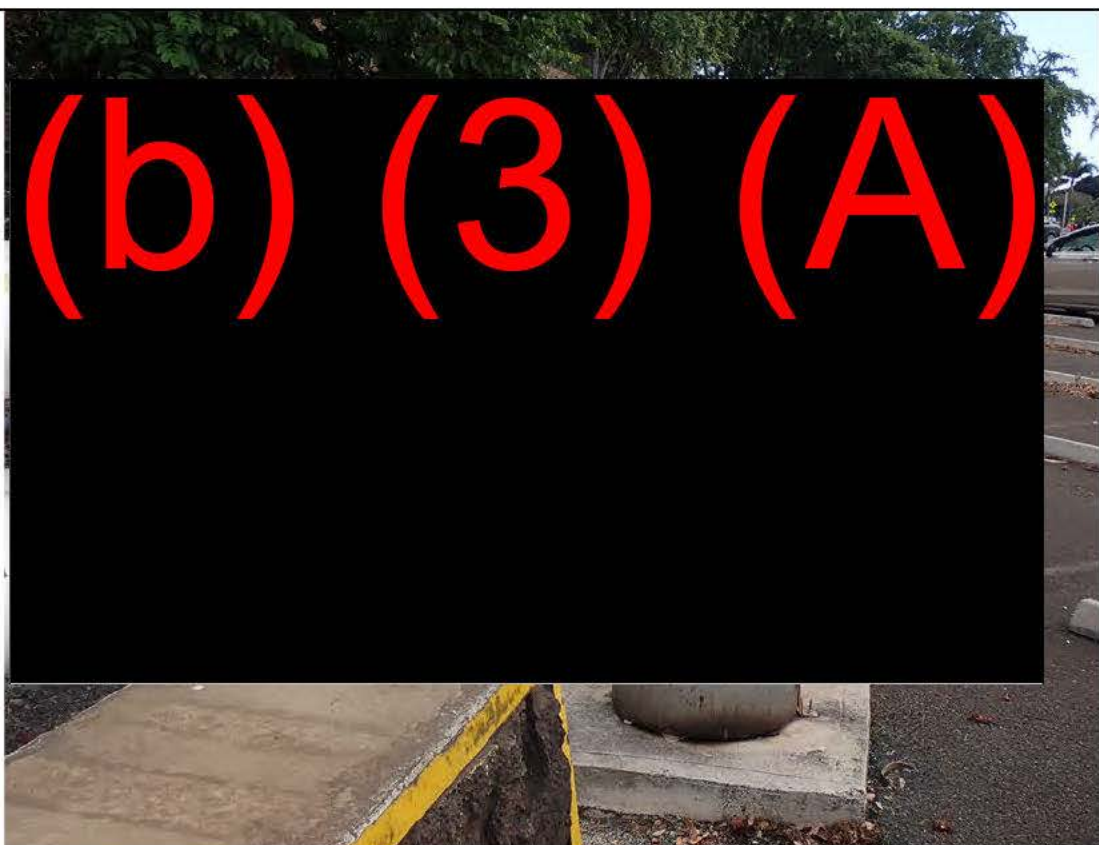
Photographer: WITUL	
Photo No. 5	Time: 1330
Direction Photo Taken: SE	
Photo Description: Fuel piping run from Pump House (b) (3) (A) to DFSP PH Airfield, alongside parking lot (b) (3) (A) Upper Tank Farm. Movable bollards to protect pipeline from vehicles are absent from distant part of piping length.

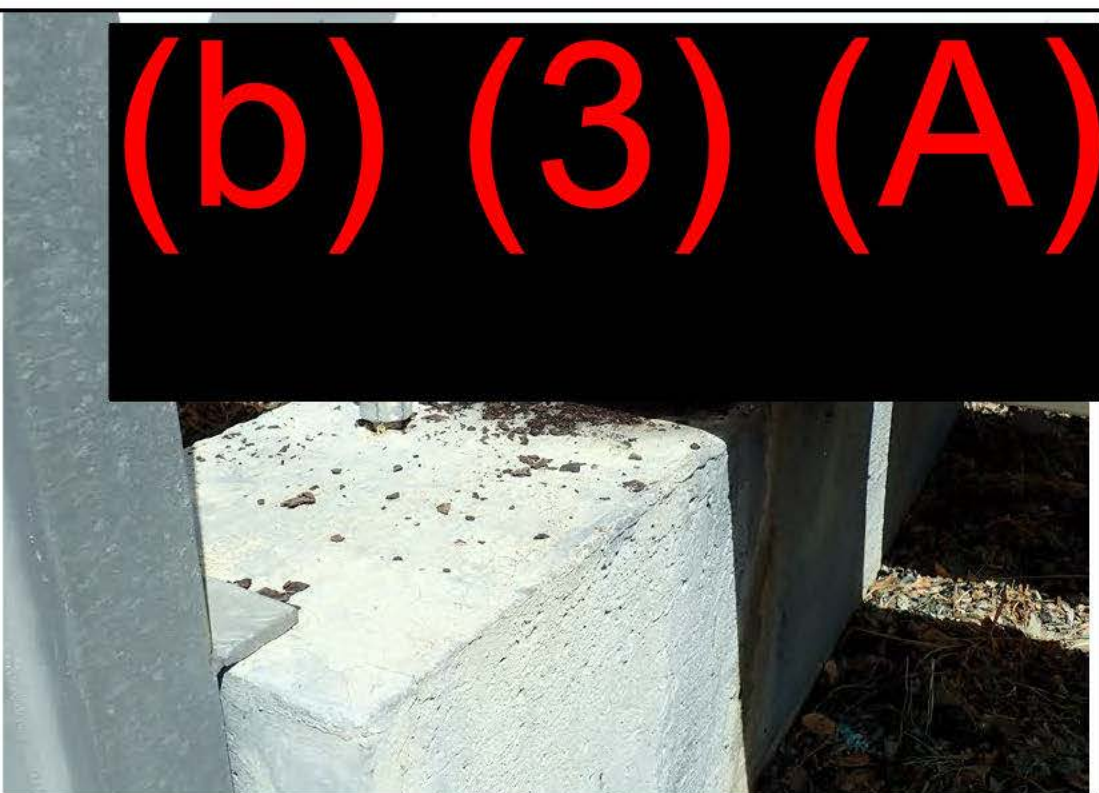
Photo No. 8	Time: 1345
Direction Photo Taken: Close-up	
Photo Description: Damaged pipe support pad, closer view.

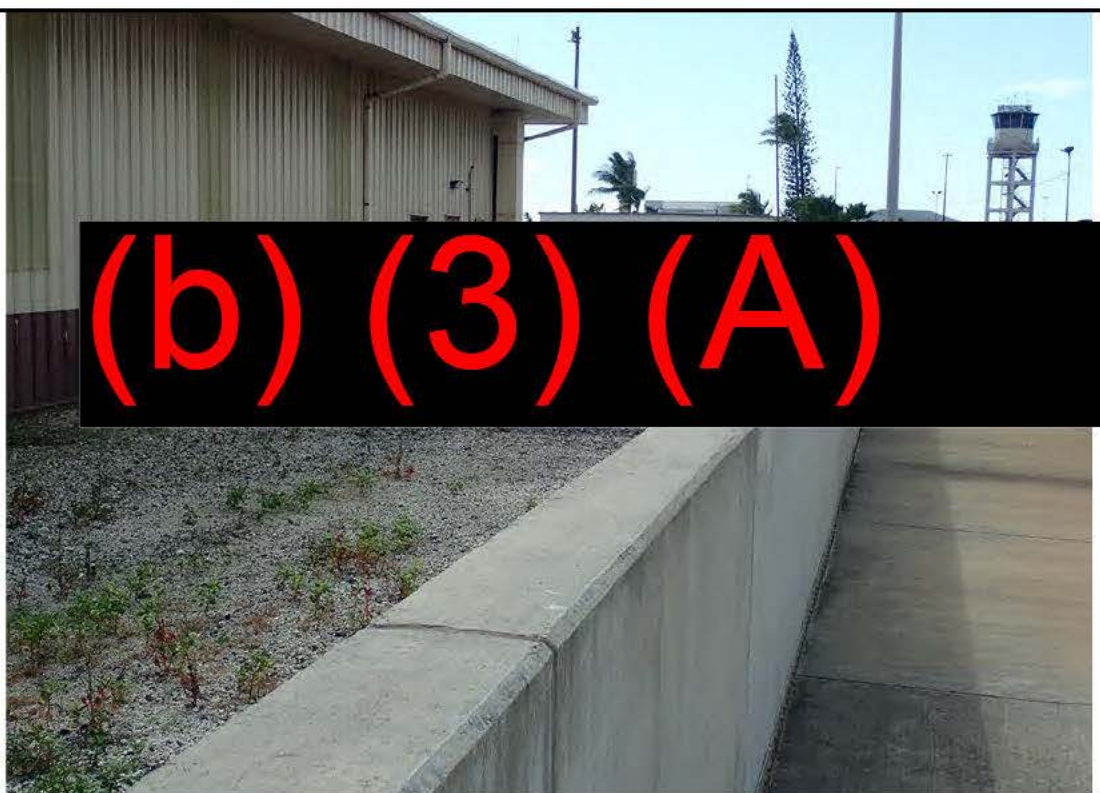
Photo No. 24	Time: 1518
Direction Photo Taken: W	
Photo Description: Piping from Tanks 3 and 4 at Hickam Fuels Area (b) (3) (A) Tank Farm to Pump House (b) (3) (A)

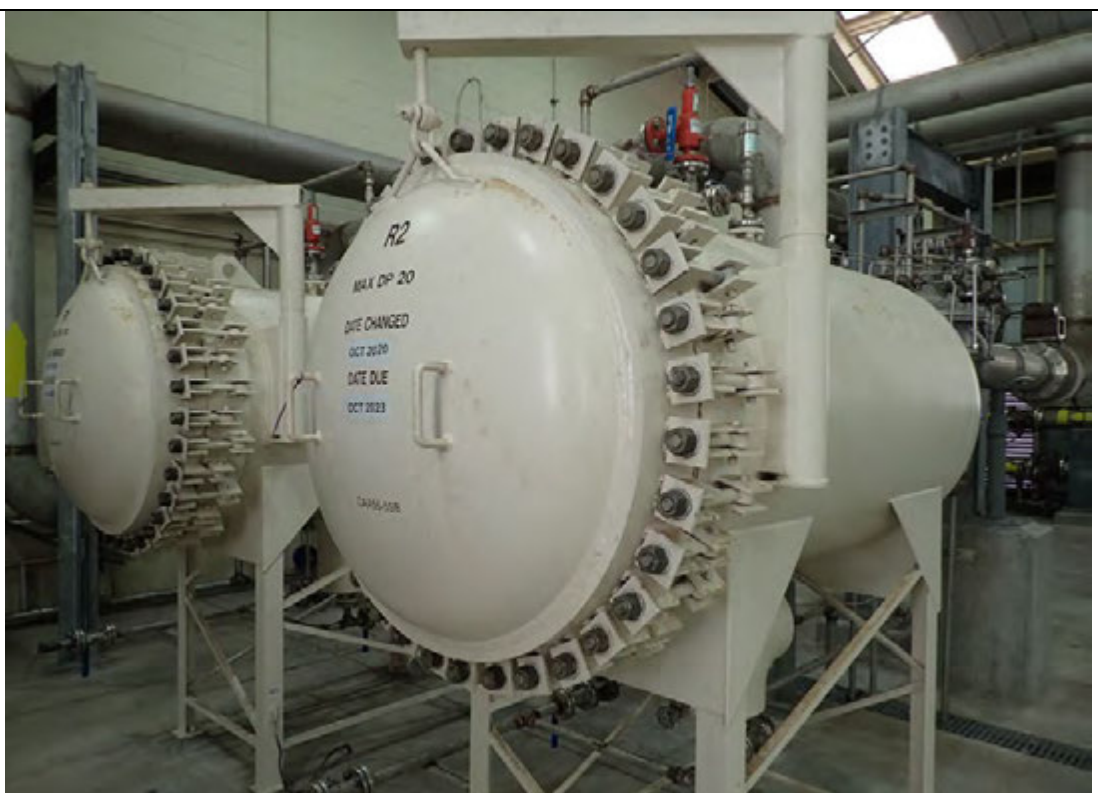
Photo No. 38	Time: 1550
Direction Photo Taken: Indoors	
Photo Description: Filters in Pump house, Bldg (b) (3) (A). Oil capacity of filters may be more than (b) (3) gallons, requiring them to be included in SPCC Plan.

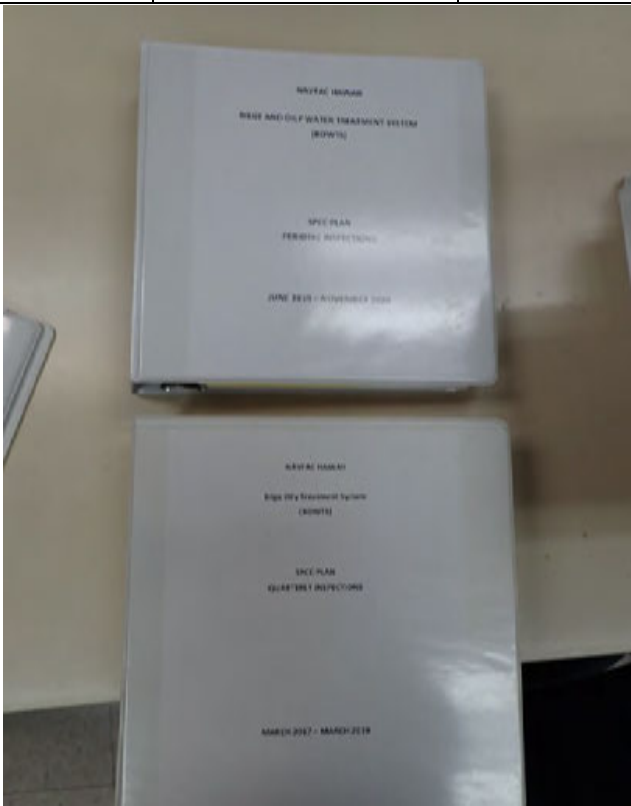
Photo No. 1	Time: 1055		
Direction Photo Taken: Close-up			
Photo Description: Bilge and Oily Water Treatment System (BOWTS) inspection binders. Prior to 2020, inspections were performed on a quarterly basis (bottom binder), rather than monthly as required by industry standards.

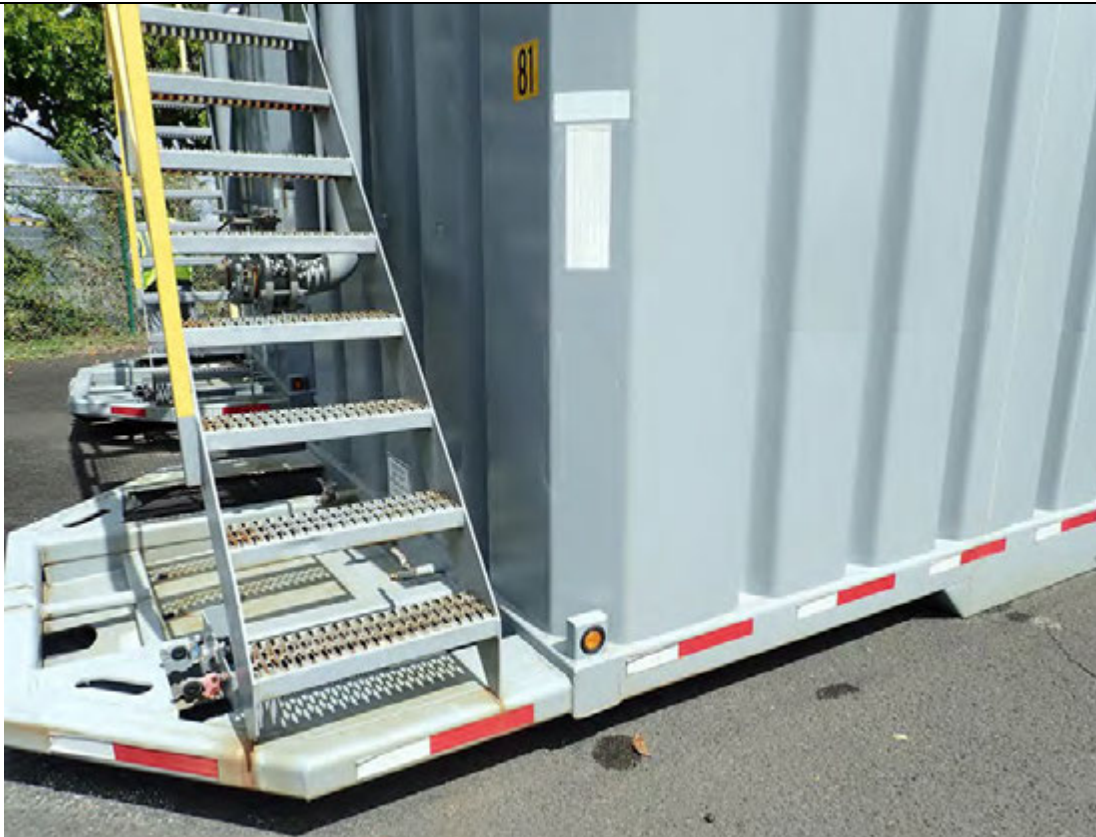
Photo No. 3	Time: 1115	
Direction Photo Taken: Close-up		
Photo Description: Frac tank with drip from upper edge. With no overfill prevention, excess oil could also discharge from top of container.

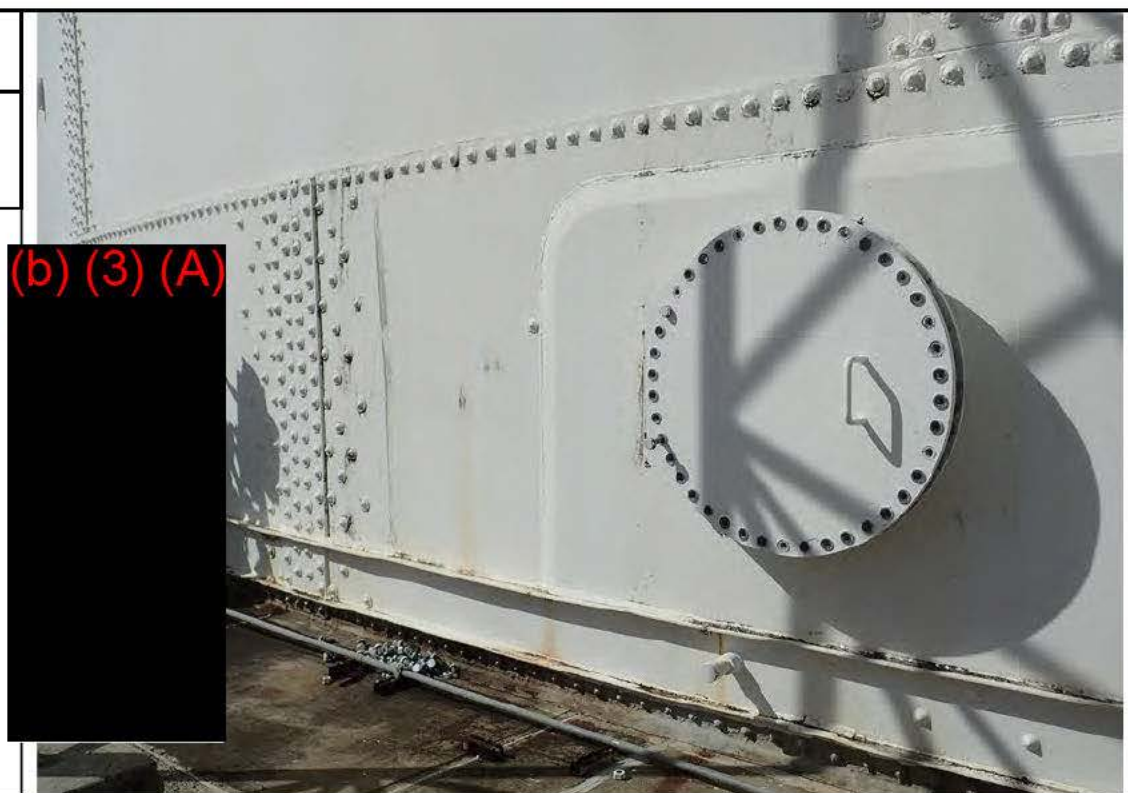
Photo No. 22	Time: 1514
Direction Photo Taken: Close-up	
Photo Description: Unsealed manway flange at tank currently undergoing cleaning, inspection, and repair.

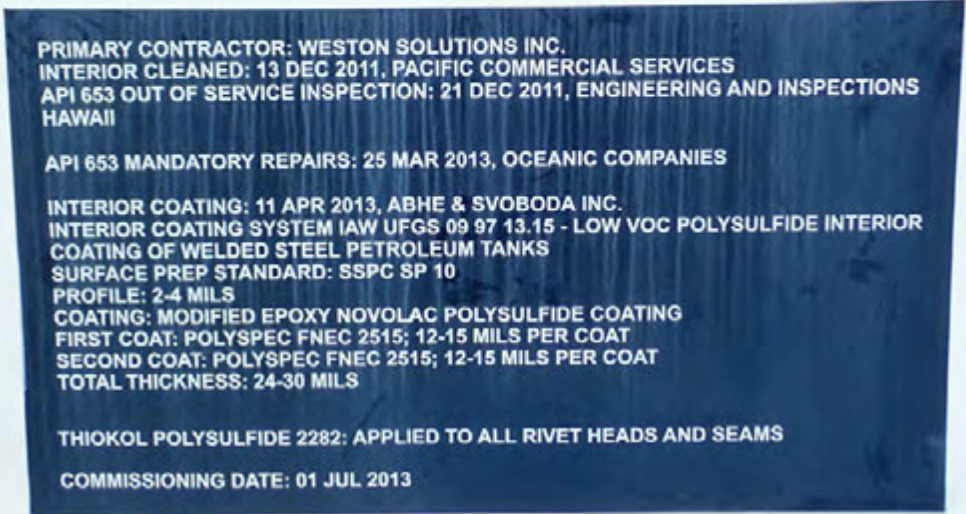
Photo No. 31	Time: 1546	
Direction Photo Taken: Close-up		
Photo Description:		
Cleaning, Inspection and Repair information on Tank 53. API 653 In Service Inspection performed July 2018. Out Of Service inspection in December 2011. Repairs made in March 2013, Interior coating applied April 2013.

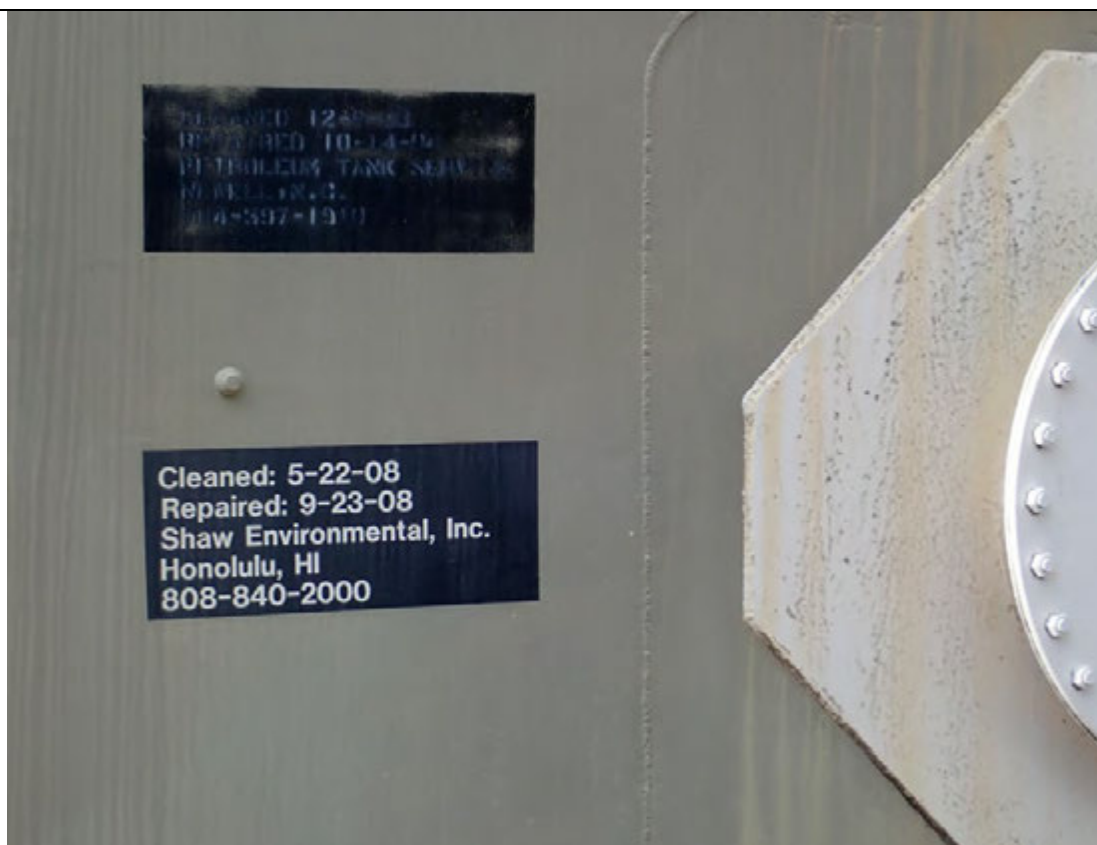
Photographer: WITUL	
Photo No. 33	Time: 1604
Direction Photo Taken: N, Close-up	
Photo Description: Cleaning and repair information on Tank B1; latest shown is 2008.

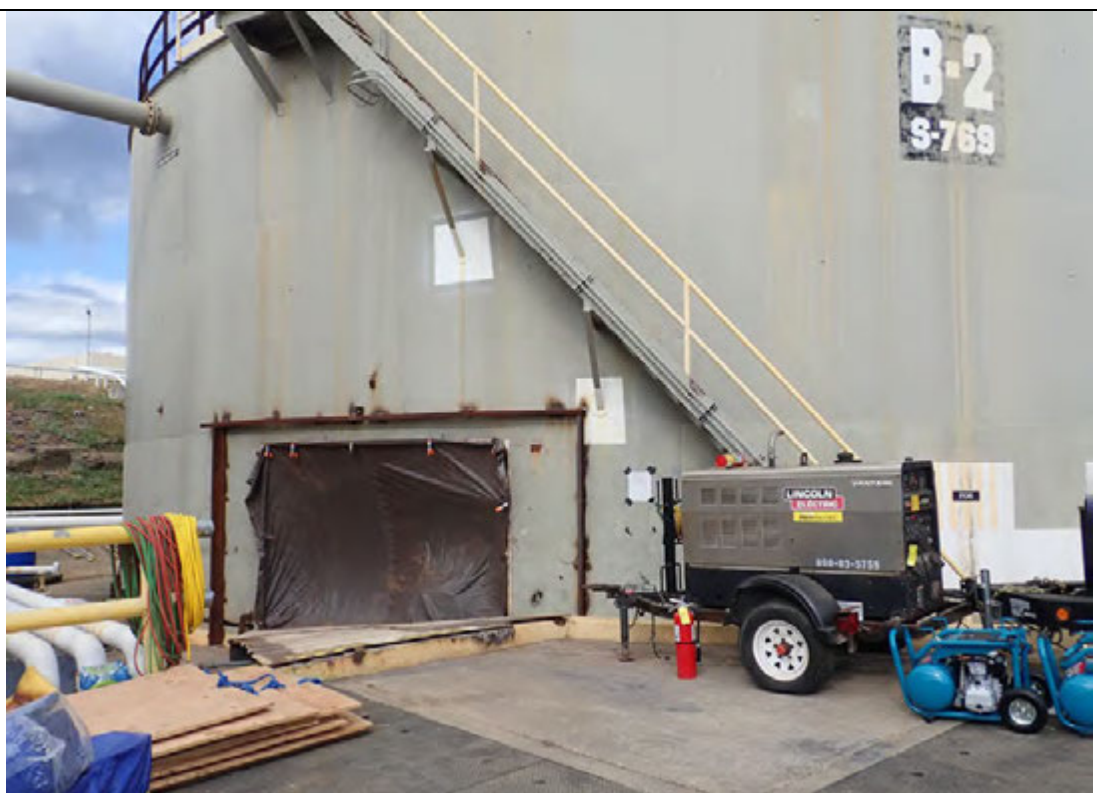
Photo No. 34	Time: 1604
Direction Photo Taken: NE	
Photo Description: Tank B2, out of service for cleaning, inspection, and repair.
