UNITED STATES ENVIRONMENTAL PROTECTION AGENCY
REGION IX
75 Hawthorne Street
San Francisco, CA 94105-3901

Re: Transmittal of the Spill Prevention, Control and Countermeasure and Underground Storage Tank Inspection Reports for Joint Base Pearl Harbor-Hickam

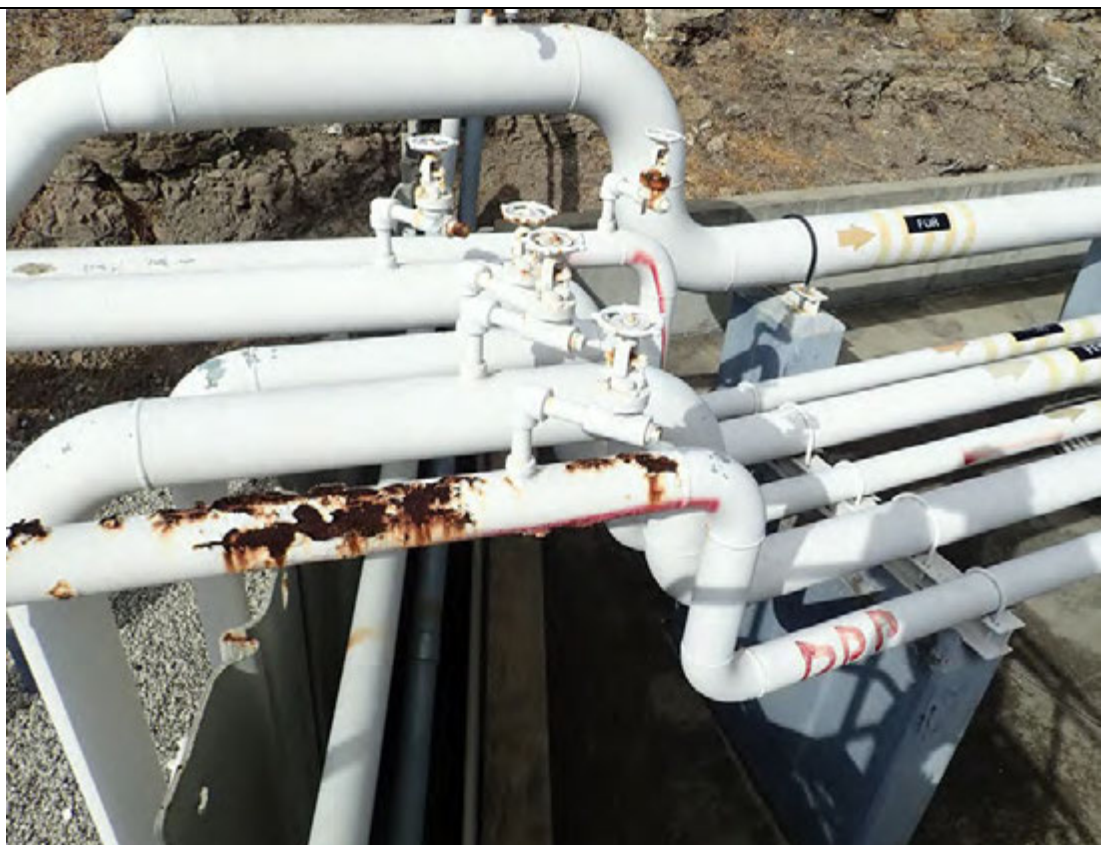
Photographer: WITUL	
Photo No. 35	Time: 1606
Direction Photo Taken: NE	
Photo Description: Piping at Fuel Oil Reclamation Facility. Rusty line in foreground is out of service.

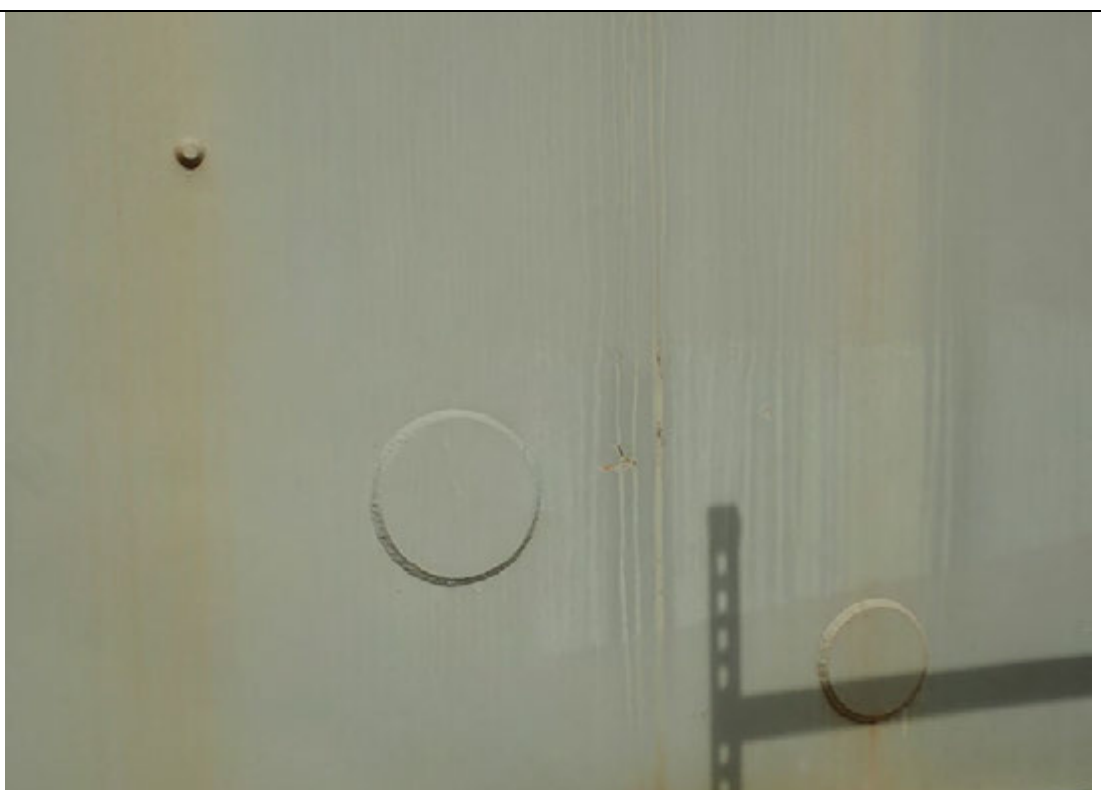
Photo No. 36	Time: 1609
Direction Photo Taken: Close-up	
Photo Description: Welded patches on tank; may be where appurtenances were removed, or other repairs.

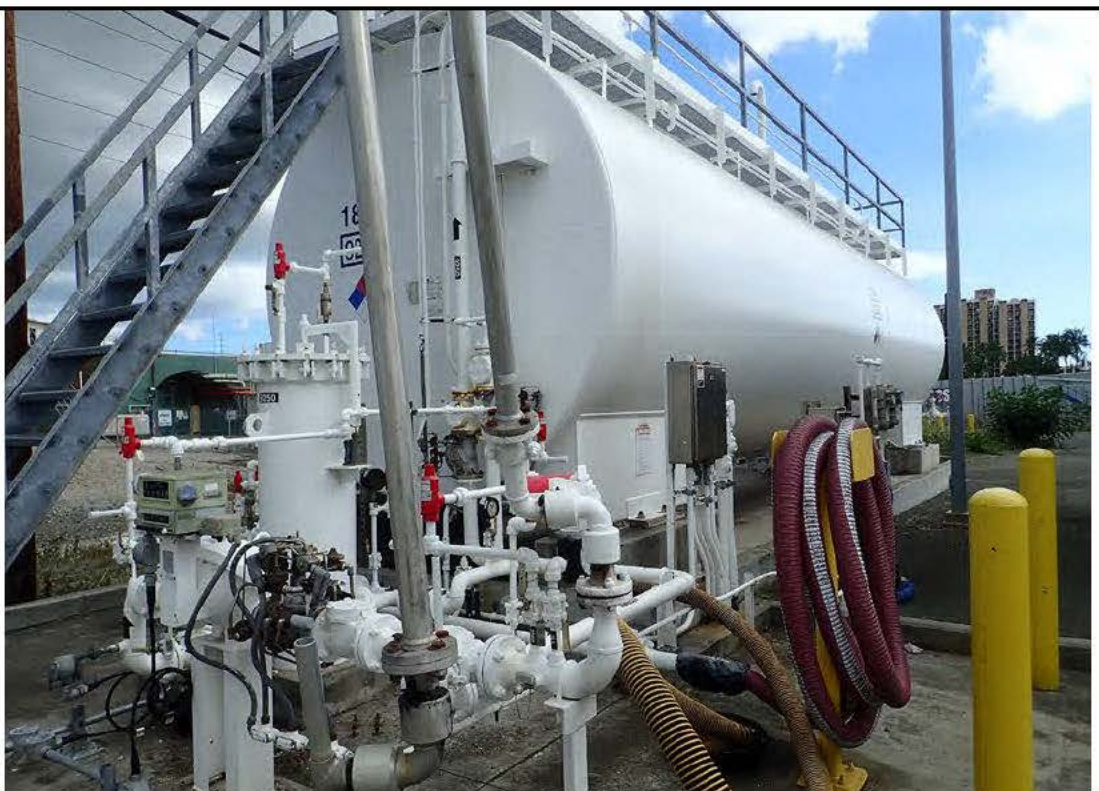
Photo No. 38	Time: 1615
Direction Photo Taken: SSE	
Photo Description: Tank FLC-1812 double-walled dual compartment engine lube oil tank, and loading/unloading rack. Tank compartment capacities are (b) (3) (A) gallons and (b) (3) (A) gallons.

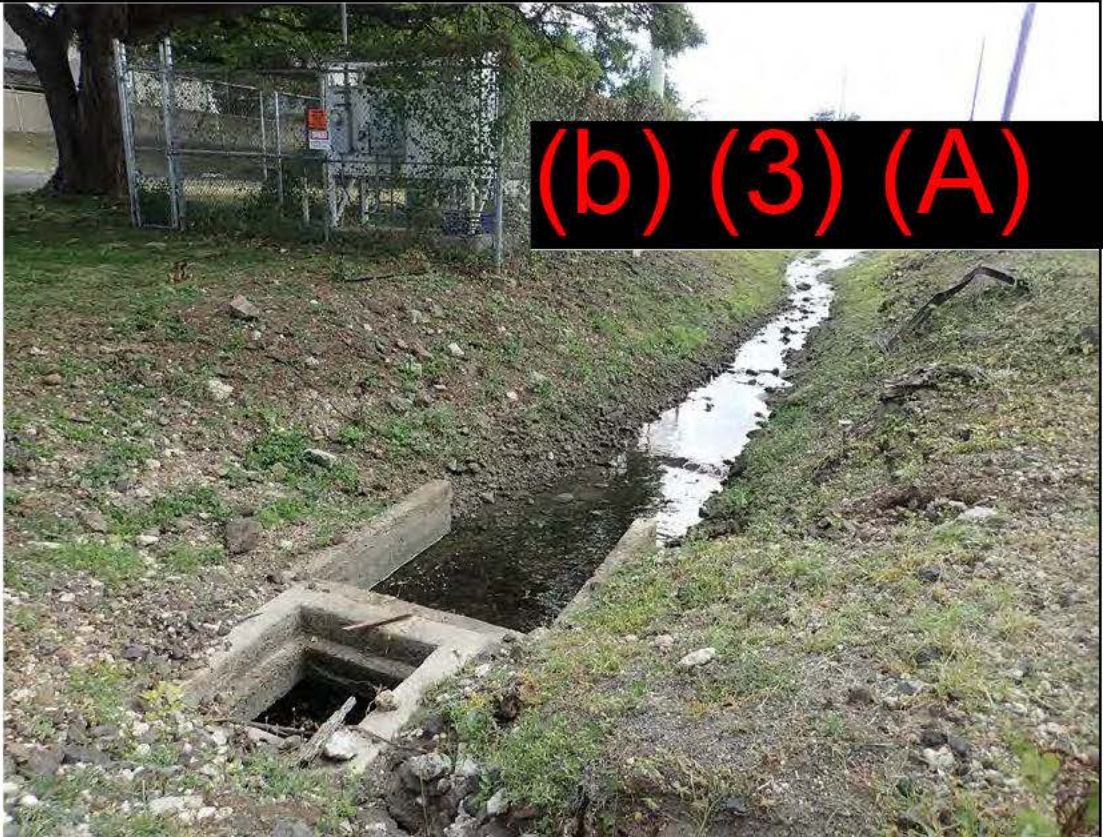
Photo No. 45	Time: 1628		
Direction Photo Taken: SSW			
Photo Description: Stream/culvert alongside pipeline jurisdictional boundary
