Region 6 - Enforcement & Compliance Assurance Division
INSPECTION REPORT

Inspection Date(s):	04/13/2022	
Media Program:	Air	
Regulatory Program(s)	SIP, Title V, NESHAP, NSPS	
Company Name:	Phillips 66 Company	
Facility Name:	Lake Charles Refinery	
Facility Physical Location:	2200 Old Spanish Trail	
(city, state, zip code)	Westlake, Louisiana, 70669	
Mailing address:	2200 Old Spanish Trail P.O. Box 37	
(city, state, zip code)	Westlake, Louisiana, 70669	
County/Parish:	Calcasieu Parish	
Facility Phone Number	337-491-4742	
Facility Contact:	Erin Strang Erin.T.Strang@P66.com	Environmental Team Lead
FRS Number:	110000539757	
Identification/Permit Number:	AI#: 2538 / 2626V-17; 2623-V19	
Media Identifier Number:	2201900005	
NAICS:	324110	
SIC:	2911	
Personnel participating in inspection:		
James Haynes	EPA ECD-AT	Inspector
Ben Rosenthal	EPA ECD-AT	Inspector
Erin Strang	Phillips 66 Company	Environmental Team Lead
Tricia Rapp	Phillips 66 Company	Environmental Specialist – Air Lead
John Tarasiewicz	Phillips 66 Company	Environmental Specialist – Tanks Lead

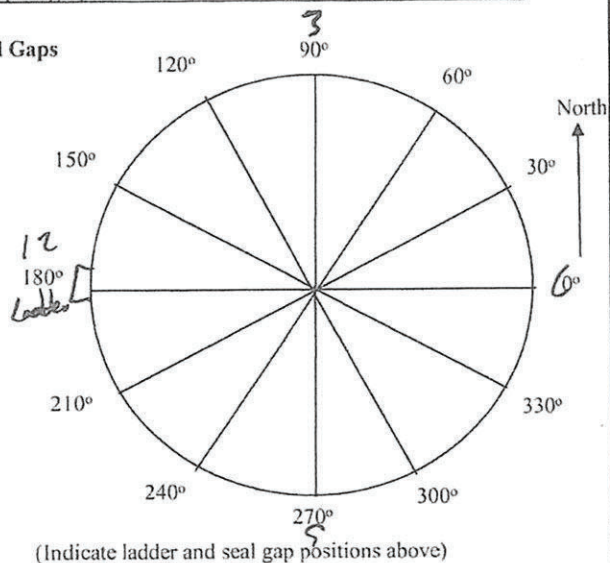
AS FOUND SEAL GAP CONDITIONS

Gap Location (clock position)	Gap length L (inches)	Max. widths W (inches)	Total Gap, A (sq. inches)
12	0	x 0	= 0
2	0	x 0	= 0
4	0	x 0	= 0
6	0	x 0	= 0
8	0	x 0	= 0
10	0	x 0	= 0
Total Gap (sq. inches) =			0
Max. Gap Width, inches =			0

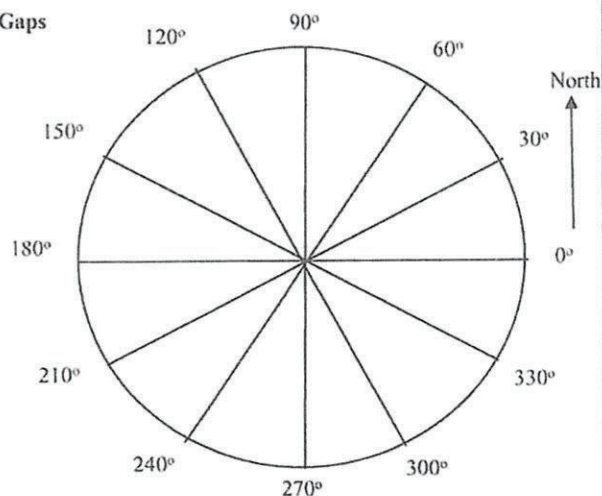
(Indicate ladder and seal gap positions above)

AS FOUND SEAL GAP CONDITIONS

Gap Location (clock position)	Gap length L (inches)	Max. widths W (inches)	Total Gap, A (sq. inches)
0	0	x 0	= 0
30	0	x 0	= 0
90	0	x 0	= 0
150	0	x 0	= 0
210	0	x 0	= 0
270	0	x 0	= 0
Total Gap (sq. inches) =			0
Max. Gap Width, inches =			0
