Subject: November 14, 2022 Municipal Separate Storm Sewer System Inspection Report

Purpose: City of East St. Louis MS4 Inspection

Facility: City of East St. Louis, IL

NPDES Permit: ILR400332

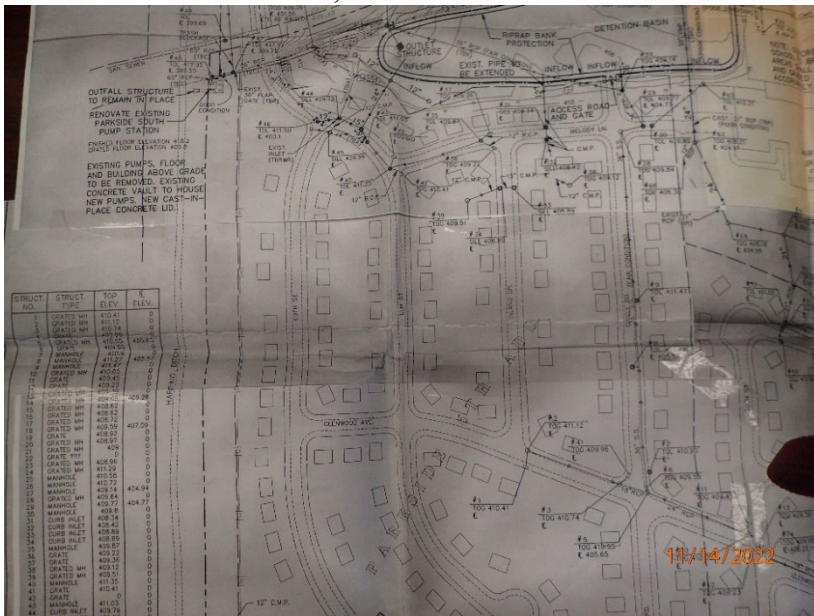
Description: East St. Louis sewer map of the Parkside and Wedgewood Pump Stations and Parkside recommended improvements. Map date is 8/1/1994.

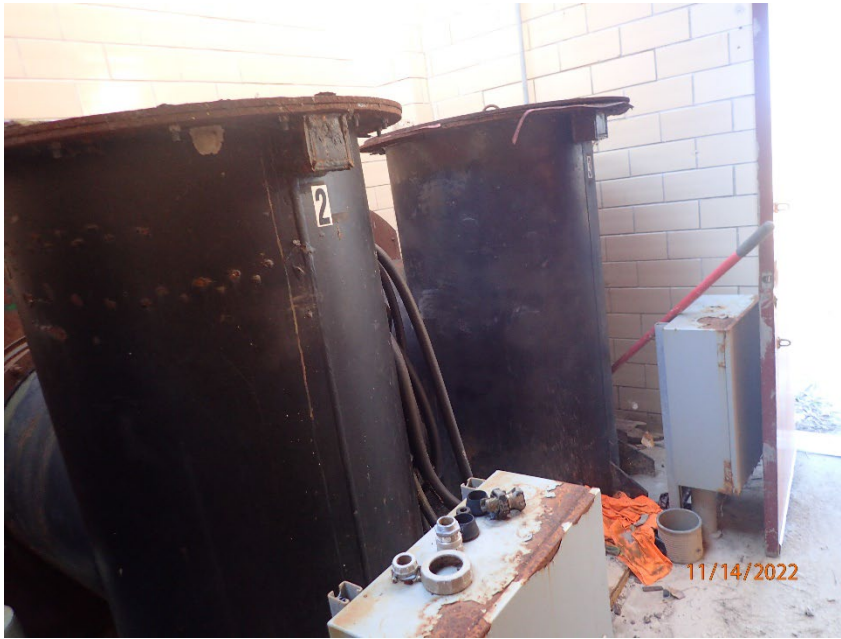
3. The Parkside Pump Station is in disrepair. Part of the roof is missing, the flapper gates are not installed or working, the equipment in the station is rusted and only one of the pumps is functional.

Description: One pump is out for repair, one is not functioning, and one is functioning.
