- SUBJECT: Long-Term Stewardship Assessment Chevron Molycorp Washington Remediation Project EPA ID: PAD030068282 300 Caldwell Avenue, Washington, PA 15301
- DATE: September 25, 2023
- TO: Alizabeth Olhasso, RCRA Corrective Action South Section Manager Long Term Stewardship File for Former Molycorp Facility RCRA Corrective Action
- FROM: Andrew Clibanoff, Remedial Project Manager

On September 14, 2023, the United States Environmental Protection Agency's (USEPA) Land, Chemicals, and Redevelopment Division (LCRD) representative, Andrew Clibanoff, conducted a long-term stewardship assessment site visit of the Chevron Molycorp Washington Remediation Project (Facility) in Washington, PA. The purpose of the LTS site visit was to assess the status of the implemented remedies at the Facility.

# September 14, 2023 Long Term Stewardship Inspection

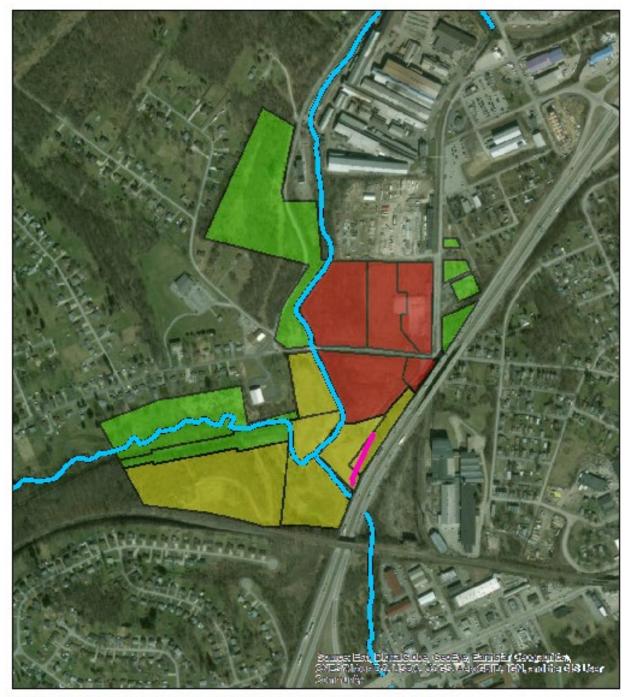
# Figure 3: Molycorp Incorporated Washington Plant EPA ID: PAD030068282

All areas of concern have been geospatially mapped and are available on the Facility's EPA Factsheet. A copy of the geospatial map for the Facility is included as Figure 3.
