**Municipality/Organization:** City of Malden  
**EPA NPDES Permit Number:** MA041046  
**MADEP Transmittal Number:** 041088  
**Annual Report Number  
& Reporting Period:** No. 9: April 1, 2011-March 31, 2012

## NPDES PII Small MS4 General Permit Annual Report

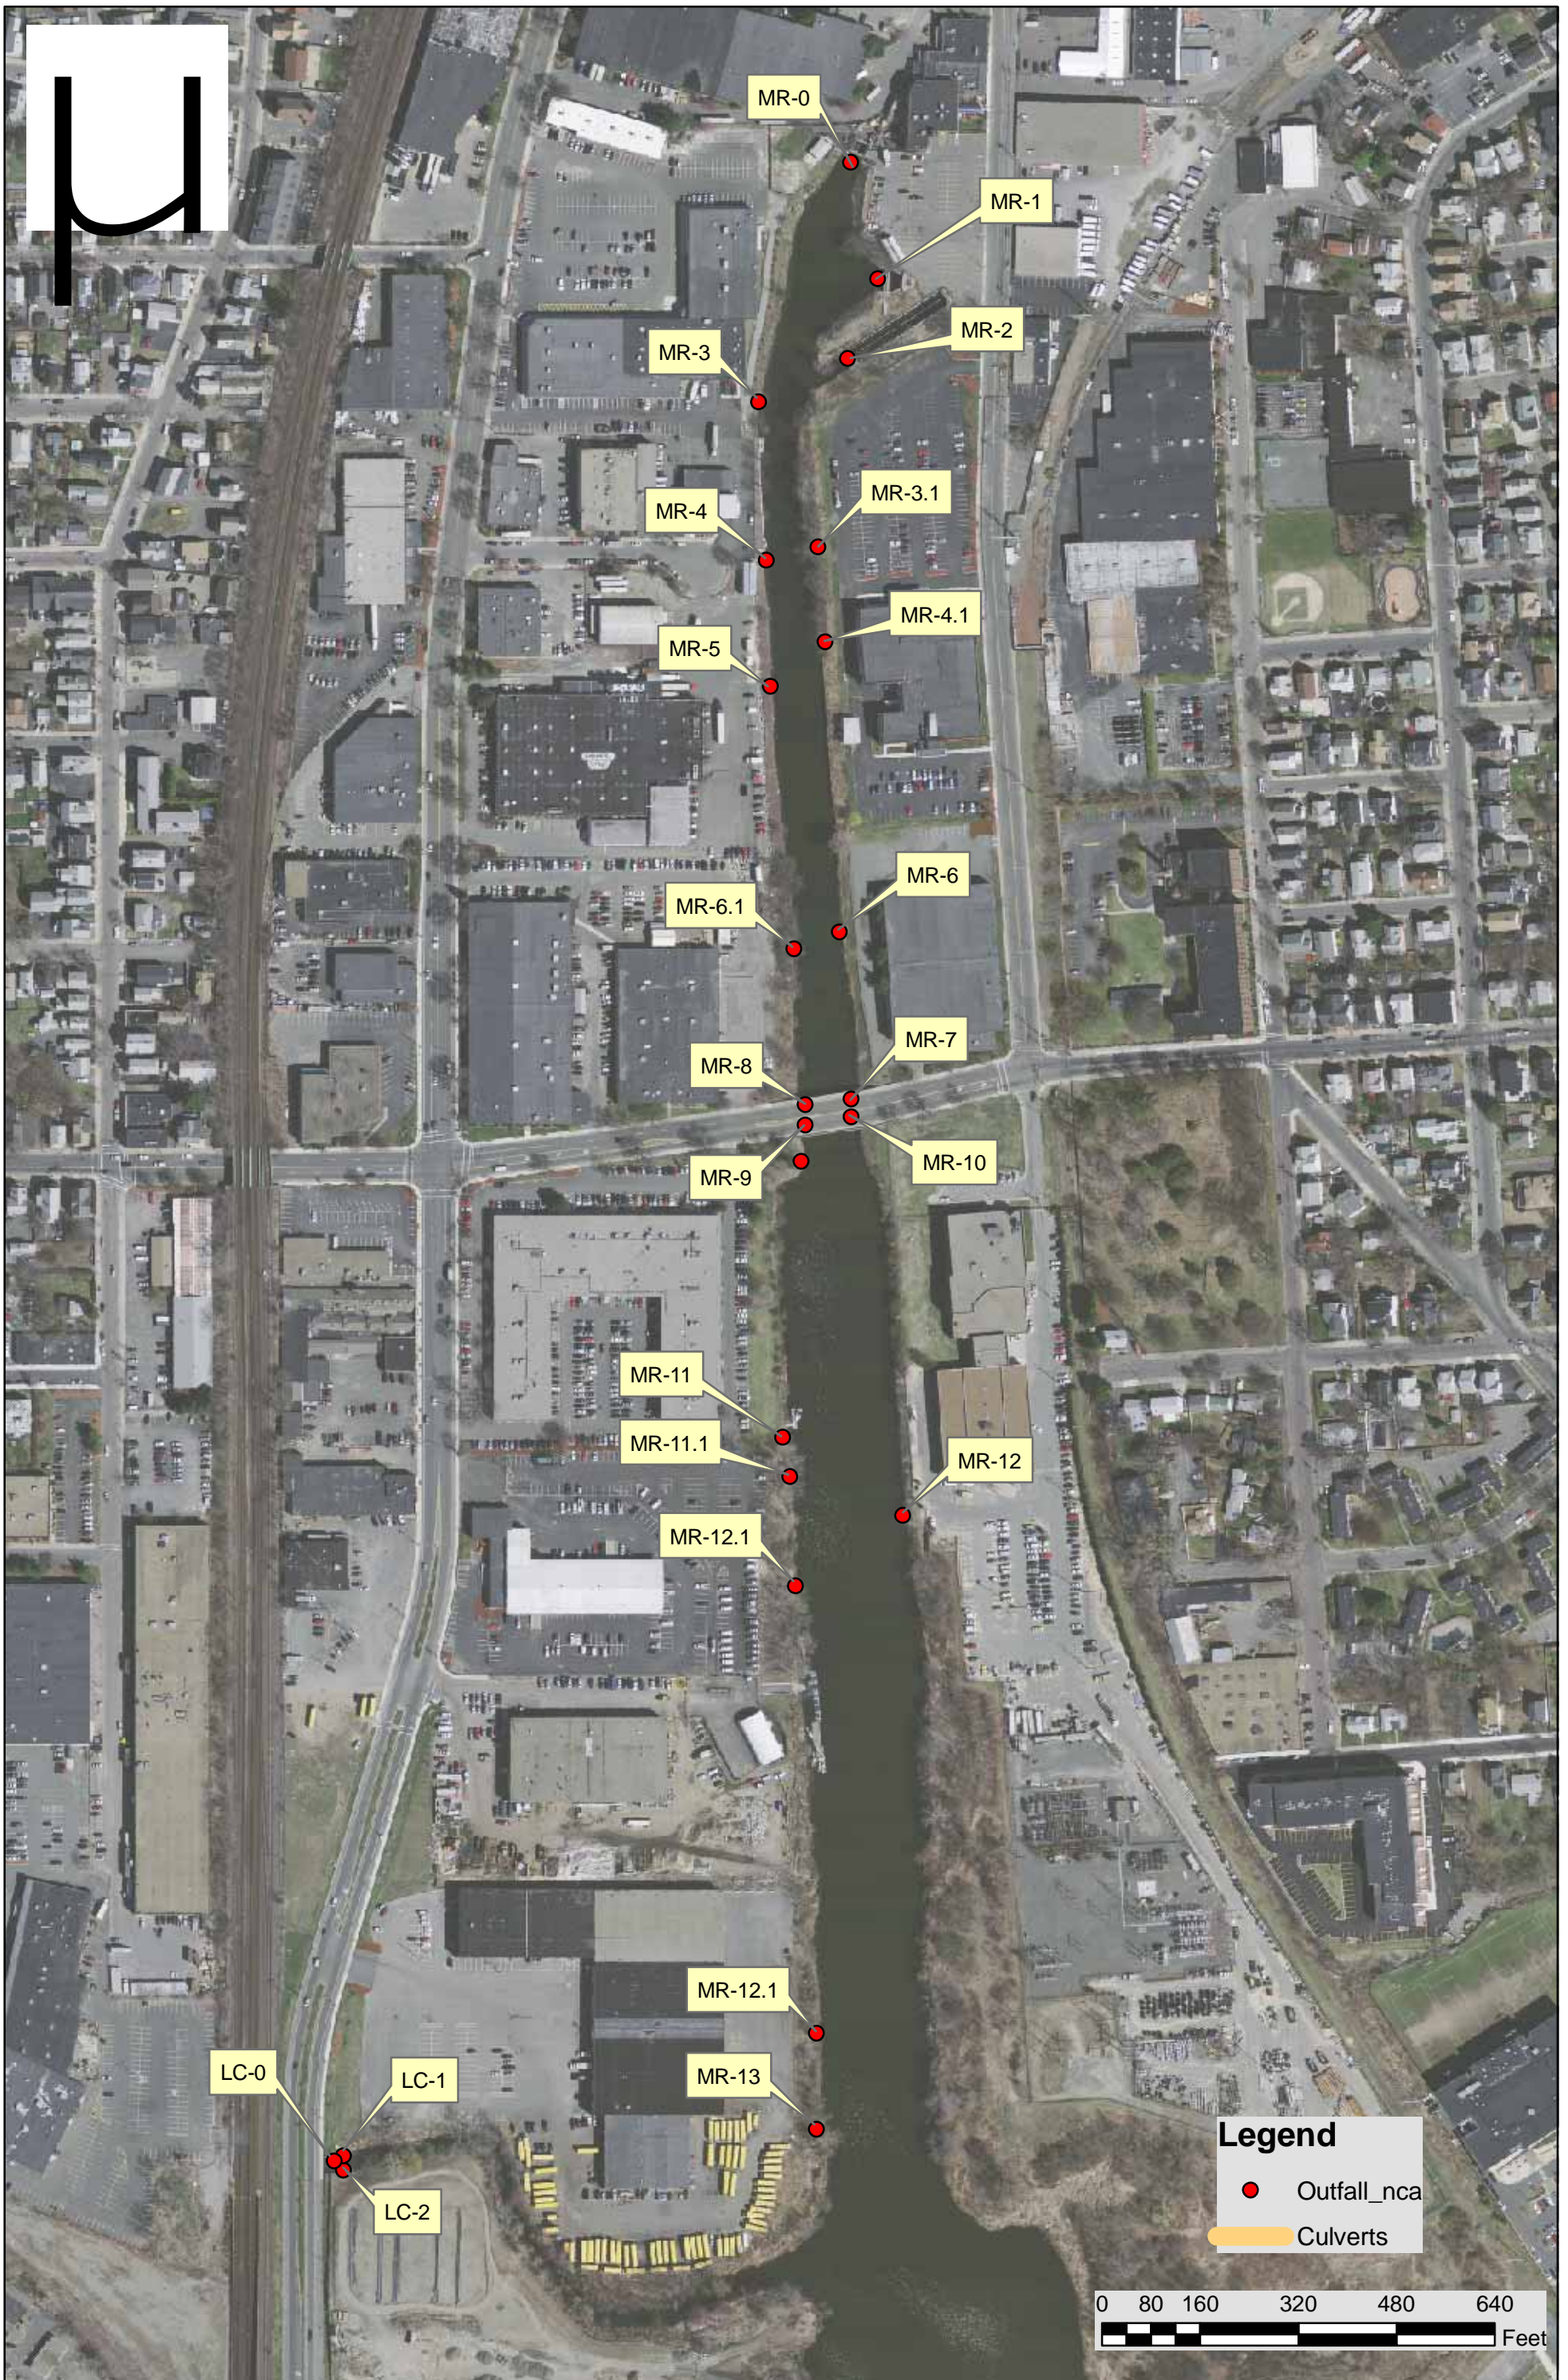
Figure 4 - Dry Weather Flow Map (as of 12-31-10)

During the course of the dry weather inspections, a number of dry weather flows, consisting primarily of waterline leaks and culverted surface waters have been identified. A summary of these flows within the municipal system that have been identified to date are shown on Figure 4, and are described as follows.

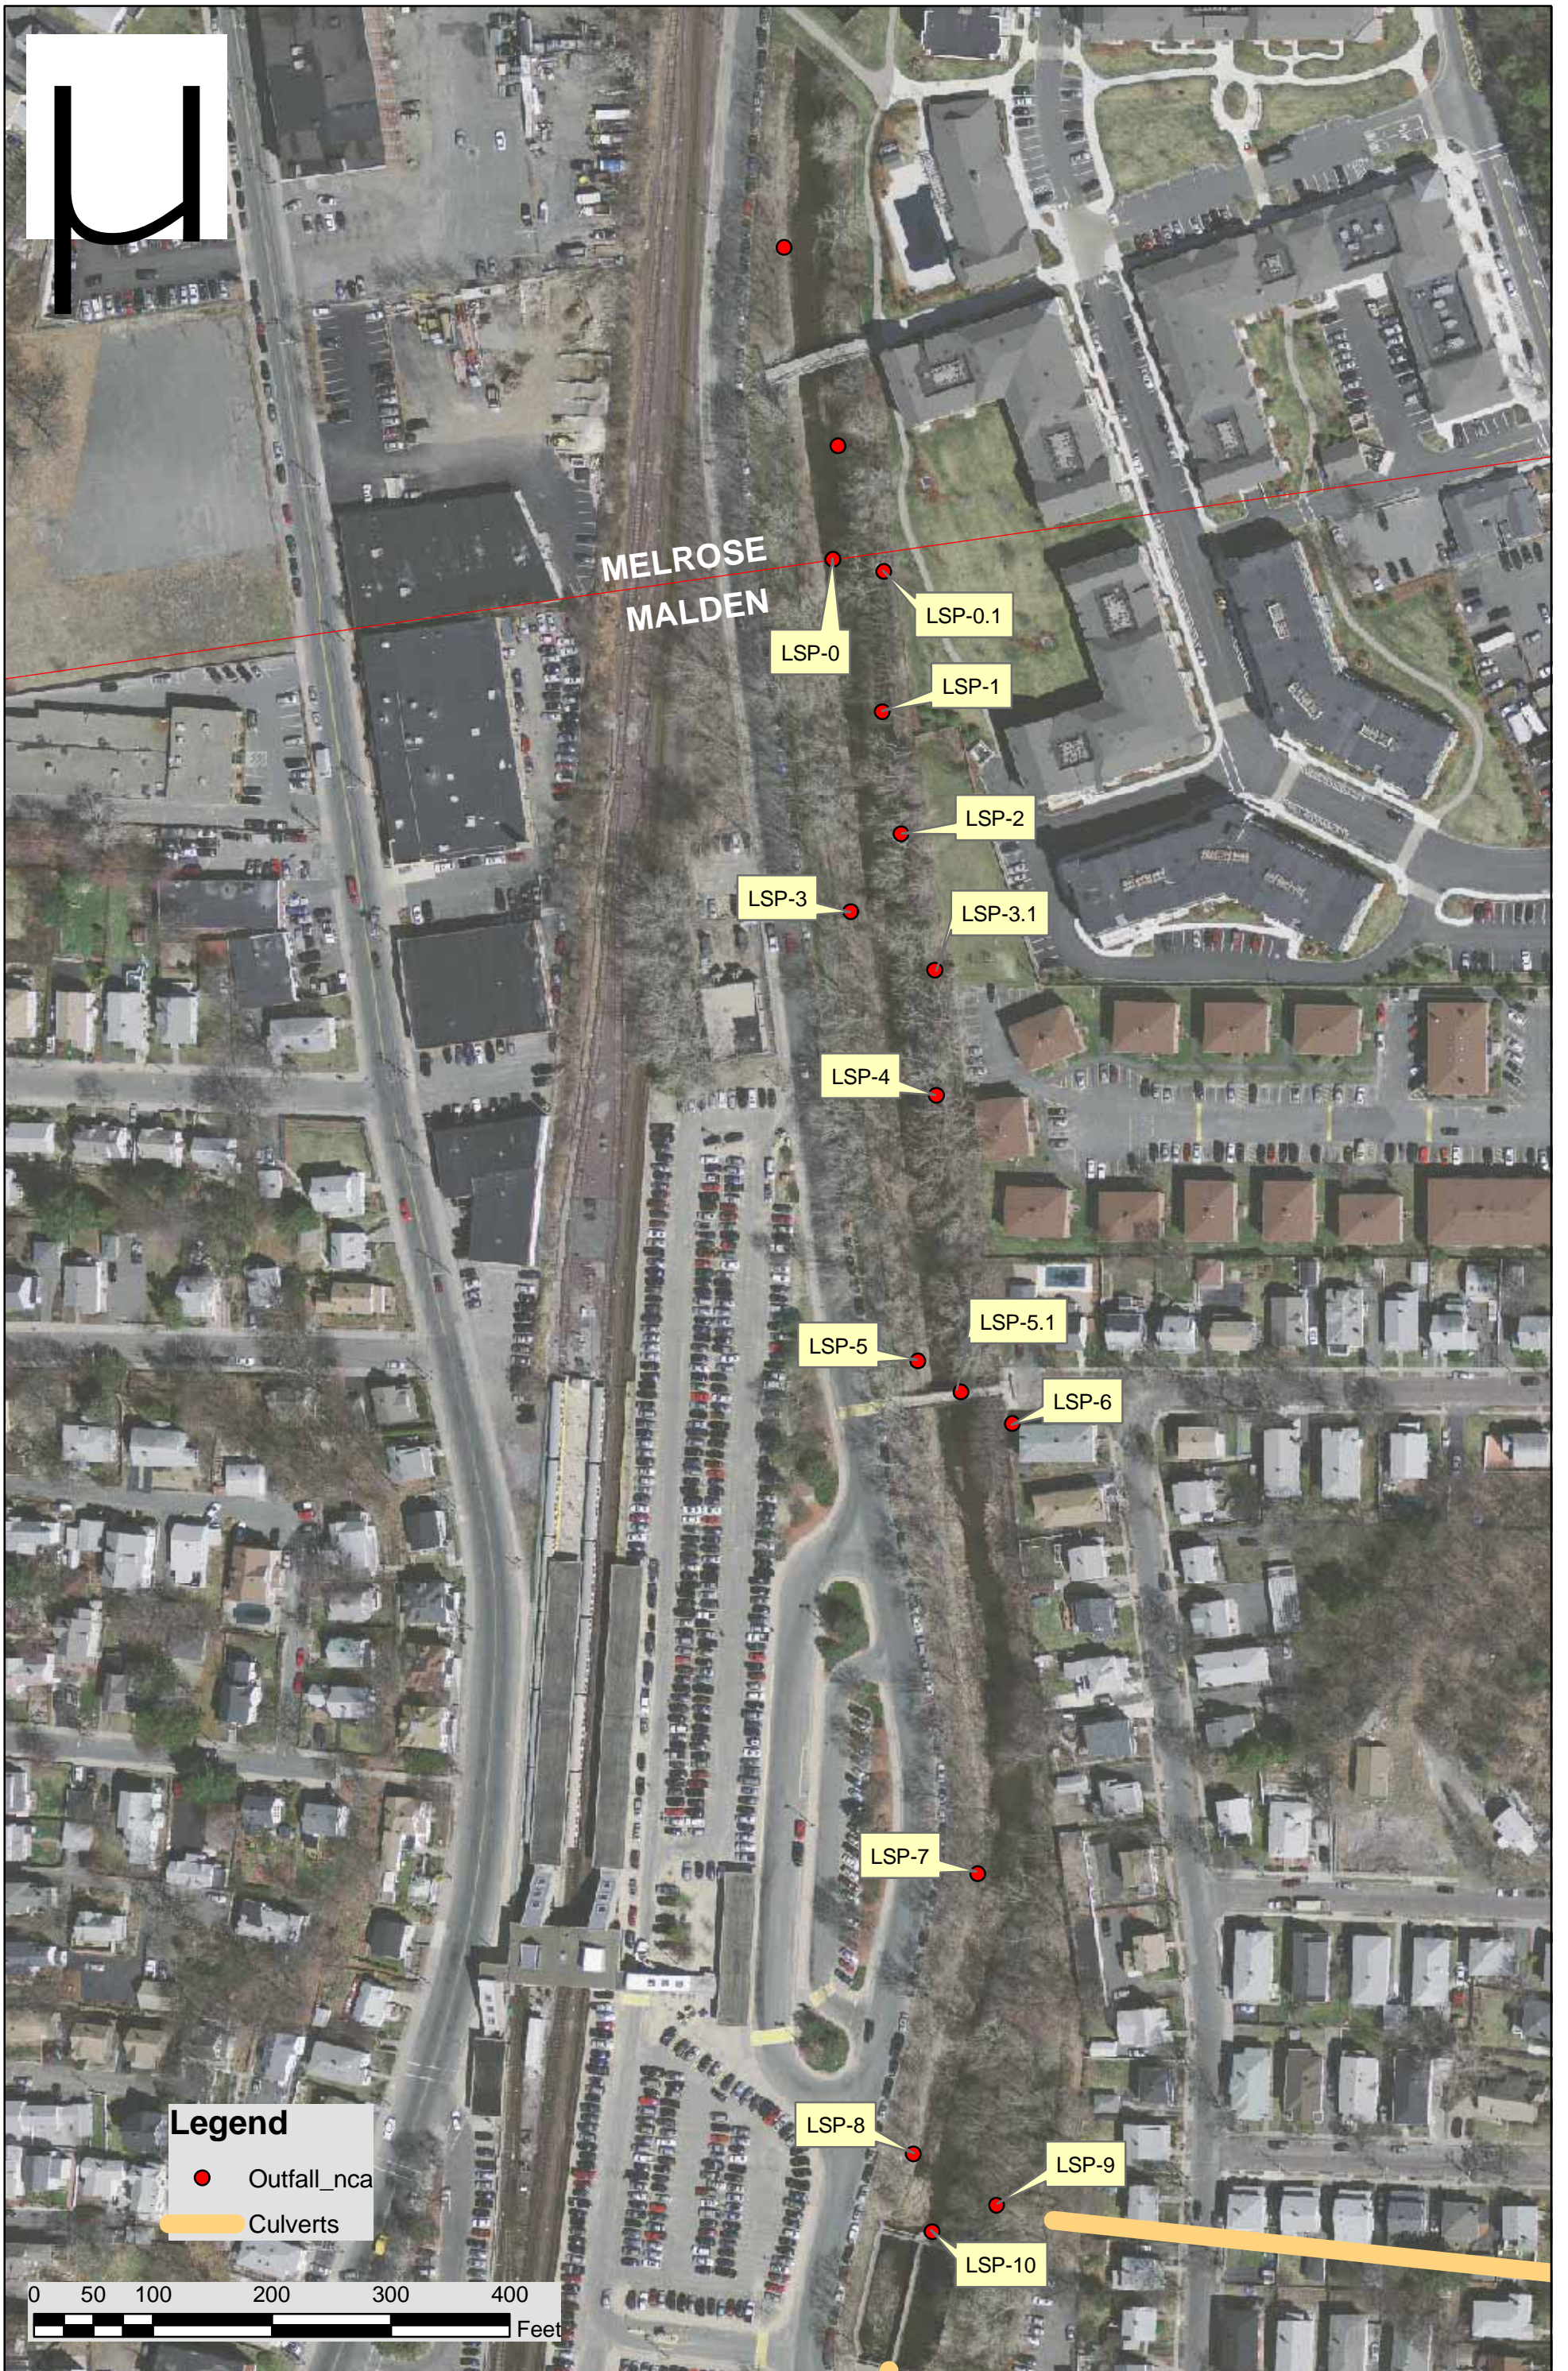
**Figure 6 - Malden River Outfalls**

The City of Malden's stormwater compliance team initially targeted potential illicit discharges to the Malden River as its highest priority. Utilizing the outfall monitoring data and information obtained during sampling events, the City has identified significant base flow as surface waters, to the Malden River during dry weather conditions. Consistent with the original design of the MDC/DCR conveyance network; this occurs primarily thorough culverted channels/brooks located in northwestern portions of the City. This flow includes contributions that originate from the Fells Reservation and Lower Spot Pond Brook. As shown on Figure 5, a total of 23 outfalls to the Malden River have been identified, nine (9) of which have been identified as flowing during dry weather conditions. Periodic dry weather sampling has been performed both my NCA and the regional watershed group, Mystic River Watershed Association (MyRWA). Reference to Table 2.0, shows that during this reporting period, E. coli levels ranged from 4.1 col/100ml (MR-6) to 9,200 col/100ml (MR-0). In addition to the level detected at MR-0, concentrations of E. coli were also encountered at MR-1 (390 col/100ml) and MR-2 (1,200 col/100ml).

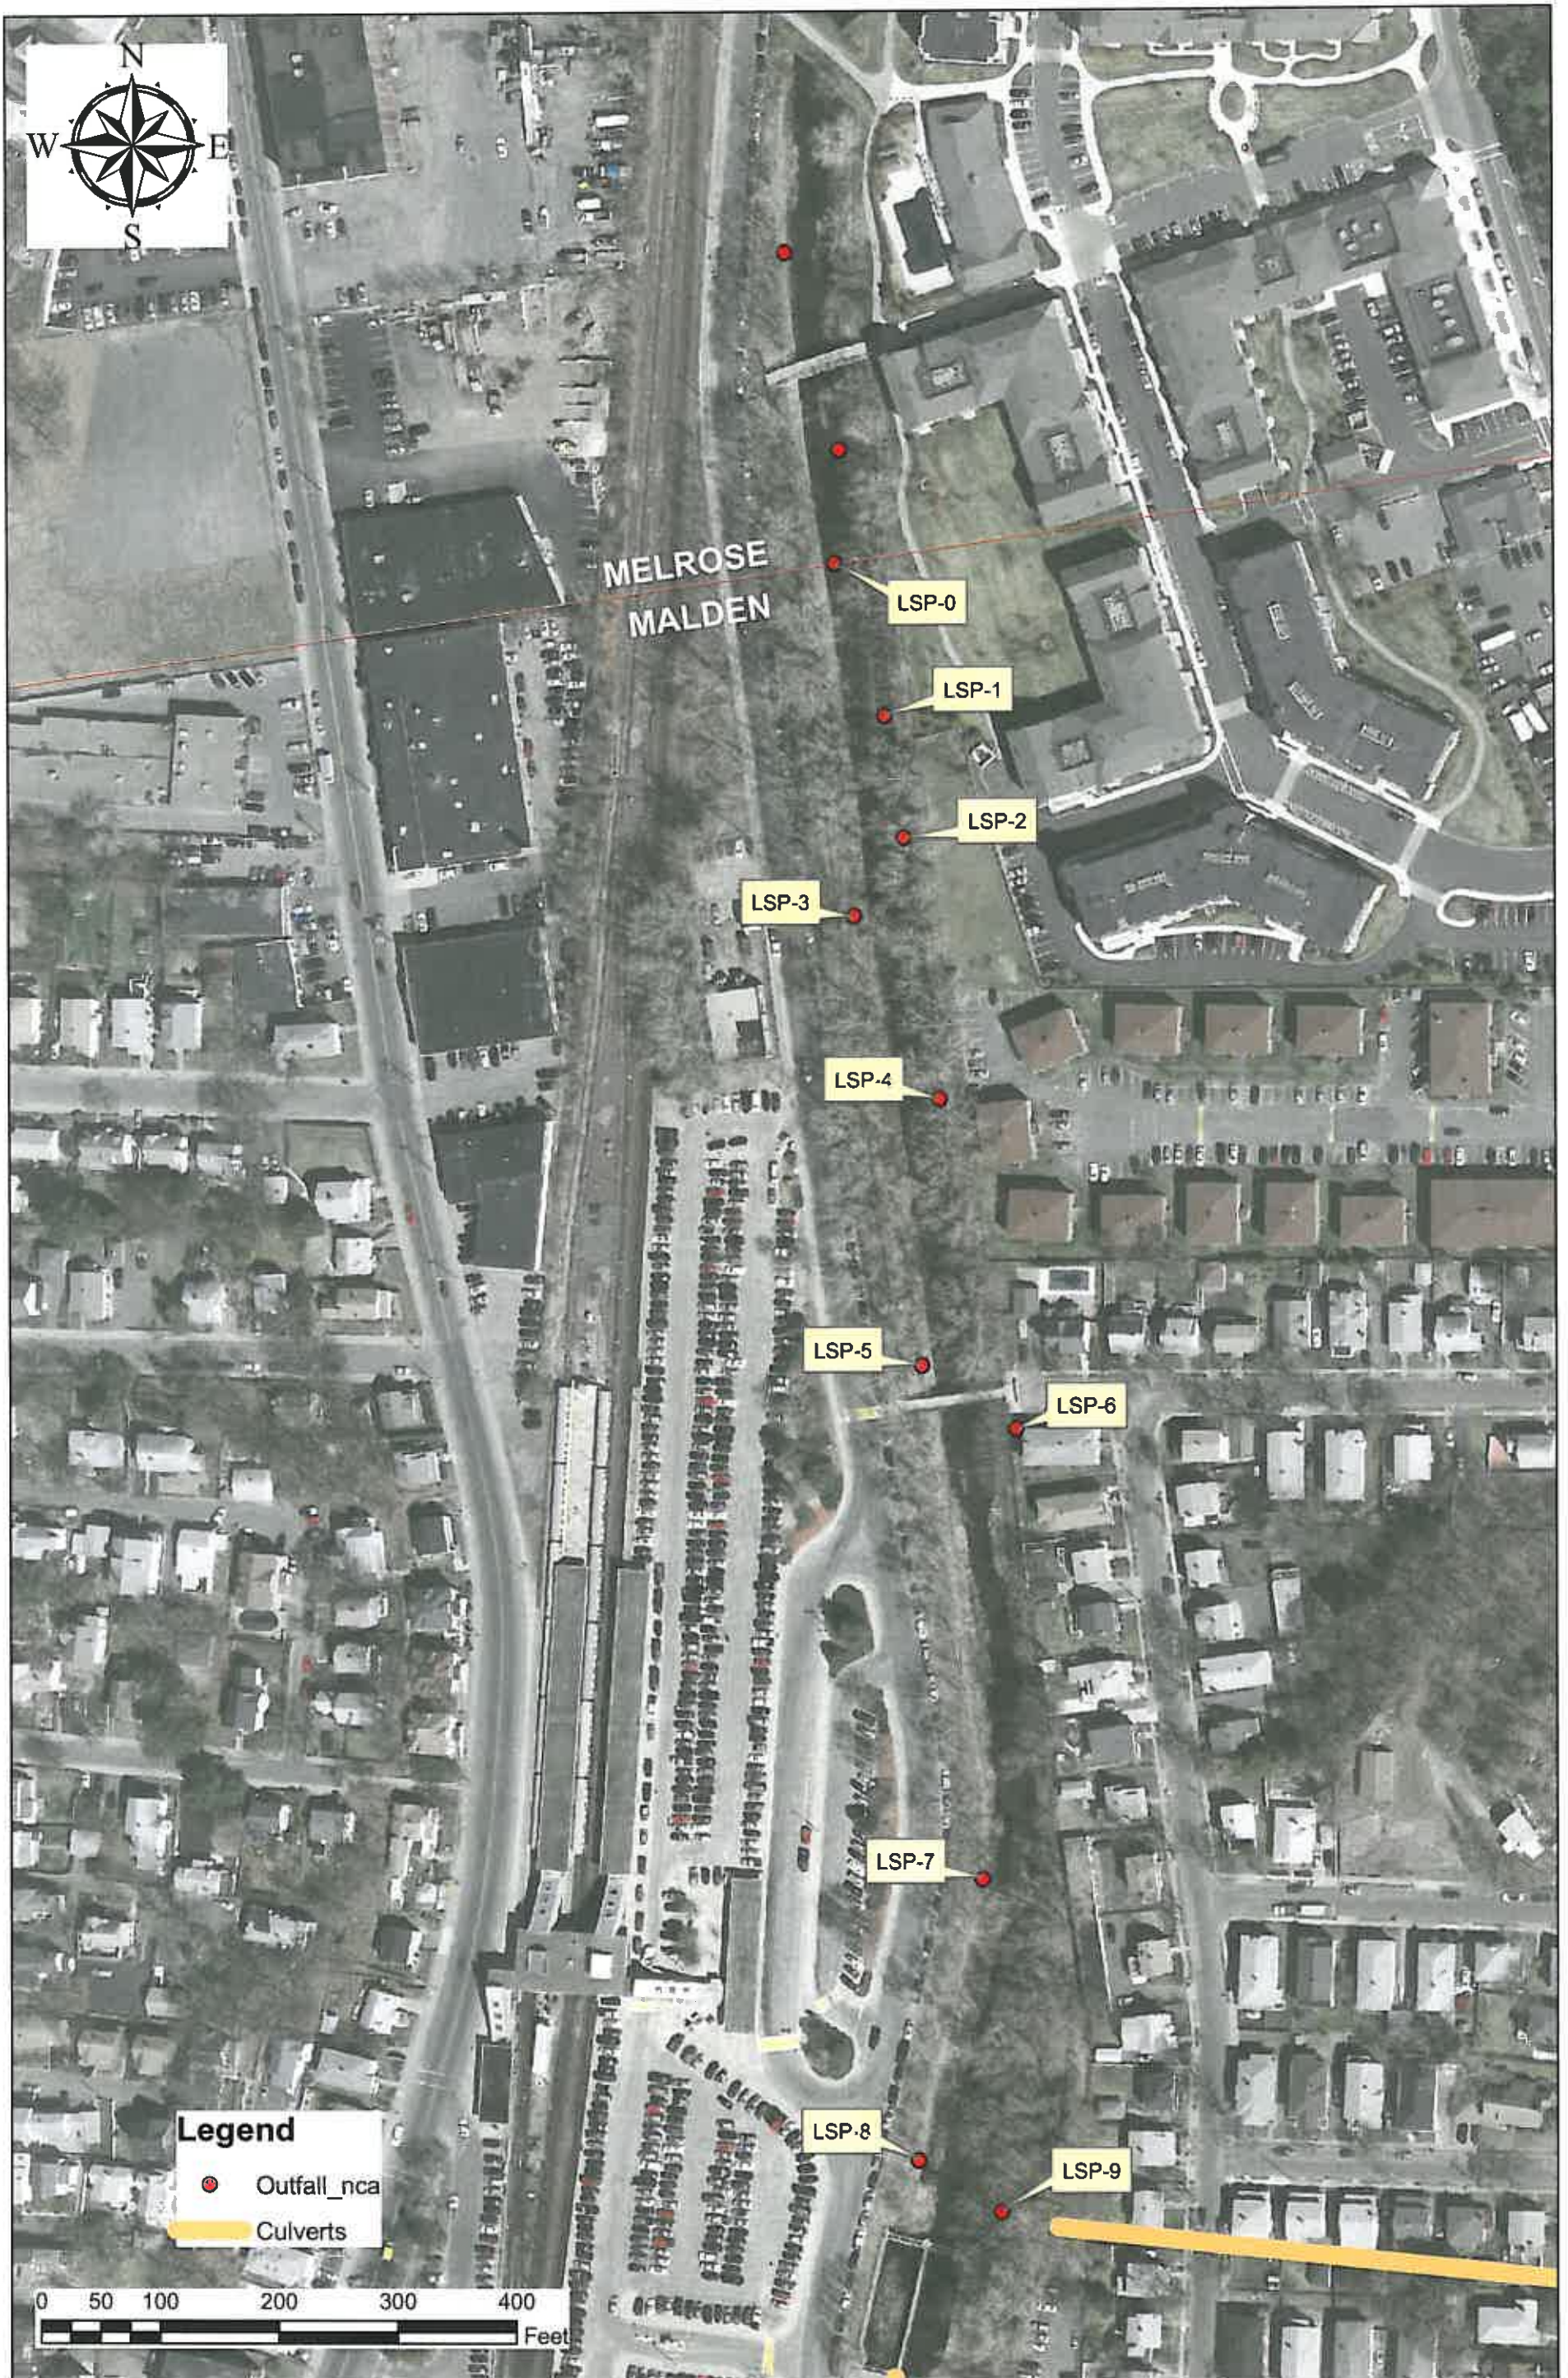
Figure 4 - Dry Weather Flow Map (as of 12-31-10)

During the course of the dry weather inspections, a number of dry weather flows, consisting primarily of waterline leaks and culverted surface waters have been identified. A summary of these flows within the municipal system that have been identified to date are shown on Figure 4, and are described as follows.

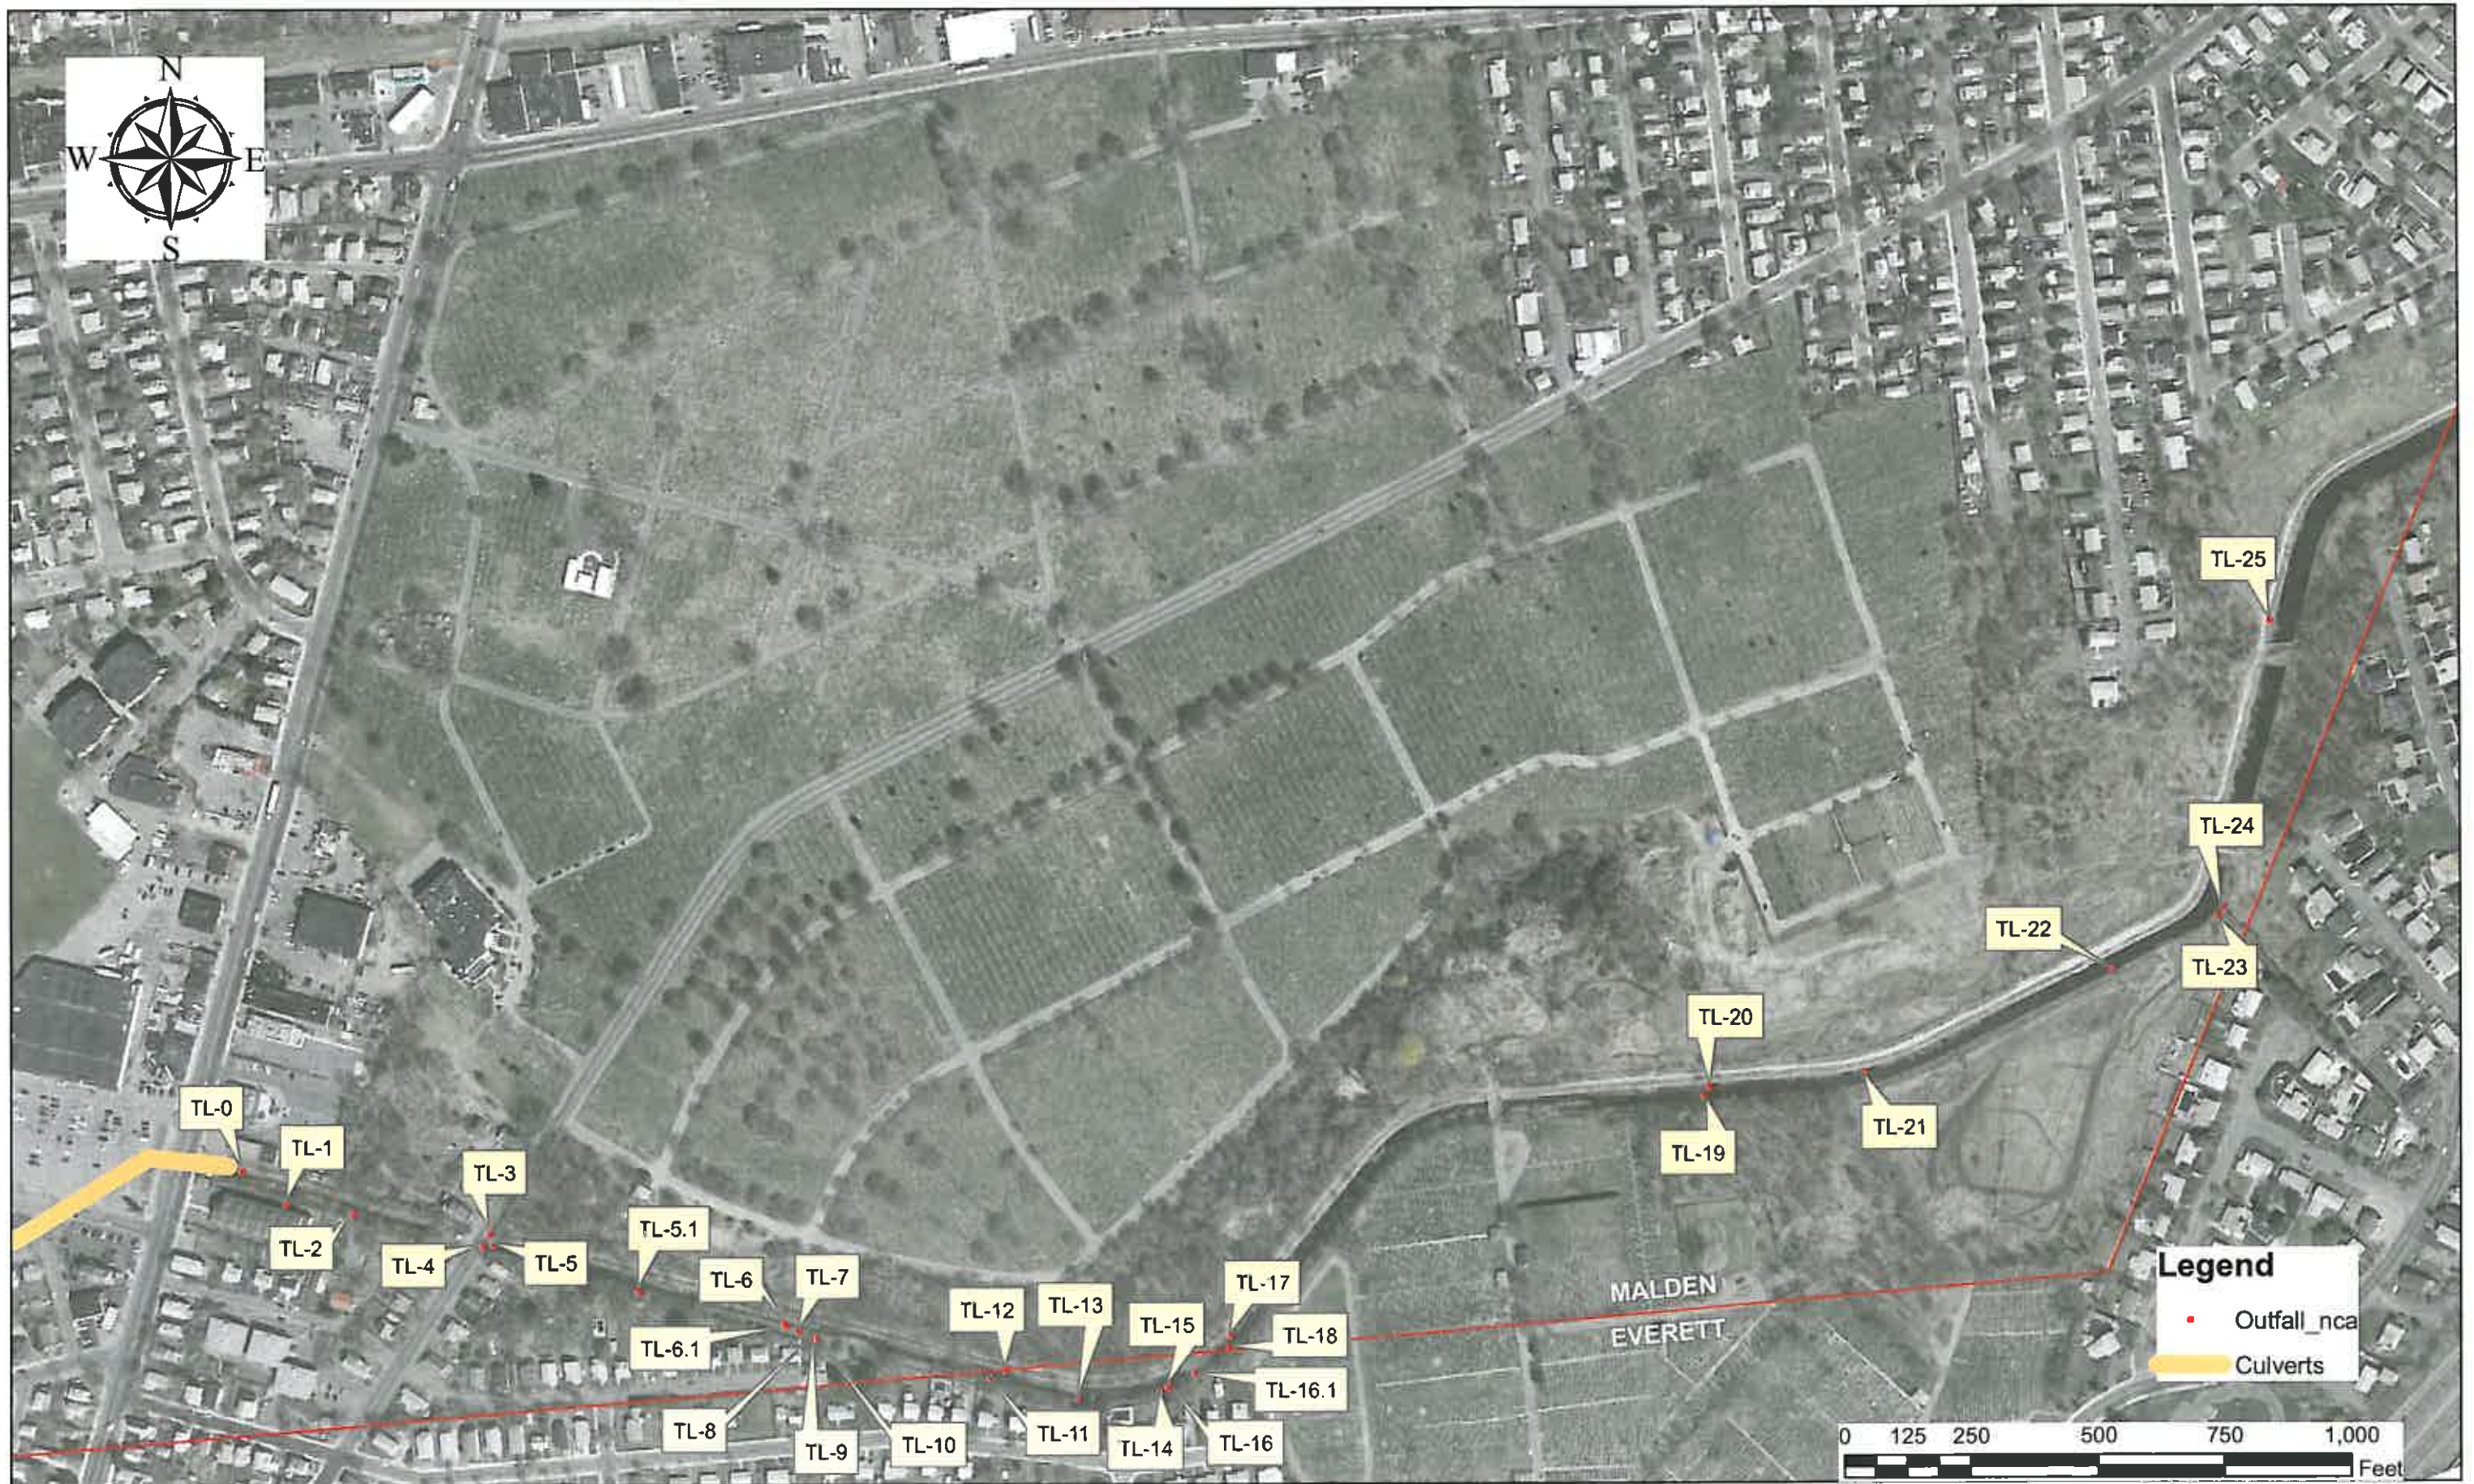
**Figure 6 - Malden River Outfalls**

As stated, the City initially targeted potential illicit discharges to the Malden River as its highest priority. Utilizing the outfall monitoring data and information obtained during sampling events, the City has identified significant base flow to the Malden River during dry weather thorough culverted channels/brooks located in northwestern portions of the City. This flow includes contributions from the Fells Reservation and Lower Spot Pond Brook Culvert. As shown on Figures 5 and 6, a total of 17 outfalls to the Malden River have been identified to date, three (3) of which have been identified as flowing during dry weather conditions.
