CHAPTER 5 - WASTEWATER TREATMENT FACILITIES

5.1 Introduction

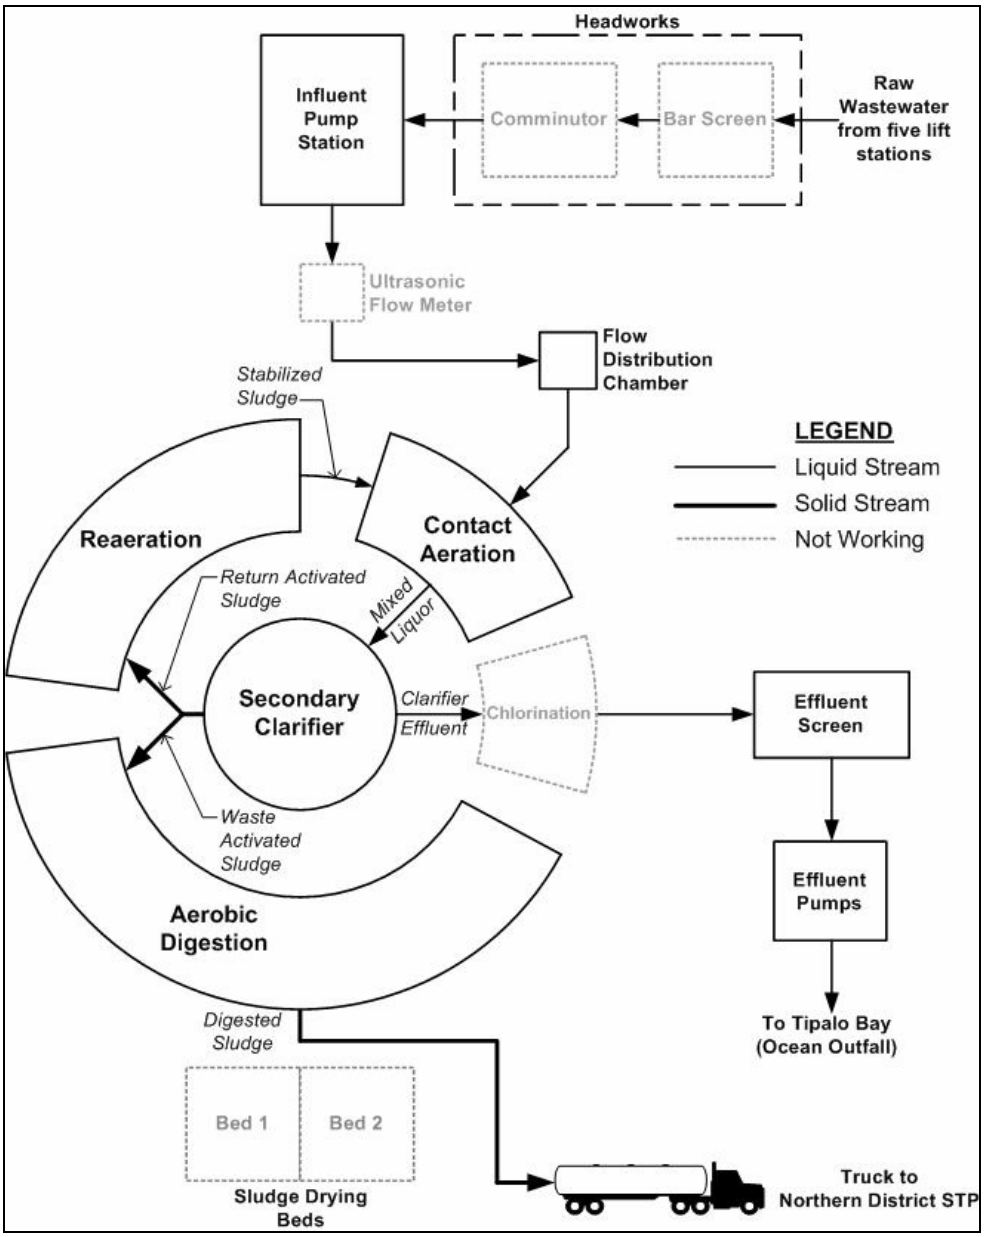
Figure 5-2 – Agat-Santa Rita STP Schematic Flow Diagram

Based on the DMRs reviewed, the Agat-Santa Rita STP was essentially out of compliance with the NPDES permit requirements 100% of the time. All of the effluent discharge parameters, including 5-day biochemical oxygen demand (BOD_5), total suspended solids (TSS), fecal coliform, and enterococci exceeded the maximum limits established in the NPDES permit, with the exception of pH. Although there are maximum limits for weekly average parameters in the NPDES permit, weekly information was not reported on the DMRs, so these data were not available. In addition, no total chlorine residual data were taken since the chlorination system was not operated. Therefore, the total chlorine residual could not have exceeded the maximum average monthly and maximum daily limits.

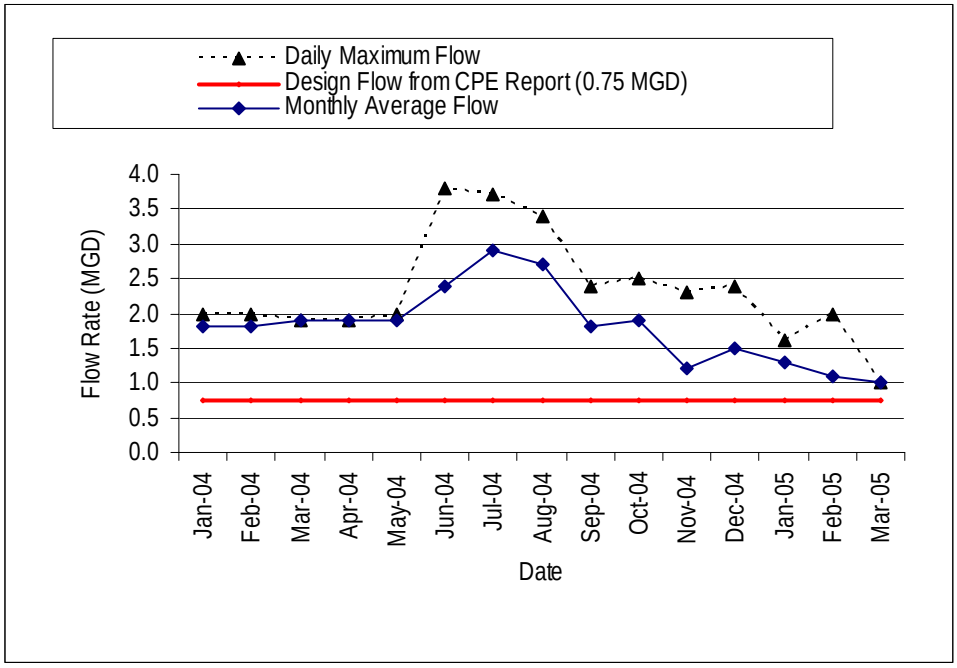
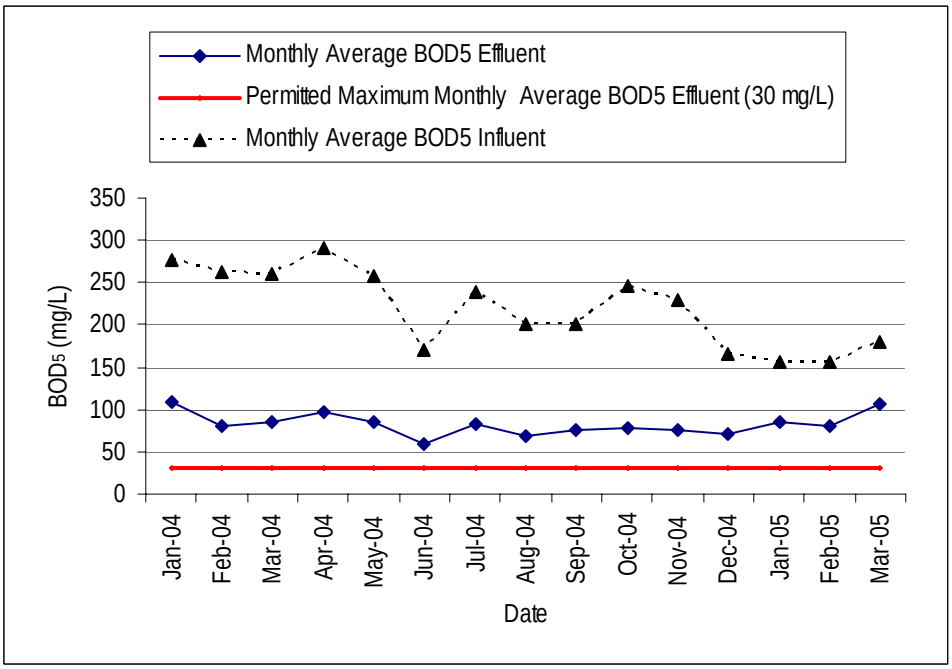
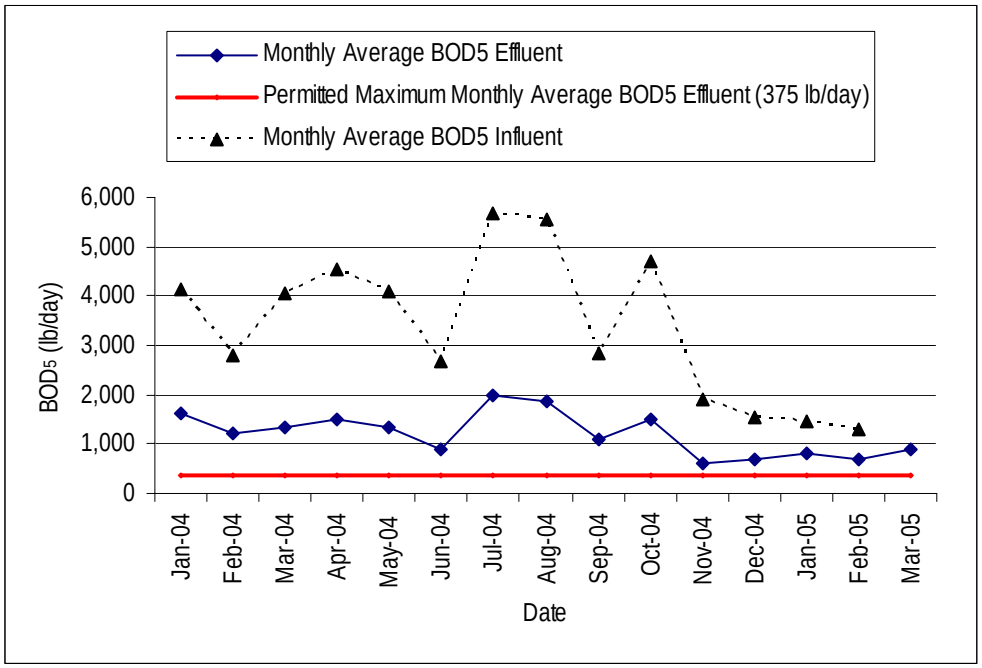
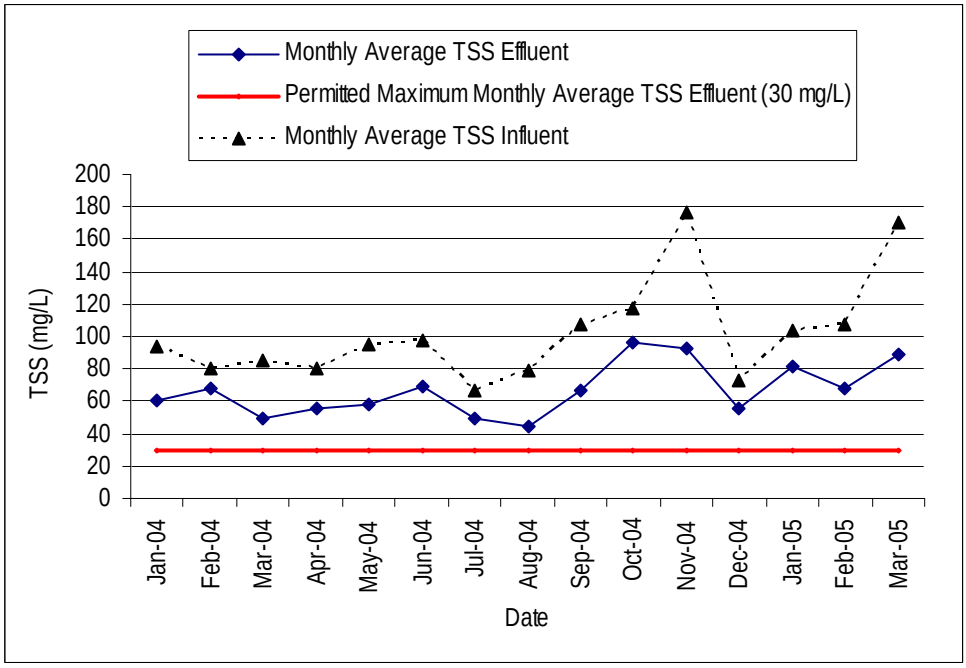
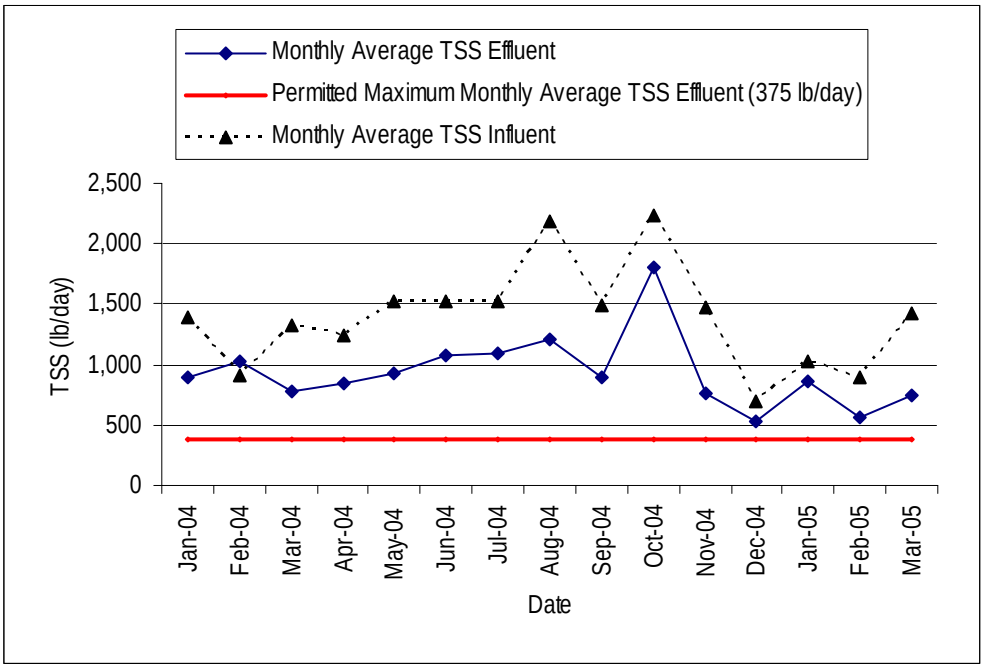
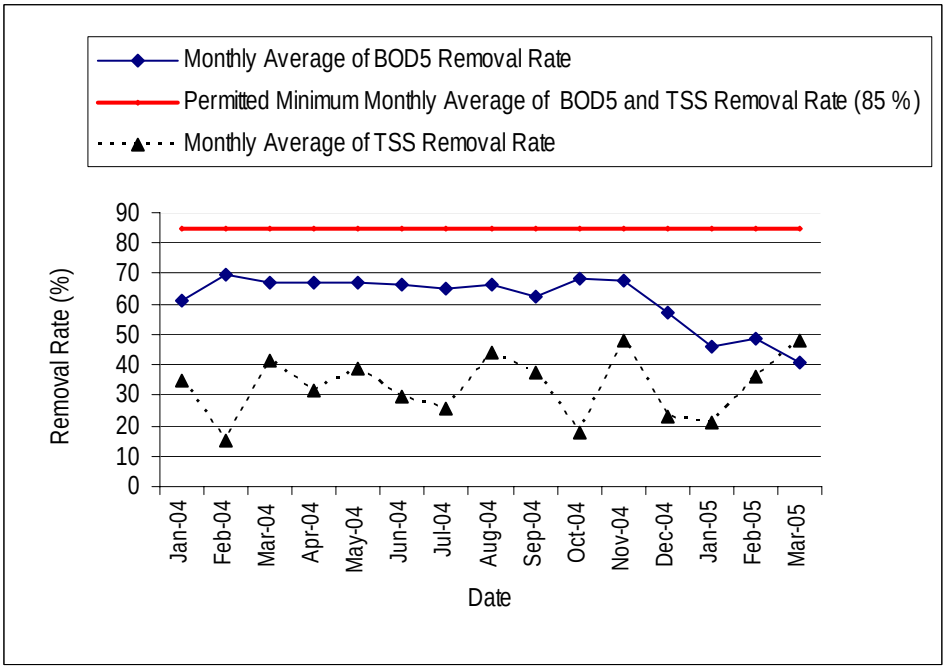
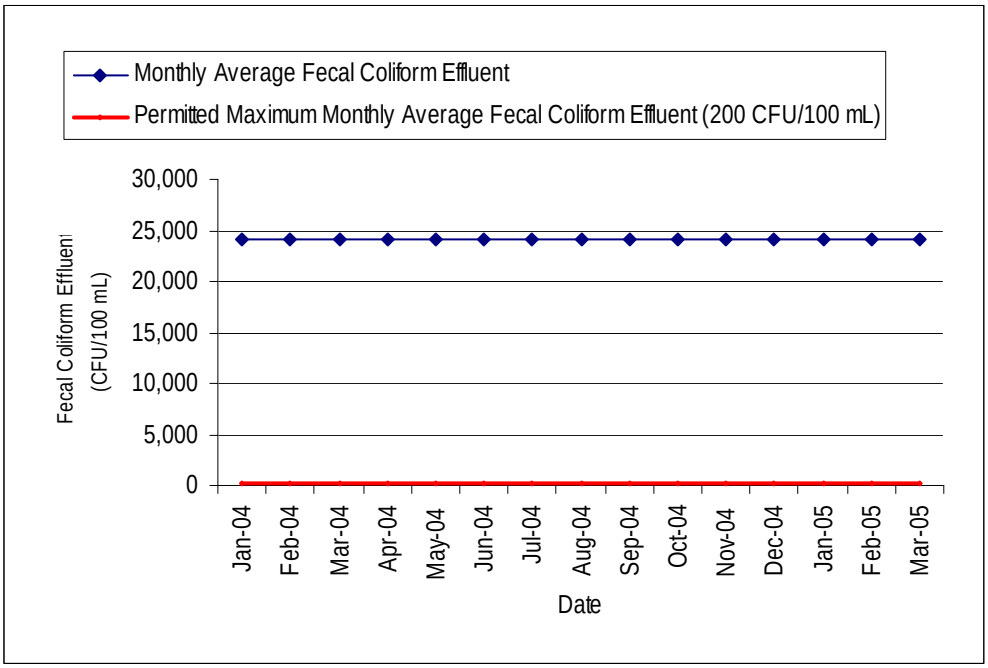
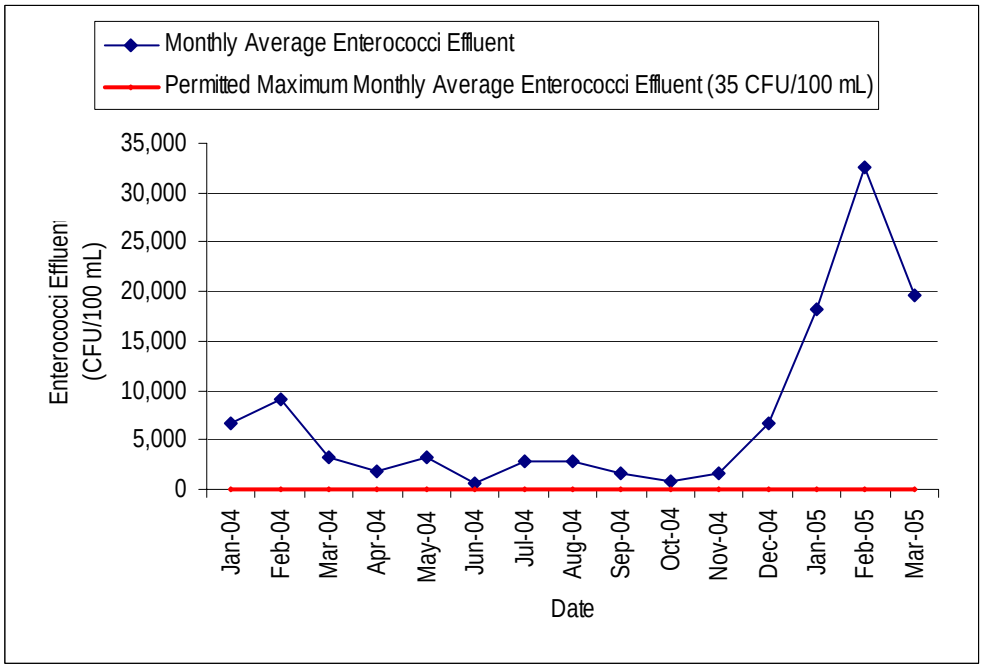
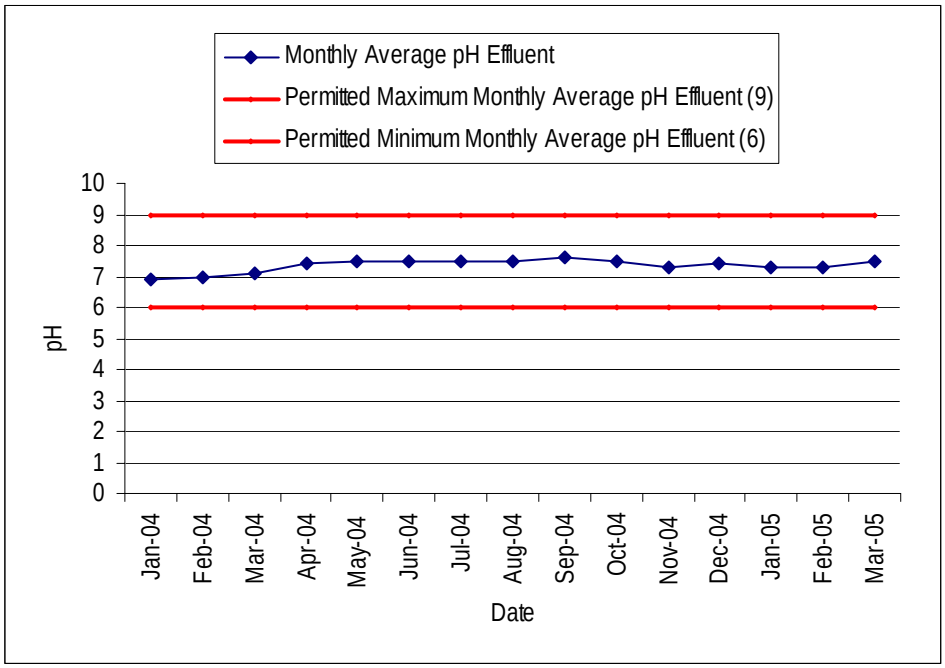
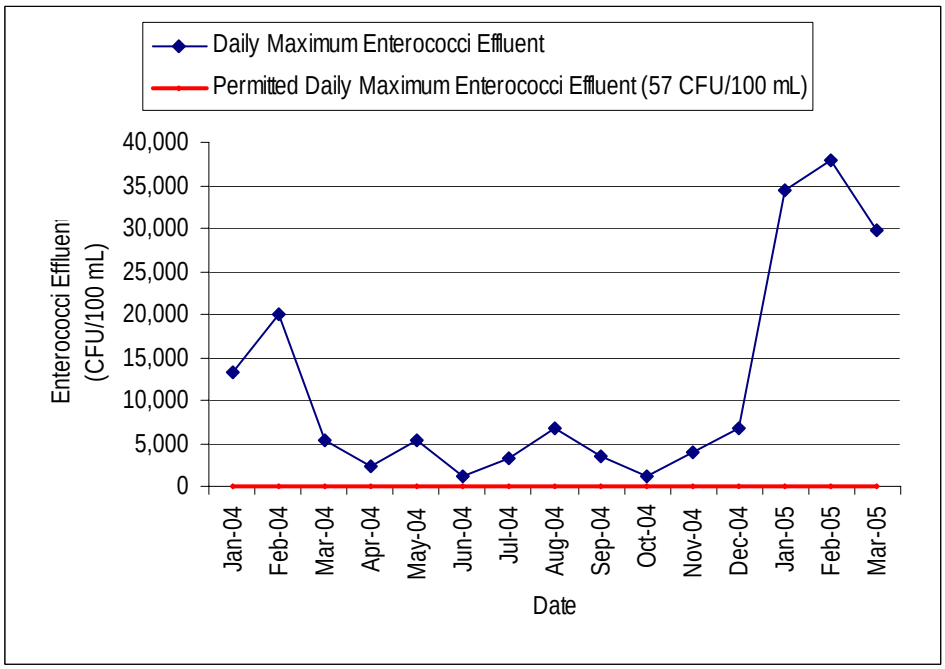
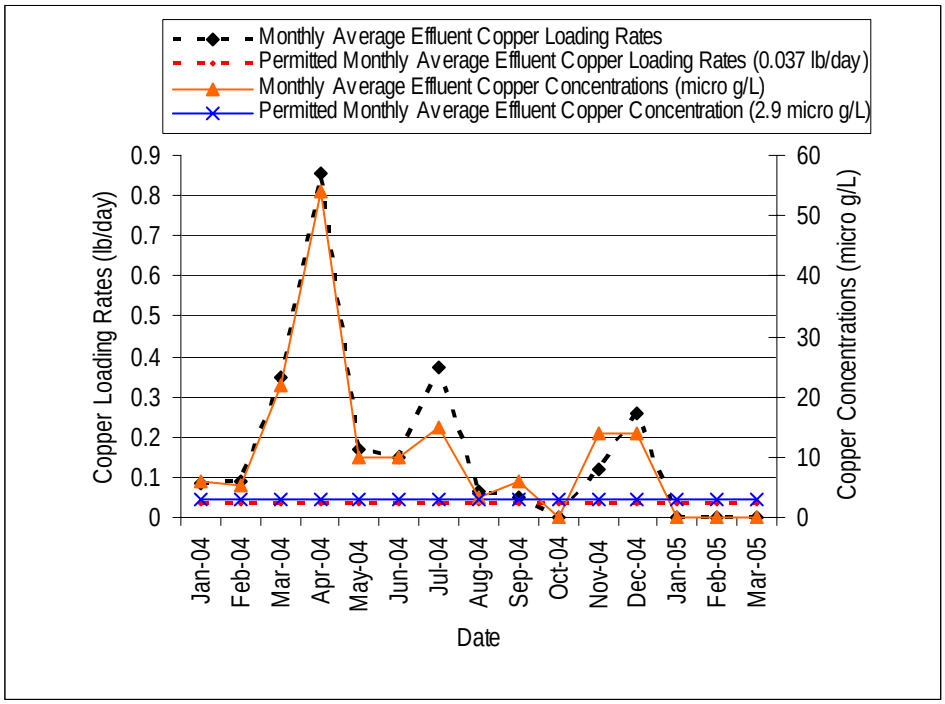
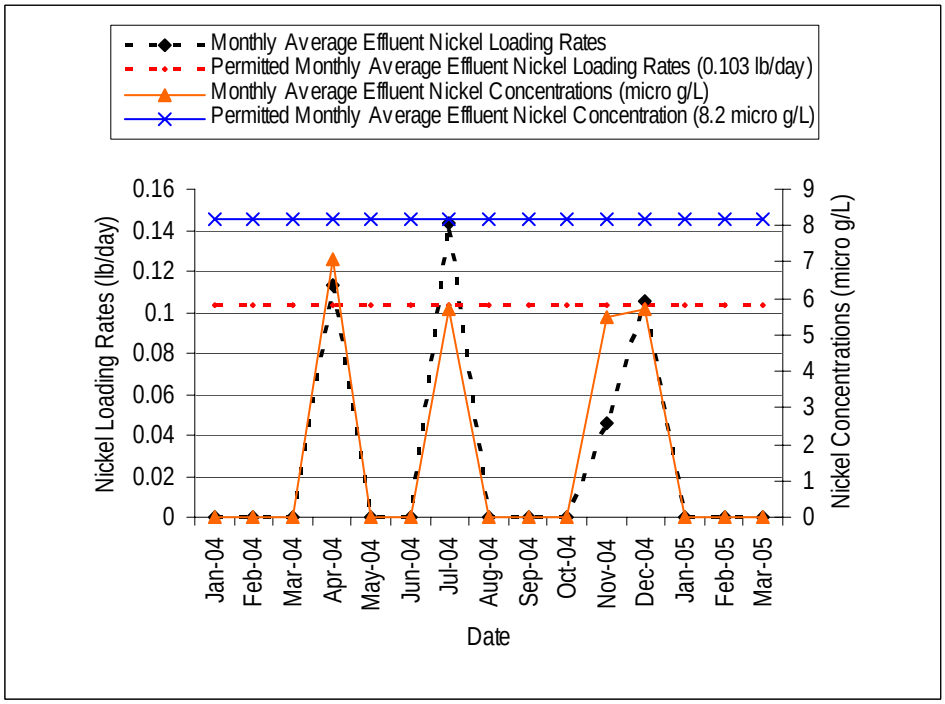
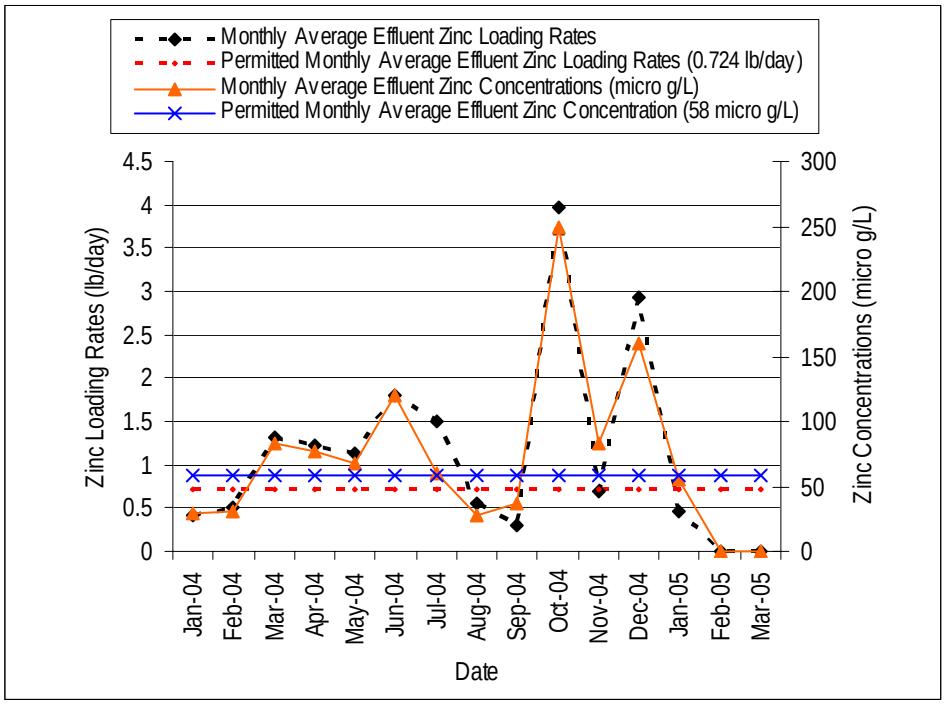
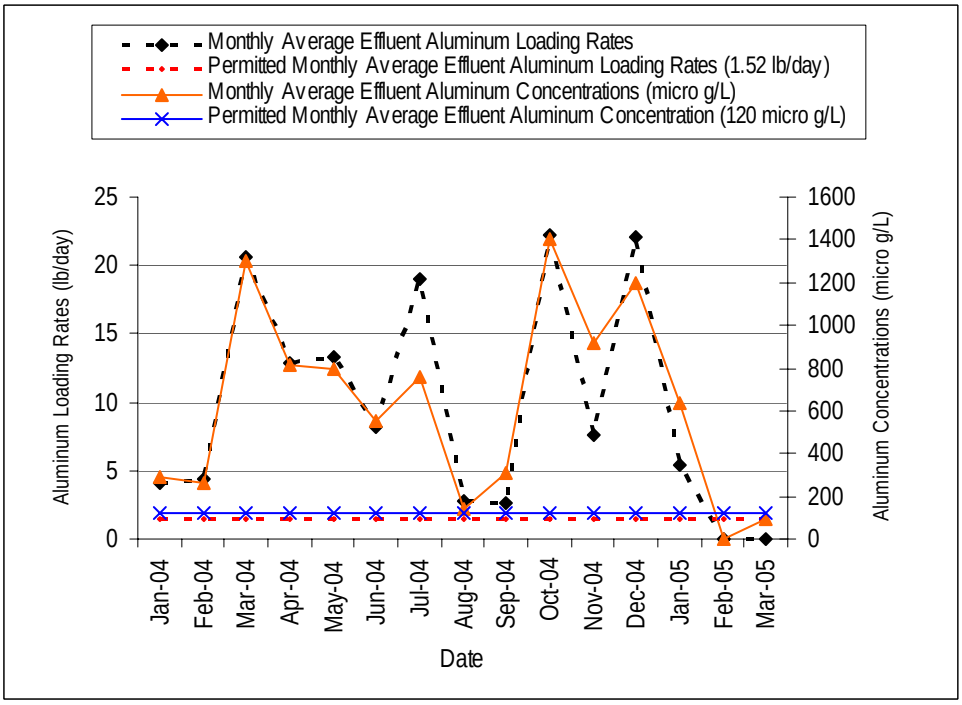
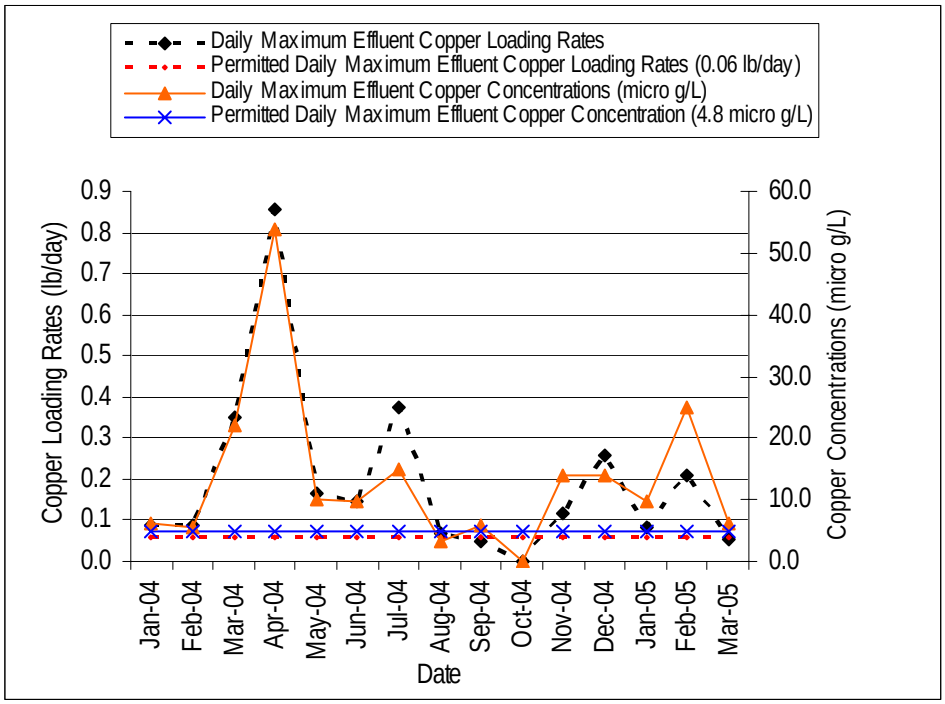
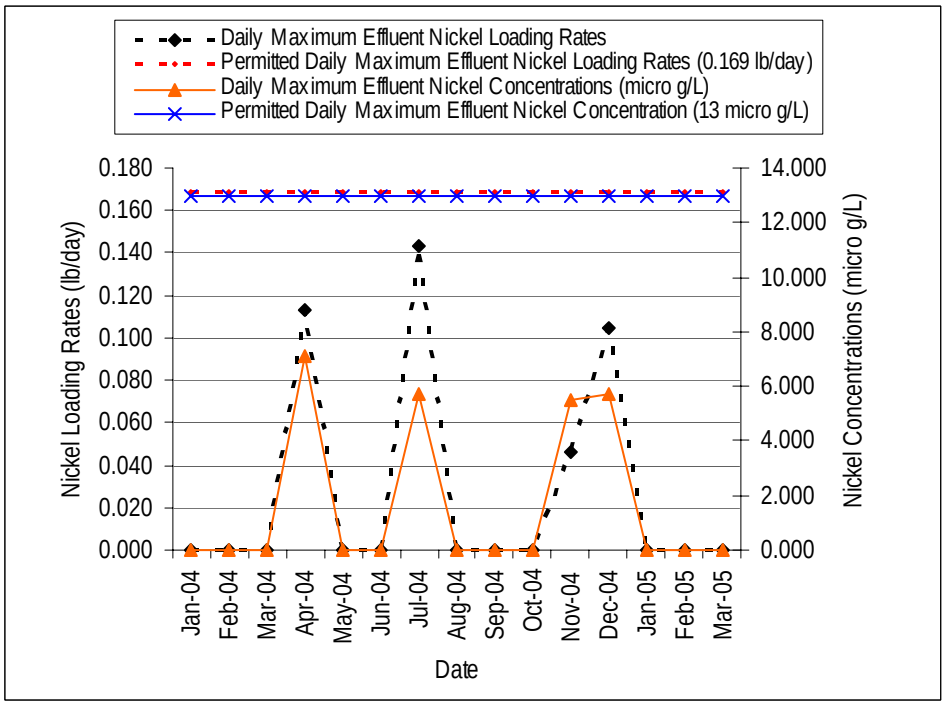
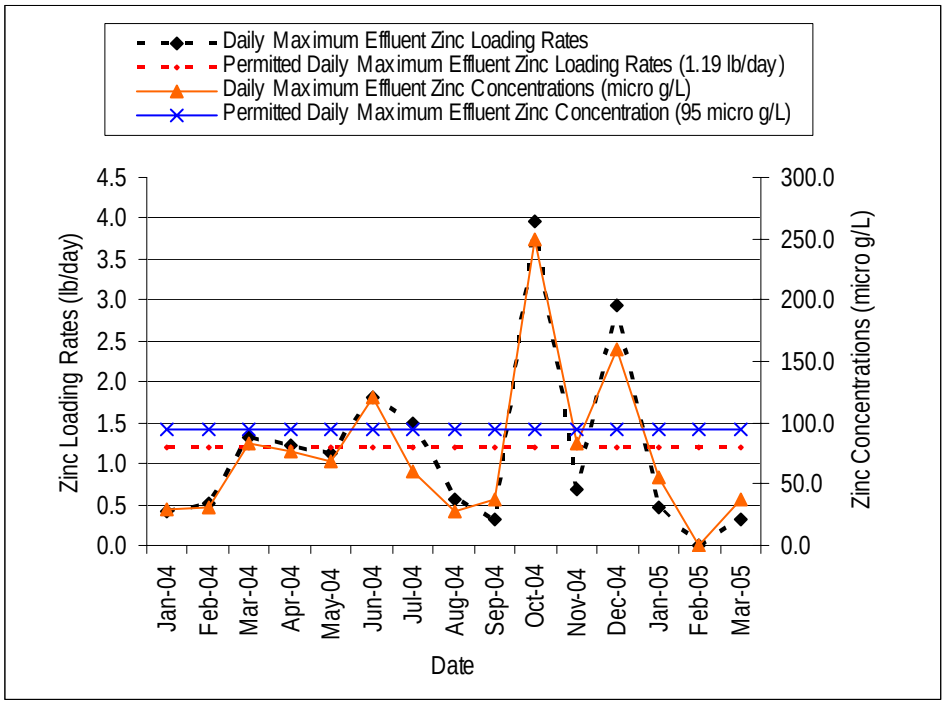
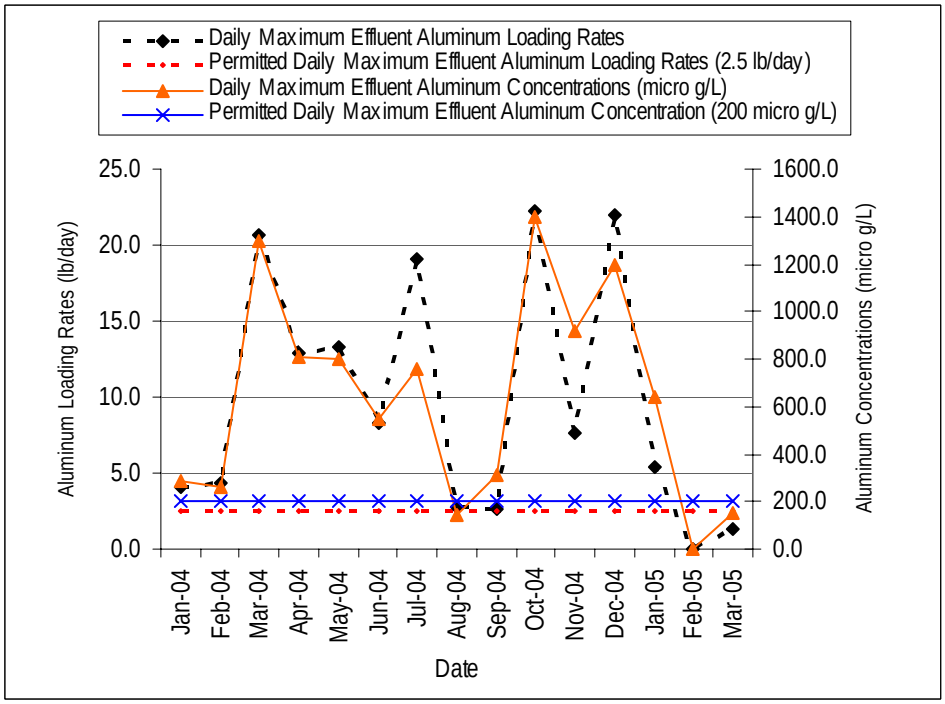
Based on the reported DMR flow data and the flow monitoring and modeling in Chapter 4 of this volume, the Agat-Santa Rita STP is currently receiving flows significantly greater than the original design capacity. This is one of the contributing issues that have caused the facility to fail to regularly meet NPDES effluent permit requirements.

The 2005 estimated flows (from Chapter 4 of this volume) exceed both the design capacity of the STP and the estimated capacity for the existing facilities (from Appendix 3B). The projected treatment capacity requirements for 2025 are even greater. The existing treatment facilities have not been able to produce effluent that complies with the existing NPDES permit requirements. This situation may be partially a result of the actual flows being greater than the treatment plant capacity and exacerbated by the poor condition of equipment, components, and facilities, creating operational challenges for the aging facility. The general lack of redundancy also makes it difficult to perform proper maintenance and timely repairs, and increases reliability risks. In addition, the operating staff lacked training and experience with the activated sludge process. Because of the insufficient capacity of the existing facility, inability to meet NPDES permit requirements, poor condition of the equipment and facilities, and aging of the existing facilities, we recommend that GWA consider a new facility in order to meet the capacity demand of current flows as well as provide for the future flows. Key improvements to provide redundancy and ease of operation and maintenance are critical to meet reliability concerns.

A TFSC facility with sufficient capacity, redundancy, and reliability to treat the year 2025 flows is used for the CIP budget model. Selection of this technology addresses tight site constraints and was also the favored option for the joint GWA-Navy facility. Figure 5-21 is a schematic flow diagram of the model replacement facility for the Agat-Santa Rita STP. In addition to new preliminary processes (headworks), both primary and secondary treatment processes and disinfection will be required to meet NPDES permit requirements. Chlorination and dechlorination facilities are included in the CIP budget estimate to meet the bacterial limits. Solids treatment is assumed to be provided at a central facility, although the existing process tankage could be retrofitted to provide aerobic digestion and gravity thickening. An in-depth facility plan task is recommended to include disposal options necessary to meet the NPDES permit. If it is deemed necessary to add follow-on tertiary treatment, this should be defined in the facility plan.

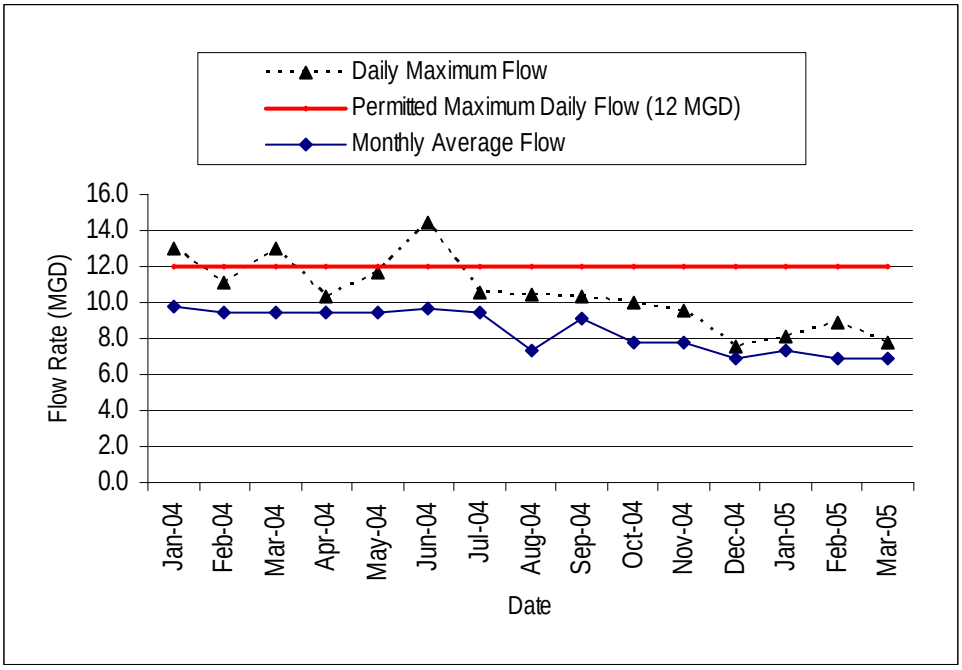
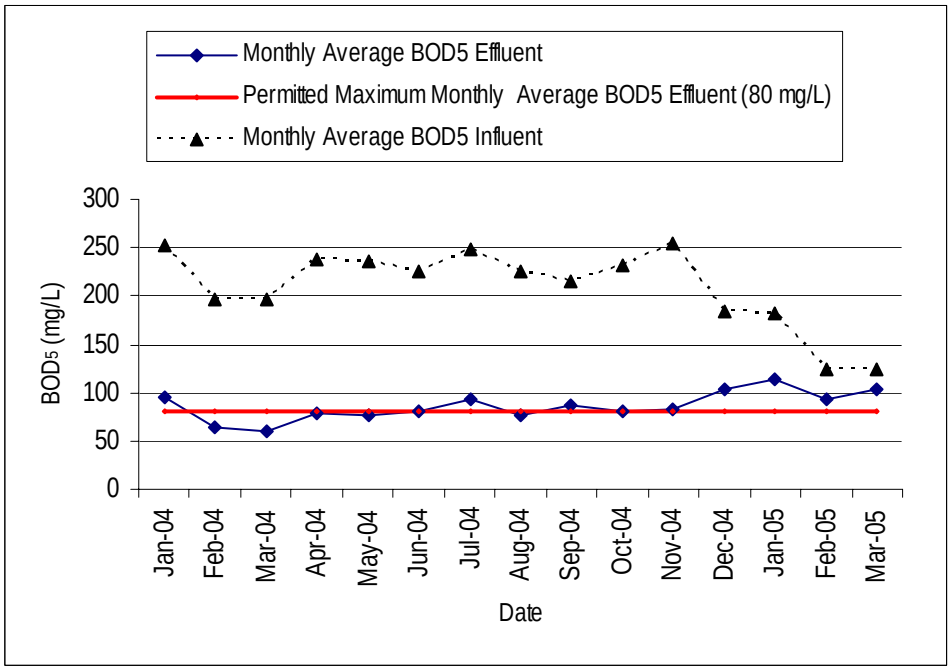
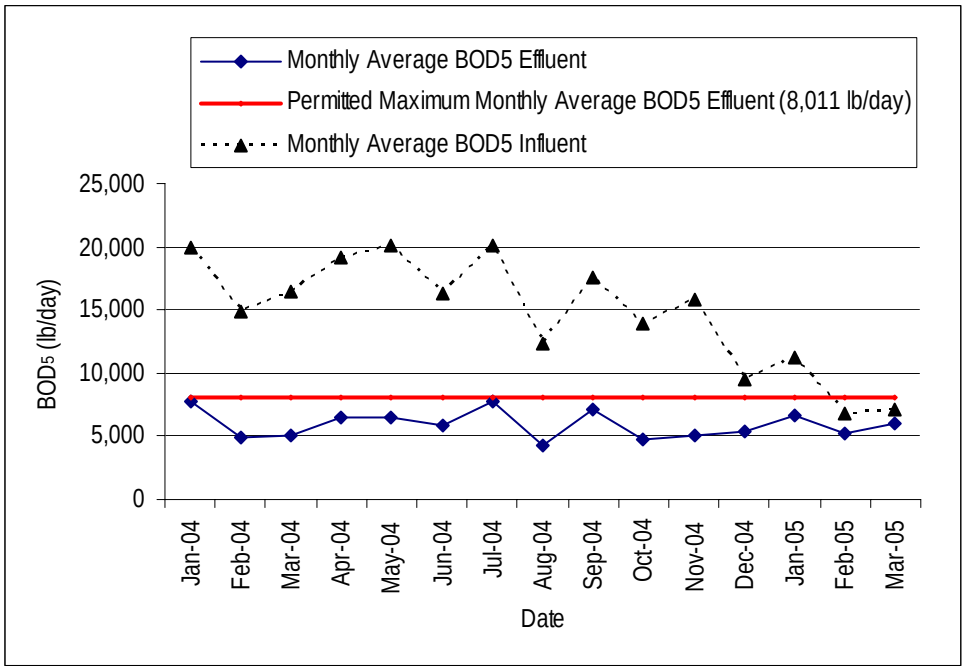
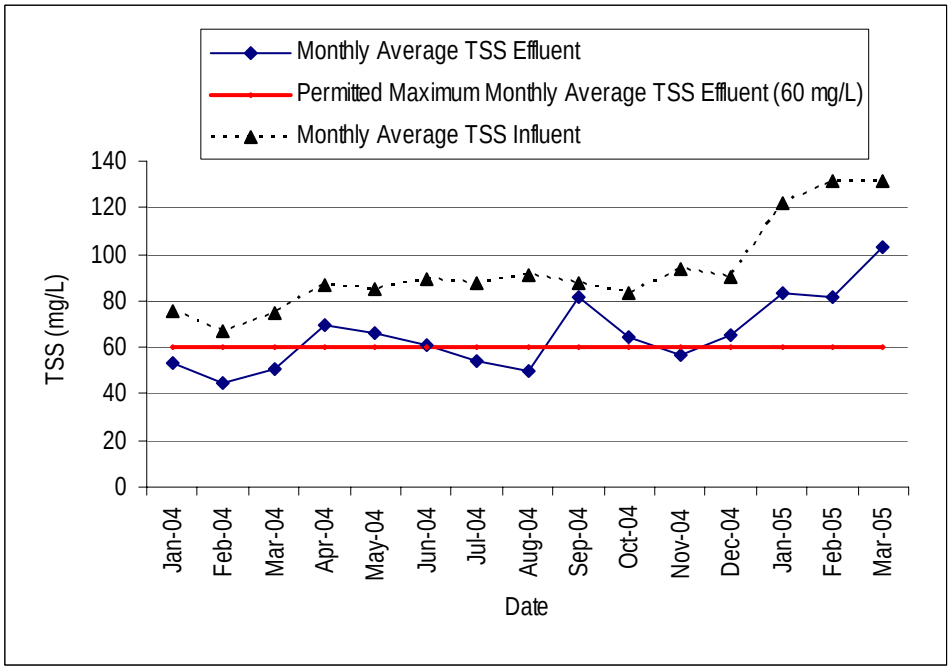
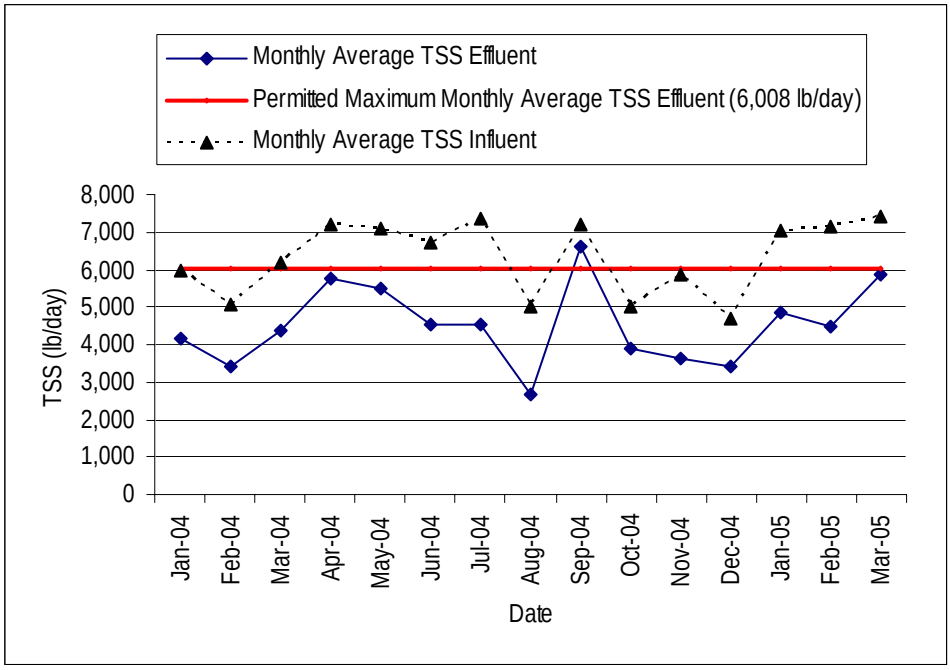
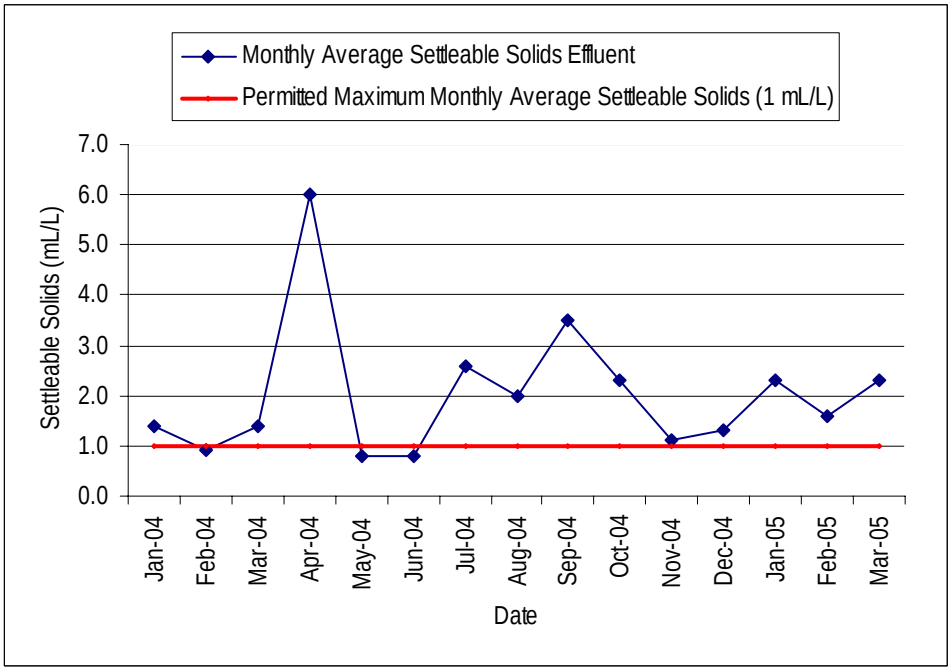
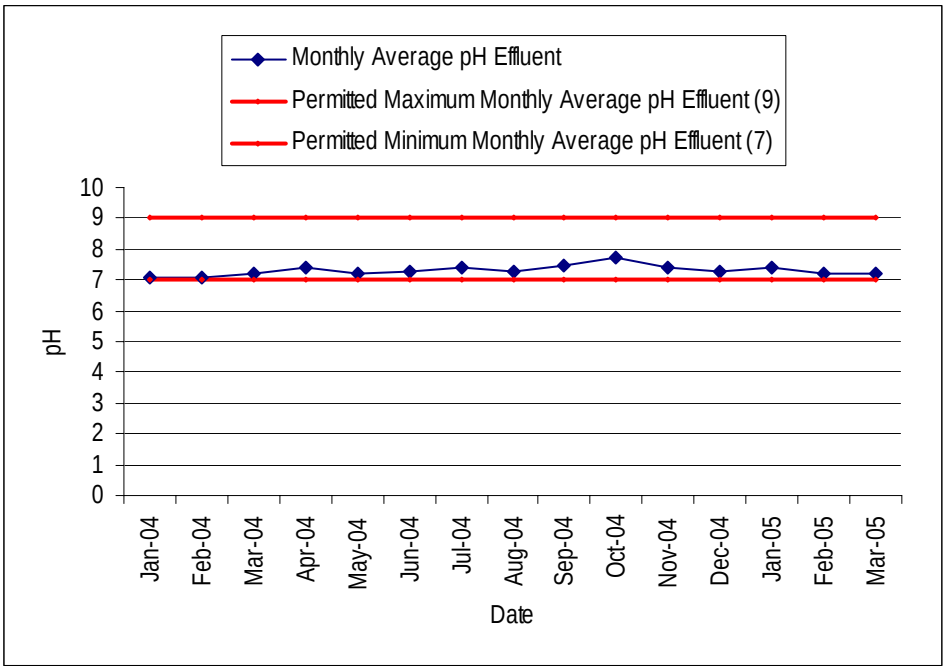
The monthly average and daily maximum DMR data reported during the January 2004 to March 2005 period are summarized in Table 5-7. Based on the DMR monthly averages, not all of the NPDES permit limits were achieved. Figure 5-23 shows a graph of influent flow rates at the Hagatna STP. Figures 5-24 and Figure 5-26 displays the monthly average effluent BOD_5 and TSS concentrations, respectively. Figure 5-25 is a graph of monthly average BOD_5 mass loading rates. Based on this information, the following is noted:

Table 5-5 indicates that current flows (from both the DMRs and the flow monitoring projections) and future projected flows are less than the capacity assessment. However, the DMR reports indicate that the effluent requirements were not always achieved, as shown in Figures 5-23 through 5-29.

The existing primary treatment process consists of three parallel primary clarifiers, each designed to treat 4 mgd. In order to confirm the actual capacity of the primary system, stress testing is recommended. However, this testing can only be performed after the primary clarifier repair projects have been completed. Assuming that the design capacity for each primary clarifier is accurate, the facility capacity would be 8 mgd, if one of the primary clarifiers is considered a standby (redundancy) for reliability. The 8-mgd capacity is sufficient for the existing flows; however, it would be insufficient for future flow projections. One additional parallel PC would be required to provide reliable treatment for the 2025 flow projections, and it is included in the CIP recommendations.

The screenings facilities located at the Hagatna influent pumping station are no longer functional, so new facilities to provide screenings and also facilities for grit removal should be considered to remove these undesirable elements from the flow stream. Space is limited at the influent pumping station and the remote location is difficult for the plant staff to operate and maintain, so it is recommended that these facilities be located onsite at the treatment plant, as part of the influent structure.
