TRANSMITTAL
ASSESSMENT OF DAM SAFETY OF
COAL COMBUSTION SURFACE IMPOUNDMENTS
FIELD ASSESSMENT CHECKLISTS FOR
SITES 24 (MITCHELL) AND 30 (BRUCE MANSFIELD)

Site Name: Bruce Mansfield Power Station	Date: 09-01-2009
Unit Name: West High Dissolved Solids (HDS) Pond	Operator's Name: First Energy
Unit I.D.: NA	Hazard Potential Classification: High <input type="checkbox"/> Significant <input checked="" type="checkbox"/> Low <input type="checkbox"/>
Inspector's Name: John Osterle / Kevin Cass

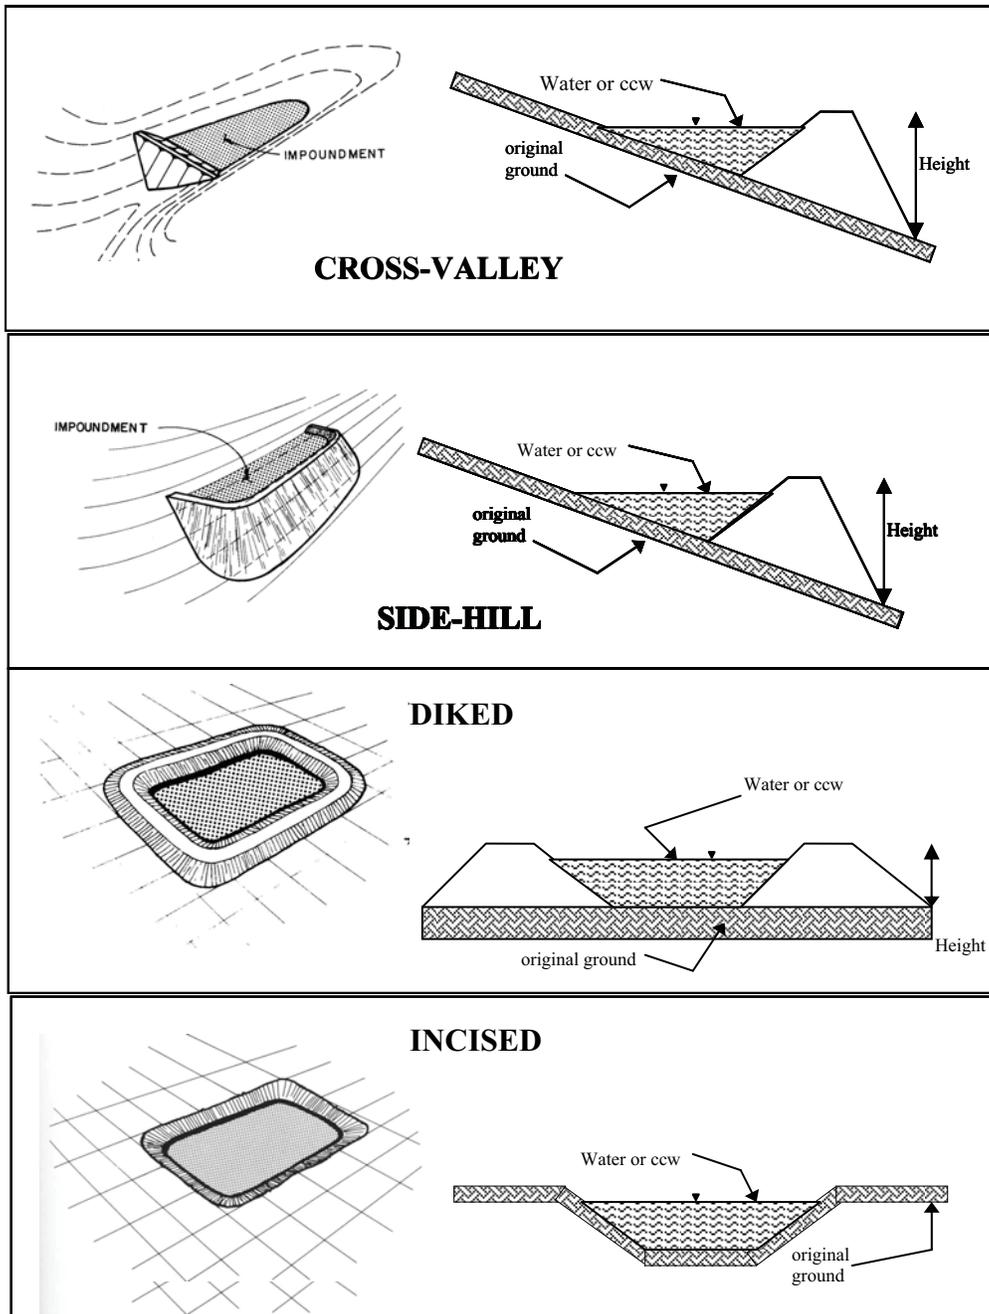
CONFIGURATION:

- Cross-Valley
- Side-Hill
- Diked
- Incised (form completion optional)
- Combination Incised/Diked

Embankment Height	<u>17</u>	feet	Embankment Material	<u>Soil with asphalt on crest and downstream slope</u>
Pool Area	<u>3.1</u>	acres	Liner	<u>Asphlat</u>
Current Freeboard	<u>2</u>	feet	Liner Permeability	<u>10⁻⁷ cm/s (estimated)</u>

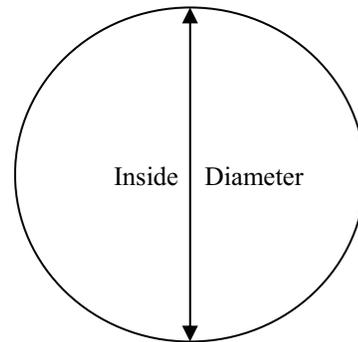
Material

- corrugated metal
- welded steel
- concrete
- plastic (hdpe, pvc, etc.)
- other (specify) _____

Is water flowing through the outlet? YES _____ NO _____

No Outlet

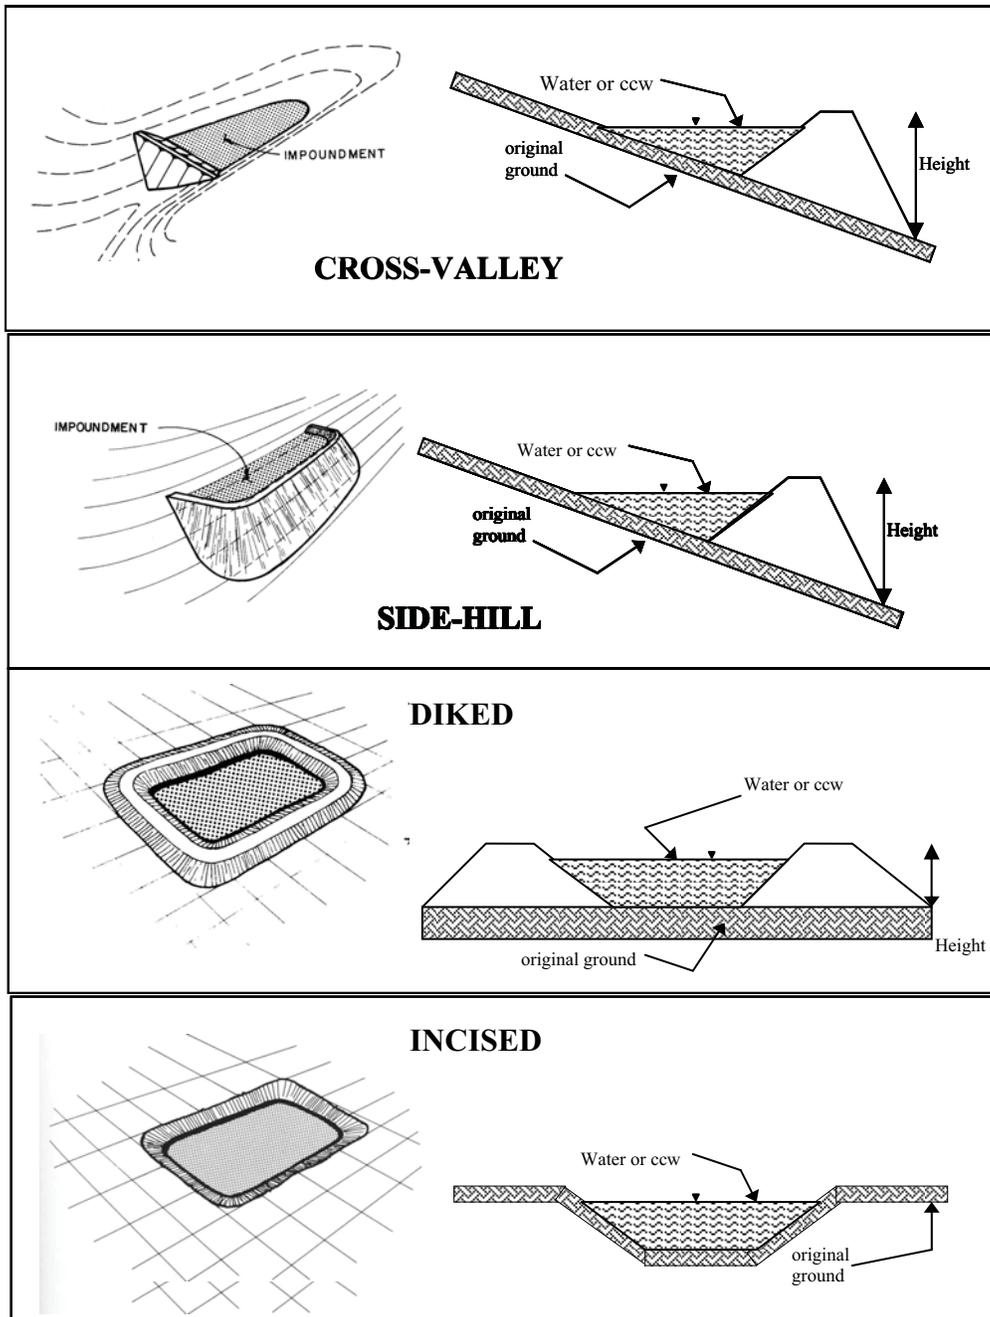
CONFIGURATION:

Cross-Valley
 Side-Hill *The South end of the impoundment is a concrete wall.
 Diked
 Incised (form completion optional)
 Combination Incised/Diked

Embankment Height 27 (max) feet Embankment Material Soil with asphalt on crest and downstream slope
 Pool Area 2.9 acres Liner Asphlat
 Current Freeboard 4± feet Liner Permeability 10⁻⁷ cm/s (estimated)

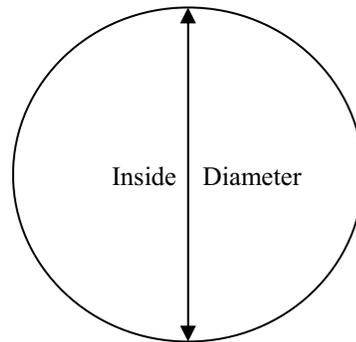
Material

- corrugated metal
- welded steel
- concrete
- plastic (hdpe, pvc, etc.)
- other (specify) _____

Is water flowing through the outlet? YES _____ NO _____

X **No Outlet**

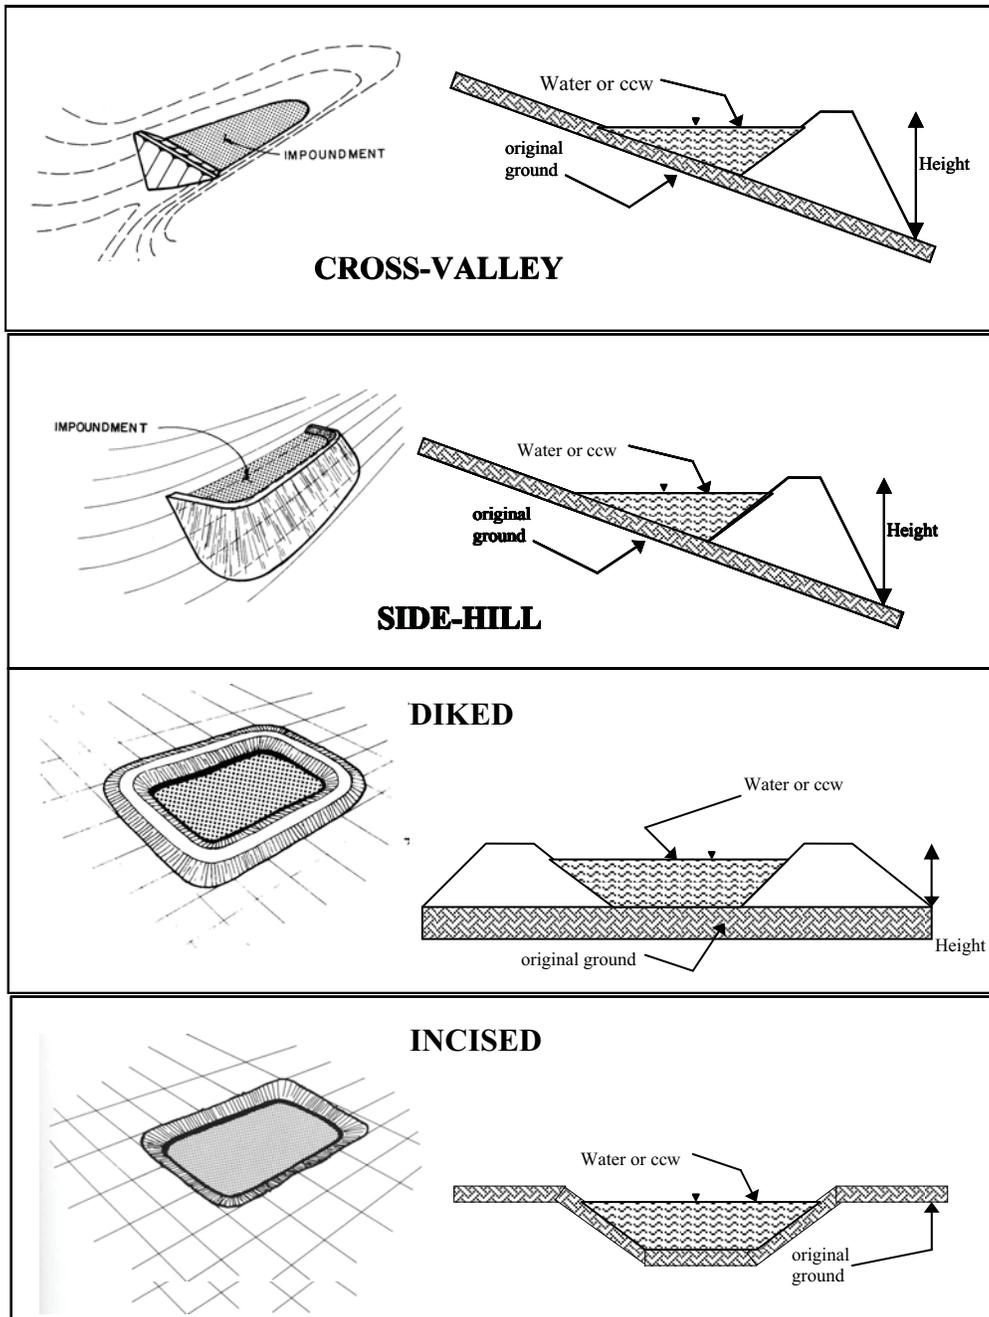
CONFIGURATION:

Cross-Valley
 Side-Hill
 Diked
 Incised (form completion optional)
 Combination Incised/Diked

Embankment Height 32 (max) feet Embankment Material Soil with asphalt on crest and downstream slope
 Pool Area 3.2 acres Liner Asphlat
 Current Freeboard 16 feet Liner Permeability 10⁻⁷ cm/s (estimated)
