CHAPTER 5 - WASTEWATER TREATMENT FACILITIES

5.1 Introduction

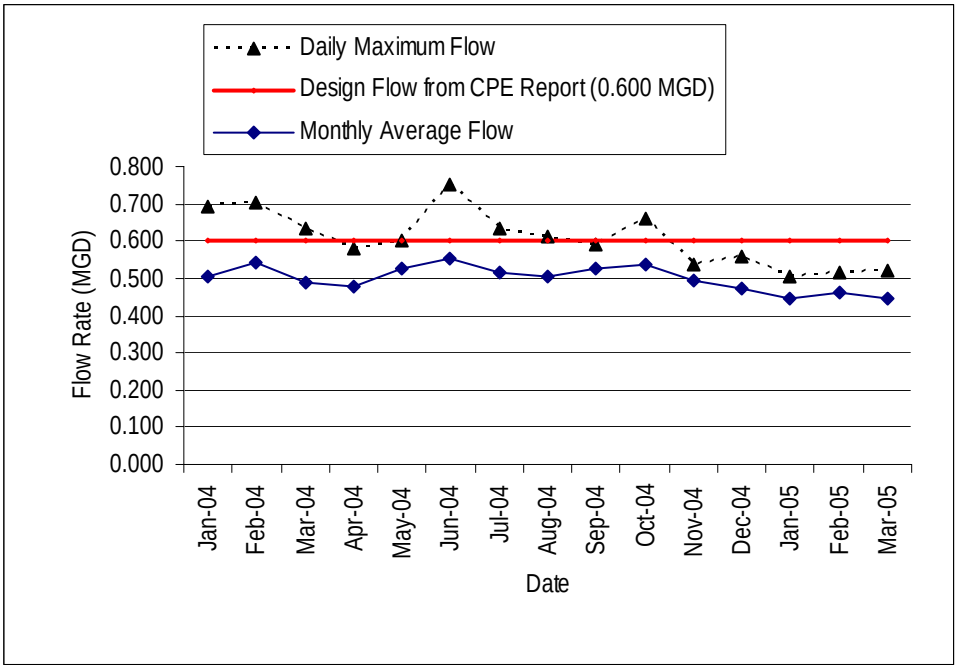
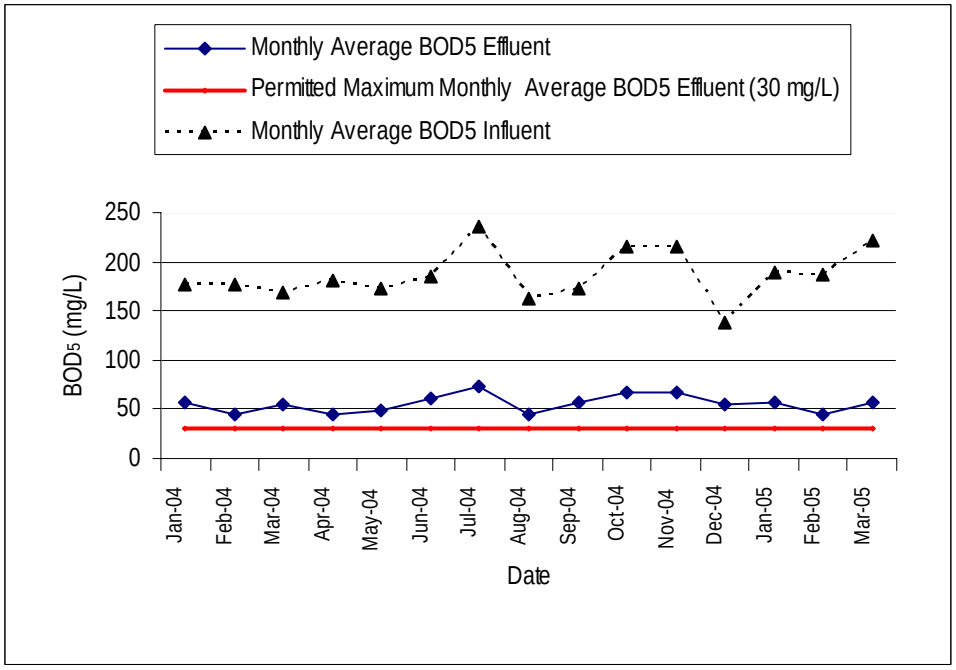
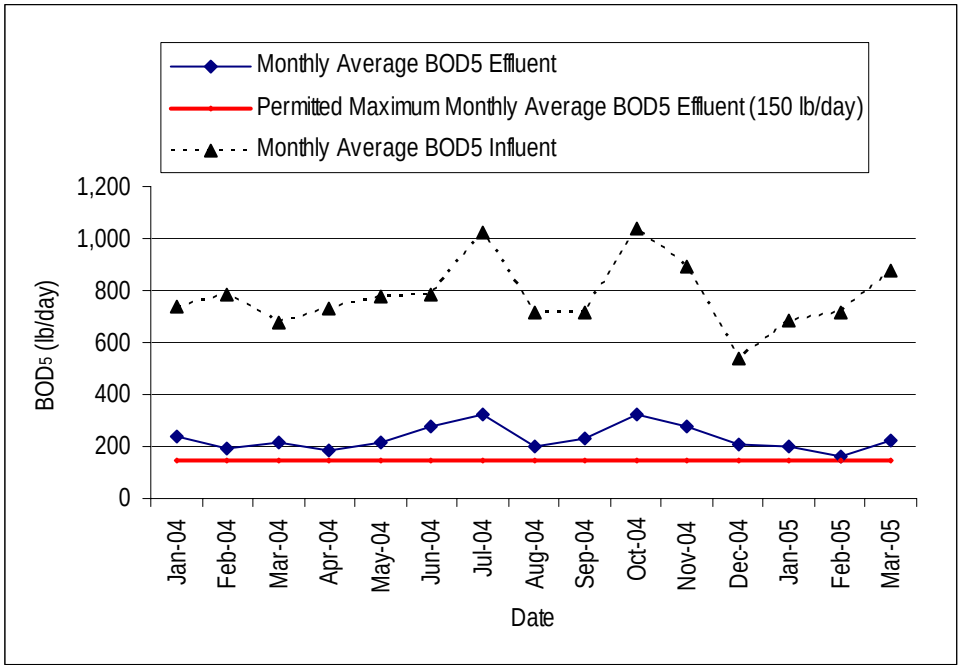
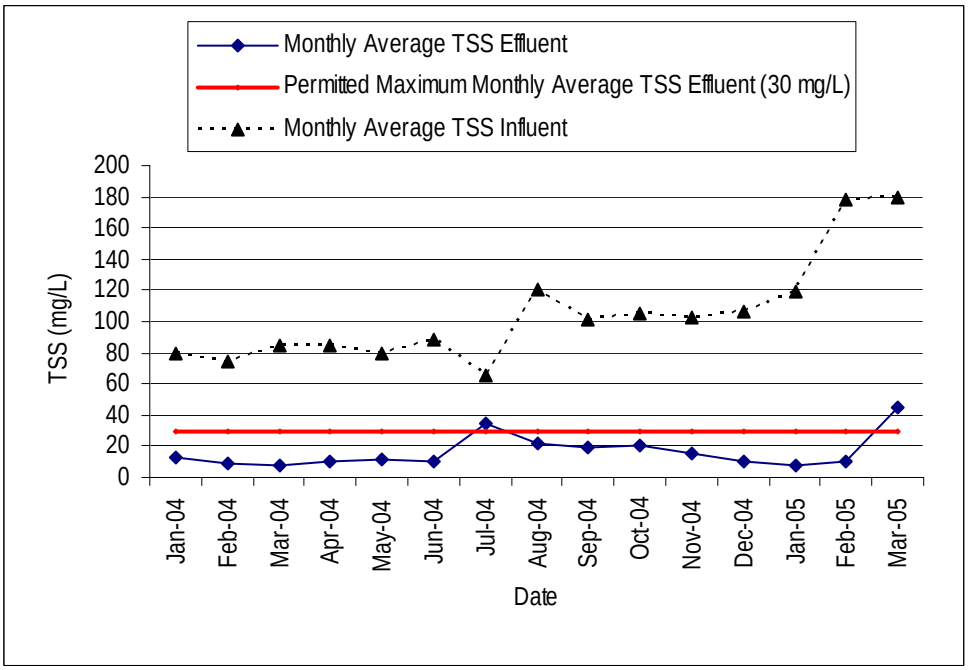
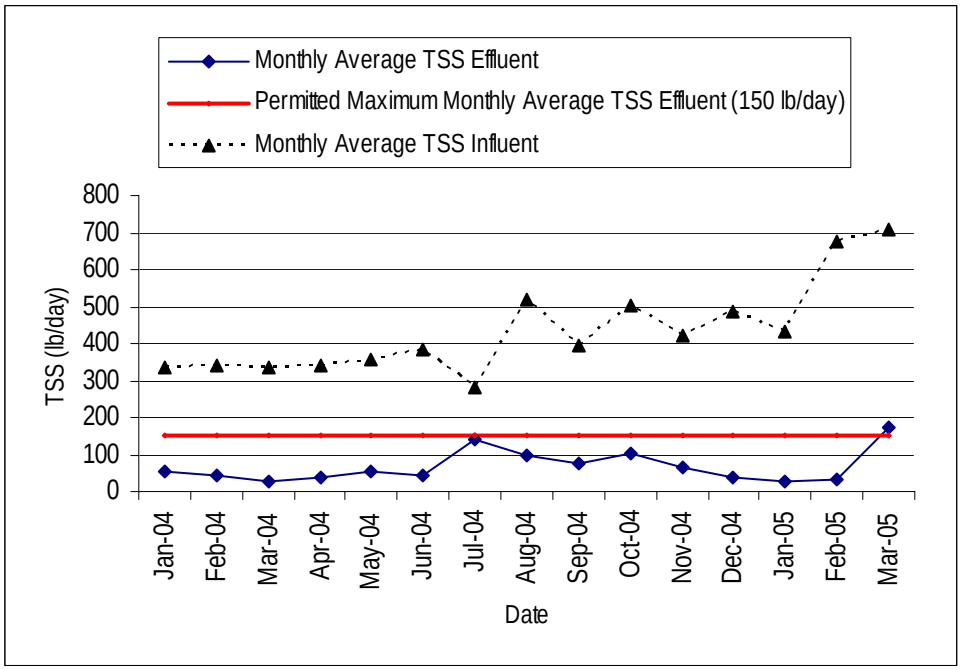
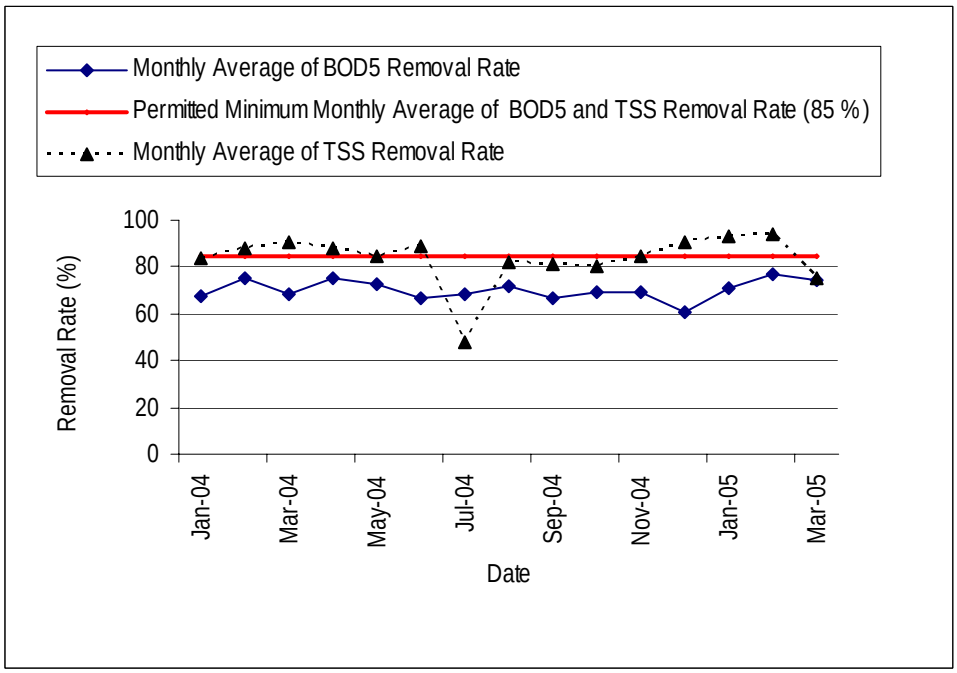
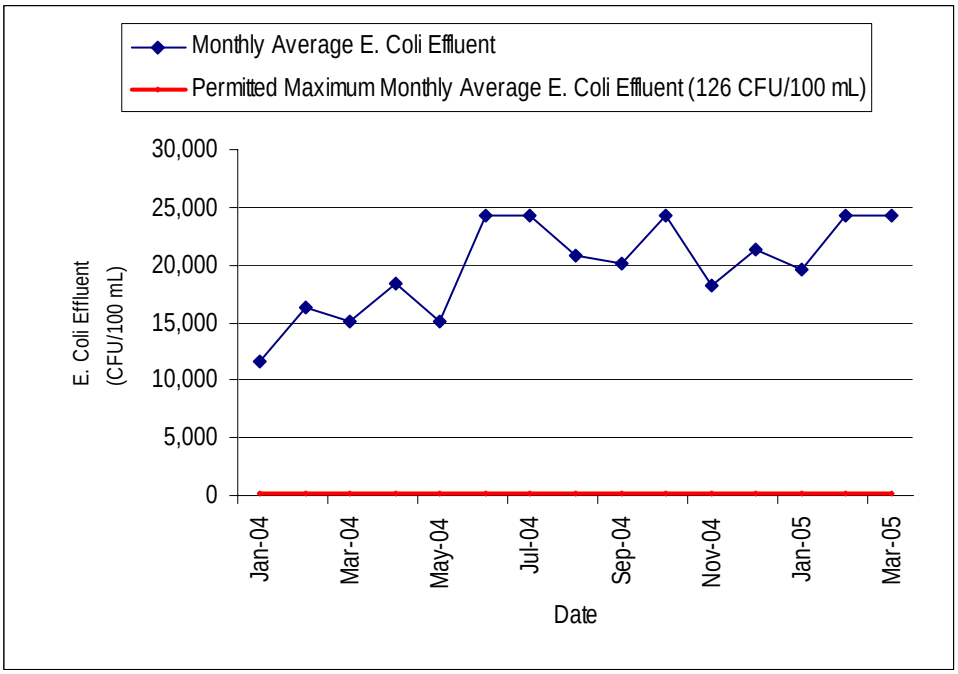
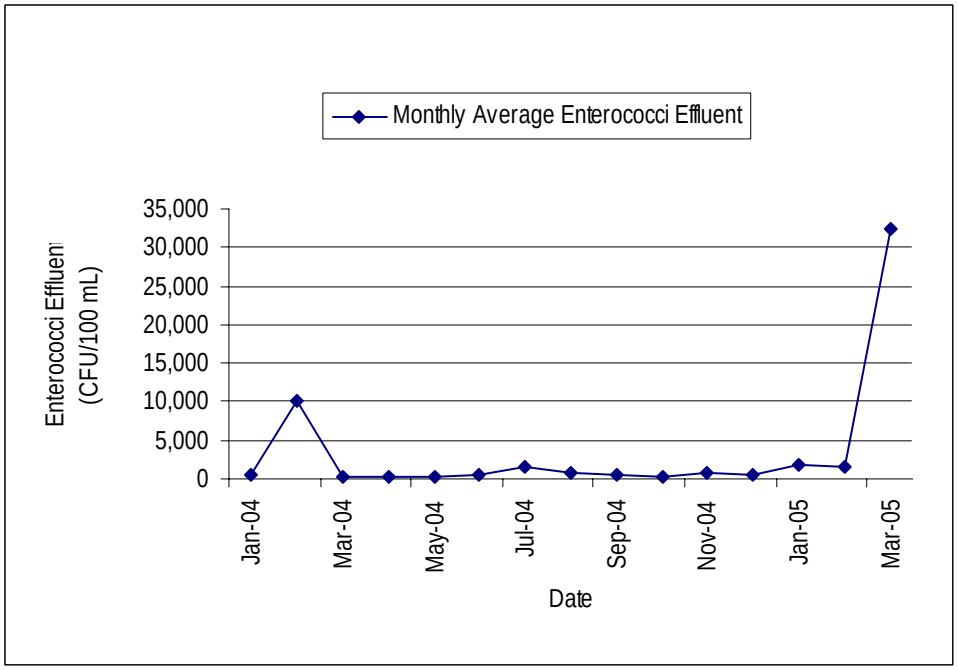
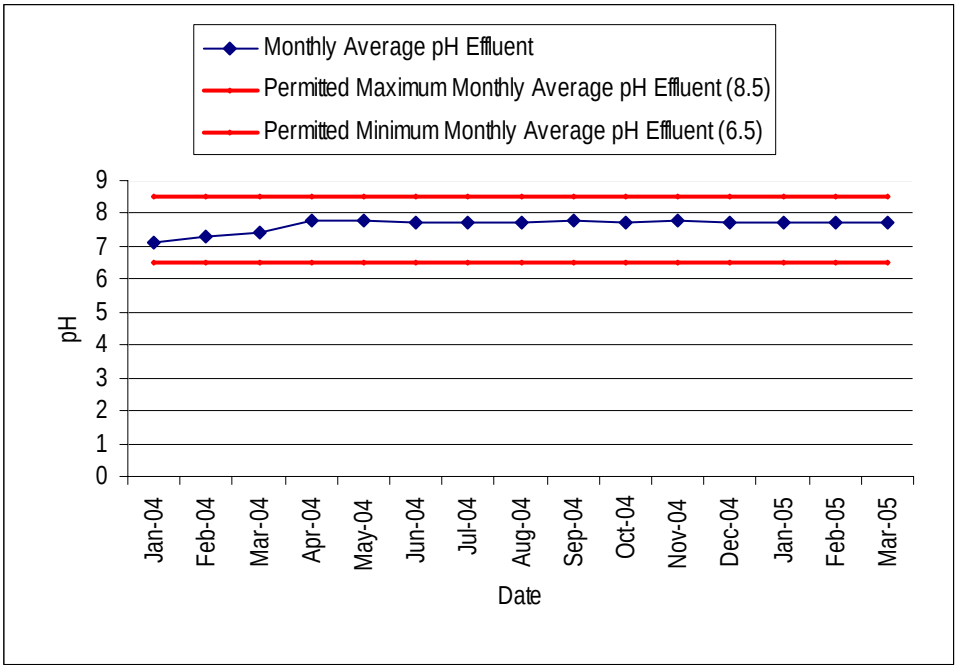
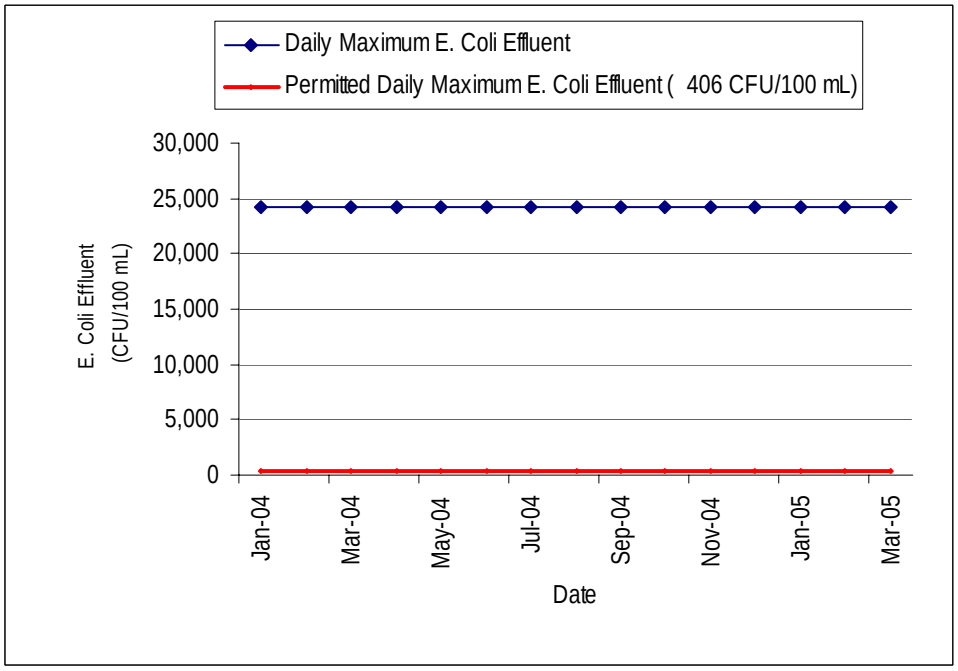
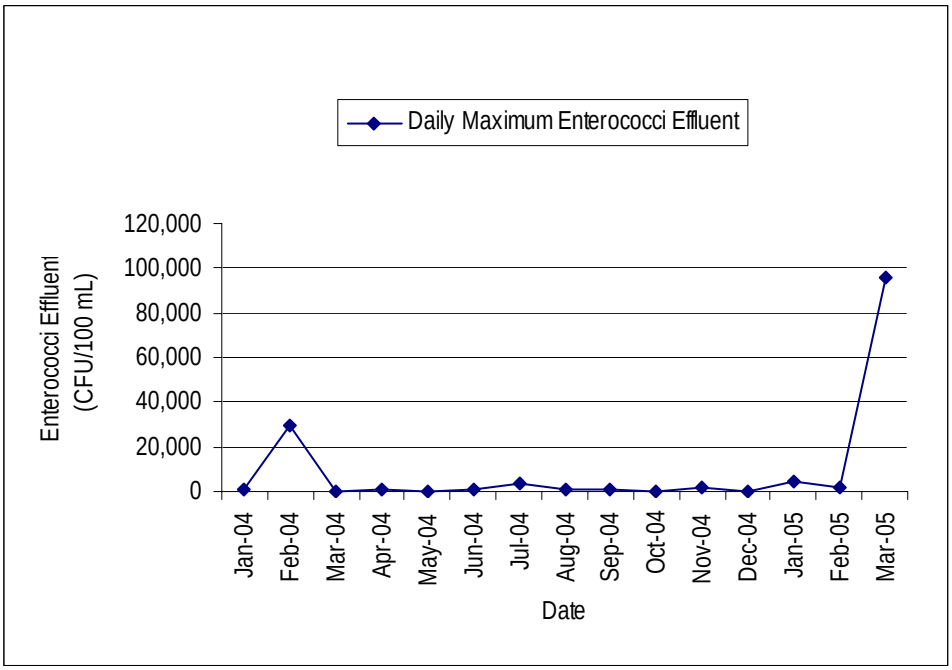
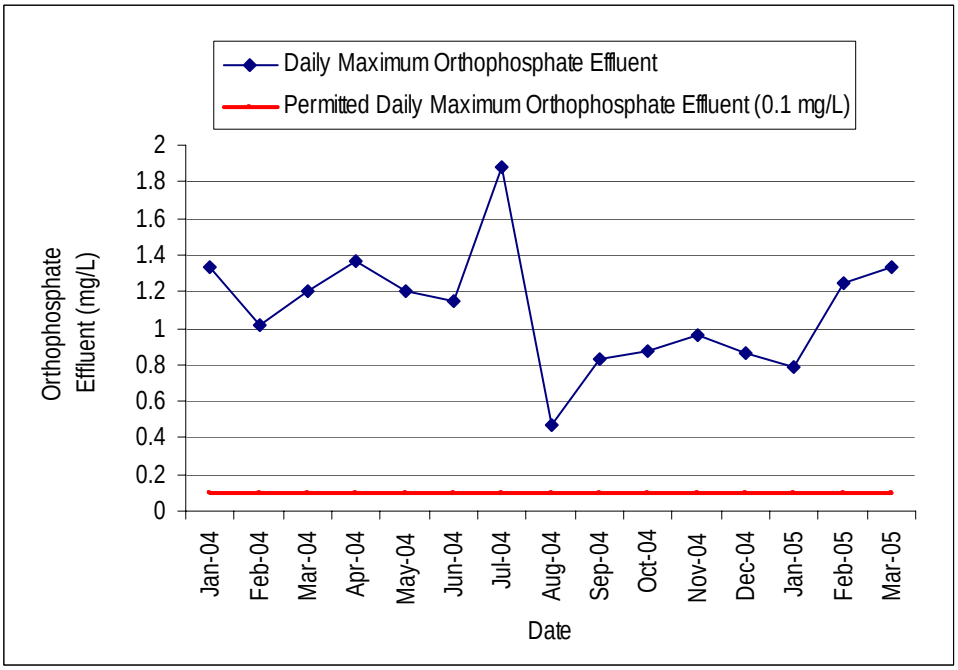
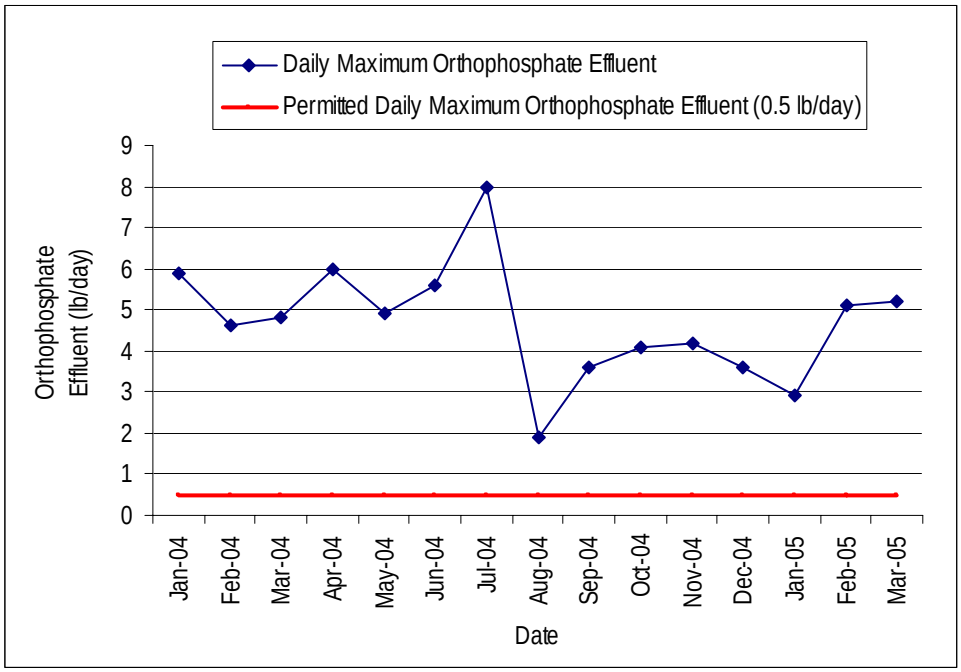
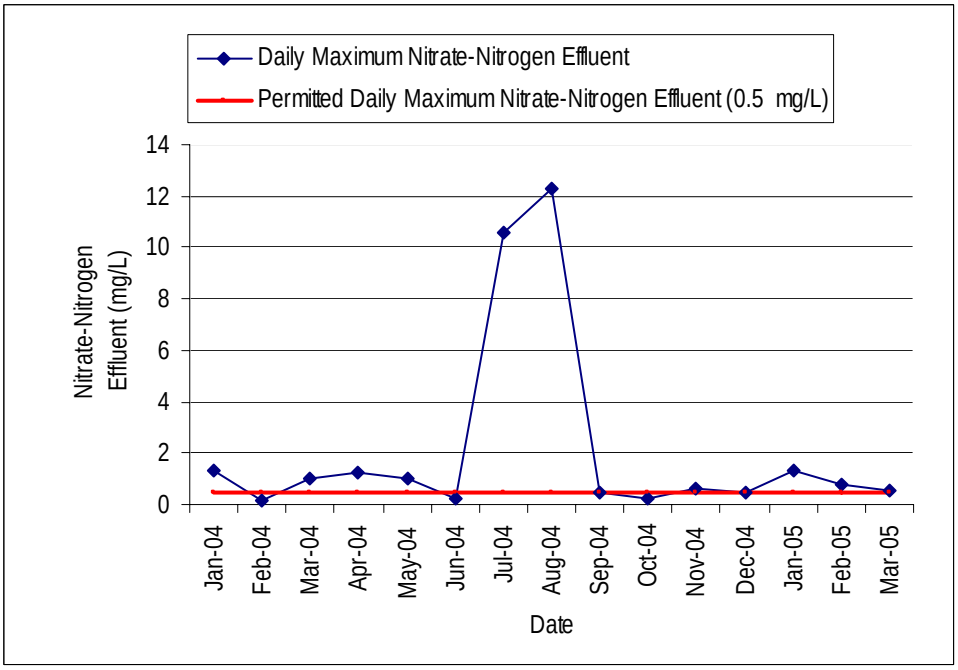
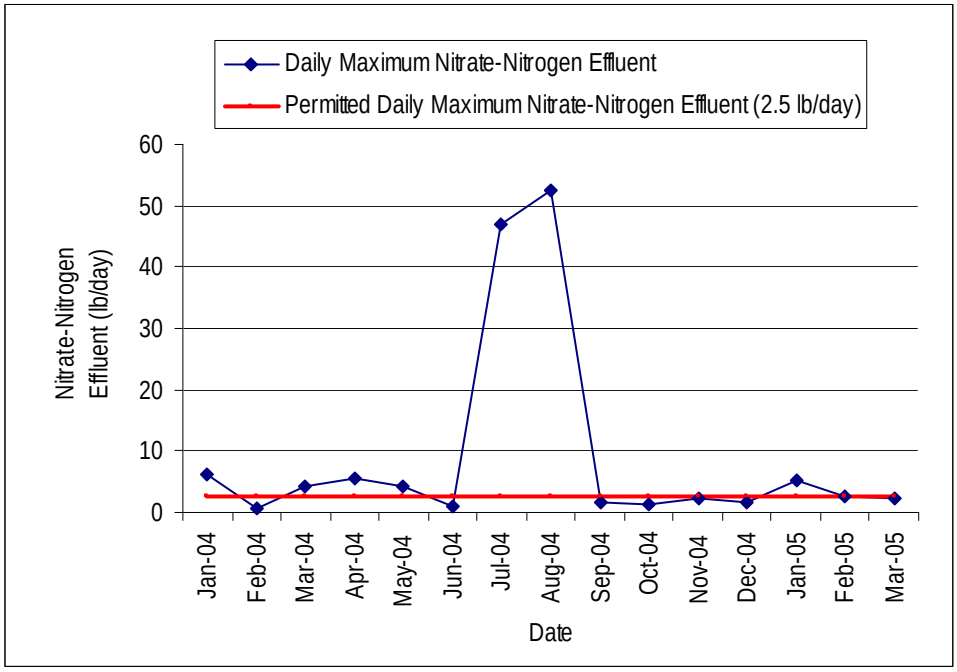
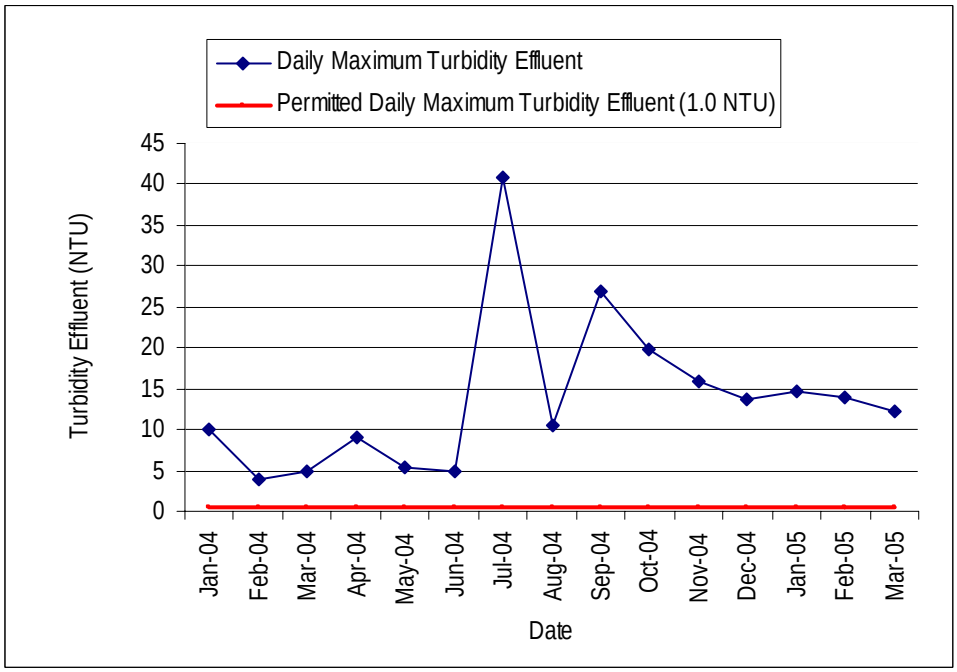
During the period of January 2004 to March 2005, the monthly average parameters for the Baza Gardens STP effluent generally did not meet the NPDES permit requirements (NPDES Permit No.GU0020095). The monthly average BOD_5 concentrations, mass loading rates, and removal rates had 100% noncompliance during the period of consideration. Compliance for TSS maximum monthly average effluent parameters ranged from 7 to 47% during the observed period. The daily maximum and monthly average E. coli effluent concentrations were out of compliance with the permit limits 100% of the time (due to the fact that disinfection is not currently performed). Although there are maximum limits for weekly average parameters in the NPDES permit, weekly information was not reported on the DMRs so the data were not available. Similar to the Agat-Santa Rita STP, no total chlorine residual data were reported by GWA because the disinfection system was not operated. Therefore, the total chlorine residual did not exceed the maximum average monthly and maximum daily limits.

The design capacity of the Baza Gardens STP is 600,000 gpd without redundancy or standby facilities, and it is currently processing roughly 250,000 gpd (Table 5-5); however, this facility has not been able to reliably achieve effluent quality within the NPDES permit requirements. The treatment process has usually been able to meet effluent TSS concentration limits; however, it has regularly failed to meet BOD requirements and is not capable of achieving the strict nutrient (phosphorus and nitrogen) limits. Alternative or additional treatment processes designed to reliably meet the low nutrient limits would be an operations and maintenance challenge and would require significant operator skills and knowledge.

One of the primary goals of the recommended facility plan should be to evaluate alternative disposal methods to eliminate the stream discharge as a primary disposal method since the low nutrient limits in the existing NPDES permit are driven by the instream standards. However, the Togcha River could serve as the backup disposal method with an NPDES permit obtained strictly for occasional use (backup purpose).

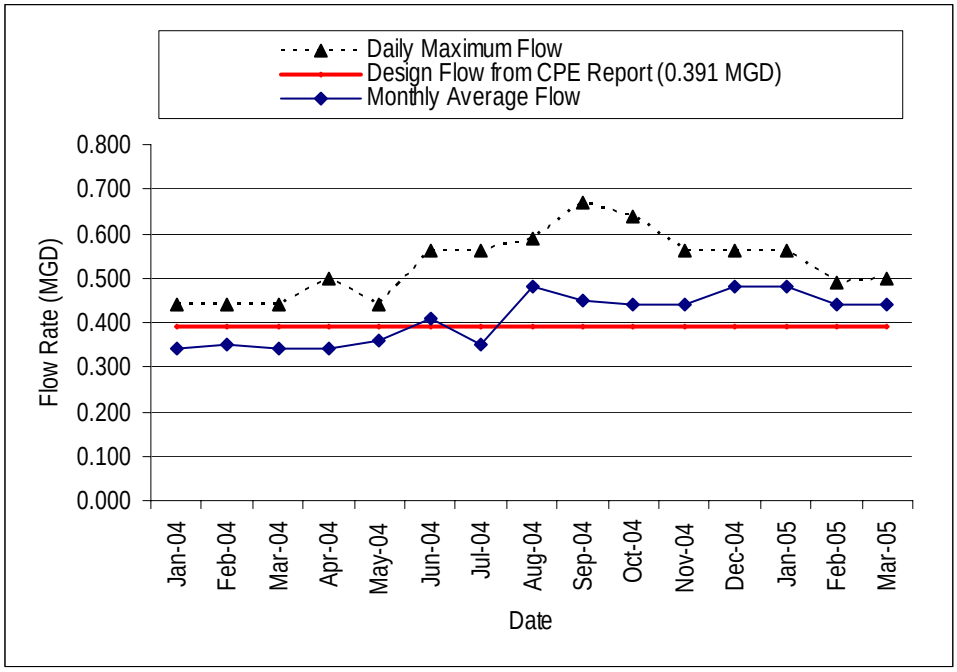
Figure 5-49 – Umatac-Merizo STP Influent Flow Rates

Table 5-11 summarizes basic parameters required by the NPDES permit; including flow rate, BOD_5, TSS, E.coli, enterococci, and pH from January 2004 to March 2005 (limited data were available between October 2004 and December 2004). The data were obtained from the DMRs that are submitted to GEPA quarterly. Figure 5-49 indicates that the monthly average

Table 5-5 suggests that the actual flows for the Umatac-Merizo STP (based on the WRMP flow monitoring and modeling) are much less than would be expected from the DMR reports (roughly half), and within the design capacity of the lagoon treatment system. Therefore, the actual mass loading rates may be less than the rates calculated by the flows in the DMR reports. Effluent characterization is necessary to determine the treatment capacity of the existing lagoon system.

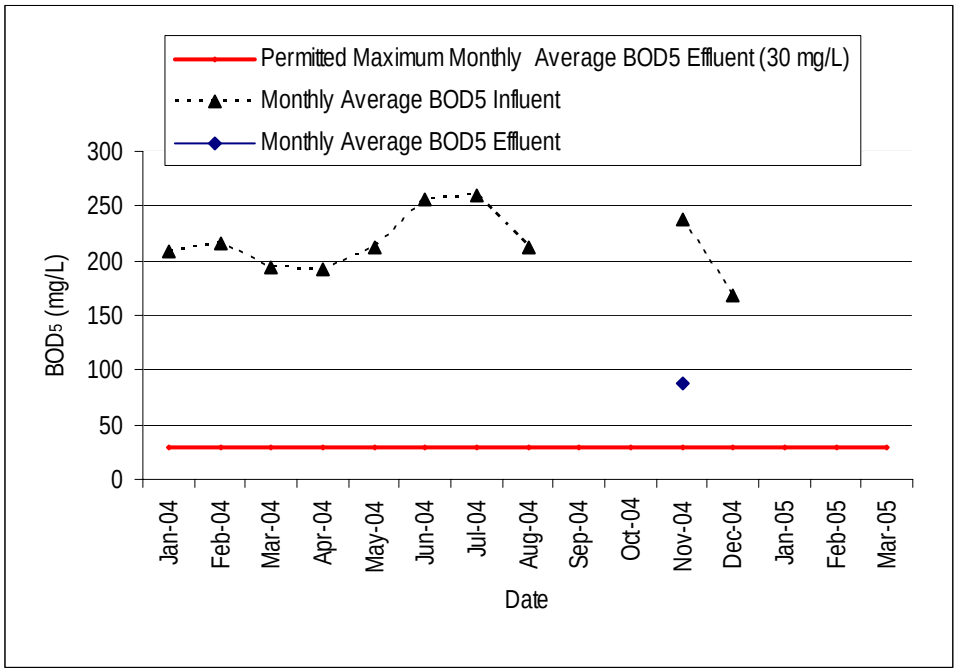
Figure 5-50 – Umatac-Merizo STP Monthly Average Influent BOD_5 Concentrations

The monthly average and daily maximum influent BOD_5 concentrations range from 168 to 259 mg/L and 169 to 359 mg/L, respectively. Figure 5-50 shows the reported monthly average BOD_5 influent concentrations plotted with the permitted monthly average BOD_5 effluent concentration. This concentration is roughly 216 mg/L, which is within the range of typical BOD_5 concentrations for domestic wastewater. The TSS influent concentrations reported were low for domestic wastewater, in the range of 44 to 101 mg/L for the monthly average, and 74 to 420 mg/L for the daily maximum. The monthly average influent TSS concentration shown in Figure 5-52 is 69.9 mg/L, which would be characterized as a low TSS concentration for domestic wastewater. Low TSS values may be attributed to accumulation of solids in the facultative lagoon; however there are no data to support this assumption. The ranges of measured parameters are diagramed in Figures 5-51 through 5-53.

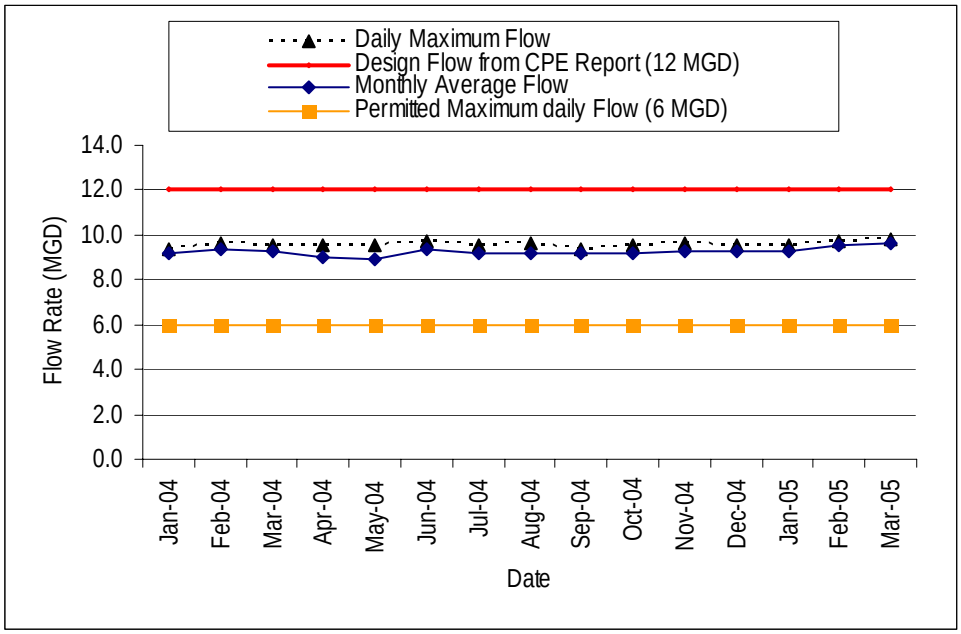
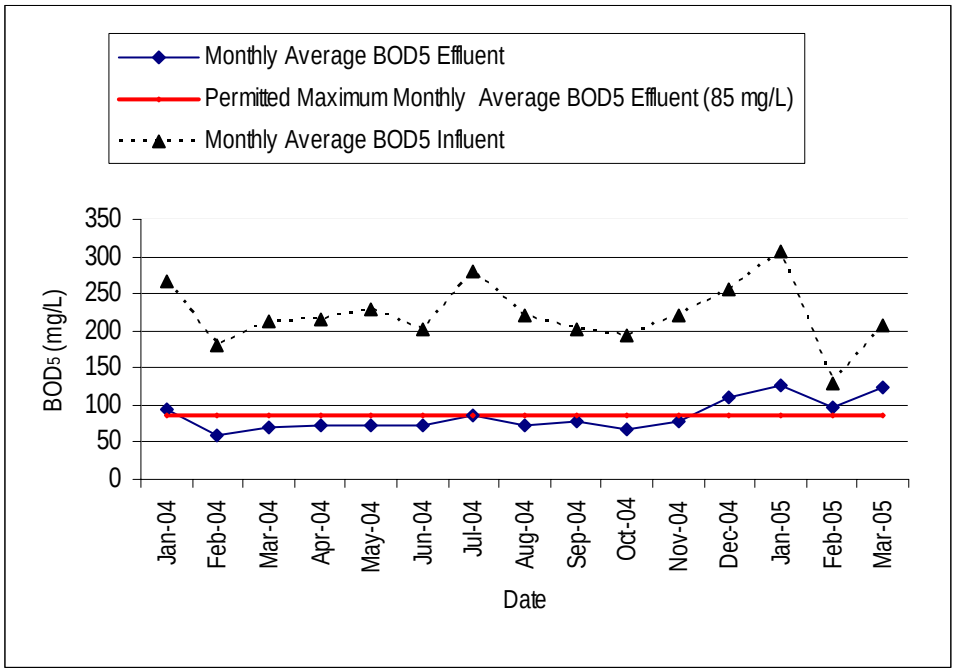
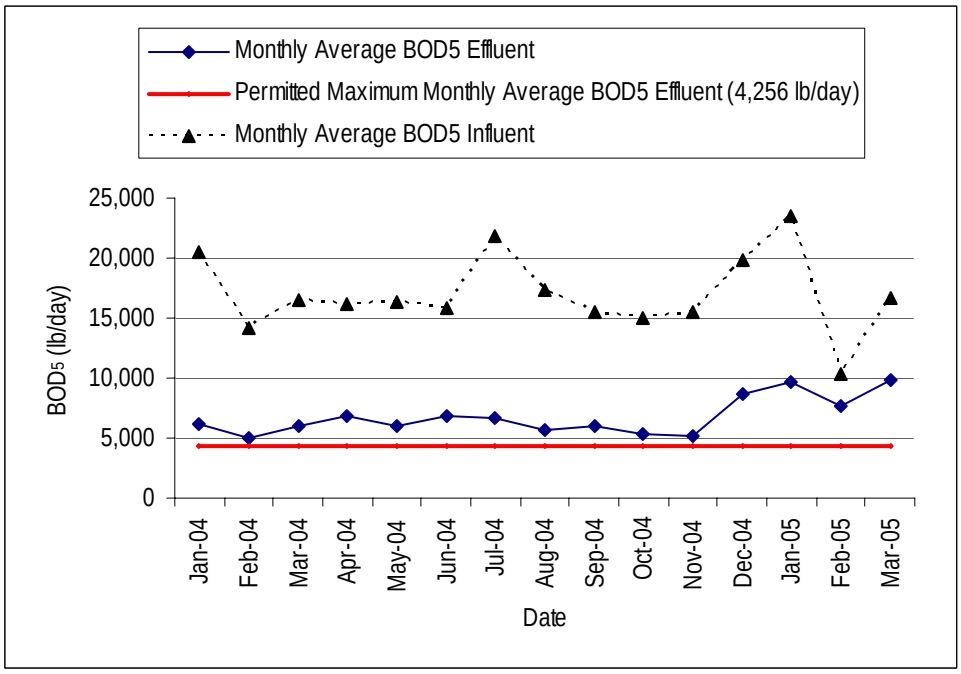
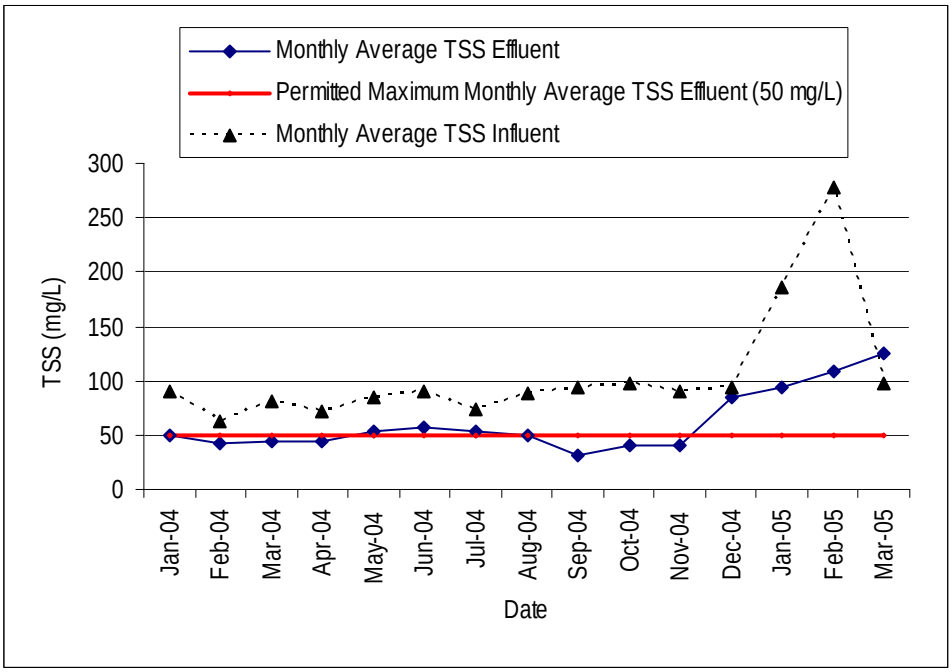
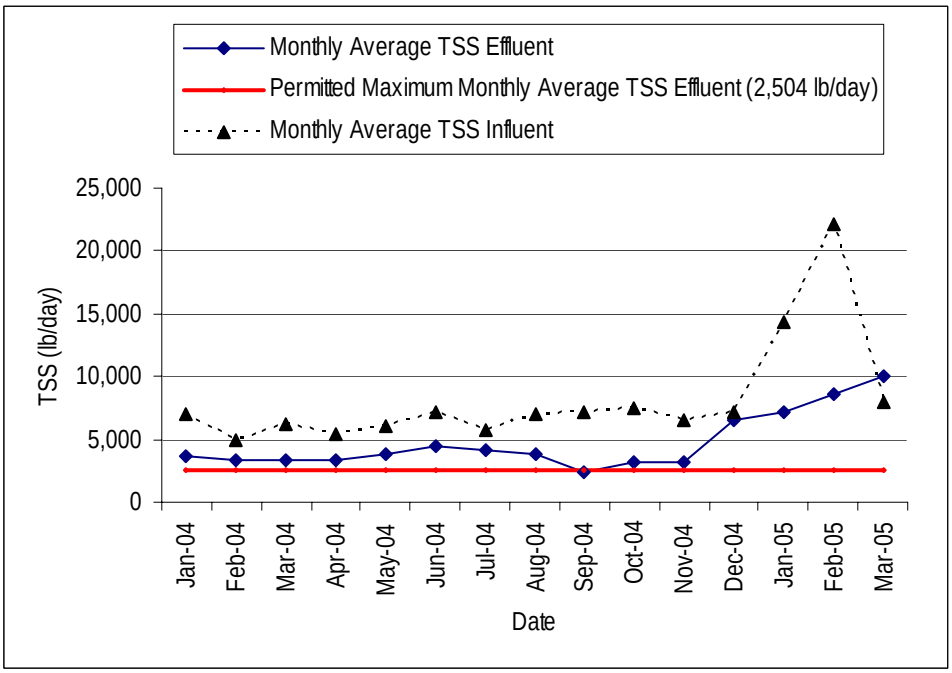
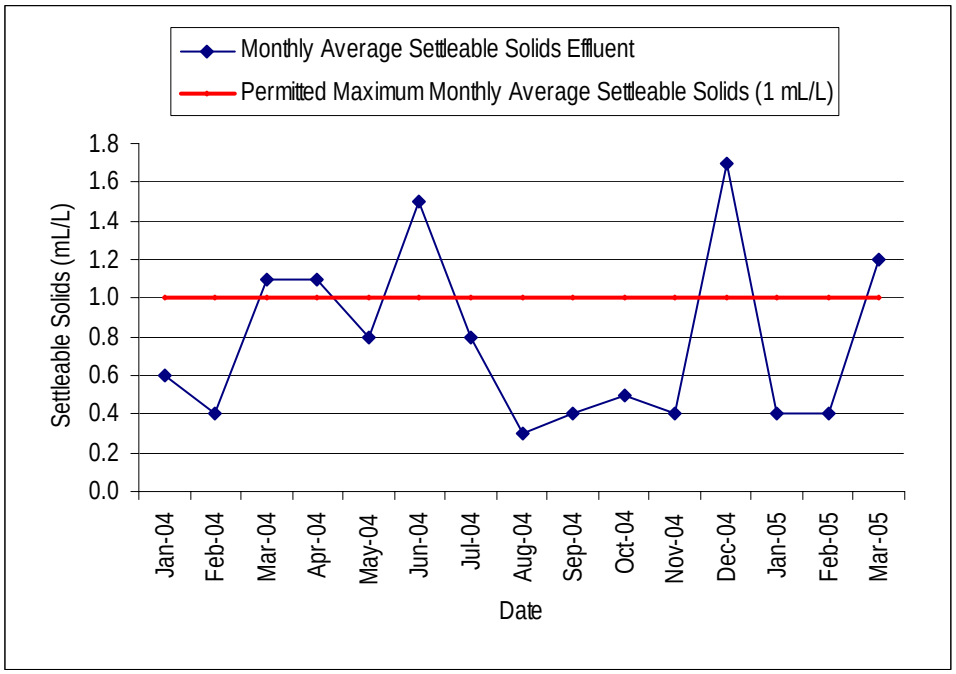
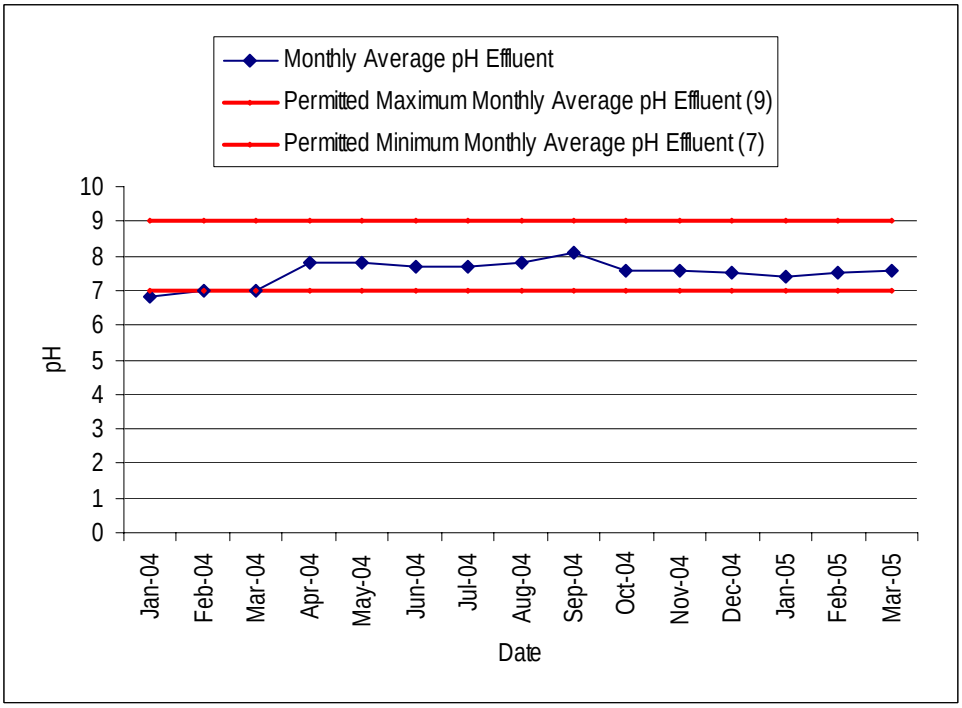
The monthly average and daily maximum reported flow rate, BOD_5, TSS, settleable solids, and pH are listed in Table 5-13. There is a discontinuity between the design-rated flow capacity of this plant (12 mgd) and the NPDES limits (6.0 mgd). The permit's mass emission rates are based on the 6 mgd flow, so many of these parameters exceeded the NPDES permit limits. This data was obtained from the January 2004 to March 2005 DMRs.

The averages of the monthly averages of BOD_5 and TSS effluent concentrations are calculated to be 85.6 mg/L and 61.2 mg/L, respectively. Both of these parameters exceed the permit limits. The removal rate based on the monthly average effluent BOD_5 ranges from 25.4 to 69.4% with an average of 60.3%. It was noted that one reported value (March 2005) for the monthly average effluent TSS removal rate has a negative value of -27.6%, as indicated in Table 5-13. This value may be a result of sampling error, laboratory error, or disturbance of accumulated settled solids in the system that was picked up in the effluent sample.

The design capacity of the NDSTP is 12.0 mgd, without any primary clarifier redundancy. If redundancy is considered, then the capacity is 6.0 mgd, since there are only two primary clarifiers. The current estimated flow is 7.8 mgd, and the projected year 2025 future flow is 11.9 mgd. Neither of these flows exceeds the original design capacity; however, both exceed the existing capacity if redundancy is considered. Therefore, it is recommended that at least one additional primary clarifier be added to the system so that both current and future flows can be reliably treated even when one primary clarifier is taken off-line for maintenance, repairs, or other reasons.

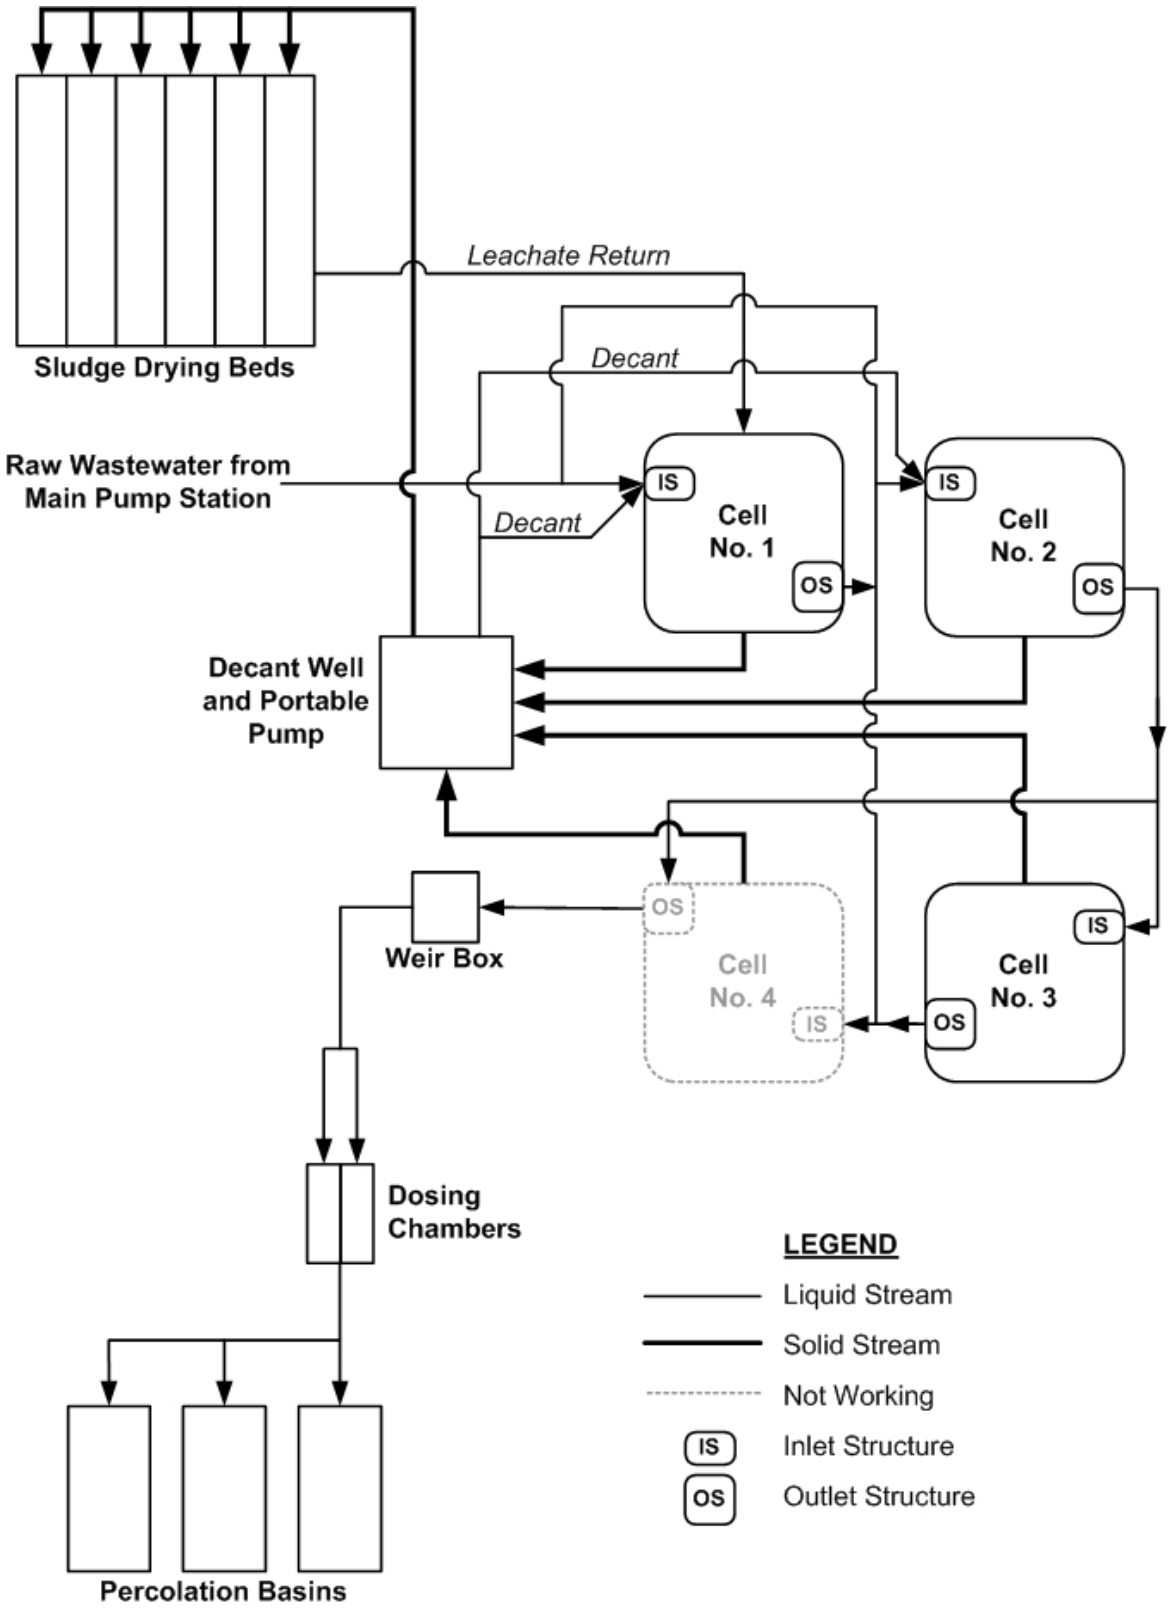
Figure 5-62 – Inarajan STP Schematic Flow Diagram

- No influent flow meter
- Severe corrosion of the percolation distribution system
