**Coal Combustion Waste Impoundment
Round 7 - Dam Assessment Report**

J.C. Weadock
Fly Ash Dike
Consumers Energy
Bay City, Michigan

Dewberry & Davis, LLC
Fairfax, Virginia

April 2011

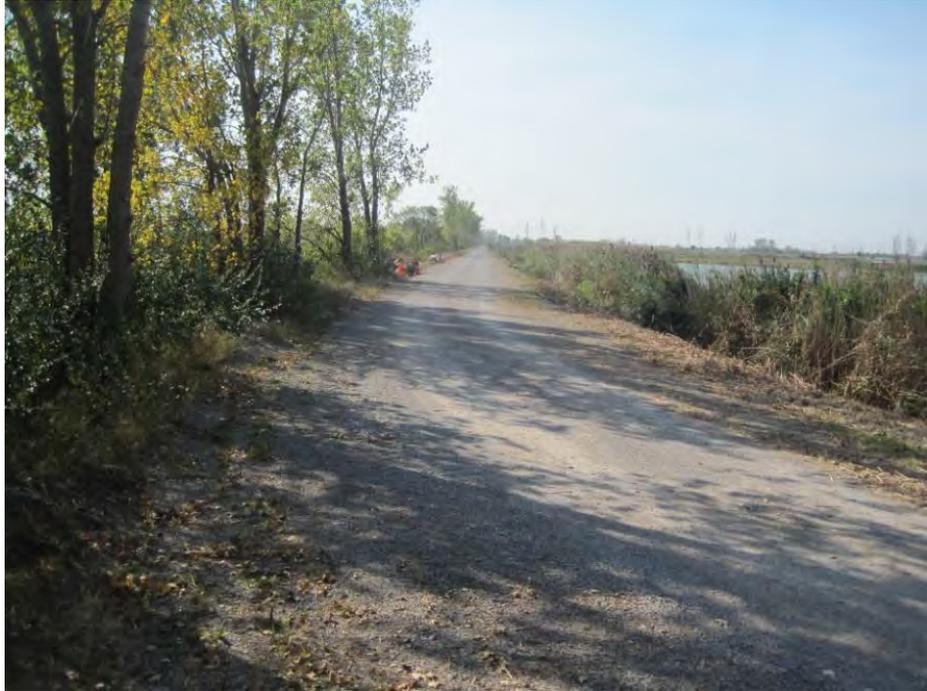
The crest did not show any signs of significant depressions or settlement. A gravel service road covers the entire length of the embankment (see Figures 1 and 2).

Figure 1 - Crest of Section C embankment, Saginaw Bay area on left, Pond F (P3) on right.

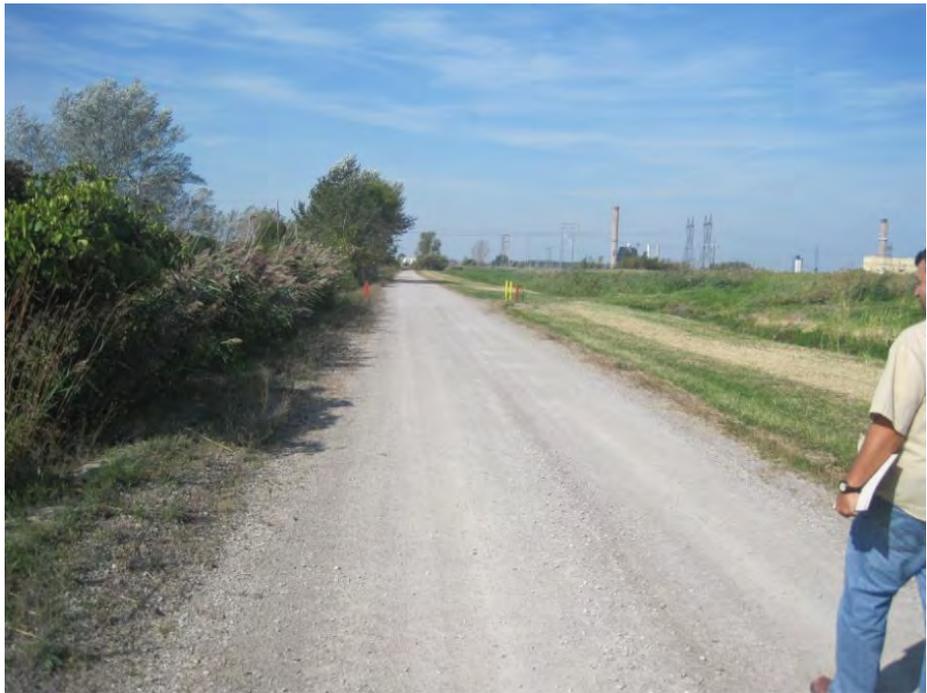
Figure 2 - Crest of Section D embankment, outside slope on left, inside slope on right.

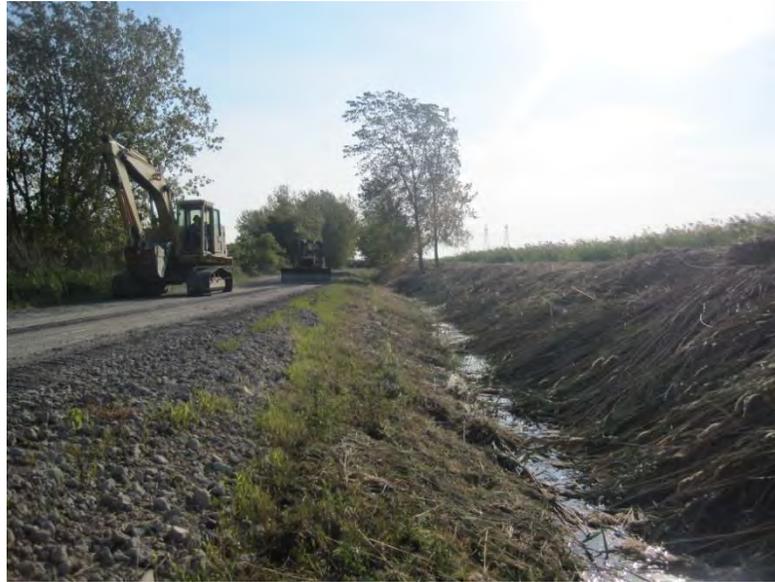
The inside slope is heavily vegetated in areas (see Figures 3 and 4). However, a vegetation management plan is in place, and much of the vegetation was being removed during the site visit. Our site investigation revealed the presence of a non-native invasive species called “phragmites.” There were no obvious indications of sloughing or erosion.

Figure 3 - Evidence of vegetation removal on inside slope on embankment Section A

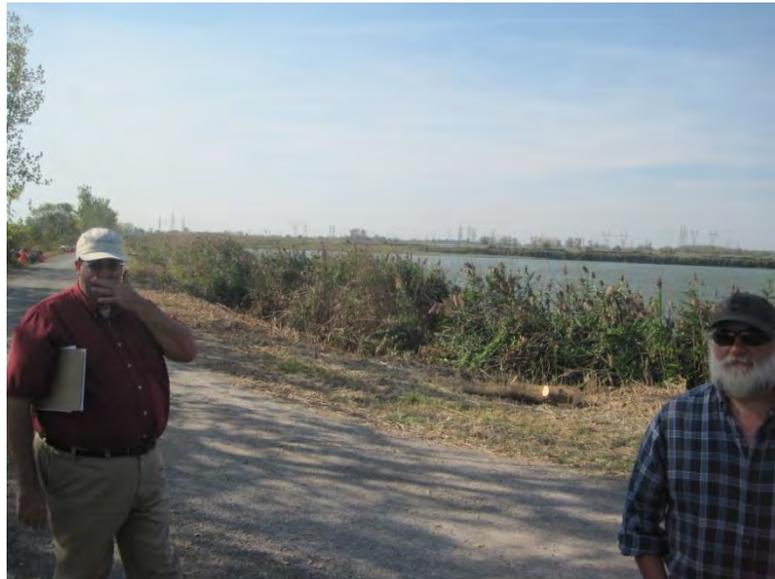
Figure 4 - Evidence of phragmites and other vegetation on inside slope of embankment Section C

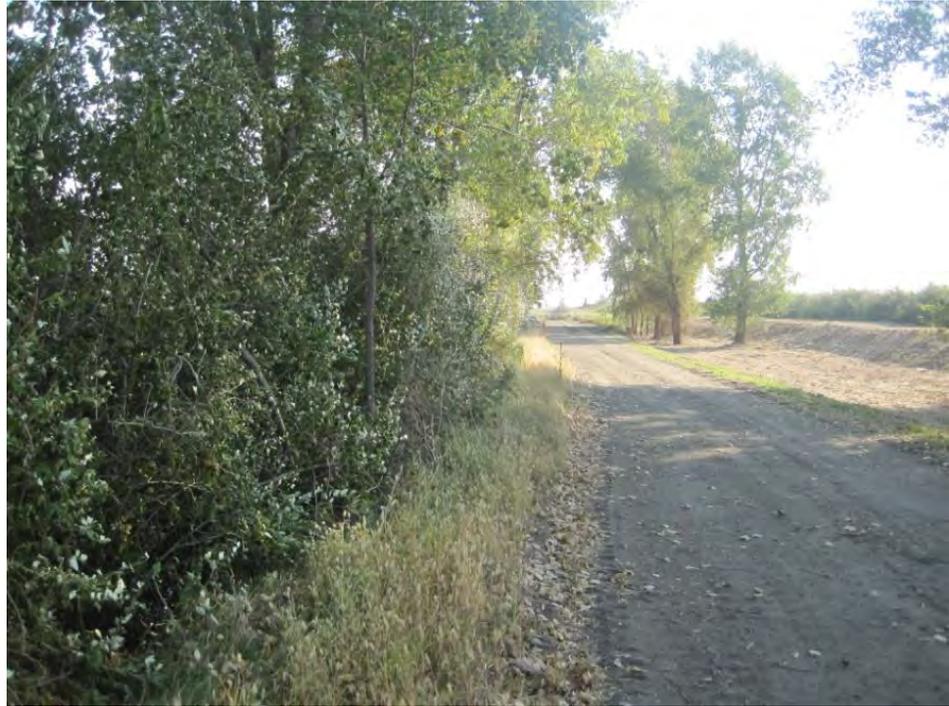
The outside embankment was heavily vegetated and contained several large trees. There was evidence of rip-rap in many locations, but presence of vegetation and trees made a thorough inspection difficult. There were no obvious indications of sloughing or erosion (Figures 5 and 6).

Figure 5 - Evidence of heavy vegetation and trees on the outside slope of embankment Section A.

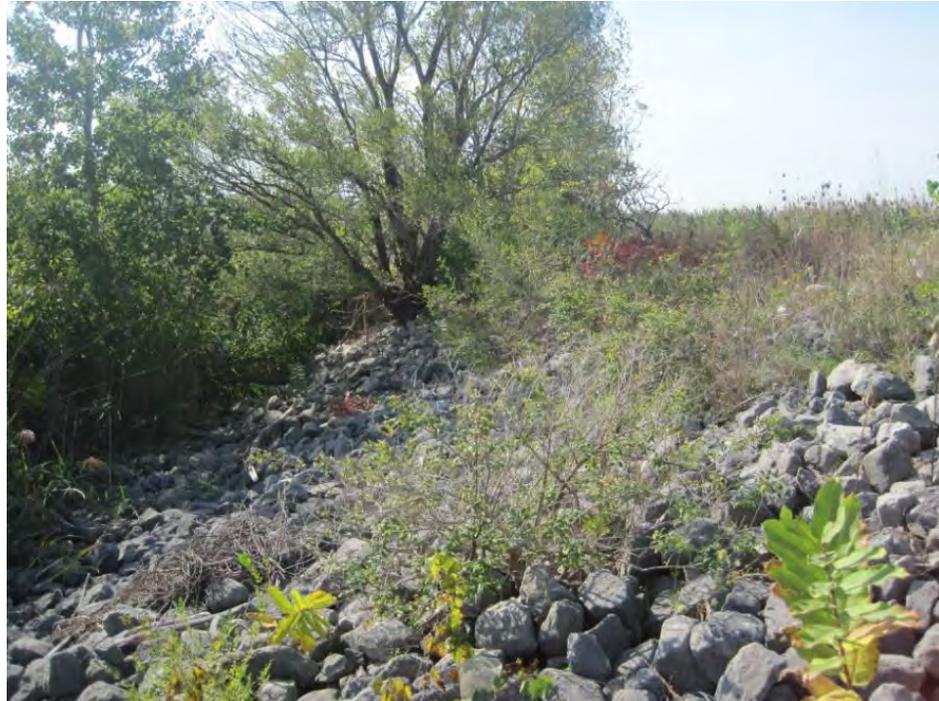
Figure 6 - Rip-rap and large tree and heavy vegetation on outside slope of embankment Section C

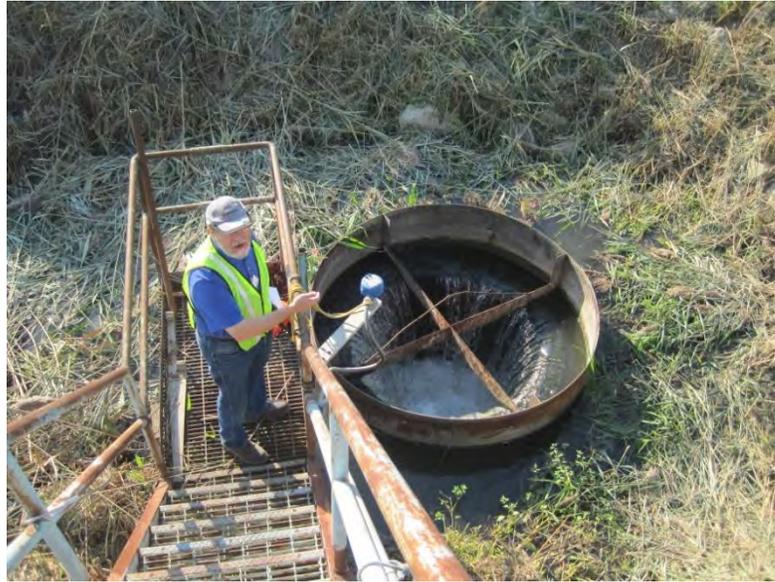
The outlet conduit is a vertical reinforced concrete pipe drop structure connected to a buried horizontal RCP discharge pipe. This vertical riser consists of a 4.5-foot diameter vertical concrete pipe with a larger diameter (8-foot) metal skimmer ring mounted to the top (Figure 7). Water is forced to flow under the metal ring and over the top of the concrete pipe to skim any floating material and prevent clogging. The water level adjacent to the edge of the riser is monitored to measure discharge flow. A horizontal 3-foot-diameter RCP discharges to the channel below the water surface and is submerged and not visible (Figure 8).

Figure 7 - Outlet conduit intake structure

The NPDES outlet structure discharge point is located upstream of the existing fish barrier (see Document 2). Discharge is controlled by a vertical reinforced concrete pipe drop structure connected to a buried horizontal reinforced concrete discharge pipe. This vertical riser consists of a 4.5-foot diameter vertical concrete pipe with a larger diameter (approximately 8-foot) metal skimmer ring mounted to the top (see Appendix B, photographs 8 and 9). Water is forced to flow under the metal ring and over the top of the concrete pipe to skim any floating material and prevent clogging. The water level adjacent to the edge of the riser is monitored to measure discharge flow. Water flowing through the NPDES outfall structure is also monitored for environmental compliance with NPDES permit requirements. A horizontal 3-foot diameter RCP discharges to the channel below the water surface and is not visible (see Appendix B, photograph 11).

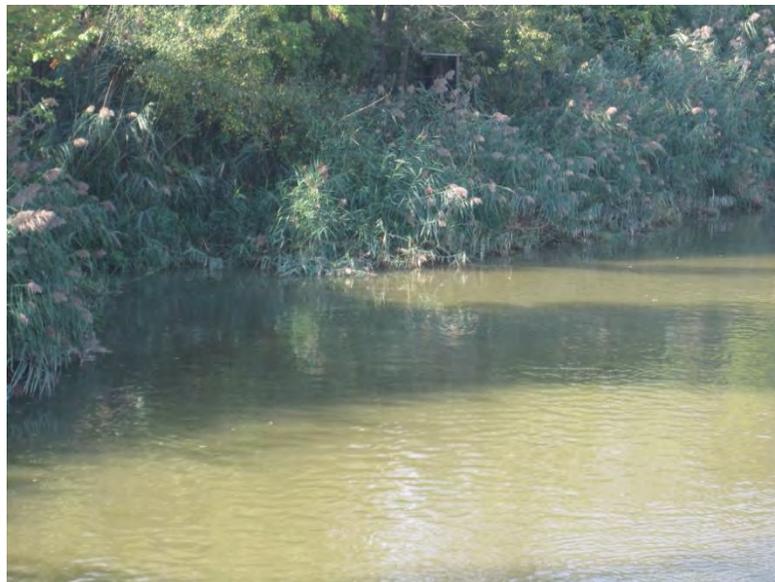
Figure 8 - Area of submerged outlet in discharge channel

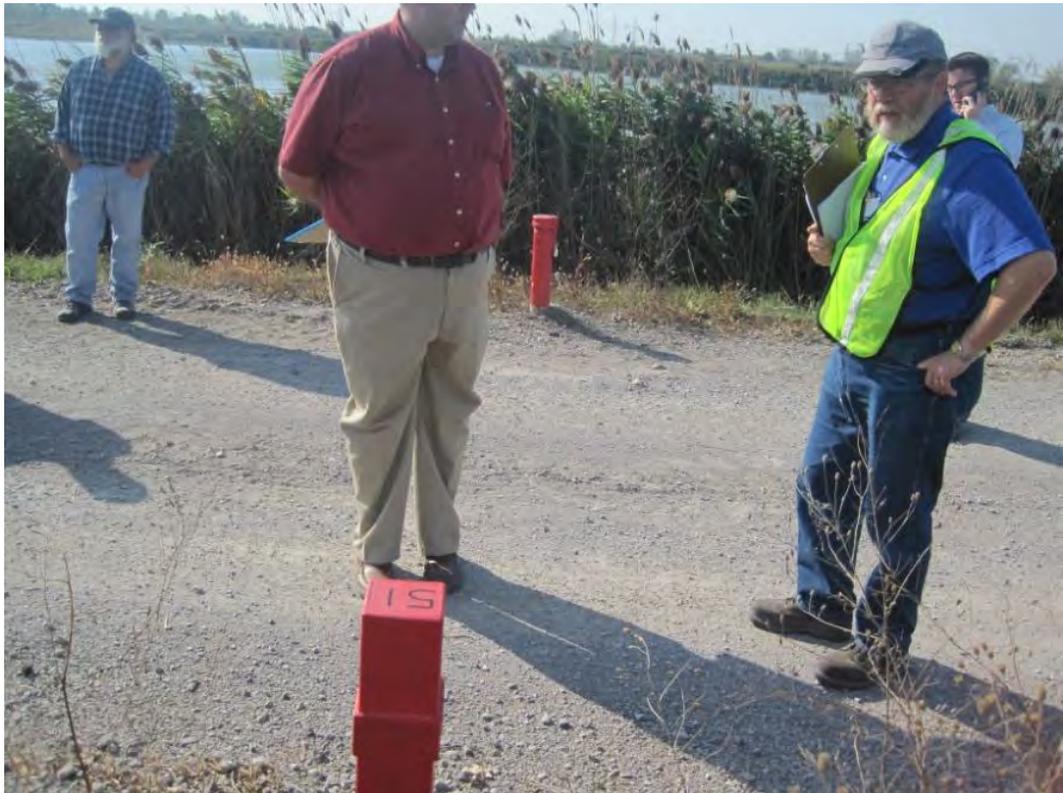
Monitoring wells for measuring water elevation are located on the inside edge of the crest and outside edge of the crest throughout the site (see below). A minimum of nineteen (19) wells are monitored on a quarterly basis. Typical groundwater elevations at these wells are shown in Document 15. There are no survey monuments along the crest to monitor settling. However, Consumers Energy conducts an annual ash aerial survey that contours the topography of the ash fields to within +/- 1.0 feet, with individual measurements accurate to 0.1 feet.

Figure 9 - Monitoring wells

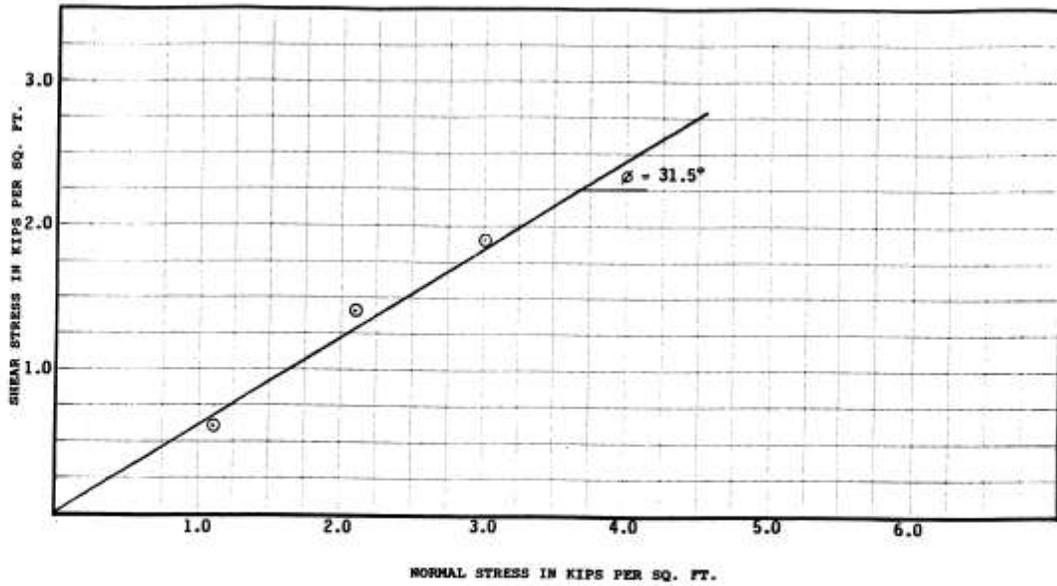
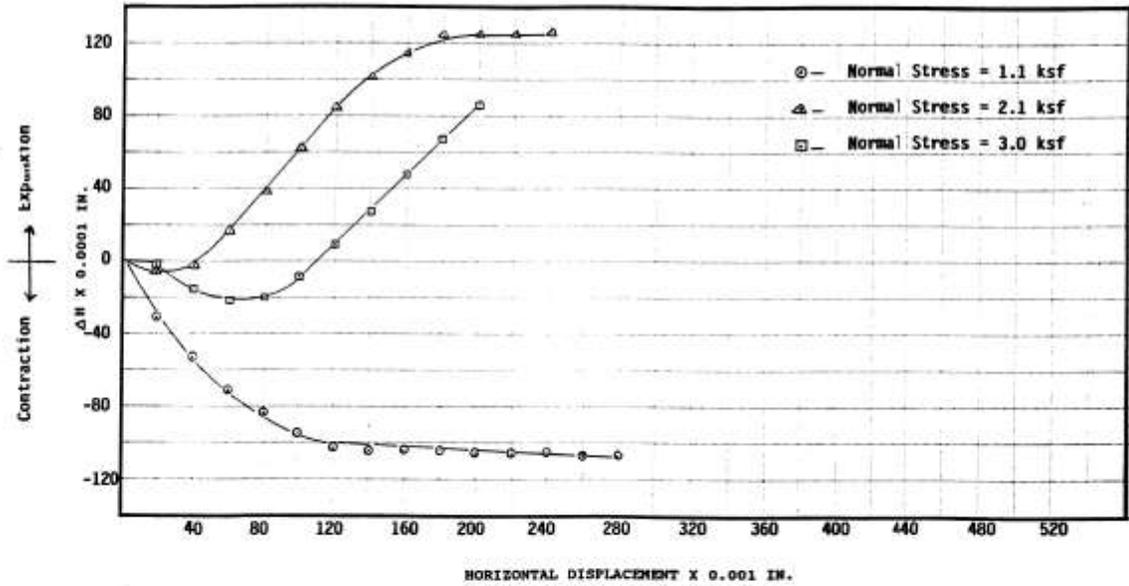
Document 7: Summary of Laboratory Test Data (4 of 11)

DESCRIPTION OF SPECIMEN: Dark brown medium to fine SAND, trace organics B-3 (9.5'-11') 34996			DIRECT SHEAR TEST ASTM D 3080	
Liquid Limit (%)		Final Void Ratio		
Plastic Limit (%)		Unit Dry weight (pcf)		
Plasticity Index (%)		Friction Angle, ϕ	31.5°	
Natural Water Content (%)	27.1	Normal Stress (ksf)		
Specific Gravity	2.61			
TEST SPECIMEN PROPERTIES				
Diameter of Specimen (in.)	2.5	1.1	2.1	3.0
Initial Height of Specimen (in.)	0.95	0.99	0.99	
Initial Water Content (%)	Dry	Dry	Dry	
Initial Void Ratio	0.64	0.72	0.71	
Initial Dry weight (pcf)	99.2	95.0	95.3	
Final Water Content (%)				
Shear Stress (ksf)	0.6	1.4	1.9

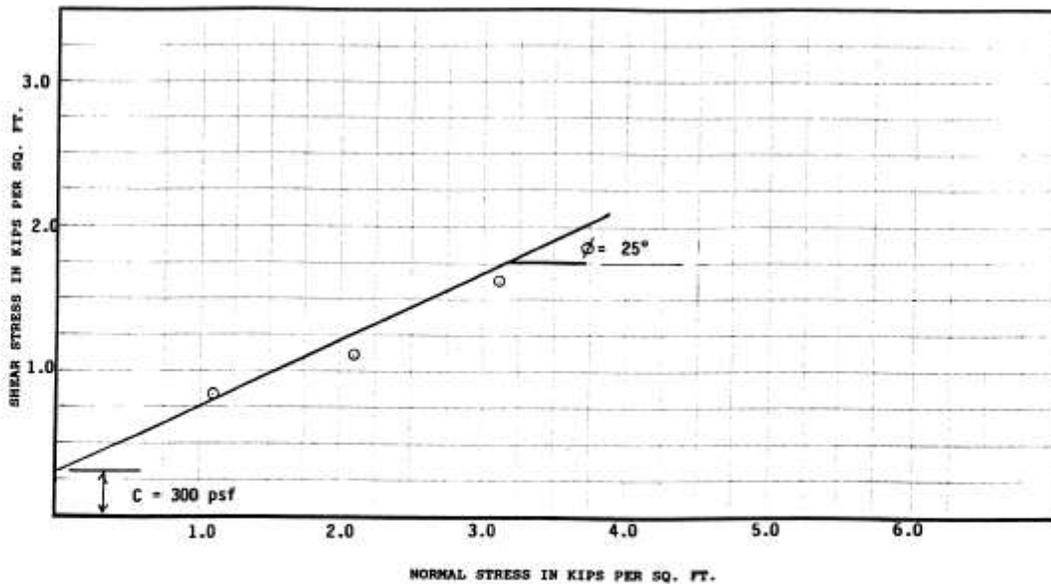
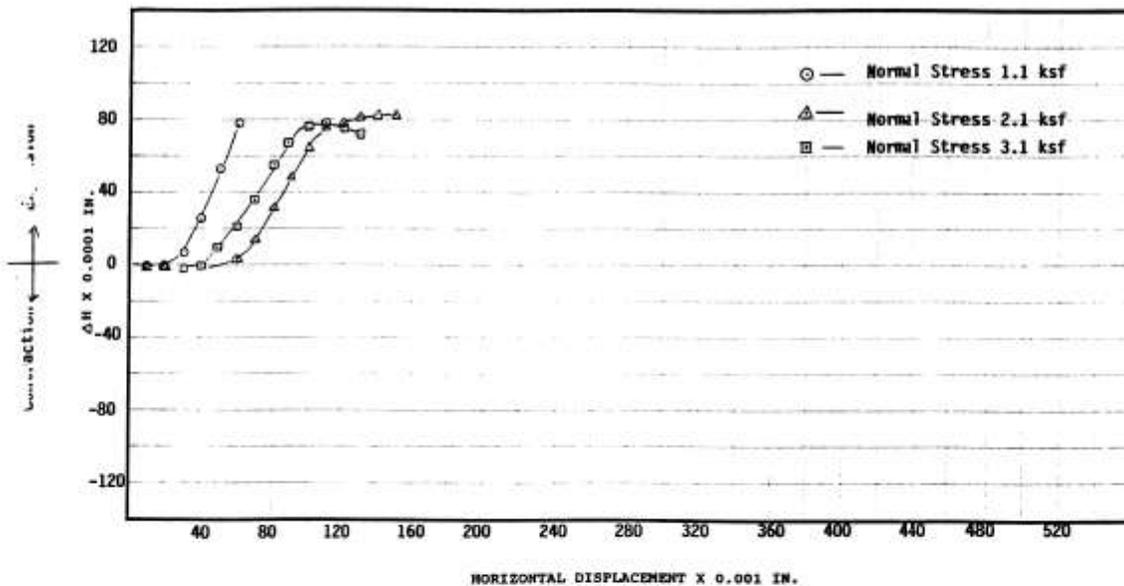
DESCRIPTION OF SPECIMEN: Gray Fly ash, B-1 (0'-2') 297Q (Compacted)		35005	DIRECT SHEAR TEST ASTM D 3080	
Upper Limit (%)		Final Void Ratio		
Elastic Limit (%)		Unit Dry Weight (pcf)		
Plasticity Index (%)		Friction Angle, φ	25°	
Natural Water Content (%)	28.3	Normal Stress (ksf)	1.1	2.1
Specific Gravity	2.22		2.5	3.1
TEST SPECIMEN PROPERTIES				
Diameter of Specimen (in.)			2.5	2.5
Initial Height of Specimen (in.)			1.0	0.99
Initial Water Content (%)			Dry	Dry
Initial Void Ratio			93	93
Initial Dry Weight (pcf)			71.9	72.4
Final Water Content (%)				72.5
Shear Stress (ksf)			0.8	1.1
				1.6
Materials Testing Consultants, Inc.			Tested by: SMT Date: 11/4/91	
			Checked by: SE Job No.: 442Q

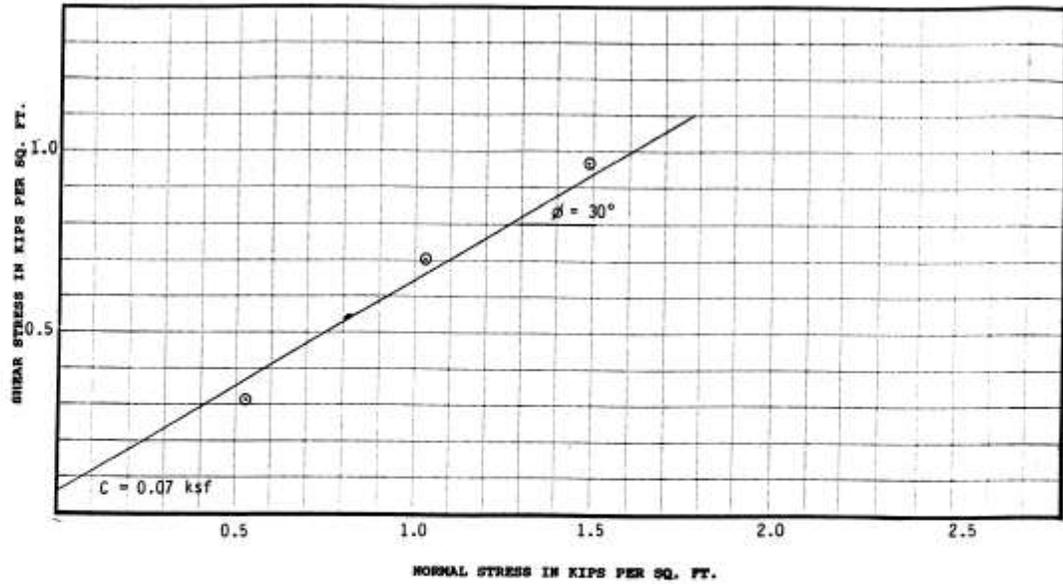
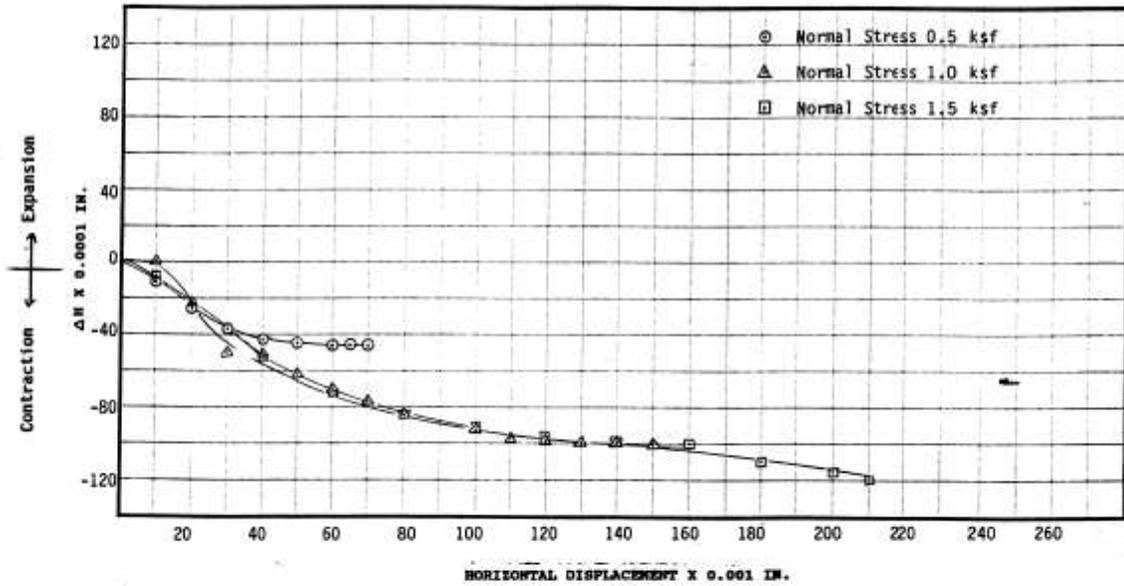
DESCRIPTION OF SPECIMEN: Gray Flyash B-5 (3' - 7') 297Q (loose)		35941	DIRECT SHEAR TEST ASTM D 3080	
Liquid Limit (%)		Final Void Ratio		
Plastic Limit (%)		Unit Dry Weight (pcf)		Friction Angle 30° Cohesion, ksf 0.07
Plasticity Index (%)				
Natural Water Content (%)	41.4	Normal Stress (ksf)		
Specific Gravity	2.47	0.5	1.0	1.5
TEST SPECIMEN PROPERTIES				
Diameter of Specimen (in.)		2.5	2.5	2.5
Initial Height of Specimen (in.)		.99	.95	.94
Initial Water Content (%)		60.9	62.3	65.5
Initial Void Ratio		1.61	1.53	1.50
Initial Dry Weight (pcf)		58.9	60.8	61.3
Final Water Content (%)		56.2	53.9	54.0

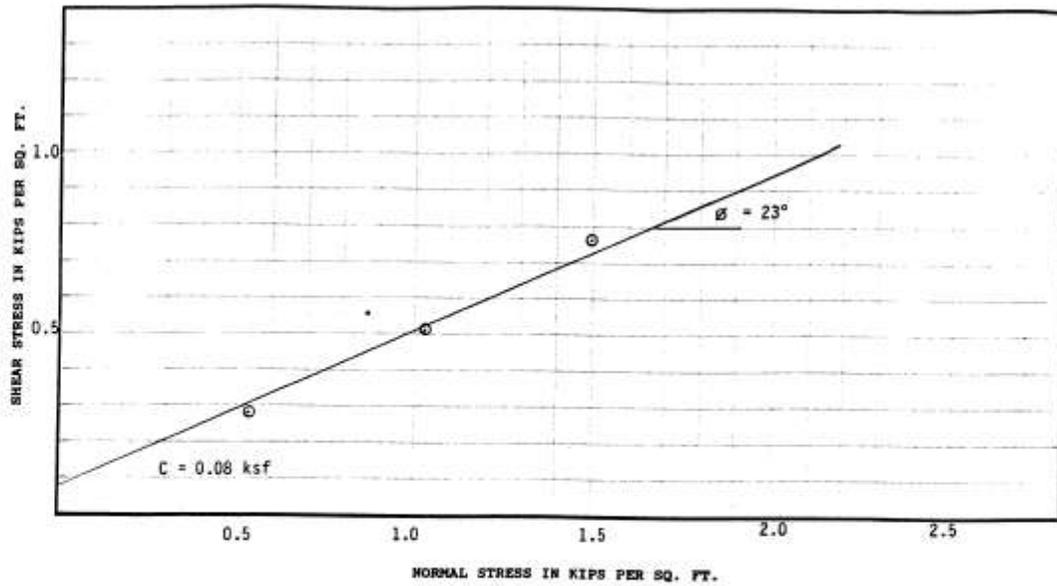
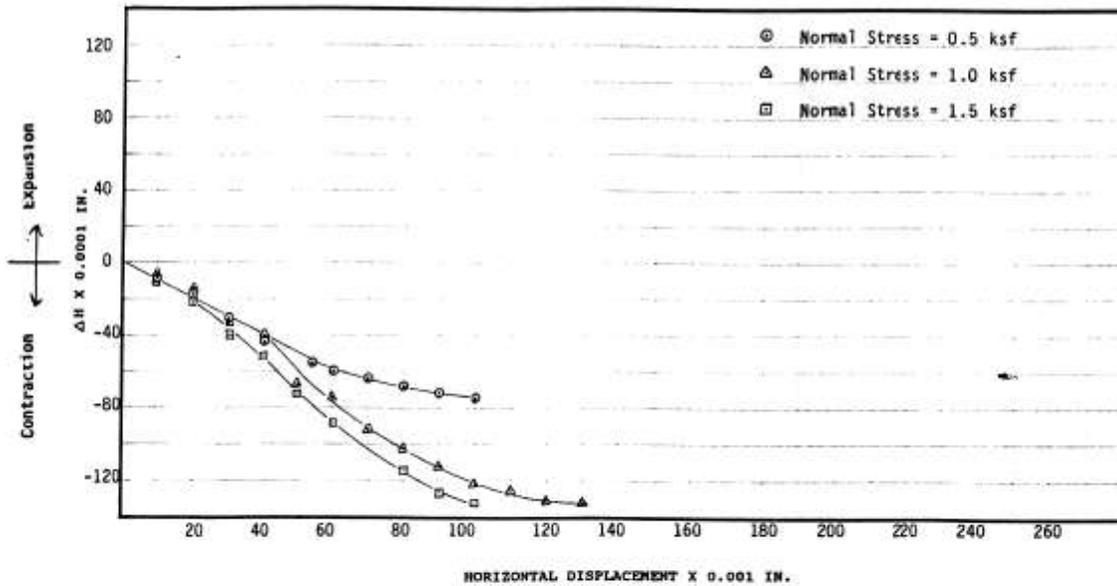
DESCRIPTION OF SPECIMEN:		Gray Flyash B-6 (3' - 7') 297Q (loose)		35939		DIRECT SHEAR TEST	
						ASTM D 3080	
Liquid Limit (%)		Final Void Ratio					
Plastic Limit (%)		Unit Dry Weight (pcf)					
Plasticity Index (%)		Friction Angle, ϕ		23°			
Natural Water Content (%)	50.4 Avg.	Cohesion (ksf)		0.08			
Specific Gravity	2.30	Normal Stress (ksf)					
TEST SPECIMEN PROPERTIES *		0.5	1.0	1.5			
Diameter of Specimen (in.)		2.5	2.5	2.5			
Initial Height of Specimen (in.)		.94	.93	.95			
Initial Water Content (%)		53.3	59.9	59.7			
Initial Void Ratio		1.23	1.21	1.25			
Initial Dry Weight (pcf)		64.5	64.8	63.7			
Natural Water Content (%)		53.8	43.4	43.7			
Shear Stress (ksf)		0.28	0.51	0.75

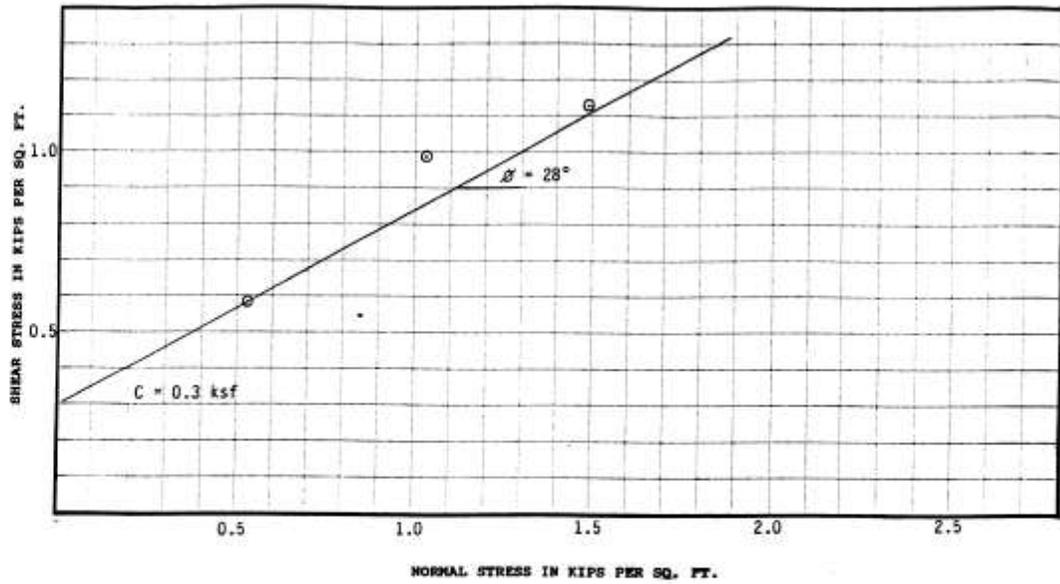
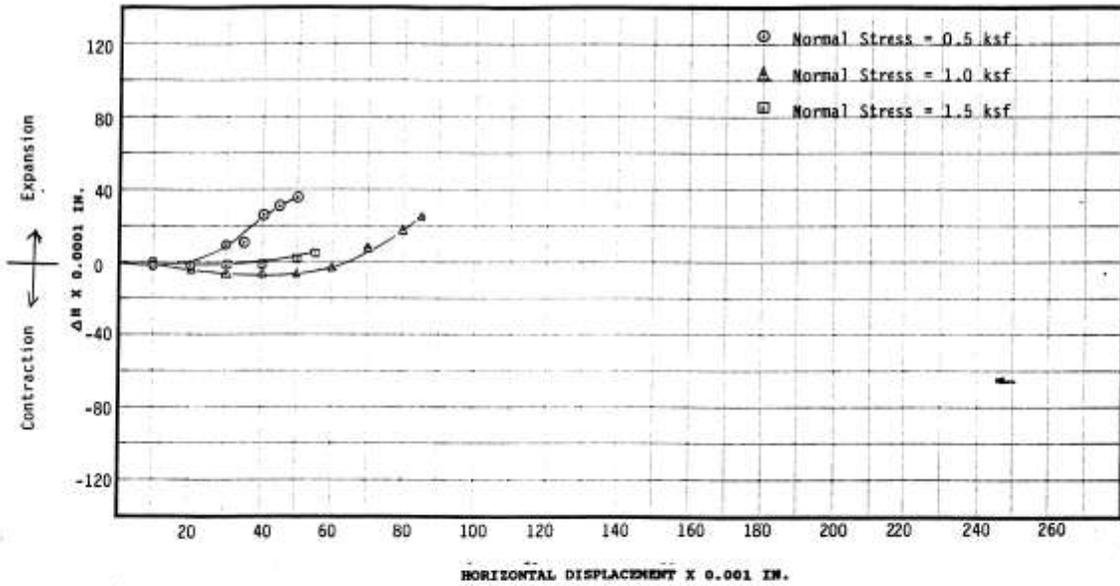
DESCRIPTION OF SPECIMEN: Gray Flyash B-6 (3' - 7') 297Q (Compacted)		35940	DIRECT SHEAR TEST ASTM D 3080	
Liquid Limit (%)		Final Void Ratio		
Plastic Limit (%)		Unit Dry Weight (pcf)		28°
Plasticity Index (%)		Friction Angle, ϕ		
Natural Water Content (%)	50.4 Avg.	Cohesion (ksf)	0.3	Materials Testing Consultants, Inc. 300 PLYMOUTH BL., CHICAGO, ILL. 60606 • PHONE 312-340-0000
Specific Gravity	2.30	Normal Stress (ksf)		
TEST SPECIMEN PROPERTIES *		0.5	1.0	1.5
Diameter of Specimen (in.)	2.5	2.5	2.5	
Initial Height of Specimen (in.)	1.00	.99	.99	
Initial Water Content (%)	43.9	43.7	43.9	
Initial Void Ratio	1.01	1.00	1.01	
Initial Dry Weight (pcf)	71.5	71.6	71.4	
Final Water Content (%)	43.7	43.4	48.5	
SHEAR STRESS (KSF)	0.50	0.67	1.13

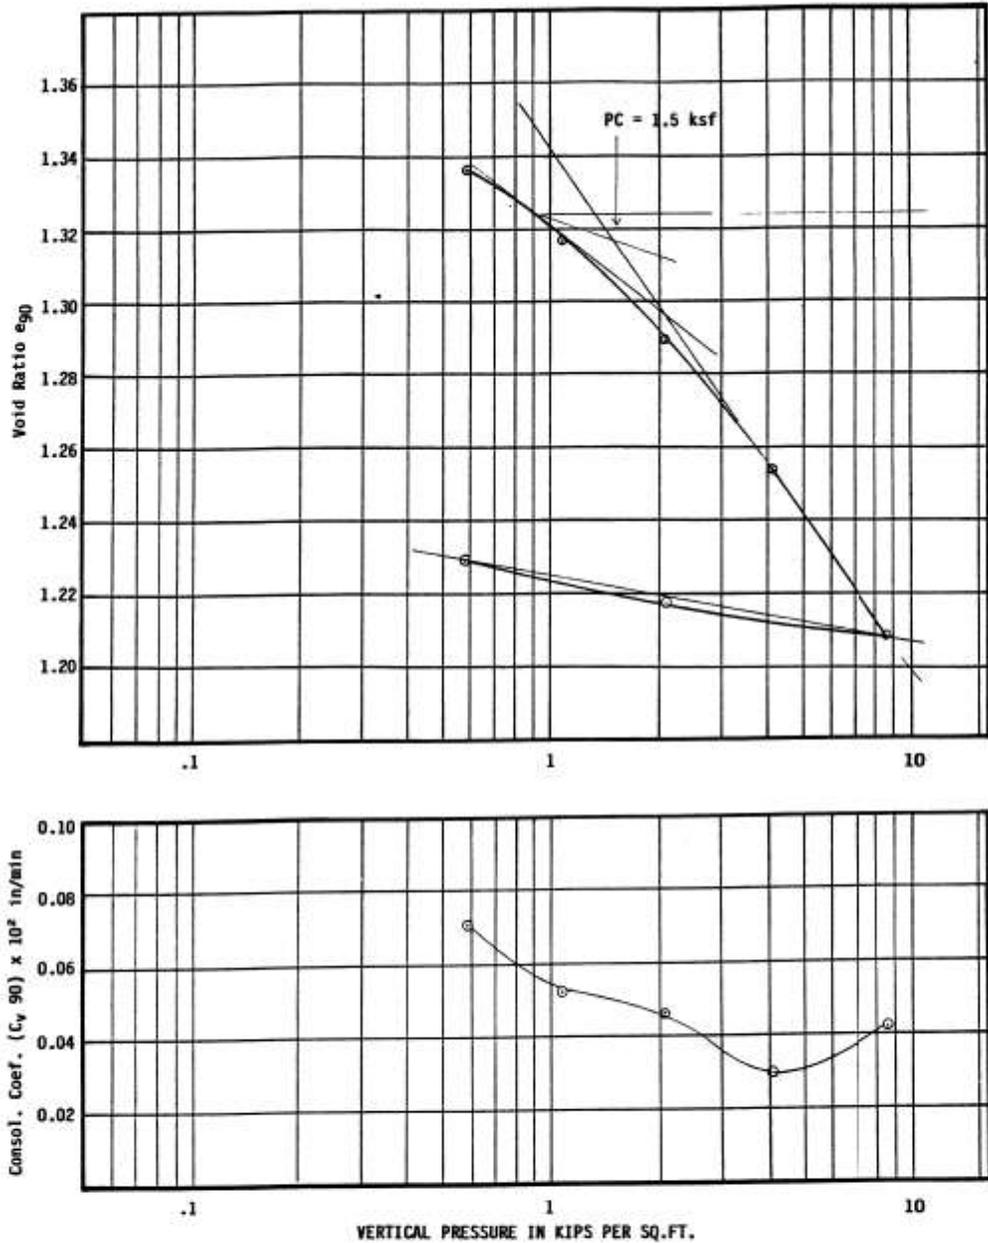
Document 7: Summary of Laboratory Test Data (9 of 11)

DESCRIPTION OF SPECIMEN: Gray flyash B-6 (3' - 7') 297Q (loose)		35939	CONSOLIDATION TEST ASTM D 2435-90
Liquid Limit (%)		Final Void Ratio	
Plastic Limit (%)		Initial Dry Density (pcf)	60.5
Plasticity Index		CONSOLIDATION PROPERTIES	
Natural Water Content (%)	AVG. 50.5	Compression Index (Cc)	0.142
Specific Gravity	2.3	Recompression (Cr)	0.018
TEST SPECIMEN PROPERTIES		Swollen Index (Cs)	0.018
Diameter of Specimen (in.)	2.5	Preconsolidation Stress (Pc) ksf	1.5
Initial Thickness of Specimen (in.)	0.75	Existing Overburden Stress (Po) ksf	
Initial Water Content (%)	59.7		
Initial Void Ratio	1.373		
			Tested by: SMT Date: 11/15/91
			Checked by: SC Job No.: 4420

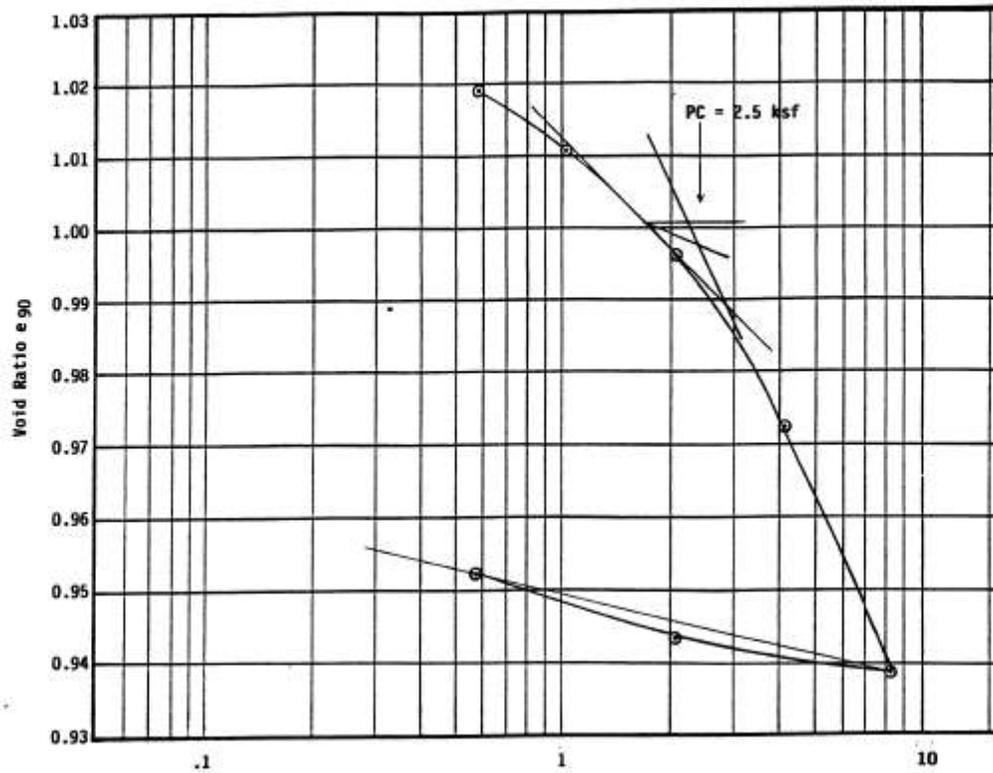
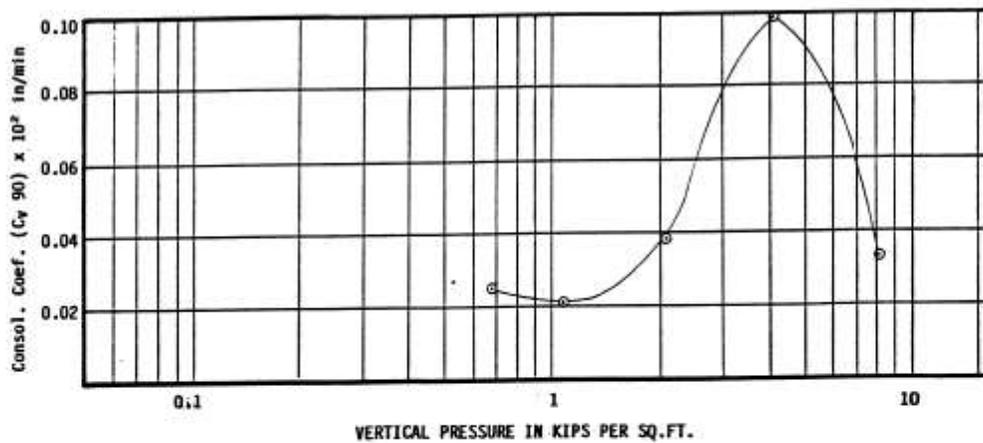
DESCRIPTION OF SPECIMEN: Gray Flyash B-6 (3' - 7') 2970 (Compacted)		35940	CONSOLIDATION TEST
Liquid Limit (%)		Final Void Ratio	0.953
Plastic Limit (%)		Initial Dry Density (pcf)	71.0
Plasticity Index		CONSOLIDATION PROPERTIES	
Natural Water Content (%)	AVG. 50.5	Compression Index (Cc)	.105
Specific Gravity	2.3	Recompression (Cr)	.012
TEST SPECIMEN PROPERTIES		Swelling Index (Cs)	2.5
Diameter of Specimen (in.)	2.5	Preconsolidation Stress (Pc) ksf	2.5
Initial Thickness of Specimen (in.)	0.75	Existing Overburden Stress (Po) ksf	
Initial Water Content (%)	44.4		
Initial Void Ratio	1.023		
			MATERIALS TESTING CONSULTANTS
Tested by: SMT			Date: 1/15/91
Checked by: [Signature]			Job No.: 4420

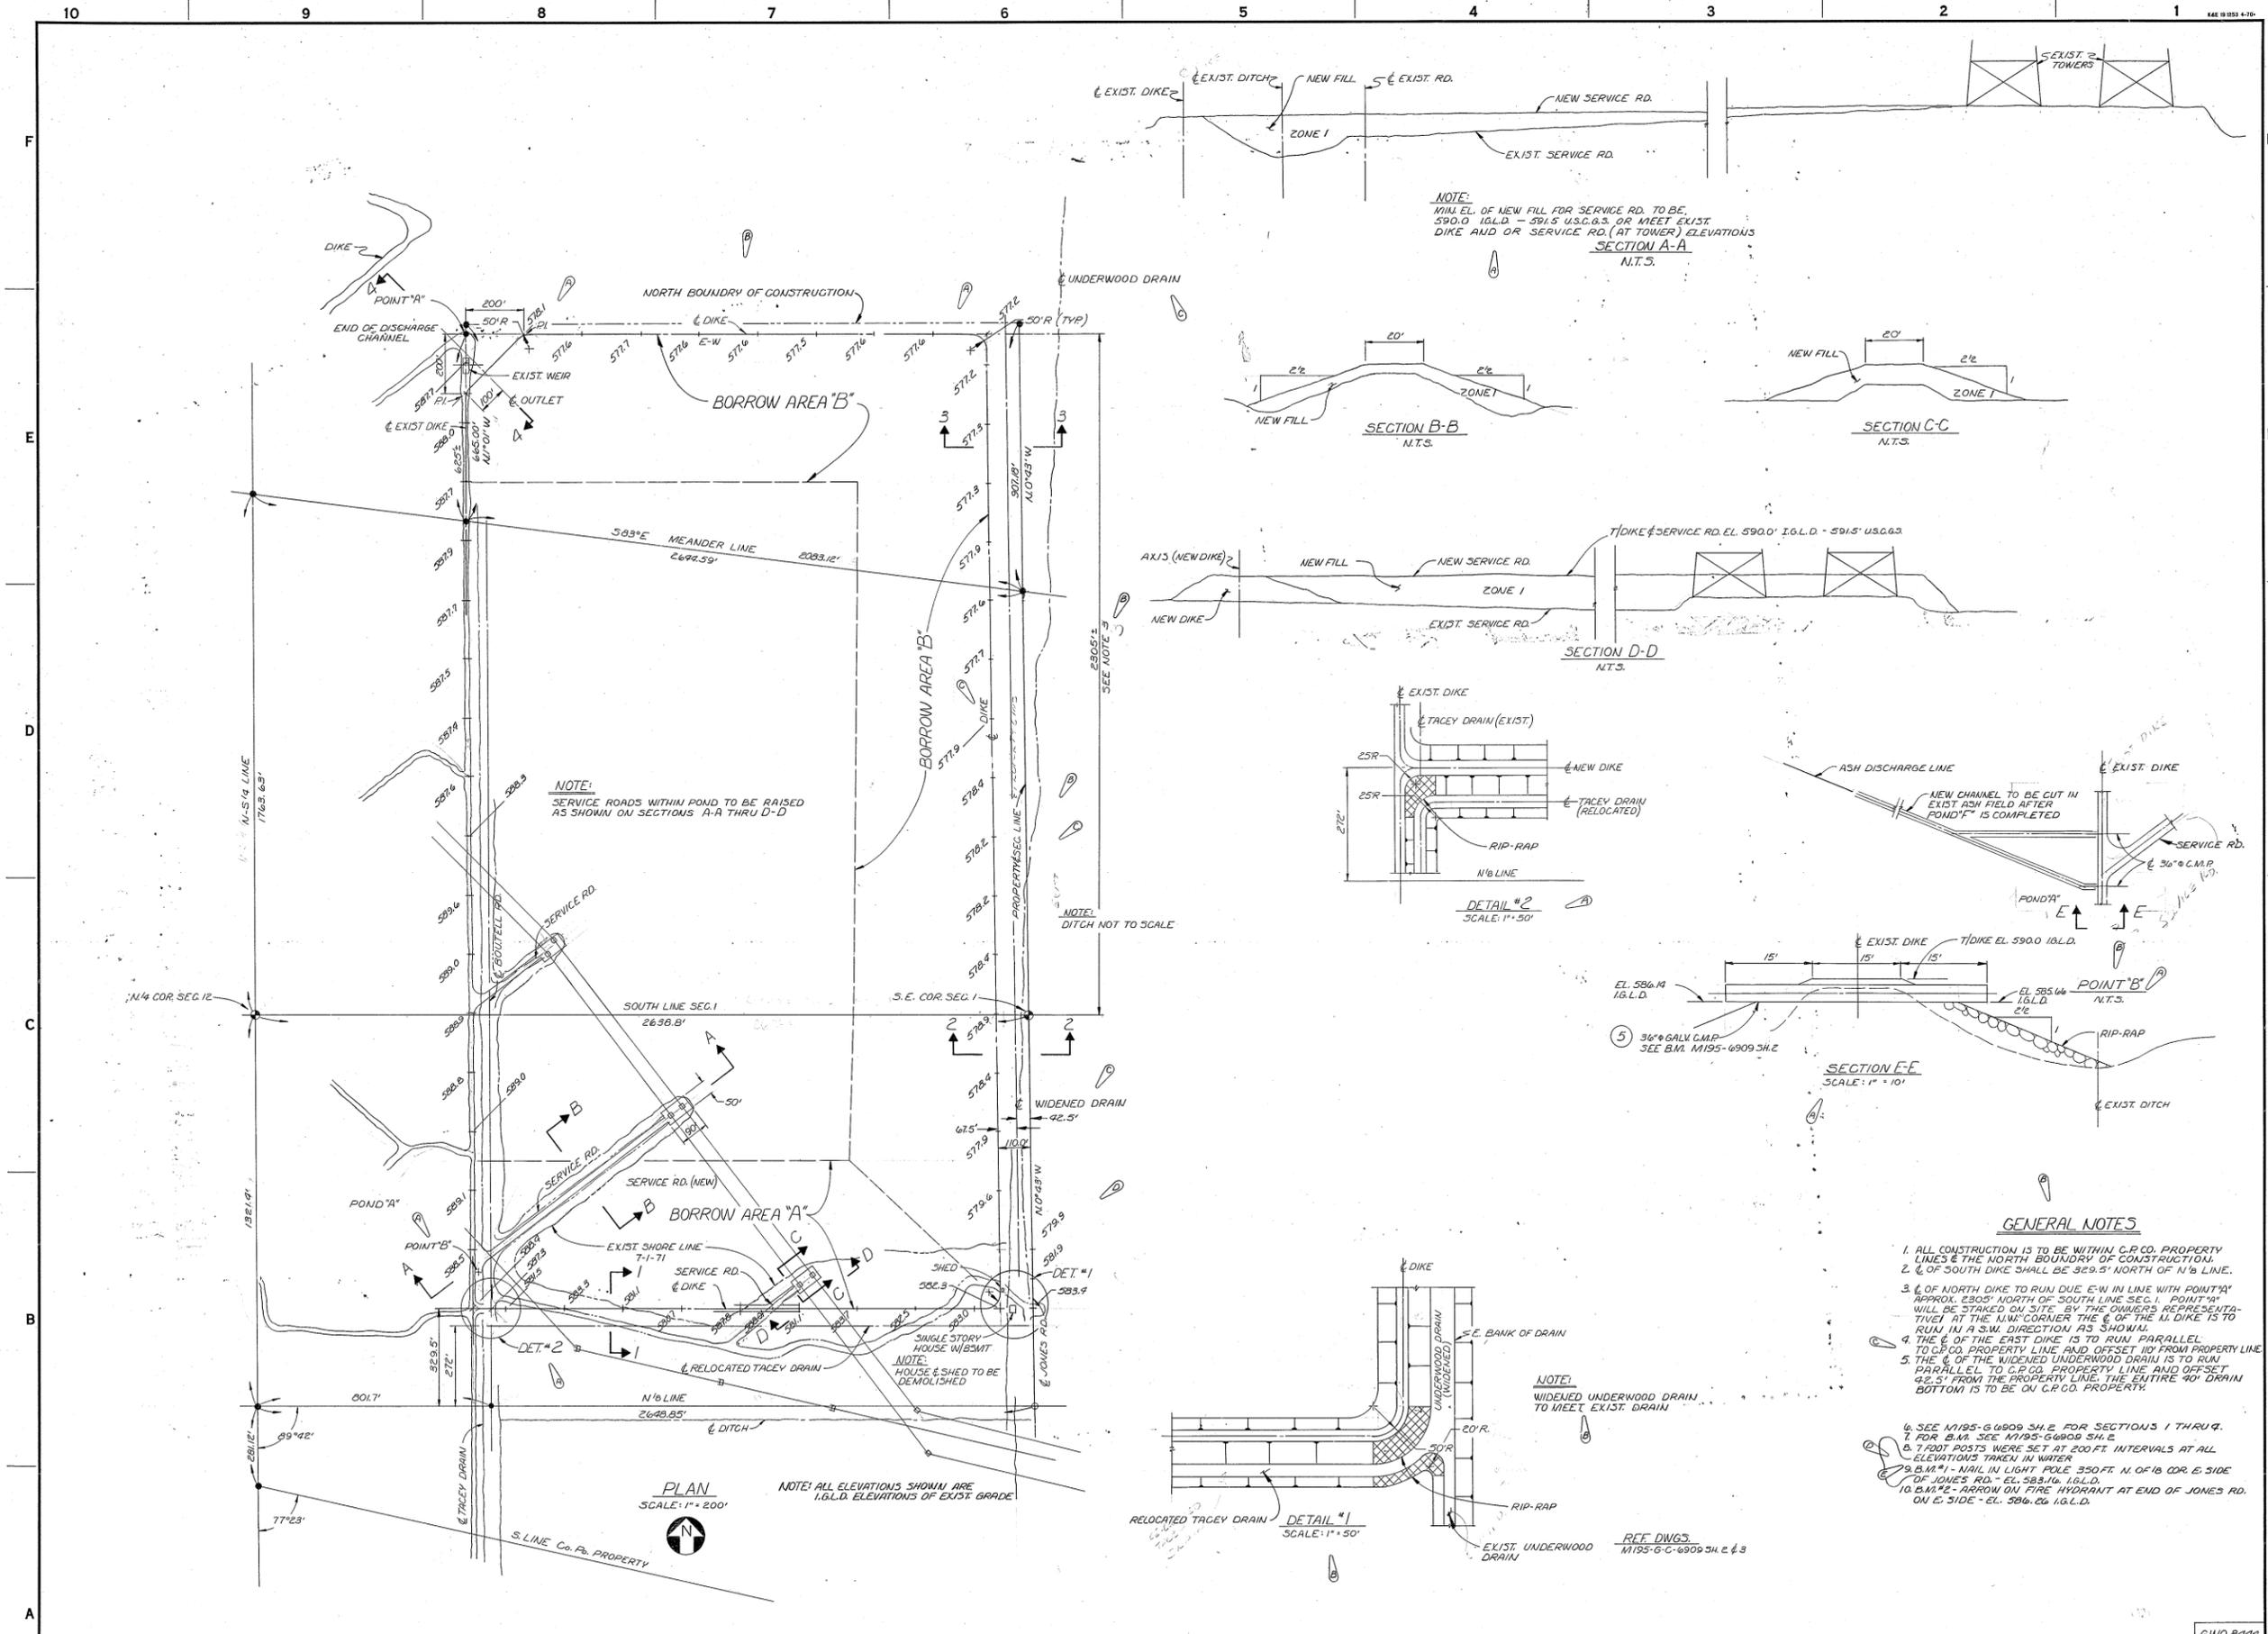
Figure 4

NOTE:
MIN. EL. OF NEW FILL FOR SERVICE RD. TO BE 590.0 I.G.L.D. - 591.5 U.S.G.S. OR MEET EXIST. DIKE AND OR SERVICE RD. (AT TOWER) ELEVATIONS
SECTION A-A
N.T.S.

NOTE:
SERVICE ROADS WITHIN POND TO BE RAISED AS SHOWN ON SECTIONS A-A THRU D-D

The east portion of the containment area was expanded in 1971 and the perimeter dikes were raised to elevation 590 feet IGLD85. Details of that construction event can be seen on Figures 4 and 5. The purpose of raising the perimeter dike was to construct a clay perimeter dike that keyed into the hydraulic confining glacial clay till layer located approximately 20 to 25 feet below the current ground surface. This clay dike was designed to prevent any potentially contaminated groundwater from seeping through the dike into Saginaw Bay from the disposal facility. However, later studies conducted revealed that this clay dike was not effectively keyed into a confining layer (CPC, 1992a).
