**Coal Combustion Waste Impoundment
Round 7 - Dam Assessment Report**

J.C. Weadock
Fly Ash Dike
Consumers Energy
Bay City, Michigan

Dewberry & Davis, LLC
Fairfax, Virginia

April 2011

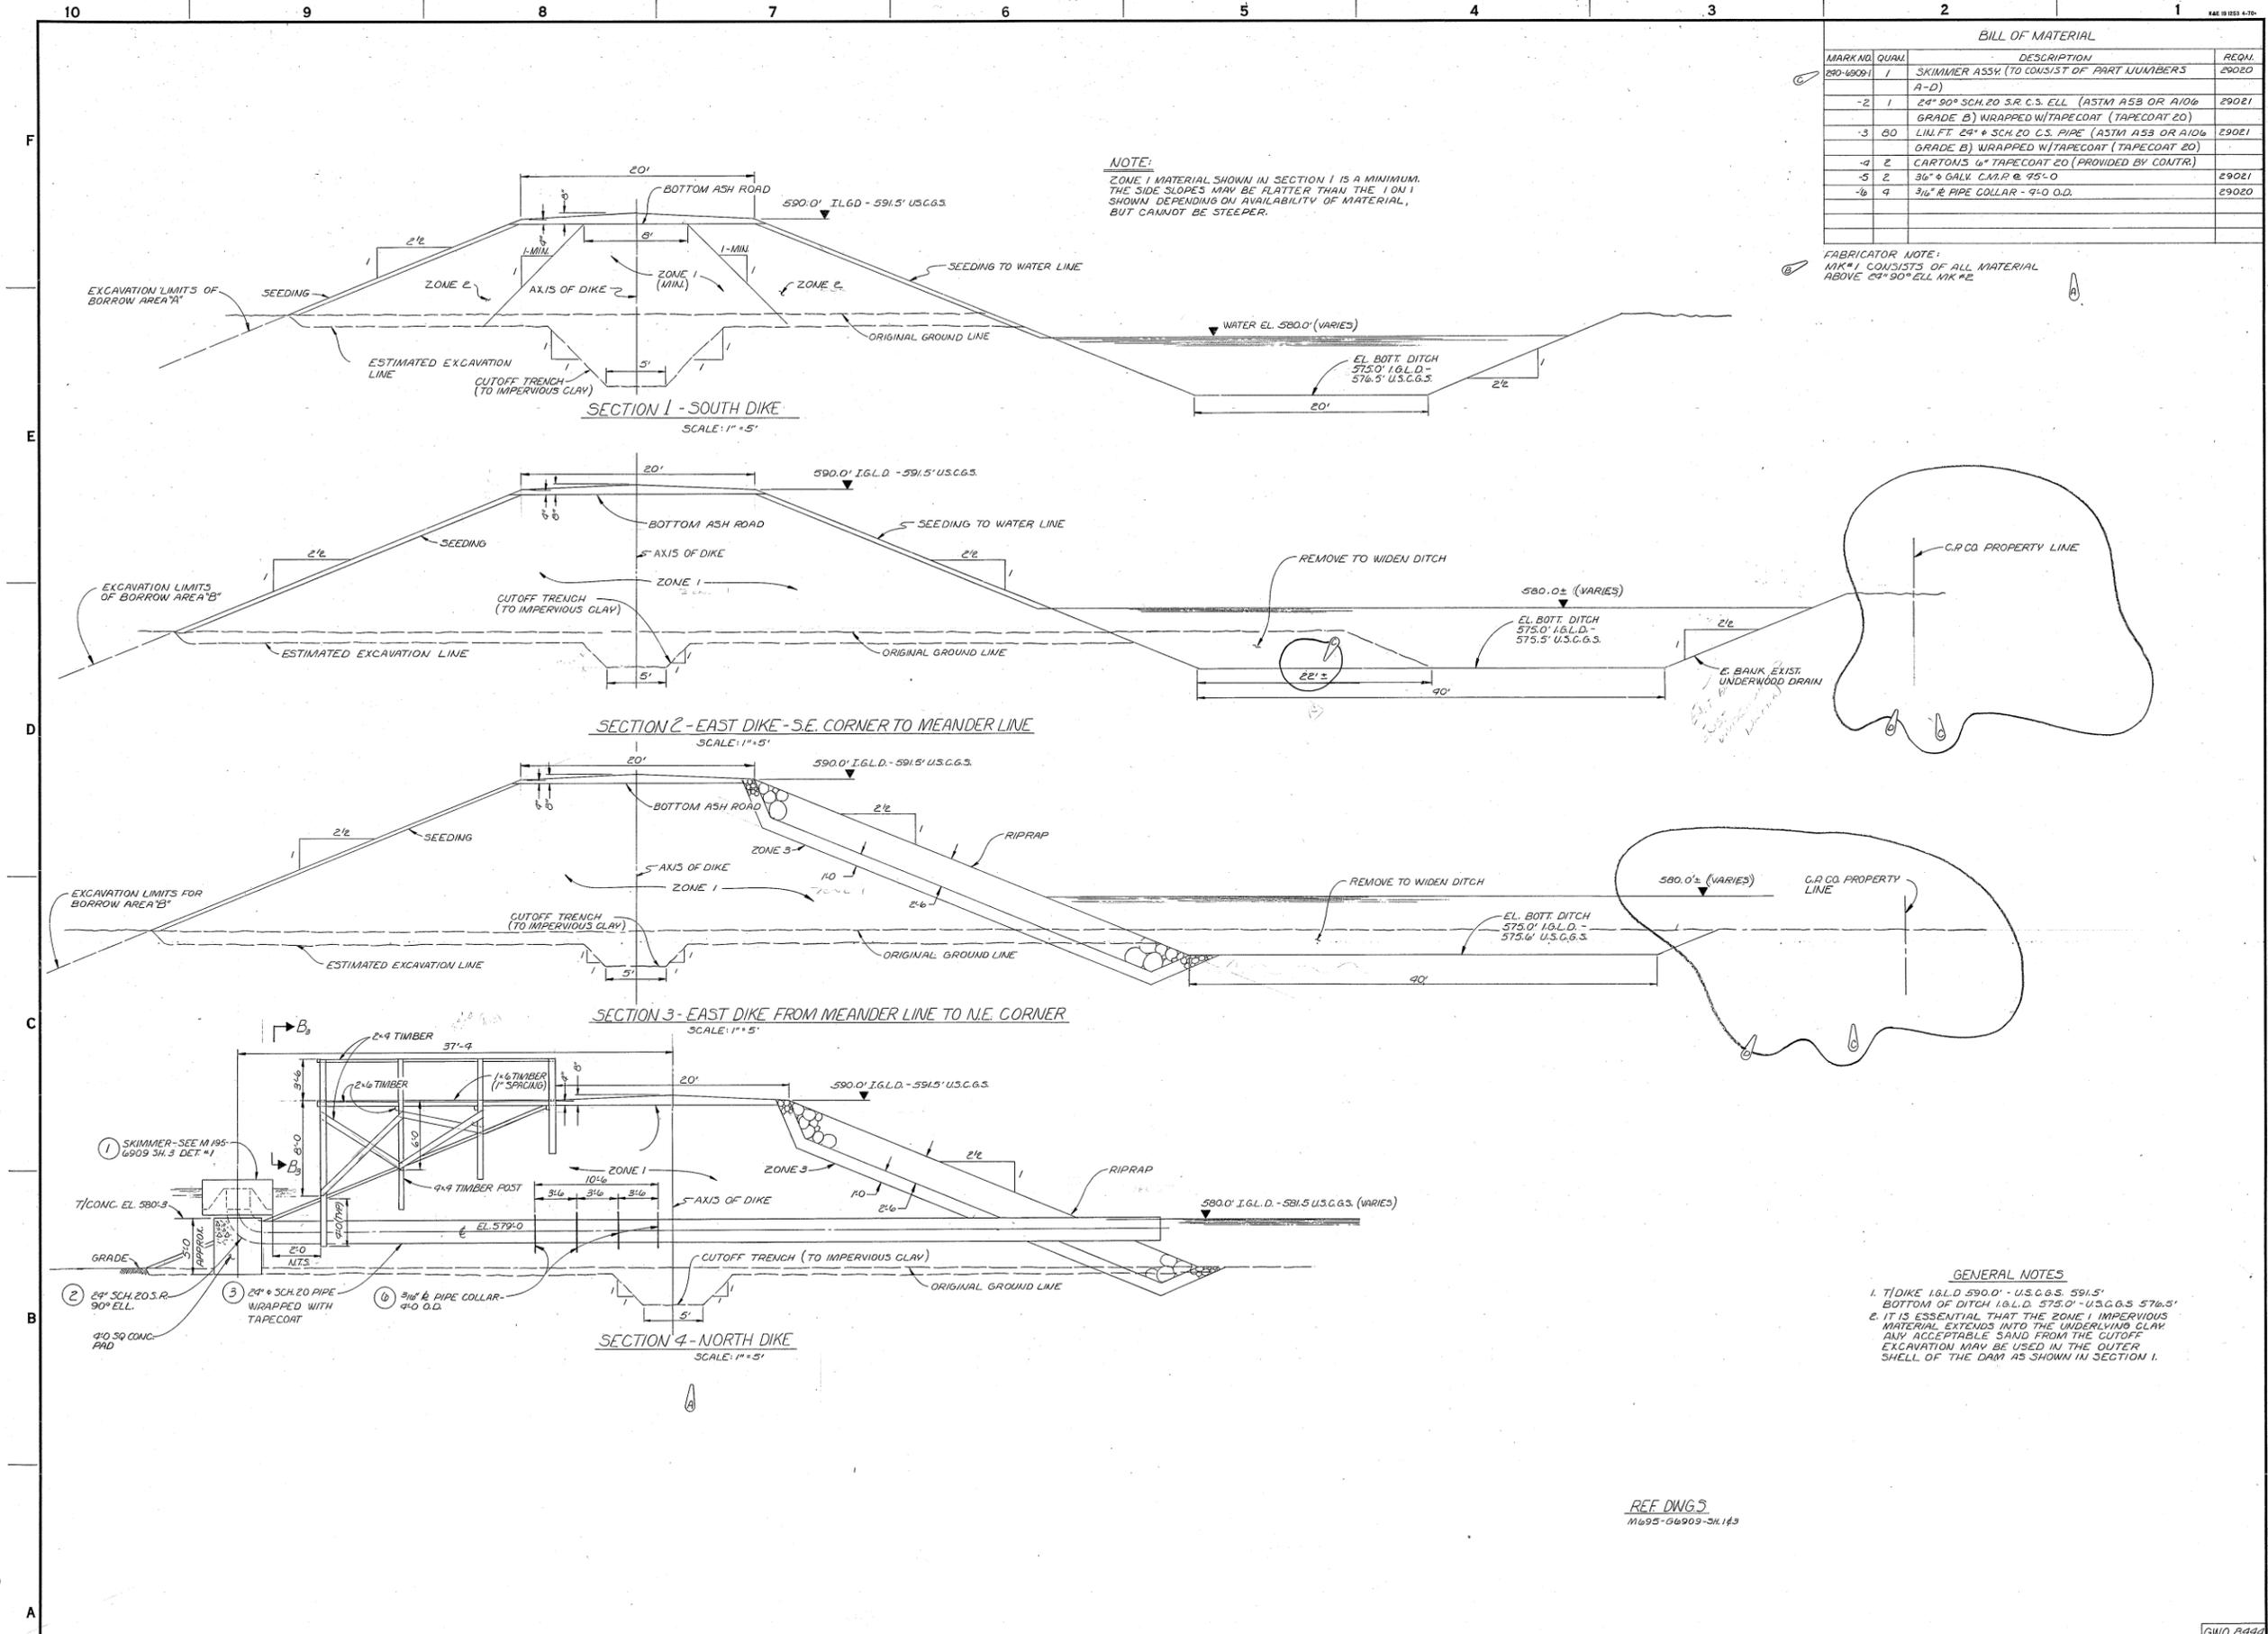
Figure 5

NOTE:
 ZONE 1 MATERIAL SHOWN IN SECTION 1 IS A MINIMUM. THE SIDE SLOPES MAY BE FLATTER THAN THE 10:1 SHOWN, DEPENDING ON AVAILABILITY OF MATERIAL, BUT CANNOT BE STEEPER.

GENERAL NOTES
 1. DIKE I.G.L.D. 590.0' - U.S.C.G.S. 591.5'
 BOTTOM OF DITCH I.G.L.D. 575.0' - U.S.C.G.S. 576.5'
 2. IT IS ESSENTIAL THAT THE ZONE 1 IMPERVIOUS MATERIAL EXTENDS INTO THE UNDERLYING CLAY. ANY ACCEPTABLE SAND FROM THE CUTOFF EXCAVATION MAY BE USED IN THE OUTER SHELL OF THE DAM AS SHOWN IN SECTION 1.

The east portion of the containment area was expanded in 1971 and the perimeter dikes were raised to elevation 590 feet IGLD85. Details of that construction event can be seen on Figures 4 and 5. The purpose of raising the perimeter dike was to construct a clay perimeter dike that keyed into the hydraulic confining glacial clay till layer located approximately 20 to 25 feet below the current ground surface. This clay dike was designed to prevent any potentially contaminated groundwater from seeping through the dike into Saginaw Bay from the disposal facility. However, later studies conducted revealed that this clay dike was not effectively keyed into a confining layer (CPC, 1992a).

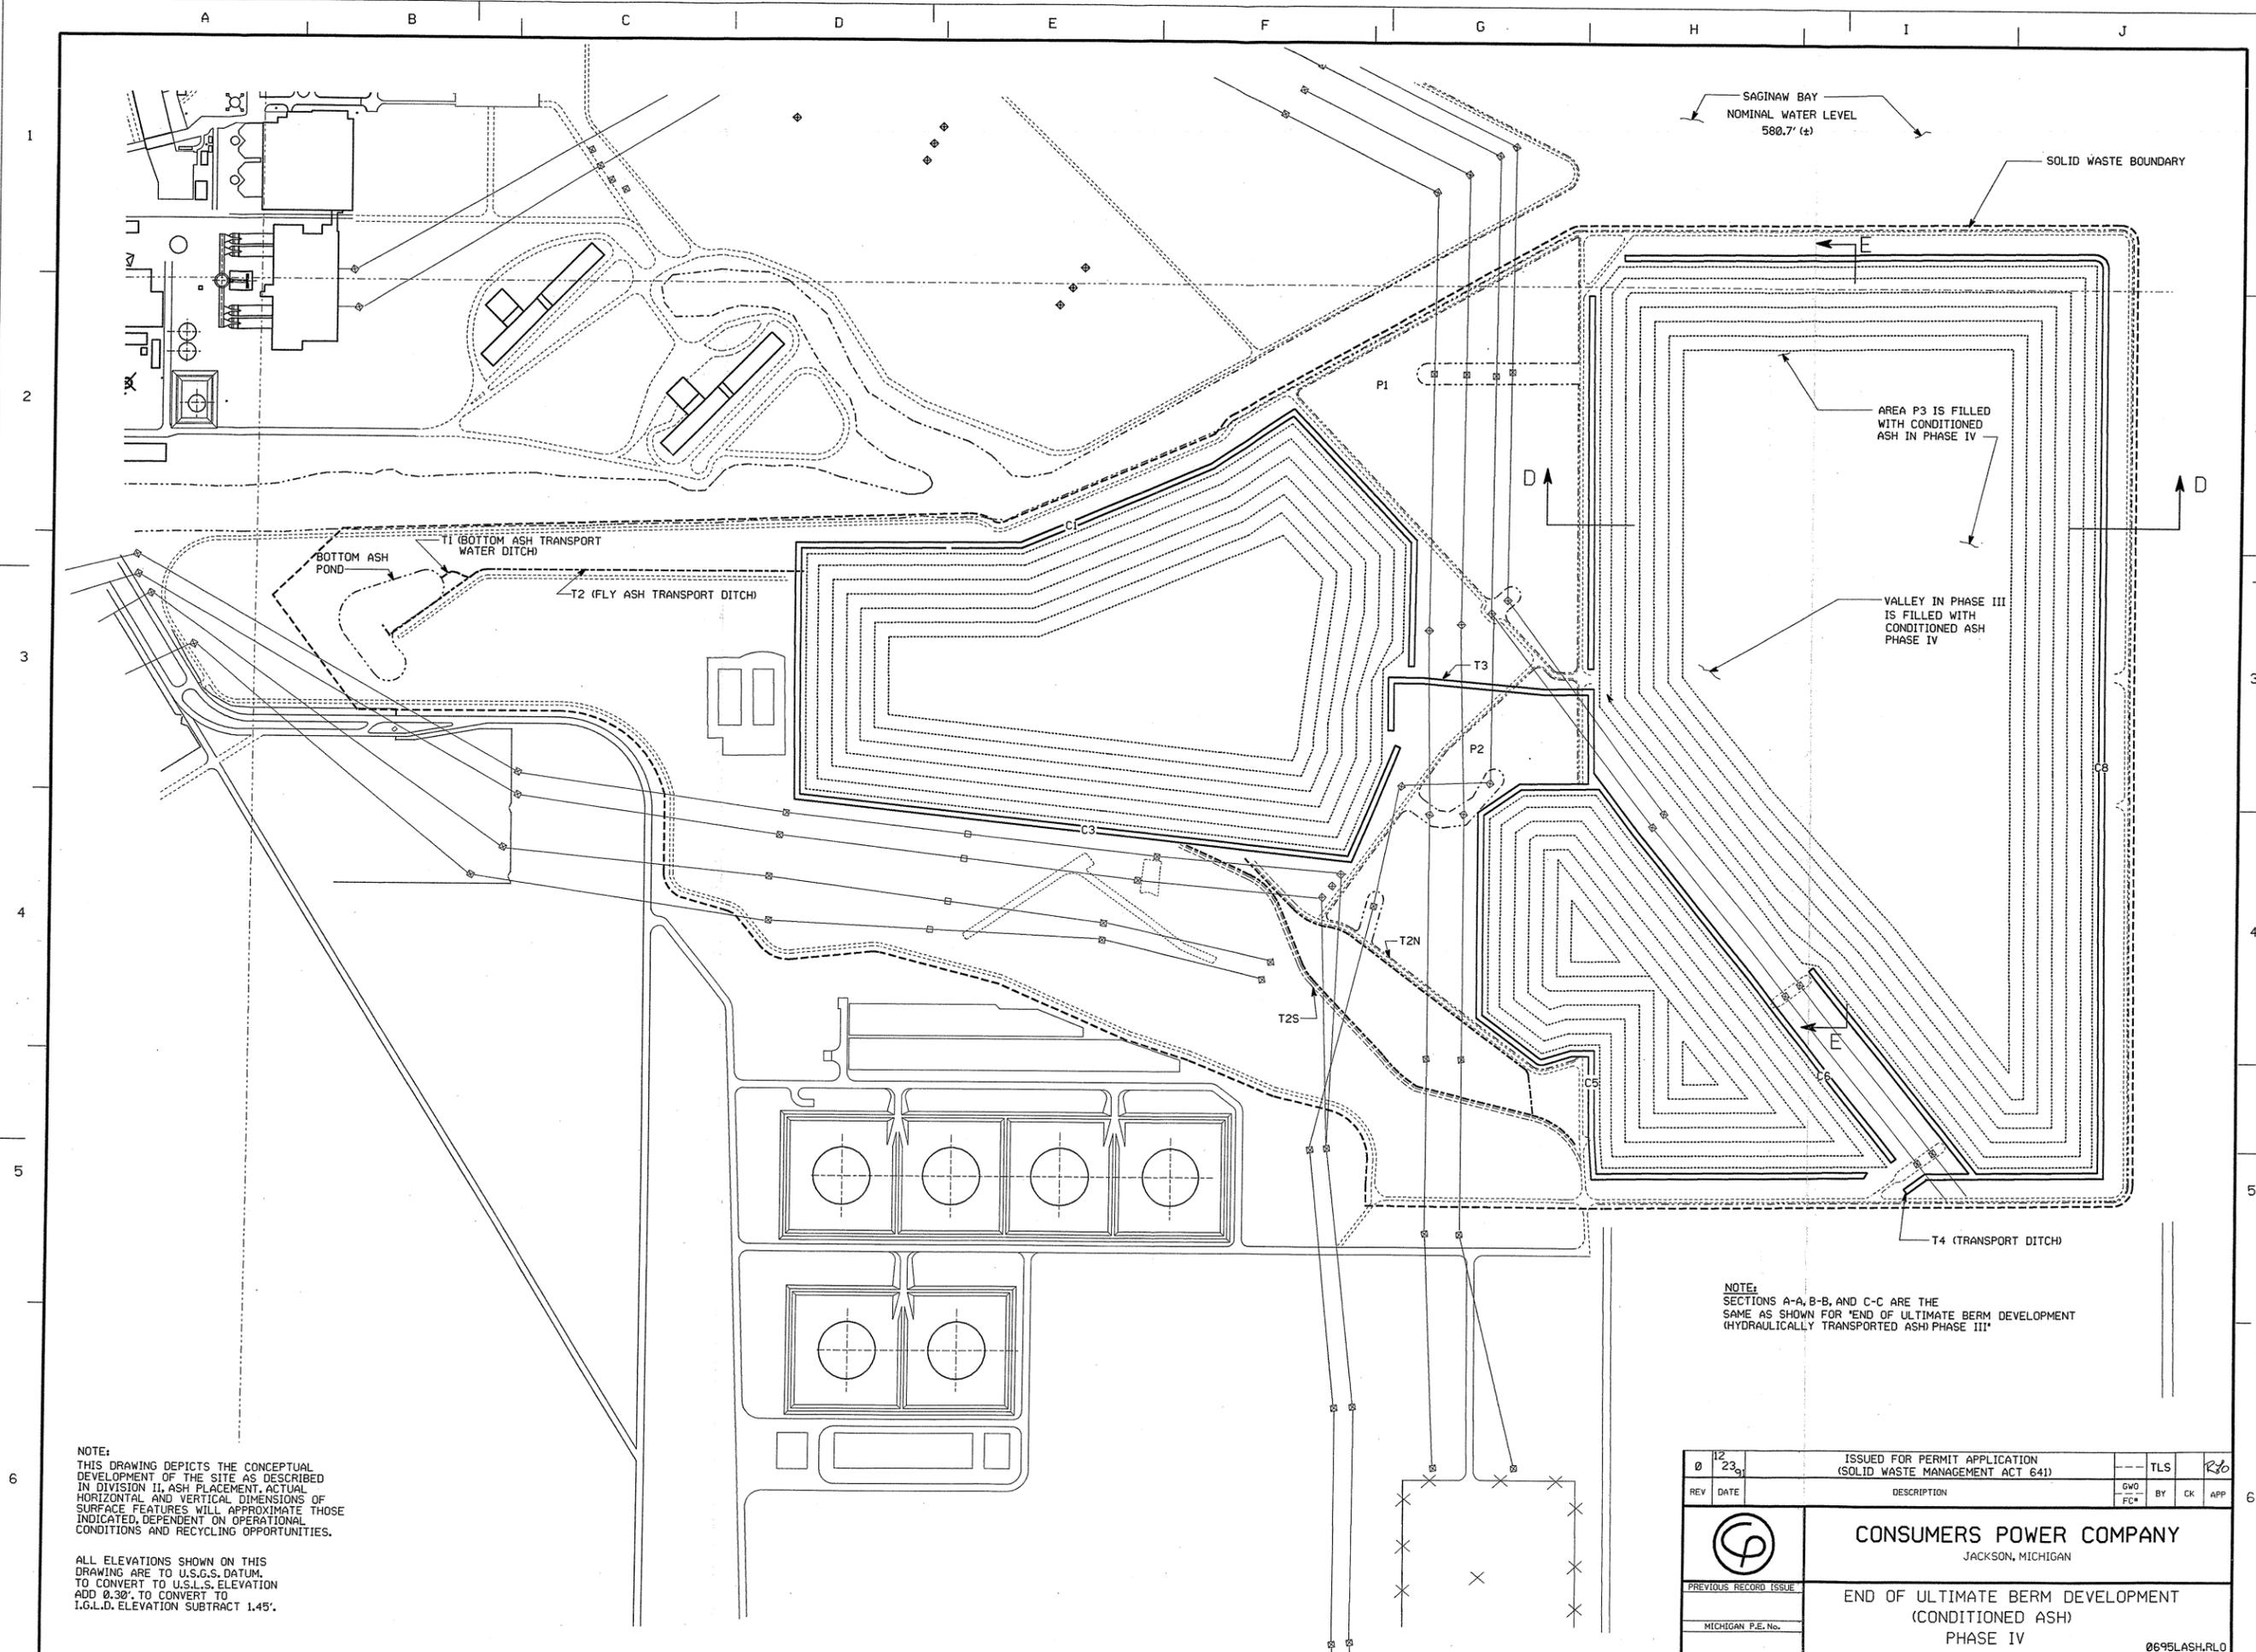
Figure 8

NOTE:
 THIS DRAWING DEPICTS THE CONCEPTUAL DEVELOPMENT OF THE SITE AS DESCRIBED IN DIVISION II, ASH PLACEMENT. ACTUAL HORIZONTAL AND VERTICAL DIMENSIONS OF SURFACE FEATURES WILL APPROXIMATE THOSE INDICATED, DEPENDENT ON OPERATIONAL CONDITIONS AND RECYCLING OPPORTUNITIES.

Water surface elevations can vary in Saginaw Bay due to wind setup and storms. A fluctuation of several feet has been observed by plant staff in the event of a strong northerly or easterly wind. The wind blows lake water into the Saginaw Bay causing the water surface elevation to rise. Waves created by the wind can also reach the perimeter dikes. It is possible to experience large waves since the fetch to the perimeter dike facing the bay is over 100 miles on the north side of the facility along Pond F. To reduce the impact of rising water surface elevations and large waves on the perimeter dike, shoreline protection was installed in 1973 along the Saginaw Bay portions of the perimeter dike. Details of this protection can be seen on Figure 8.

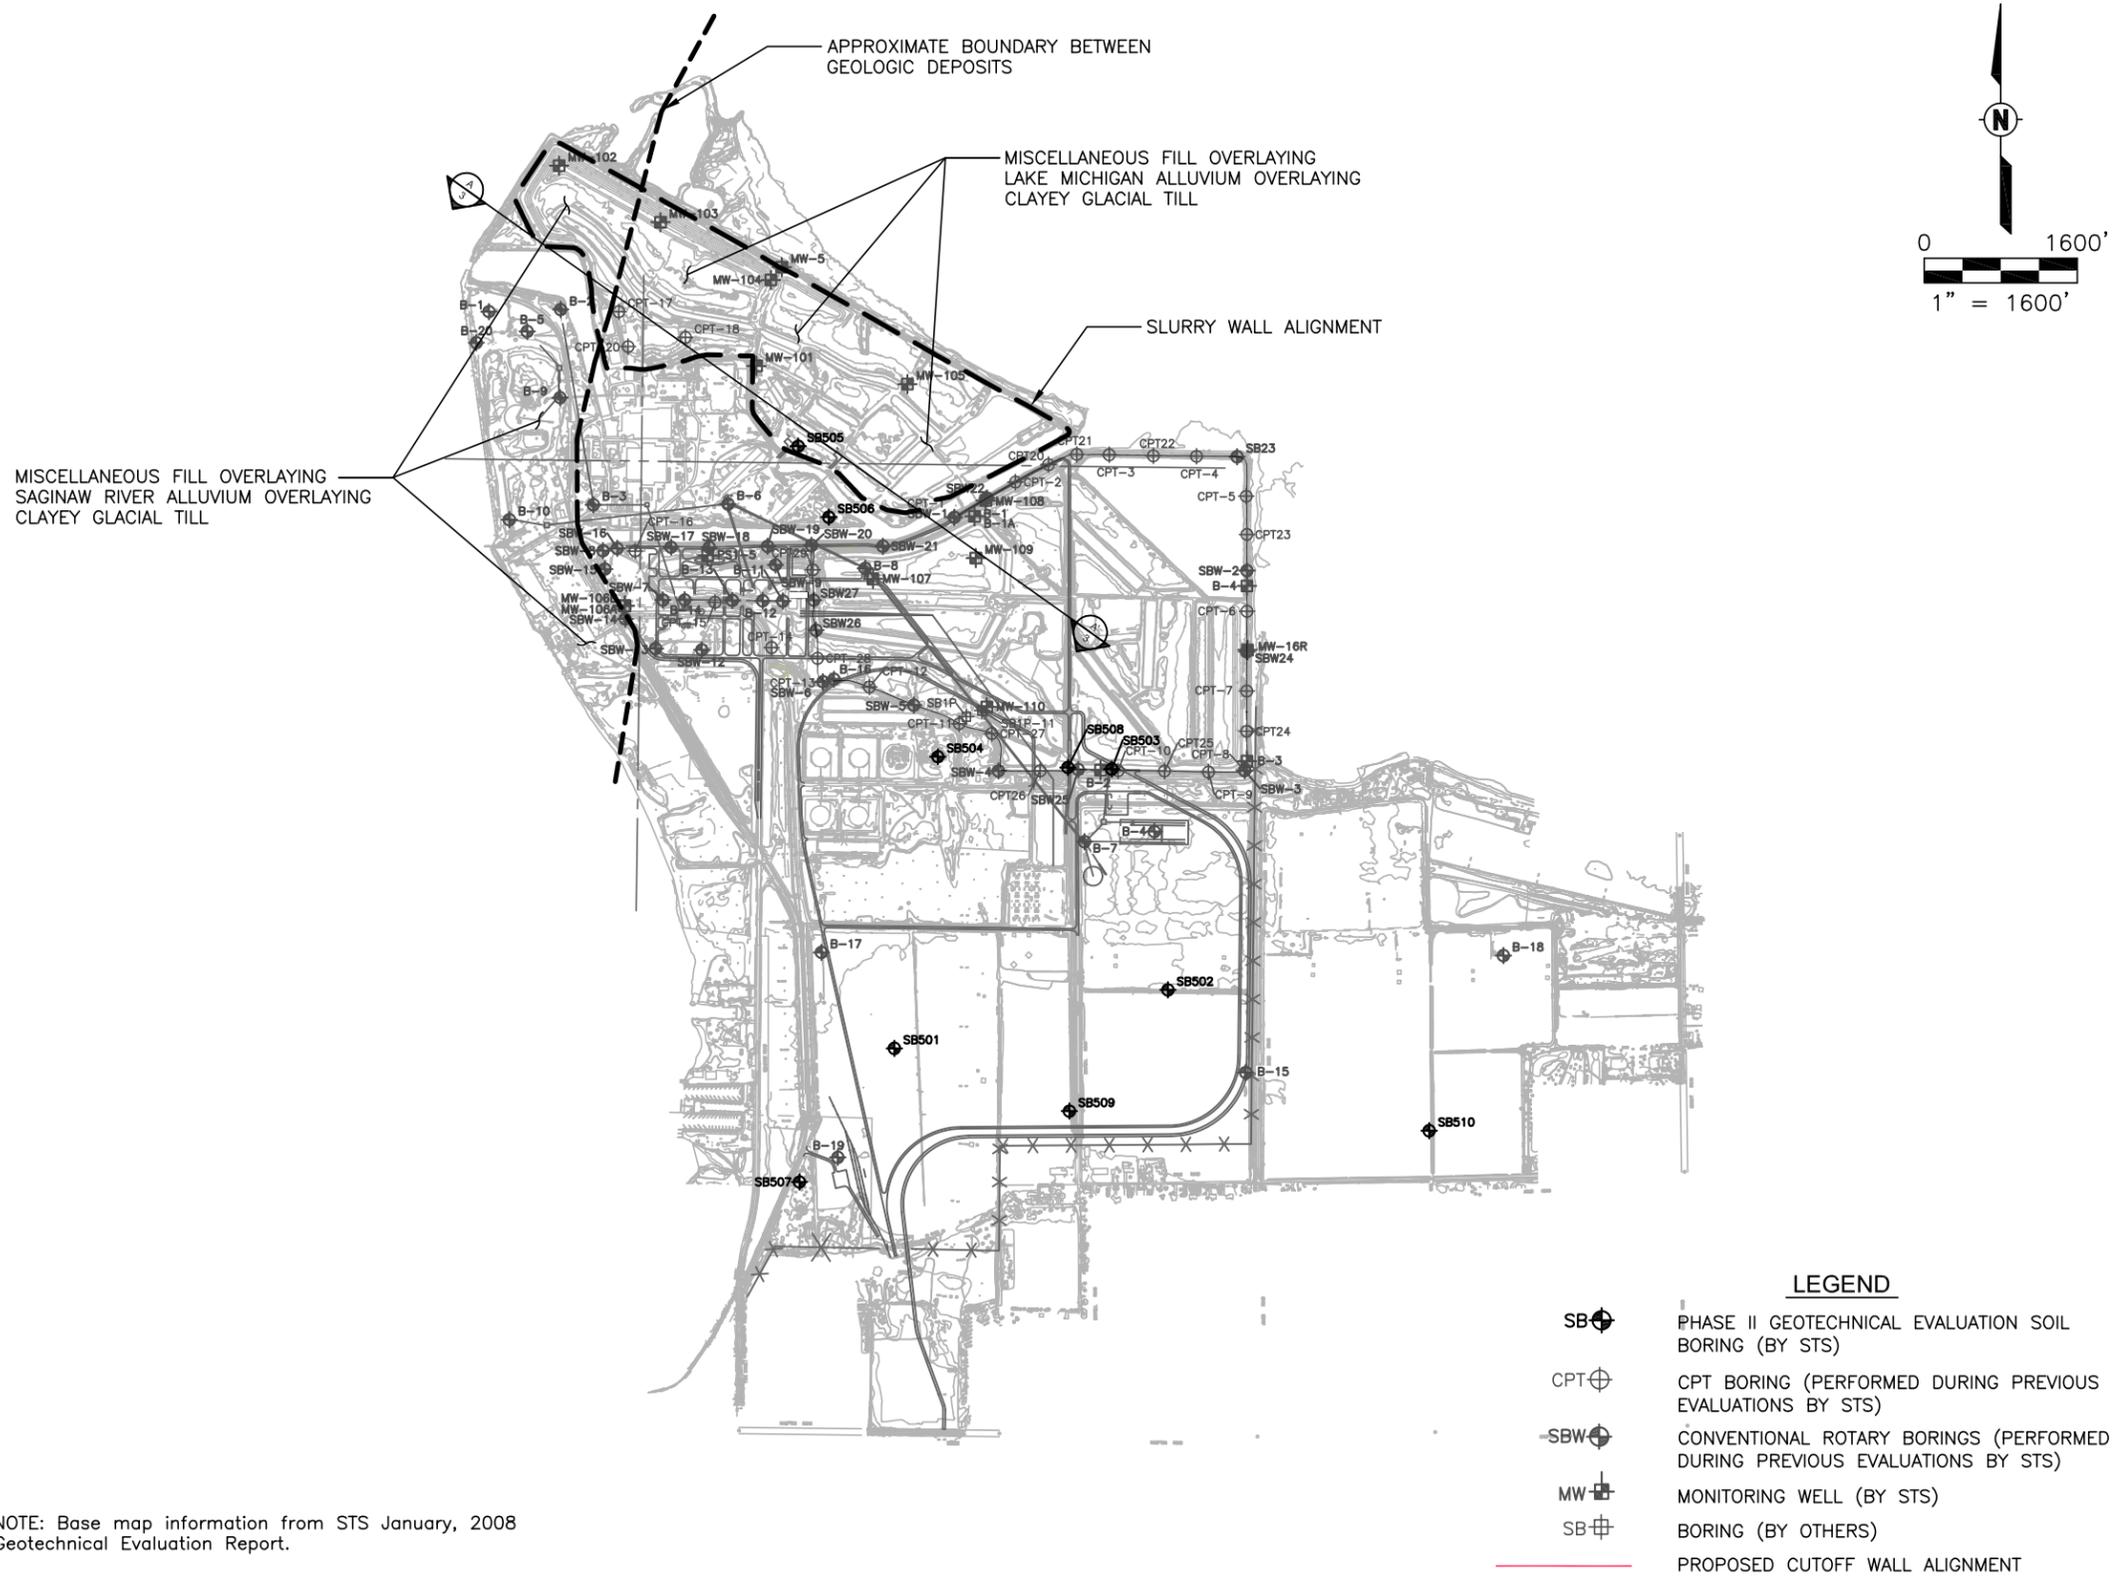
Drawn :	LDJ	06/18/2009
Checked:	MFP	06/18/2009
Approved:		
PROJECT NUMBER		
FIGURE NUMBER	10

OVER ALL SITE PLAN
 KARN ASH LANDFILL SLURRY WALL
 FEASIBILITY STUDY
 CONSUMERS ENERGY COMPANY
 D.E. KARN AND J.C. WEADOCK GENERATING FACILITIES
 ESSEXVILLE, MICHIGAN

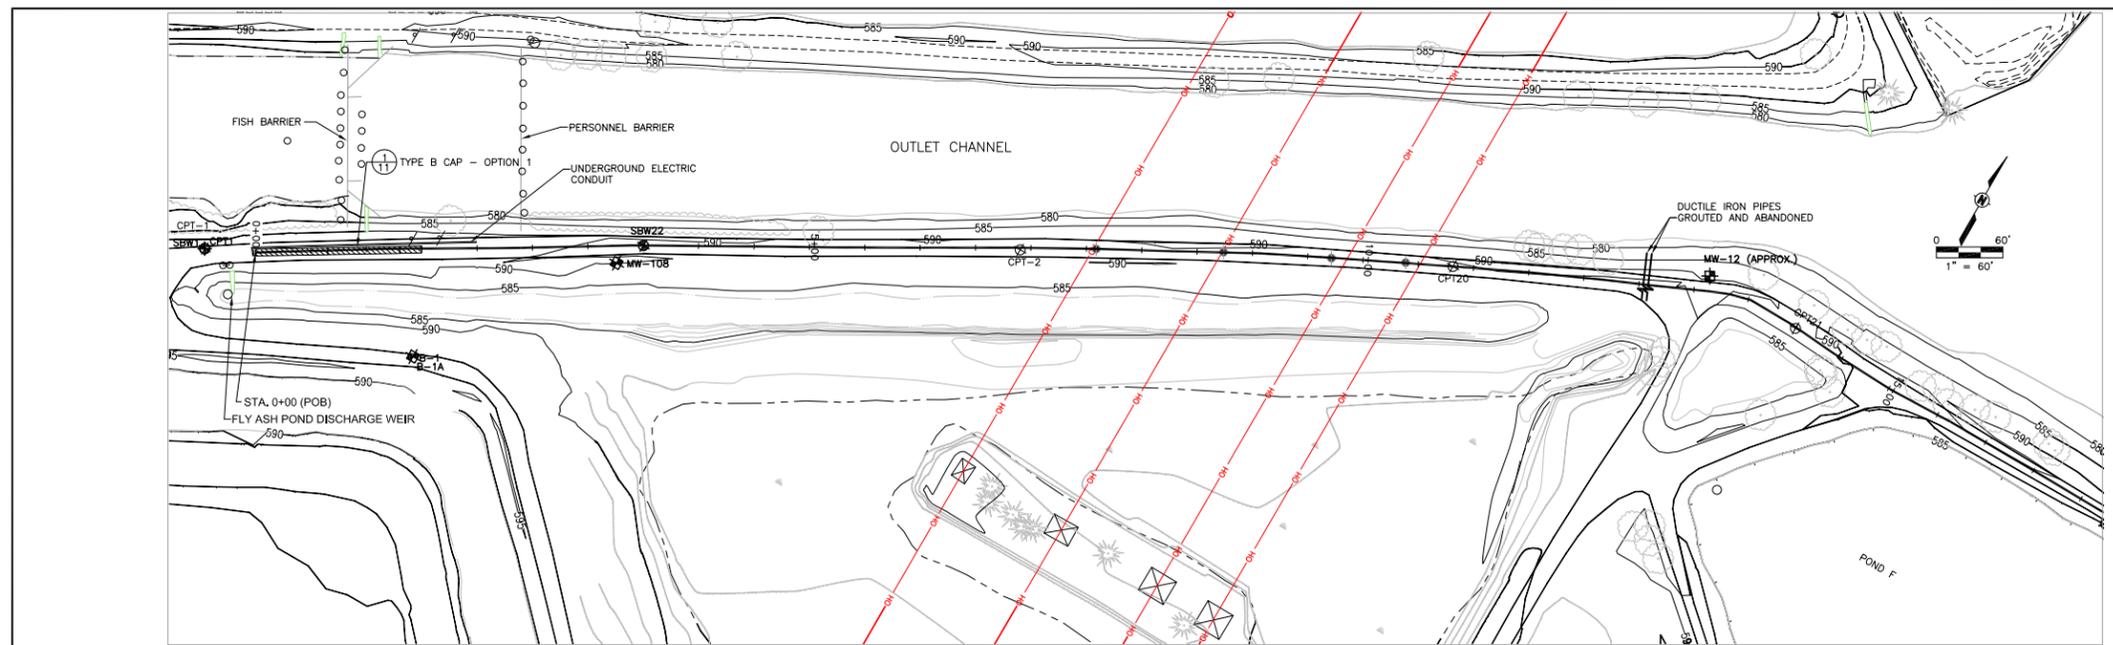
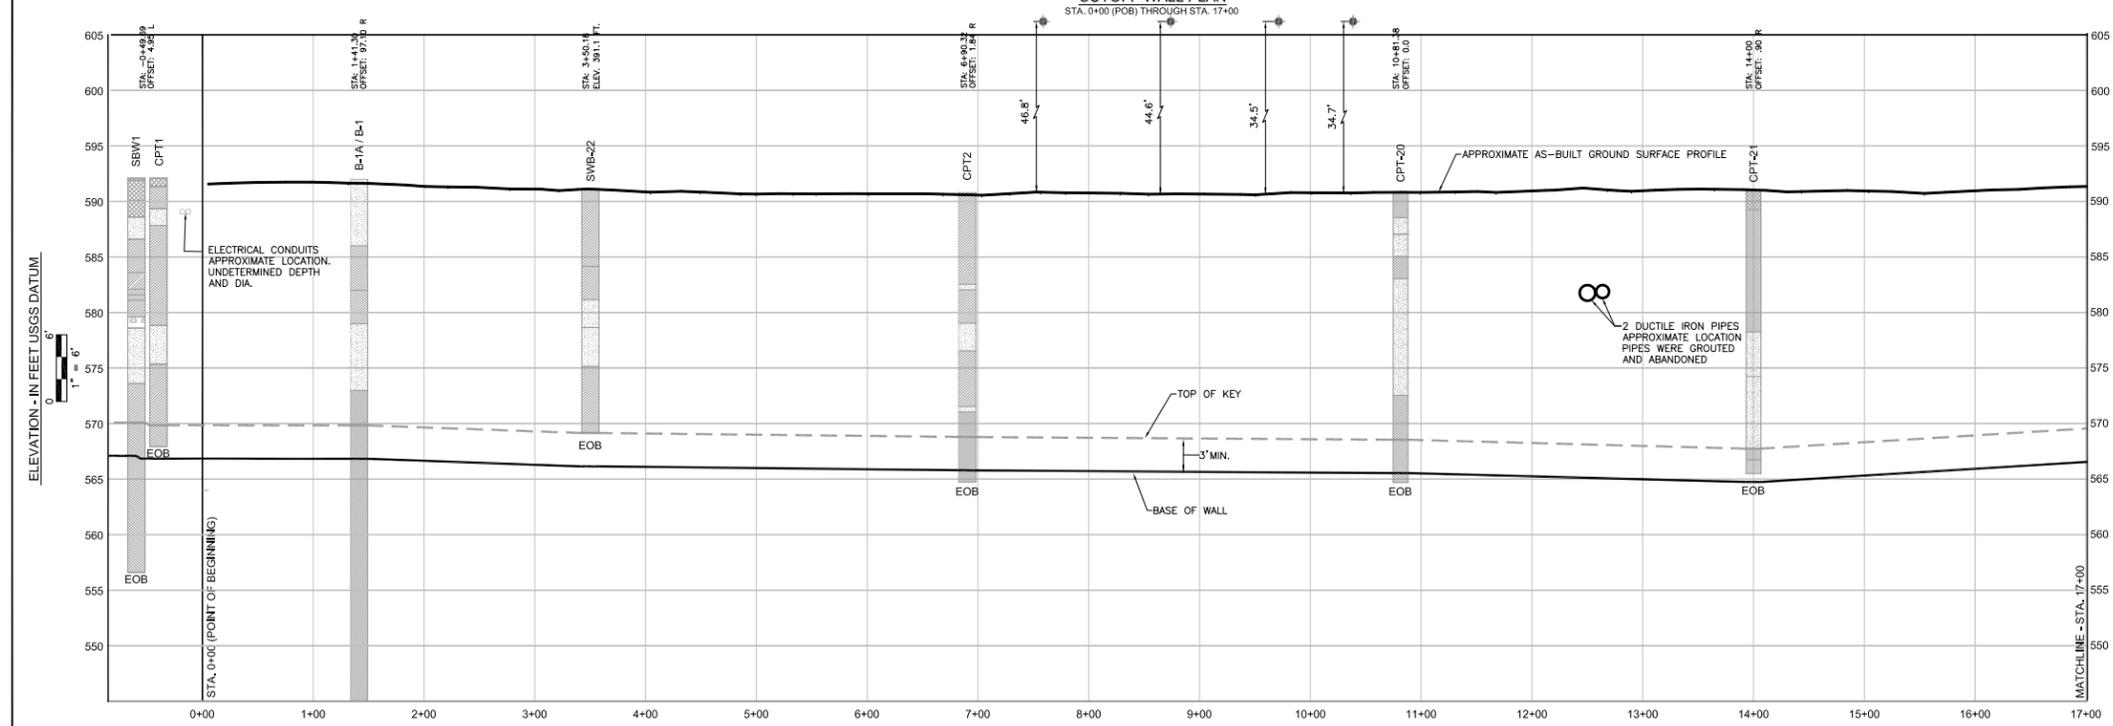
SCALE	DRAWING NO.	SHEET	REV.
JOB	195-6909	SH25	A

FLY ASH SLURRY WALL
STA 0+00 TO STA 17+00
WITH BORING DATA

Many soil borings have been drilled at the project site. Figure 13 shows the known locations of the boreholes and Figures 14, 15, 16, 17, 18, 19, 20, and 21 shows a generalized profile of the subsurface conditions along the perimeter dike where the slurry wall was installed. Soil boring information generally supports the local geologic conditions and dike construction described in the paragraphs above. Copies of soil boring logs and laboratory test results are included on the attached CD.

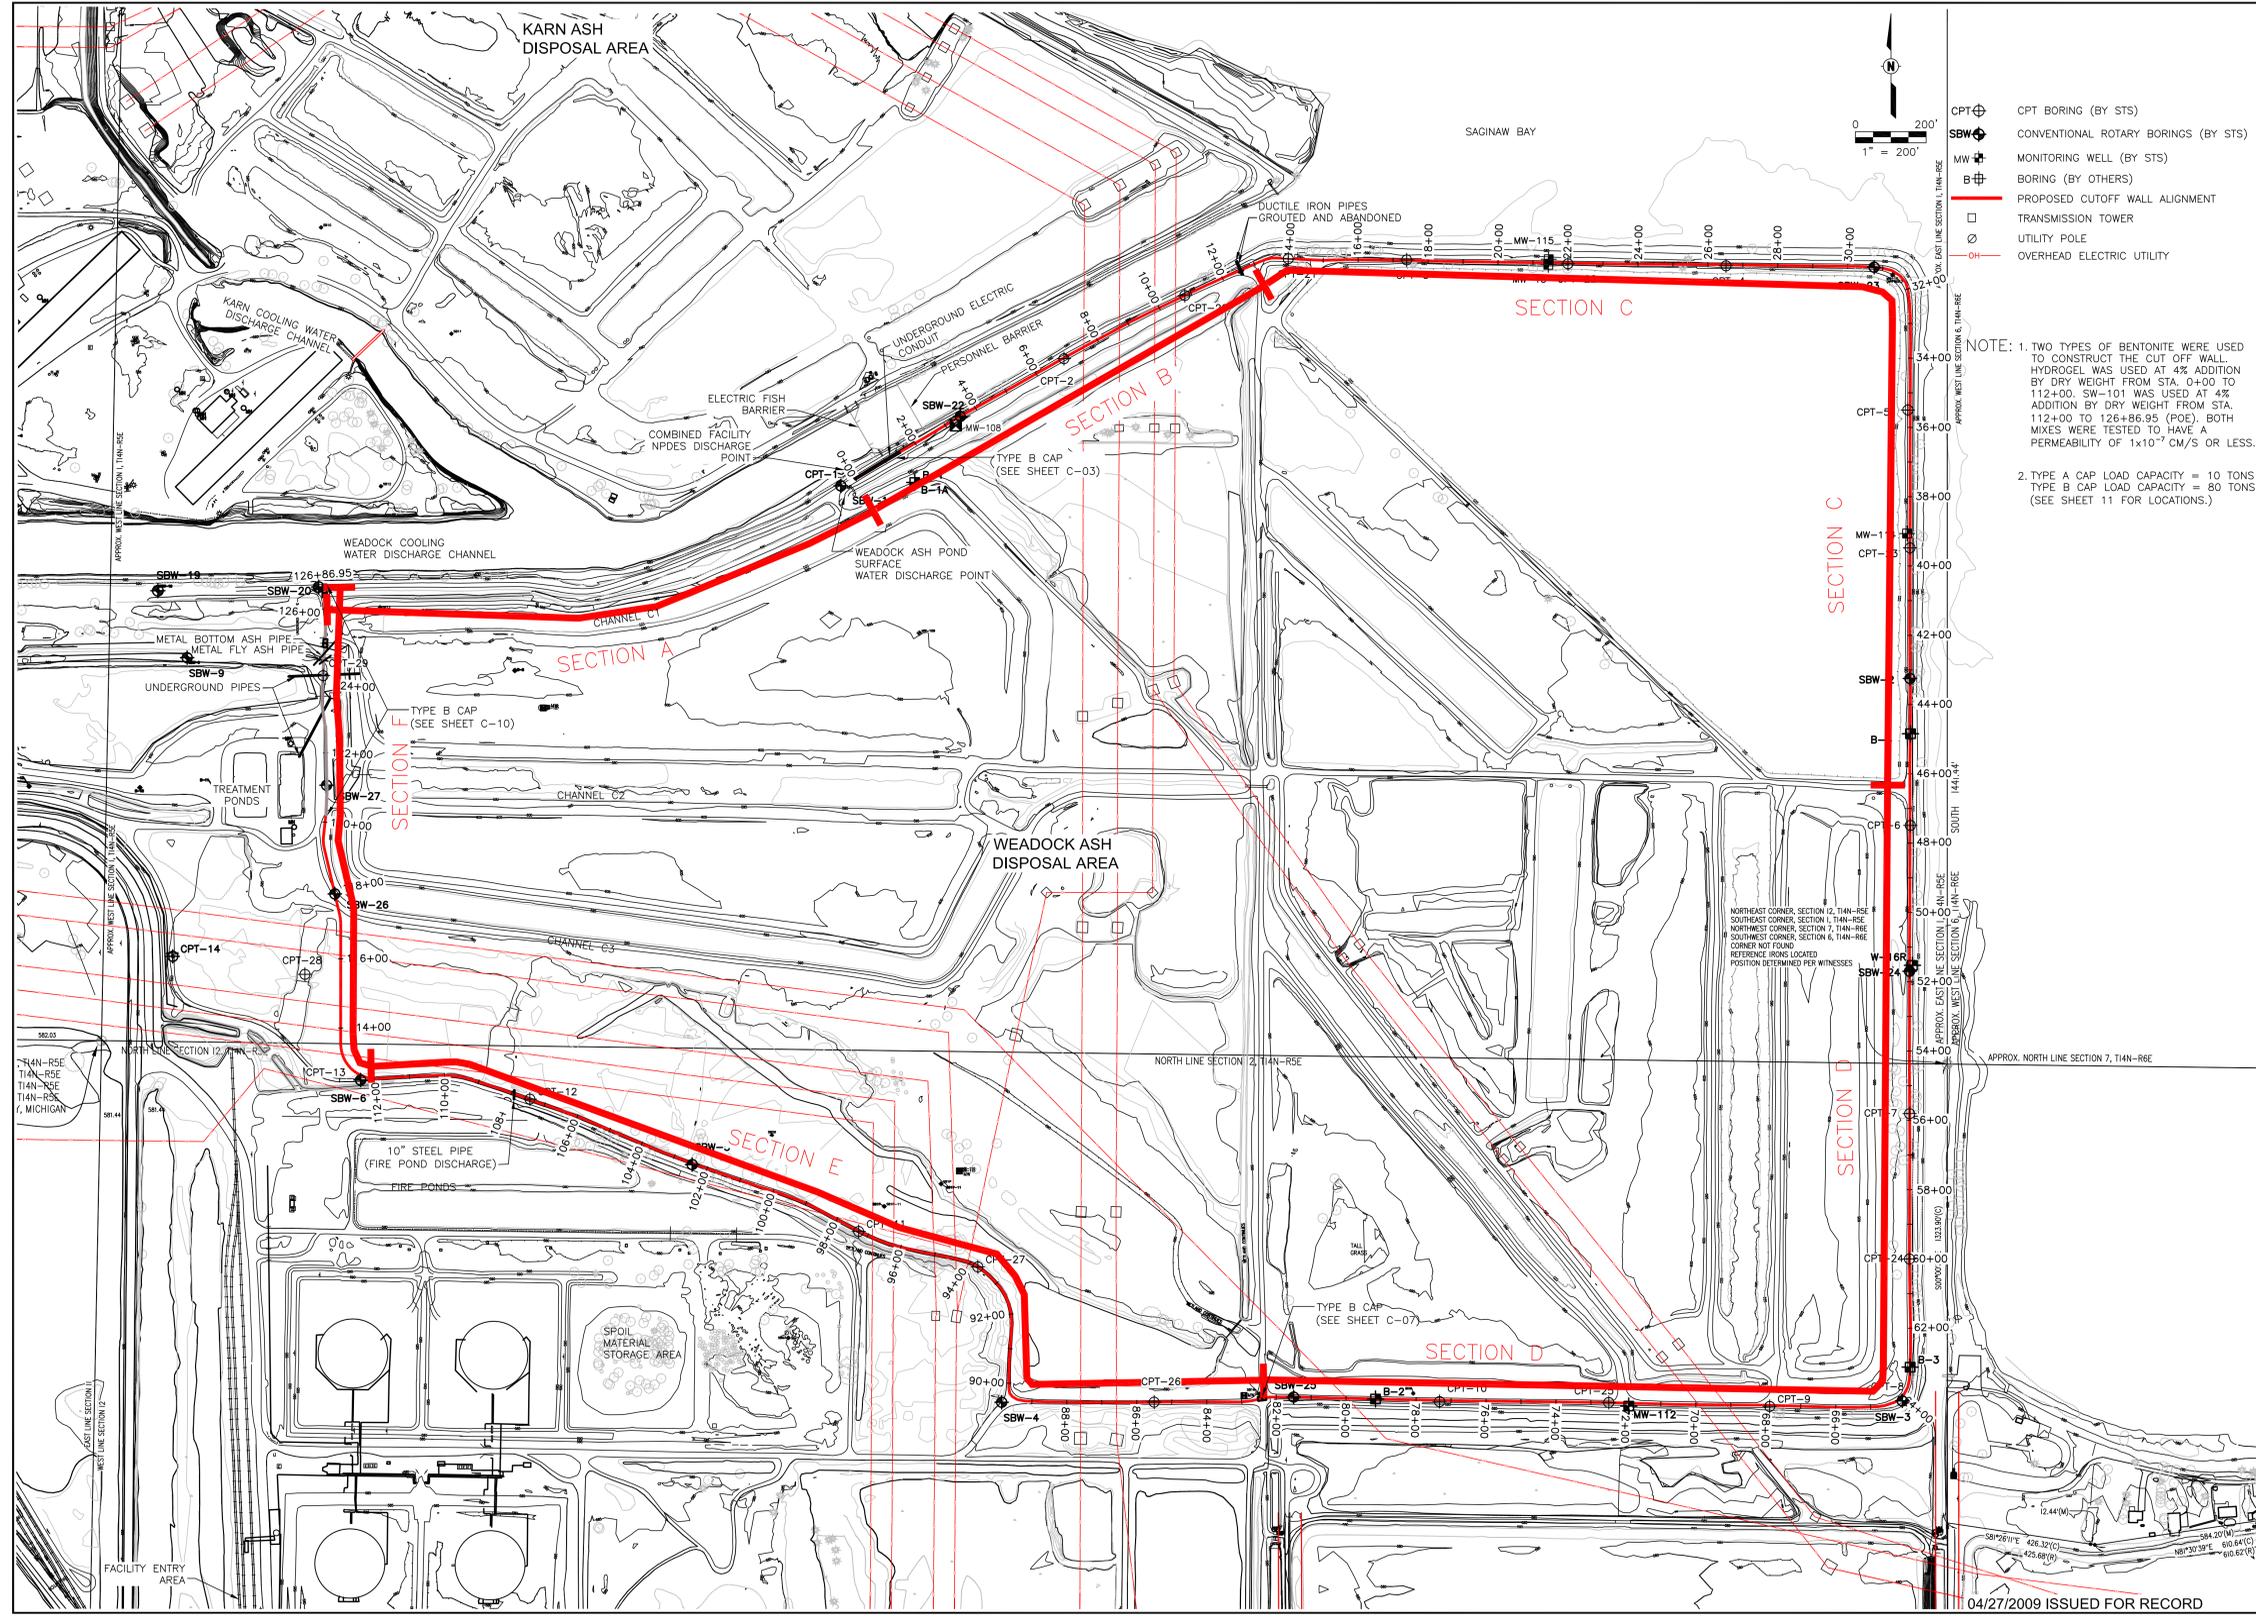
- Legend:**
- CPT ⊕ CPT BORING (BY STS)
 - SBW ⊕ CONVENTIONAL ROTARY BORINGS (BY STS)
 - MW ⊕ MONITORING WELL (BY STS)
 - B ⊕ BORING (BY OTHERS)
 - PROPOSED CUTOFF WALL ALIGNMENT
 - TRANSMISSION TOWER
 - UTILITY POLE
 - OVERHEAD ELECTRIC UTILITY
- NOTE:**
- TWO TYPES OF BENTONITE WERE USED TO CONSTRUCT THE CUT OFF WALL. HYDROGEL WAS USED AT 4% ADDITION BY DRY WEIGHT FROM STA. 0+00 TO 112+00. SW-101 WAS USED AT 4% ADDITION BY DRY WEIGHT FROM STA. 112+00 TO 126+86.95 (POE). BOTH MIXES WERE TESTED TO HAVE A PERMEABILITY OF 1×10^{-7} CM/S OR LESS.
 - TYPE A CAP LOAD CAPACITY = 10 TONS
 TYPE B CAP LOAD CAPACITY = 80 TONS
 (SEE SHEET 11 FOR LOCATIONS.)

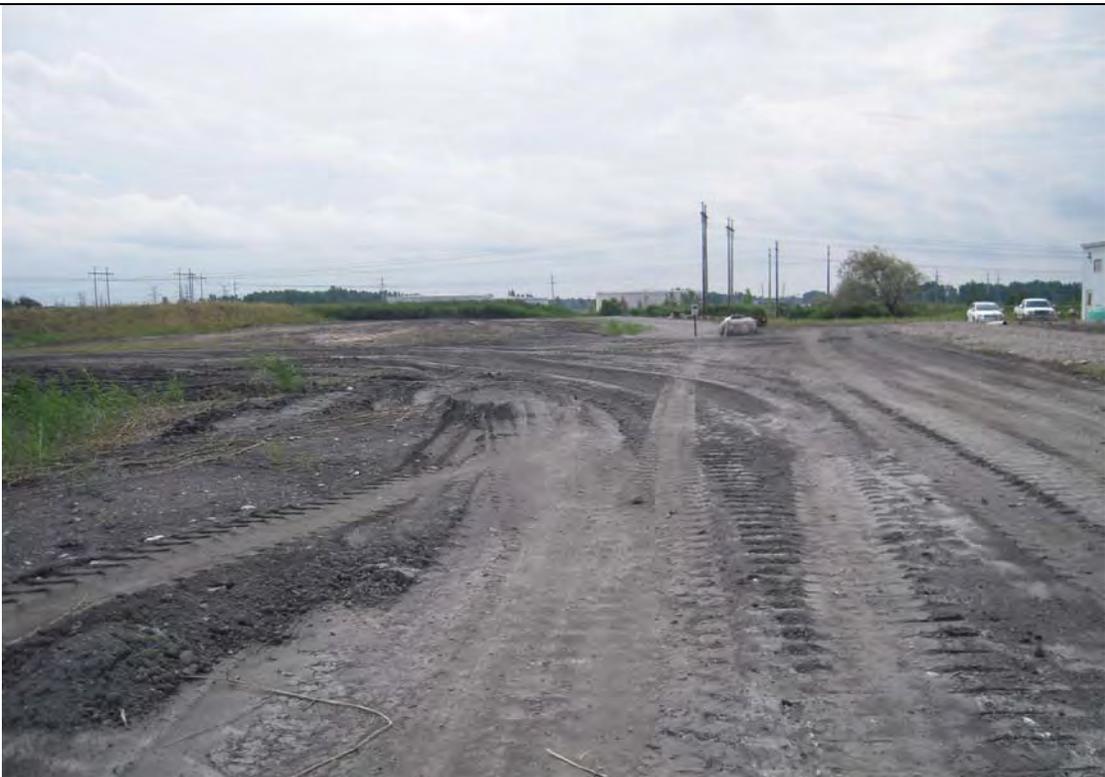
Photo No.: 2	Date: 8/17/09

Direction Photo Taken: South				
Description: Interior dike with slurry wall to the east of the chemical treatment ponds.

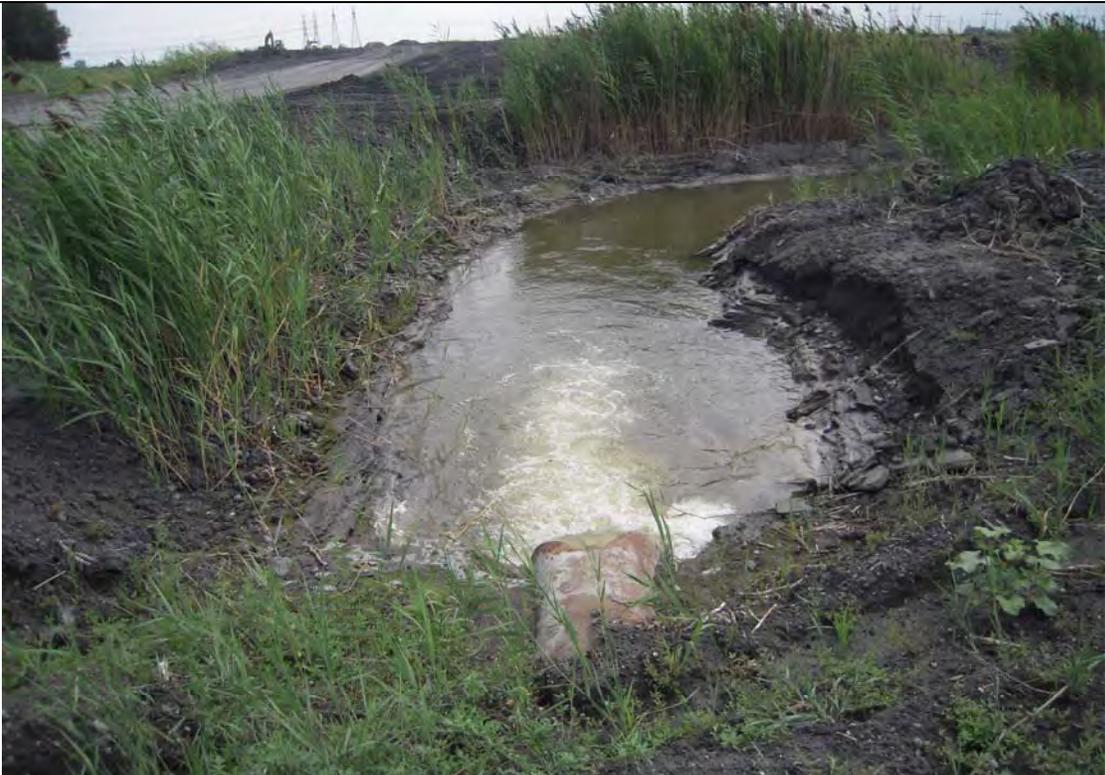
Photo No.: 4	Date: 8/17/09

Direction Photo Taken: East				
Description: Interior sluice channel culvert between channels.

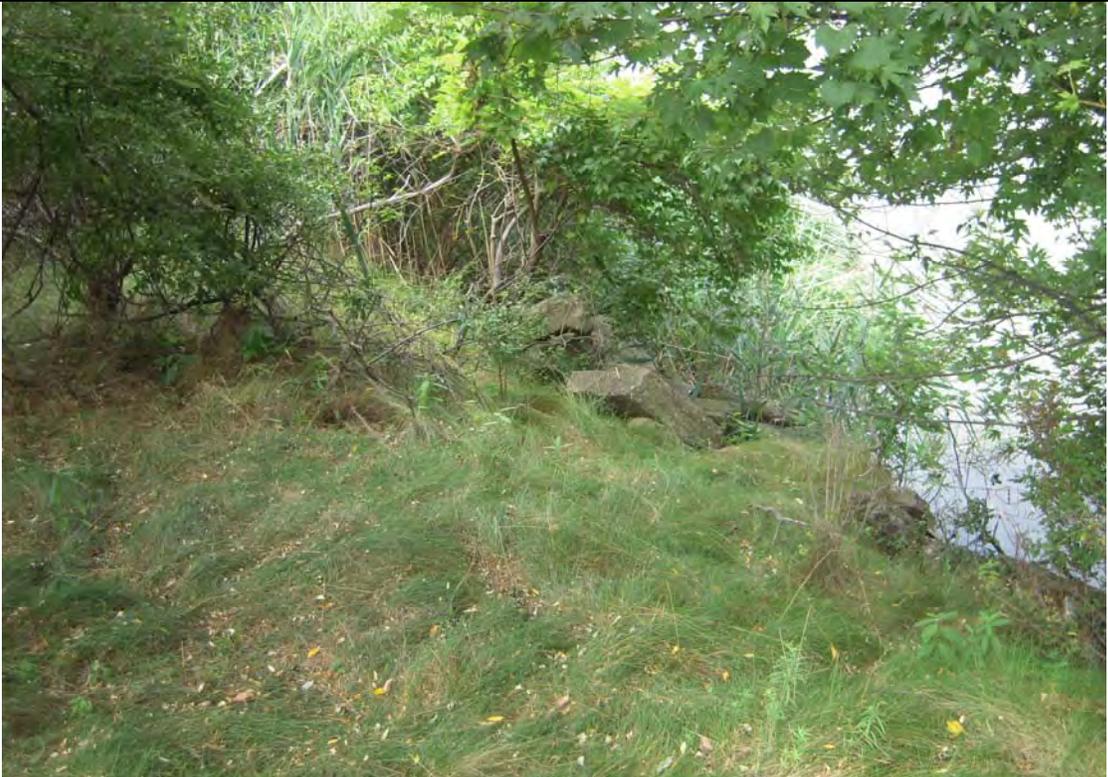
Client Name: Consumers Energy Company		Site Location: J.C. Weadock Ash Disposal Area		Project No.: 60100985
Photo No. 5	Date: 8/17/09

Direction Photo Taken: Northwest				
Description: View of perimeter dike exterior slope in the discharge channel upstream from the electric fish barrier.

The inspection team walked the crest and along the downstream and upstream slopes of the perimeter dike. Overall, the slopes that could be observed appeared to be in good condition and free of any erosion, cracking, or signs of movement (Photos 5, 9, 10, 11, 12, 16 and 19). The crest is generally uniform with no visible signs of vertical settlement, lateral moving, or cracking (Photo 2, 13, 15 and 22). Some erosion of the crest was noted near the fire ponds (Photos 23 and 24). The ash landfill slope was lightly vegetated (Photo 21). Trees were observed on the ash slope and within the storm water drainage ditch (Photos 5, 12, 15 and 16). The downstream slope of the perimeter dike ranges from an estimated 1.5H:1V to 4H:1V along the discharge channel, Saginaw Bay, and Tacey and Underwood Drains. The ground is generally flat along the southern and western perimeter of the project where there is no apparent dike (Photo 22). Trees were growing on a majority of the containment dike slopes along with very tall grasses (phragmites, see Photos 5, 9, 10, 11, 12, 13, 15, 16, 17, 18, 19, 20, 23 and 24). Due to the amount of heavy vegetation, a conclusive visual inspection of the dike slopes could not be performed. However, areas with thinner vegetation where the slope could be seen appeared to be in good condition. Varying amounts and sizes of riprap were noted on the slopes (Photos 5, 10, 12, 16 and 19). However, riprap was not observed along portions of the dike slope along the discharge channel.

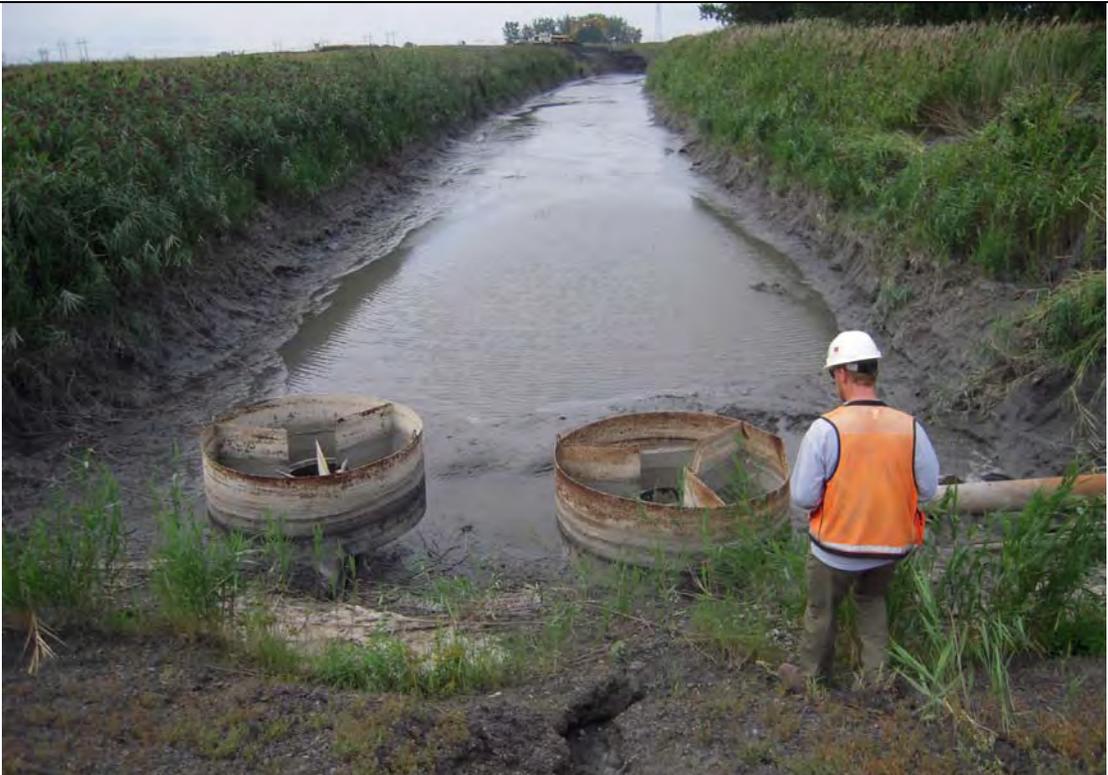
Photo No. 6	Date: 8/17/09

Direction Photo Taken: West				
Description: Typical drop structures and pipes between interior sluice channels.
