Final Third Five-Year Review Report for the Hudson River PCBs Superfund Site

APPENDIX 7

FIVE-YEAR REVIEW TEAM AND

Third Five-Year Review
Team Meeting #1

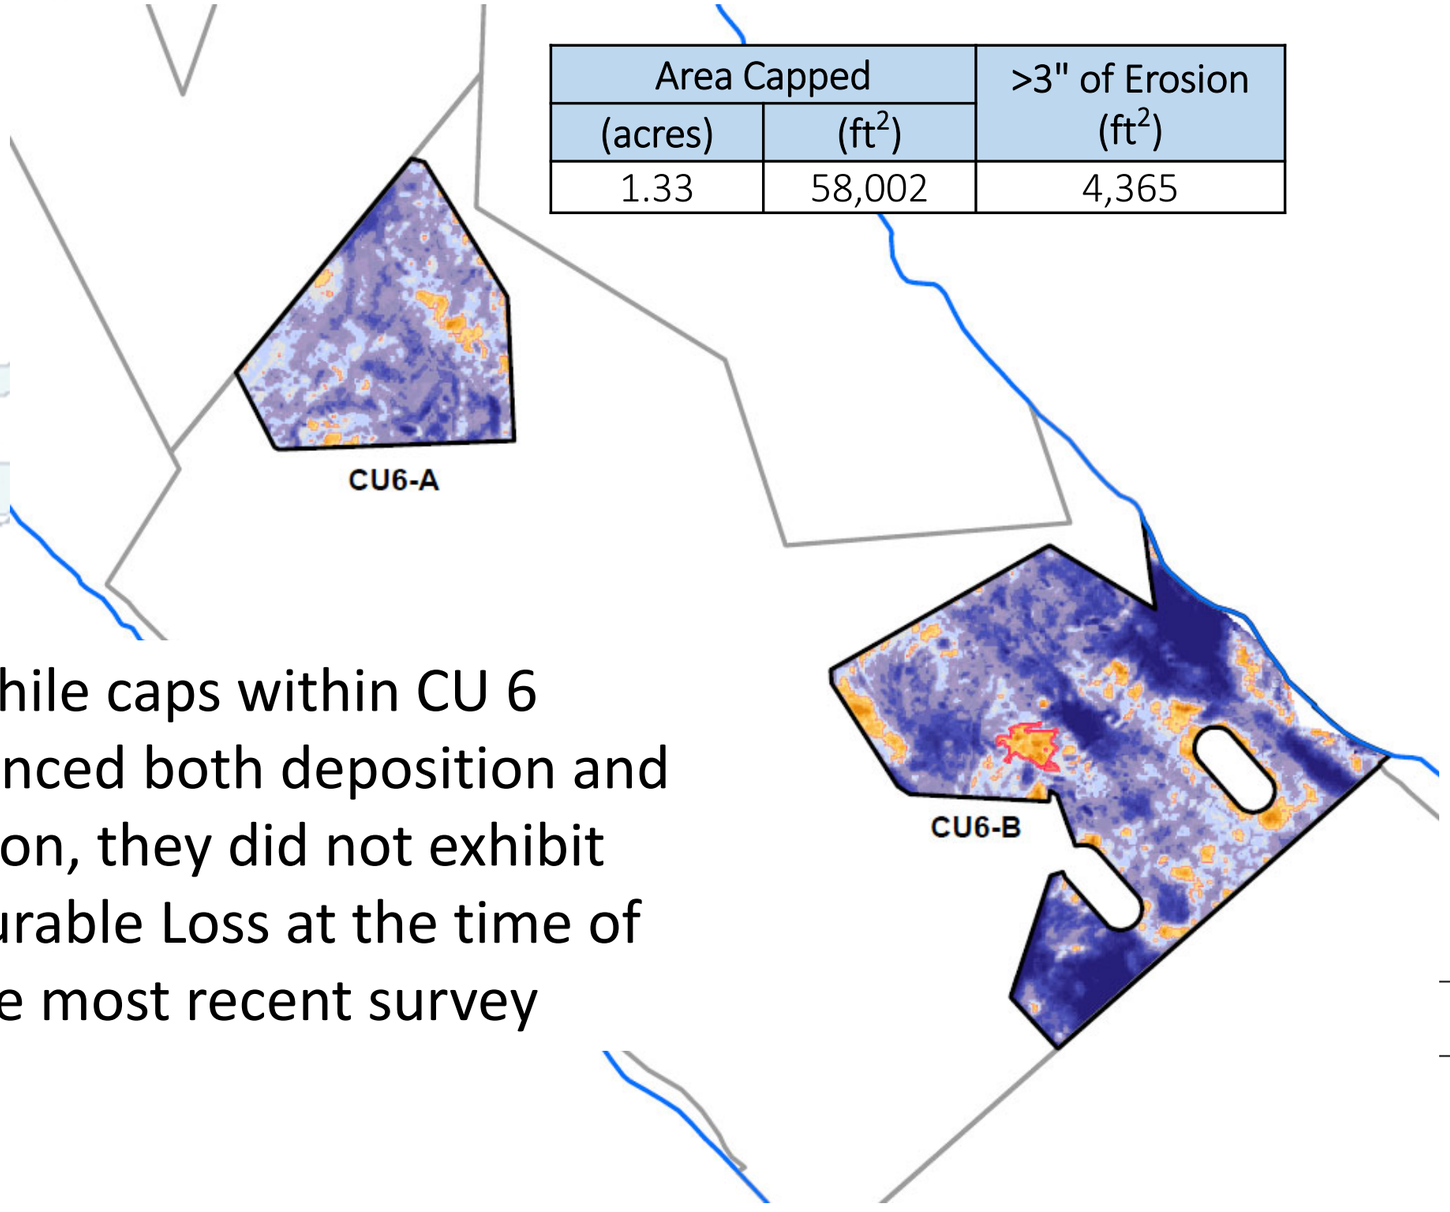
While caps within CU 6 experienced both deposition and erosion, they did not exhibit Measurable Loss at the time of the most recent survey

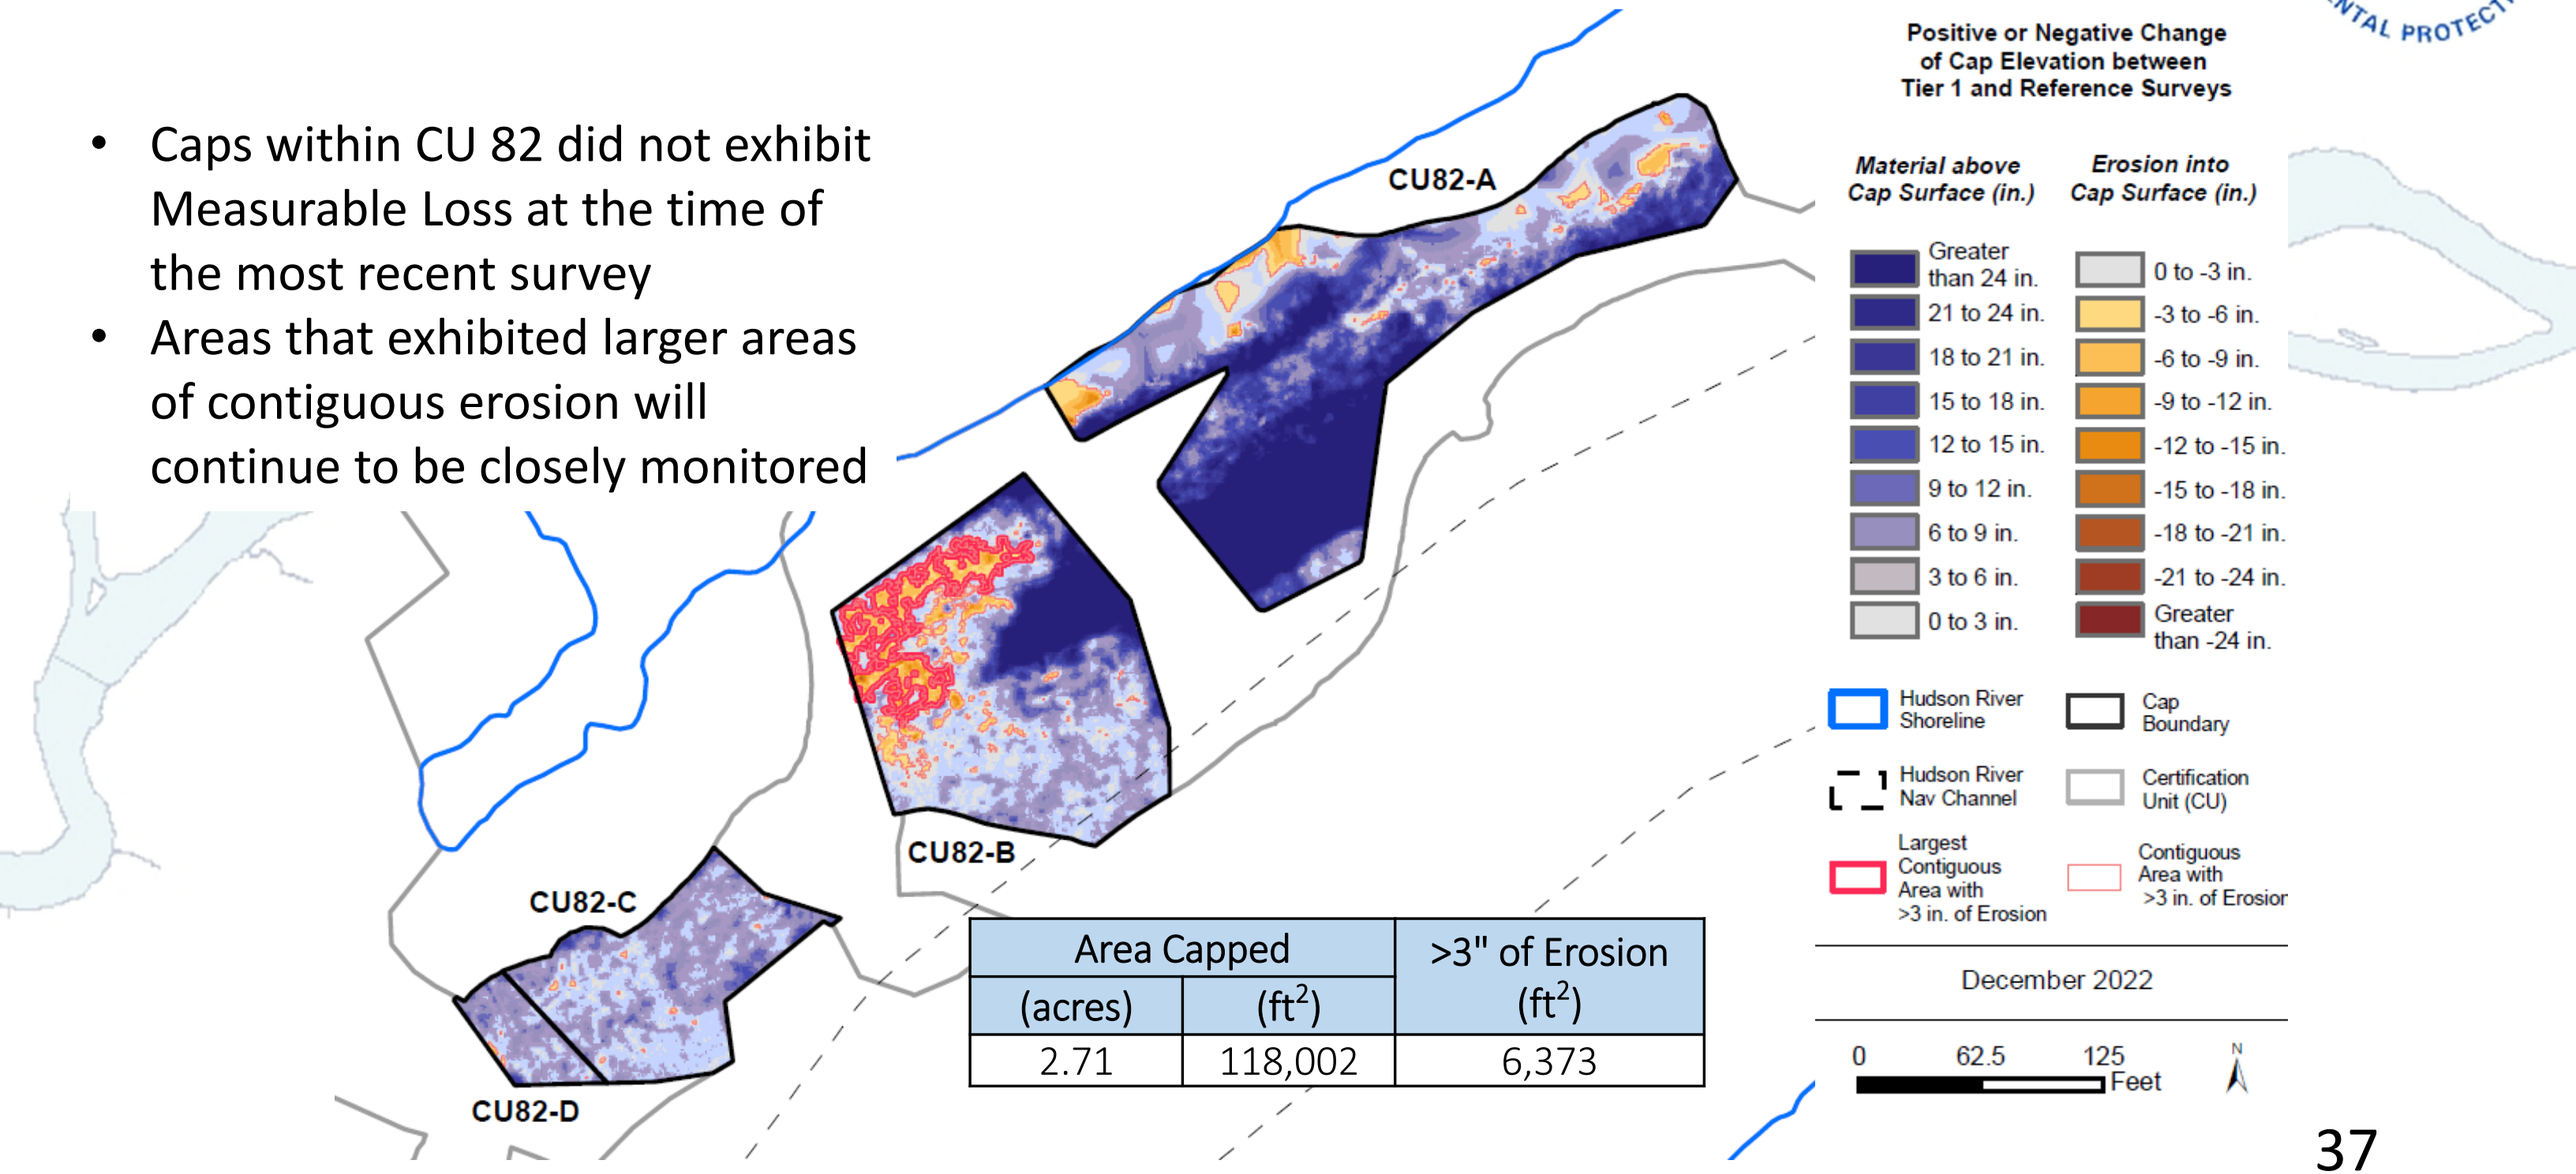
- Caps within CU 82 did not exhibit Measurable Loss at the time of the most recent survey
- Areas that exhibited larger areas of contiguous erosion will continue to be closely monitored

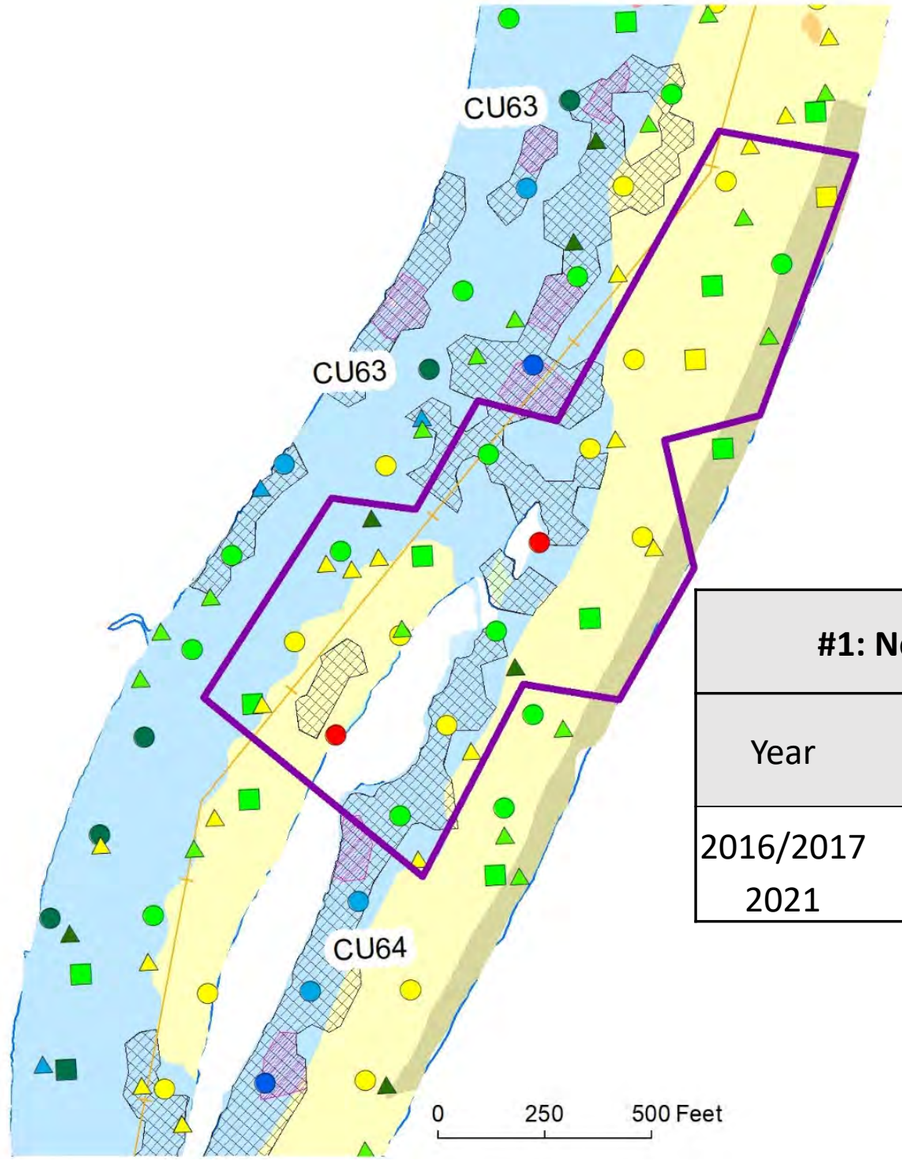
#1: Near Galusha Island (~21 acres)				
Year	Count	Tri+ PCB (mg/kg)		
		Max	Min	Average
2016/2017	20	43	1.0	8
2021	15	8	0.7	3.5

- 2021 data:
  - 15 samples were collected within 50 feet of the areas of interest boundary (ave = 3.5 mg/kg)
  - 10 samples > 3 mg/kg, max = 8 mg/kg, ave = 4.5 mg/kg

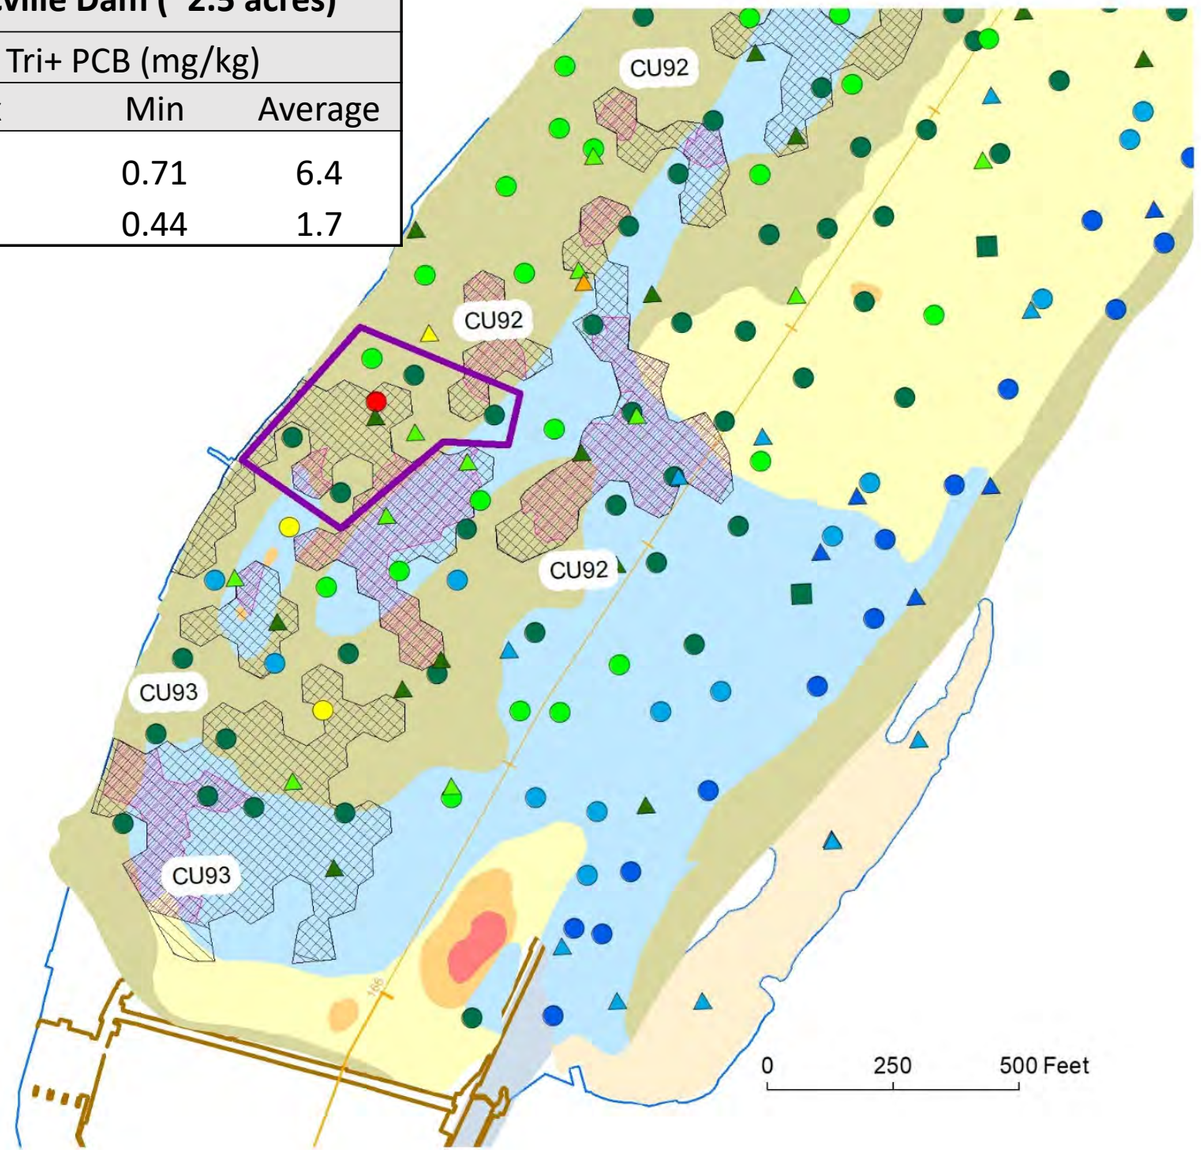
#2: Near Upper Mechanicville Dam (~2.5 acres)				
Year	Count	Tri+ PCB (mg/kg)		
		Max	Min	Average
2016/2017	6	33	0.71	6.4
2021	5	3.7	0.44	1.7

- 2021 data:
  - 2 samples inside the boundary (ave = 1.1 mg/kg)
  - 5 samples were collected within 50 feet of the boundary (ave = 1.7 mg/kg)

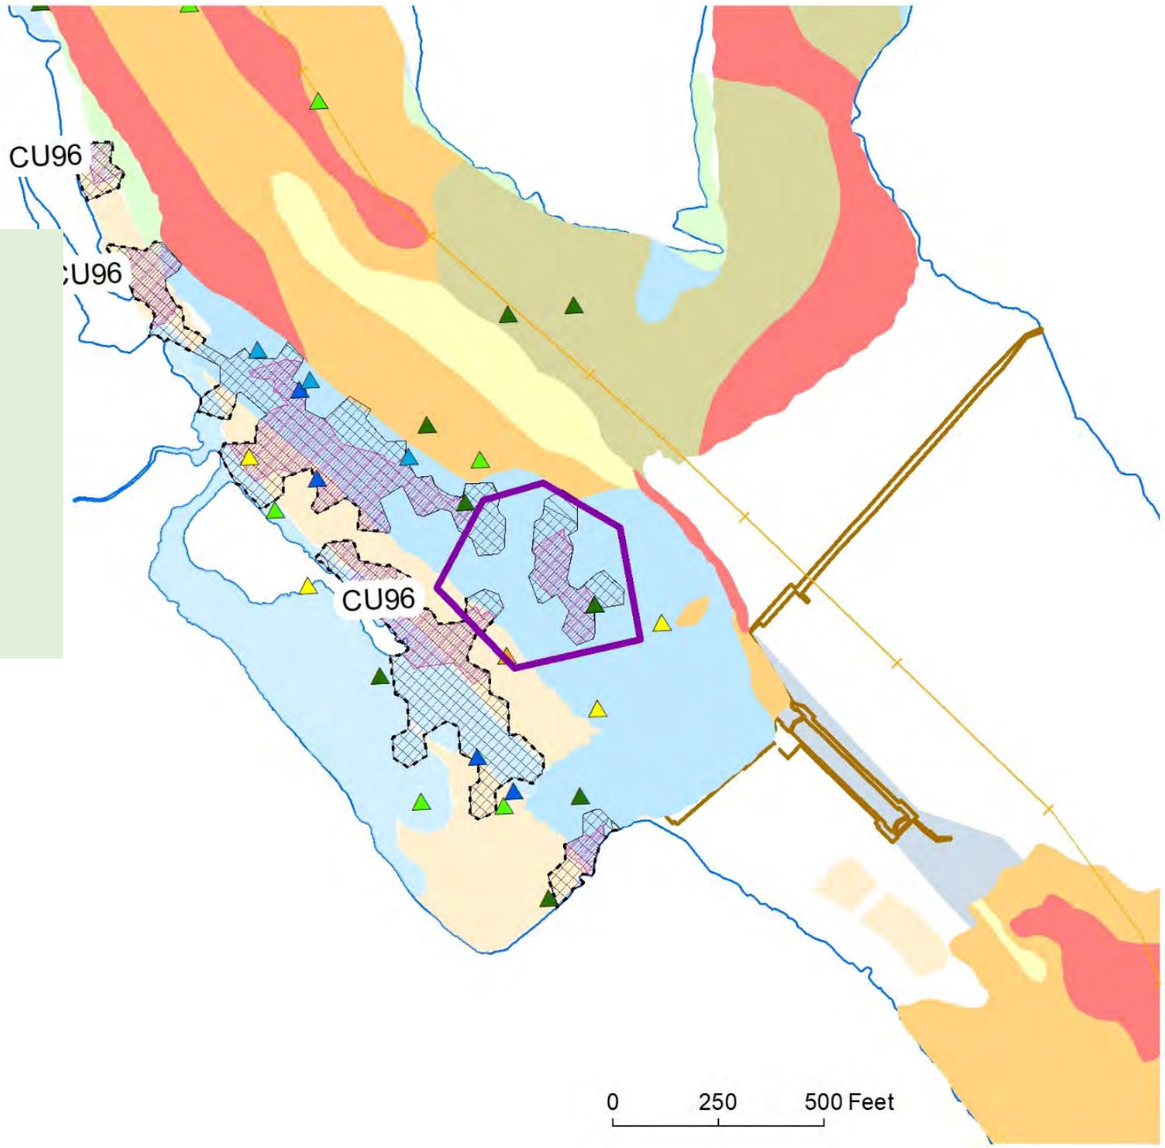
- 2021 data:
  - 4 samples were collected within 50 feet of the areas of interest boundary
  - max: 13 mg/kg
  - average: 4.0 mg/kg
