**Coal Combustion Waste Impoundment
Round 7 - Dam Assessment Report**

J.C. Weadock
Fly Ash Dike
Consumers Energy
Bay City, Michigan

Dewberry & Davis, LLC
Fairfax, Virginia

April 2011

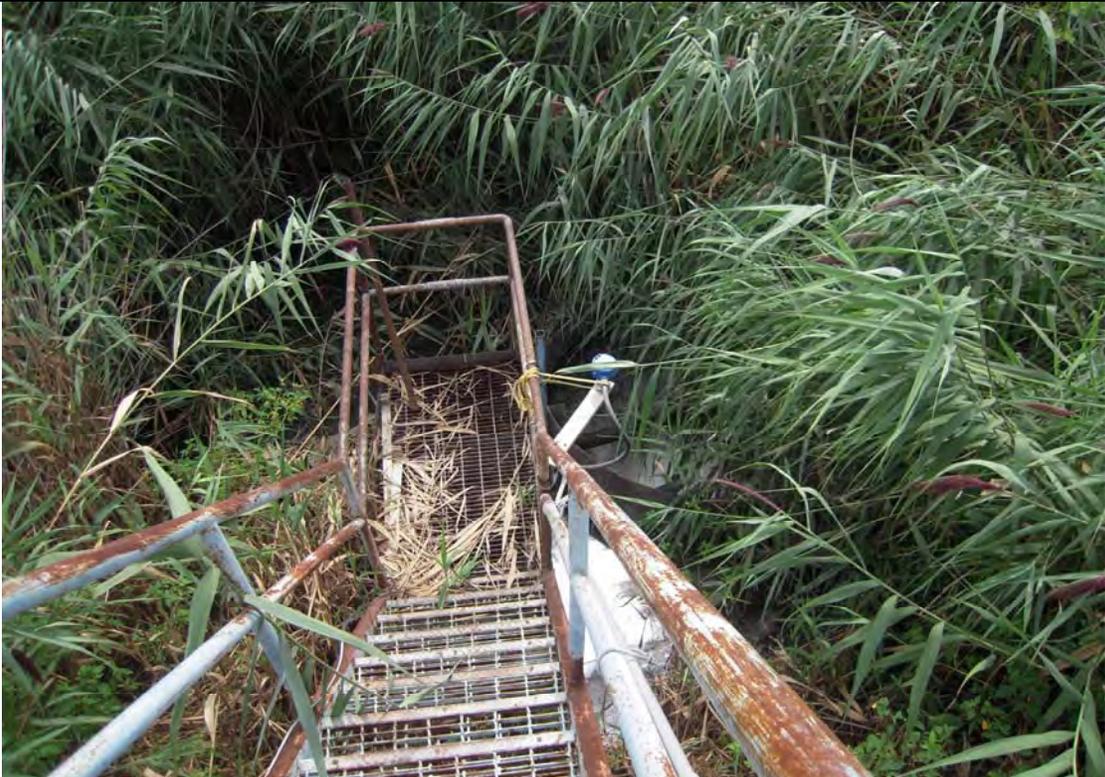
Client Name: Consumers Energy Company		Site Location: J.C. Weadock Ash Disposal Area		Project No.: 60100985
Photo No.: 7	Date: 8/17/09

Direction Photo Taken: South				
Description: NPDES discharge weir at the bottom right of staircase.

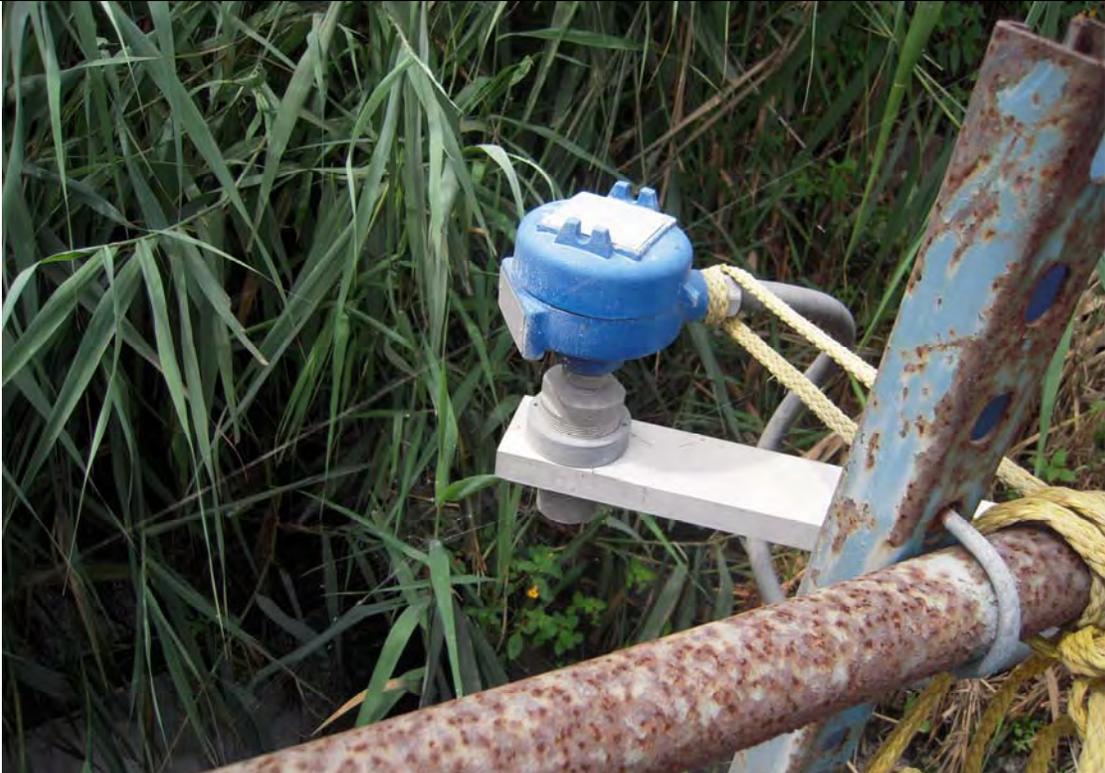
Photo No.: 8	Date: 8/17/09

Direction Photo Taken: West				
Description: Instrumentation for measuring flow over the discharge weir.

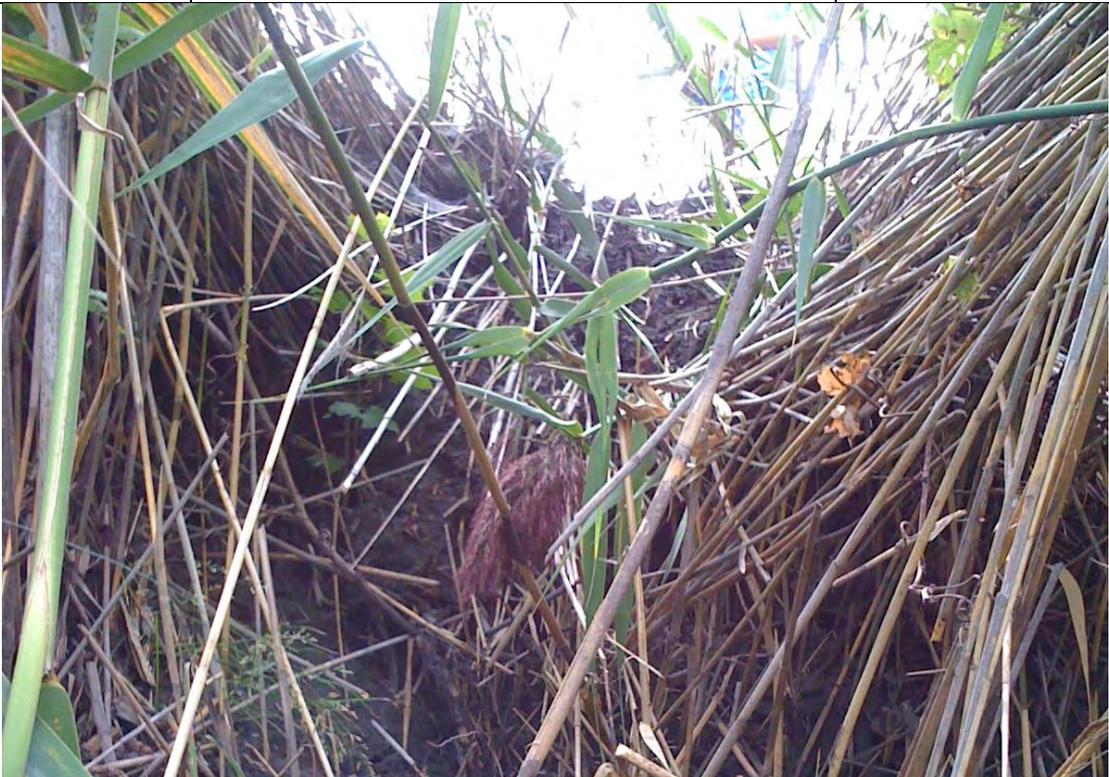
Client Name: Consumers Energy Company		Site Location: J.C. Weadock Ash Disposal Area	Project No.: 60100985
Photo No.: 11	Date: 8/17/09

Direction Photo Taken: South			
Description: Heavy vegetation and steep slope of perimeter dike along the discharge channel.

The inspection team walked the crest and along the downstream and upstream slopes of the perimeter dike. Overall, the slopes that could be observed appeared to be in good condition and free of any erosion, cracking, or signs of movement (Photos 5, 9, 10, 11, 12, 16 and 19). The crest is generally uniform with no visible signs of vertical settlement, lateral moving, or cracking (Photo 2, 13, 15 and 22). Some erosion of the crest was noted near the fire ponds (Photos 23 and 24). The ash landfill slope was lightly vegetated (Photo 21). Trees were observed on the ash slope and within the storm water drainage ditch (Photos 5, 12, 15 and 16). The downstream slope of the perimeter dike ranges from an estimated 1.5H:1V to 4H:1V along the discharge channel, Saginaw Bay, and Tacey and Underwood Drains. The ground is generally flat along the southern and western perimeter of the project where there is no apparent dike (Photo 22). Trees were growing on a majority of the containment dike slopes along with very tall grasses (phragmites, see Photos 5, 9, 10, 11, 12, 13, 15, 16, 17, 18, 19, 20, 23 and 24). Due to the amount of heavy vegetation, a conclusive visual inspection of the dike slopes could not be performed. However, areas with thinner vegetation where the slope could be seen appeared to be in good condition. Varying amounts and sizes of riprap were noted on the slopes (Photos 5, 10, 12, 16 and 19). However, riprap was not observed along portions of the dike slope along the discharge channel.

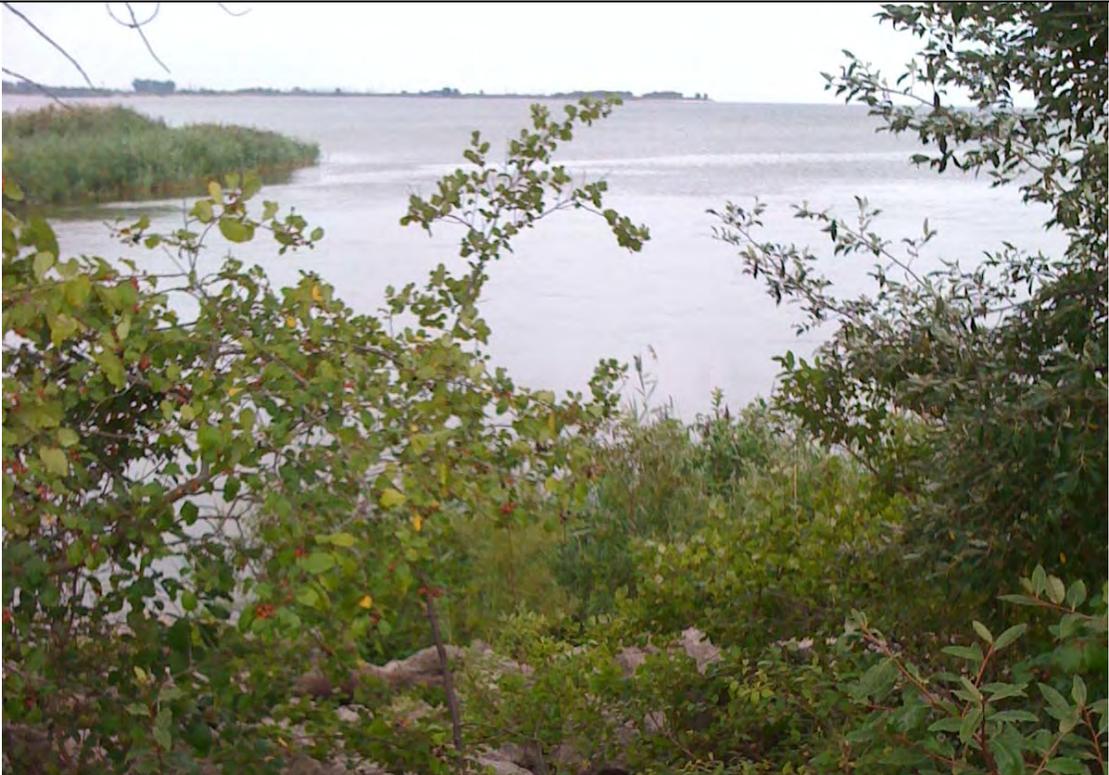
Photo No.: 12	Date: 8/17/09

Direction Photo Taken: North		
Description: Perimeter dike at outlet of discharge channel showing rip rap and heavy vegetation.

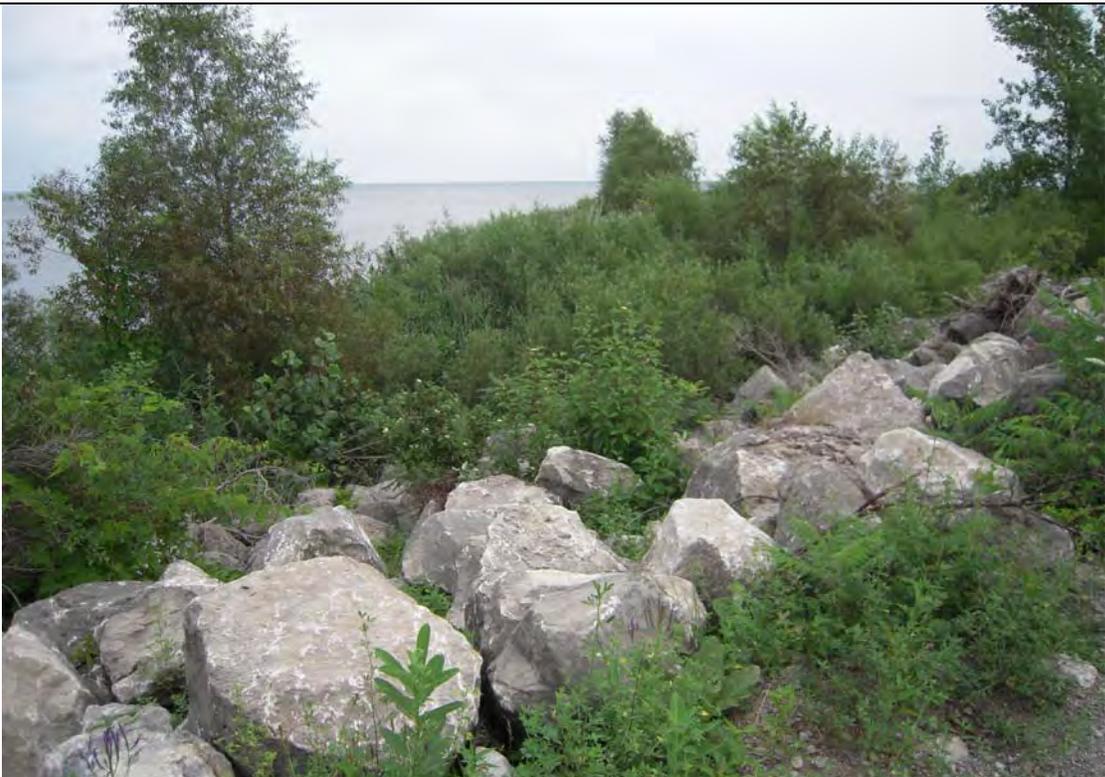
Photo No.: 16	Date: 8/17/09

Direction Photo Taken: Northwest			
Description: Exterior slope of perimeter dike along Saginaw Bay (4H:1V).

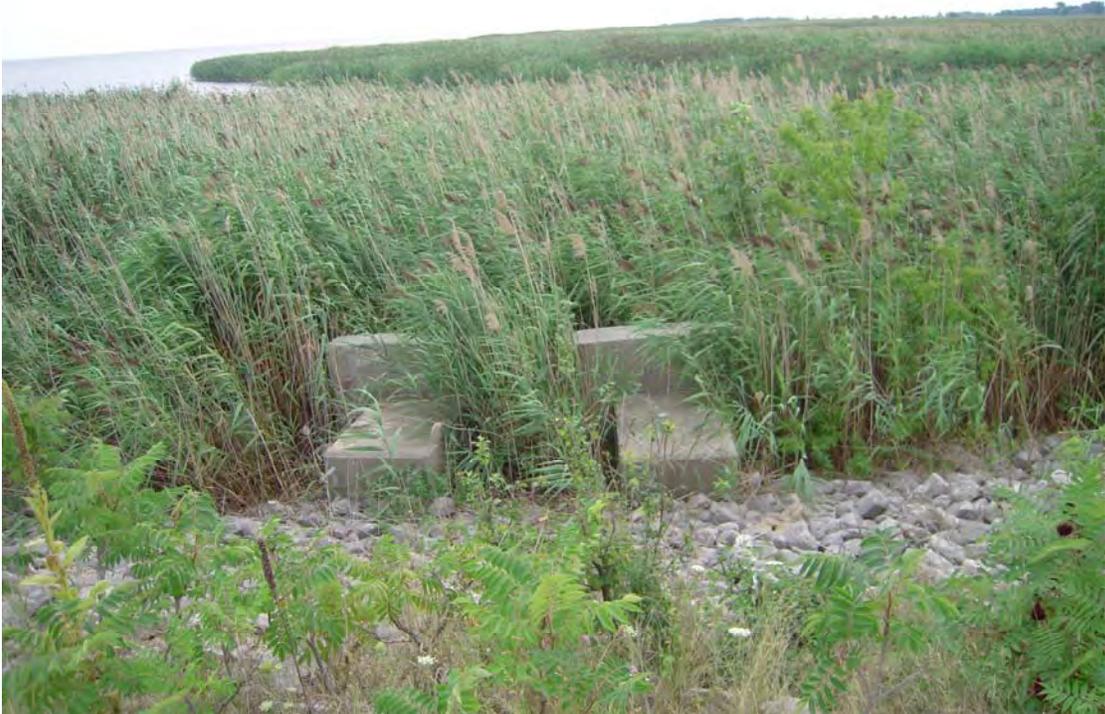
Client Name: Consumers Energy Company		Site Location: J.C. Weadock Ash Disposal Area		Project No.: 60100985
Photo No.: 19	Date: 8/17/09

Direction Photo Taken: East				
Description: Perimeter dike slope bordering Underwood Drain (3V:1H).

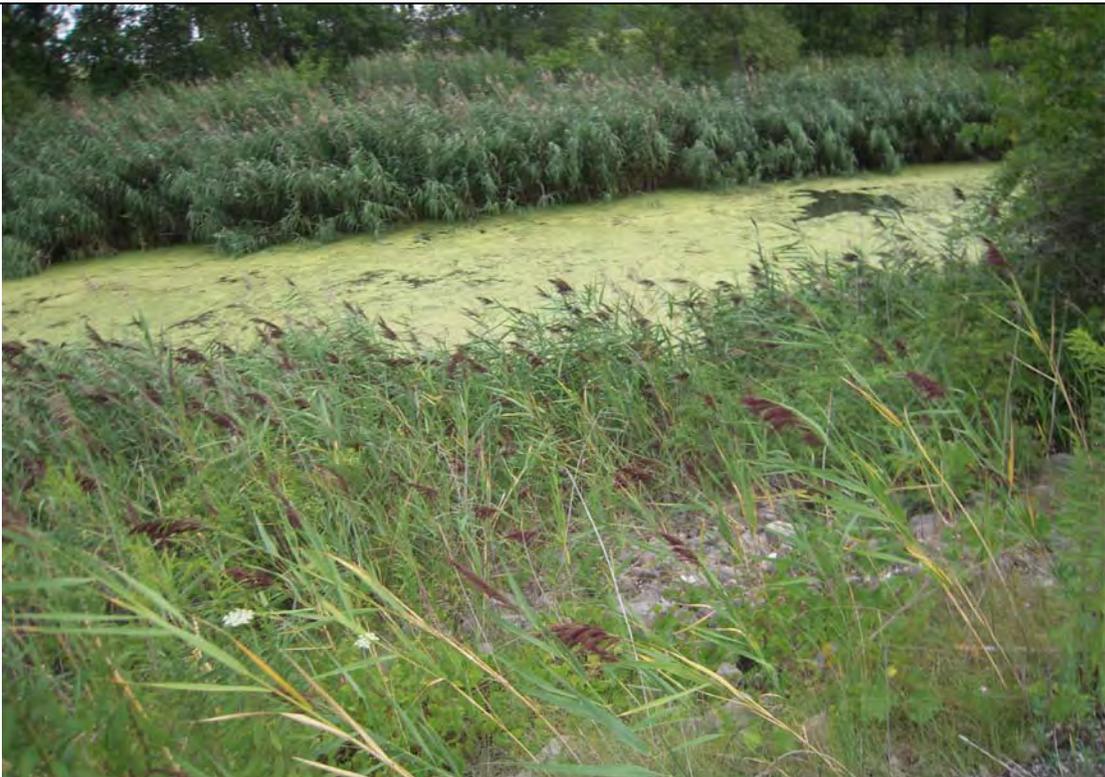
Photo No.: 20	Date: 8/17/09

Direction Photo Taken: East				
Description: Perimeter dike slope bordering Underwood Drain (3V:1H).

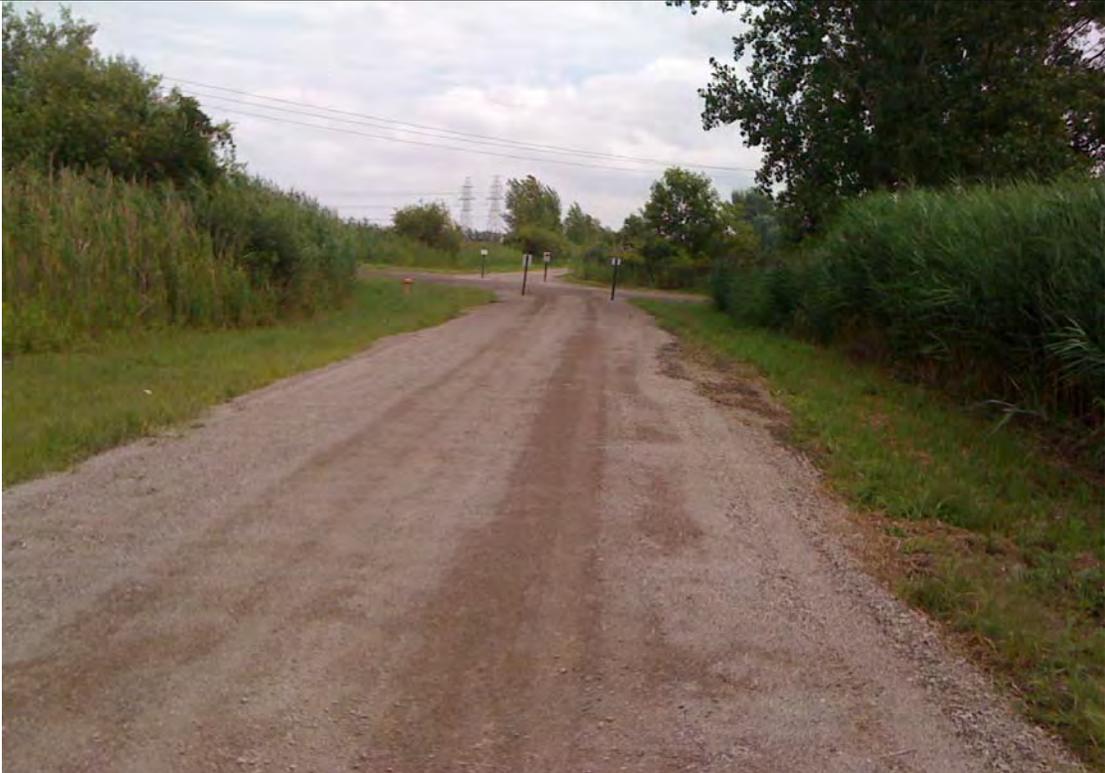
Photo No.: 22	Date: 8/17/09

Direction Photo Taken: West		
Description: View of perimeter dike (access road) in upland areas.

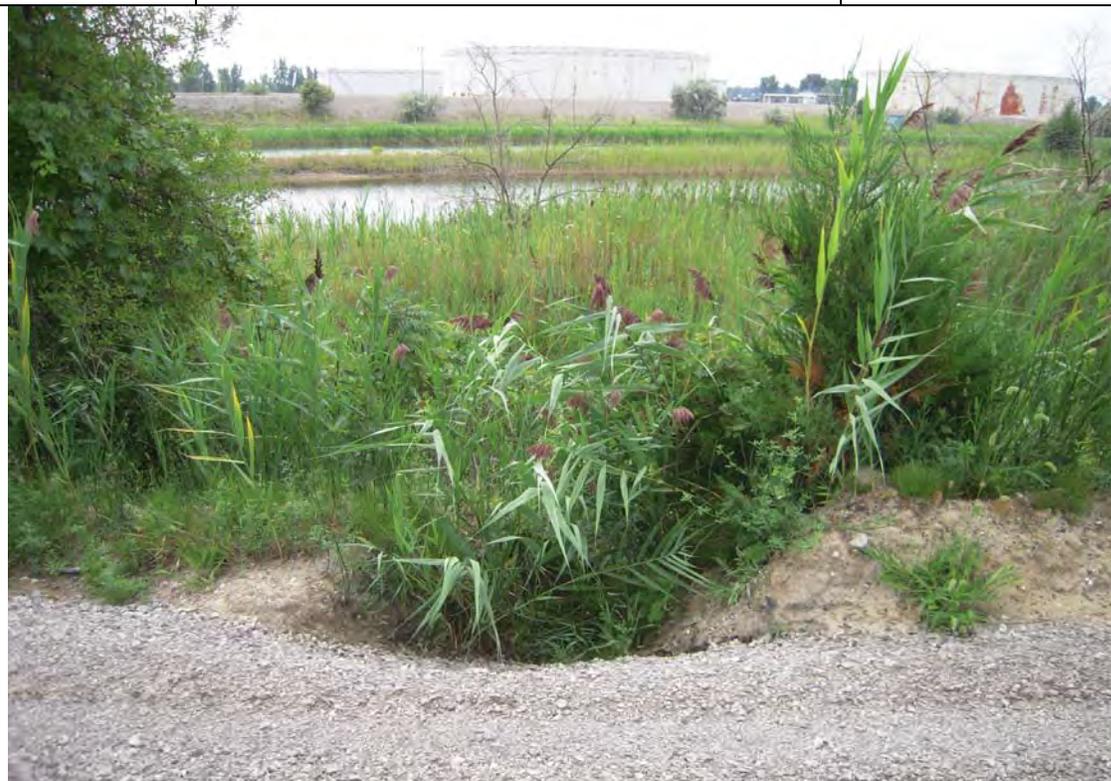
Photo No.: 23	Date: 8/17/09
Direction Photo Taken: South

View of fire ponds and remaining erosion from the 2009 overtopping of the perimeter dike.

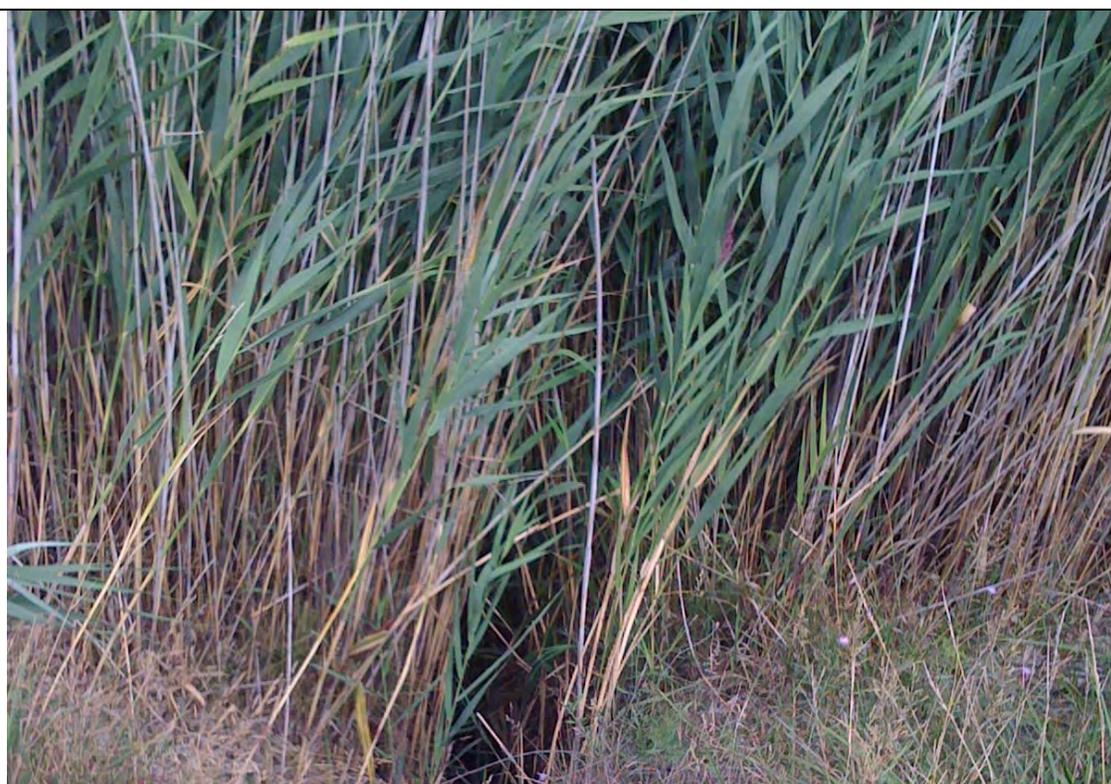
Photo No.: 24	Date: 8/17/09
Direction Photo Taken: South

Remaining erosion from 2009 dike overtopping near fire ponds.

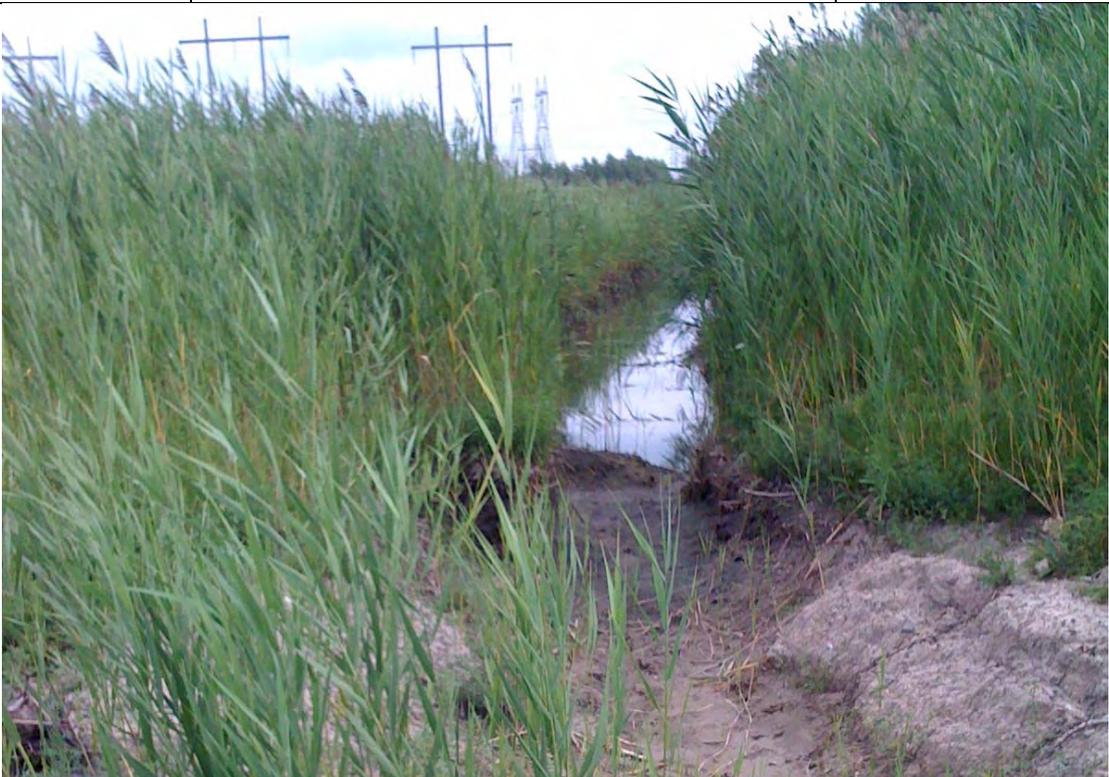
Client Name: Consumers Energy Company		Site Location: J.C. Weadock Ash Disposal Area		Project No. 60100985
Photo No. 25	Date: 8/17/09

Direction Photo Taken: East				
Description: View of interior perimeter ditch used to discharge fire pond water.

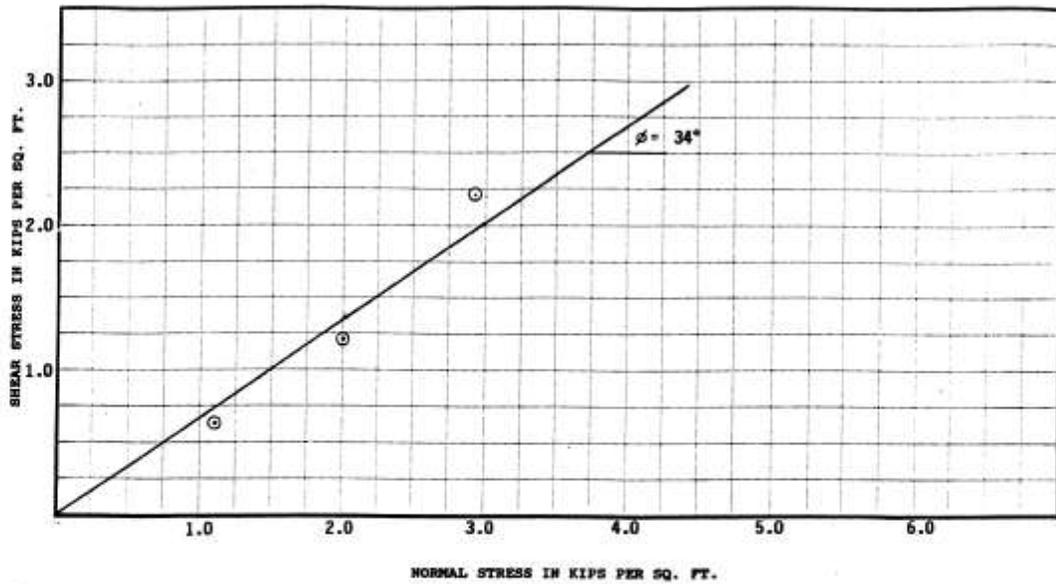
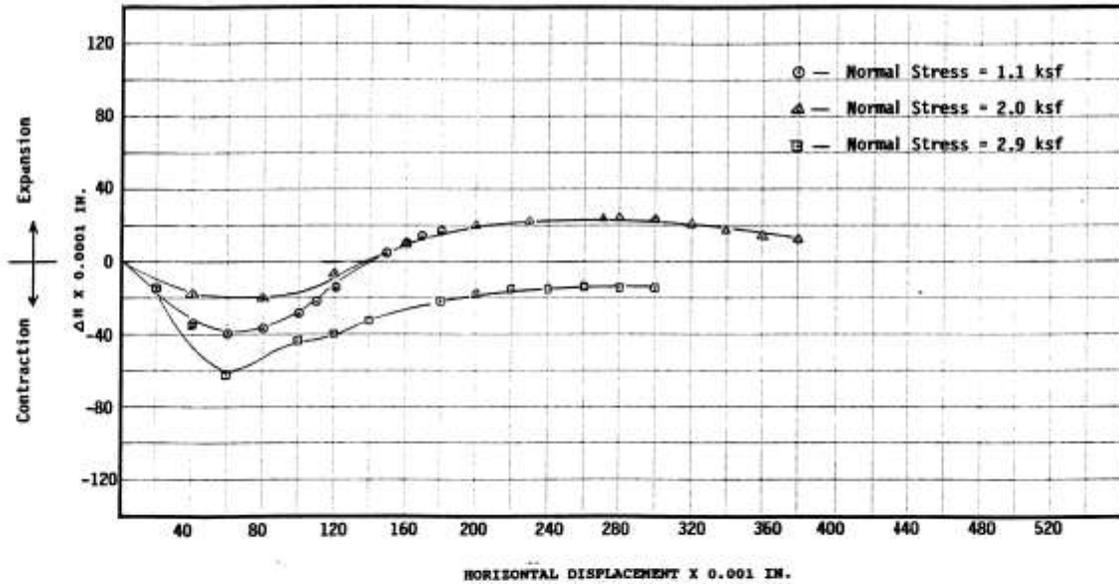
DESCRIPTION OF SPECIMEN: Brown coarse to fine ^s SAND with shell fragments B-1 (14.5'-16') 34991			DIRECT SHEAR TEST ASTM D 3080		
Liquid Limit (%)		Final Void Ratio			
Plastic Limit (%)		Unit Dry Weight (pcf)			
Plasticity Index (%)		Friction Angle, ϕ	34°		
Natural Water Content (%)	20.4	Normal Stress (ksf)			
Specific Gravity	2.70				
TEST SPECIMEN PROPERTIES			1.1	2.0	2.9
Diameter of Specimen (in.)			2.5	2.5	2.5
Initial Height of Specimen (in.)			0.99	0.99	0.99
Initial Water Content (%)			Dry	Dry	Dry
Initial Void Ratio			0.72	0.71	0.70
Initial Dry Weight (pcf)			97.8	98.6	99.2
Final Water Content (%)					
Final Void Ratio					
Shear Stress			0.6	1.2	2.2

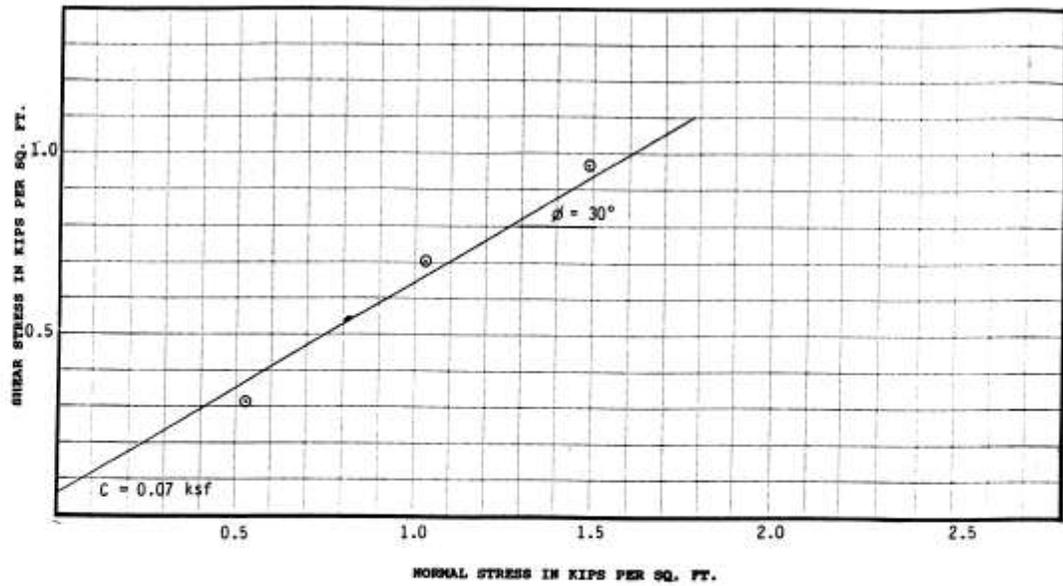
DESCRIPTION OF SPECIMEN: Gray Flyash B-5 (3' - 7') 297Q (loose)		35941	DIRECT SHEAR TEST ASTM D 3080	
Liquid Limit (%)		Final Void Ratio		
Plastic Limit (%)		Unit Dry Weight (pcf)		30°
Plasticity Index (%)		Friction Angle		
Natural Water Content (%)	41.4	Cohesion, ksf	0.07	Materials Testing Consultants, Inc. 300 N. WOODSTOCK AVE., SUITE 200, WASHINGTON, D.C. 20001 • PHONE (301) 271-1100
Specific Gravity	2.47	Normal Stress (ksf)		
TEST SPECIMEN PROPERTIES		0.5	1.0	1.5
Diameter of Specimen (in.)		2.5	2.5	2.5
Initial Height of Specimen (in.)		.99	.95	.94
Initial Water Content (%)		60.9	62.3	65.5
Initial Void Ratio		1.61	1.53	1.50
Initial Dry Weight (pcf)		58.9	60.8	61.3
Final Water Content (%)		56.2	53.9	54.0

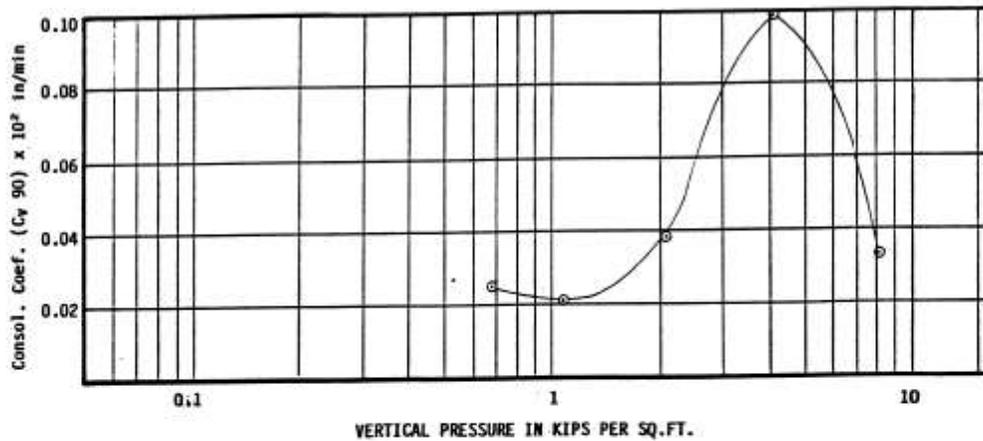
DESCRIPTION OF SPECIMEN: Gray Flyash B-6 (3' - 7') 2970 (Compacted)		35940	CONSOLIDATION TEST
Liquid Limit (%)		Final Void Ratio	0.953
Plastic Limit (%)		Initial Dry Density (pcf)	71.0
Plasticity Index		CONSOLIDATION PROPERTIES	
Natural Water Content (%)	AVG. 50.5	Compression Index (Cc)	.105
Specific Gravity	2.3	Recompression (Cr)	
TEST SPECIMEN PROPERTIES		Swelling Index (Cs)	.012
Diameter of Specimen (in.)	2.5	Preconsolidation Stress (Pc) ksf	2.5
Initial Thickness of Specimen (in.)	0.75	Existing Overburden Stress (Po) ksf	
Initial Water Content (%)	44.4		
Initial Void Ratio	1.023		
			MATERIALS TESTING CONSULTANTS
Tested by: SMT			Date: 1/15/91
Checked by: [Signature]			Job No.: 4420

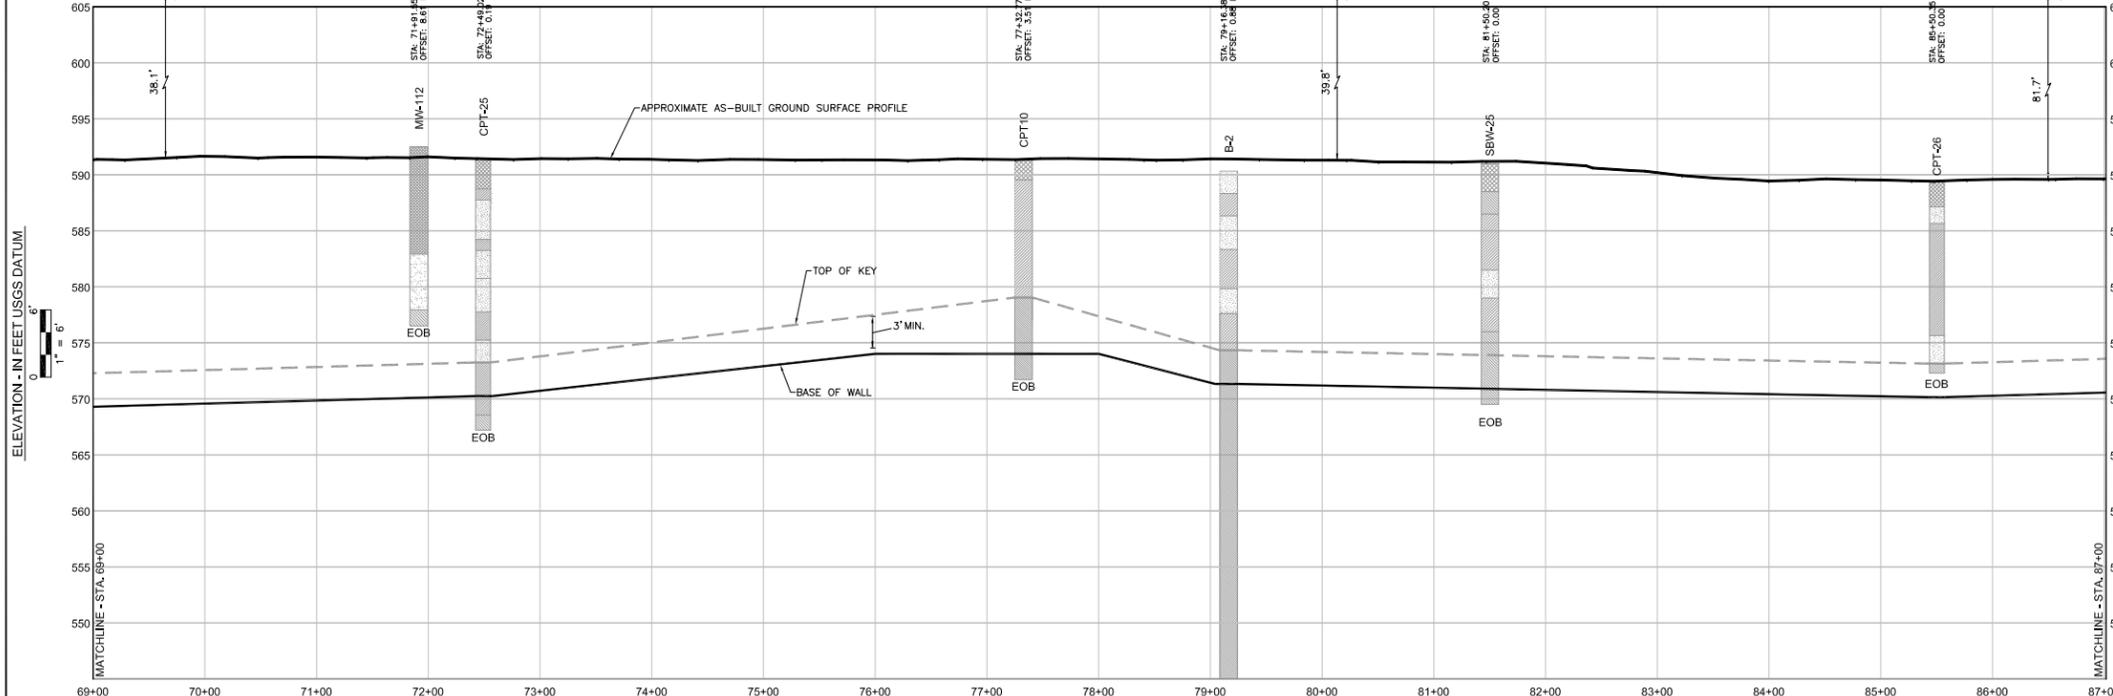
CUTOFF WALL PROFILE
STA. 69+00 THROUGH STA. 87+00

CUTOFF WALL PLAN
STA. 69+00 THROUGH STA. 87+00

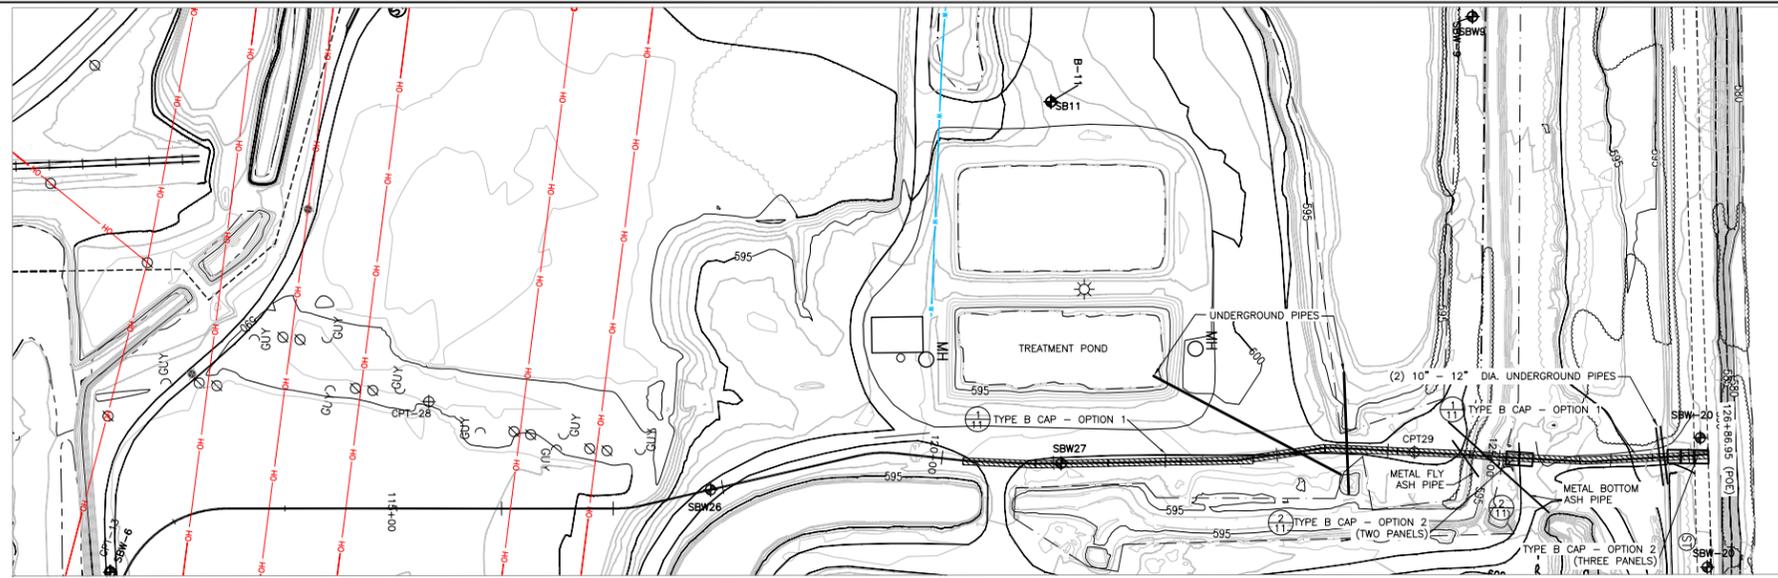
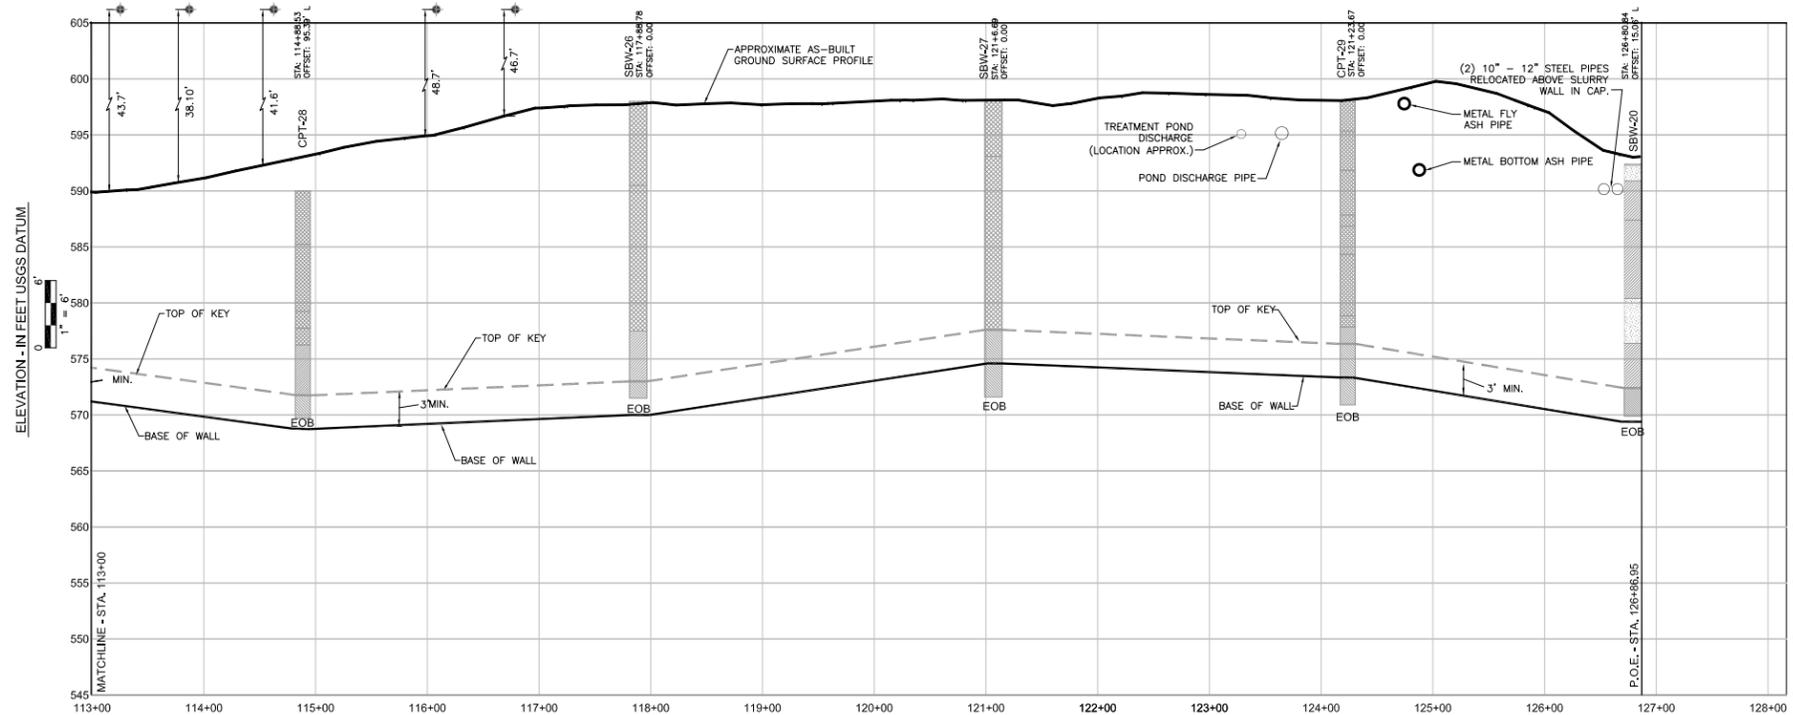
Figure 15

CUTOFF WALL PLAN
STA. 113+00 THROUGH STA. 126+86.95 (P.O.E.)

CUTOFF WALL PROFILE
STA. 113+00 THROUGH STA. 126+86.95 (P.O.E.)

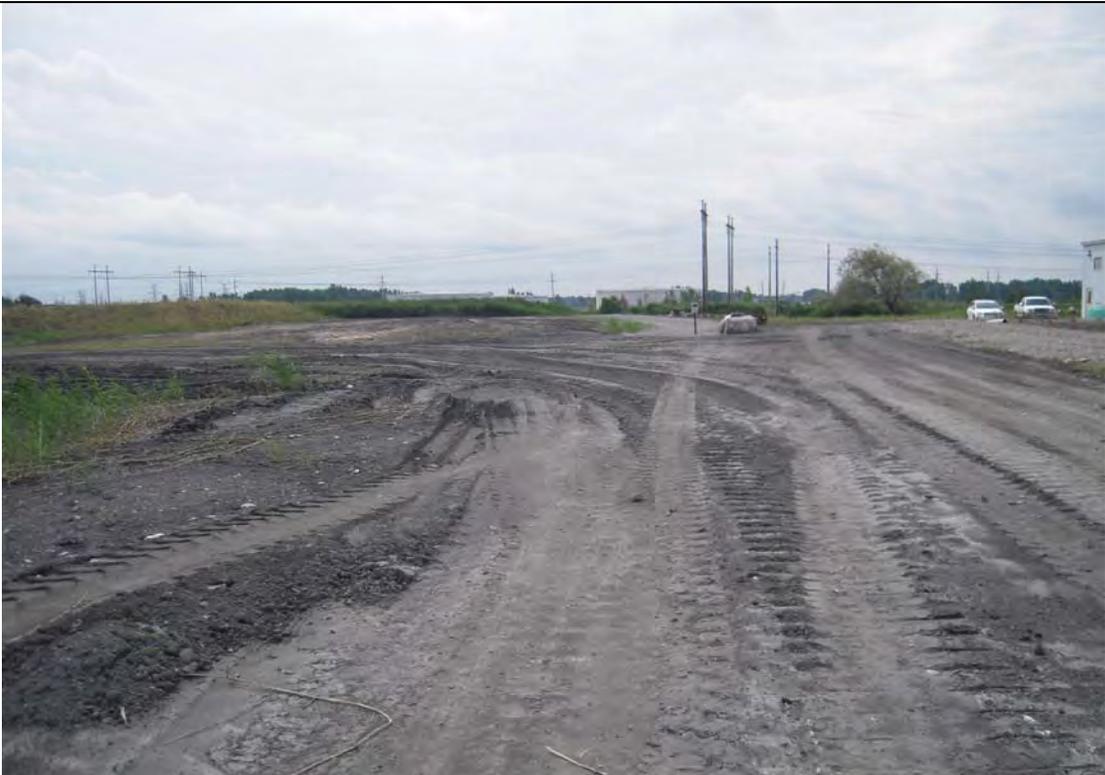
Photo No.: 2	Date: 8/17/09

Direction Photo Taken: South				
Description: Interior dike with slurry wall to the east of the chemical treatment ponds.

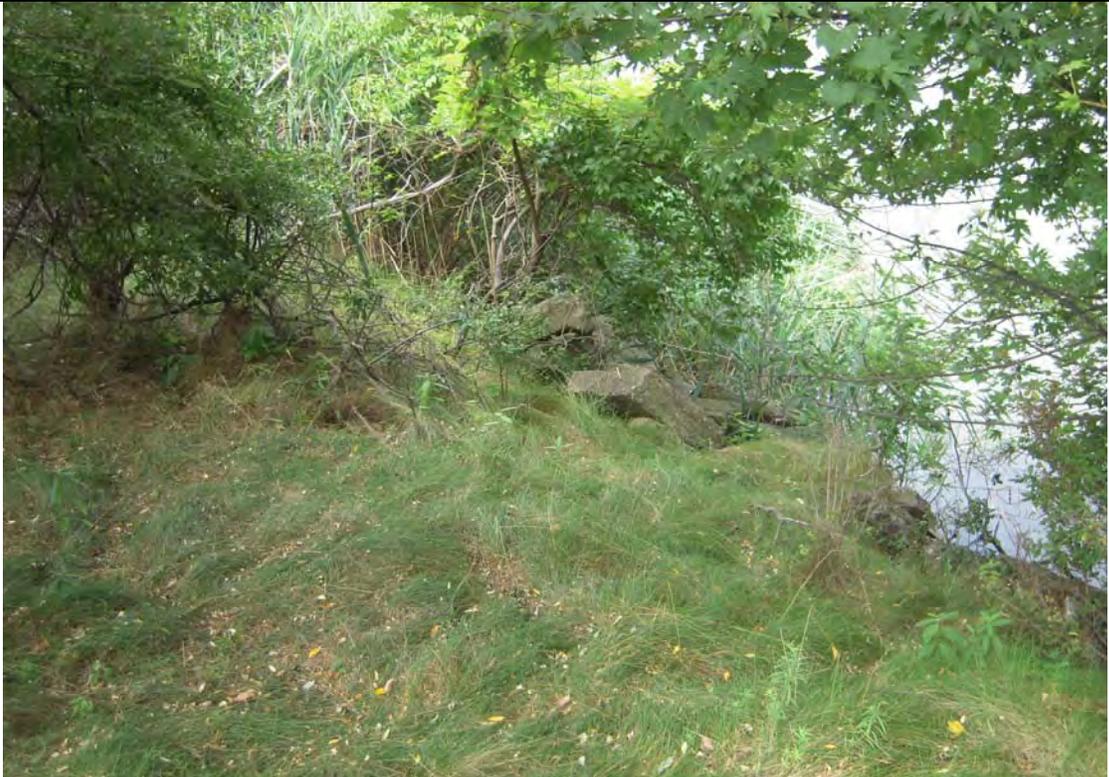
Client Name: Consumers Energy Company		Site Location: J.C. Weadock Ash Disposal Area		Project No.: 60100985	
Photo No. 5	Date: 8/17/09

Direction Photo Taken: Northwest					
Description: View of perimeter dike exterior slope in the discharge channel upstream from the electric fish barrier.

The inspection team walked the crest and along the downstream and upstream slopes of the perimeter dike. Overall, the slopes that could be observed appeared to be in good condition and free of any erosion, cracking, or signs of movement (Photos 5, 9, 10, 11, 12, 16 and 19). The crest is generally uniform with no visible signs of vertical settlement, lateral moving, or cracking (Photo 2, 13, 15 and 22). Some erosion of the crest was noted near the fire ponds (Photos 23 and 24). The ash landfill slope was lightly vegetated (Photo 21). Trees were observed on the ash slope and within the storm water drainage ditch (Photos 5, 12, 15 and 16). The downstream slope of the perimeter dike ranges from an estimated 1.5H:1V to 4H:1V along the discharge channel, Saginaw Bay, and Tacey and Underwood Drains. The ground is generally flat along the southern and western perimeter of the project where there is no apparent dike (Photo 22). Trees were growing on a majority of the containment dike slopes along with very tall grasses (phragmites, see Photos 5, 9, 10, 11, 12, 13, 15, 16, 17, 18, 19, 20, 23 and 24). Due to the amount of heavy vegetation, a conclusive visual inspection of the dike slopes could not be performed. However, areas with thinner vegetation where the slope could be seen appeared to be in good condition. Varying amounts and sizes of riprap were noted on the slopes (Photos 5, 10, 12, 16 and 19). However, riprap was not observed along portions of the dike slope along the discharge channel.

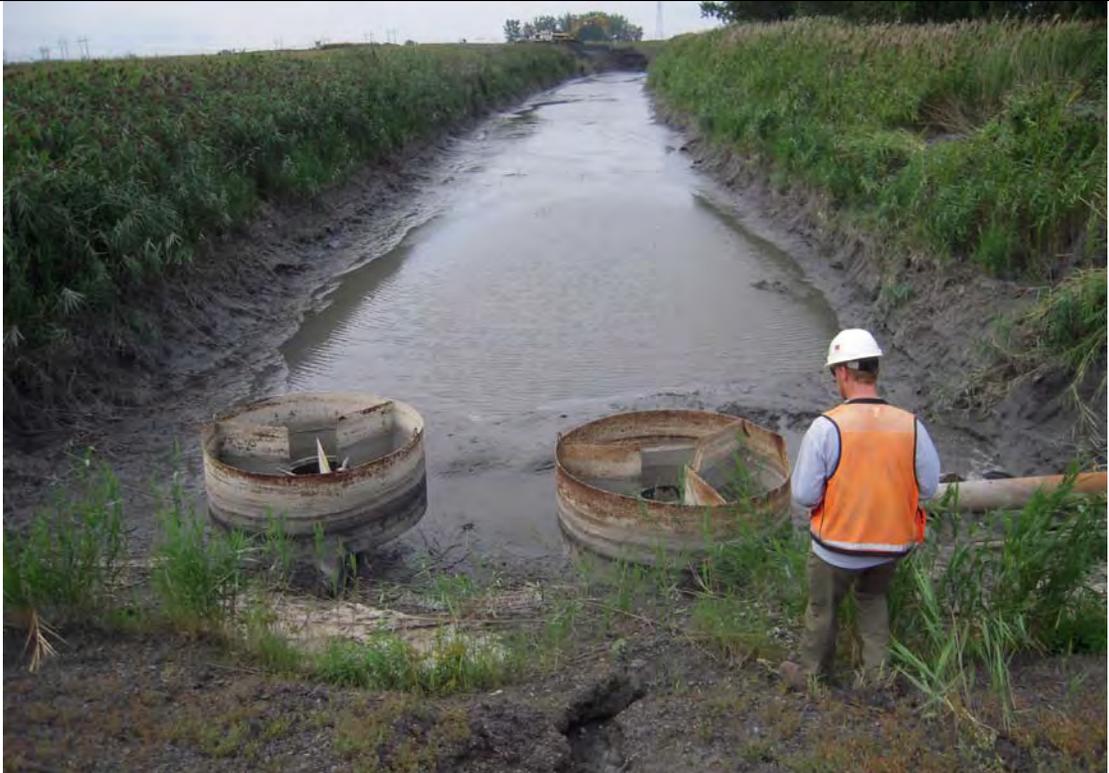
Photo No. 6	Date: 8/17/09

Direction Photo Taken: West					
Description: Typical drop structures and pipes between interior sluice channels.

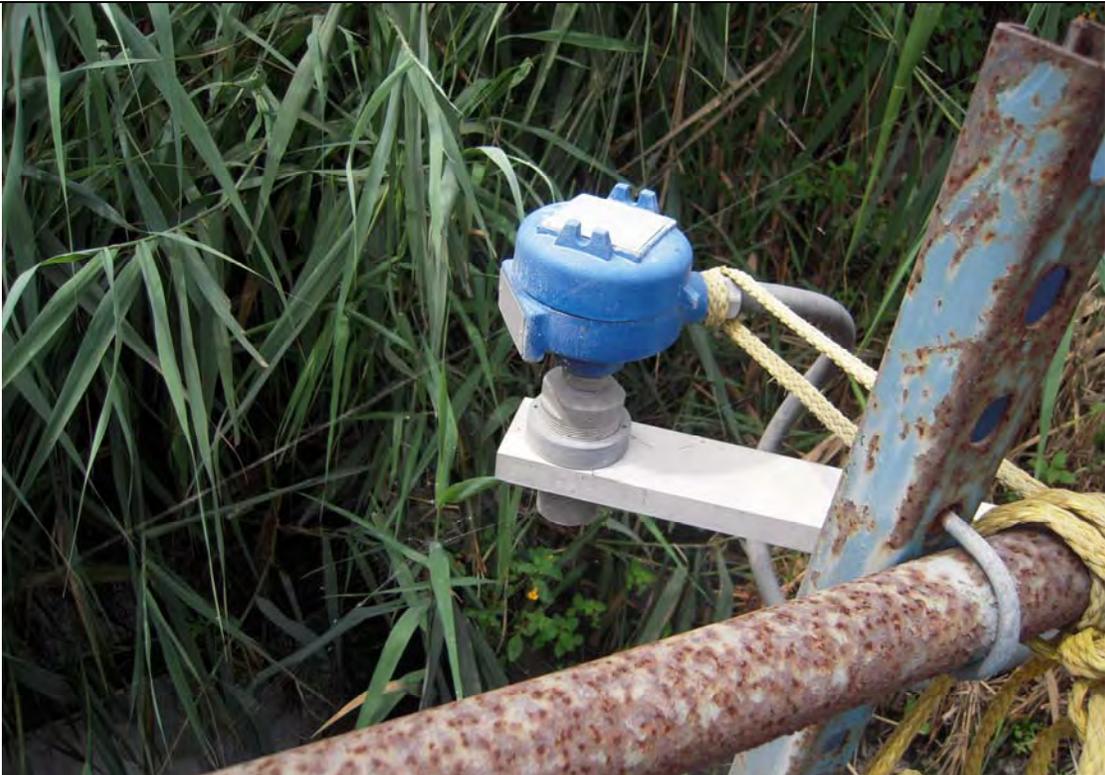
Photo No.: 8	Date: 8/17/09

Direction Photo Taken: West		
Description: Instrumentation for measuring flow over the discharge weir.

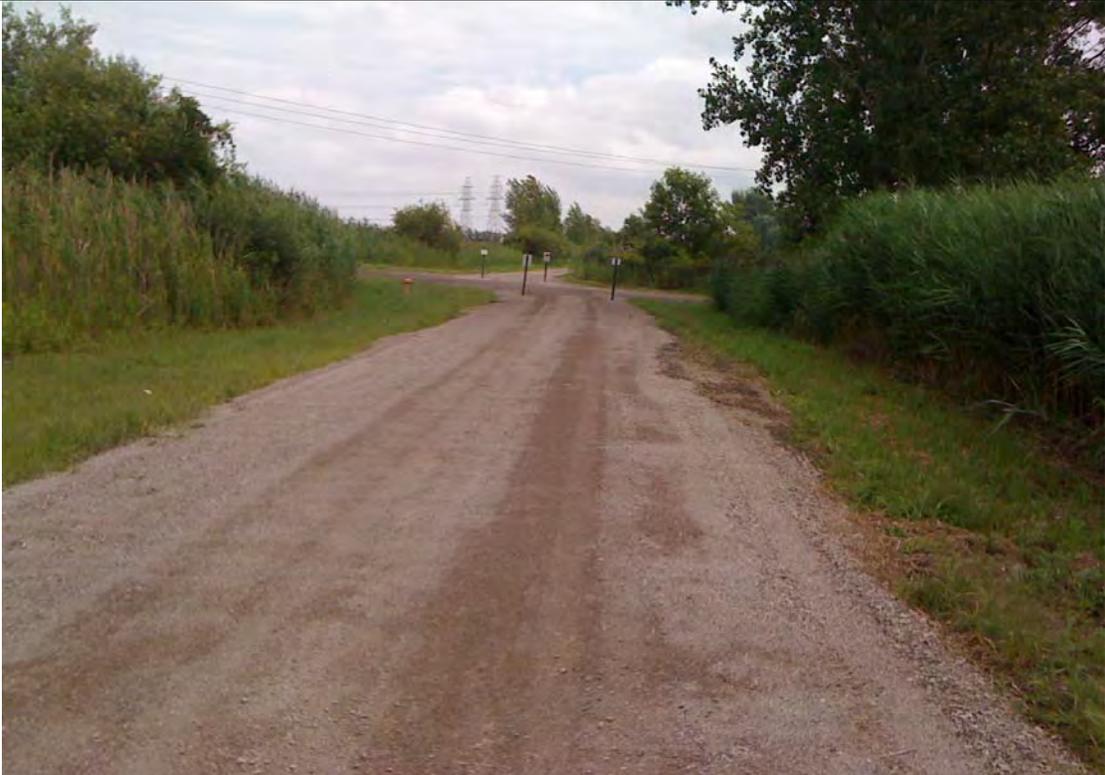
Photo No.: 22	Date: 8/17/09

Direction Photo Taken: West		
Description: View of perimeter dike (access road) in upland areas.

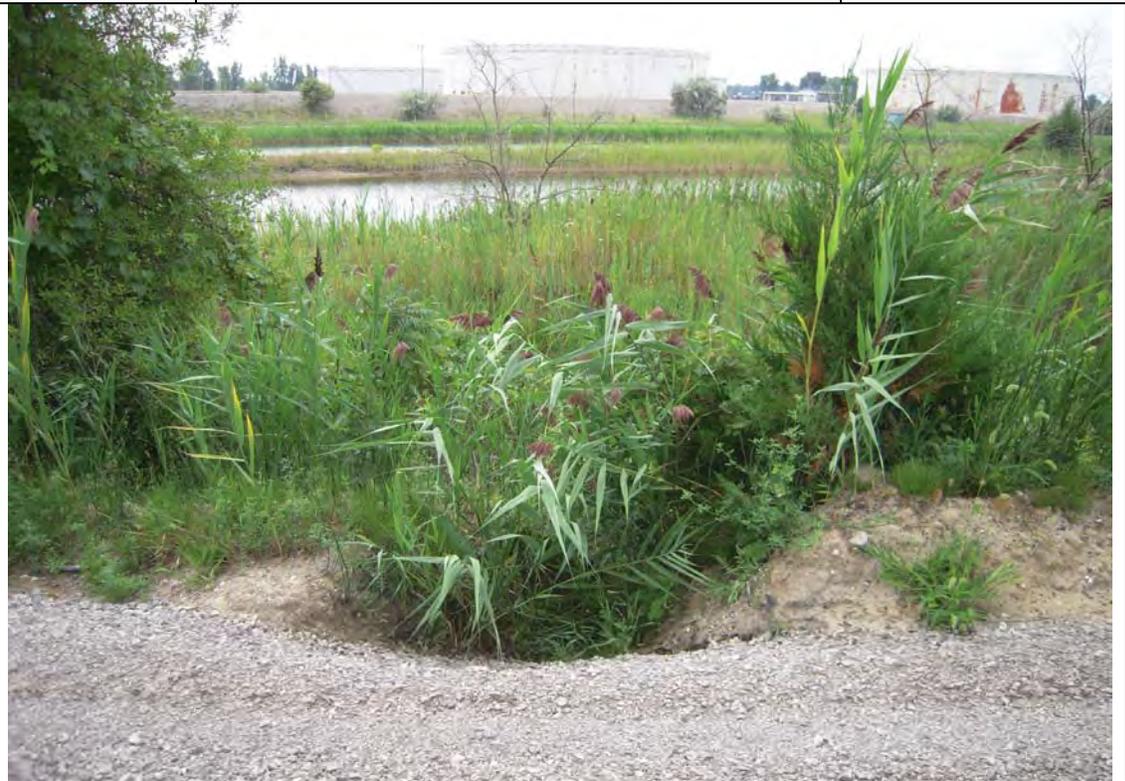
Photo No. 23	Date: 8/17/09
Direction Photo Taken: South

View of fire ponds and remaining erosion from the 2009 overtopping of the perimeter dike.
