**Coal Combustion Waste Impoundment
Round 7 - Dam Assessment Report**

J.C. Weadock
Fly Ash Dike
Consumers Energy
Bay City, Michigan

Dewberry & Davis, LLC
Fairfax, Virginia

April 2011

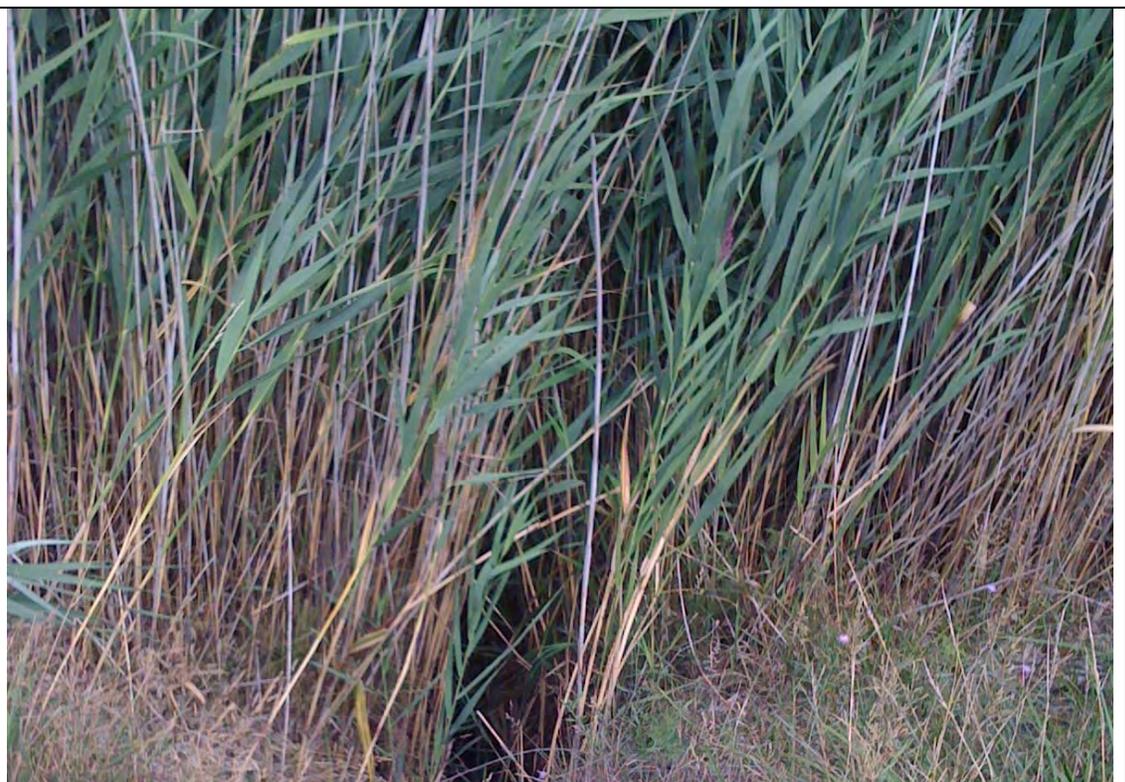
Photo No. 24	Date: 8/17/09
Direction Photo Taken: South

Remaining erosion from 2009 dike overtopping near fire ponds.

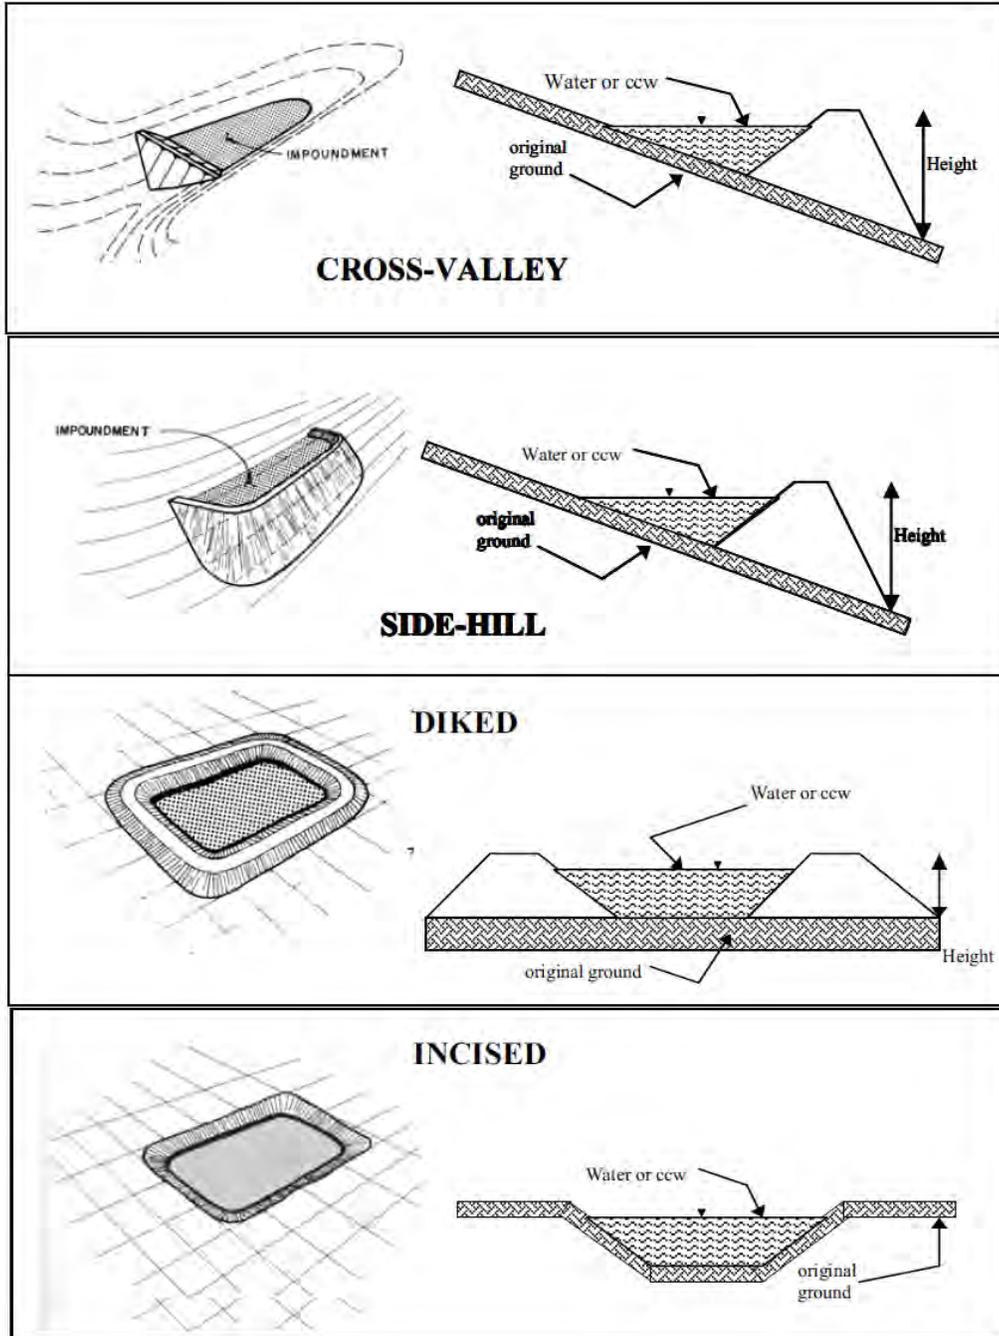
CONFIGURATION:

- Cross-Valley
- Side-Hill
- Diked
- Incised (form completion optional)
- Combination Incised/Diked

Embankment Height (ft)	+/- 15 ft	Embankment Material	Compacted clay core and sandy silt
Pool Area (ac)	+/- 101.3 ac	Liner	Clay with perimeter Bentonite cut-off wall
Current Freeboard (ft)	+/- 8 to 10 ft	Liner Permeability	Clay 10^{-6} cms; Bentonite 10^{-8} cms
