# Assessment of Dam Safety Coal Combustion Surface Impoundments Draft Report

Georgia Power  
Company

Plant Bowen

Cartersville, Georgia

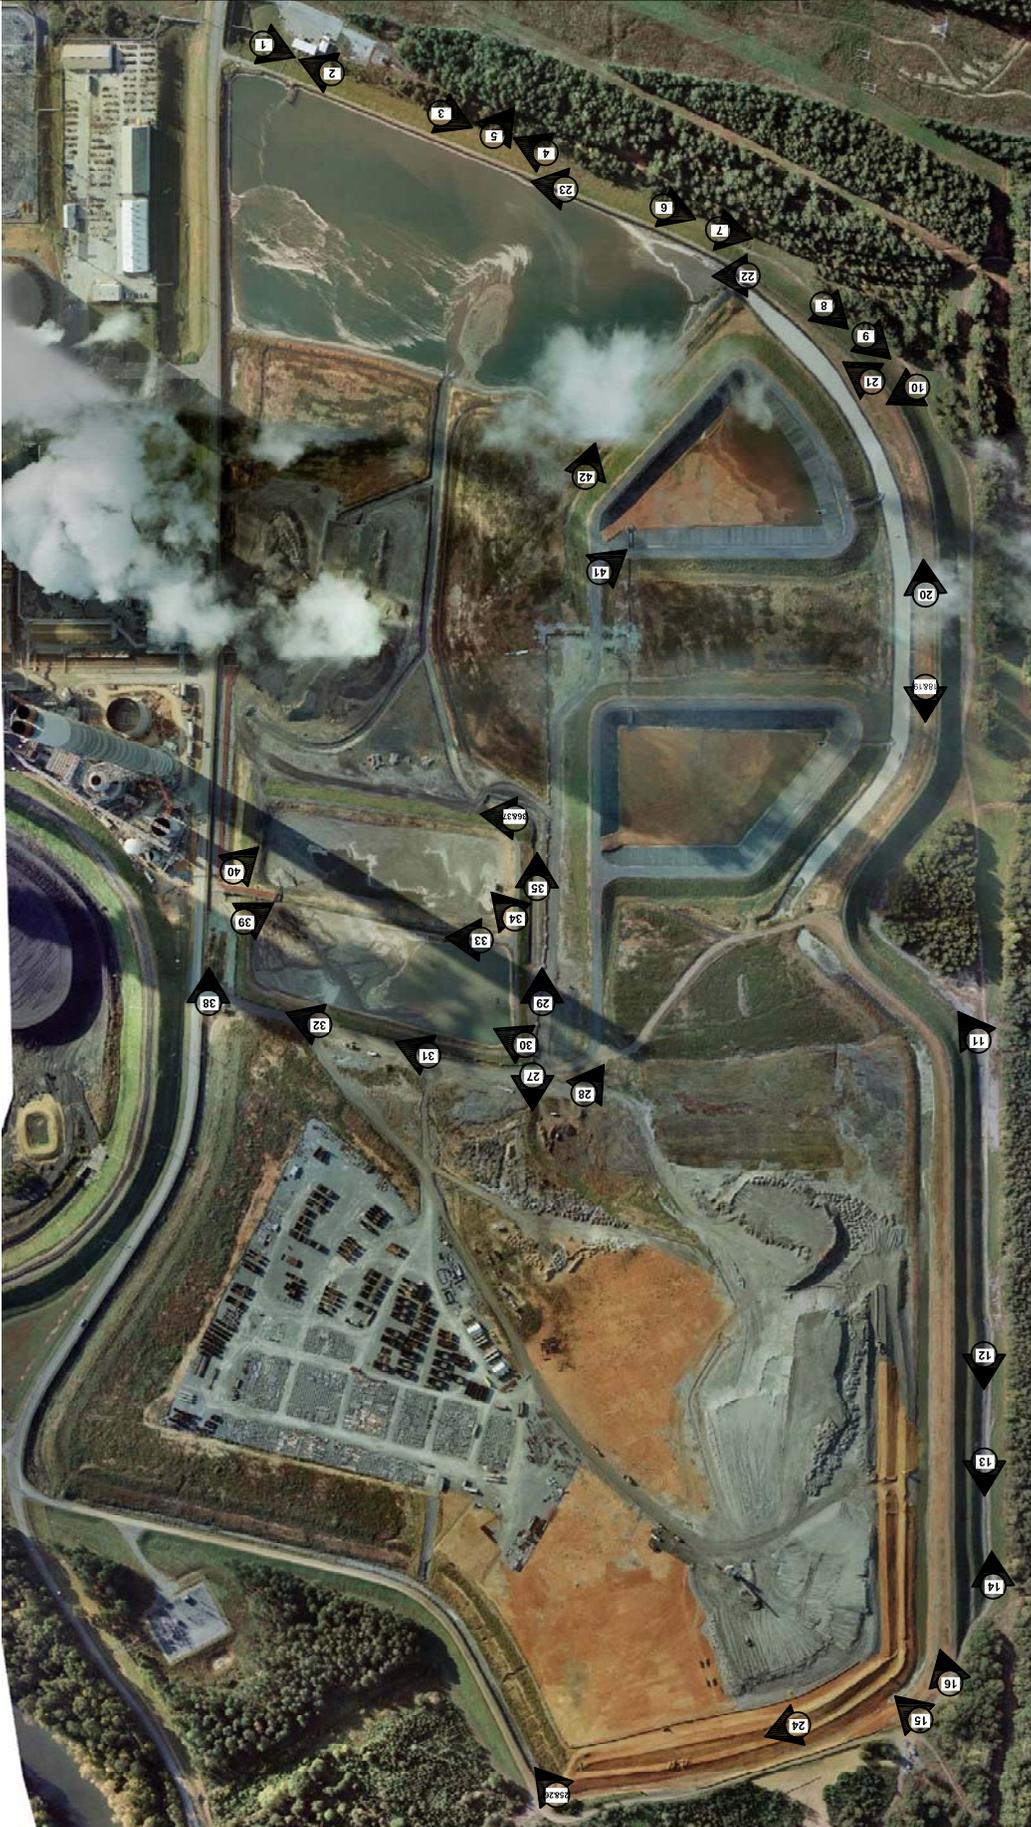
PROJECT NO.  
20085.1000  
DATE: JULY 2009  
FIGURE 9

SITE PHOTO LOCATION MAP  
PLANT BOWEN  
GEORGIA POWER COMPANY  
CARTERSVILLE, GEORGIA

CHA performed visual observations of the main and north dikes following the general procedures and considerations contained in FEMA's Federal Guidelines for Dam Safety (April 2004), and FERC Part 12 Subpart D to make observations concerning settlement, movement, erosion, seepage, leakage, cracking, and deterioration. A Coal Combustion Dam Inspection Checklist Form, prepared by the US Environmental Protection Agency, was completed on-site during the site visit for the ash pond. A copy of the completed form was submitted via email to a Lockheed Martin representative approximately three days following the site visit to Plant Bowen. A copy of this completed form is included at the end of Section 2.5. A photo log of photos taken during the site visit and a Site Photo Location Map, Figure 9, are also located at the end of Section 2.5.
